A SURVEY OF DEFENDED ENCLOSURES IN CEREDIGION, 2006: GAZETTEER OF ORDNANCE SURVEY GRID SQUARE SN44

RHIF YR ADRODDIAD / REPORT NO. 2006/20 RHIF Y PROSIECT / PROJECT RECORD NO. 54269

K Murphy, R Ramsey and M Page

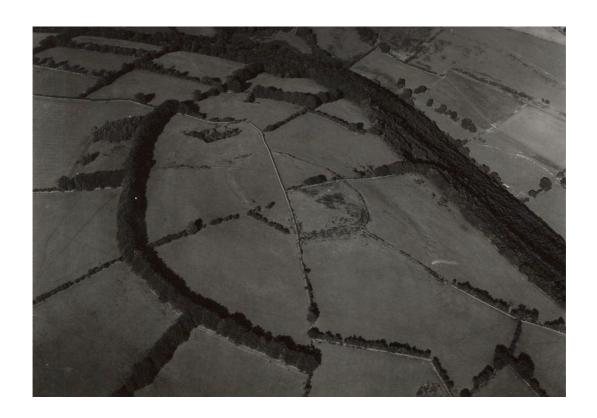
Aerial photograph Cambria Archaeology.

Pencoed y Foel is a univallate defended enclosure lying on the summit of a rounded hill at 250m above sea level. The defensive circuit consisting of a bank, ditch and slight counterscarp bank is 11m wide in total and with an overall height of 2.5m, and encloses a roughly oval area 160m north - south and 125m east - west. The crest of the bank has been robbed. The entrance lay on the north, but here the bank has been destroyed. The interior of the fort is covered with small, shallow stone quarries, mistaken by Evans for huts. A bronze half collar, probably of the 1st century BC was found here in the late 19th century during quarrying. Aerial photographs and maps show field boundaries concentric to the fort's defensive circuit. These may lie on an outer defence, defining a large concentric annexe. These boundaries have not been checked in the field. The interior of the fort and the ramparts are under improved pasture with a little scrub.

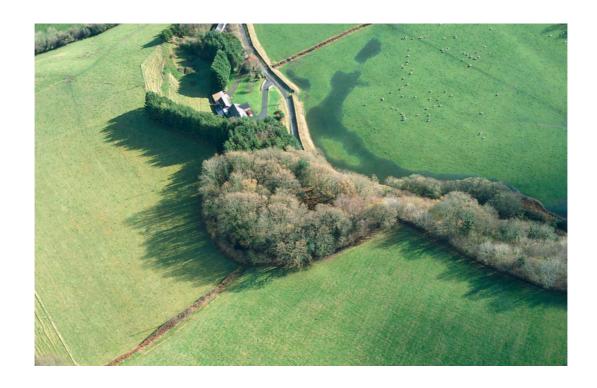
Aerial photograph RCAHMW Crown Copyright © reference 2002-cs-1572.

This defended site lies on the edge of a steep valley side at 90m above sea level, 25m above the floodplain of the Teifi. It is naturally well defended on the south side by the valley side. Here a slight bank supplements the natural defence. On other sides a curving length of bank and ditch encloses a semi-circular area approximately 55m across. The defences are substantial with the bank rising 2m - 3m above the interior and 5m above the bottom of the ditch. A simple gap on the north side forms the entrance. The site is under deciduous woodland.

he date of this site is uncertain. King records a castle in the commote of Gwynionydd in 1216, but it is not firmly identified with this site. Given the size of the defences and the small internal area a medieval date is most likely, but an Iron Age date cannot be ruled out.

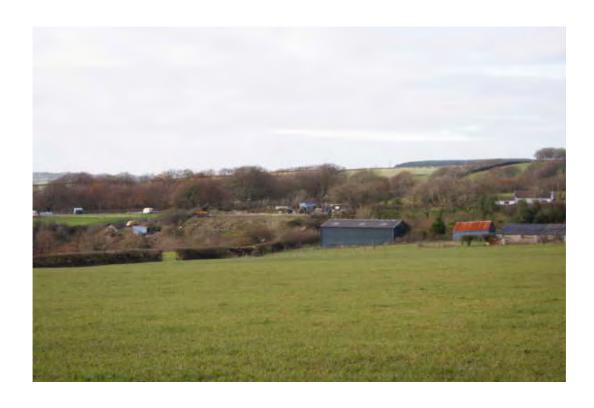
This site is marked on the 1st Edition of the Ordnance Survey one-inch map of 1834. It is an unusual location for a defensive site, lying on a slope towards the head of a small valley. The 1994 County History records nothing here. The site, on the fringe of a hamlet, has been considerably altered in recent years. Several metres of hardcore had been dumped across the location of the site to form a level platform. It must be assumed that the site has been destroyed.

Ground photograph - distant view to location of destroyed site.

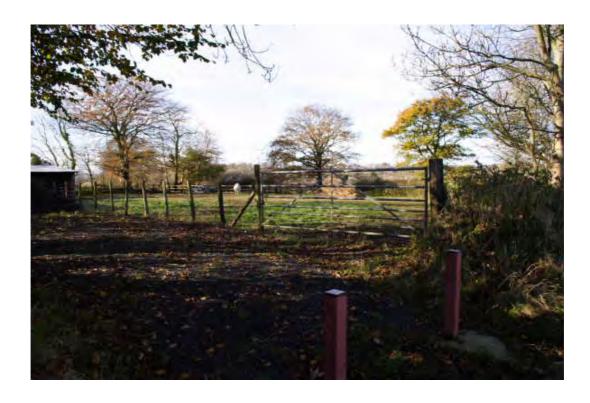
The 1st Edition Ordnance Survey map of 1831 places Castell Gwilym (called Castell Bwillim on the map) immediately to the south of Castell Gwilym cottage in what is now a small field or paddock surrounded by earth and stone hedge-banks. The owners of the cottage and paddock remember removing a curving section of earth bank from this paddock a few years ago. This was presumably the bank mentioned by Hogg in the 1994 Cardiganshire History. There is now no trace of the bank and the paddock is used for pony grazing, with a small area of hard standing. However, a section of curving bank with ditch lies in a pasture field 50m to the west and northwest of the cottage. If this were part of the site, then the defended enclosure would be c. 100m diameter, with the cottage at its centre.

The site is located on level ground, towards the northwest end of a rounded hill, at 175m above sea level. To the northwest and west land falls away into a small valley.

Ground photograph - looking over location of site.

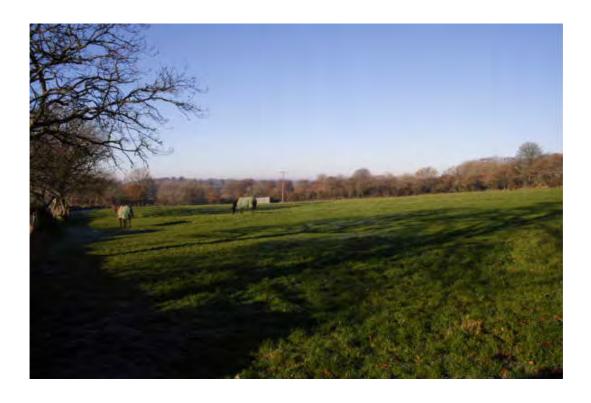
Located on a gentle southwest-facing slope at 215m above sea level, Cae Perth Caerau is a rectangular earthwork enclosure. The enclosure is sharp-cornered and approximates to an 80m square. A bank approximately 10m wide and up to 0.7m high forms three sides of the enclosure - south, east and west. The bank fades to the north, and, indeed, is hardly visible on the northern side. There is no trace of a ditch outside the bank. A lower section of bank to the west end of the south side may mark an entrance, but this is not certain, and it could equally well as lie on the reduced northern side. In 2005, the site was under improved pasture.

Ground photograph showing slight earthworks of site.

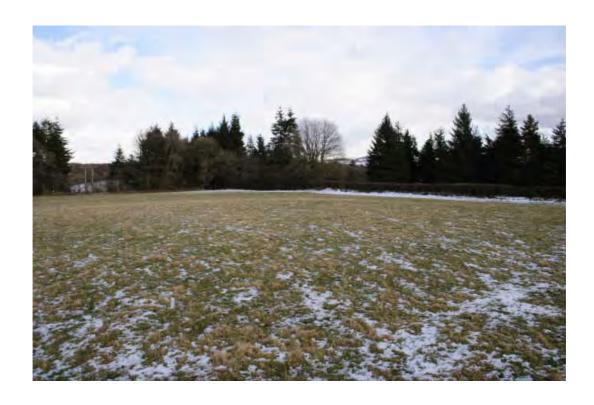
There seems to be some confusion about the exact location of this site. Its proper location seems to be at SN49184309. This is on level ground at 105m above sea level, on an inland promontory formed by steep slopes to the south and east. A quarry has taken away the point of the promontory, and the steep slopes are tree covered. The level area is under improved pasture. There is no trace of earthworks to indicate a defensive site as recorded by earlier authorities.

Ground photograph looking over location of site.

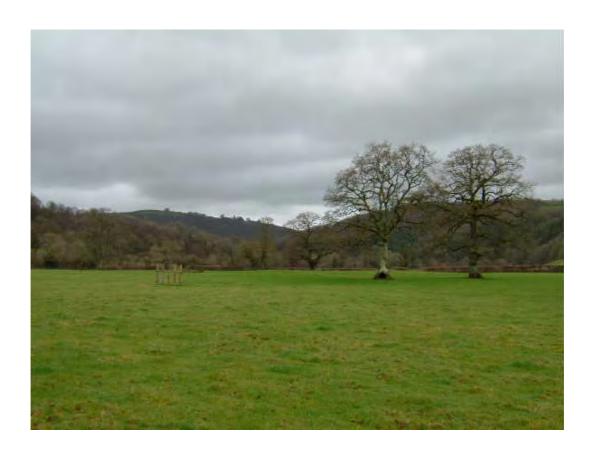
A sub-circular earthwork enclosure lies on a terrace of the River Teifi at 70m above sea level, a few metres above the floodplain. On aerial photographs it shows as a sub-circular enclosure, approximately 60m diameter, defined by a bank and ditch, with a west facing entrance. On the ground it is clear that the enclosure occupies a slightly elevated position above the rest of the terrace. The defensive bank is low, perhaps no more that 0.5m, and seems to incorporate the rising natural ground in its circuit. The ditch is hardly detectable. A slightly higher area within the centre of the otherwise flat interior may indicate the site of a building.

A geophysical survey by Gemma Bezant in 2005 confirmed the nature of the site, although the survey indicated a pear-shaped enclosure, rather than a subcircular one. The survey also indicated the presence of a rectangular building in the centre of the enclosure. Excavation followed on from the survey - the results are awaited, but initial results suggest that this was a medieval/post medieval site. In 2005, the site was under improved pasture.

Ground photograph looking over earthworks.

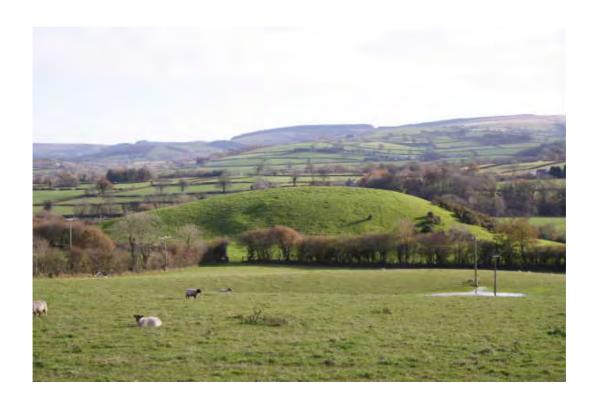
Myrick mentions a site of uncertain form in 1810. The exact location is uncertain, but an elongated conical hill, a distinctive landscape feature, called Crug-y-Chwil is the most likely position. Crug-y-Chwil rises 20m from surrounding farmland to the north, west and south and 30m from the Teifi floodplain to the east. The summit is oval in shape, 60m by 30m, and round-topped. Apart from a slight stepped break of slope along the eastern side of the summit, which may be the remains of a bank, there is nothing to indicate any constructed elements to the hill. Staff and students from Lampeter University excavated a trench on the west site of the summit a few years ago - the results are not currently known. The hill is under improved pasture with a little gorse scrub on the eastern slopes.

Ground photograph - distant view of site.
