A SURVEY OF DEFENDED ENCLOSURES IN CEREDIGION, 2006: GAZETTEER OF ORDNANCE SURVEY GRID SQUARE SN67

RHIF YR ADRODDIAD / REPORT NO. 2006/20 RHIF Y PROSIECT / PROJECT RECORD NO. 54269

SITE GAZETTEER OF 10KM GRID SQUARE SN67

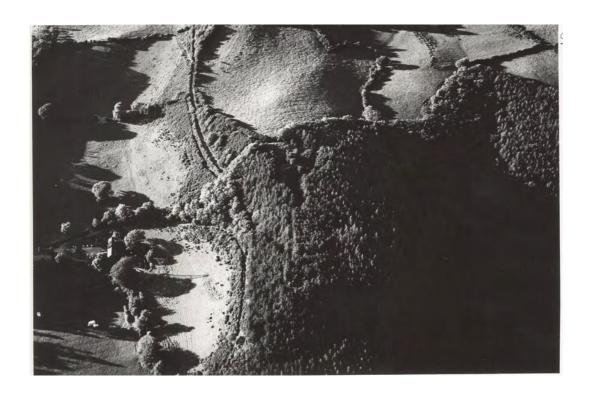
Castell Pant-mawr is located on a naturally well-defended inland promontory at 100m above sea level on the edge of the Ystwyth valley. Steep valley sides provide a natural defence to the west, south and east. The north, easily approachable side is provided with built defences.

This is a difficult site to interpret on account of its massive and complex nature and because it is overgrown. The Ordnance Survey and Cadw describe it as a two-phase Iron Age promontory fort. Toby Driver considers it more likely to be a medieval castle. Cadw and the OS describe it as a massive bank and ditch up to 35m wide and rising 7m - 8m above the natural ground surface defending an area about 75m by 25m, with a second slight bank up to 1m high to the north. These remains are interpreted as a first, slight phase of defence later trengthened by a massive bank. T Driver cannot reconcile the remains with an Iron Age fort. He considers the that the remains are of a low motte or ringwork on the upslope side, separated by a rock-cut ditch to the south and with a defensive bank or modified outcrop beyond. The site is overgrown in deciduous woodland with bracken on the earthworks.

Aerial photograph Cambria Archaeology.

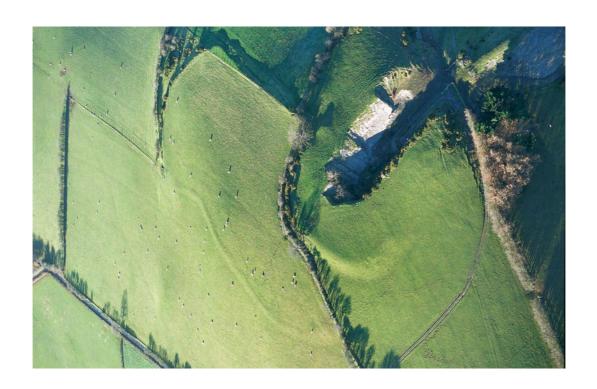
Newcross is a defended enclosure lying at 190m above sea level on the crest of a local summit/ridge. It is naturally well-defended by steep slopes to the north and northeast. Elsewhere the slopes are more gentle. It consists of a near circular enclosure with an annexe or outer enclosure attached to its west and south sides at a slightly lower level. A small, deep quarry (shown of the 1888 Ordnance Survey 1:2500 map) has removed about 50% of the internal enclosure. Possibly of two phases.

The internal enclosure is approximately 65m diameter internally, surrounded by a bank up to 1m high with traces of a ditch. As noted above approximately 50% of the interior has been quarried away along with a c. 40m length of bank on the north side. However, on aerial photographs the bank seems to

terminate short of the steep slope on the north side and therefore no bank may have been present here prior to quarrying. The surviving interior and defence is under improved pasture and in good condition. The location of the entrance is unclear. An irregular-shaped annexe is attached to the west and south side of the inner enclosure. This measures 175m east -west and 84m north - south. It is defended by a slight bank to south, east and west - this is very faint on the east side - and by the artificially scarped steep slope to the north. It is under improved pasture with scrub on the steep slopes. There is machine and animal erosion of the southeast corner of the annexe.

Aerial photograph RCAHMW Crown Copyright $\ @$ reference 2001-cs-1848.

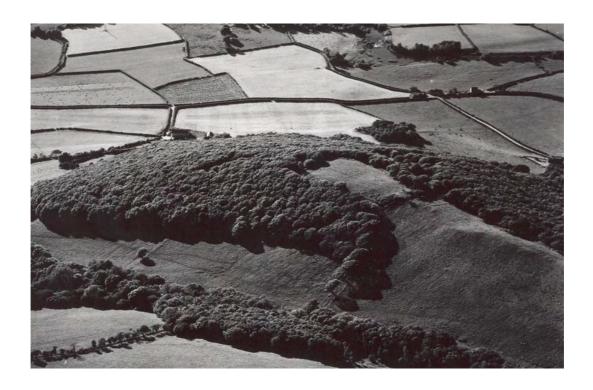
This is an Iron Age fort located on an inland promontory above the Rheidol valley at 190m above sea level. It is naturally well defended on the west, northwest and southwest sides by the steep valley sides. On the east side a bank 2.4m high with a ditch 0.7m deep cut across the narrowest point of the promontory and continues about halfway along the south and north sides. There are traces of a quarry ditch inside the bank on the north side. The internal area is roughly rectangular, 90m east - west and 34m north - south. An original simple entrance lies midway along the northern side. Traces of an 8m square building were noted by the Ordnance Survey outside this entrance in 1974. A modern gap has been pushed through the eastern rampart - this could easily be mistaken for an original entrance. A possible house platform lies in the uneven centre of the fort. The site is under bracken/rough grazing and is surrounded by woodland.

Aerial photograph Cambria Archaeology.

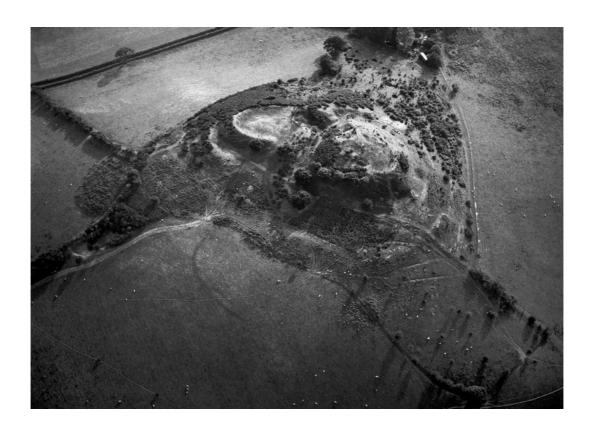
Pen-y-castell lies on the summit of a rocky hill at 120mabove sea level. A quarry excavated across the centre of the hill sometime prior to the Ordnance Survey 1888 1:2500 map has partially destroyed the site and rendered its interpretation problematical. King identifies the site as a motte and bailey - possibly Garth Crugyn built by Maelgwn Fechan in 1242. Hogg rejects this and considers it a small Iron Age fort mutilated by quarrying.

Essentially the site is a pear-shaped enclosure 100m north - south by 40m east - west protected by a substantial bank, and cut across in the middle by a substantial disused quarry. Because there is a change in height either side of the quarry it has been argued that this is a motte and bailey, with the quarry masking an original ditch division. The site is under improved pasture with a little bracken and gorse on the banks and steep slopes.

Aerial photograph RCAHMW Crown Copyright © reference 905058-11.

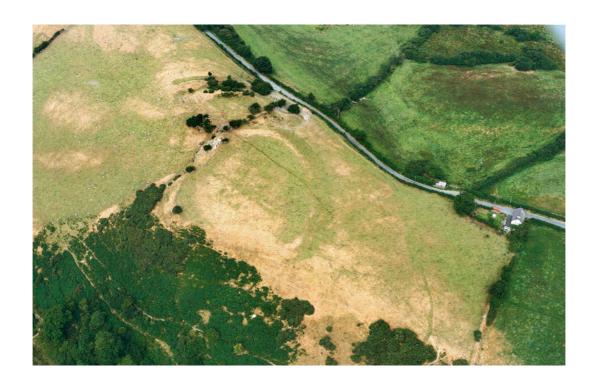
Lying on the summit of a rounded ridge at approximately 170m above sea level, Caer Argoed is a small hillfort. On the south side the land falls away steeply to the Afon Wyre 50m below, on other sides the slopes are gentler. The internal area of 0.43ha is irregularly shaped, approximating to a triangle and reflects the shape of the hill. It is defended by a univallate rampart standing up to 2m high and over 15m wide. The location of the entrance is unclear. A small rectangular annexe appended to the northwest side is defended by a single rampart except on the northwest side where it becomes bivallate. Aerial photographs show a cropmark ditch running roughly concentric and 50m from to the main enclosure on the northeast side. This may be an outer line of defence, or another annexe. The site is under improved pasture, with a little gorse scrub on the annexe banks.

Aerial photograph RCAHMW Crown Copyright © reference 99-cs-1937.

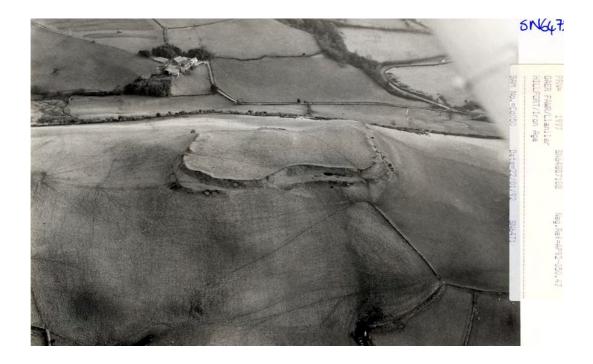
Aerial photograph Cambria Archaeology.

Gaer Fawr is a bivallate fort, situated on the summit of a rounded hill at 280m above sea level. The land falls away steeply on all side, but particularly so to the south, down to the floor of a minor valley 190m below. The fort is roughly rectangular in shape, 180m by 100m internally, following the course of the contours around the hilltop. Two ramparts on the north side defend the site. These curve round to the east and west where the outer bank fades and the defence becomes univallate. On the south side where the steep slope provides the defence the rampart is at its slightest. There is an inturned entrance through the ramparts on the east side. Because of the incomplete circuit of the outer rampart, Hogg suggests it is unfinished. The site is under improved pasture.

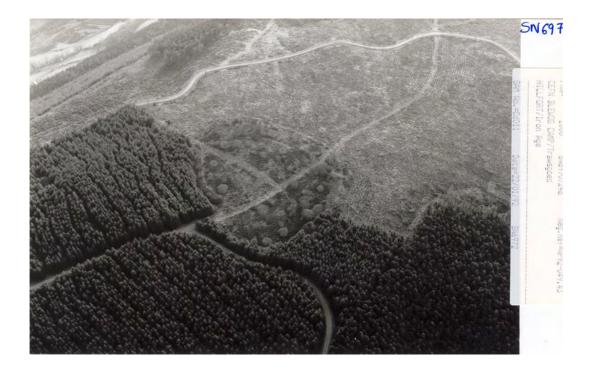
Aerial photograph Cambria Archaeology.

Cefn Blewog is a small fort located at the western end of a rounded ridge at 310m above sea level. Land falls away steeply on all sides except the east where it rises to the ridge summit. The sub-circular internal area measures c. 120m by 80m. It is defended on the west side by widely spaced bivallate ramparts and on the east by a single rampart. Both of these fade to the north and south, giving an unfinished appearance to the fort. The banks of the ramparts stand on average up to 1m high. A hollow to just within the west-facing entrance may be a guard chamber. The site is under rough grass with occasional trees and is surrounded by a coniferous forestry plantation.

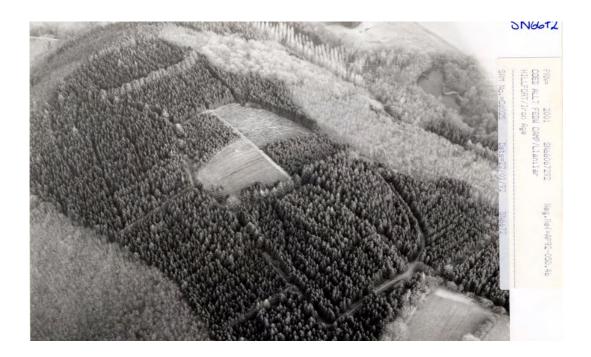
Aerial photograph Cambria Archaeology.

This is a defended enclosure lying on a knoll towards the east end of a rounded ridge at 180m above sea level. Land falls away steeply from the site to the north, east and south. To the west land is fairly level. It consists of a curving length of bank, 6m wide and 2-3m high defining the northern side of the site. There is no obvious defence on the southern side. However, the whole site has been ploughed and planted with coniferous trees - these obscure detail. The enclosure would have been approximately sub-circular, 70m across internally. 150m to the east and at a lower level a 140m length of bank and ditch cut across the ridge (PRN 2002). As Hogg states, it is difficult to see how this related the enclosure.

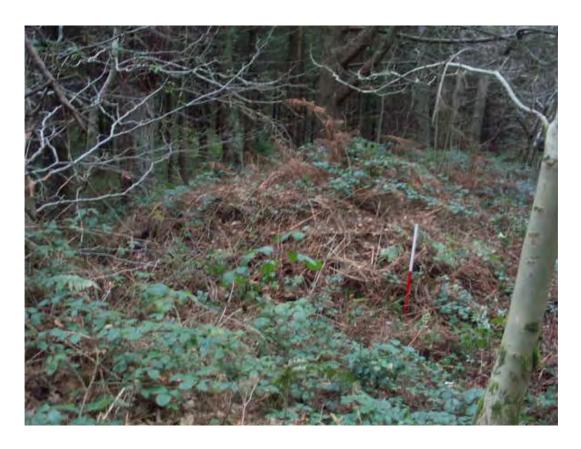
This possible promontory fort lies at the eastern end of a ridge at 170m above sea level, approximately 190m east of Coed Allt Fedw Camp (PRN 2001). Land falls away from the site to the north, east and west, but rises to the east. Essentially the site consists of a curving length of bank with a ditch on the west side cutting off the end of the ridge, giving a roughly rectangular internal area of 100 by 60m. The bank is about 130m long, 8m wide and up to 2.5m high. There are several modern breaks in the bank; there is no obvious original entrance. The site is under a coniferous forestry plantation. Planting has damaged the bank, and there is also damage from badgers.

Ground photograph looking along earthwork bank.

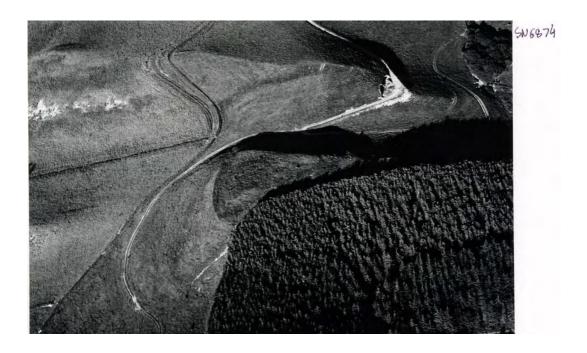
Aerial photograph Cambria Archaeology.

Cwnc y Bugail is a small but complex fort situated on a roughly triangular, modified knoll. To the north and west of the fort the slopes are precipitous, and very steep to the south. The ramparts on these sides are simple affairs, consisting of scarping and a low stony bank. On the eastern side the rampart curves around at its southern point and back north for a short distance, forming a 'command post' on a minor summit dominating the southeasterly approaches. The entrance lies on the west side. Quartz boulders line what seems to be an entrance 'passage'. 40m outside the gate a U-shaped mound forms a bastion, or small annexe. The interior measures c. 70m by 50m and contains a possible small house platform. Aerial photographs indicate possible further house site. The site is now under improved pasture.

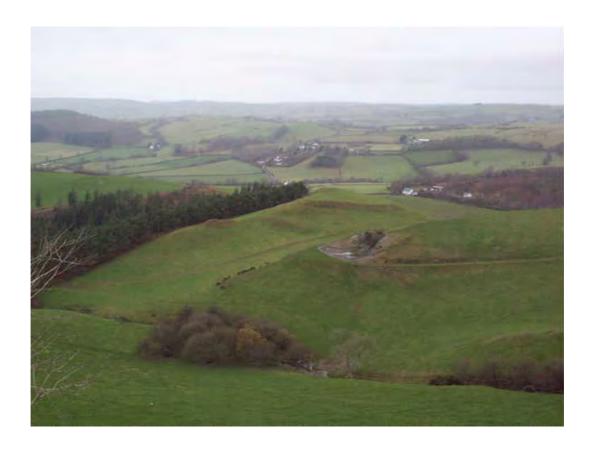
Ground photograph distant view of site.

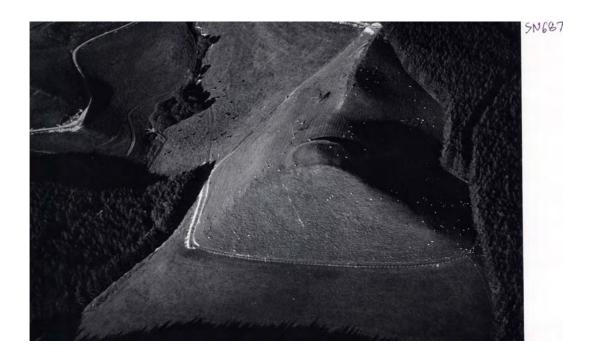
Aerial photograph Cambria Archaeology.

Castell Disgwlfa is a small scarp-edge fort lying at the western end of a ridge at 210m above sea level. The ridge terminates abruptly at the western end resulting in a steep slope that falls away very steeply to a stream over 100m below. The north and south flanks of the ridge are steep-sided. The steep scarp edge forms one side of a defensive circuit from which runs a horseshoe-shaped bank up to 2m high and 6m wide. There is no ditch. The internal area enclosed by the bank measures c. 40m by 30m. A possible entrance lies on the north side. The site is now under improved pasture.

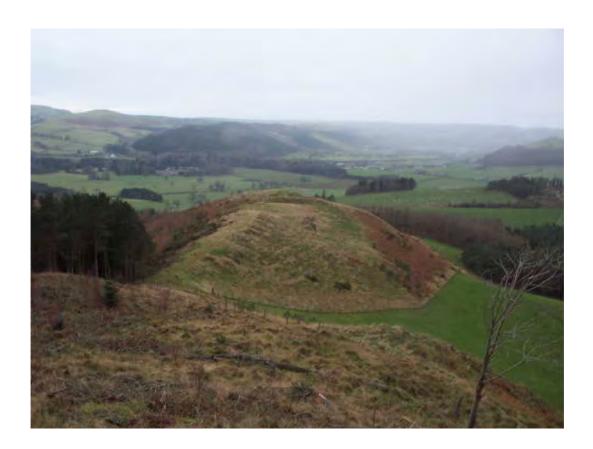
Ground photograph distant view of site.

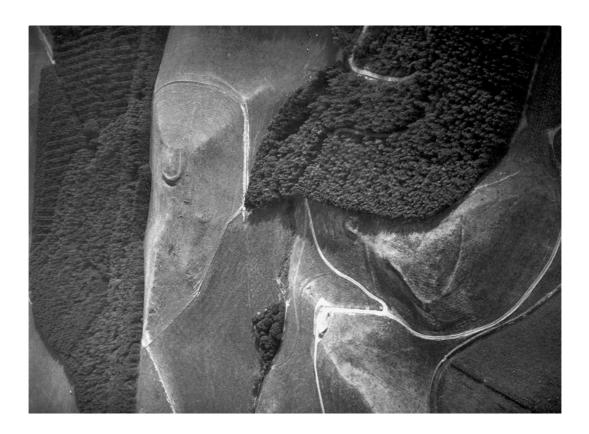
Aerial photograph RCAHMW Crown Copyright © reference 905059-5.

This site is marked on the 1835 OS map. It lies on a local summit or spur at 220m above sea level. To the west, north and south the land falls away steeply from the site, but to the east it falls into a saddle and then rises steadily. A bank c. 20m long, 5m wide and up to 1m high cuts off the spur on the east/northeast side, defending the summit area of c. 60m by 40m. The other sides of the spur may have been scarped. The site is under improved pasture.

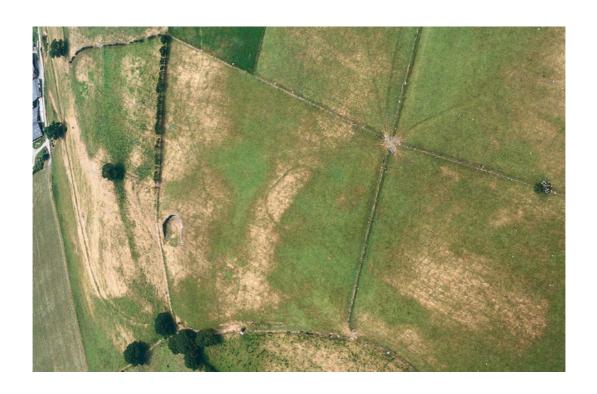
Aerial photograph RCAHMW Crown Copyright © reference 99-cs-1949.

Evidence, situated on level ground at 140m above sea level just off the highest point of a rounded hilltop. The enclosure is polygonal in shape, approximately 40m across, and defined by a cropmark ditch with slight parch-marks indicating the remains of a inner bank on the south side. There is no obvious entrance. In 2005, the site was under improved pasture.

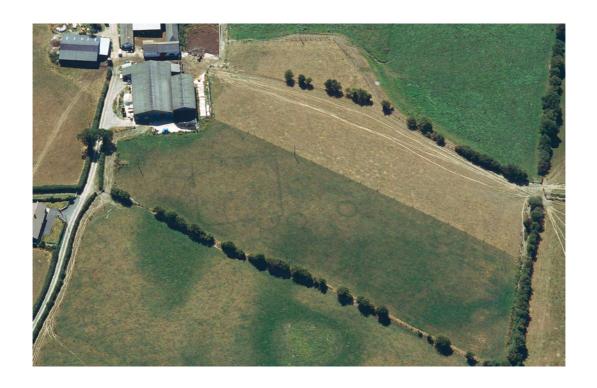
Aerial photograph RCAHMW Crown Copyright © reference 95-cs-23400.

Pyllau Isaf is a crop-mark enclosure, with no earthwork or other surface evidence, lying just above the floodplain of the Afon Ystwyth at c. 35m above sea level. It is a square crop-mark ditched enclosure, approximately 38m across with a possible entrance midway along the east side. There are four circular crop-mark ditches, each c. 9m diameter, immediately to the northwest corner of the enclosure - one of these overlaps with the corner of the enclosure. These are possibly Bronze Age ring ditches. The enclosure is not a typical late prehistoric defended enclosure in form or location. In 2005, the site was under improved pasture.

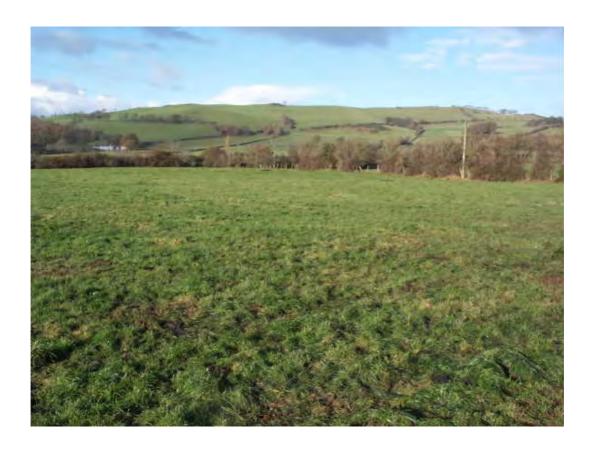
Ground photograph looking over site of cropmark enclosure.

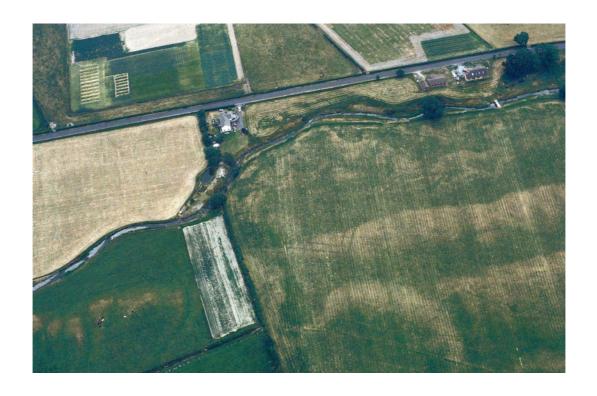
Aerial photograph RCAHMW Crown Copyright © reference 95-cs-1512.

Aerial photographs show part of what seems to be a rectangular crop-mark enclosure lying on a gentle south-facing slope close to the valley bottom of the Afon Magwr at 65m above sea level. It is a crop-mark only with no obvious earthworks or other surface evidence. However, the slope levels out slightly at the location of the crop-mark, and poorly defined very low earthworks may represent some remains of the enclosure. Aerial photographs show a bivallate ditched enclosure c. 80m east -west, with an unknown dimension north - south. The corners of the enclosure are sharp. In 2005, the site was under improved pasture.

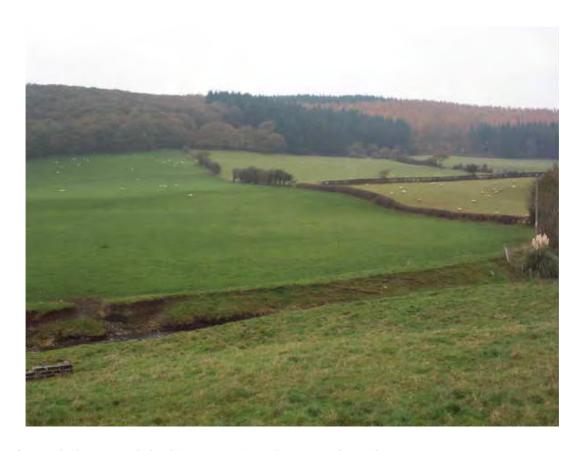
Ground photograph looking over site of cropmark enclosure.

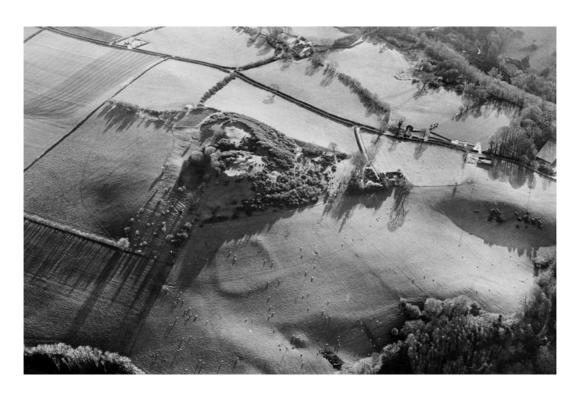
Aerial photograph RCAHMW Crown Copyright © reference 2001-3523-8.

This is a roughly rectangular earthwork enclosure lying on a north-facing slope at 100m above sea level, below Pen-y-Castell hillfort. The enclosure measures approximately 48m north - south and 45m east - west internally. The bank is spread and is c. 4m wide and up to 0.2m high. A gap in the northwest corner marks the entrance. There is no trace of a ditch. In 2005, the site was under improved pasture.

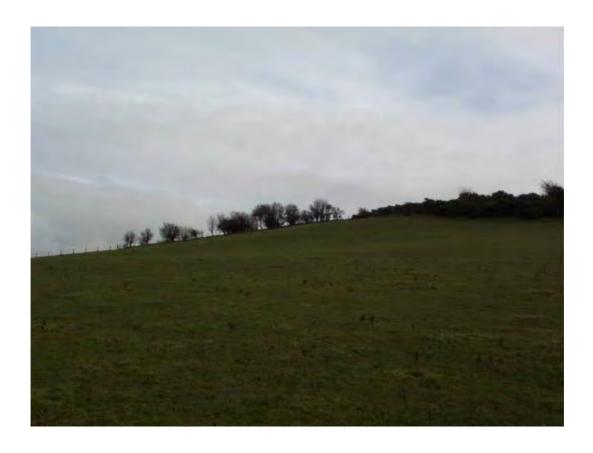
Ground photograph looking over site of earthwork enclosure.

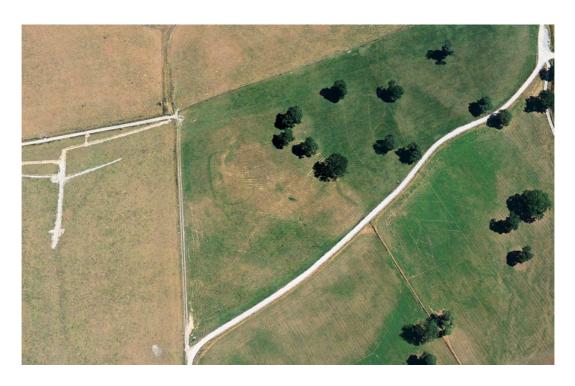
Aerial photograph RCAHMW Crown Copyright © reference 95-cs-2315.

This enclosure lies on a weak spur on a west-facing slope 100m above sea level. Discovered from the air as a parch-mark. However, this site survives as an earthwork. An oval-shaped enclosure approximately 56m east - west and 42m north - south is surrounded by a bank up to 1m high, with a possible entrance on the west side. Aerial photographs show possible disturbance on the south side, but this was not evident on the ground. In 2005, the site was under improved pasture.

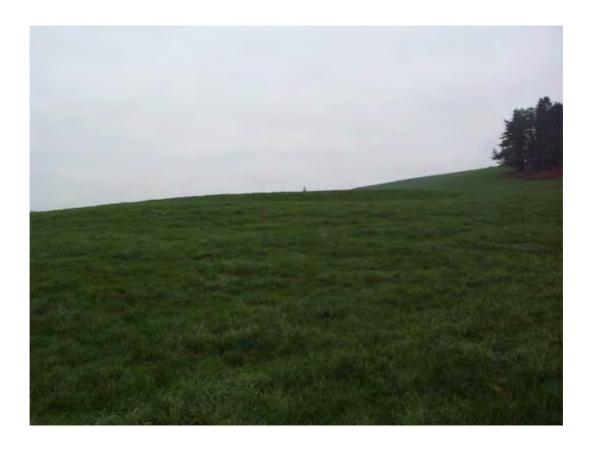
Ground photograph looking over site of enclosure.

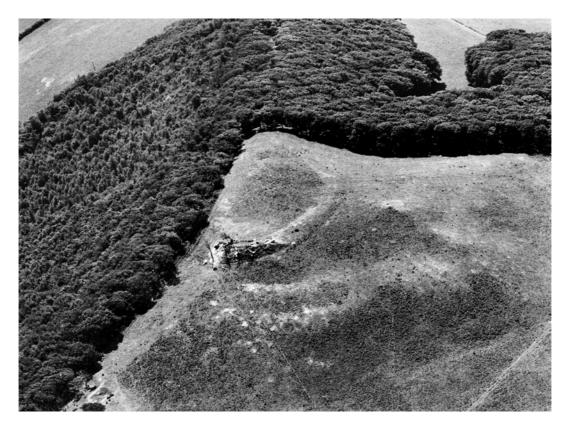
Aerial photograph RCAHMW Crown Copyright © reference 2003-5107-47.

This is an inland promontory fort occupying a naturally well-defended site above the Rheidol valley at 150m above sea level. To the west, south and east the valley side falls steeply away to the valley floor 120m below. Ramparts defend the easily approachable north side. An inner enclosure measuring 45m north - south and 35m east - west internally is defended by a bank and ditch. On the photographs these are clearly upstanding earthworks, perhaps 1m high or greater. Interestingly the bank seems to curve around the south and east sides of the enclosure where the site seems to have adequate natural defences. The northeast facing entrance has overlapping and in-turned terminals. A bivallate outer defence or annexe lies some 25m to north of the inner defence. It shows as two c. 55m long parch lines representing spread banks. From the photographs it is unclear whether these outworks are part of an annexe to the main enclosure, two phases of enclosure construction, or a multivallate single-phase site with widely spaced ramparts. The site is under improved pasture.

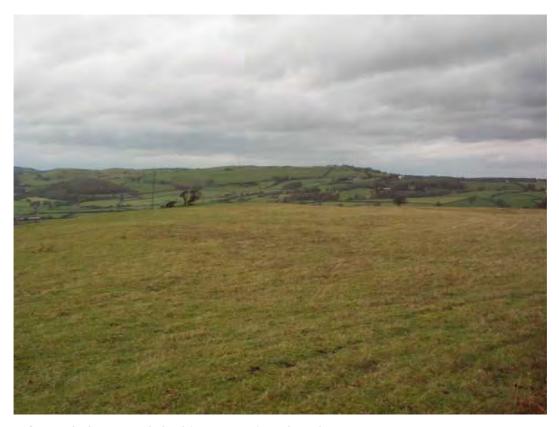
Penlan-isaf defended enclosure lies on the edge of a weak southwest-facing inland promontory at 150m above sea level. To the east the land rises from the site onto a rounded summit; the site is overlooked from this side. It is an oval, univallate enclosure, with traces of outworks on the southwest side. It measures 110m northwest - southeast by 60m southwest - northeast. The surrounding bank is reduced and spread, generally only 0.4m high and up to 7m wide, but slightly better preserved on the southwest side. On the south side the earthworks have been ploughed out. The southwest entrance is marked by a slight in-turn of the rampart. Slight outworks show on aerial photographs on the south side as parch-marks, and are marked on the ground as very indistinct, low earthworks. The site is under improved pasture, but is somewhat boggy. There is some vehicle erosion through the entrance, and sections of the rampart are suffering slight erosion.

Ground photograph looking over site of enclosure.

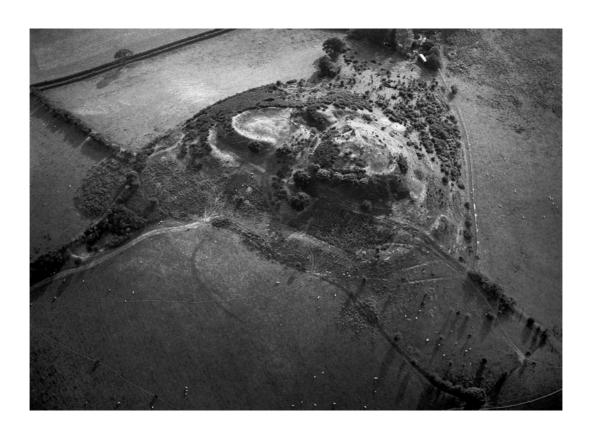
Aerial photograph RCAHMW Crown Copyright © reference 905058-11.

A partial cropmark probably of a defended enclosure lies on north-facing slopes at 120m above sea level below Pen-y-Castell hillfort. An 80m section of curving crop-mark ditch is visible on aerial photographs, possible with an entrance. The site is under improved pasture.

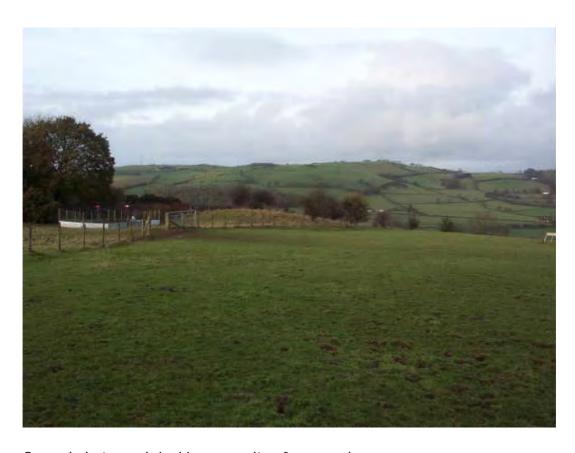
Ground photograph looking over site of cropmark.

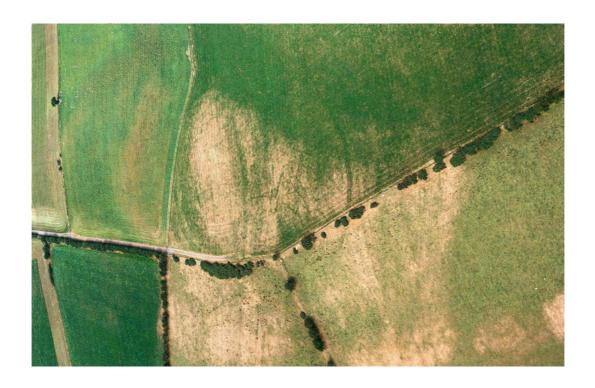
Aerial photograph RCAHMW Crown Copyright $\ \ \, \mathbb{C}$ reference 99-cs-1936.

Brynchwyth is a concentric defended enclosure lying on a rounded local summit at 190m above sea level. To the northeast the land continues to rise by 10m from the site onto a high point some 150m distant. Aerial photographs show an incomplete oval inner enclosure c.95m north - south and 55m east - west surrounded by a crop-mark ditch, with a 95m length of concentric ditch, presumably of an annexe, some 60m to the east. A further ditch may lie outside this annexe ditch. The position of an entrance is unclear. On the ground the inner enclosure shows as barely perceptible earthworks. In 2005, the site was under improved pasture.

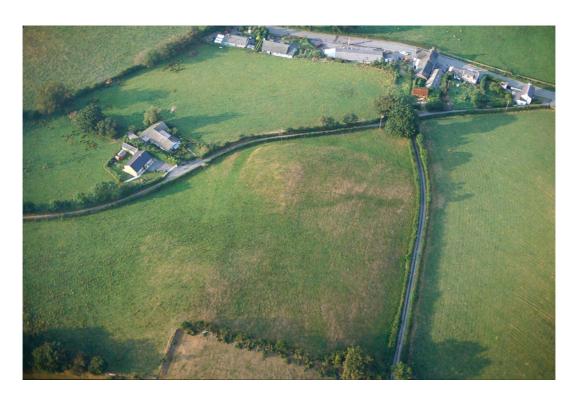
Aerial photograph RCAHMW Crown Copyright $\ensuremath{@}$ reference 90-cs-720.

This is an oval crop-mark enclosure with no surviving earthworks or other surface evidence. Aerial photographs show a ditch enclosing a roughly oval area pproximately 75m east - west and 40m north - south, internally. The site is situated on an east-facing slope at 160m above sea level. The site itself, owever, consists of a low natural mound or hillock, around the base of which runs the crop-mark enclosing ditch. There is no obvious entrance. In 2005, the site was under improved pasture.

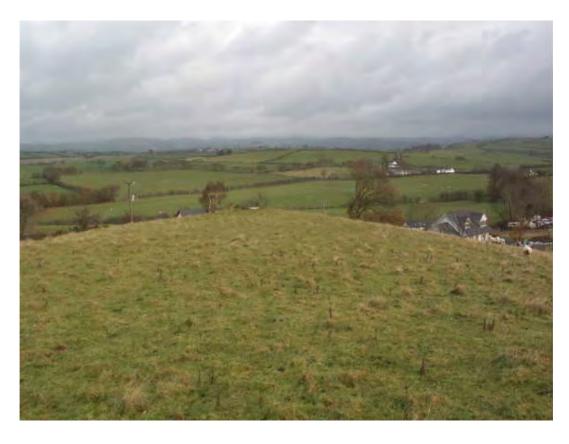
Ground photograph looking over site of enclosure.

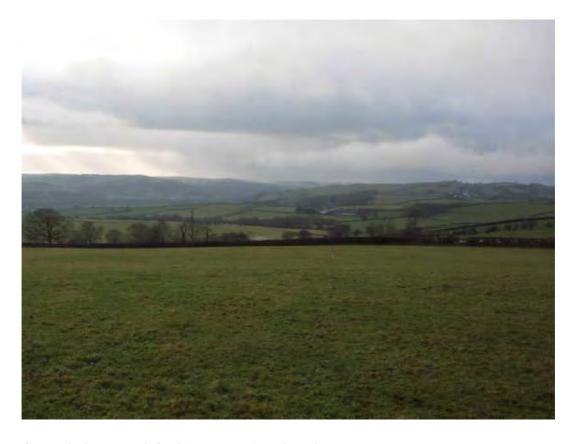
Penuwch-fawr is an univallate defended enclosure situated on a gentle southwest-facing slope at 180m above sea level. The site itself lies on a slight terrace in the slope, which is probably natural, but may have been emphasised by the enclosure builders. Aerial photographs show a roughly oval enclosure, 75m southwest - northeast and 44m northwest - southeast, surrounded by the incomplete circuit of a crop-mark ditch. On the ground a slight earthwork bank up to 0.2m high on its best-preserved eastern side marks the line of the defensive circuit. A possible gap in the bank on the south side may mark the site of the entrance. In 2005, the site was under improved pasture.

Ground photograph looking over site of enclosure.

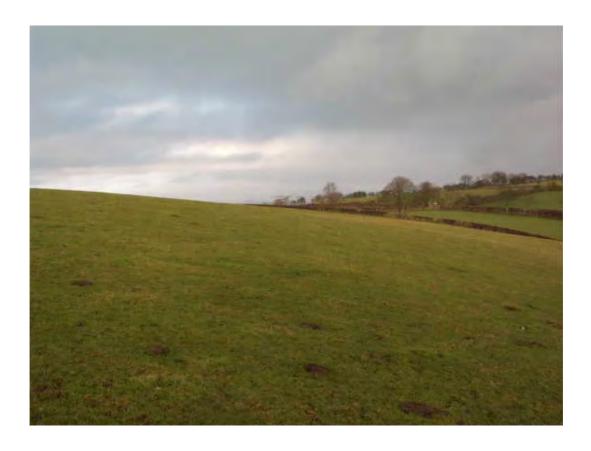
Sarnau Fawr defended enclosure is located on a gentle southeast-facing slope at 185m above sea level. To the southeast of the site the ground falls away more steeply into a minor valley. The enclosure is a crop-mark site only; there are no earthworks or other surface indications of the site. On aerial photographs the site shows as an oval enclosure defined by a crop-mark ditch, approximately 40m north - south and 30m east - west, with a northeast-facing entrance. In 2005, the site was under improved pasture.

Ground photograph looking over site of enclosure.

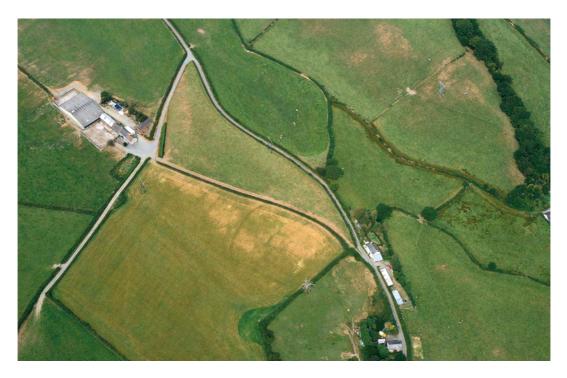
Aerial photograph RCAHMW Crown Copyright © reference 99-cs-1947.

Cynon-fawr defended enclosure lies on a slightly raised area on a broad gentle north-facing slope at 115m above sea level. To the north the land falls more steeply away. The site is overlooked from the southeast. It is a crop-mark site, with just very slight surface irregularities possibly marking the position of the defensive circuit. Aerial photographs show two sides (south and west) of an almost square enclosure defined by a crop-mark ditch, approximately 60m across internally. A square ditched enclosure, c. 16m across, lies in the centre of the main enclosure. In 2005, the site was under improved pasture.

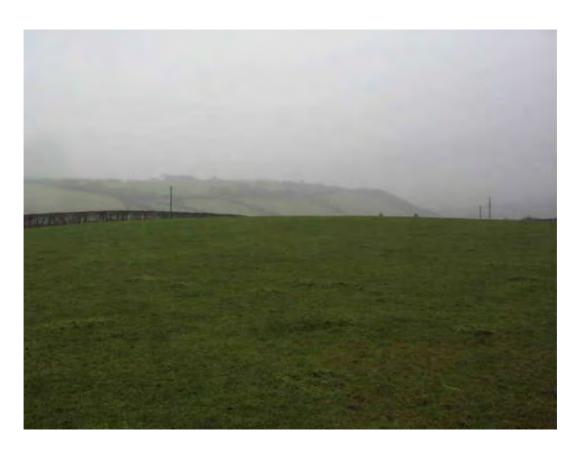
Ground photograph looking over site of enclosure.

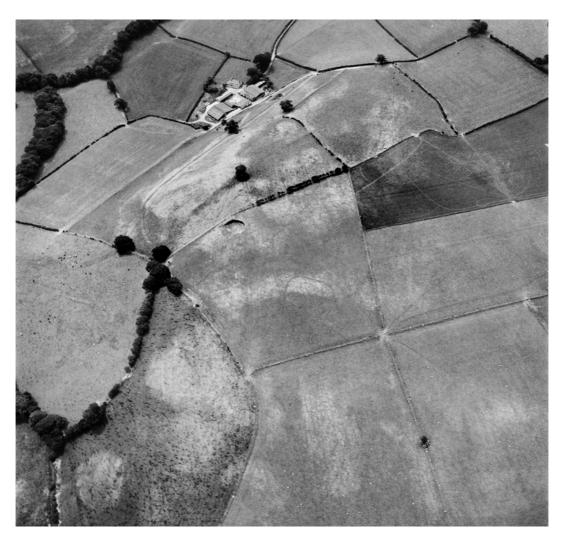
Aerial photograph RCAHMW Crown Copyright © reference 995091-49.

Banc y Mor is a crop-mark defended enclosure lying on a north-facing slope at 165m above sea level. To the north of the site the land falls sharply away. Aerial photographs show a partial oval enclosure defined by a crop-mark ditch, approximately 90m east - west and 50m? north - south. There position of the entrance is unknown. On the ground a slight hollow marks the location of the site, and barely perceptible earthworks may mark the line of the defensive bank - but this is doubtful. In 2005, the site was under improved pasture.

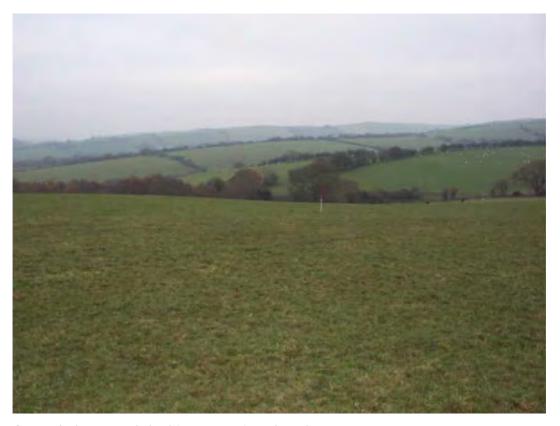
Ground photograph looking over site of enclosure.

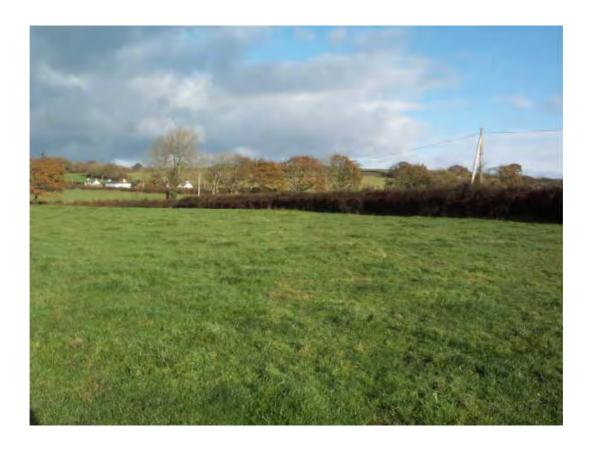
This univallate circular crop-mark defended enclosure lies on a river terrace of the Afon Ystwyth/Afon Llanfihangel at 40m above sea level. It is a crop-mark site only, with no earthwork or other surface evidence. Aerial photographs show a partial near circular enclosure, divided by a farm lane, approximately 45m in diameter internally, and defined by a crop-mark ditch. There is a simple entrance on the WNW side. In 2005, the site was under improved pasture.

Ground photograph looking over site of cropmark enclosure.

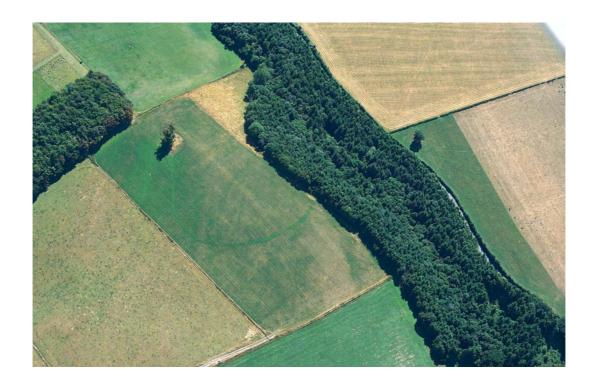
Aerial photograph RCAHMW Crown Copyright © reference 95-cs-2311.

Cwm Rhydyfelin is a univallate defended enclosure lying on a rounded, low, sloping spur at 100m above sea level. To the south land falls away into Cwm Rhydfelin, providing a natural defence on this side, while to the west and north land falls more gently away. To the east land rises a few metres up the spur, before climbing steeply up a valley side some 400m distant from the site. Aerial photographs show a crop-mark ditch enclosing a roughly oval area 130m east - west and 110m north south. There is a simple entrance midway along the west side, and there maybe possible internal divisions of the enclosure. On the ground the southwest, west and northwest side of the defensive circuit are marked by a spread, low curving bank up to 0.4m high. Nothing is visible elsewhere. In 2005, the site was under improved pasture.

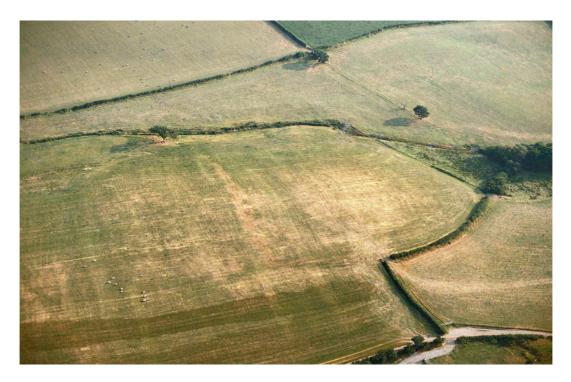
Aerial photographs show a thin, broken and somewhat disjointed crop-mark ditch defining an irregular area approximately 100m southwest - northeast and 70m northwest to south east. The site lies on a spur of land at 160m above sea level, overlooking a valley to the south, with land sloping down from the site to the west and northwest. On the ground the line of the crop-mark ditch is manifest as a very low, intermittent earthwork bank. This is an unusual site. The thin ditch and irregular enclosure are not typical of Iron Age enclosures of Ceredigion - possibly of earlier prehistoric date? In 2005, the site was under improved pasture.

Aerial photograph RCAHMW Crown Copyright © reference 95-cs-725.

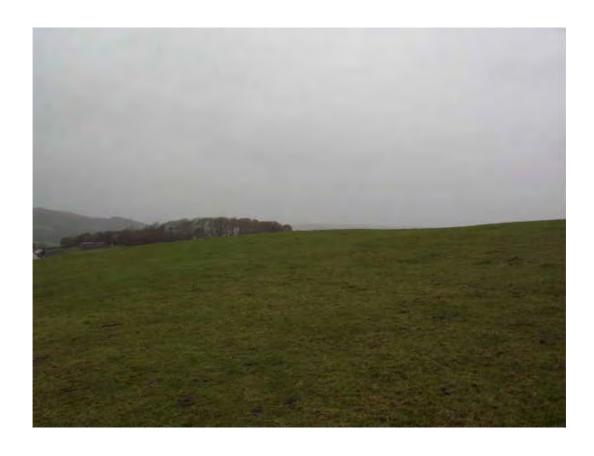
Ground photograph looking over site of enclosure.

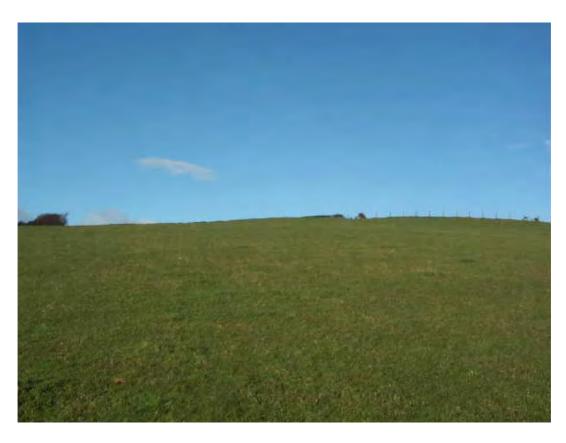
Aerial photographs show a 50m curving section of crop-mark ditch - possible a fragment of a defended enclosure. The site lies on a north-facing slope at 145m above sea level. There are no earthwork or other surface evidence of this site. In 2005, the site was under improved pasture.

Ground photograph looking over site of enclosure.

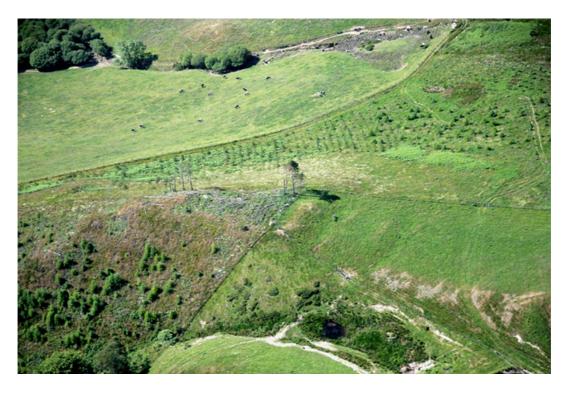
Aerial photograph RCAHMW Crown Copyright © reference 2005-cs-1109.

This is an inland promontory fort located at 250m above sea level. To the north, west and south land falls away from the site, but to the east the land falls slightly in a saddle before rising to 290m; the site is overlooked from this side. A bivallate defence, of widely spaced ramparts, cuts off the promontory on the easily approachable east side. The inner rampart consists of a bank up to 1.7m high and 19m long with a ditch on its east (external) side. The outer rampart lies c. 18m from the inner and is 0.9m high with external ditch. The location of the entrance is unclear. The triangular interior measures 62m by 40m. The ramparts are under improved pasture, but the interior has recently been cleared of its coniferous plantation and at the time of the site visit was under a deep matting of brash.

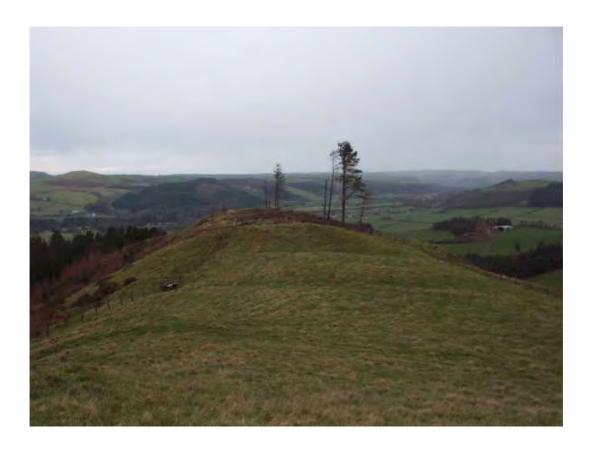
Ground photograph looking towards enclosure.
