TIR GOFAL MANAGEMENT PLAN: HERITAGE MANAGEMENT INFORMATION (HE2)

**Prepared for:
Hafod Fawr**

**Tir Gofal Reference No. W/12/5343
ACA Report No. 2006/6
Project Record No. 55281**

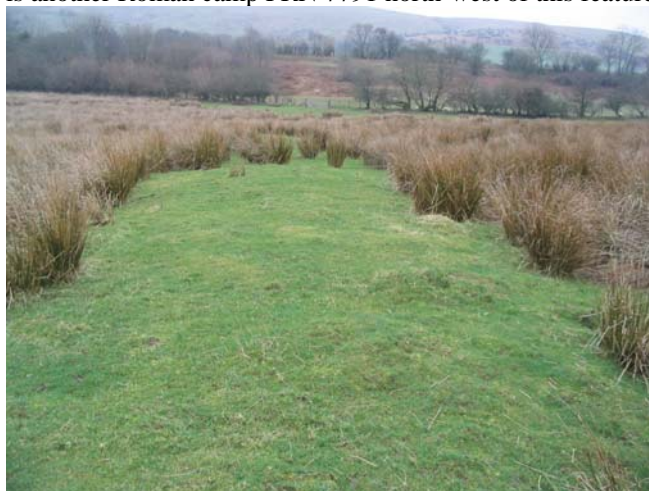
A small Roman fort or practice camp, approximately 35m square, located to the west of Y Pigwn marching camp, close to the probable line of the Roman road to Llandoverly. A centrally located entrance has been recorded in each side, 3m wide and each with a tutulus (a short section of bank and ditch fronting the entrance), although these are difficult to identify on the ground. The site consists of low grass covered banks c3-4m wide with traces of an external ditch. It lies in a wet pasture field currently covered in rushes. There is another Roman camp PRN 7791 north-west of this feature. *Visited 24/01/2006 (PP)*

Facing SE, looking along a length of bank marking out the Roman marching/practice camp.

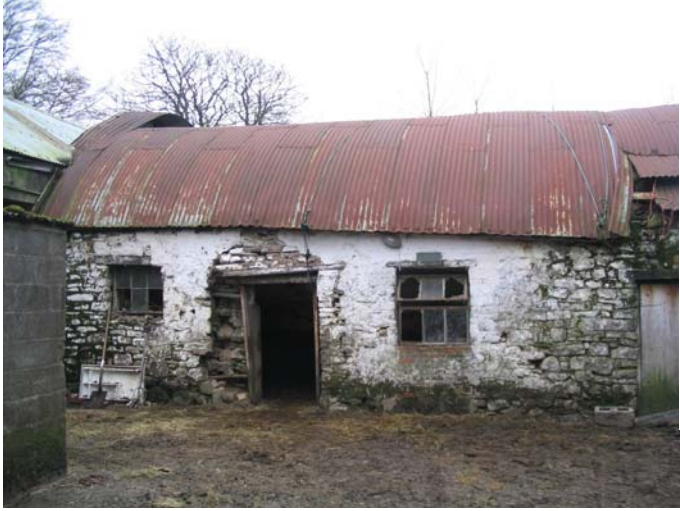
Name (& PRN)	Period/Site type	NGR	Status SAM/listing	Management required
1	HAFOD FAWR <u>(55615)</u>	Post Med/ Farmstead	SN8147631242	B	Specific
<p>A working farmstead complex to the southeast of Llandovery. The date of its origin is unclear. The farmstead lies adjacent to a possible Roman road that was later used as a coach road, and the name suggests it originated as a seasonal dwelling on summer pastures. The farmstead is recorded on the old series Ordnance Survey map of 1832. The more detailed 1st edition Ordnance Survey map of 1887 shows the complex consisting of the farmhouse with an opposing L-shaped range of farm buildings to the north. The farmhouse remains with a single opposing traditional farm building. An adjoining barn forming the L-shaped range has since been replaced with a more modern barn. The traditional barn is built of mortared random rubble, whitewashed, with a rounded corrugated iron roof (apparently originally stone tiled). Two doorways and three windows, two of which are part blocked former doorways, face the farmhouse, with a doorway in the rear wall. The barn is still used as a cow shed but with a deteriorating roof and areas of loose masonry. <i>Visited 24/01/2006 (PP)</i></p>

<p>NNW facing shot of the traditional farm building.</p> </div>					
	TROED-Y-RHIW <u>(55617)</u>	Post Med/ Dwelling	SN7802133524	B	Generic
<p>A roadside dwelling marked on the 1st edition Ordnance Survey map of 1886, and possibly also on the old series Ordnance Survey map of 1831. The dwelling is 2-storey, rendered, with a slate roof and a chimney in both gable walls. A small complex of farm buildings on the opposite side of the road indicates this may have functioned as the farmhouse of a small farmstead. The house appears in good stable condition although its current state of occupation is unknown. <i>Visited 24/01/2006 (PP)</i></p>

The aim of the management for this site should be the maintenance and preservation of the traditional farm building within the farmstead complex. The building is still in use as a cow barn but the rounded corrugated iron roofing is deteriorating and has slipped in places. Facing stones have also come away from around one of the doorways, threatening the integrity of the doorway itself. The rear wall may also need to be examined for its structural integrity.

- The roof structure should be repaired using appropriate materials and techniques. The semi-circular corrugated iron roofing is likely to have been in place throughout much of the 20th century, therefore it would be preferable to retain a corrugated iron roof. Ideally a semi-circular profile should also be retained however it may be unrealistic to keep it, this would partly depend on the condition of the roof structure which was not closely examined during the farm visit. The costs of re-roofing in corrugated iron in both the semi-circular profile and standard pitched profile should be established to determine the best option.
- The masonry around the doorway should be repaired and consolidated.

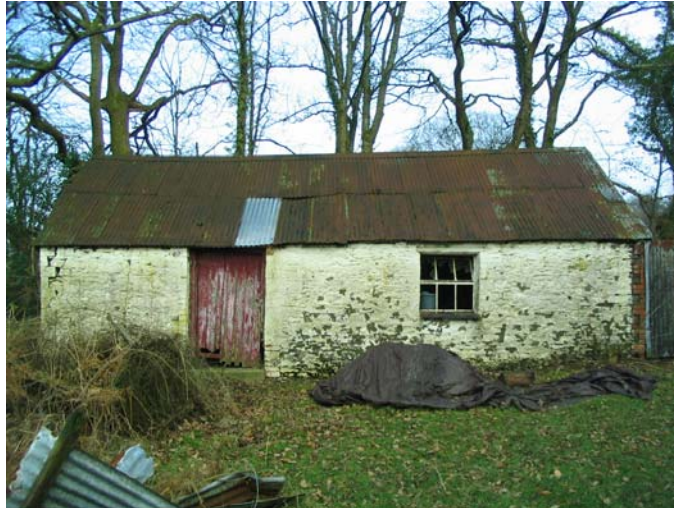
A small rectangular barn first marked on the 2nd edition Ordnance Survey map of 1906. The building is built of whitewashed mortared stone with brick quoins and door and window surrounds and a corrugated iron roof. Modern farm buildings stand to the south forming a small farmstead complex along with dwelling PRN 55617 across the road. Some of the farm buildings are still in use although this barn is possibly only be used for storage now. The roof is beginning to deteriorate to the rear and masonry appears to be loose along the rear wall and at the northwest corner. *Visited 24/01/2006 (PP)*

NE facing shot of the traditional barn marked on the 1906 Ordnance Survey map.
