BETTER WOODLANDS FOR WALES MANAGEMENT PLAN HERITAGE MANAGEMENT INFORMATION (WHE2)

Coed Parc Taliaris

BWW Reference No 3239

**Prepared by
Will Steele
Project Record No. 62216**

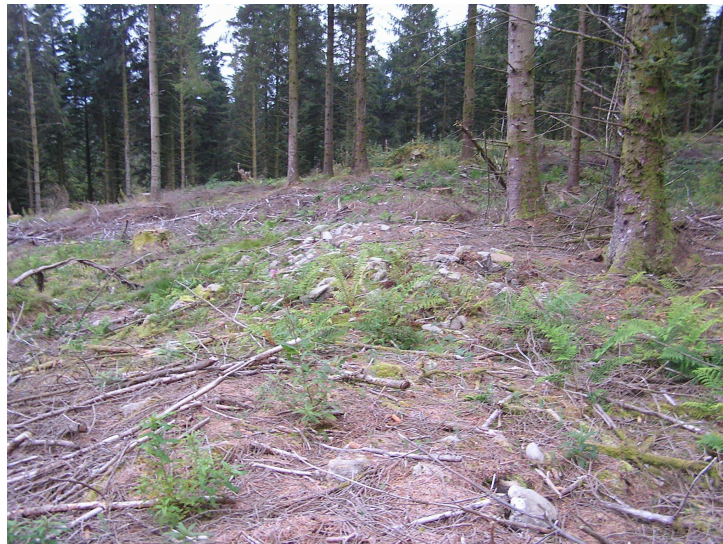
The sloping interior is roughly circular, approximately 120m in diameter, and is now heavily disturbed by forestry activity following at least two planting phases. At the time of visiting the area was under coniferous woodland and overgrown with dense tree growth and low growing vegetation.

Facing north along the denuded rampart.

The defended enclosure has been subjected to heavy disturbance by past forestry operations. Successive planting and harvesting has denuded the rampart bank and is likely to have severely damaged below ground archaeological remains within the interior. The visibility of the defended enclosure has also been severely affected: areas of more recent planting and forestry debris now obscure much of the interior and surrounding area.

Future management should aim to enhance the visibility of the site, whilst preventing further damage to below ground and upstanding archaeological remains.

- Exclude the defended enclosure and a buffer zone of approximately 15m from future commercial forestry operations. Particular care should be taken around the area of the stone rampart on the eastern side.
- Beneficial management would see a deciduous canopy established over the area of the defended enclosure and a 15m buffer zone surrounding it in order to suppress scrub growth and promote a stable environment for the long term.
- Consider undertaking measures to control scrub along the line of the eastern rampart in the meantime. Such vegetation should be cut off at ground level with its roots being left in the ground rather than pulled up or dug out. Ensure that machinery does not cause further disturbance.

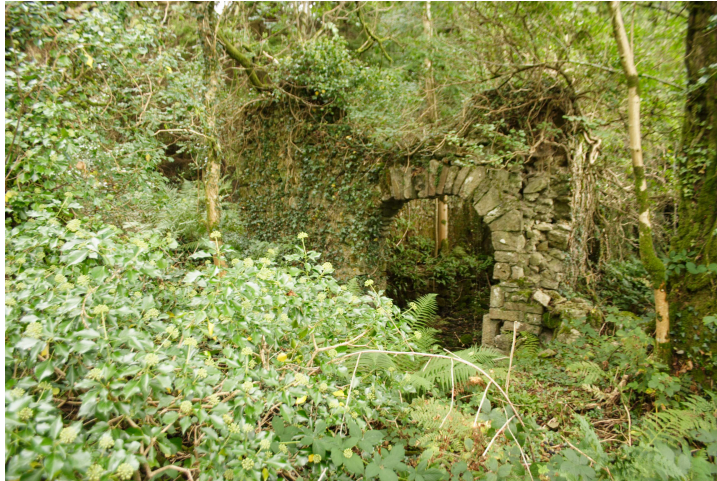
Today the boat house still stands but is now ruinous and overgrown. It is of rubble stone construction, approximately 6m wide by 6m long with a stone arched boat entrance (2m wide by 2.5m wide) in the north-west wall and a standard width doorway in the south-east wall. Fragments of roof slates lie in the vicinity. The boat house is connected to the lake by a short length of canal, approximately 5m long and 2m wide.

It is now overgrown with some young trees growing out of the wall tops and derelict trees leaning on the walls.

The ruinous boathouse. Facing east towards the boat entrance.

Management should consider how best to protect the boat house in the long term.

- Monitor mature trees growing on or close to the building. Fell mature trees which are at risk of damaging standing remains by windthrow.
- Fell derelict trees on the structure which pose a threat by leaning on the walls, through falling limbs or root bowl damage.
- Cut or spray back young trees on the standing remains leaving the roots in situ. Consider spot treating to prevent re-growth.

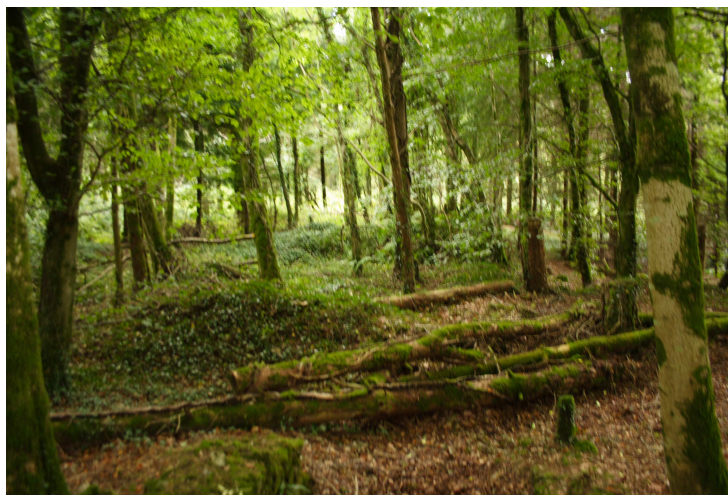
Today, the cottage is evidenced by its broken down walls, identifying a rectangular structure approximately 20m NE-SW by 7m NW-SE, divided into two units of roughly equal size and possibly representing two former cottages. The area is rather obscured by vegetation growth and no further interpretation was possible.

Facing south along the line of the former cottages.

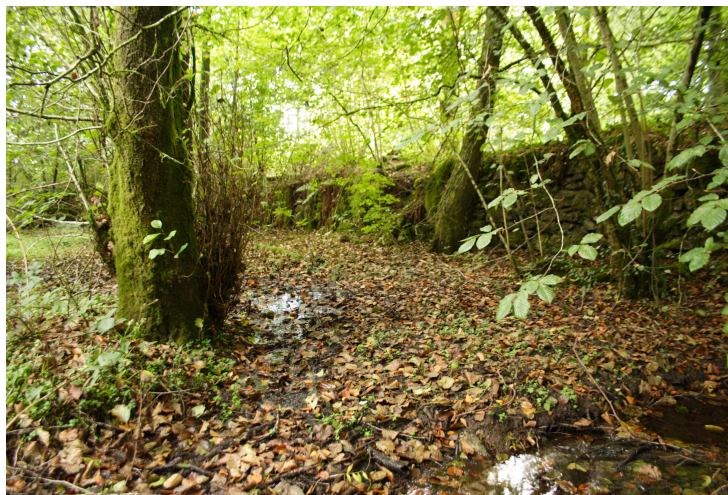
Holding pond formerly serving the sawmill at Taliaris. Identified on the Ordnance Survey 1st edition map (1888). The dam wall is breached and the pond is now dry and overgrown. A rock cut, then brick lined culvert extends from the eastern side of the pond in the direction of the mill. An overflow leat extended south (WWS 2006 after Cadw/ICOMOS 2002).

The site is now overgrown with native woody vegetation. The pond profile and outline is still clearly discernible.

The interior of the now overgrown former holding pond, facing south.

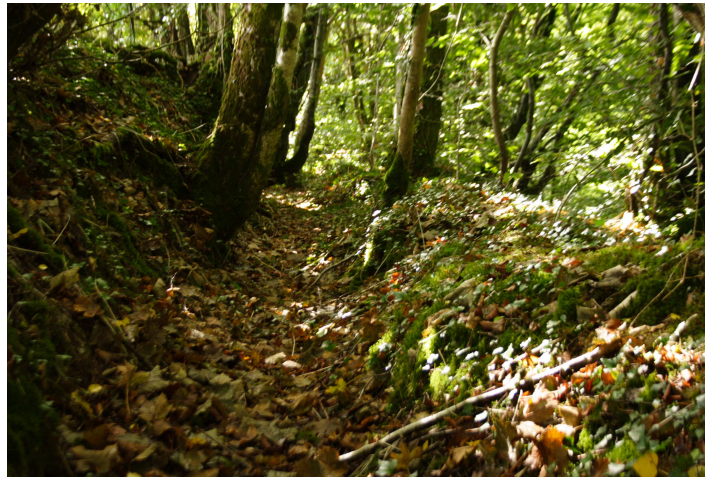
An overflow leat runs south from mill pond (PRN 62154). It is now visible as a cut earth channel, with spoil upcast on the downslope side, measuring approximately 1m wide by 0.6m high. The leat is not marked on either the Ordnance Survey 1st or 2nd edition maps (1889, 1906).

The site lies within forestry.

Facing south along the overflow leat.
