A SURVEY OF DEFENDED ENCLOSURES IN CARMARTHENSHIRE, 2007-08: GAZETTEER OF ORDNANCE SURVEY GRID SQUARE SN31

RHIF YR ADRODDIAD / REPORT NO. 2007/27
RHIF Y PROSIECT / PROJECT RECORD NO. 62767

SITE GAZETTEER OF 10KM GRID SQUARE SN31

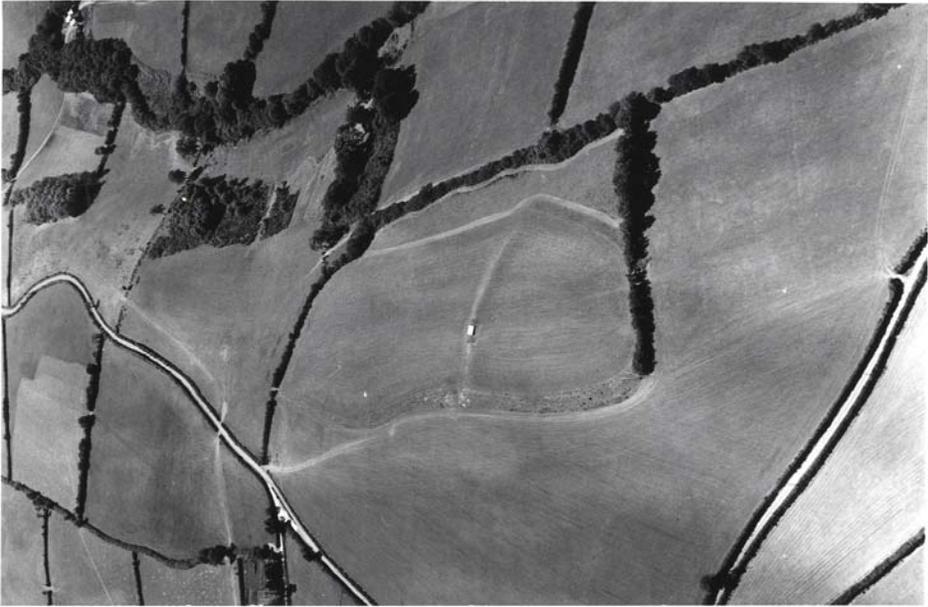
Aerial photograph of 2134. Reference DAT AP84-61.32.

Pen y Gaer is a hilltop defended enclosure with a large annexe attached to its western side. The site lies on a rounded ridge, which achieves a height of over 110m. To the north, east and west of the enclosure steep slopes provide a good natural defence and only a light defensive bank has been constructed here. The western approach along the ridge-top is defended by a strong bank and ditch that cuts across the ridge. The bank survives up to 3.3m high with traces of a ditch surviving at the southern end. A concrete platform has been built midway along the bank. The location of the entrance is unclear. Internally the sub-circular enclosure measures c.85m E-W and 70m N-S.

A long annexe, 180m E-W and 70m N-S, is attached, slightly downslope, to the western side of the enclosure. The bank on the south side of this annexe is slight and diminishes in size away from the enclosure. The west end and north side of the annexe are not traceable other than as a break of slope. The site is under improved pasture.

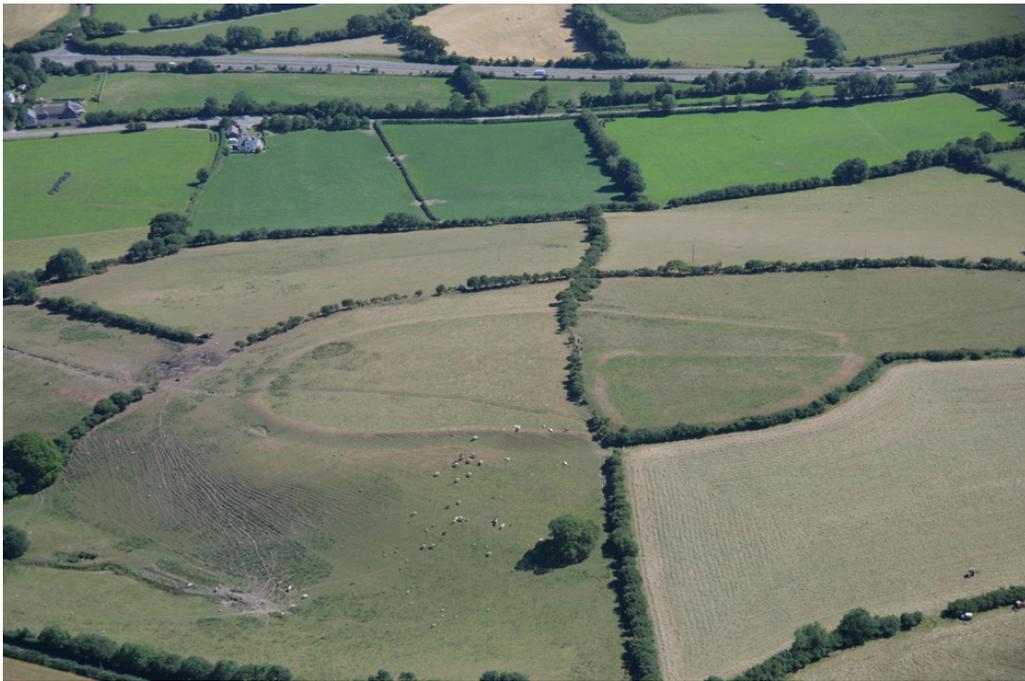
Aerial photograph of 2135. RCAHMW Crown Copyright © reference AP_2006_3267.

Castell y Gaer is an oval, univallate hillfort, with an inner enclosure occupying the NW quadrant of the fort on the highest point at 100m above sea level. The main enclosure measures c.240m E-W and 120m N-S. It is defended by a simple bank, 2m - 3m high, with traces of an external ditch. There are two entrances, a simple one at the western end and an inturned one at the eastern end. In 1983 aerial survey revealed further outworks. Immediately to the east of the inturned entrance were the cropmarks of two opposed, inturned ditches protecting the entrance. These ditches appear to peter out some distance either side. Parching between these ditches and the main defences indicate the presence of denuded secondary banks, indicating some form of outwork. A cropmark running up to this eastern entrance may suggest a hollow-way.

The inner enclosure measures c.100m E-W and 70m N-S. The location of the entrance into this inner enclosure is unclear. The site is under improved pasture.

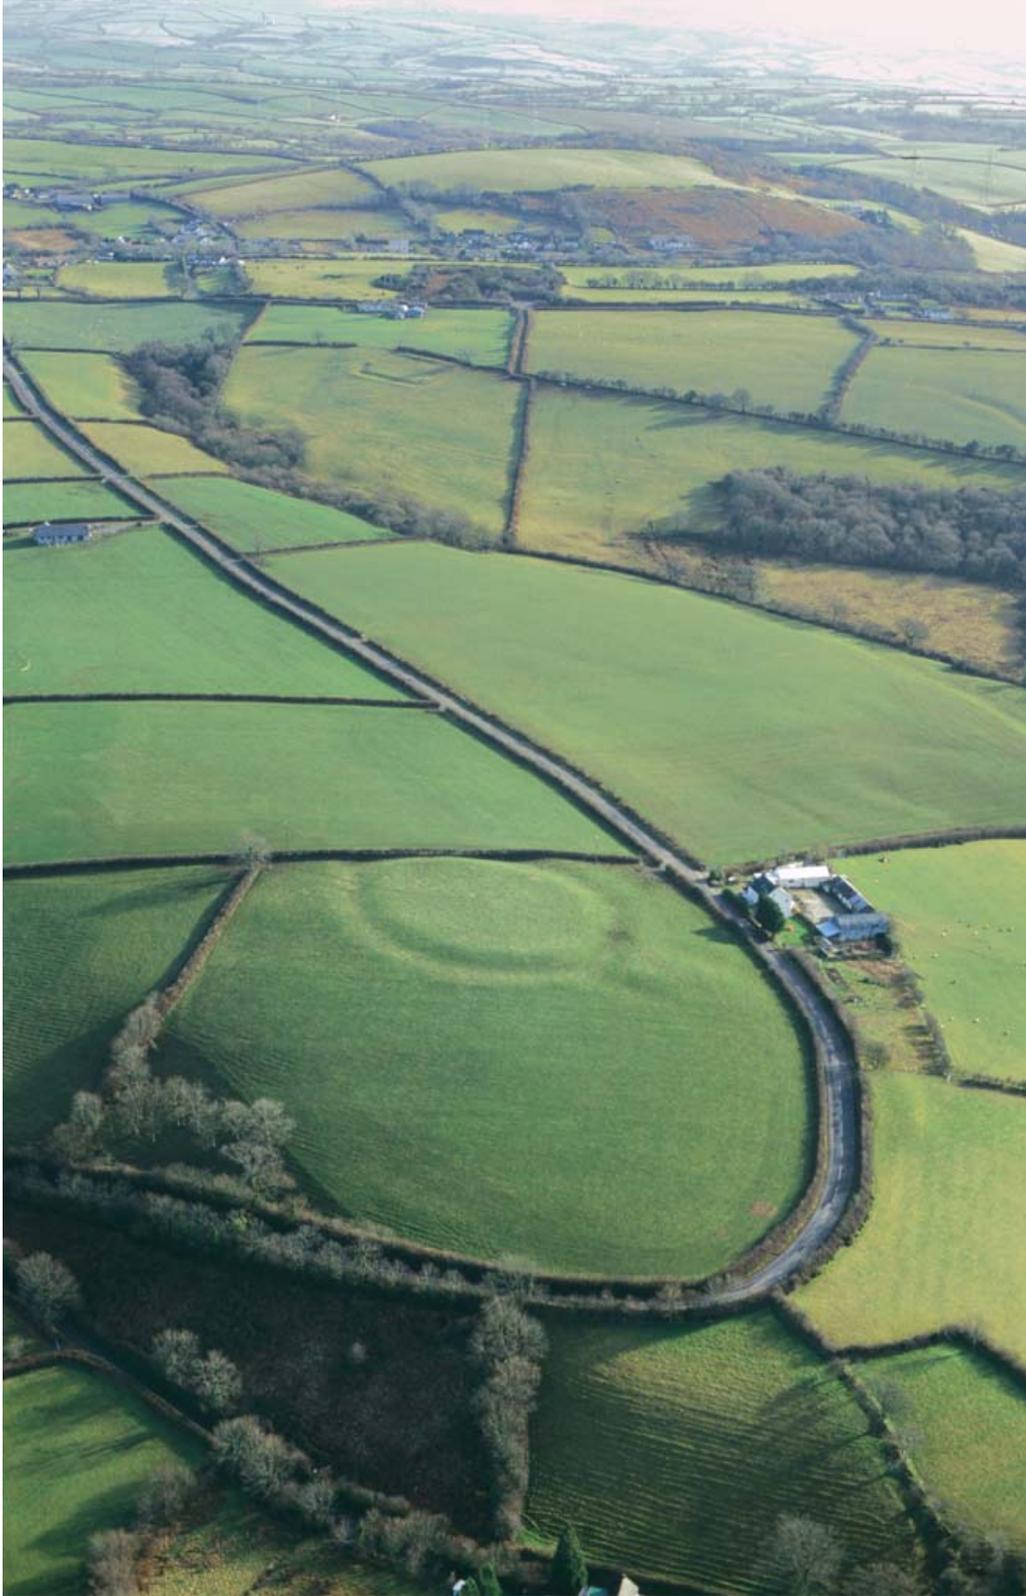
Aerial photograph of 2136. RCAHMW Crown Copyright © reference DI2007_1689.

Bwlch y Seiri is a sub-circular defended enclosure with a 'barbican' entrance, occupying a west-facing slope at 80m above sea level. Internally the enclosure measures c.55m diameter and is defended by an earthwork bank that rises c.1m above an external ditch. The southwest-facing entrance has an external platform c. 20m by 20m on its northwest side that probably functioned as a barbican or bastion. This is an unusual feature for an enclosure this small. The site is under improved pasture.

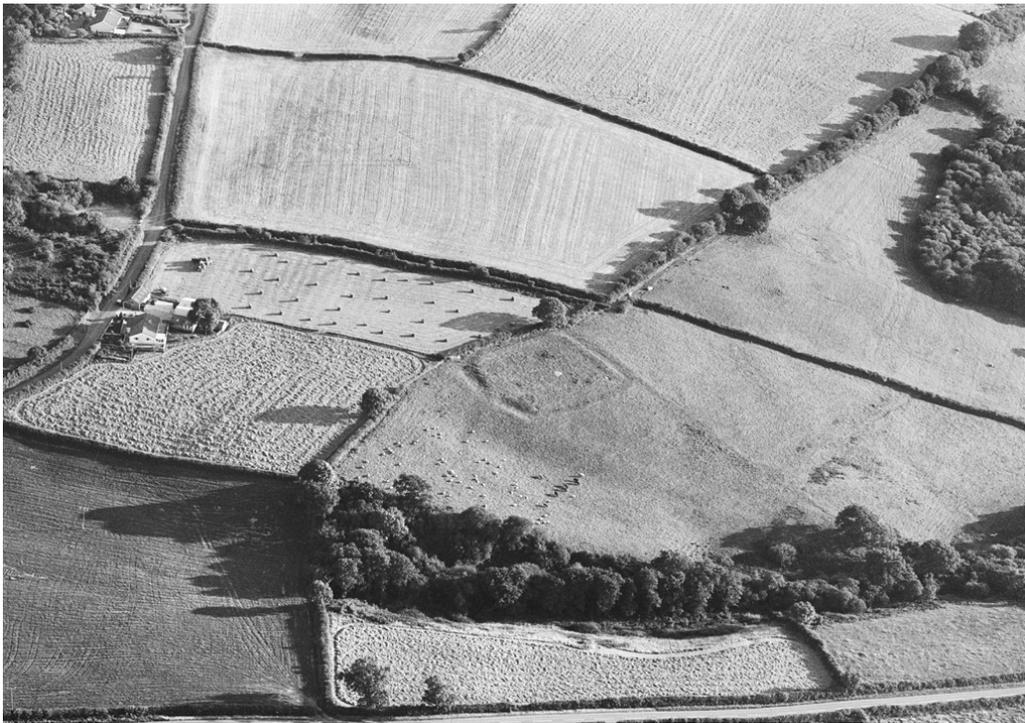
Aerial photograph of 2137. RCAHMW Crown Copyright © reference DI2007_1725.

Bryn Cywyn (Llangynog II) is a rectangular defended enclosure occupying a north-facing slope in improved pasture at 120m above sea level. The enclosure measures c.48m E-W and 31m N-S internally and is defined by a low bank with an external ditch. There is an entrance on the east side. The site was excavated over two seasons in the early 1970s. The entrance and part of the interior were investigated. No definite buildings were identified, and few finds recovered, although radiocarbon dates indicated that the site was occupied in the early Roman period.

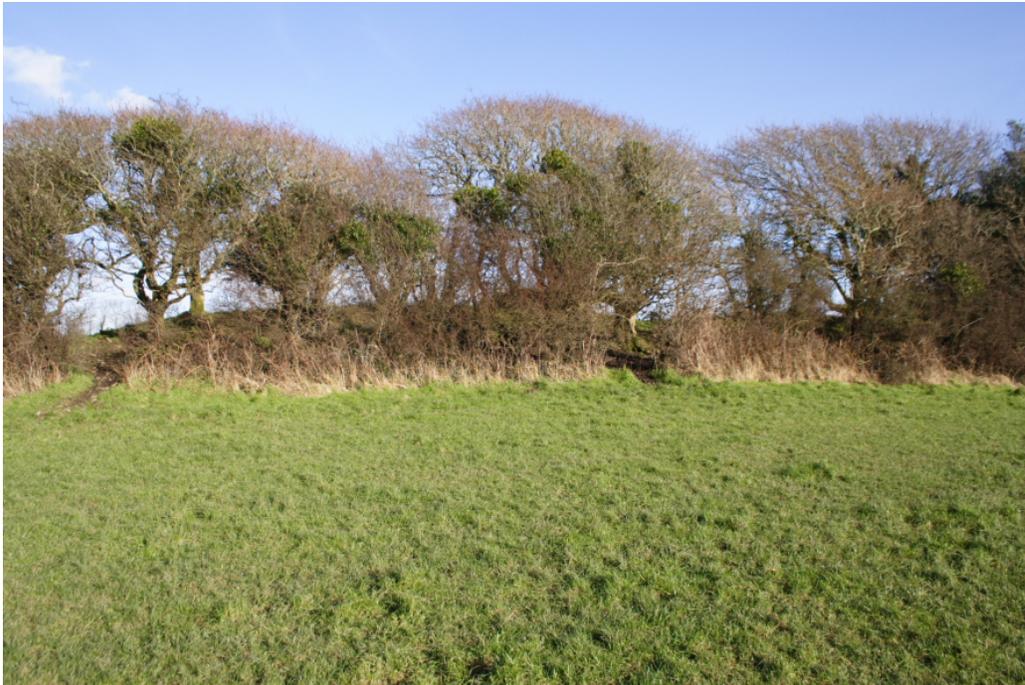
Castell y Gathen is an oval, defended enclosure occupying a west-facing slope at 90m above sea level. Internally it measures c.90m E-W by 50m N-S. The defensive bank only survives on the east side where it is overlain by a hedgebank; here it is up to 1.2m high. It fades to less than 0.2m high on the north side, and elsewhere there is now no surface evidence for it at all. There is no trace of a ditch or of an entrance. The RCAHM in 1917 recorded dry-stone walling in the bank on the east side. The site is under improved pasture.

Looking E at remains of enclosure bank within hedge/field boundary

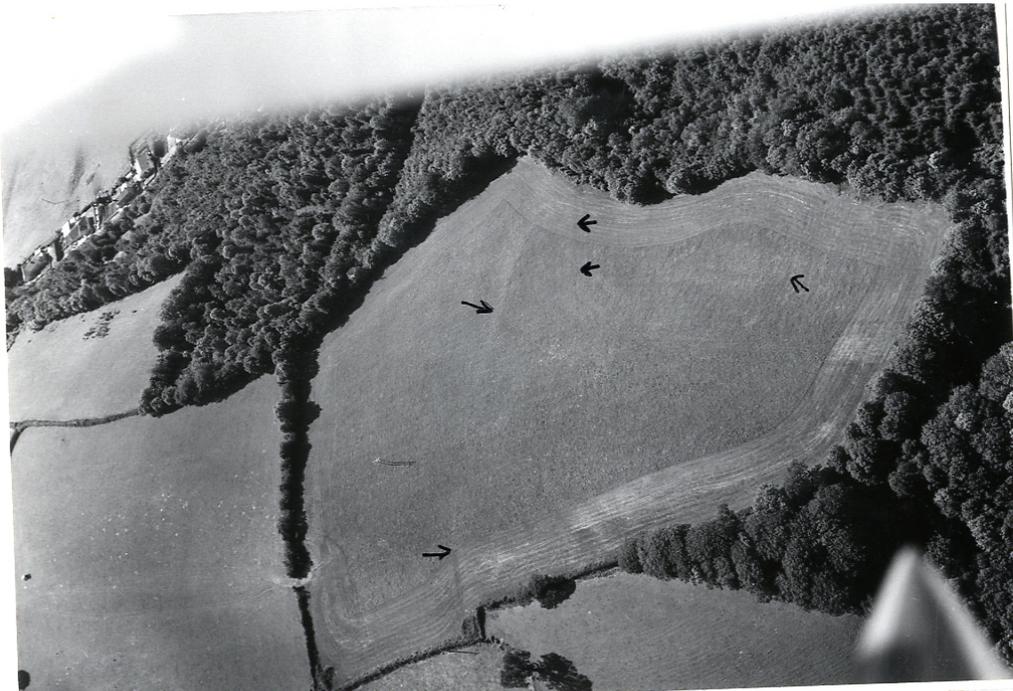
Aerial photograph of 2144. Reference DAT AP84-97.17.

Allt-y-Cnap is a defended enclosure occupying the highest point of an inland promontory at c.90m above sea level. Land falls steeply away from the site to the north, east and south, providing a natural defence on these sides. The site does, however, seem to be an enclosure rather than a promontory fort.

The site was identified by Savory in 1954-56 from vertical aerial photographs taken in 1946. Savory described it as a polygonal, single banked enclosure. Subsequent field visits by the Ordnance Survey in 1966 and 1967 failed to reveal any trace of a site and they considered any surviving earthworks to be natural or part of an old field bank. However, aerial photographs taken in 1984 by Dyfed Archaeological Trust seem to show at least part of an enclosure. On the ground there are earthworks, some of which are natural, but others may relate to a defensive bank and stand up to 0.25m-0.3m in height. These are, however, not easy to define. The exact size and shape of the enclosure is therefore impossible to assess. The site is under improved pasture.

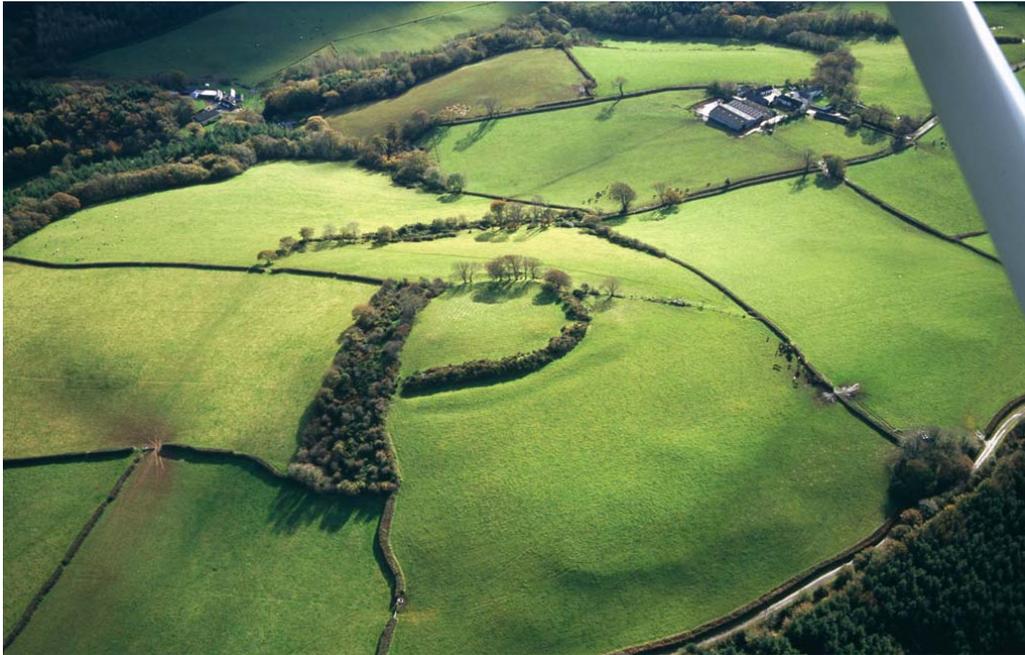
Aerial photograph of 2154. RCAHMW Crown Copyright © reference DI2007_1698.

Castell Cogan is a bivallate hillfort with an annexe occupying the summit of a rounded hill at 125m above sea level. On the east side of the hillfort the slope is very steep and here little or no defences have been constructed. The more easily approachable west and south sides are provided with bivallate defences. The inner bank is very strong, rising to over 2.5m above its ditch. The outer bank is weaker, being only 0.8m above its ditch.

A simple southwest-facing gap marks the entrance through the inner bank; however, the outer bank swings out towards the southwest at this point, making a complex barbican or hornwork entrance. The outer bank terminates here. On the south and southeast sides of the enclosure a low univallate bank is visible. The sub-circular internal area measures c.90m SW-NE and 75m SE-NW.

On aerial photographs an earthwork bank of a possible annexe can be seen c.120m northwest of the main defences.

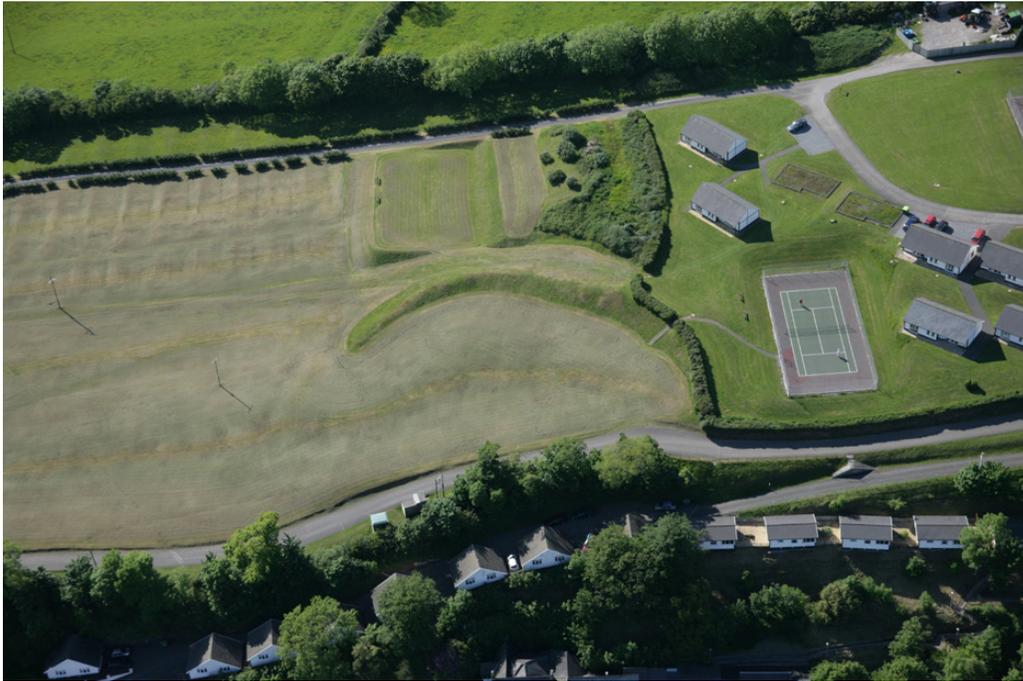
Aerial photograph of 2158. RCAHMW Crown Copyright © reference AP_2005_0871.

Glan y Mor defended enclosure comprises a crescent-shaped rampart defending the north, west and south sides of the site, whilst steep slopes that fall away to the Taf estuary protect the east side. The site lies at 60m above sea level on a gentle southwest-facing slope. The semicircular internal area measures c.50m NE-SW. The rampart is best preserved on the north where the bank stands up to 1.5m high and there are slight traces of a ditch. The rampart curves around to the east to meet the steep slope on this side, but on the south-southwest side the rampart stops abruptly some 40m short of the steep slope. A geophysical survey in 1991 showed that the ditch accompanying this bank also stops short of the slope edge, possibly indicating that the defences were unfinished. The geophysical survey detected little of interest in the interior. The site is now an open space within a holiday park.

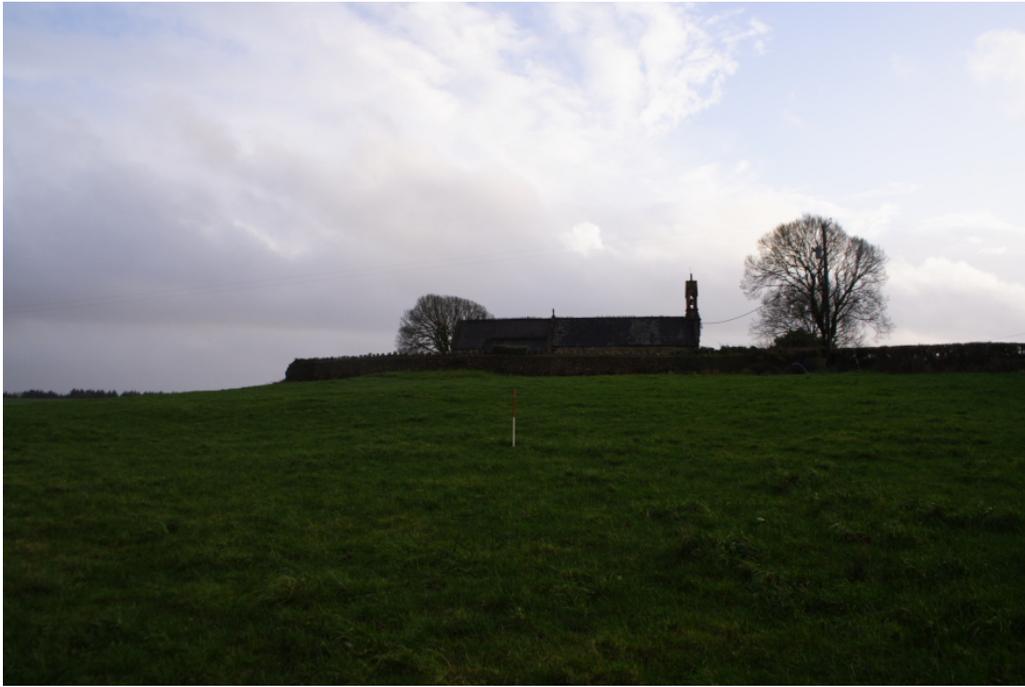
Llangynog Church lies in a circular churchyard of c.45m diameter, leading several authorities to conclude that it is located within an Iron Age enclosure. This suggestion was strengthened by the discovery in 1984, through aerial photography, of a curving length of ditch concentric to the churchyard and c.30m to the west of it. The ditch may represent an annexe to the inner enclosure occupied by the churchyard. On the ground there is no trace of the cropmark ditch shown on aerial photographs, but there does seem to be a low earthwork bank and ditch to the north of the church, which may be a continuation of the cropmark. The site is therefore possibly an Iron Age enclosure with concentric annexe, which was later reused in the medieval period. The site occupies the top of a rounded hill at almost 100m above sea level.

Looking S at circular churchyard marking earlier IA enclosure - Llangynog church

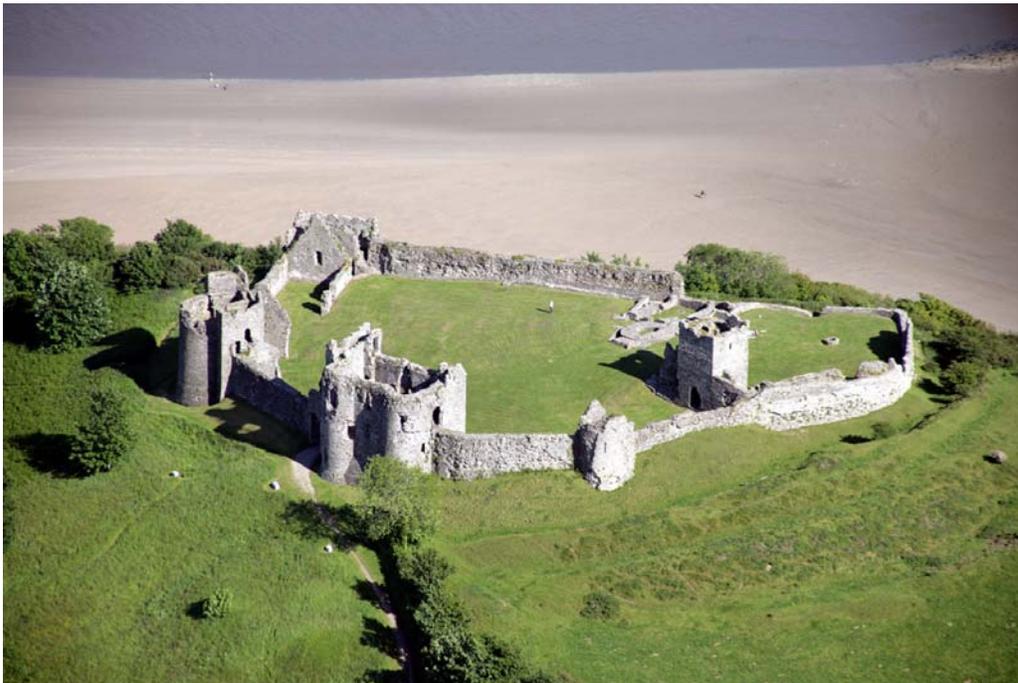
Aerial photograph of 2198. RCAHMW Crown Copyright ©.

An Iron Age promontory fort lies beneath the massive ruins of Llansteffan Castle. It would seem that the original builders utilised the steep coastal slope on the southeast side as a natural defence and built a rampart to protect the north, west and south sides. The earthworks of the Iron Age fort were incorporated into the medieval defences, and it is now impossible to estimate the original size and extent of the earlier fort. The medieval/Iron Age earthworks survive best to the west of the medieval castle, as three lines of bank and ditch, with a further line of bank and ditch 70m to the west. The inner multivallate defences were sample excavated in 1971, revealing a complex history, with origins in the early Iron Age. However, owing to the small scale of the excavations it was impossible to determine whether the site was multivallate or univallate during the Iron Age.

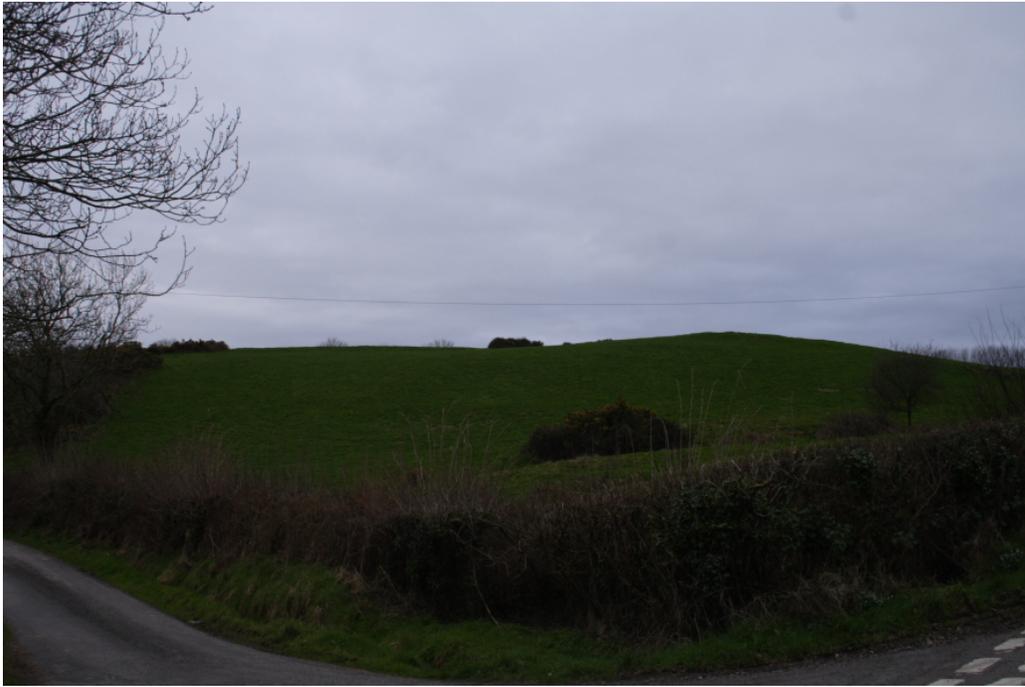
This irregularly shaped defended enclosure occupies a rocky outcrop on the crest of a ridge at c.120m above sea level. The defences consist of a low earthwork bank that at its western end incorporates the rocky outcrop. Ploughing at the eastern end has probably removed the entrance. The enclosure measures c.70m E-W by 40m N-S. A geophysical survey and topographic survey in 1983 confirmed the nature of the site. The site in 2008 was under rough grass.

Looking SW towards area of enclosure earthwork

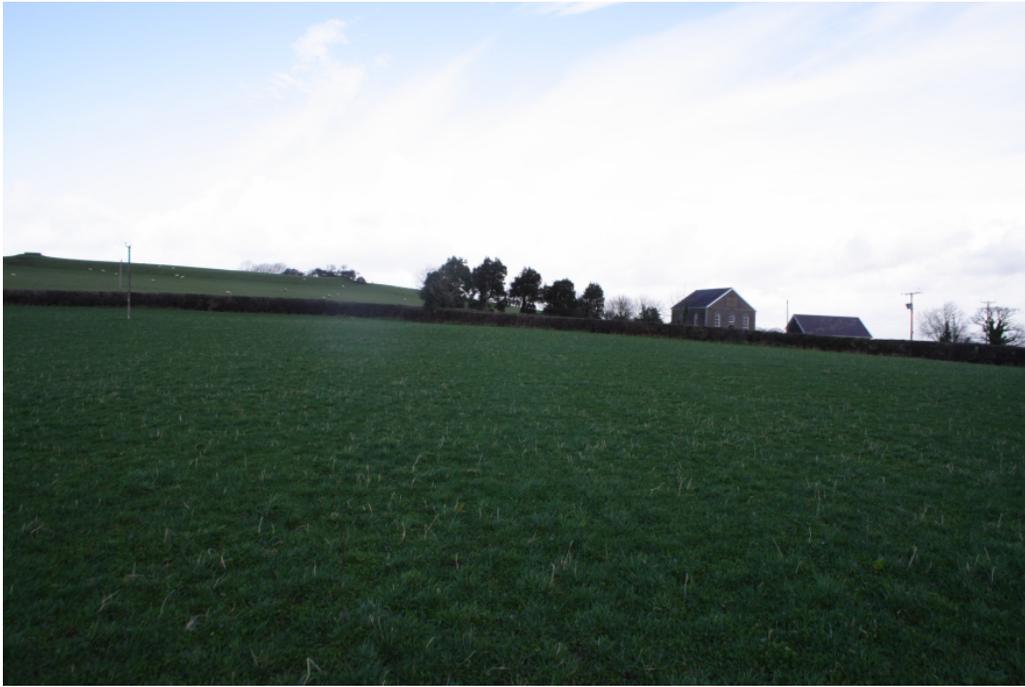
This is an oval cropmark enclosure occupying a gentle SE-facing slope at c.95m above sea level. There is no surface evidence for the enclosure. Aerial photographs show a curving length of ditch - the western side of an oval enclosure measuring c.80m SE-NW and 70m SW-NE. The eastern side of the enclosure lies partly in a separate field, partly under a house and partly under a road. A clear west-facing entrance is visible in the cropmark ditch. In 2008 the site was under improved pasture, but is regularly ploughed for barley.

Looking NE across area of cropmark enclosure

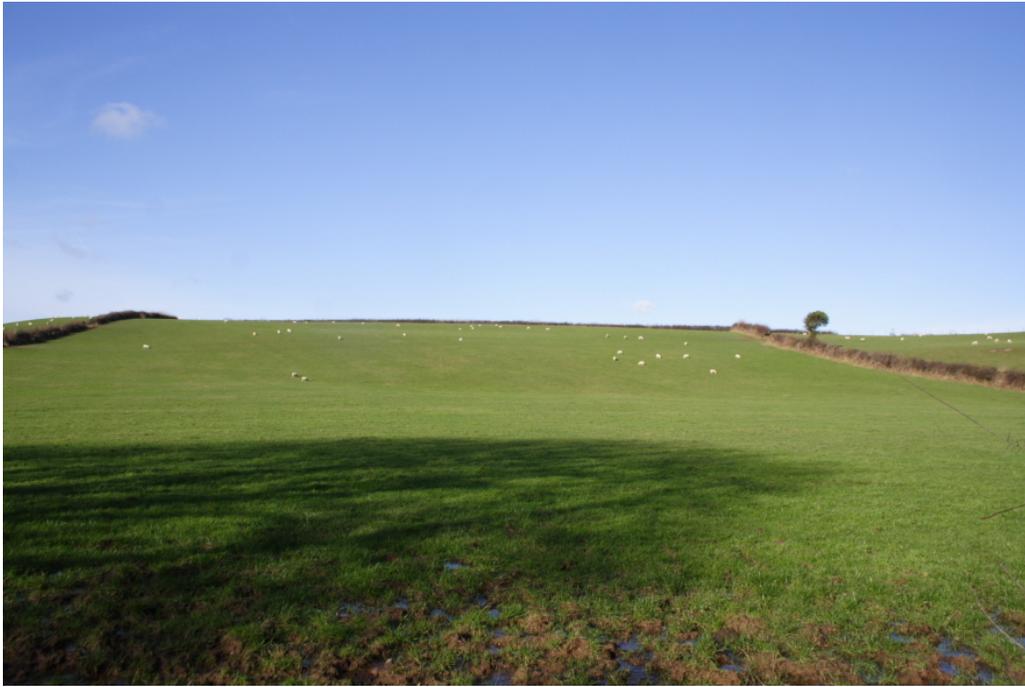
This small, rectangular defended enclosure was completely excavated in 1983 and fully published (Murphy 1983). The enclosure measured c.40m by 30m internally and contained one large roundhouse, a four-post structure and internal divisions, which were all Iron Age in date. A Roman period roundhouse was constructed over the reduced bank. Waterlogged deposits in the defensive ditch provided good environmental evidence. The entrance to the enclosure was approached by a ditched trackway, with the ditches splaying out at the ends. The enclosure is located at the foot of a slope at 85m above sea level. In 2008, traces of the earthwork were still visible on the ground.

Looking NW across defended enclosure site - excavated in 1983

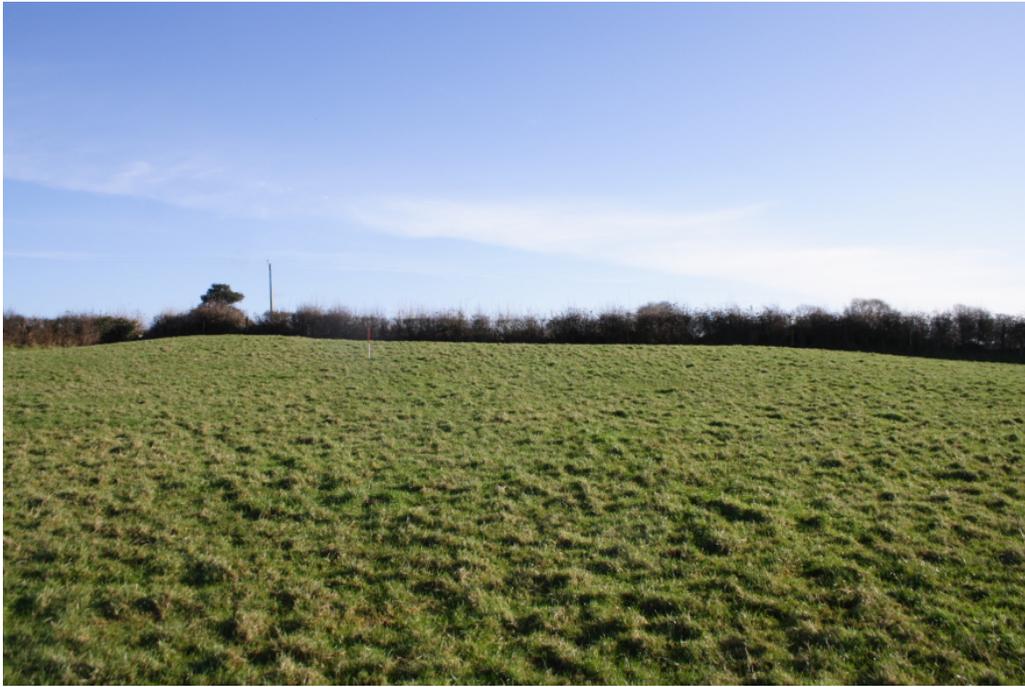
This is a small, earthwork, sub-circular defended enclosure occupying a gentle south-facing slope at a little over 80m above sea level. The enclosure lies in two fields, divided by a N-S hedge bank. Internally the enclosure measures c.25m-30m across. The defences are best preserved on the west side where the bank stands up to 0.5m high and the ditch is clearly traceable. On the east side the bank is just 0.35m high. There is a simple east-facing entrance. In 2008 the site was under improved pasture.

Looking E across defended enclosure earthwork

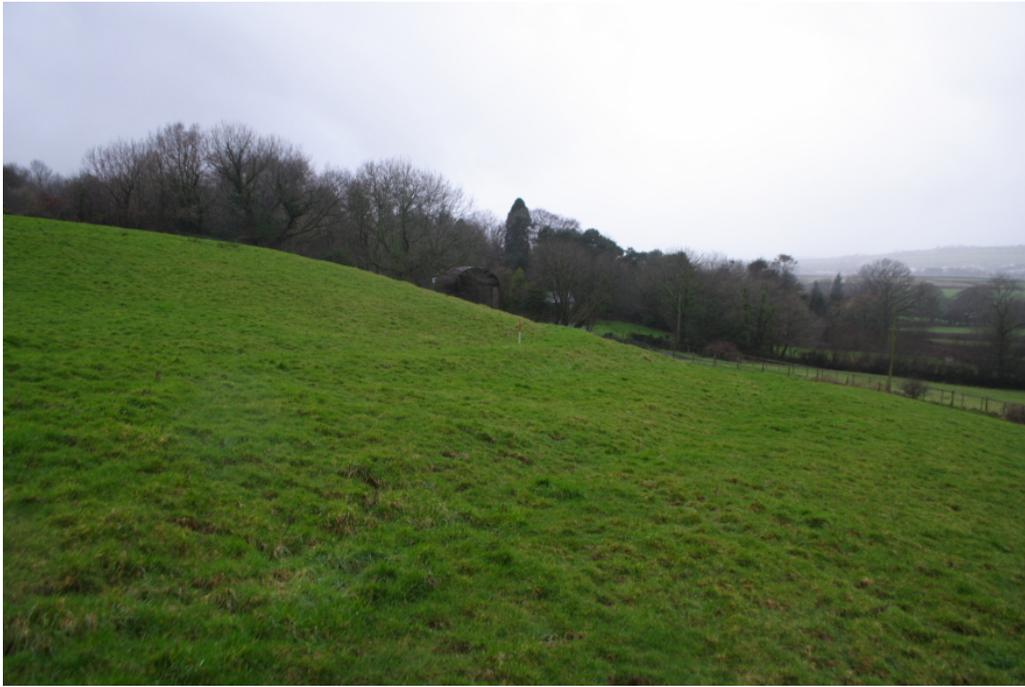
Looking SW showing earthwork of defended enclosure

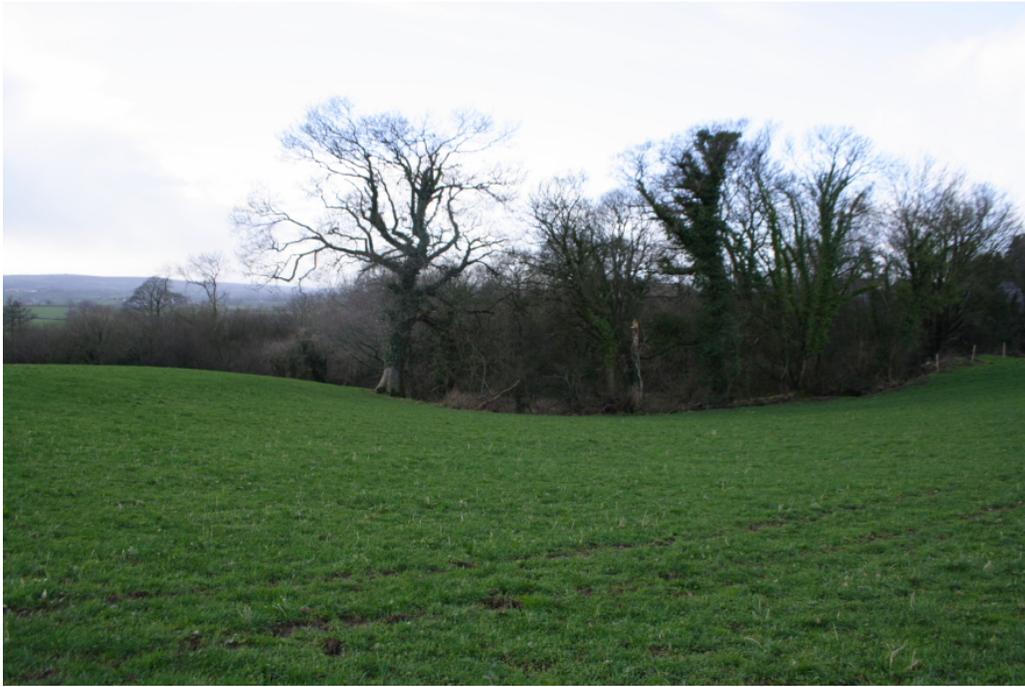
Looking W across area of putative cropmark enclosure

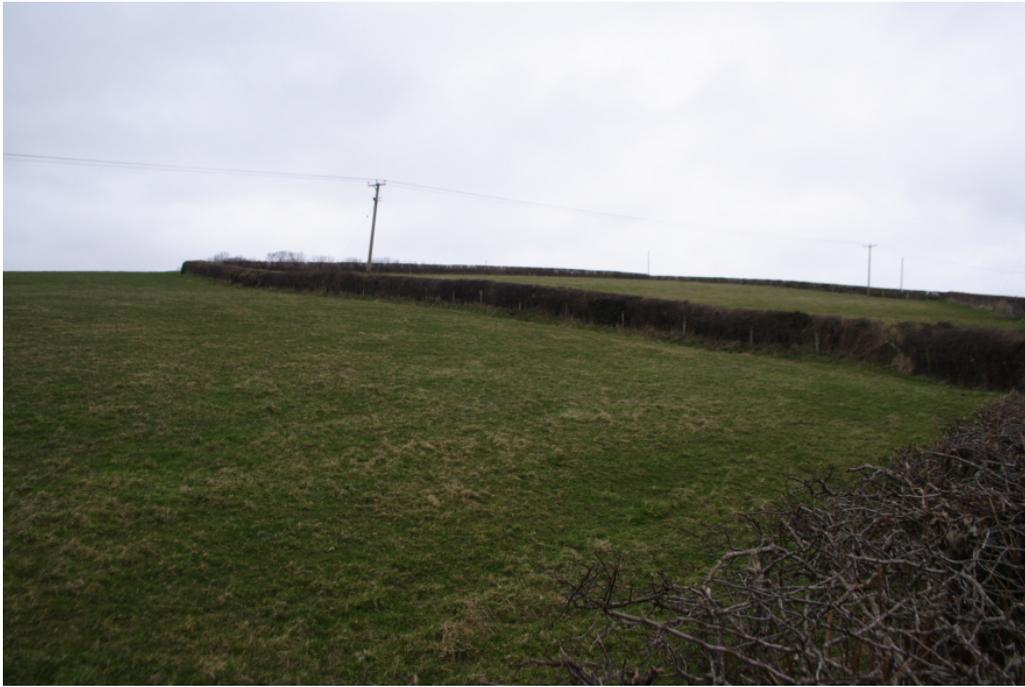
Looking N across area of cropmark enclosure

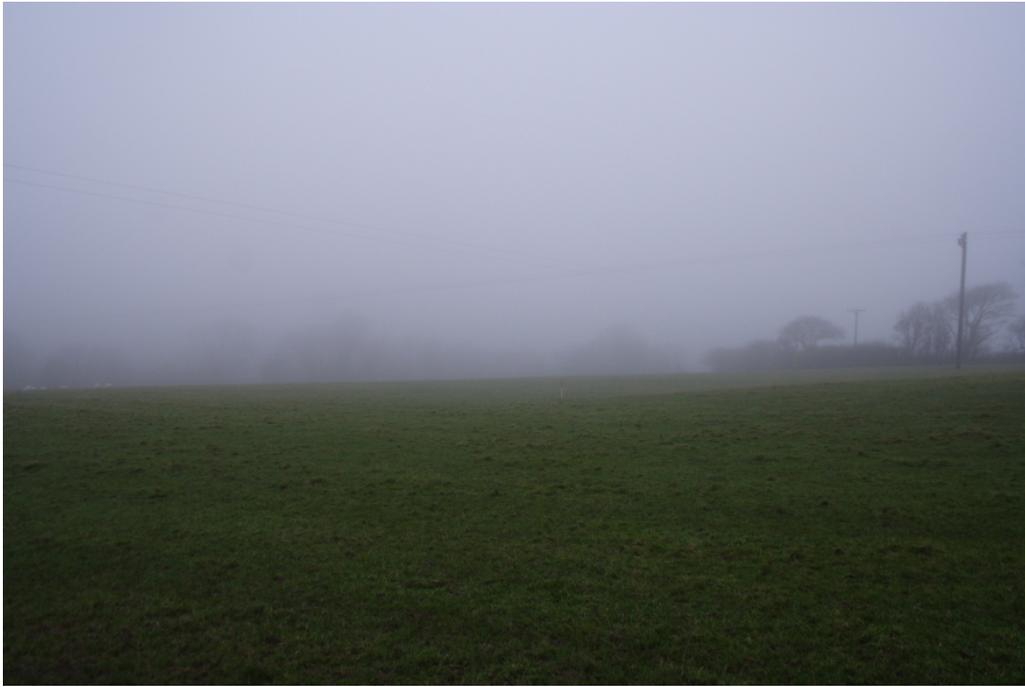
Looking NW across area of putative cropmark enclosure

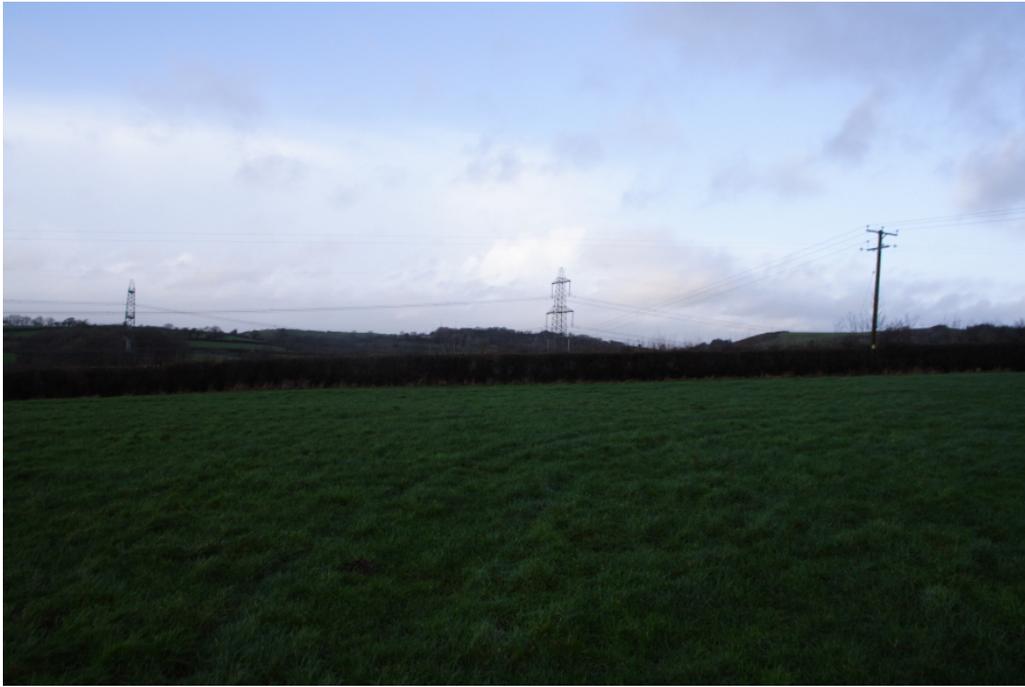
Mistake on co-ordinates of enclosure?
 The co-ordinates above put this enclosure inside the churchyard - which is clearly isn't. More likely set of co-ordinates: SN 3363 1494
 HGM 19/02/03

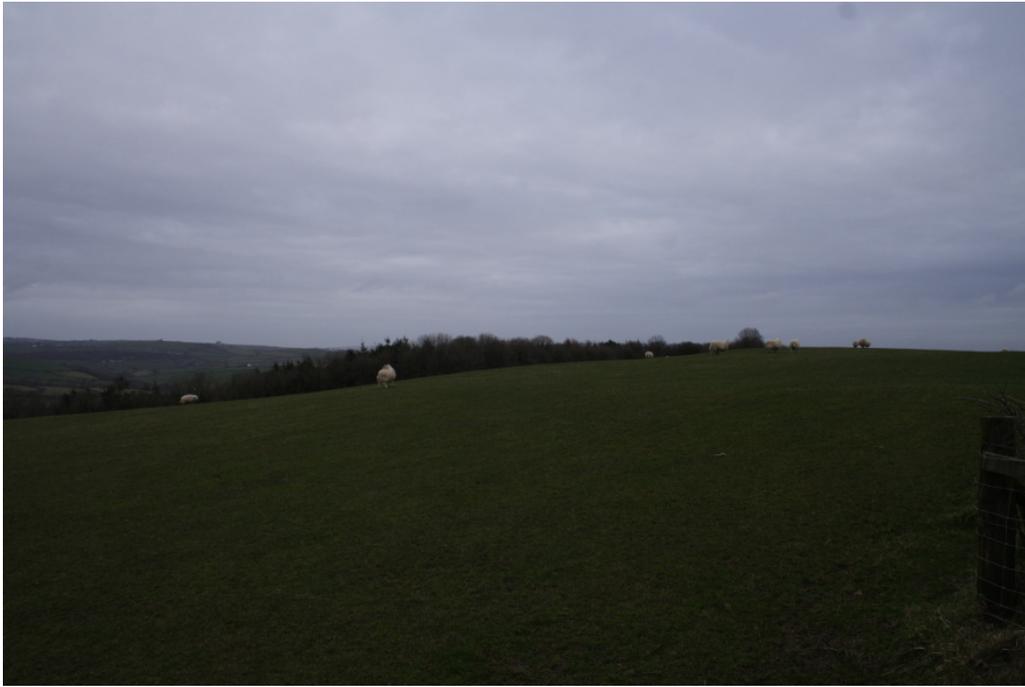
Looking NE across earthwork of defended enclosure

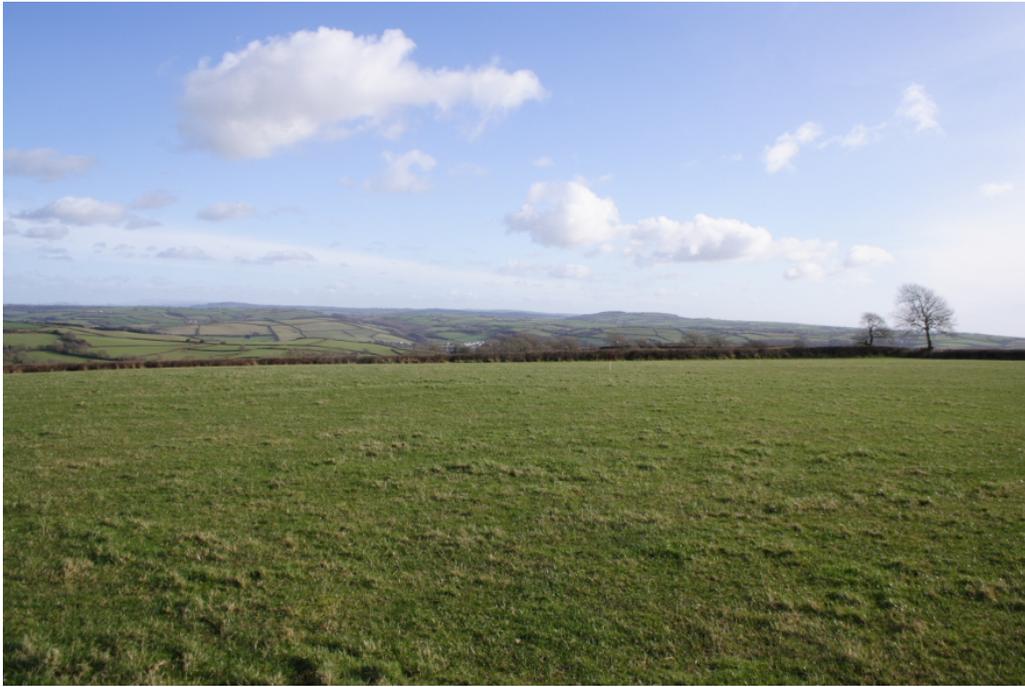
This is a circular cropmark enclosure occupying a gentle east-facing slope at 125m above sea level. Aerial photographs taken when the site was under barley show a curving ditch forming approximately 70% of the circuit of a circular enclosure that has an internal diameter of c.50m. The ditch on the north side of the enclosure is not visible. There is no trace of an entrance. On the ground there are very faint traces of a curving bank, which may correspond to the cropmark, but essentially this site has been reduced to a cropmark. A geophysical survey in 1983 failed to detect the enclosure. In 2008, the site was under improved pasture.

Looking E across area of cropmark enclosure

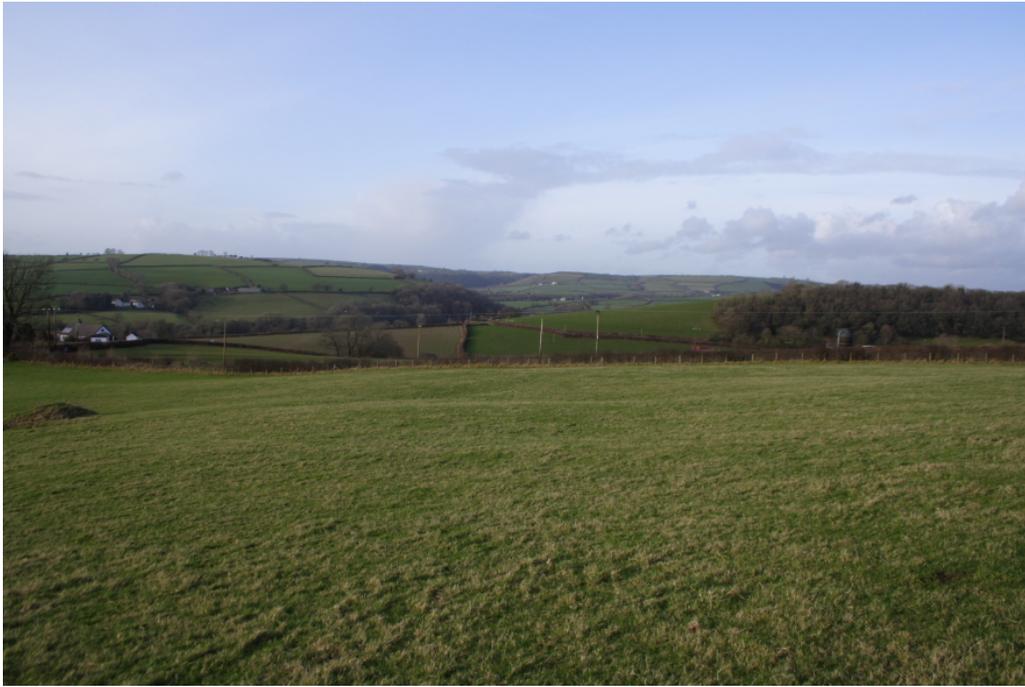
Looking NW across area of cropmark enclosure

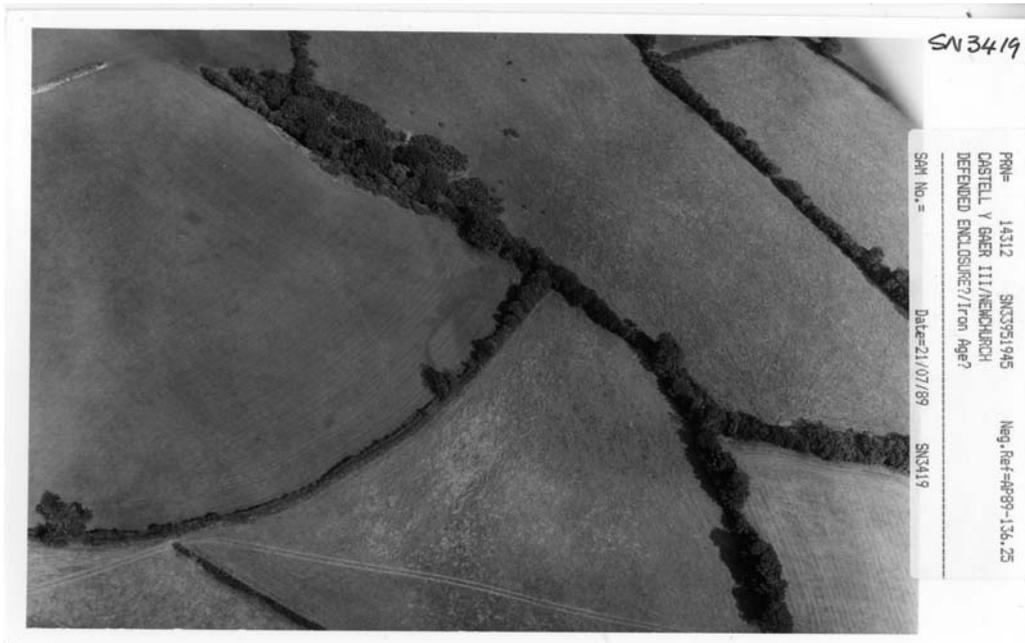
Aerial photograph of 14312. Reference DAT AP89-136.25.

Aerial survey in 1989 noted a semi-circular cropmark lying on a west-facing hillslope at 85m above sea level. The two ends of the semi-circle end where they meet a north-south running hedgebank that lies to the west of the cropmark. On the other side of the hedgebank there is no trace of a cropmark. The diameter of the semi-circle is approximately 50m.

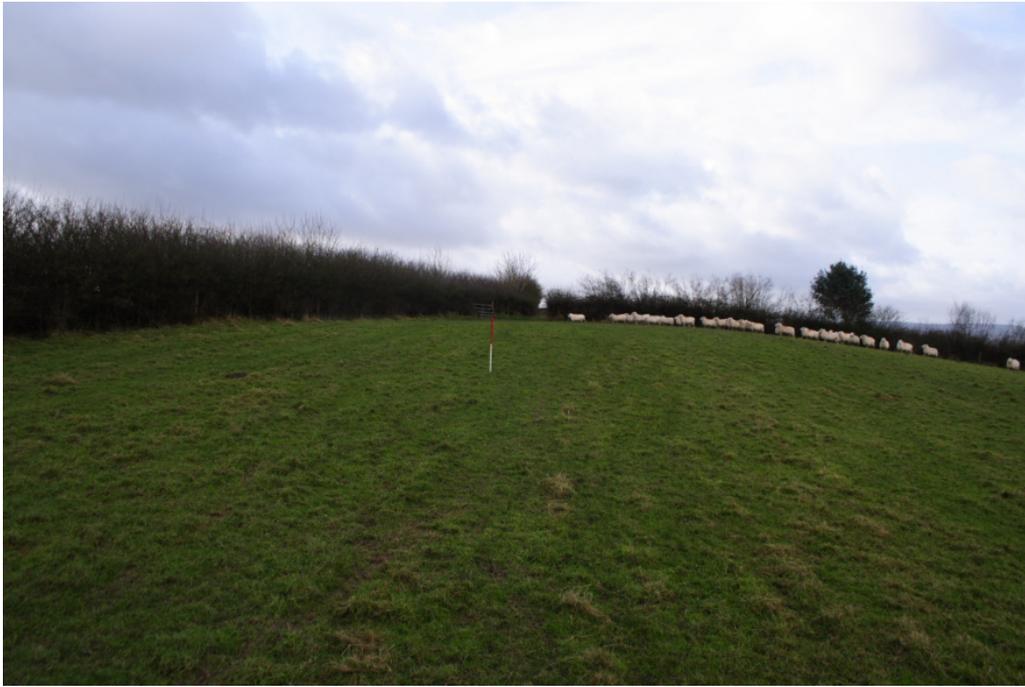
Looking SSW towards area of cropmark enclosure
