TIR GOFAL MANAGEMENT PLAN: HERITAGE MANAGEMENT INFORMATION (HE2)

**Prepared for:
Swn-y-don**

**Tir Gofal Reference No
W/13/7125**

**DAT Report No. 2008/93
Project Record No. 63668**

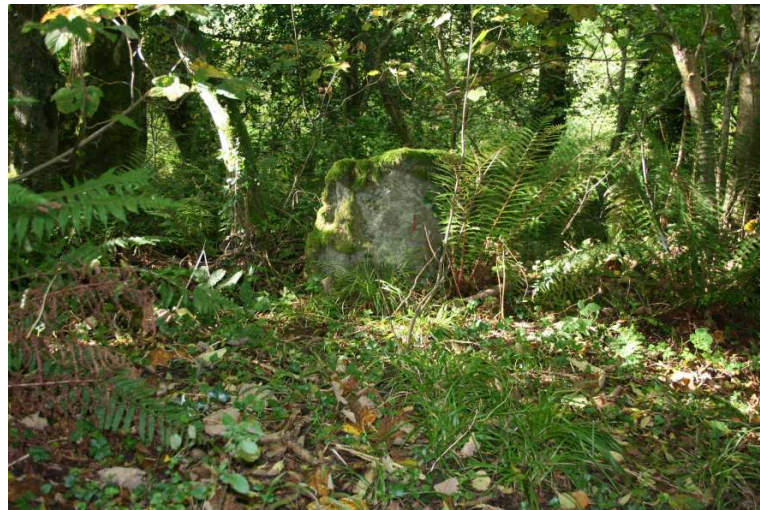
A roughly shaped semi-circular sectioned stone, standing approximately 0.6m high by 0.5m wide at its base, tapering to a rounded top.

The stone is situated at a break in a relict hedge bank, defining a small paddock enclosure and may have served as a gatepost, although the possibility that it could have been a standing stone in the prehistoric or medieval periods cannot be discounted.

Facing north-west to the standing stone
