TIR GOFAL MANAGEMENT PLAN: HERITAGE MANAGEMENT INFORMATION (HE2)

**Prepared for:
Swn-y-don**

**Tir Gofal Reference No
W/13/7125**

**DAT Report No. 2008/93
Project Record No. 63668**

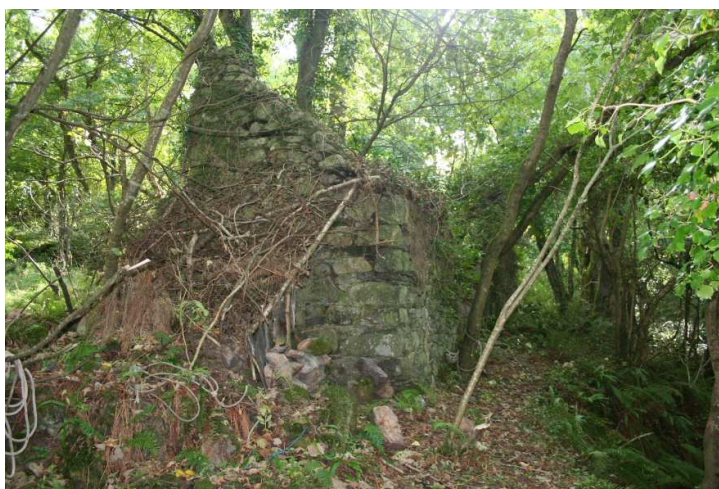
A ruinous small farmstead complex, recorded on the Ordnance Survey 1st edition map (1889) with two loosely opposing main ranges and a separate smaller building to the rear.

The complex lies within deciduous woodland and is currently in a fairly stable condition. Stone and slate has been taken from the building in the past and used to create bivoacs and other structures. This activity seems to have stopped now.

Facing south – the north-east end gable wall of the farmhouse.

Management should consider how best to protect the farmhouse ruin in the long term.

- Monitor mature trees growing on or close to the building. Fell mature trees which are at risk of damaging standing remains by windthrow.
- Fell derelict trees on the structure which pose a threat by leaning on the walls, through falling limbs or root bowl damage.
- Cut or spray back young trees on the standing remains leaving the roots in situ. Consider spot treating to prevent re-growth.

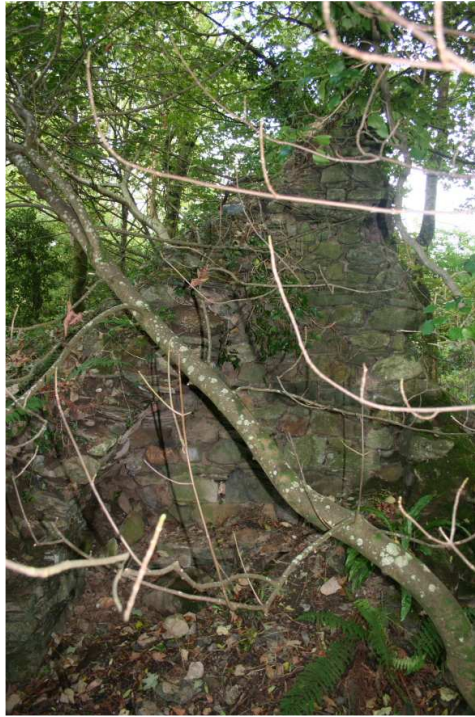
Facing north-east- the remains of a corbelled fireplace surviving inside the farmhouse.

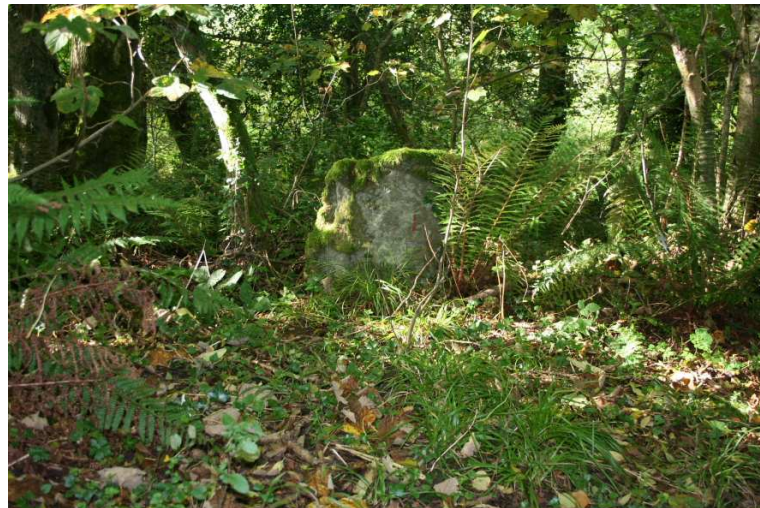
A roughly shaped semi-circular sectioned stone, standing approximately 0.6m high by 0.5m wide at its base, tapering to a rounded top.

The stone is situated at a break in a relict hedge bank, defining a small paddock enclosure and may have served as a gatepost, although the possibility that it could have been a standing stone in the prehistoric or medieval periods cannot be discounted.

Facing north-west to the standing stone
