# BERRY COTTAGE, TOWER HILL FISHGUARD

**Archaeological Watching Brief**

RHIF YR ADRODDIAD / REPORT NO. 2008/107 RHIF Y PROSIECT / PROJECT RECORD NO. 94524

# Berry Hill, Tower Hill, Fishgurard Archaeological Watching Brief

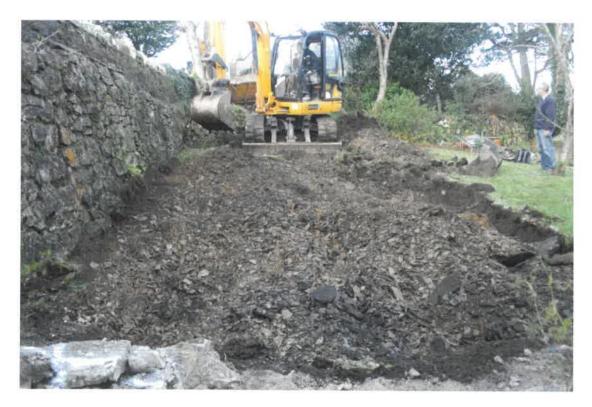
Photo. 1: Site after checking the top of bedrock for any features. View  $\ensuremath{\mathsf{W}}$

The machined then reduced entire top of the bedrock by 0.1m to 0.2m, using a toothed bucket, to make certain that no archaeological features were cut into it (Photo. 1). As there were no features the watching brief was curtailed and the contractor was left to excavated the footprint of the building to the depth required.

The surface of the bedrock only sloped very slightly and it appeared that the natural hill-slope has been considerably terraced, leaving little chance of archaeological survival at this location.
