BERRY COTTAGE, TOWER HILL FISHGUARD

Archaeological Watching Brief

Report No 2008/107

Prepared by Dyfed Archaeological Trust
For: Mr P Kedward

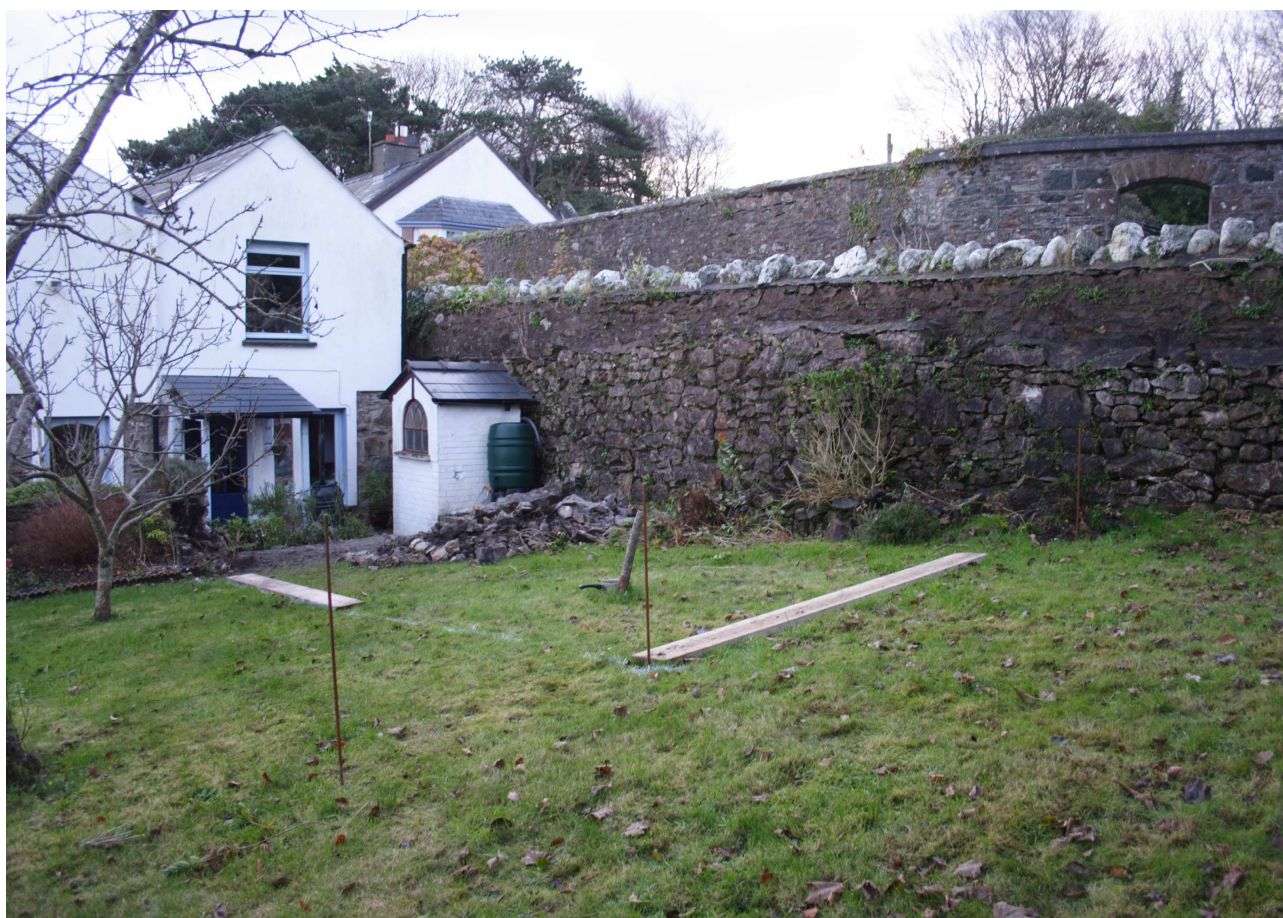
Cover Photo.: Location of development prior to start. View SE

The watching brief was undertaken on the morning of 20 November 2008. The weather was fine but cool, with broken cloud. The building plot was in the southeast corner of the garden (cover photo. and Fig. 2). The footprint cleared was 4.8m out from the rear garden wall and 7.2m long.

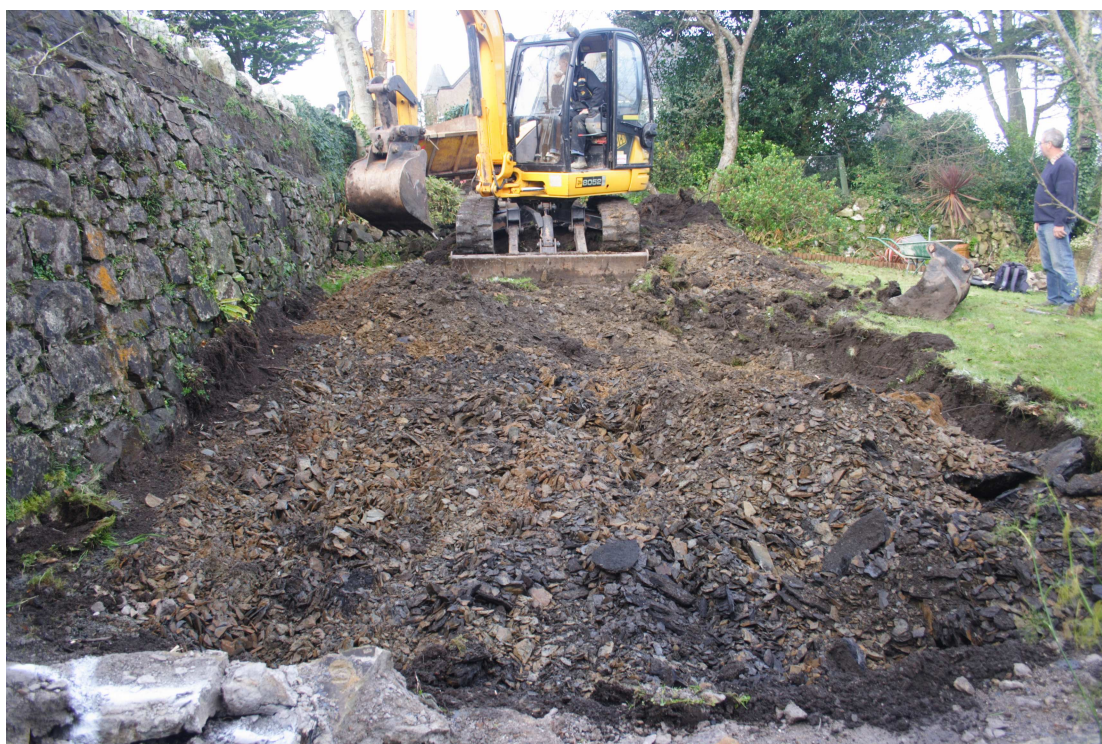
The machined then reduced entire top of the bedrock by 0.1m to 0.2m, using a toothed bucket, to make certain that no archaeological features were cut into it (Photo. 1). As there were no features the watching brief was curtailed and the contractor was left to excavated the footprint of the building to the depth required.

Photo. 1: Site after checking the top of bedrock for any features. View W

The surface of the bedrock only sloped very slightly and it appeared that the natural hill-slope has been considerably terraced, leaving little chance of archaeological survival at this location.
