Part of Stacky Estate.

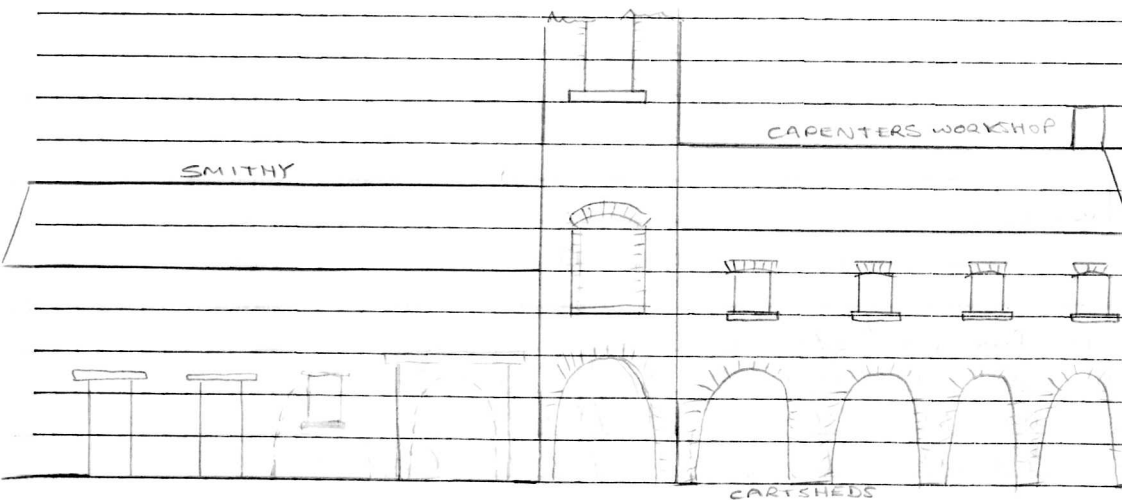
Smithy

Apexing tower section of cartshed/carpenter workshop. Single storey. Partile roof. Front elevation: 2 doors on left with brick voussiors. Probably 2 cart arches to right, now altered and used as garage/workshop.
