Visited following planning application to demolish.

J1/CMS 17-3-85

Cottage - one and a half storey - two ground floor rooms with lean to on the back - central entrance - two front windows - two small windows to lean-to; one upper floor window at end.

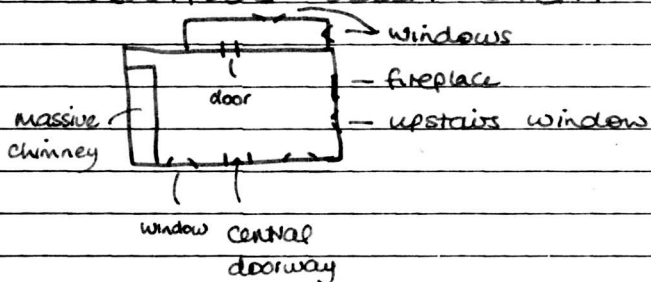
Walls - Stone - irregular shale - roughly coursed - no quoins etc or such.

Roof - gabled - slated - destroyed.

Chimneys - lateral - internal - stone built - drip coursing on stacks - one massive with oven.

All traces of internal features are destroyed.
