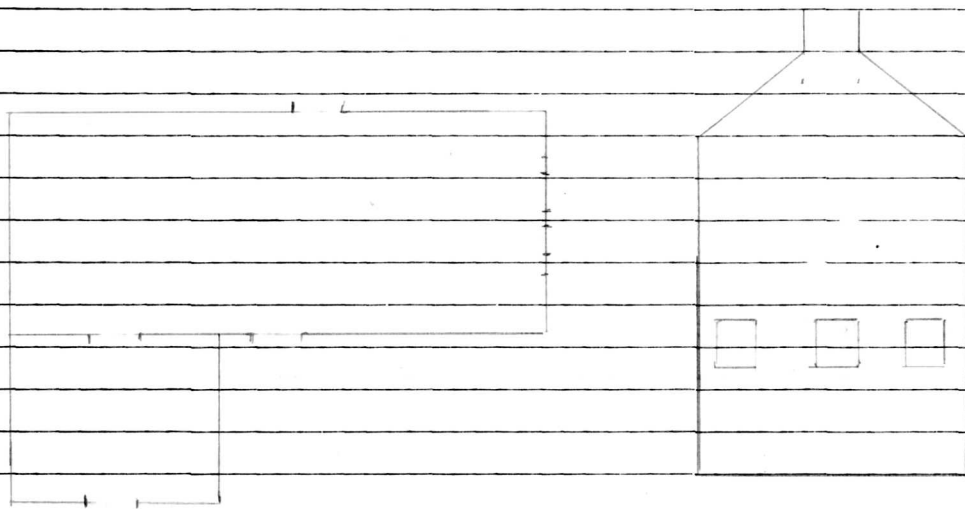
Main structure of mill rectangular in shape with adjoining square 1 1/2 storey building. The wheel housing was originally situated outside the SW wall which has aperture for the wheel axle and a water gate at its base. Building was 3 storey, evidence of third floor level: high windows. 2nd level: timber floors with door from mill into adjoining building and other to rear of mill. Irregular cut stone construction with stone quoins / lime mortar, building is roofless with some remaining timbers on eastern building. Churny beams? at NW and SE ends, possibly bell cote (?) Mill is overgrown and walls covered with ivy. Interior of mill filled with debris.
