According to the farmer, John Gibson,  
This was a farmstead. A large enclosed  
area surrounded by high banks with  
a rough deeply worn trackway running  
from field entrance W  $\rightarrow$  E.

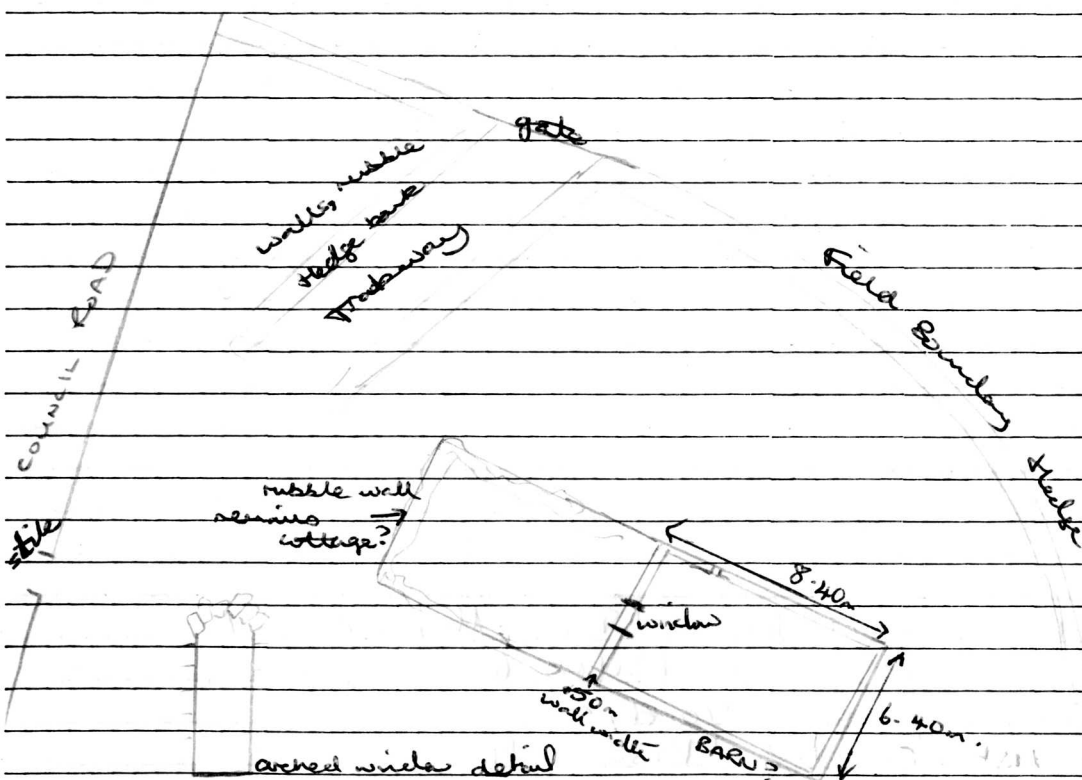
AM/11/4/85

Ruin of several buildings/cottages.  
The ruin of a chapel? barn? sited  
near the centre of the enclosed area,  
rubble stone construction, lime mortar,  
with ventilation slits? low on walls  
and long arched window facing South.  
South and North walls standing to  
approx full height (1½ storeys) of previous  
roof (no remains of roof).

Walls West & East standing to height  
of approx 1m.

Cottage? adjoining South wall.

Other wall remains in NE of enclosure,  
and SW.
