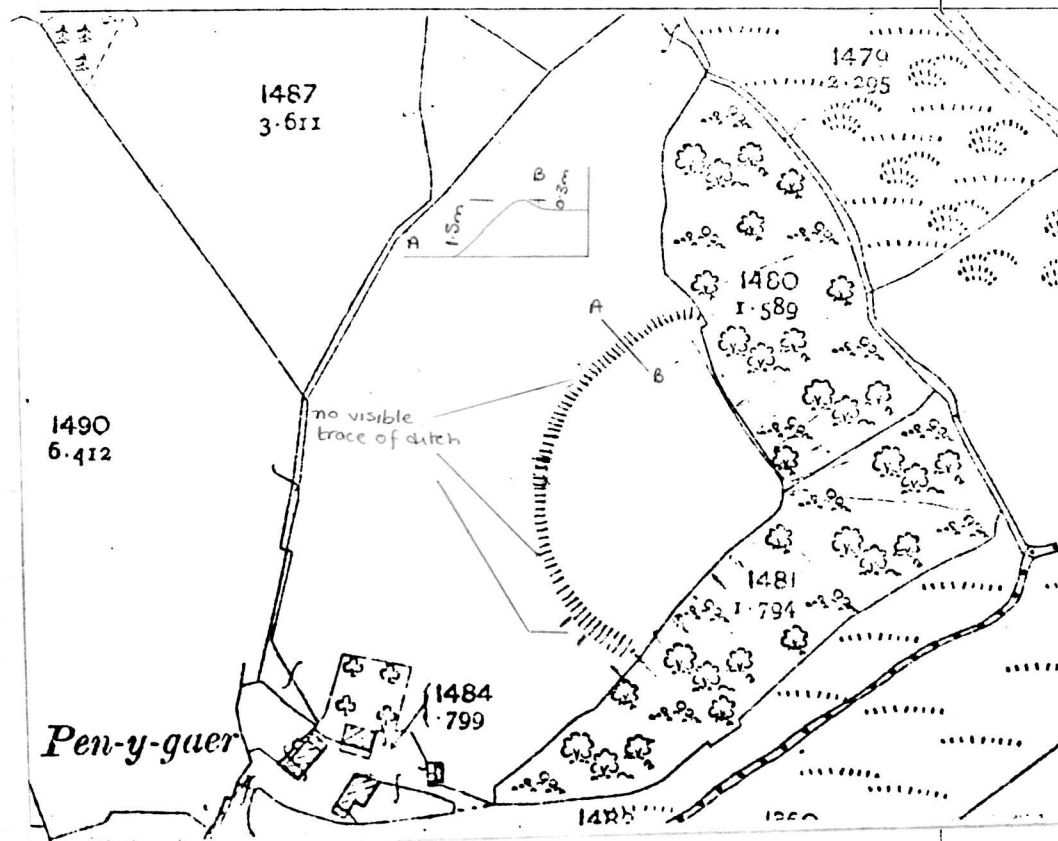
The fort is defended on the east side by steep natural slopes and on the west side by semicircular ramparts. These are much ploughed down, the best preserved area being to the N. the ditch is visible at the northern and southern end of the fort. There is some slight animal erosion and blackthorn growth on the NW bank.
