A derelict drift mine with a large red brick mining building beside the road. See plan in DRF.

L. Weeks DAT  
22.7.85

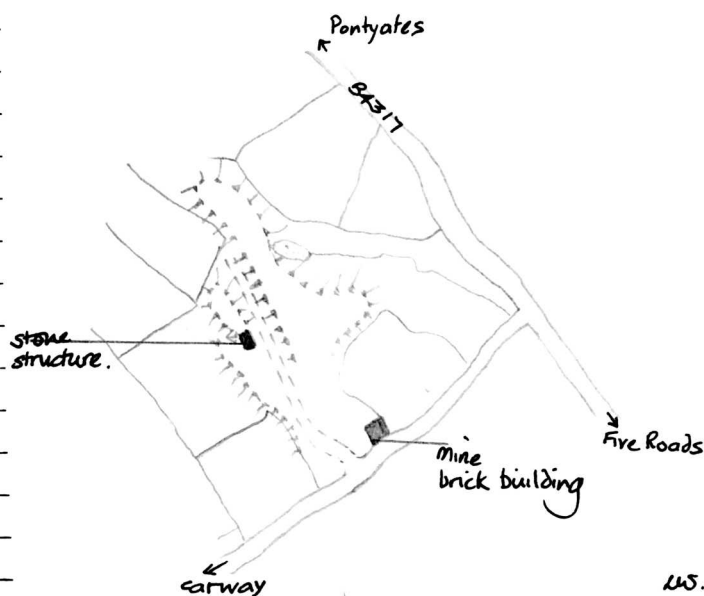
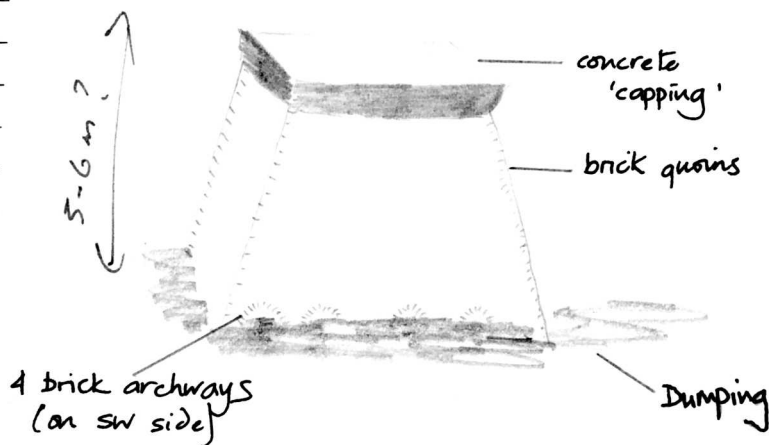
A rectangular pillar type structure (see sketch below) is situated 170m down the track

The purpose of this building is unknown to us, but if the spoil was removed from the base of the structure then features now obscured may suggest a use.

The stone was of various kinds. The western edge of the structure was badly cracked. It appears to have been capped with concrete as a safety precaution.
