by Roger J C Thomas, Royal Commission on the Historical Monuments of England

# PENALLY

# TRAINING CAMP

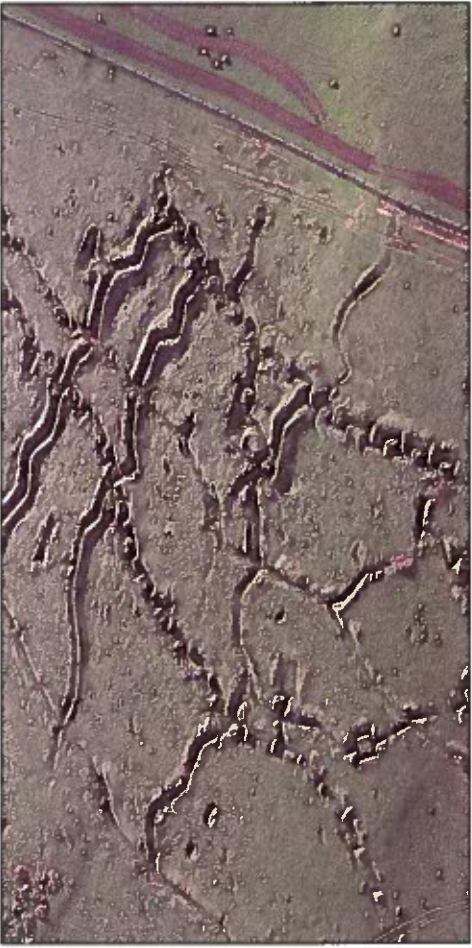
- 1 Digging practice trenches during the First World War
- 2 Penally trenches Crown copyright: Royal Commission on the Ancient and Historical Monuments of Wales
- 3 Volunteer's Field, Penally 1976
- 4 First World War timber barrack hut
- 5 The Guardroom built 1860
- 6 Second World War 'curved asbestos' huts

Practice trenches were also dug at a number of locations, both within and outside of the training area. The largest trench complex remains extant, on the ridge to the south of the railway bridge at Valley Bottom. The complex is located just below the crest of the ridge, and consists of a cremallere (indented plan) fire trench, linked by a number of zig-zag communication trenches, running back to a parallel support trench.

The trenches, which survive to a depth of up to 1.5m in places, are revetted in stone and are traversed to prevent enfilade fire. Evidence of command posts, shelters, and latrines remain as earthwork spurs off the communication trenches.
