Clegyrn, Castle Morris Pembrokeshire Historic Environment Appraisal

September 2013

Jenny Hall, MIfA & Paul Sambrook, MIfA
Trysor

Trysor Project No. 2013/318

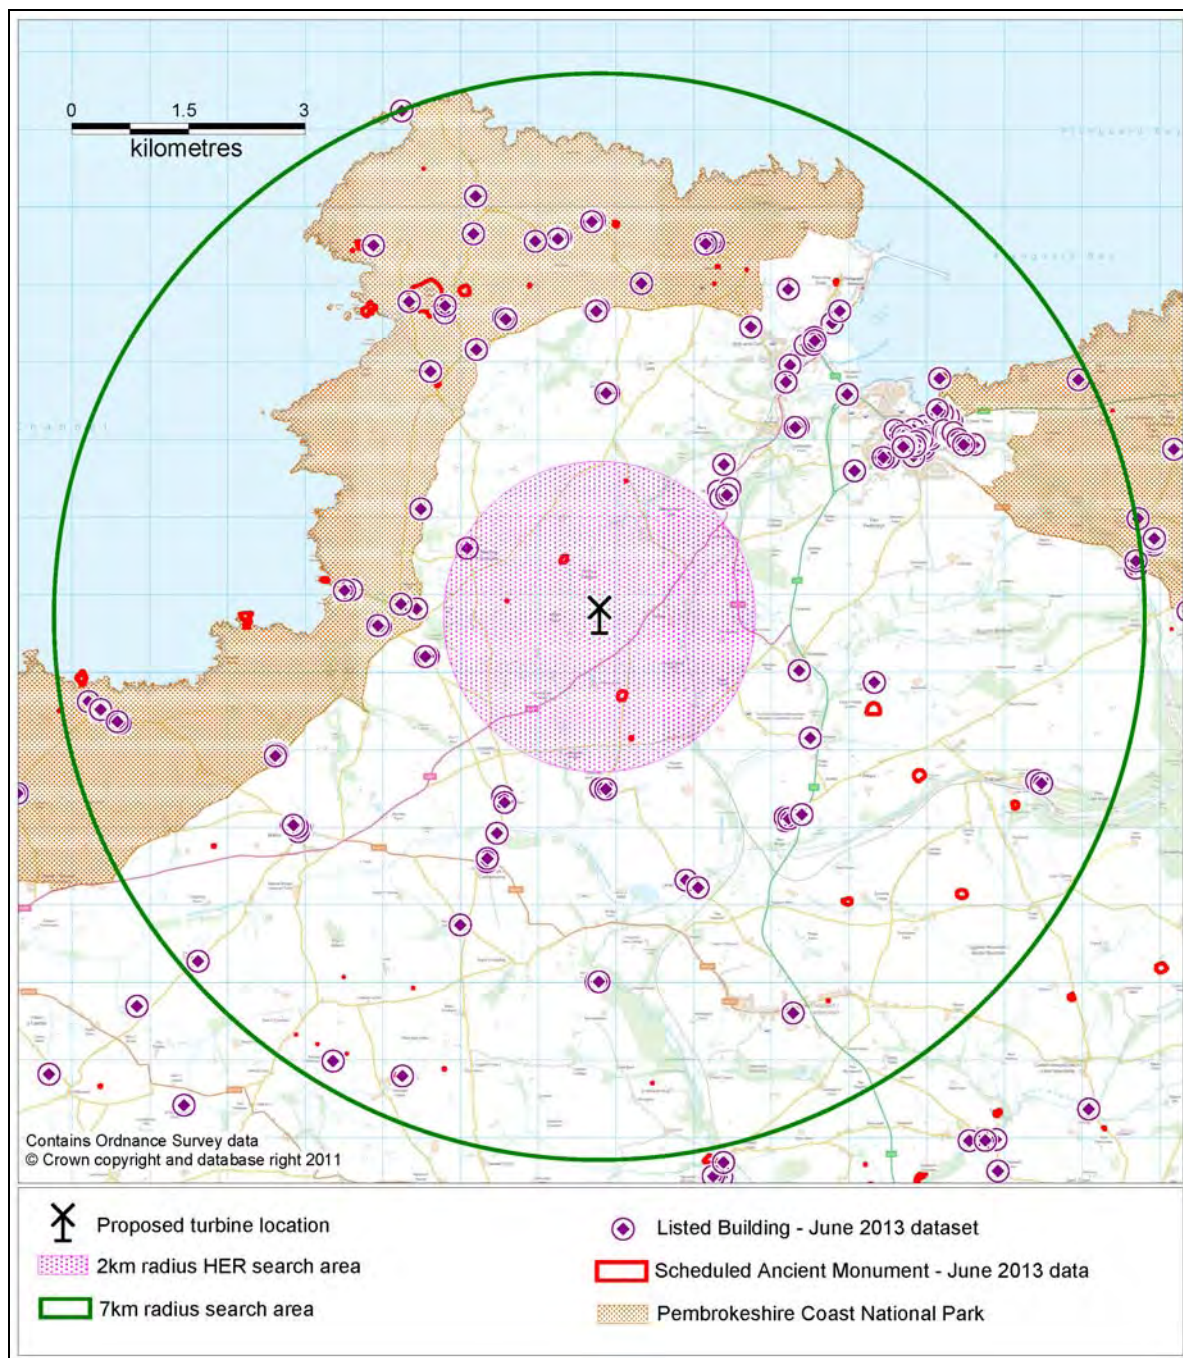
Figure 1: Location of the proposed turbine, showing the 2km radius appraisal area and then a wider 7km radius search area.

5.1 It was proposed that a 50kw single turbine, 24.6m to the hub and 34.2m to the upright blade tip, would be located in a single field parcel at SM9186734755 at Clegyrn, Castle Morris, Pembrokeshire, SA62 5XA, see Figure 1.

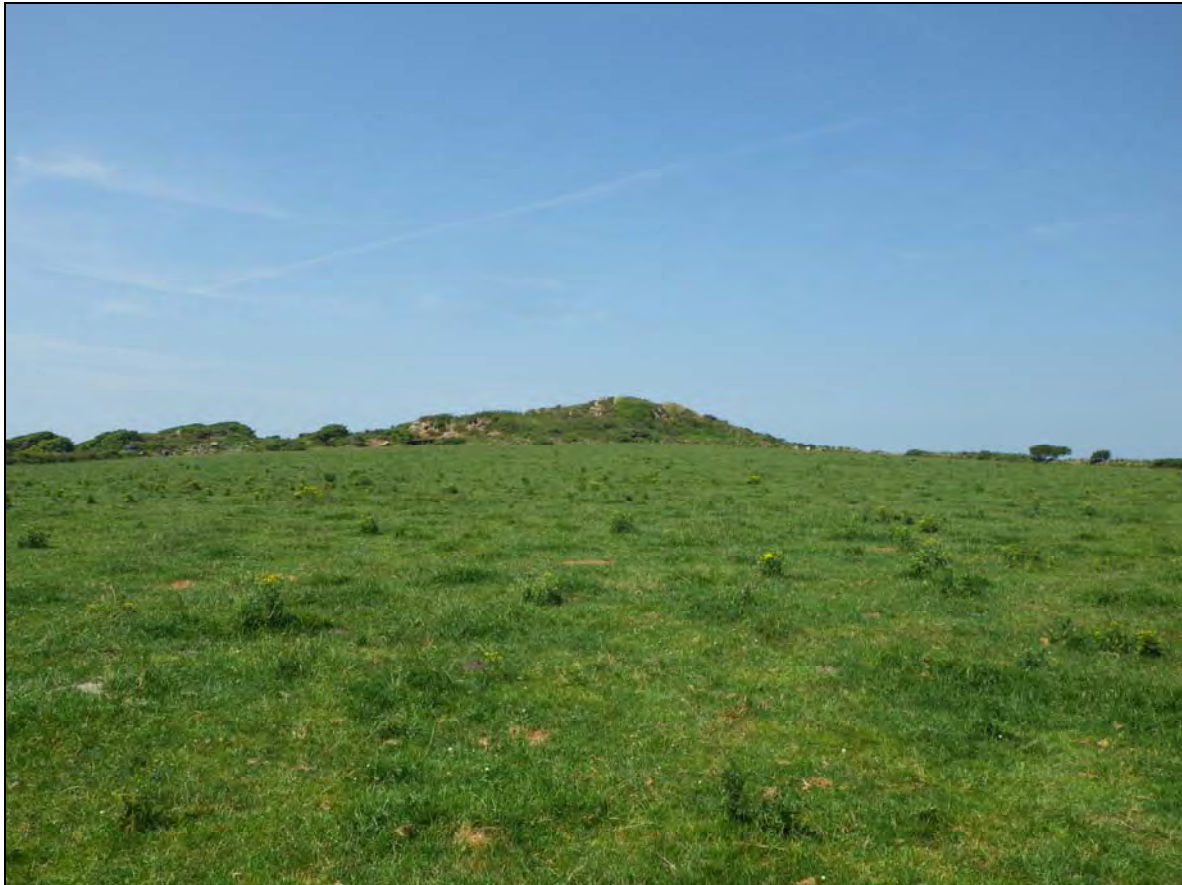
Plate 1: Photograph taken at the proposed turbine site looking northwards towards Pencaer. The Garn, a rock outcrop at the end of the field will block the view of the lower part of the turbine when viewed from the north of Clegyrn.

The impact of the proposed turbine on those parts of the HLC area from where it would be visible are assessed as being Very Low, due to the distances involved, the size of the turbine (35 metres to the tip of the blade) and the fact that the Garn outcrop would obscure the lower part of the turbine from sight when viewed from prominent viewpoints such as Garn Fawr, see Plates 1, 2 & 3.

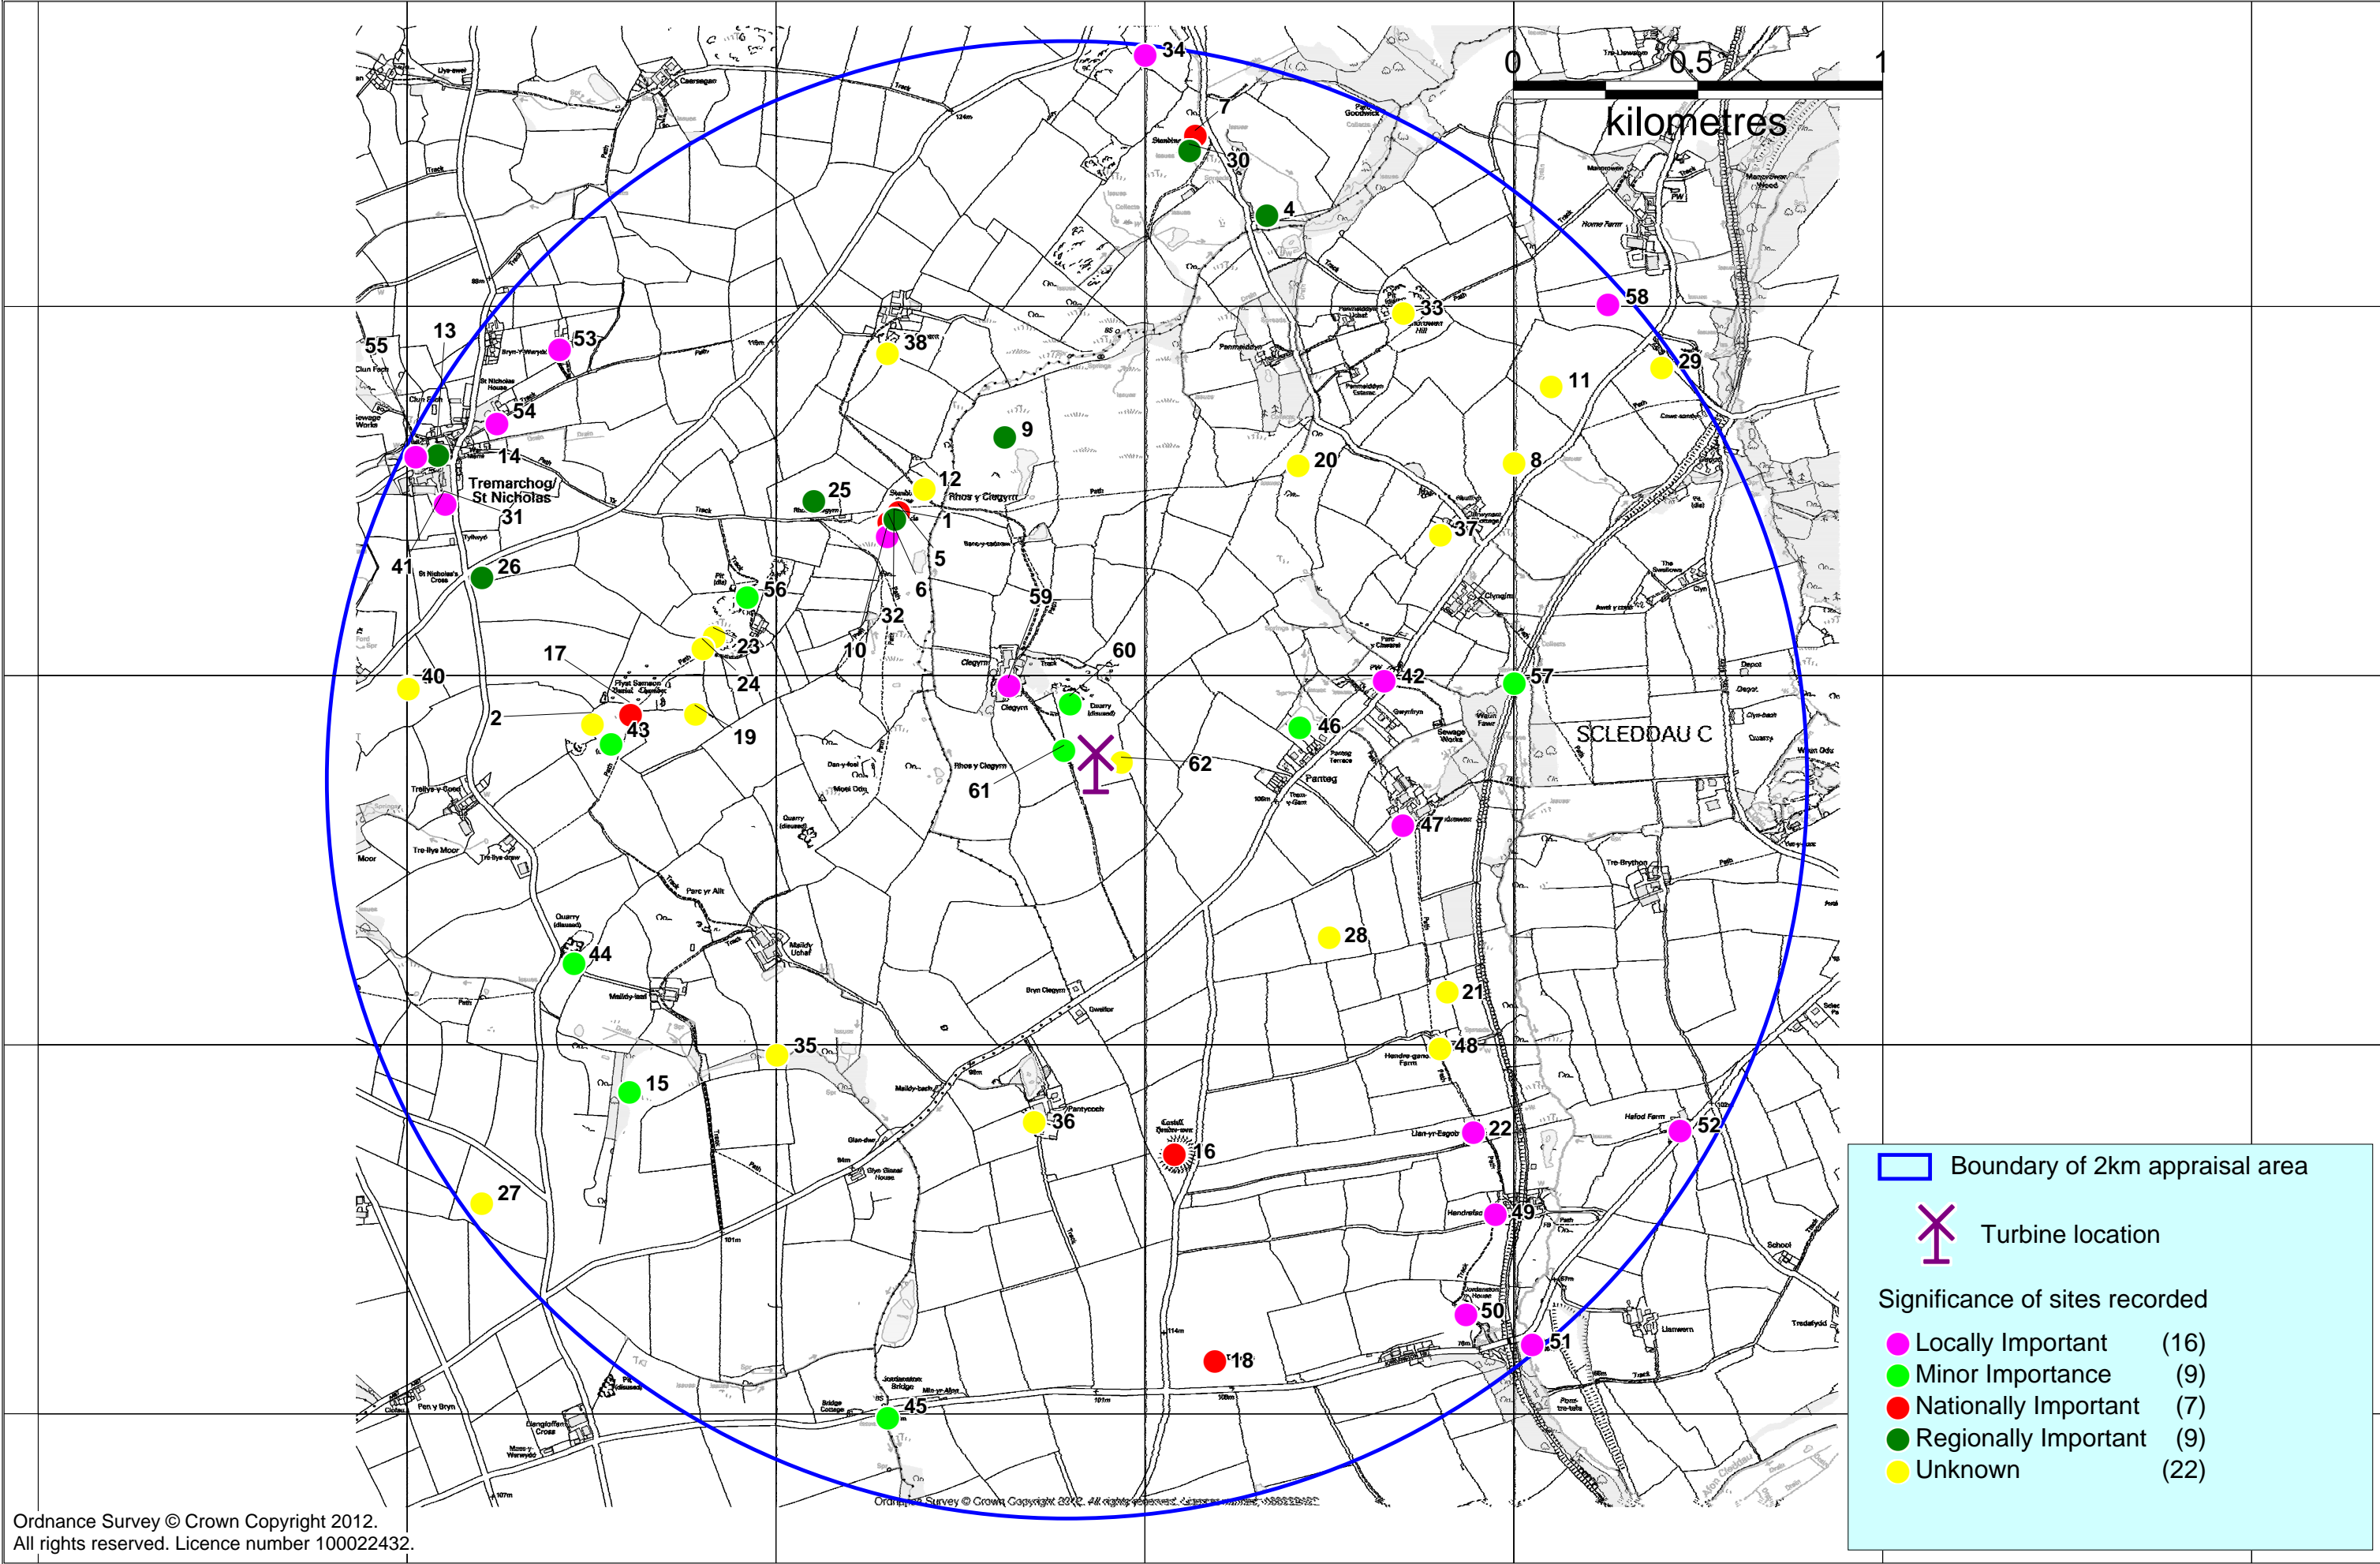
Figure 2: The 2km appraisal area showing sites showing significance, labelled with Project ID number

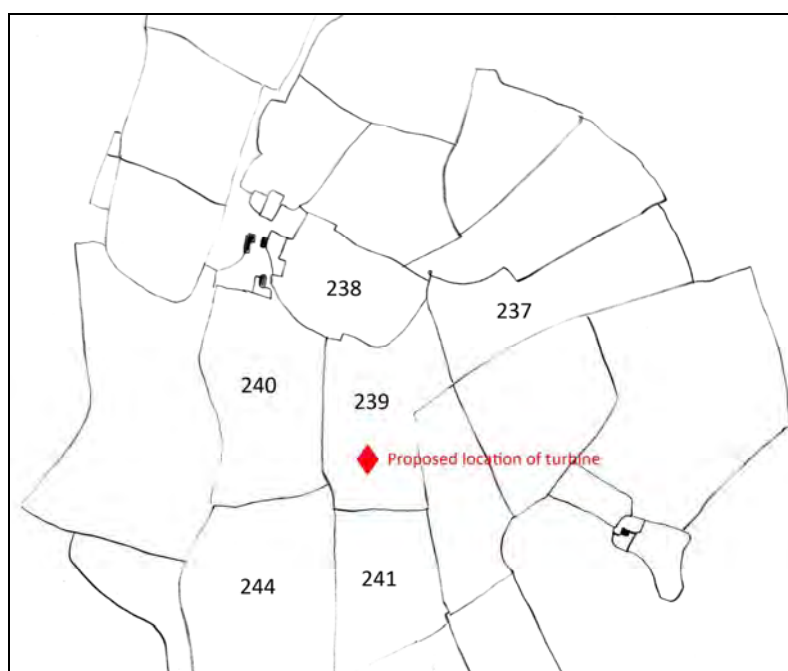
Figure 3: Jordanston parish tithe map

7.3 The field system at Clegyrn (ID number 63) is shown clearly for the first on the Jordanston parish tithe survey in 1840s (apportionment 1843 and map 1846). The field where the turbine would be located has remained the same shape and size since then, as has most of the rest of the field system. The property was noted as being owned by John Colby and occupied by Thomas Beynon (see Figure 3);

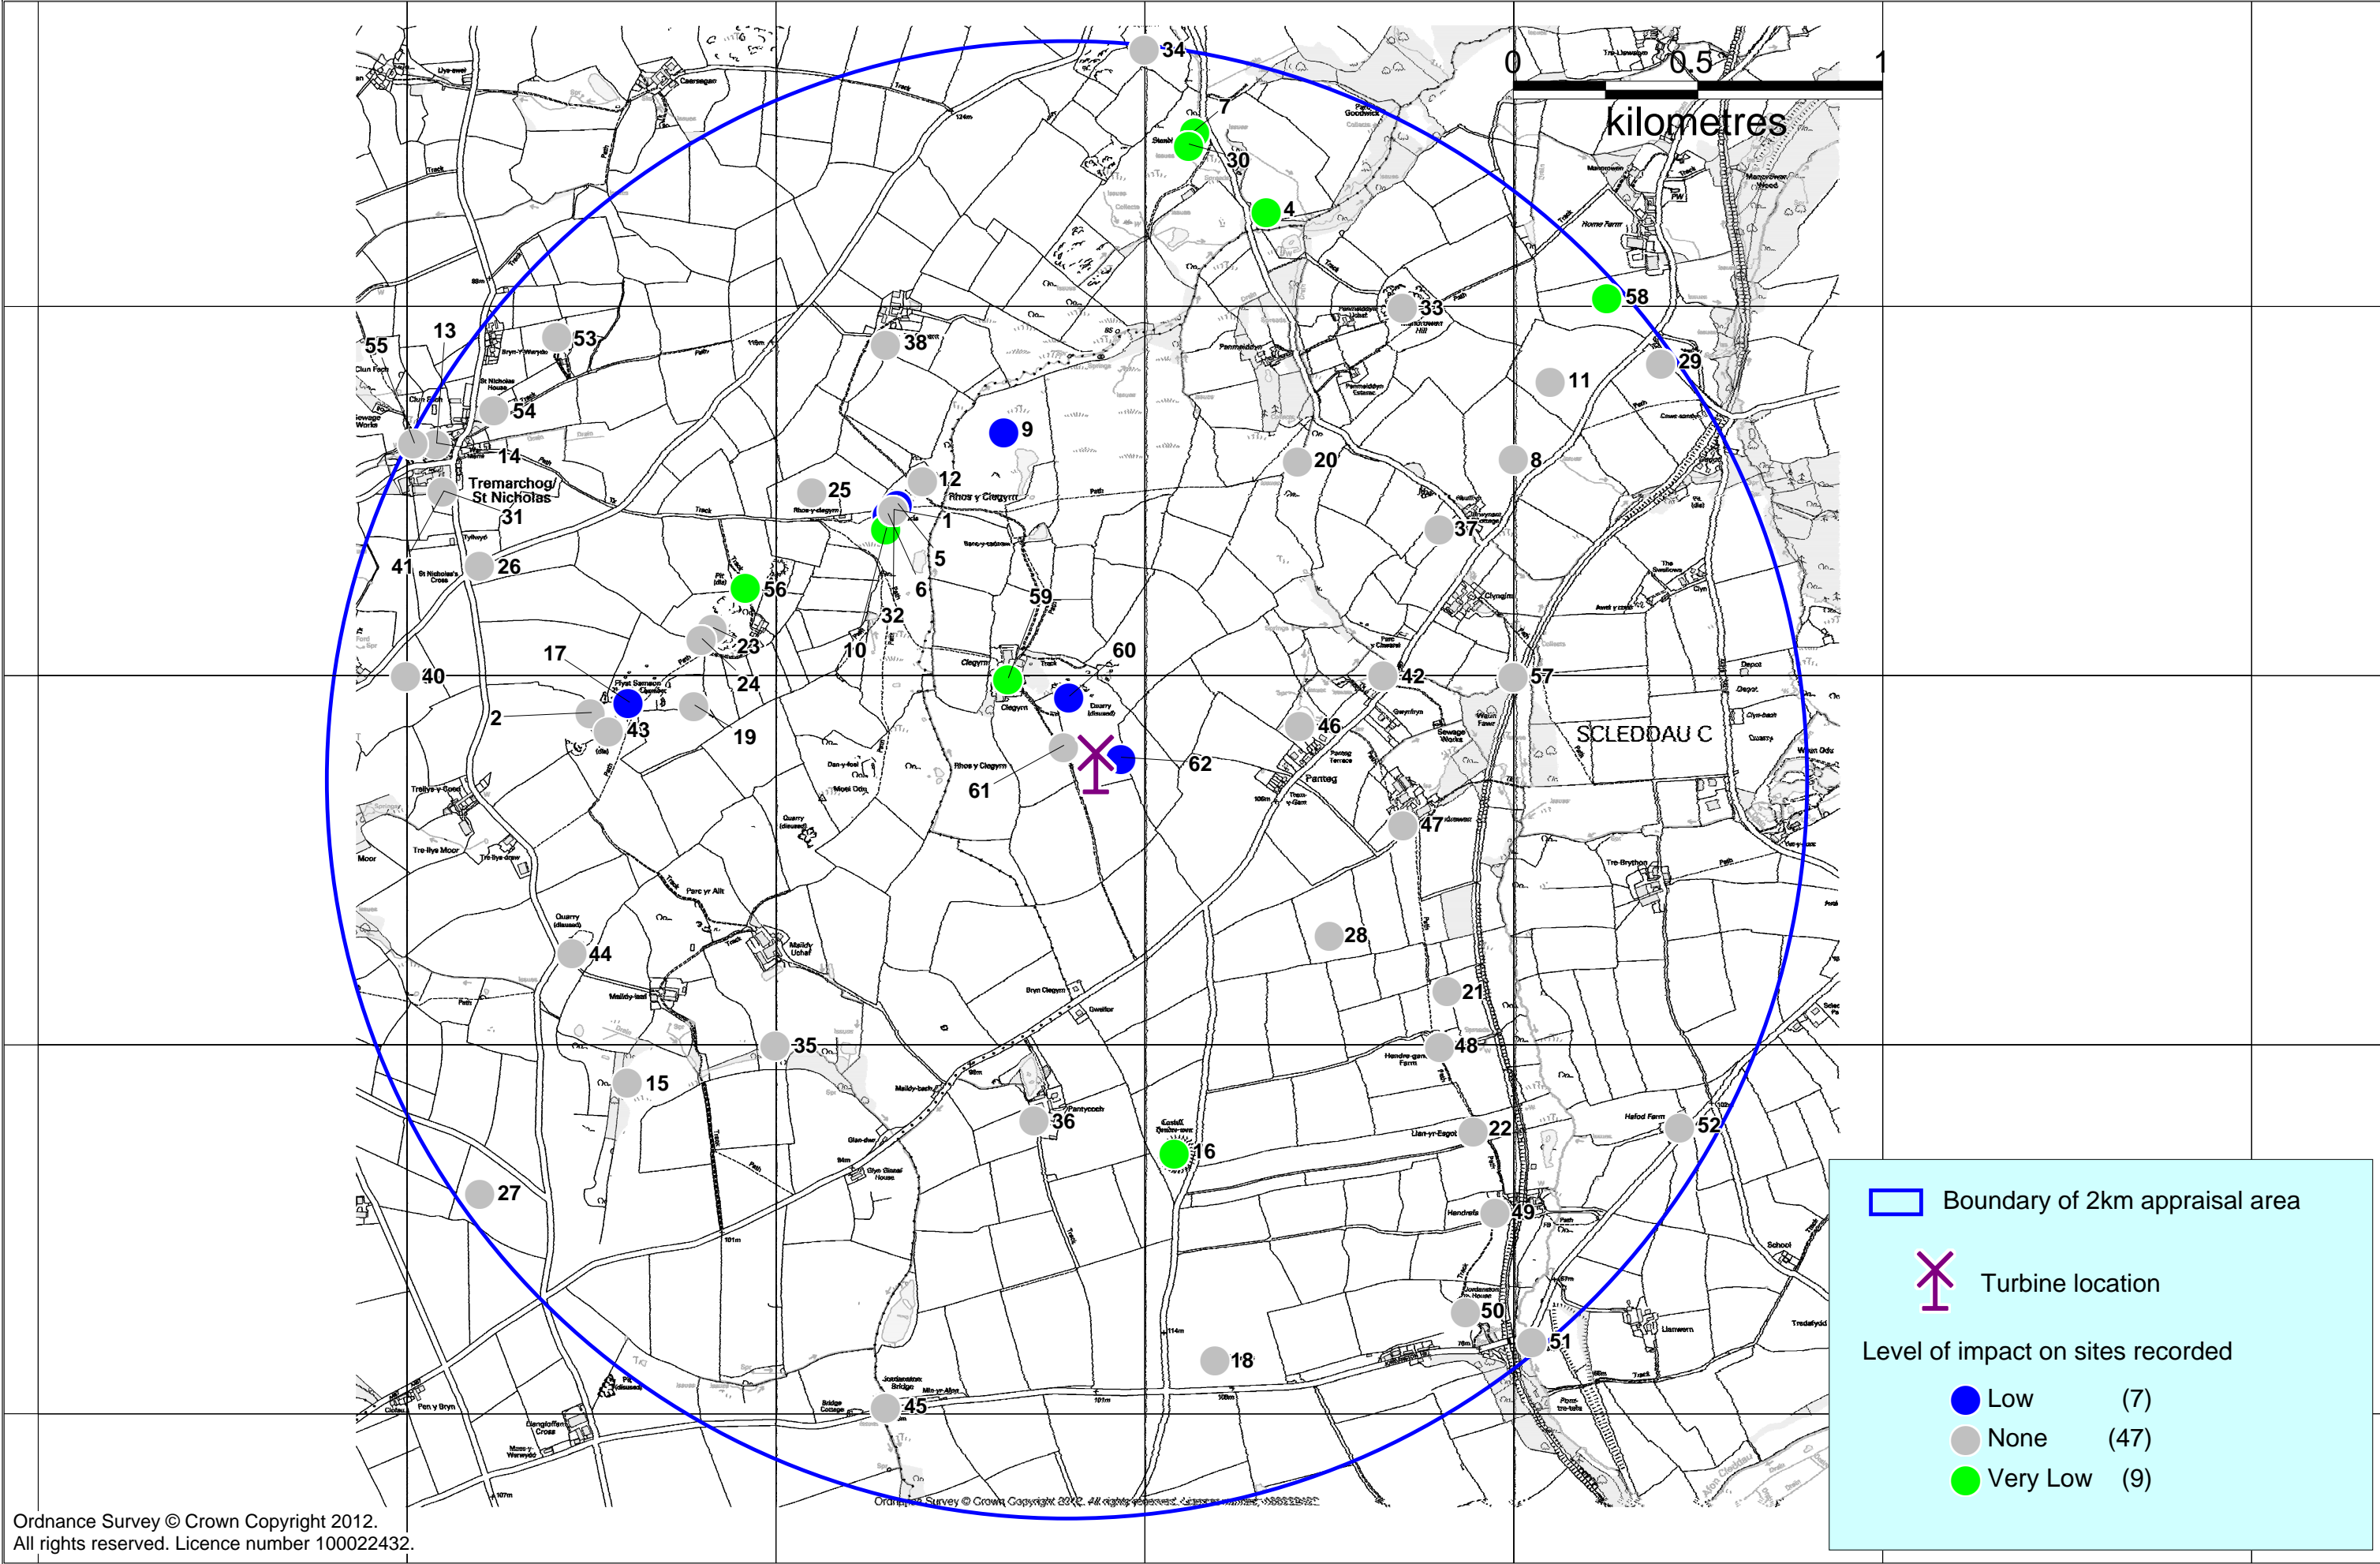
Figure 4: The 2km appraisal area showing sites showing impact, labelled with Project ID number

9.2 The Direct and Indirect impact on each site was assessed taking into account both physical and non-physical impacts. Each impact was assessed within the scale Very Low, Low, Moderate, High and Very High, taken into account the significance of the site and the nature of the impact. A full table is found in Appendix A but a summary is tabulated in Table 1 below and illustrated in Figure 4.

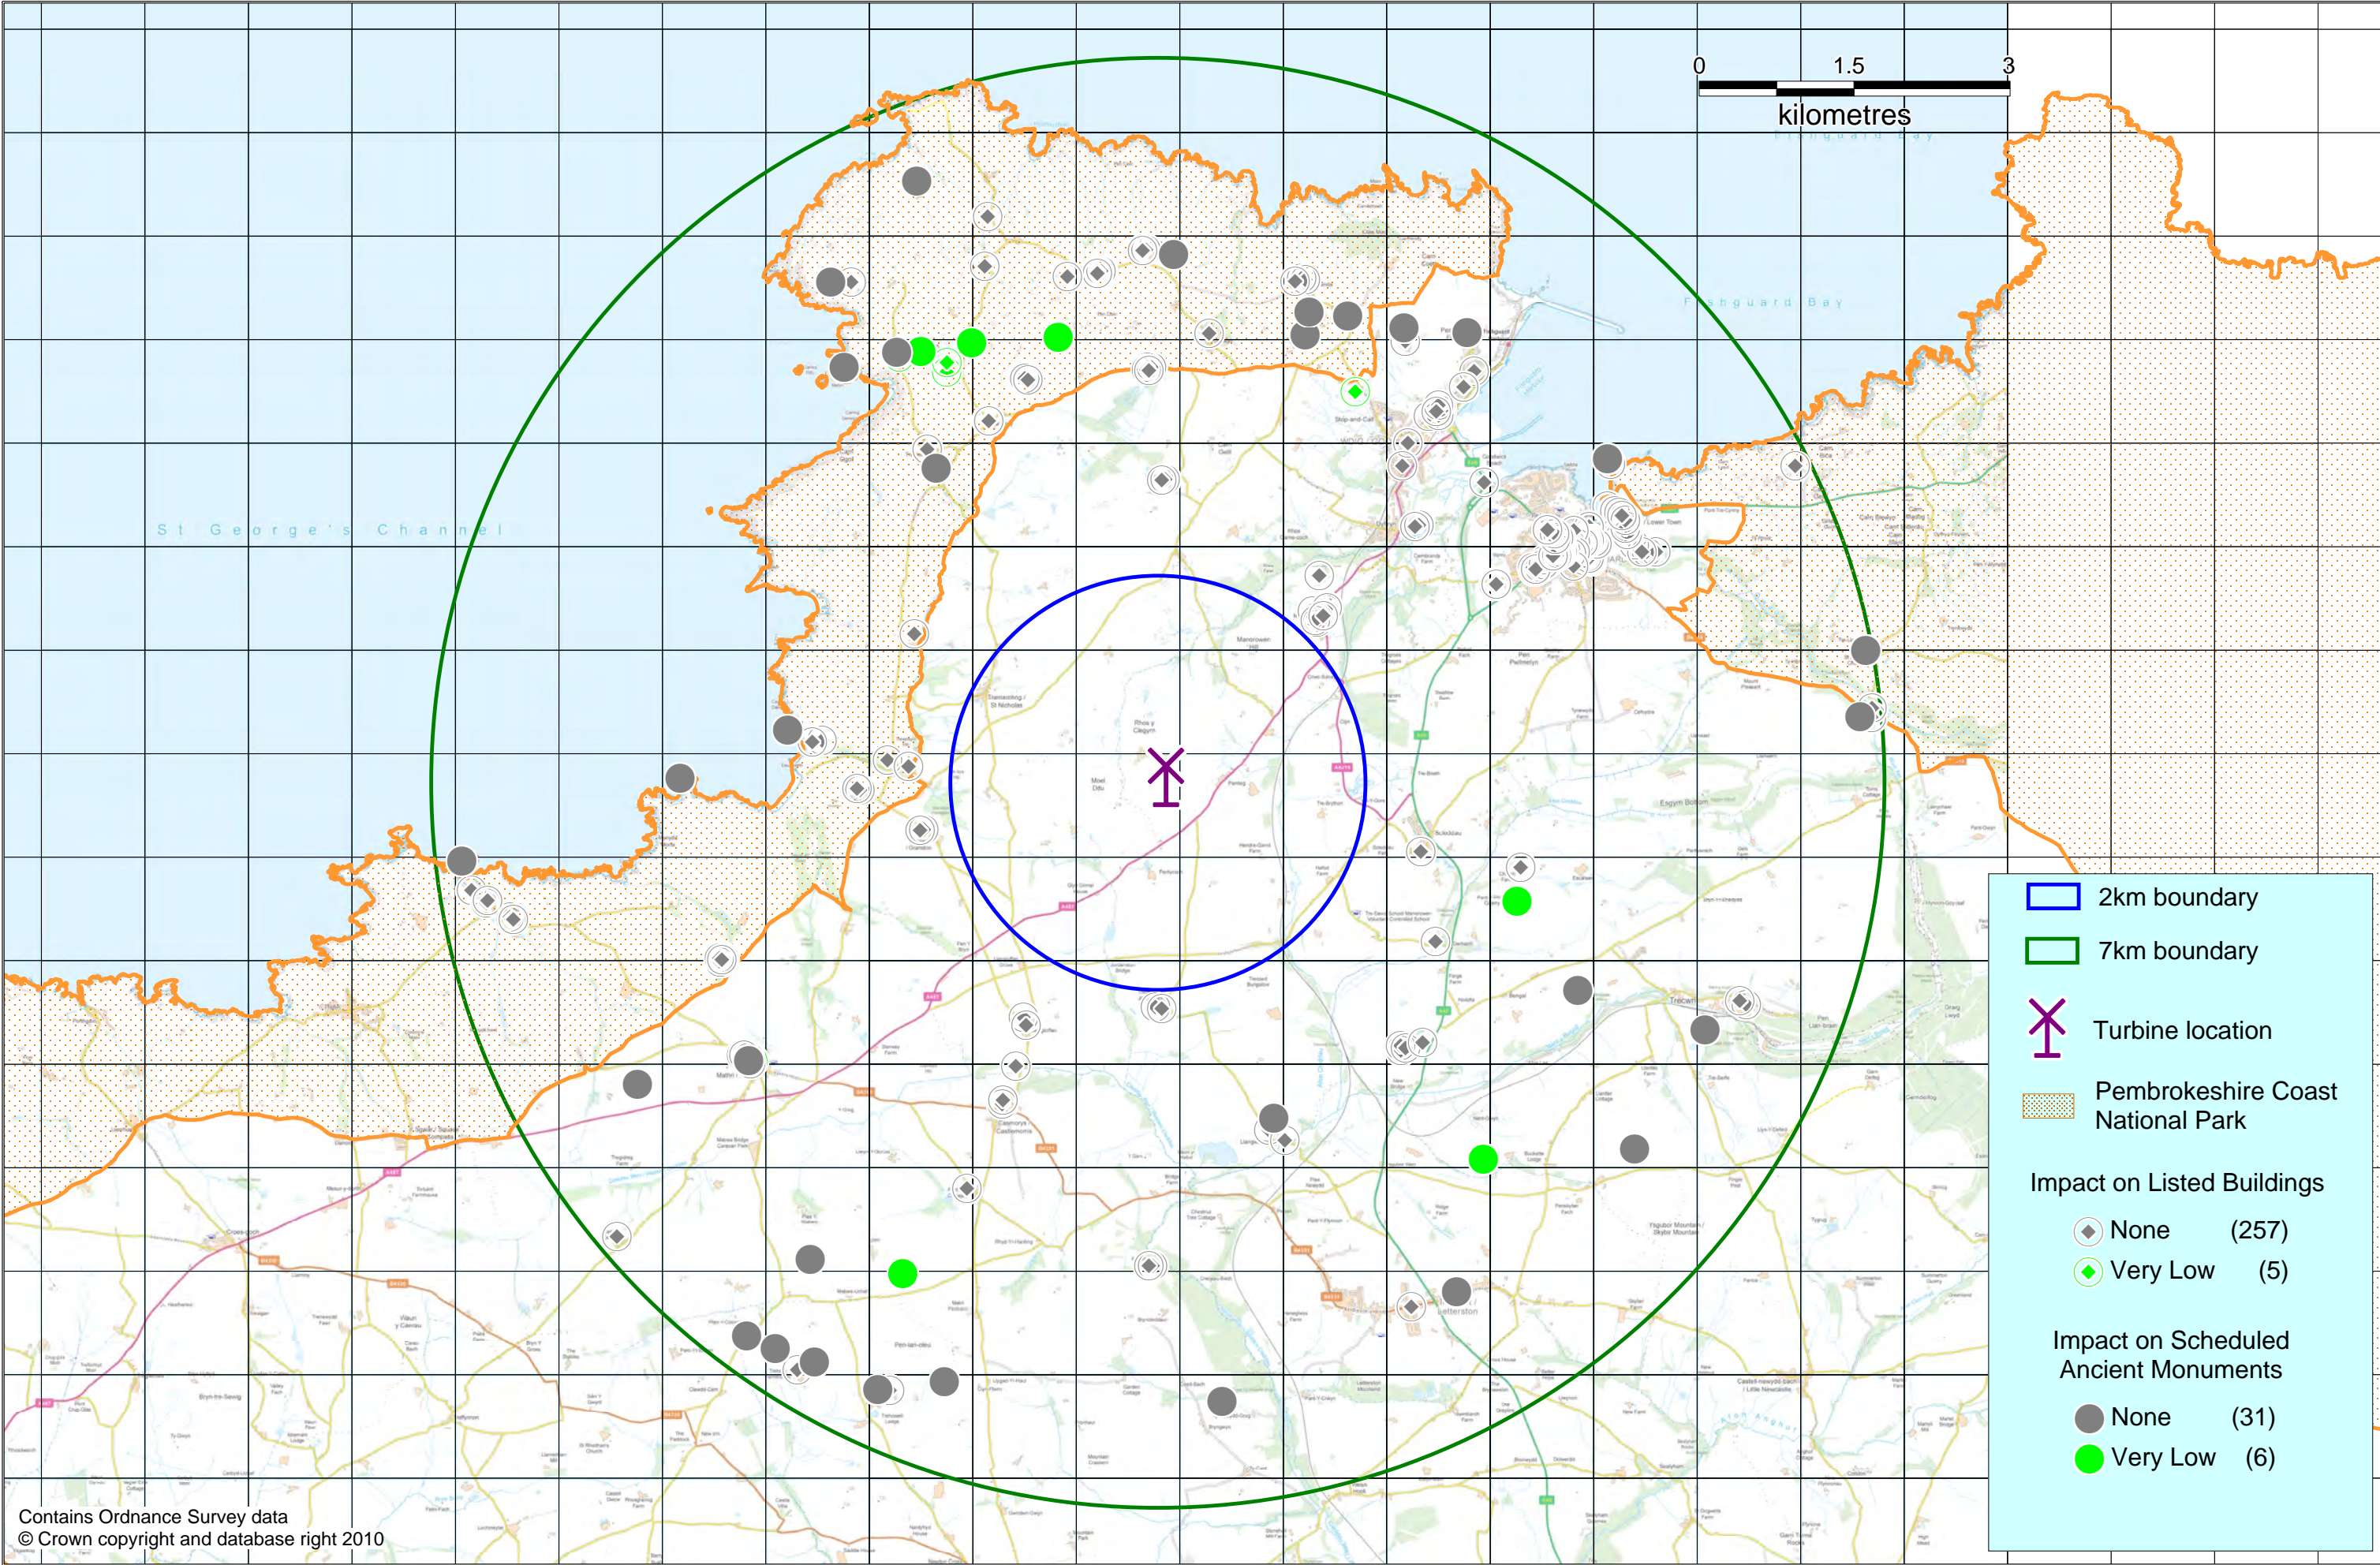
Figure 5: The 2km to 7km area showing the impact on Listed Buildings and Scheduled Ancient Mounuments within that area.

10.2 The indirect impact on Listed Buildings and Scheduled Ancient Monuments was assessed and a summary is illustrated in Figure 5. Five Listed Buildings and six Scheduled Ancient Monuments would have a Very Low impact from the proposed turbine, with partial intervisibility over distance and no effect on setting.

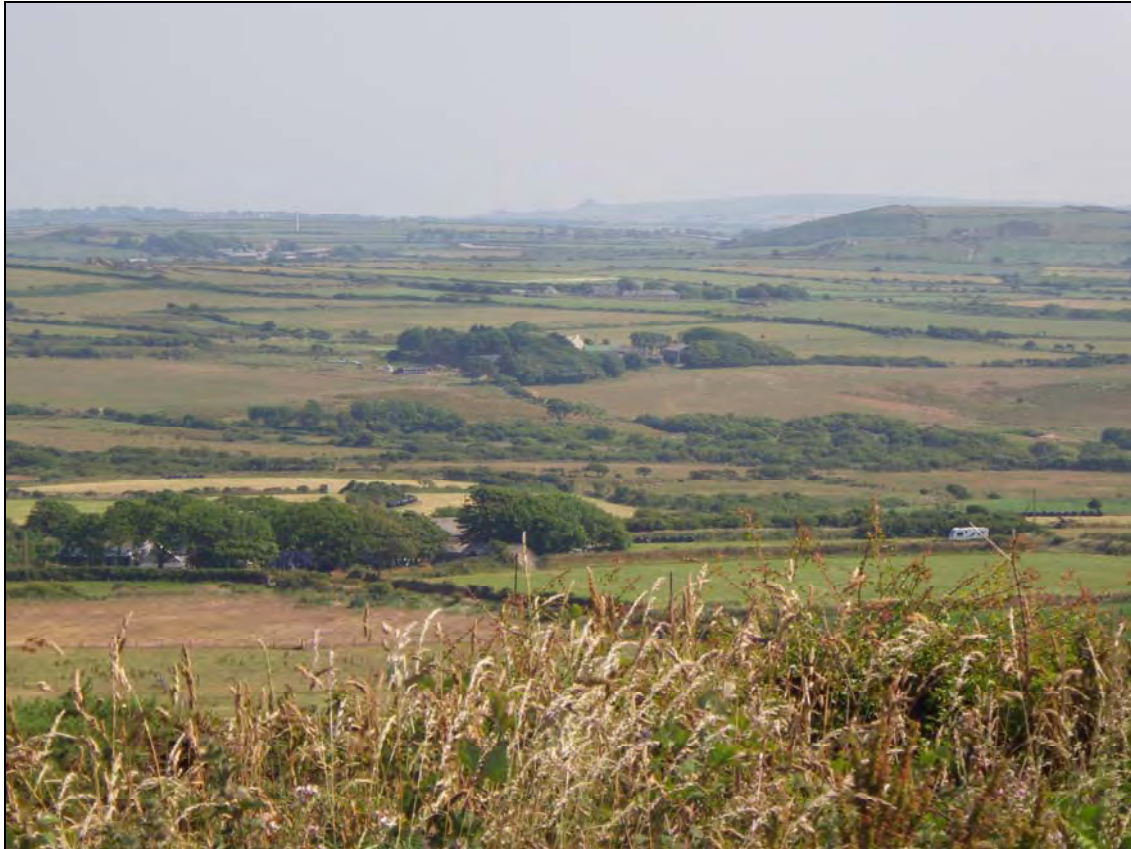
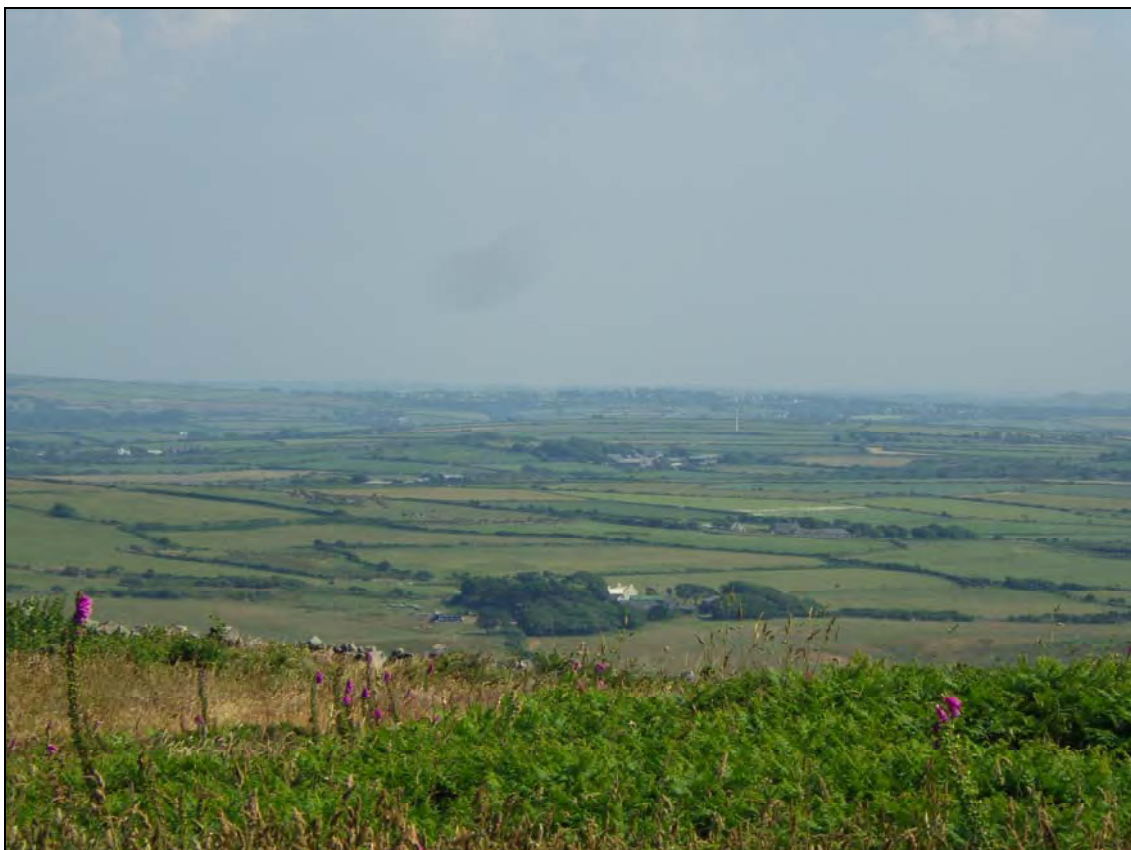
Plate 2 & 3: Viewed from Garn Fawr in clear conditions, the existing turbine at Gwelfor is not a dominant or significant feature in the landscape. The Clegyrn turbine would be less visible as it would be partly hidden behind the Garn outcrop.

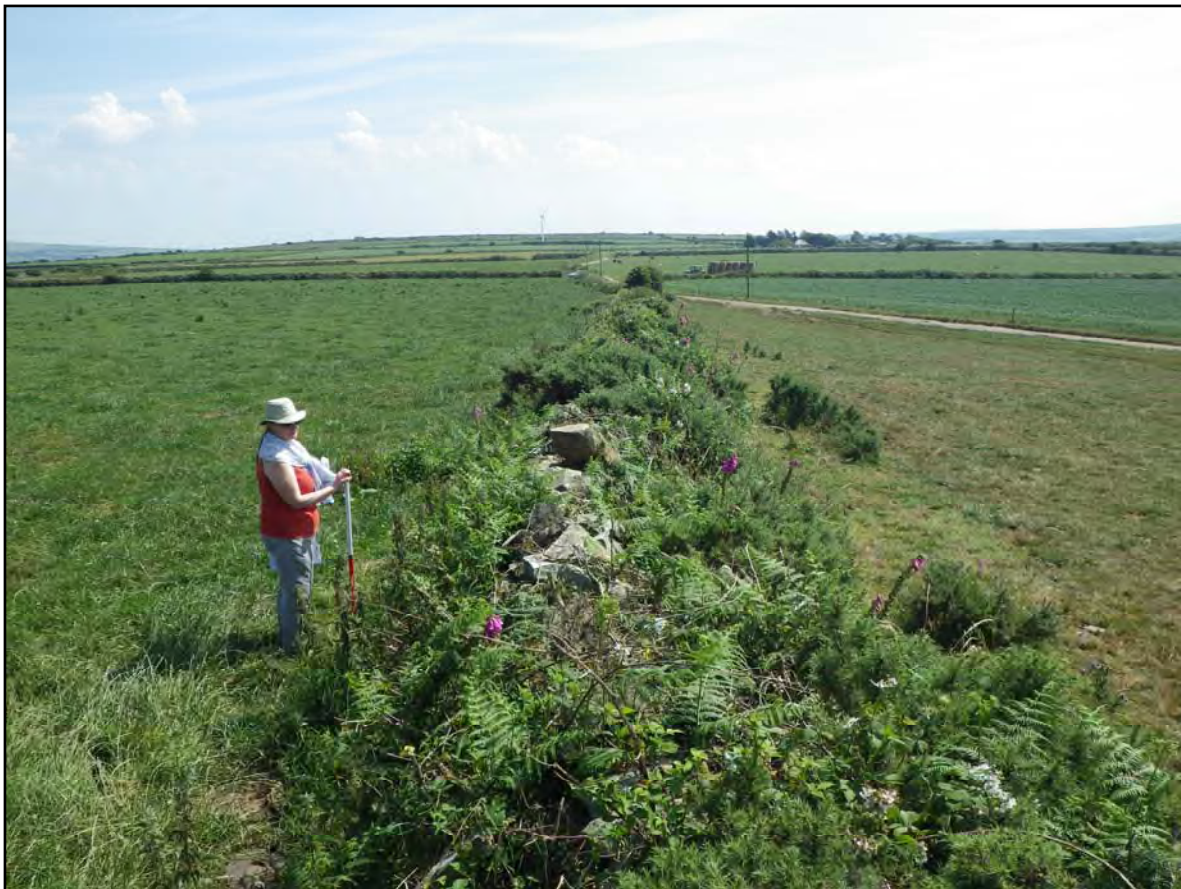
Plate 4: Looking south southeast along the field boundary ID number 61

ID number: 61 CLEGYRN FIELD BOUNDARY
HER PRN: NMR NPRN: 0
NGR: SM9178034811 Grid reference taken at point along linear site
Broadclass:
Period: Post Medieval
Form: Earthwork **Condition:** Near Intact
Site Status: **SAM number:** **LB number:** 0 **grade:**
Description: This field boundary is a straight bank, composed of earth and stone and covered with gorse and bracken when seen in the summer of 2013. The vegetation is suggestive of the land here being marginal land prior to enclosure during earlier post-medieval times. The bank has a rounded profile, standing up to 1 metre high. It is c.275 metres long and runs north-northwest to south-southeast. It appears on the parish tithe map of 1846.
Rarity: Common
Reference:
Documentation:
Group Value: Part of field system of Clegyrn farm
Evidential Value: Largely intact earth and stone feature.
Historical Value: None
Aesthetic Value: None
Communal Value: None

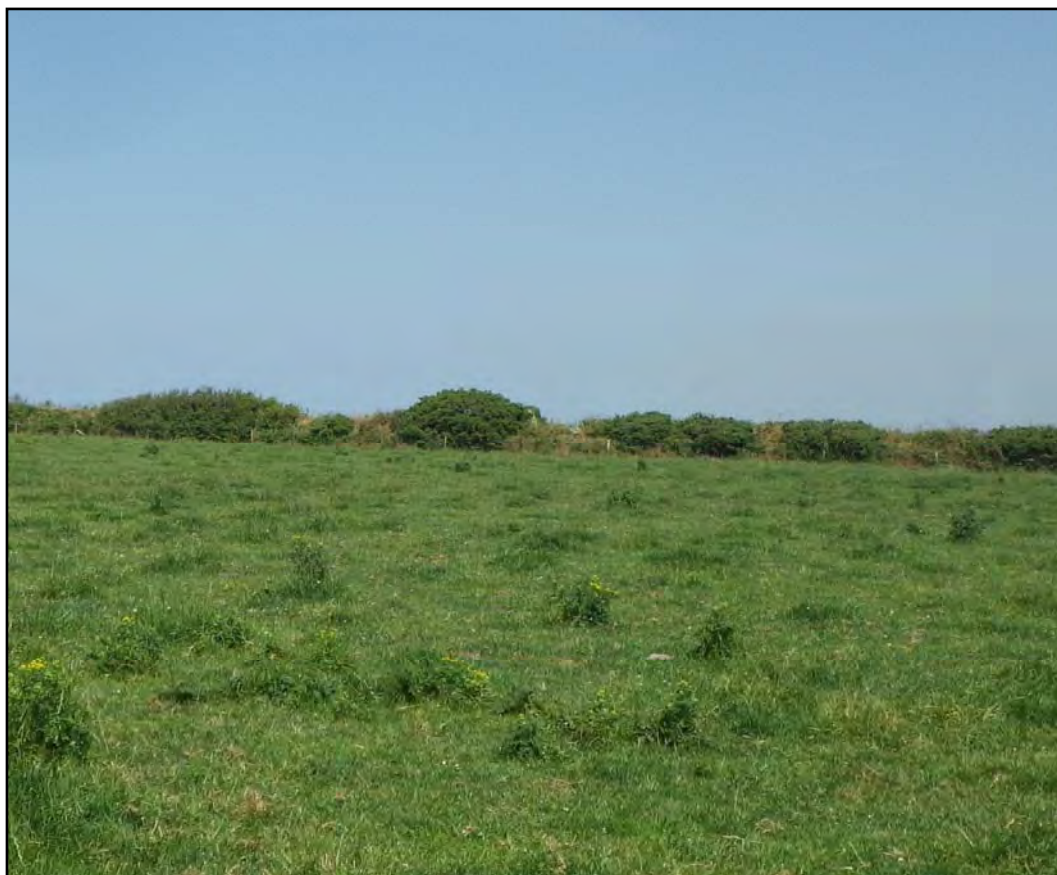
Plate 5: The stone (ID number 62) can be seen on the right hand edge of a bush. It stands in the eastern boundary of the field that the turbine would stand in, photograph looking east.

1.6 On the basis of this appraisal, the only archaeological mitigation thought necessary is a watching brief on the excavation of the turbine foundation hole and the associated cable trench, in view of the proximity of stone (ID number 62) at the edge of the field. The possibility of buried archaeological features cannot be ruled out in this context.
