Coachlands, Carew, Tenby Pembrokeshire

Historic Environment Appraisal

Planning number: 14/0427/PA

Report by: Trysor

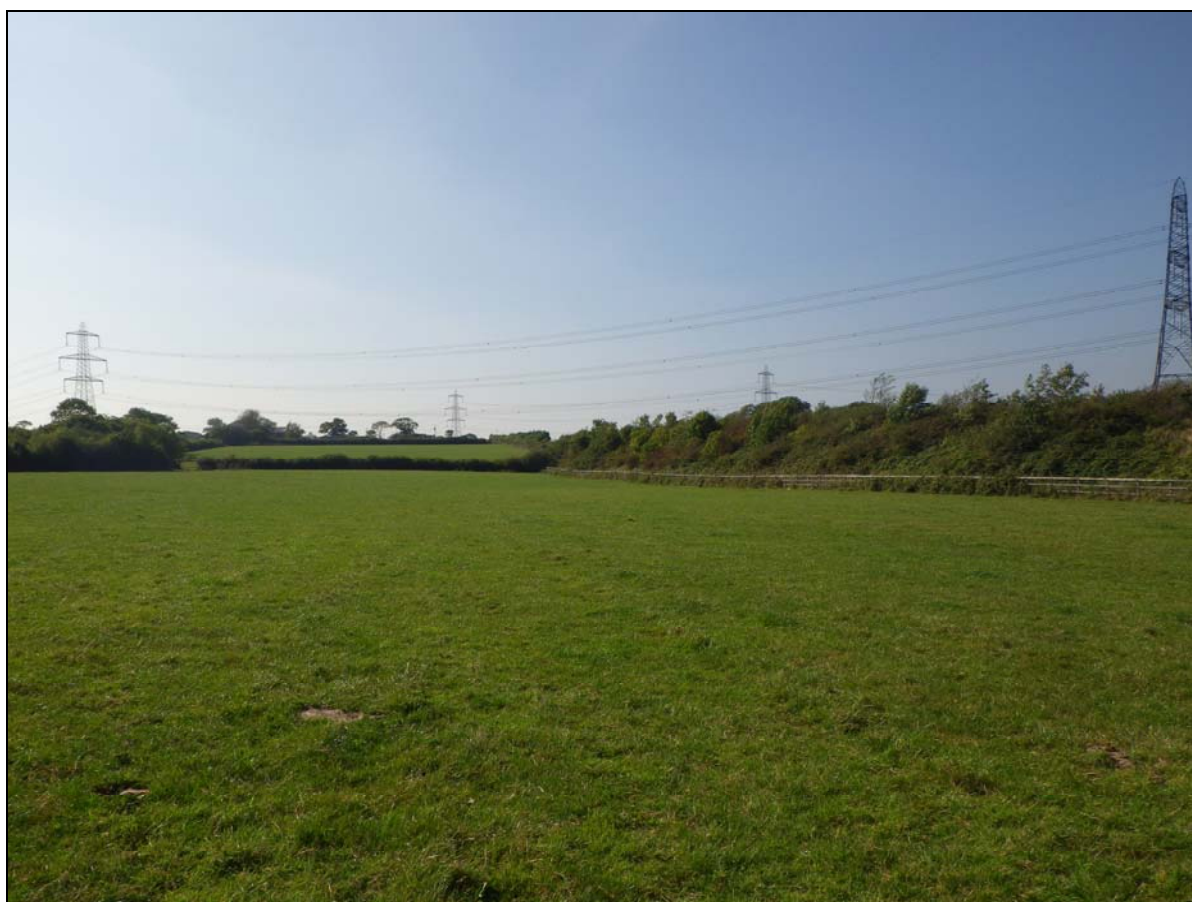
Cover photograph: From the approximate location of the proposed turbine, looking west, with pylons and bypass embankment in view. Carew Castle lies 2.8km away in this direction.
