# Drim and Highfield Archaeological Appraisal

Report by: Trysor

**For: Bowler Energy**

Trysor Project No. 2012/261

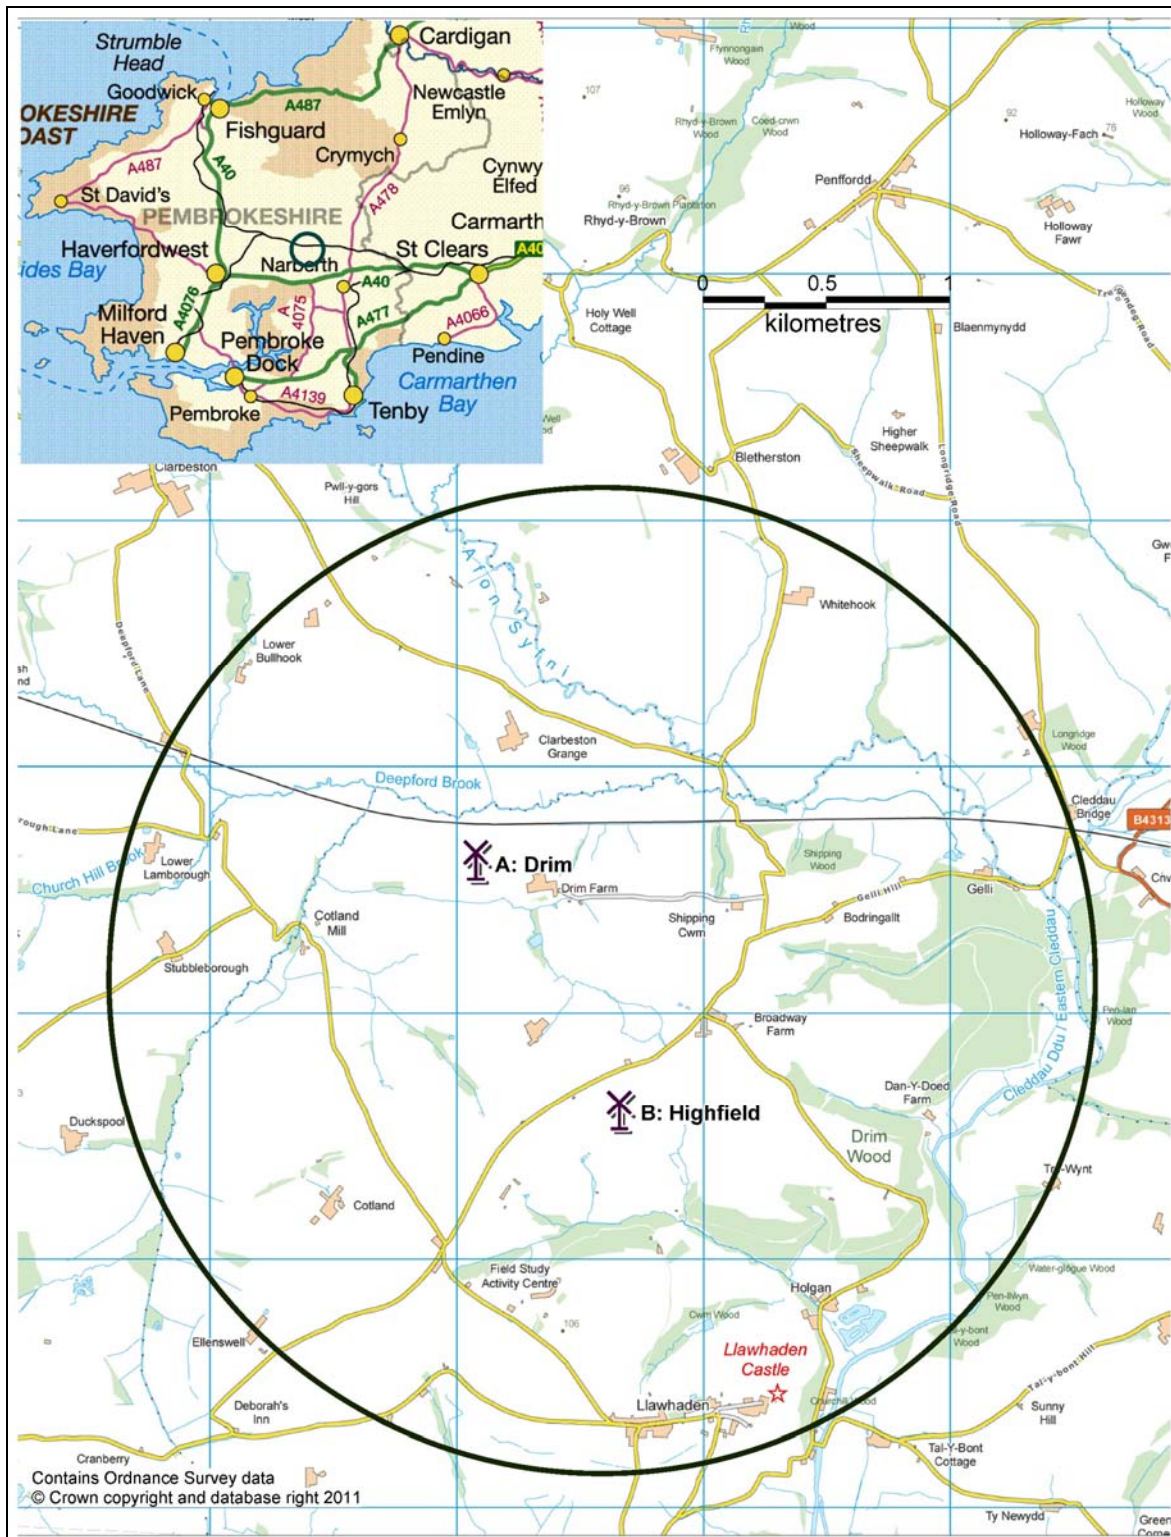
Figure 1: Location of the two proposed turbines

It is proposed that an 11kw Gaia wind turbine, which has an 18m tower and blades of 13m diameter, will be located at SN0600219645 on Drim Farm. A second turbine, a 50kw Endurance Turbine, with a 24m or 36.5m tower and three blades of 19.2m diameter, is proposed for SN0666518595, at Highfield, see Figure 1.

Each turbine will require a foundation hole approximately 6 metres square and will serviced by cable trenches to nearby existing transformers.

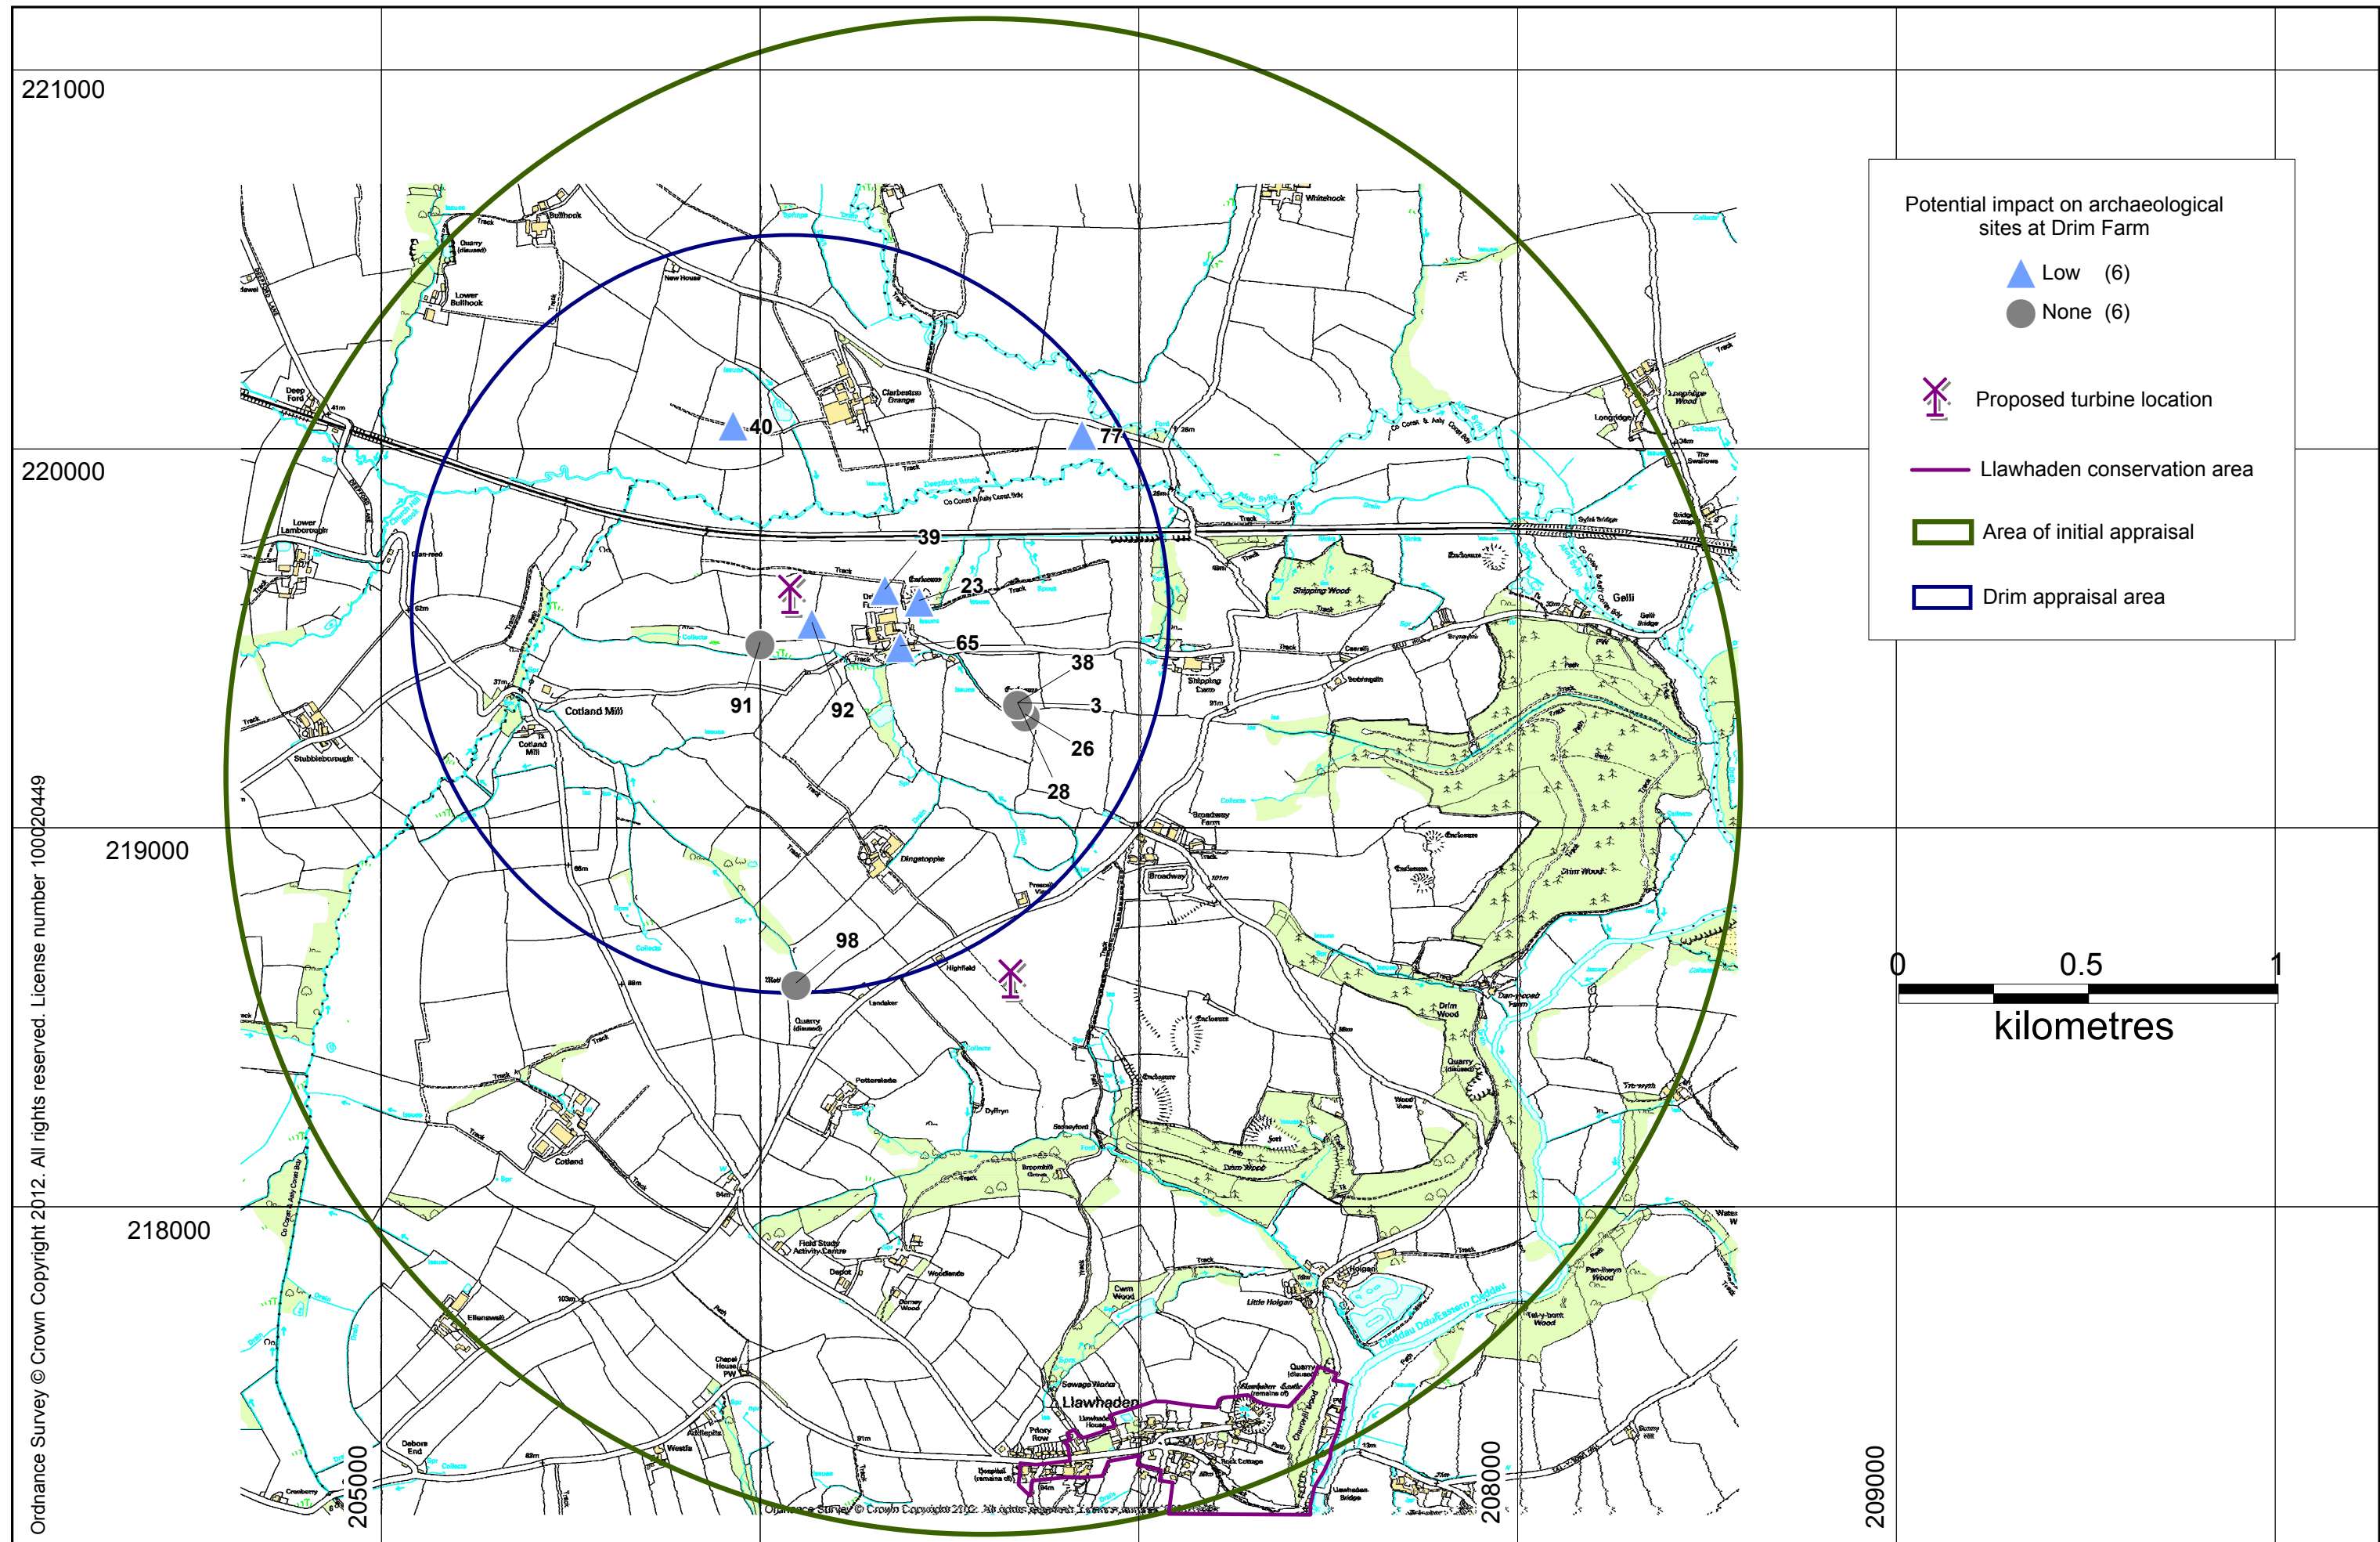
Figure 2: Assessment of the impact of the proposed turbine at Drim Farm on the recorded historic assets

6.4 As Table 1 and Appendix A show, no archaeological sites within a 1km radius were determined to be exposed to any significant impact from the proposed turbine development. (Details of the appraisal for direct and indirect impact for each of the sites in Table 1 can be found in Appendix A).

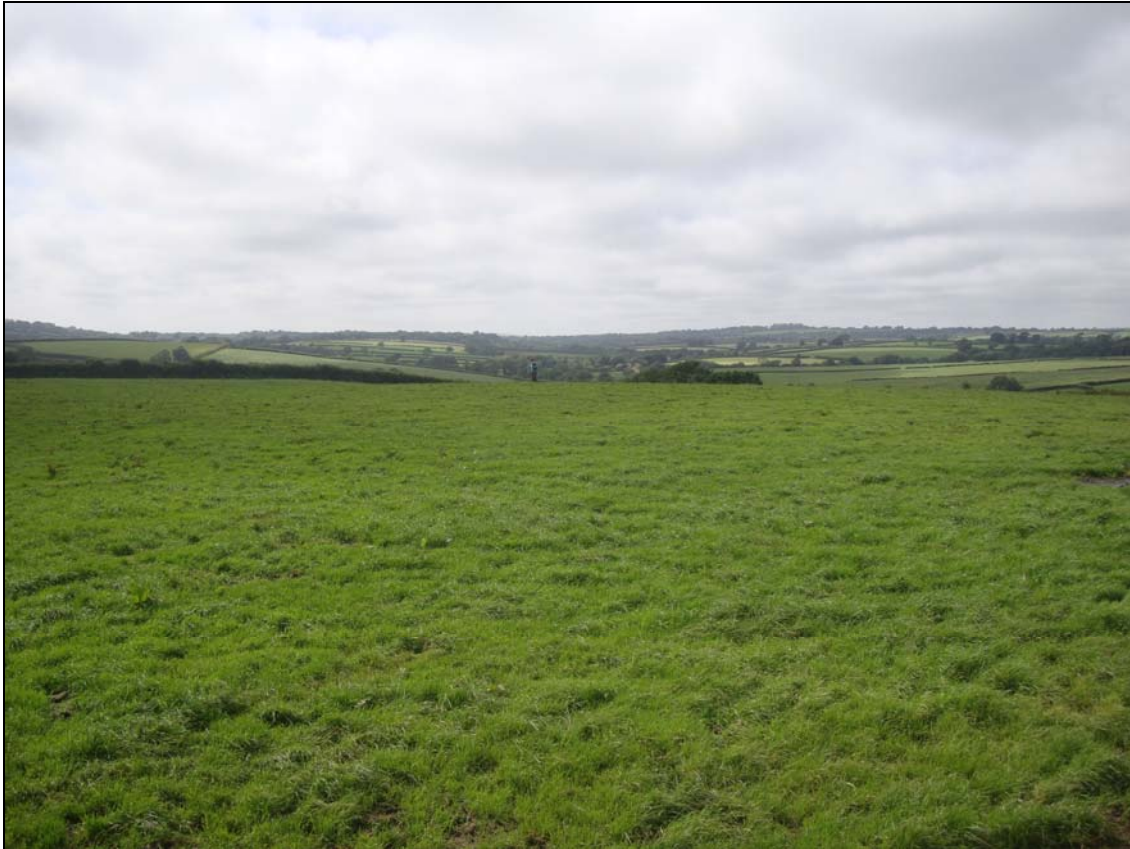
*Plate 1: A view of the proposed location of the Drim Farm turbine, looking west.*

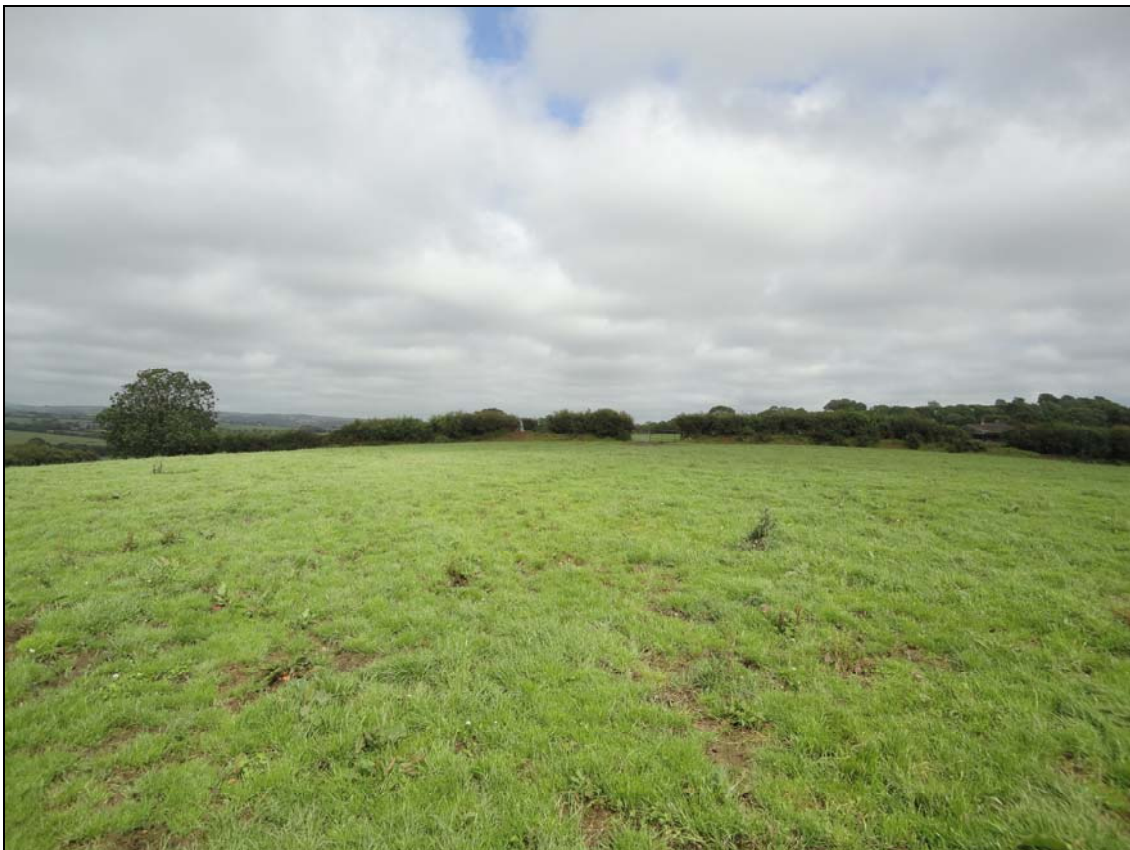
*Plate 2: A view from the proposed location of the Drim Farm turbine, looking east. Drim Castle is out of sight behind two hedgerows and a slight rise in the land surface.*

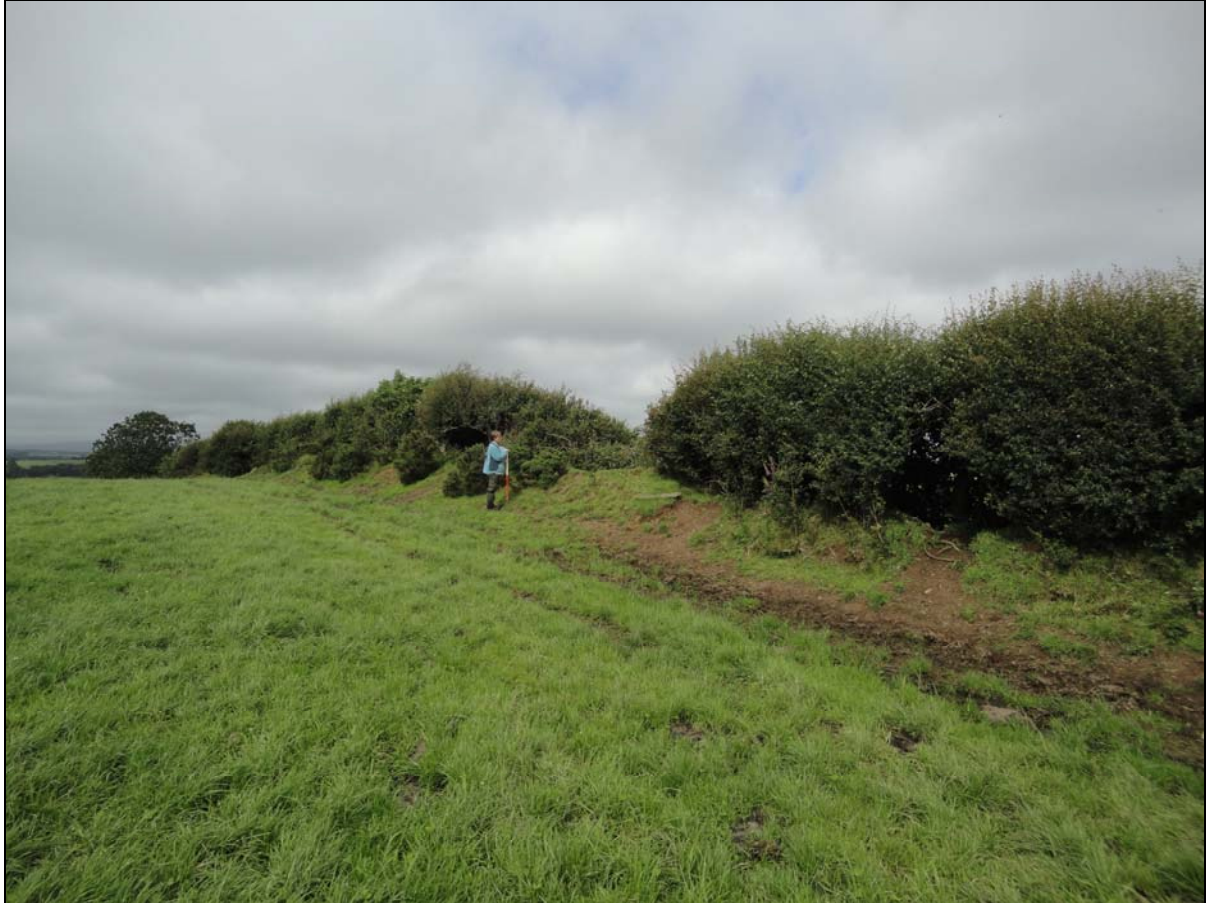
*Plate 3: The boundary bank and hedgerow at the eastern side of Croft field, Drim Farm, through which the cable trench would have to run..*

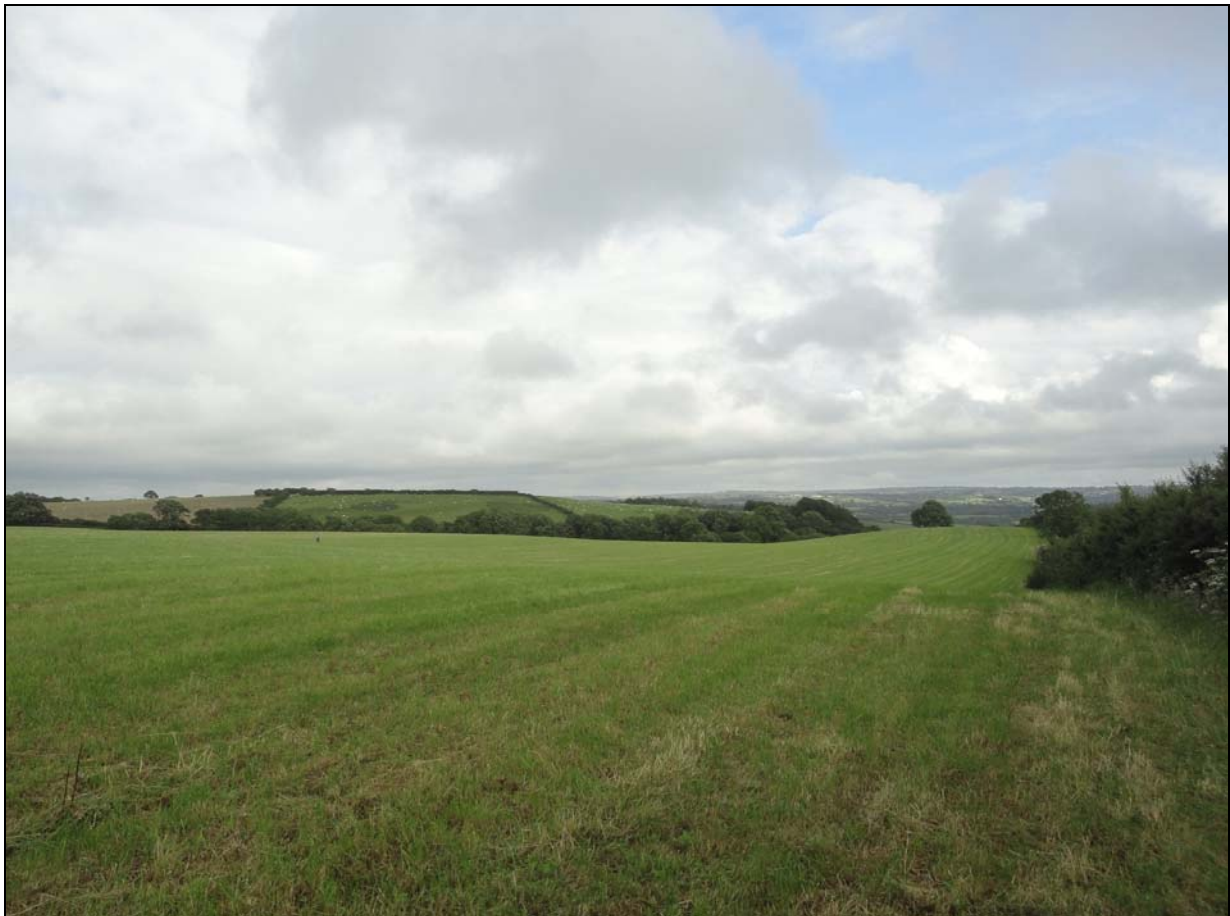
*Plate 4: A view from the transformer location back along the line of the proposed cable trench to the proposed location of the Highfield turbine, looking east-southeast. Broadway hillfort is on the higher ground to the left of centre.*

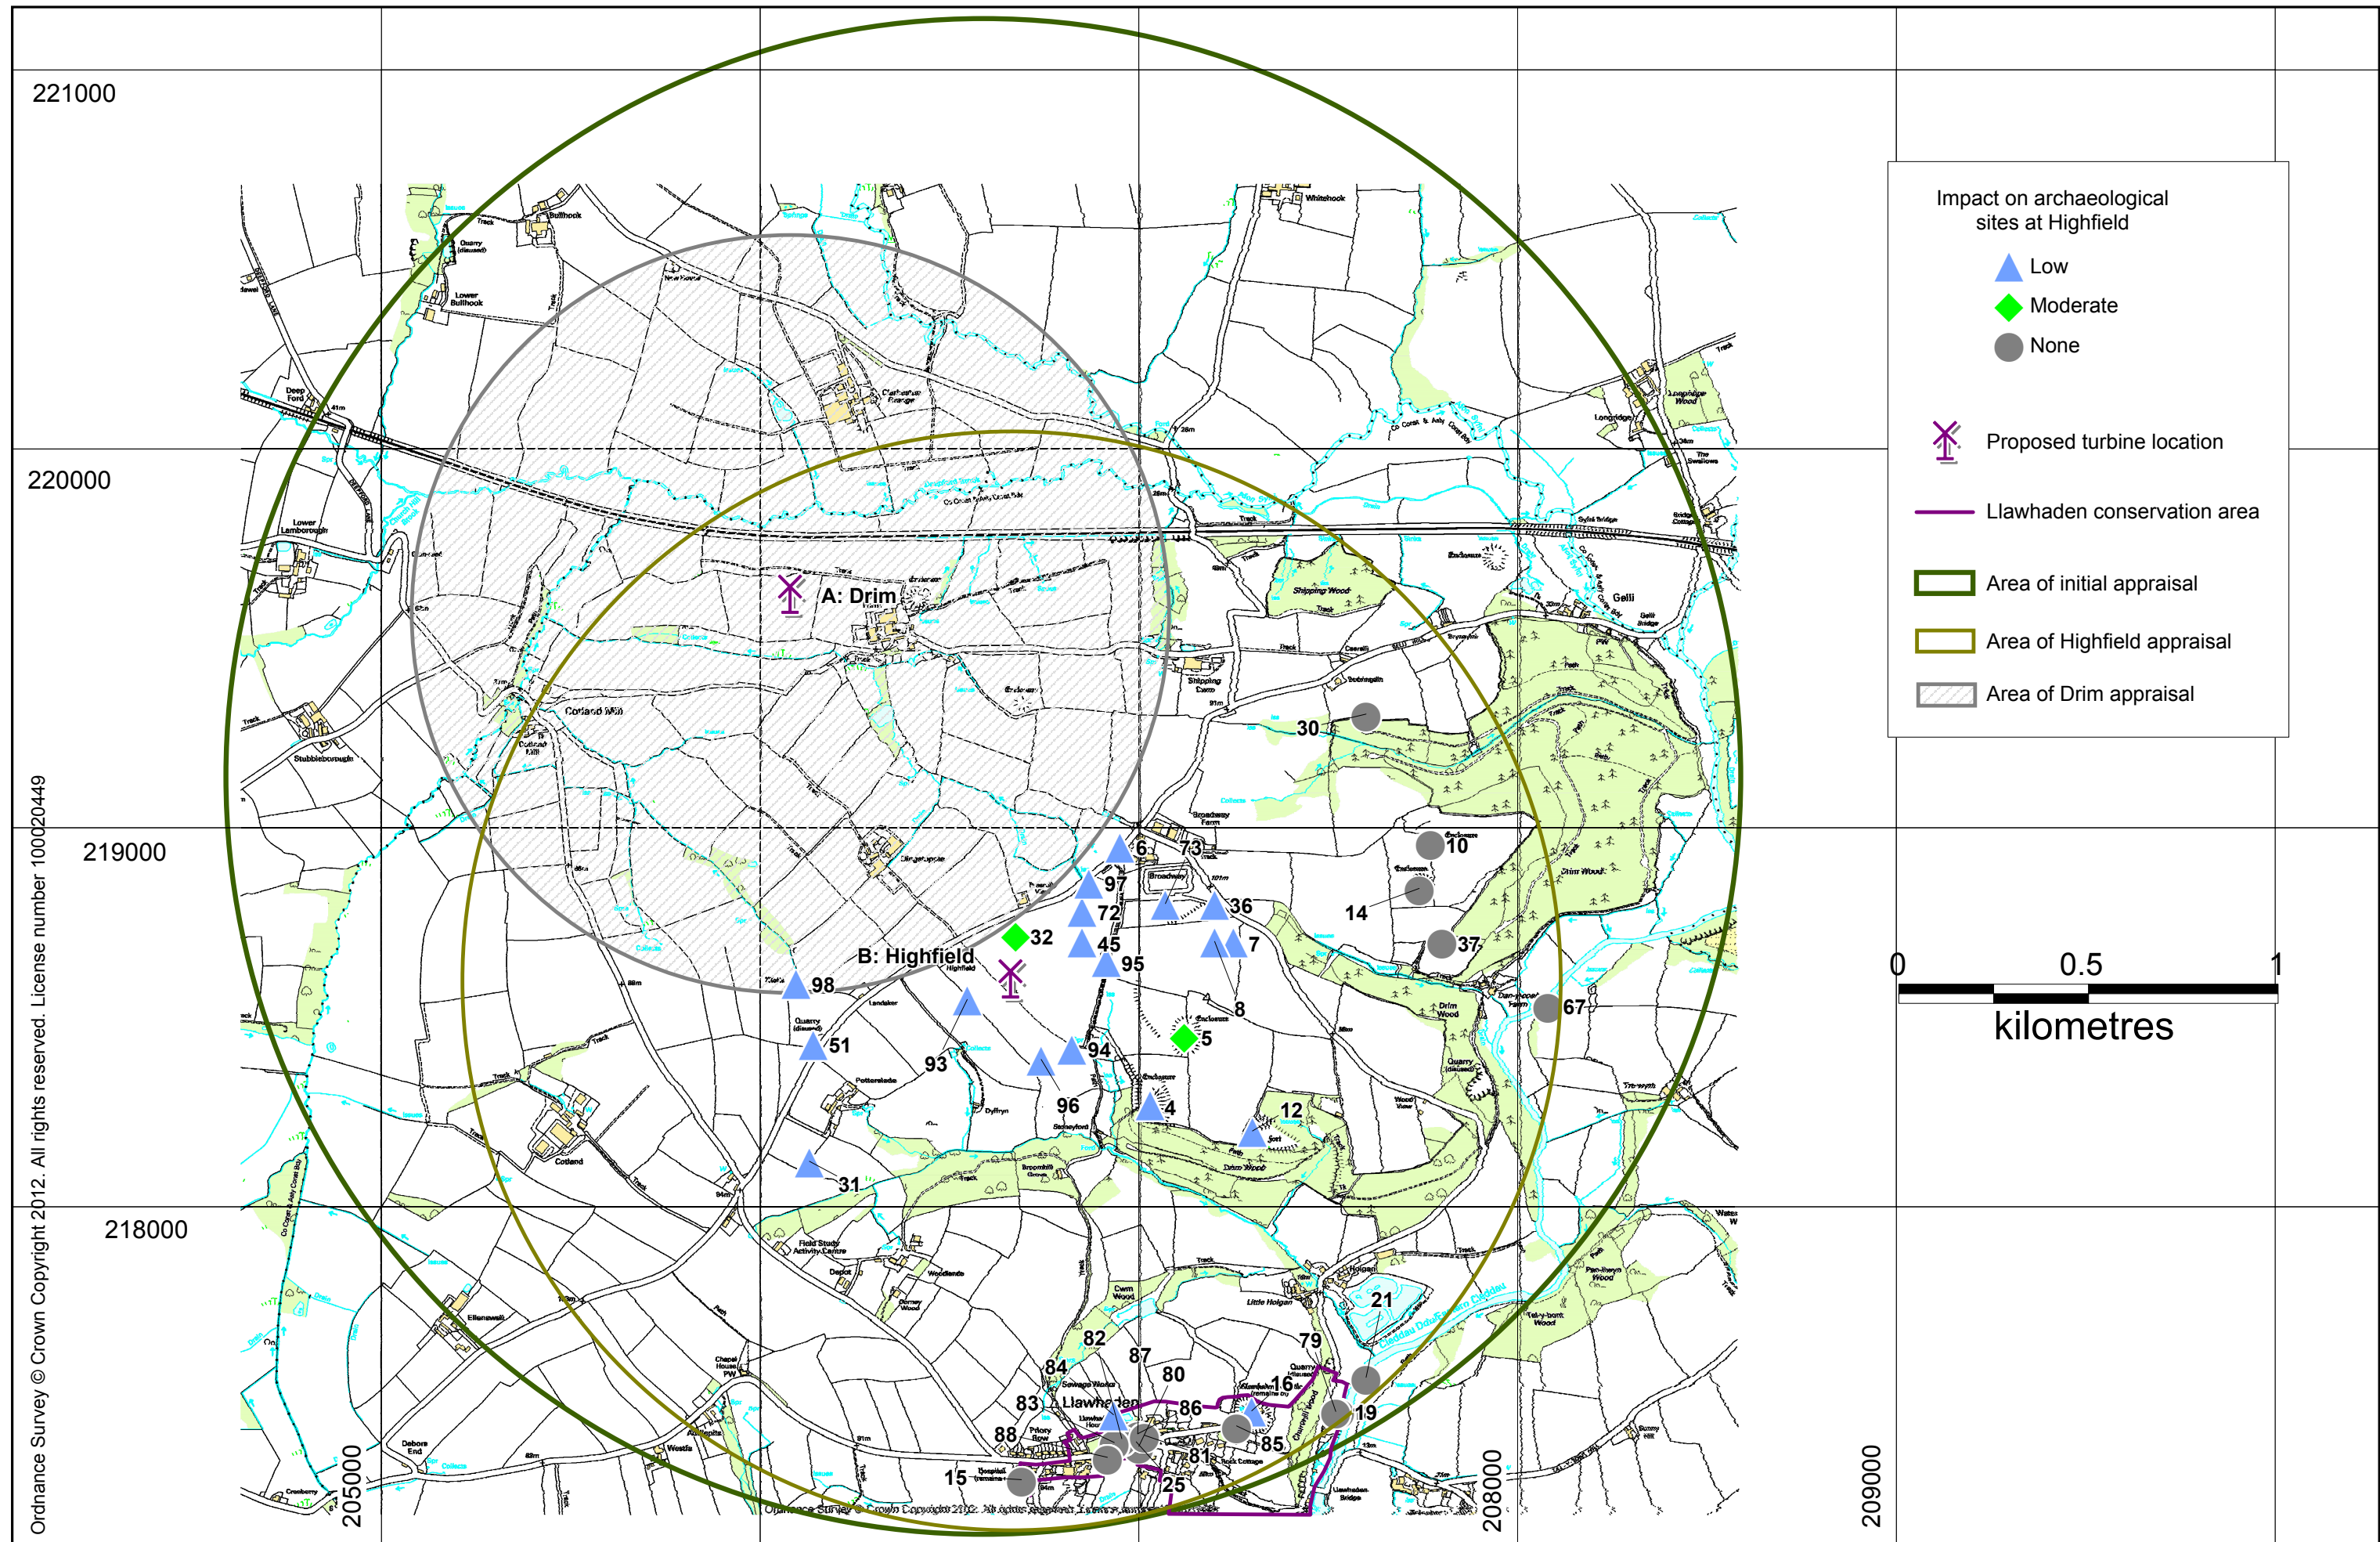
Figure 3: Assessment of the impact of the proposed turbine at Highfield on the recorded historic assets

7.5 As Table 2 and Appendix B show, two archaeological sites within a 1.45km radius were determined to be exposed to a moderate impact from the proposed turbine development. (Details of the appraisal for direct and indirect impact for each of the sites in Table 2 can be found in Appendix B). No other archaeological sites were determined to be exposed to any significant impact from the proposed turbine development.

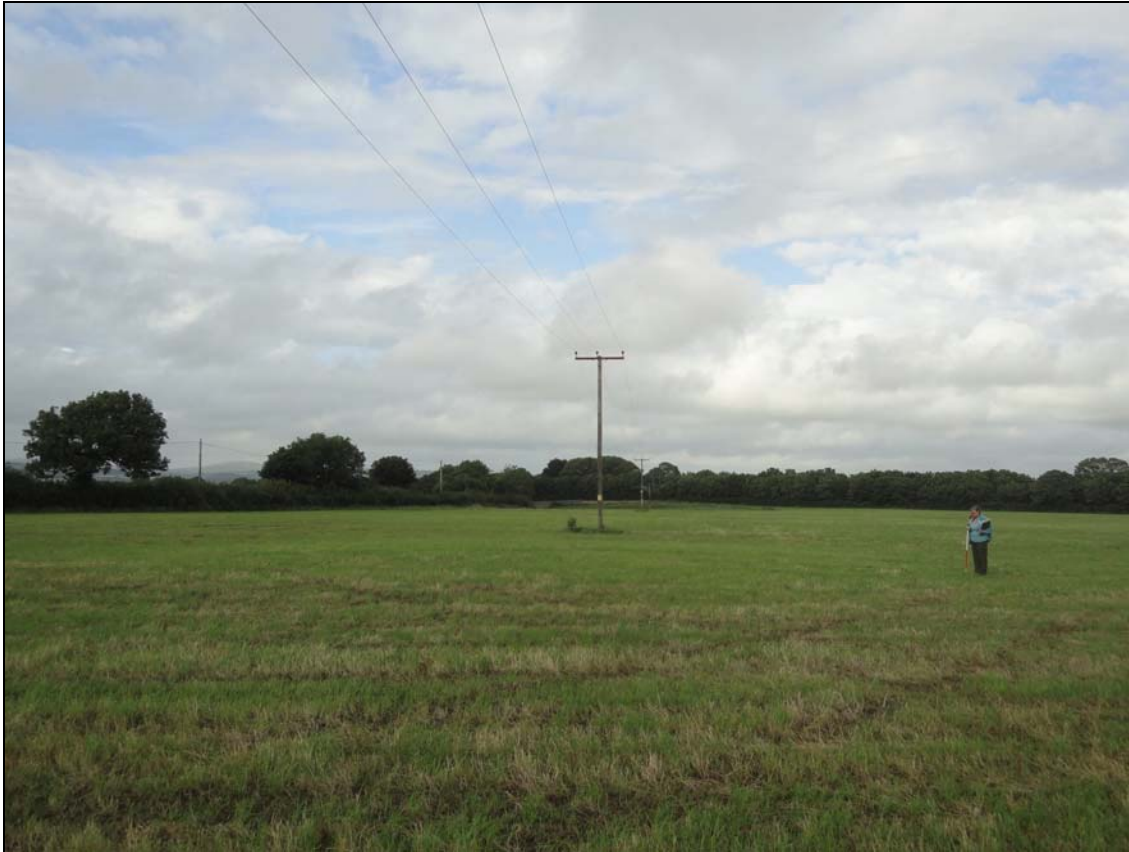
7.10 The site is the only round barrow recorded within the 2km appraisal area, which enhances its archaeological significance. Historic ploughing has left the barrow mound in a denuded condition, but there is no evidence that subsurface archaeological features have been greatly disturbed and the monument may still have significant archaeological potential, particularly in terms of the survival of the burial cist and any associated features.

*Plate 5: The low mound of the denuded Highfield round barrow is faintly visible to the left of the figure and in front of the electricity pole. The photograph was taken in a dull light.*

7.11 The present landowner has acquired the field in relatively recent times and was unaware of the existence of the Highfield round barrow at the time of the field visit. Raising awareness of the monument with the landowner would in itself help mitigate against the monument suffering unnecessary damage during any construction phase, servicing works or decommissioning works. Consideration should be given to temporarily marking or fencing off the round barrow site during the construction phase to ensure that vehicular access does not impact on the monument.

8.3 The impact on the Bronze Age round barrow at Highfield (ID number 32) could include damage by vehicles crossing the field during construction as it lies between the access gates into the field and the proposed turbine site. The present landowner has acquired the field in relatively recent times and was unaware of the existence of the Highfield round barrow. Raising awareness of the monument with the landowner would in itself help mitigate against the monument suffering unnecessary damage during any construction phase, servicing works or decommissioning works. Consideration should be given to temporarily marking or fencing off the round barrow site during the construction phase to ensure that vehicular access does not impact on the monument.

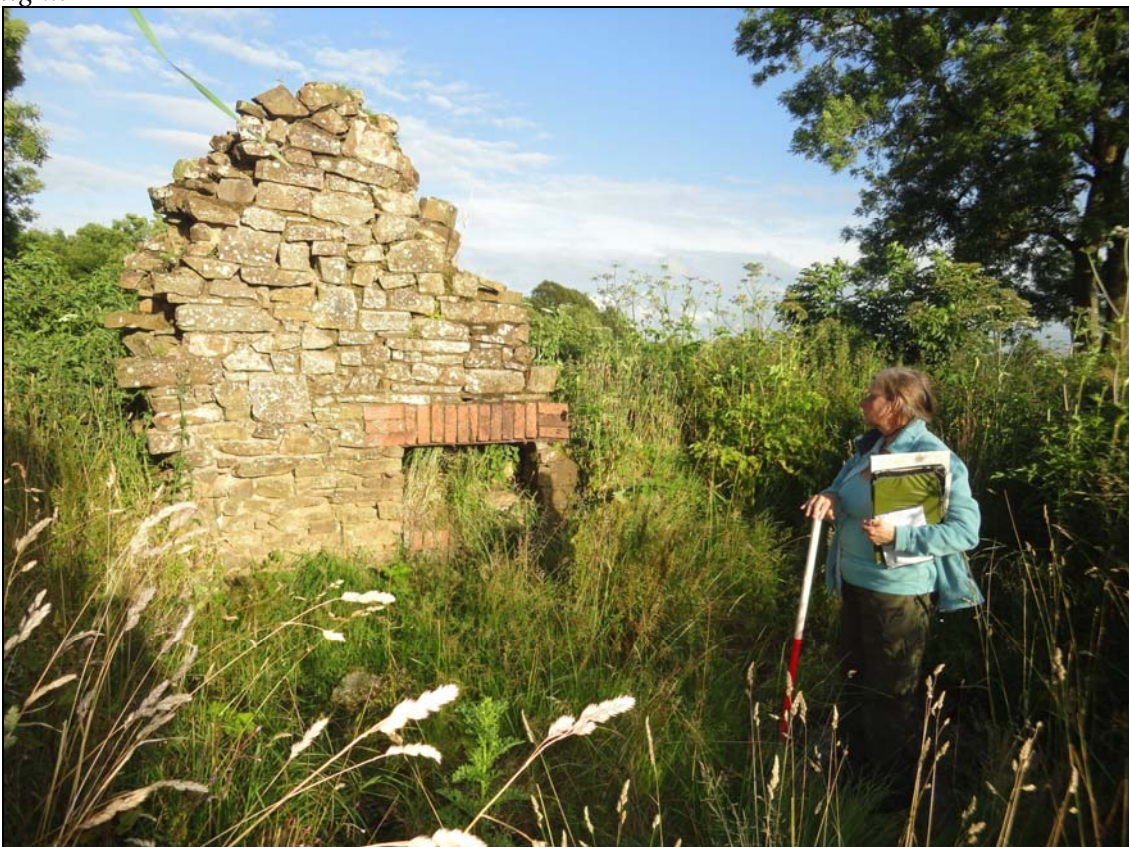
*Plate 6: The ruins of Pilscomwell cottage.*

**Description:** This ruined, single-storey cottage is shown as being occupied on 19th and early 20th century Ordnance Survey maps. In 1851 a railway engineer lodged here with a clogmaker. It was abandoned by the second half of the 20th century, although the landowner is aware that in recent decades some consideration was given to rebuilding the house. It has now fallen into complete ruin however, with only fragments of the lateral walls still standing to their original height, whilst the east-southeast gable end still largely stands but is in a dangerous condition and leaning to the west-northwest. The door was in the north-facing side of the cottage and this appears to have been flanked by a window on either side. Overall dimensions were 8.75 metres east-southeast to west-northwest by 6 metres wide. The drystone walls were clay bonded, and measured 0.50 metres thick at the east-southeast gable wall and up to 0.75 metres in the lateral walls. Some cement was present on the window sills and the floor seems to have been concreted at some time. The lateral walls were up to c.2 metres high and the gable at least 2.5 metres high. There was a brick-surrounded fireplace in the east-southeast gable and evidence of a smaller grate at the opposite gable end, where the iron firebasket remained in place. The site was heavily vegetated when recorded in July 2012 and made the survey difficult. There was some evidence of a possible extension to the east-southeastern gable end, in the form of a thick stone wall, which ran out for 4.5 metres to the east-southeast from the eastern corner of the cottage.

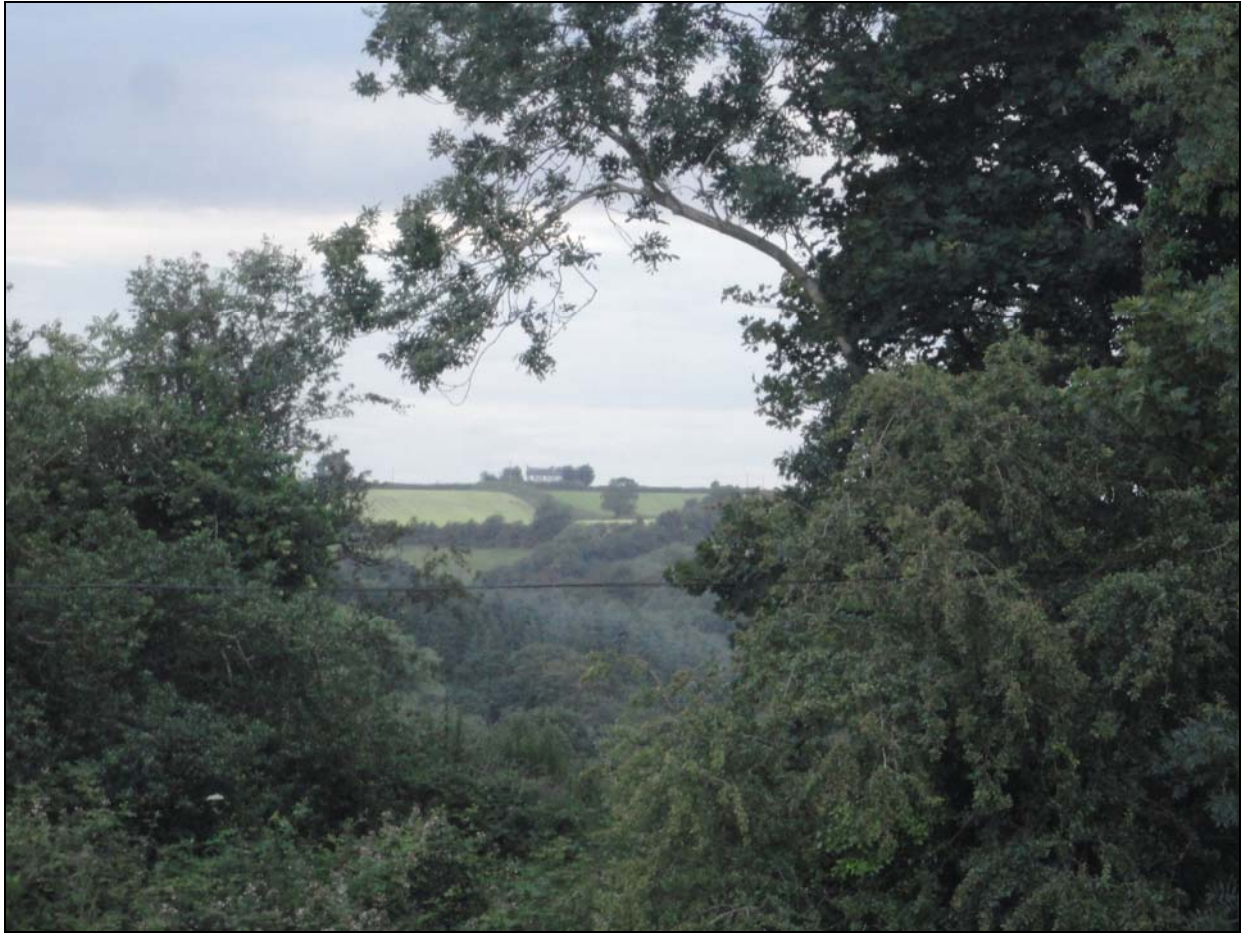
*Plate 7: The only possible view from ground level within Llawhaden Castle back northwest towards Highfield only gives a sighting of neighbouring Landsker, a house some 400m west of the proposed turbine site. The view is interrupted by mature trees growing at the northern edge of the castle site. A wind turbine would only be visible during the winter when the trees are defoliated.*

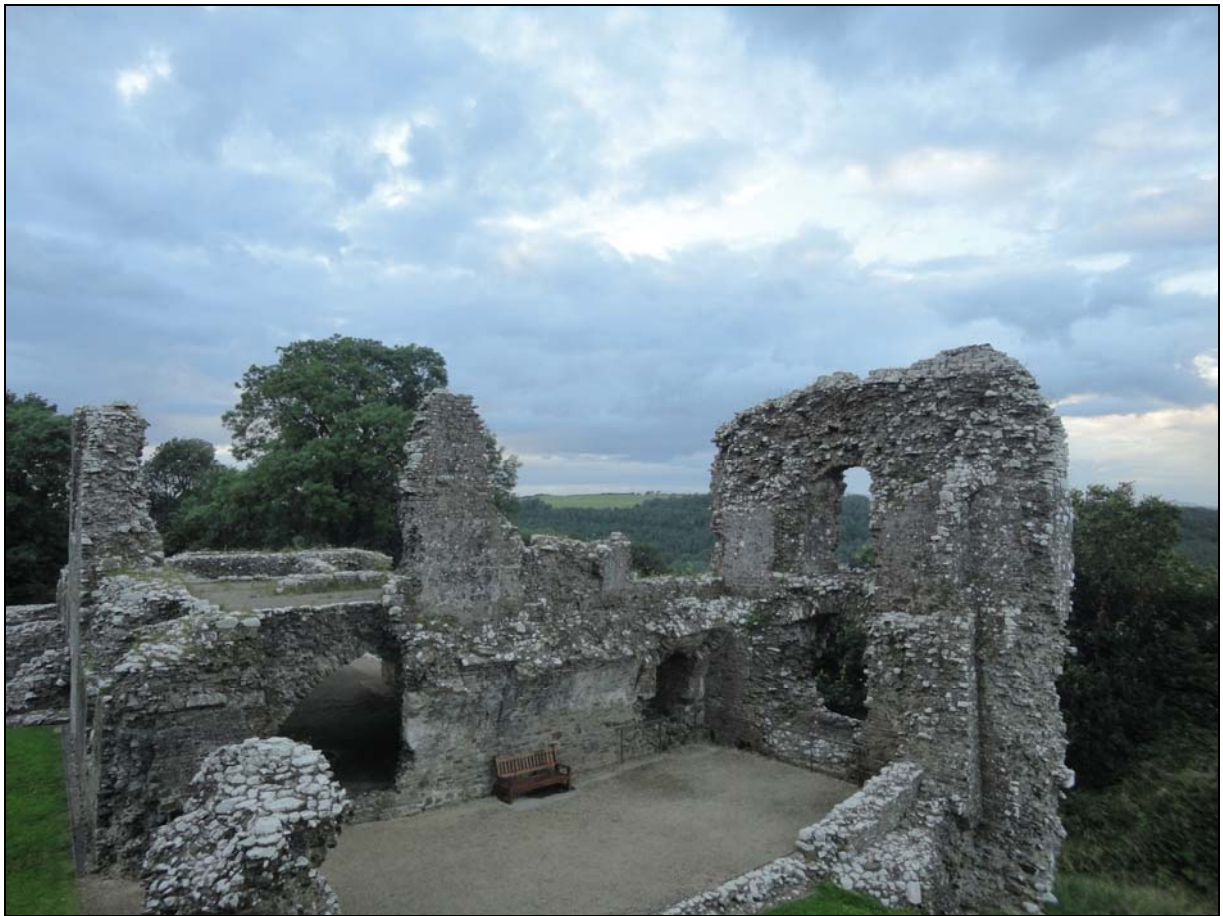
*Plate 8: A view from the highest publicly accessible point on the walls of Llawhaden castle reveals a view northwards to Broadway hillfort (in the far distance). Highfield and the proposed turbine site are blocked by the trees to the left of the photograph and would only be visible when the trees are defoliated during winter.*
