Maerdy Farm, Penycwm Pembrokeshire Historic Environment Appraisal

Maerdy Farm, Penycwm, Pembrokeshire Historic Environment Appraisal

Trysor Project No. 2013/309

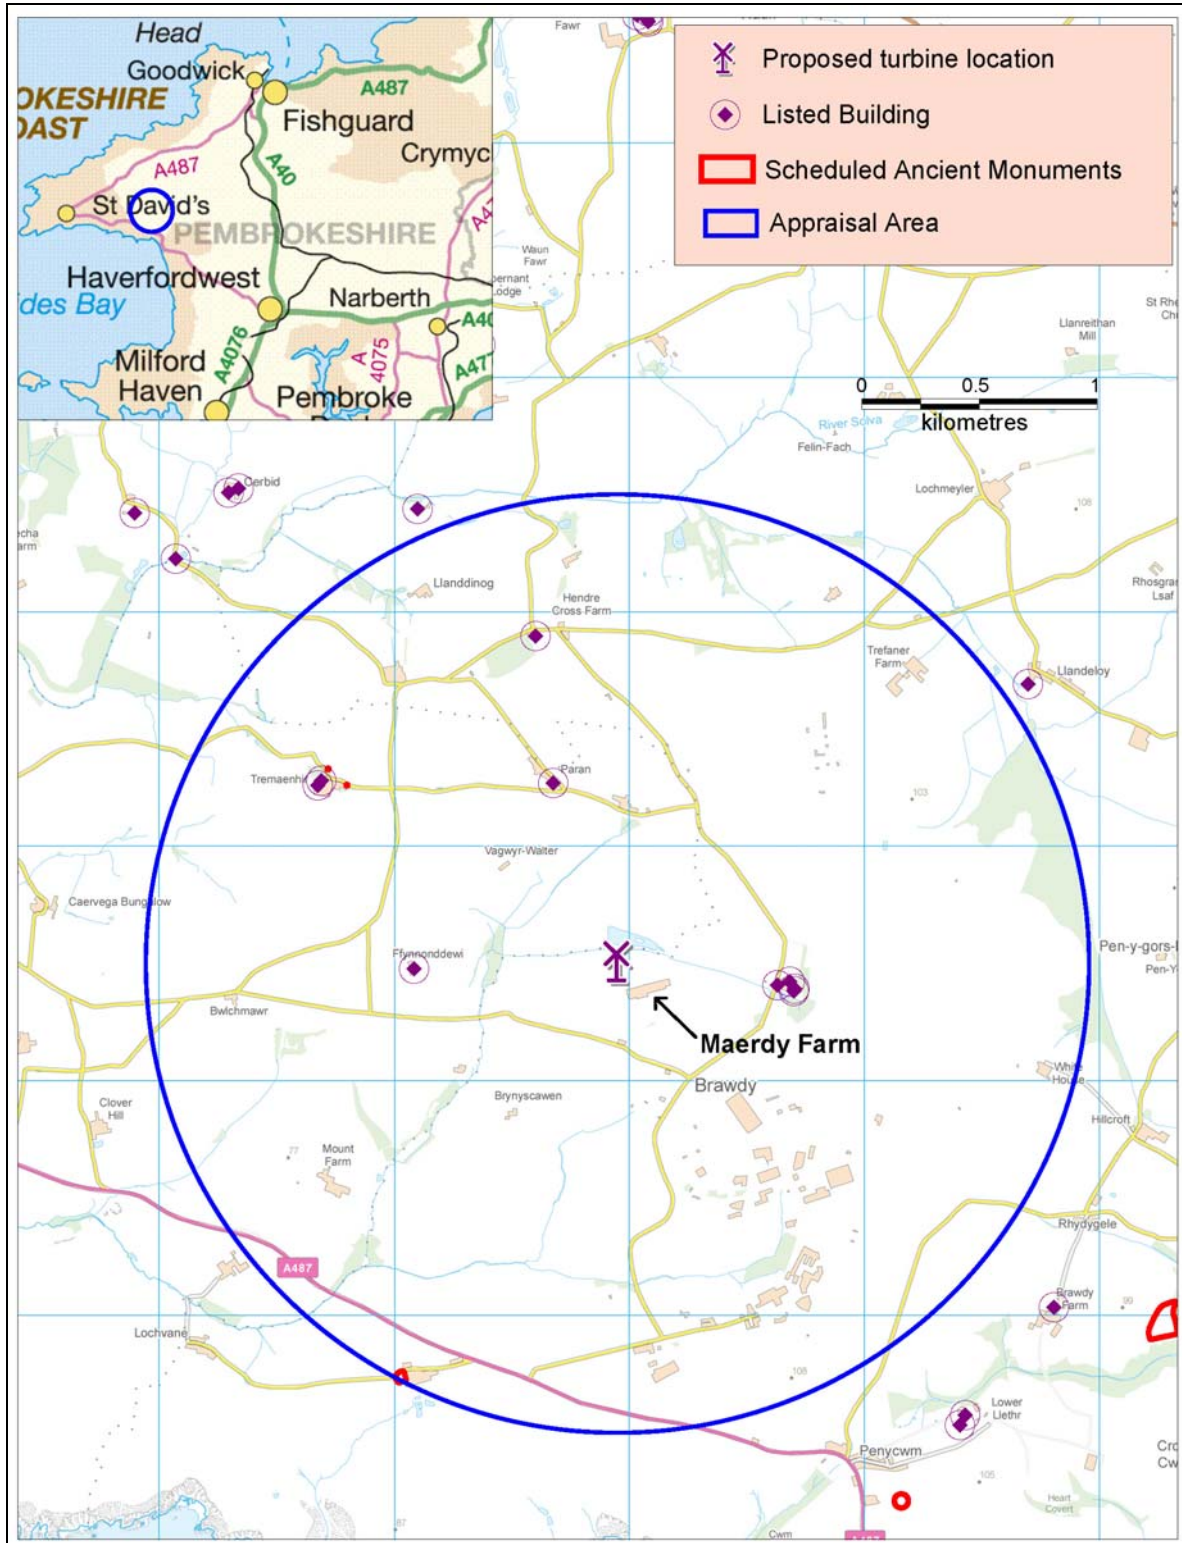
Figure 1: Location of the proposed turbine, showing the 2km radius appraisal area.

4.1 It is proposed that a single wind turbine, standing 24.8m to the hub and 34.5 metres to the upright blade tip, will be located on the boundary bank between two field parcels at SM8395025500 on Maerdy Farm, Pen y Cwm, Haverfordwest (see Figure 1).

4.2 The turbine will require a foundation hole up to 7 metres square and a cable trench will run south or southeastwards towards the farmyard for about 140 metres, and buried to a depth of up to 1 metre.

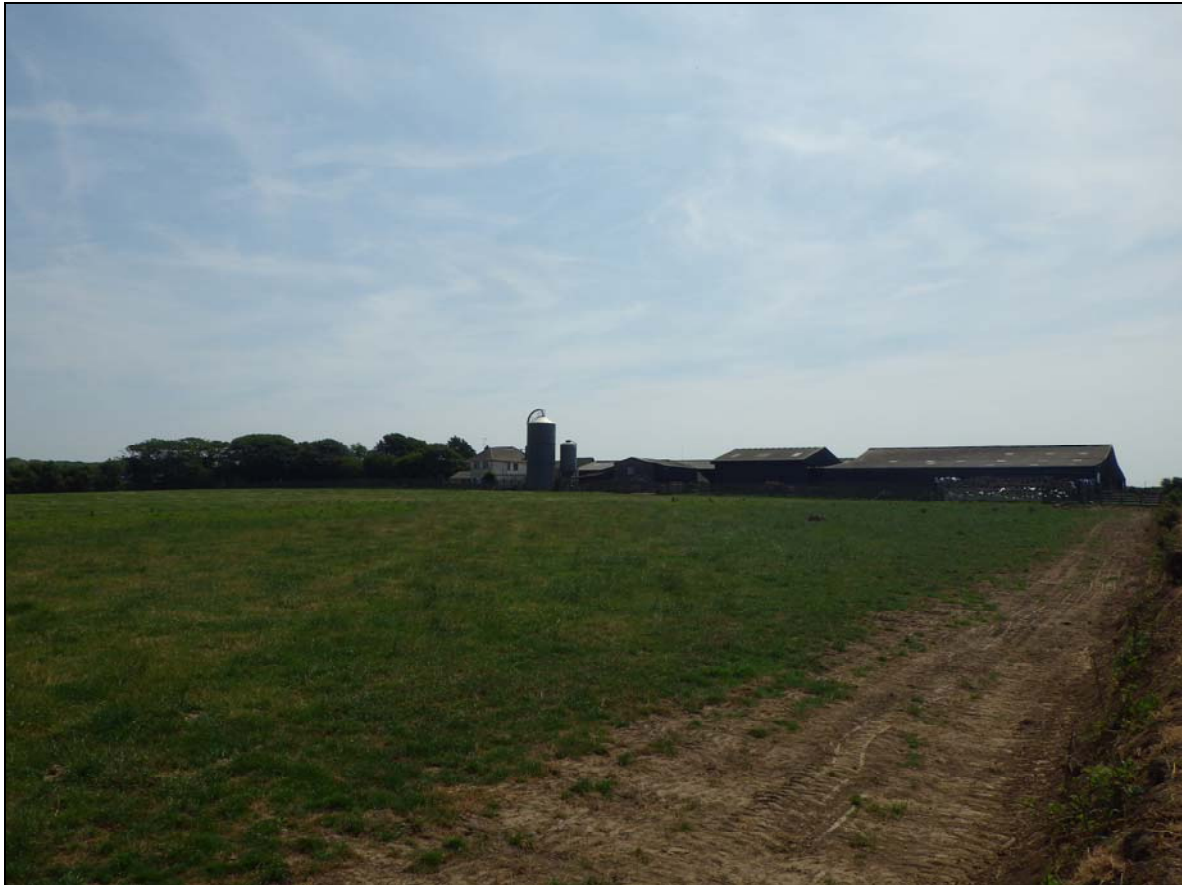
Plate 1: Looking southeast towards the farm buildings from the proposed turbine site.

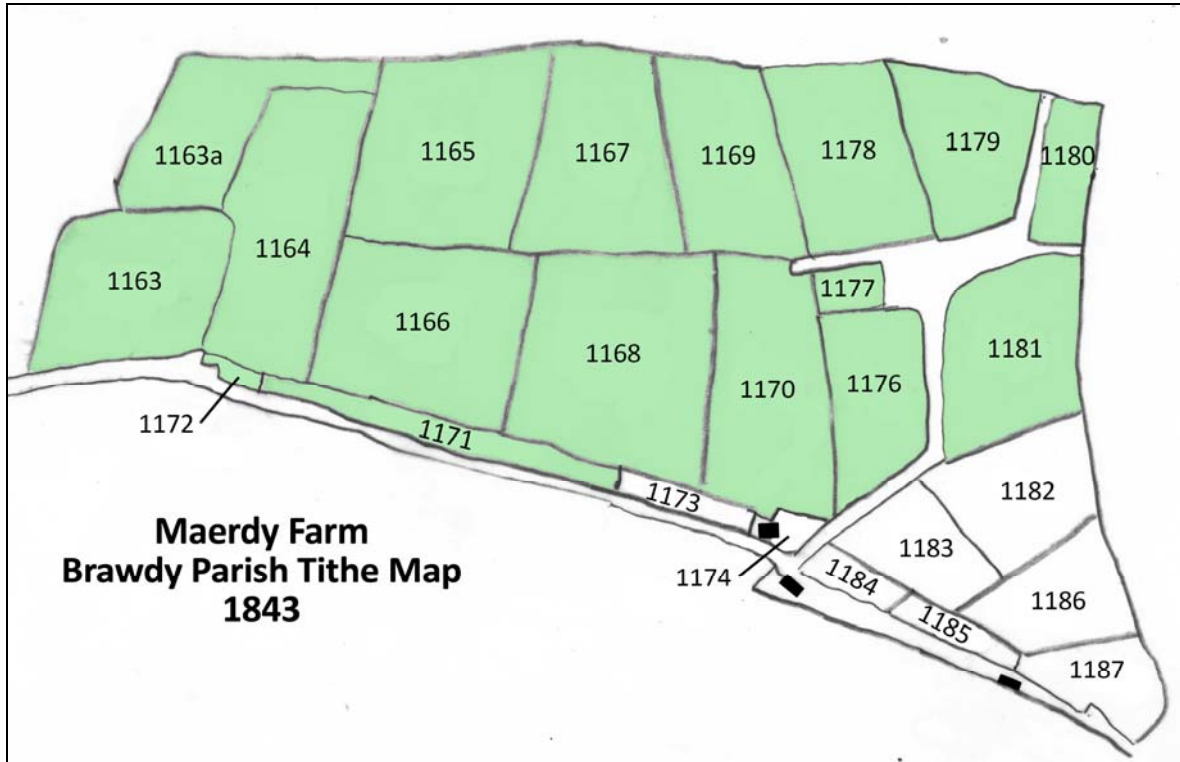
Figure 3: 1843 Brawdy tithe map accompanying the 1842 apportionment, extent of Maerdy Farm in 1842 shown in green.

6.7 The boundary bank into which the proposed turbine would be inserted is shown on the tithe map and is evidently part of the original post-medieval field system of the holding.

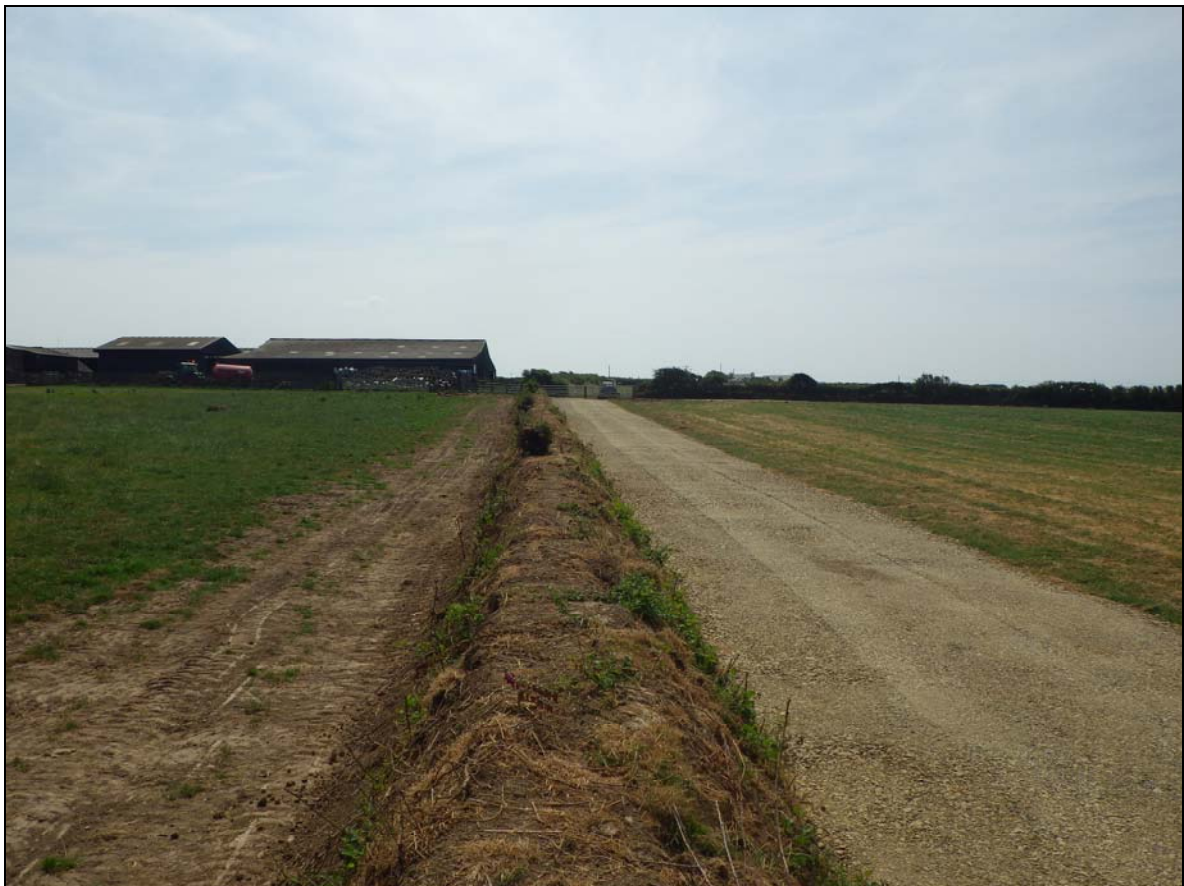
Plate 2: The recently repaired boundary bank (ID number 66) looking southwards from the location of the proposed turbine.

ID number:	66	MAERDY	BOUNDARY BANK (EARTHWORK)
HER PRN:		NMR NPRN:	
NGR:	SM8395125477	Grid reference taken at point along linear site	
		Broadclass:	Agriculture and Subsistence
Period:	Post Medieval		
Form:	Earthwork	Condition:	Intact
Site Status:		SAM number:	
		LB number:	grade:
Description:	This field boundary lies between field parcels 1169 and 1178 on the Brawdy parish tithe map of 1843. It is an earthwork boundary bank about 1.2 metres high and up to 2 metres wide at base.		
Rarity:	Common

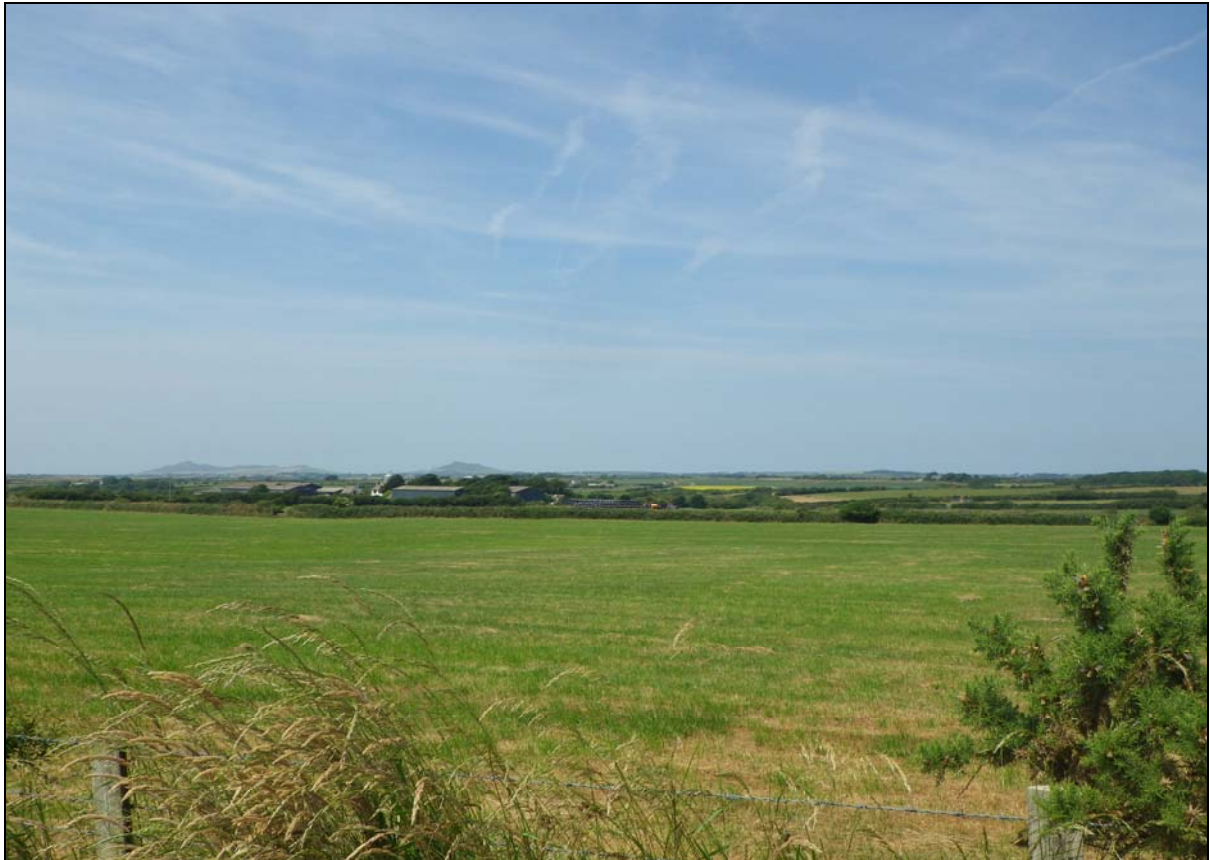
Plate 3; The view northwest towards Maerdy Farm, taken from the roadside 225 metres southwest of Rickeston Hall.

10.3 One grade II* listed building at Rickeston Hall (ID number , has been found to be likely to be exposed to moderate impact, in terms of indirect visual impact, although there would be no effect on its essential setting. Two other Listed Buildings would experience a very low, indirect visual impact over distance.

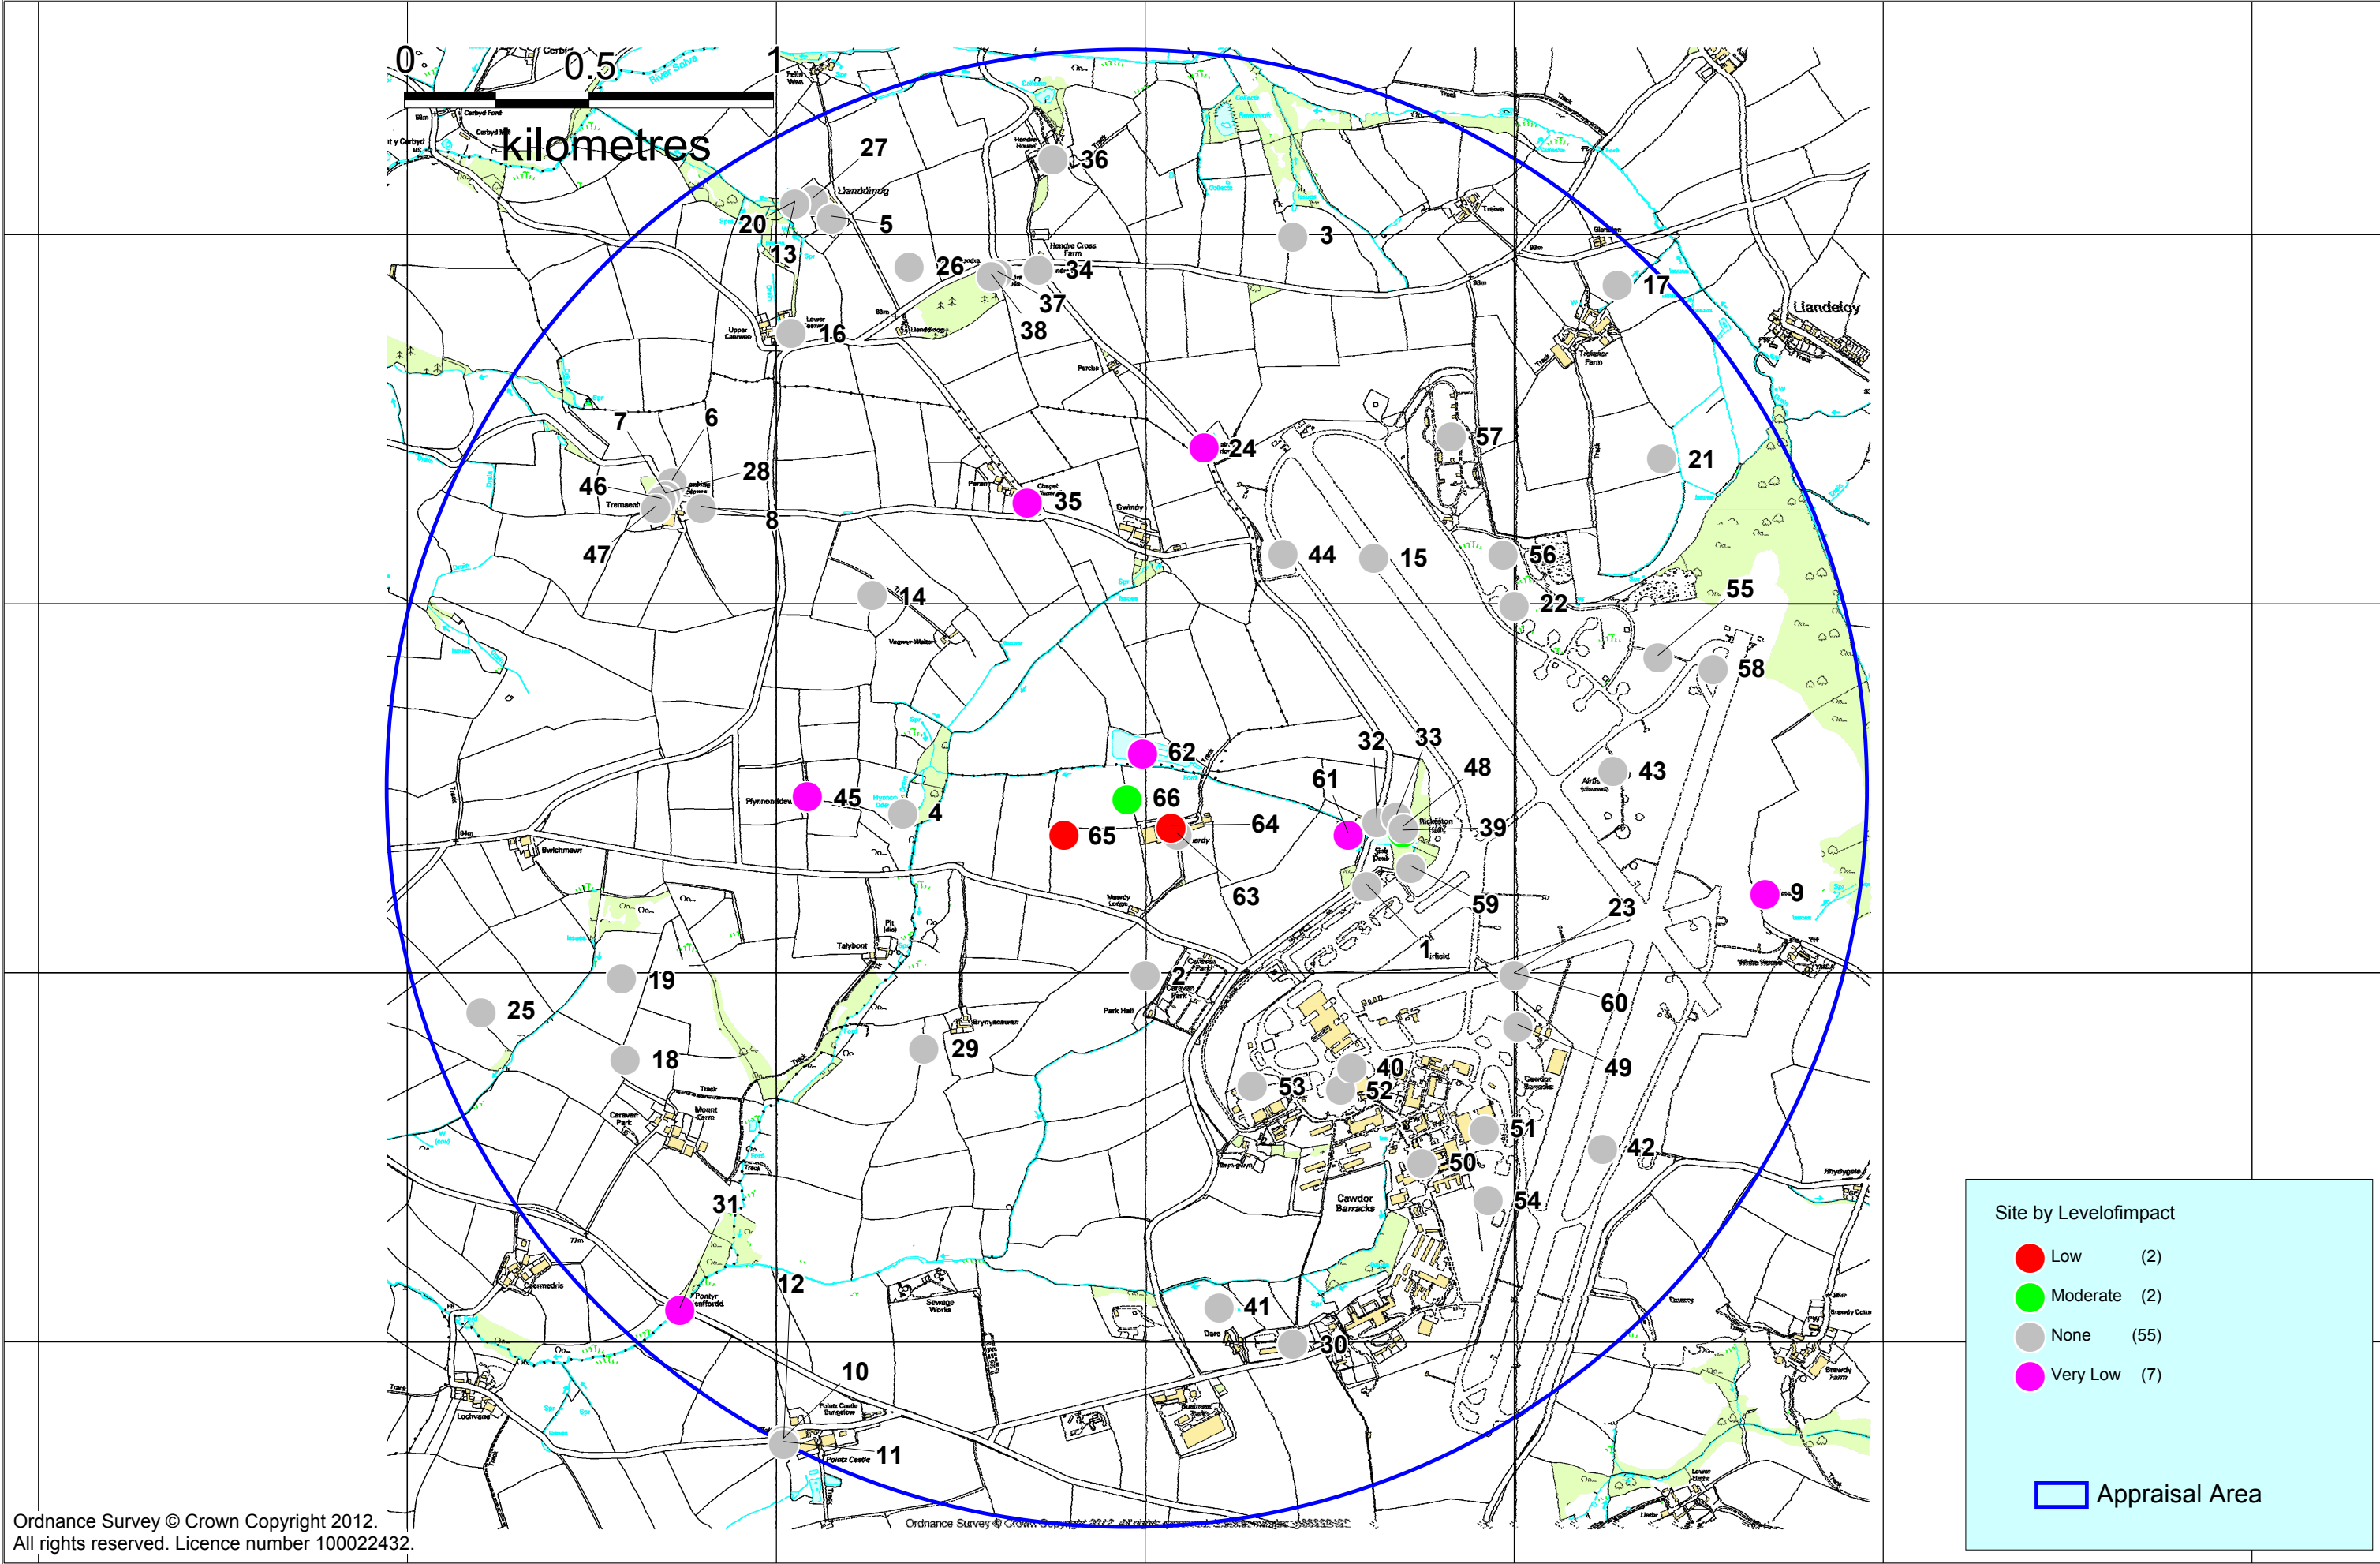
Figure 4: Sites showing impact, labelled with Project ID number

8.2 The Direct and Indirect impact on each site was assessed taking into account both physical and non-physical impacts. A full table is found in Appendix A but a summary is tabulated in Table 1 below and illustrated in Figure 4.
