# Parsonage Farm, Amroth Pembrokeshire Historic Environment Appraisal

Report by: Trysor

September 2013

Trysor Project No. 2013/316

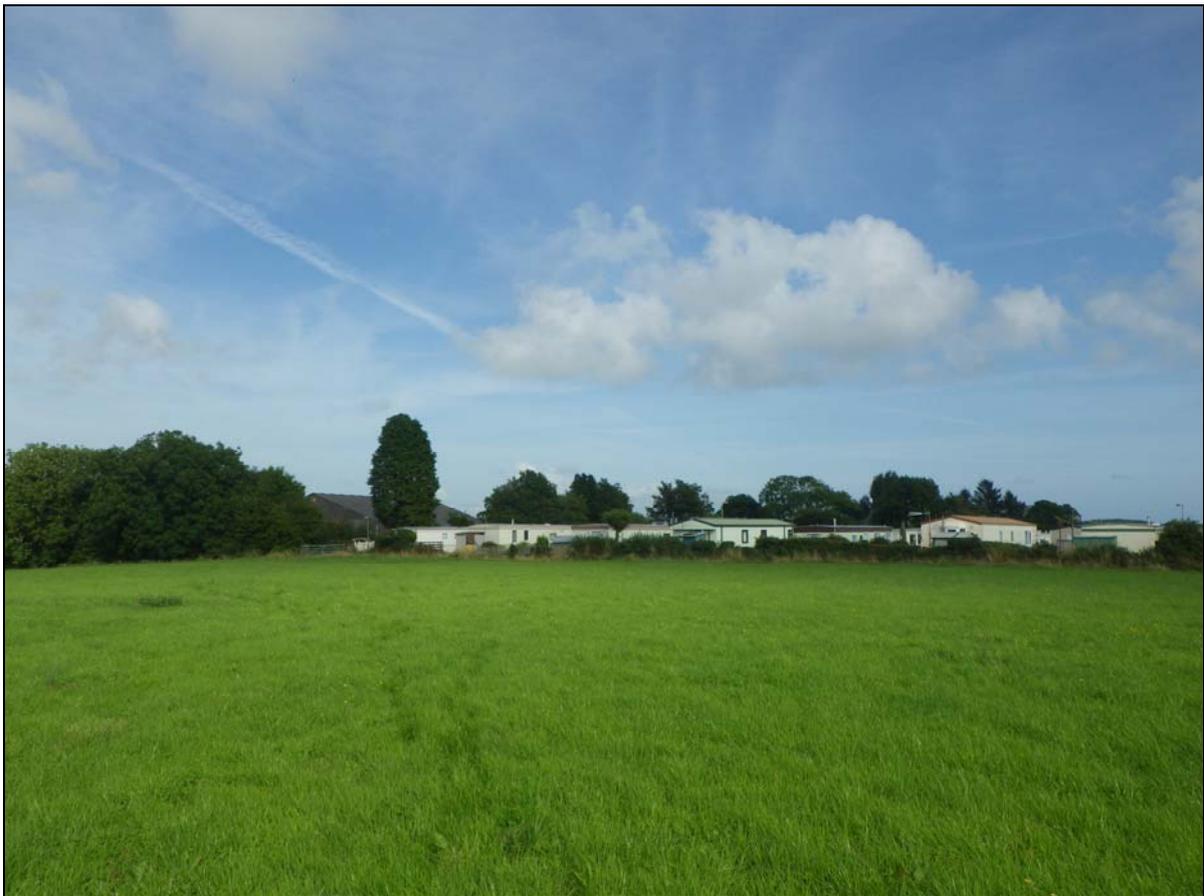
*Cover photograph: Location of the proposed turbine, looking east.*

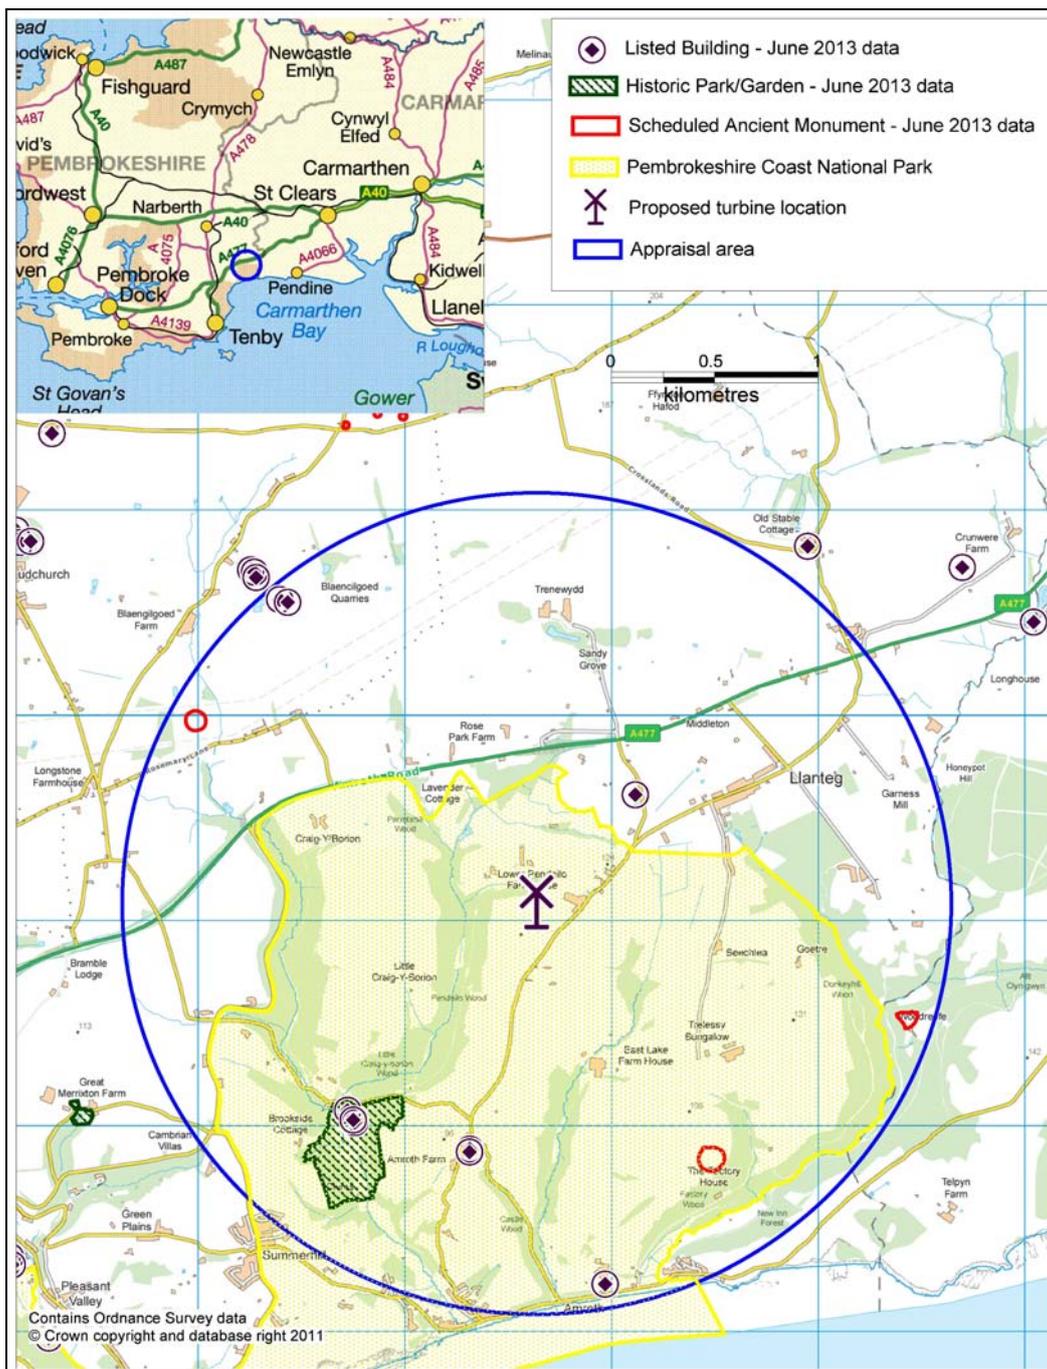
Figure 1: Location of the proposed turbine, showing the 2km radius appraisal area.

4.1 It is proposed that a single turbine with a 20 m high tower and 23.5 m to the upright blade tip will be located in a single field parcel at SN1663709083 at Parsonage Farm, Amroth, Narberth, Pembrokeshire, SA67 8PR, see Figure 1. The field parcel lies within the Pembrokeshire Coast National Park

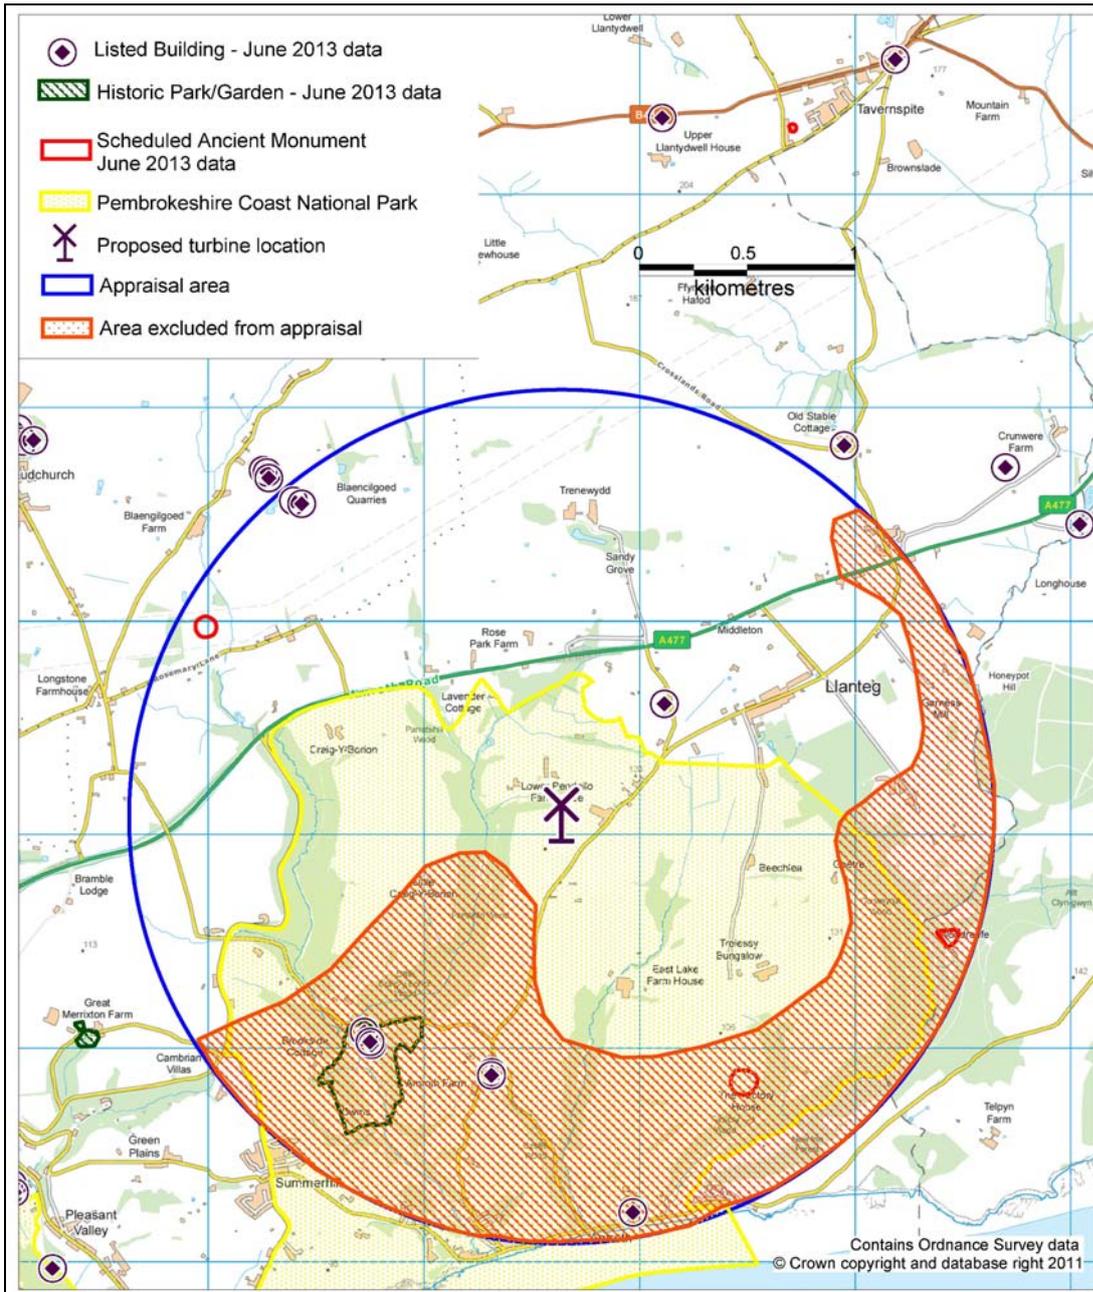
Figure 2: Showing the area excluded from the appraisal area as there was no intervisibility between the areas.

5.1 A study area of 2km radius circle centred on SN1663709083 was chosen for the initial appraisal of sites. This area was revised to exclude areas on the east and southern sides where there was no intervisibility or possibility of impact on setting of historic assets, see Figure 2. These areas either dipped down to the coast or lay within one of the incised valleys that characterise the district.

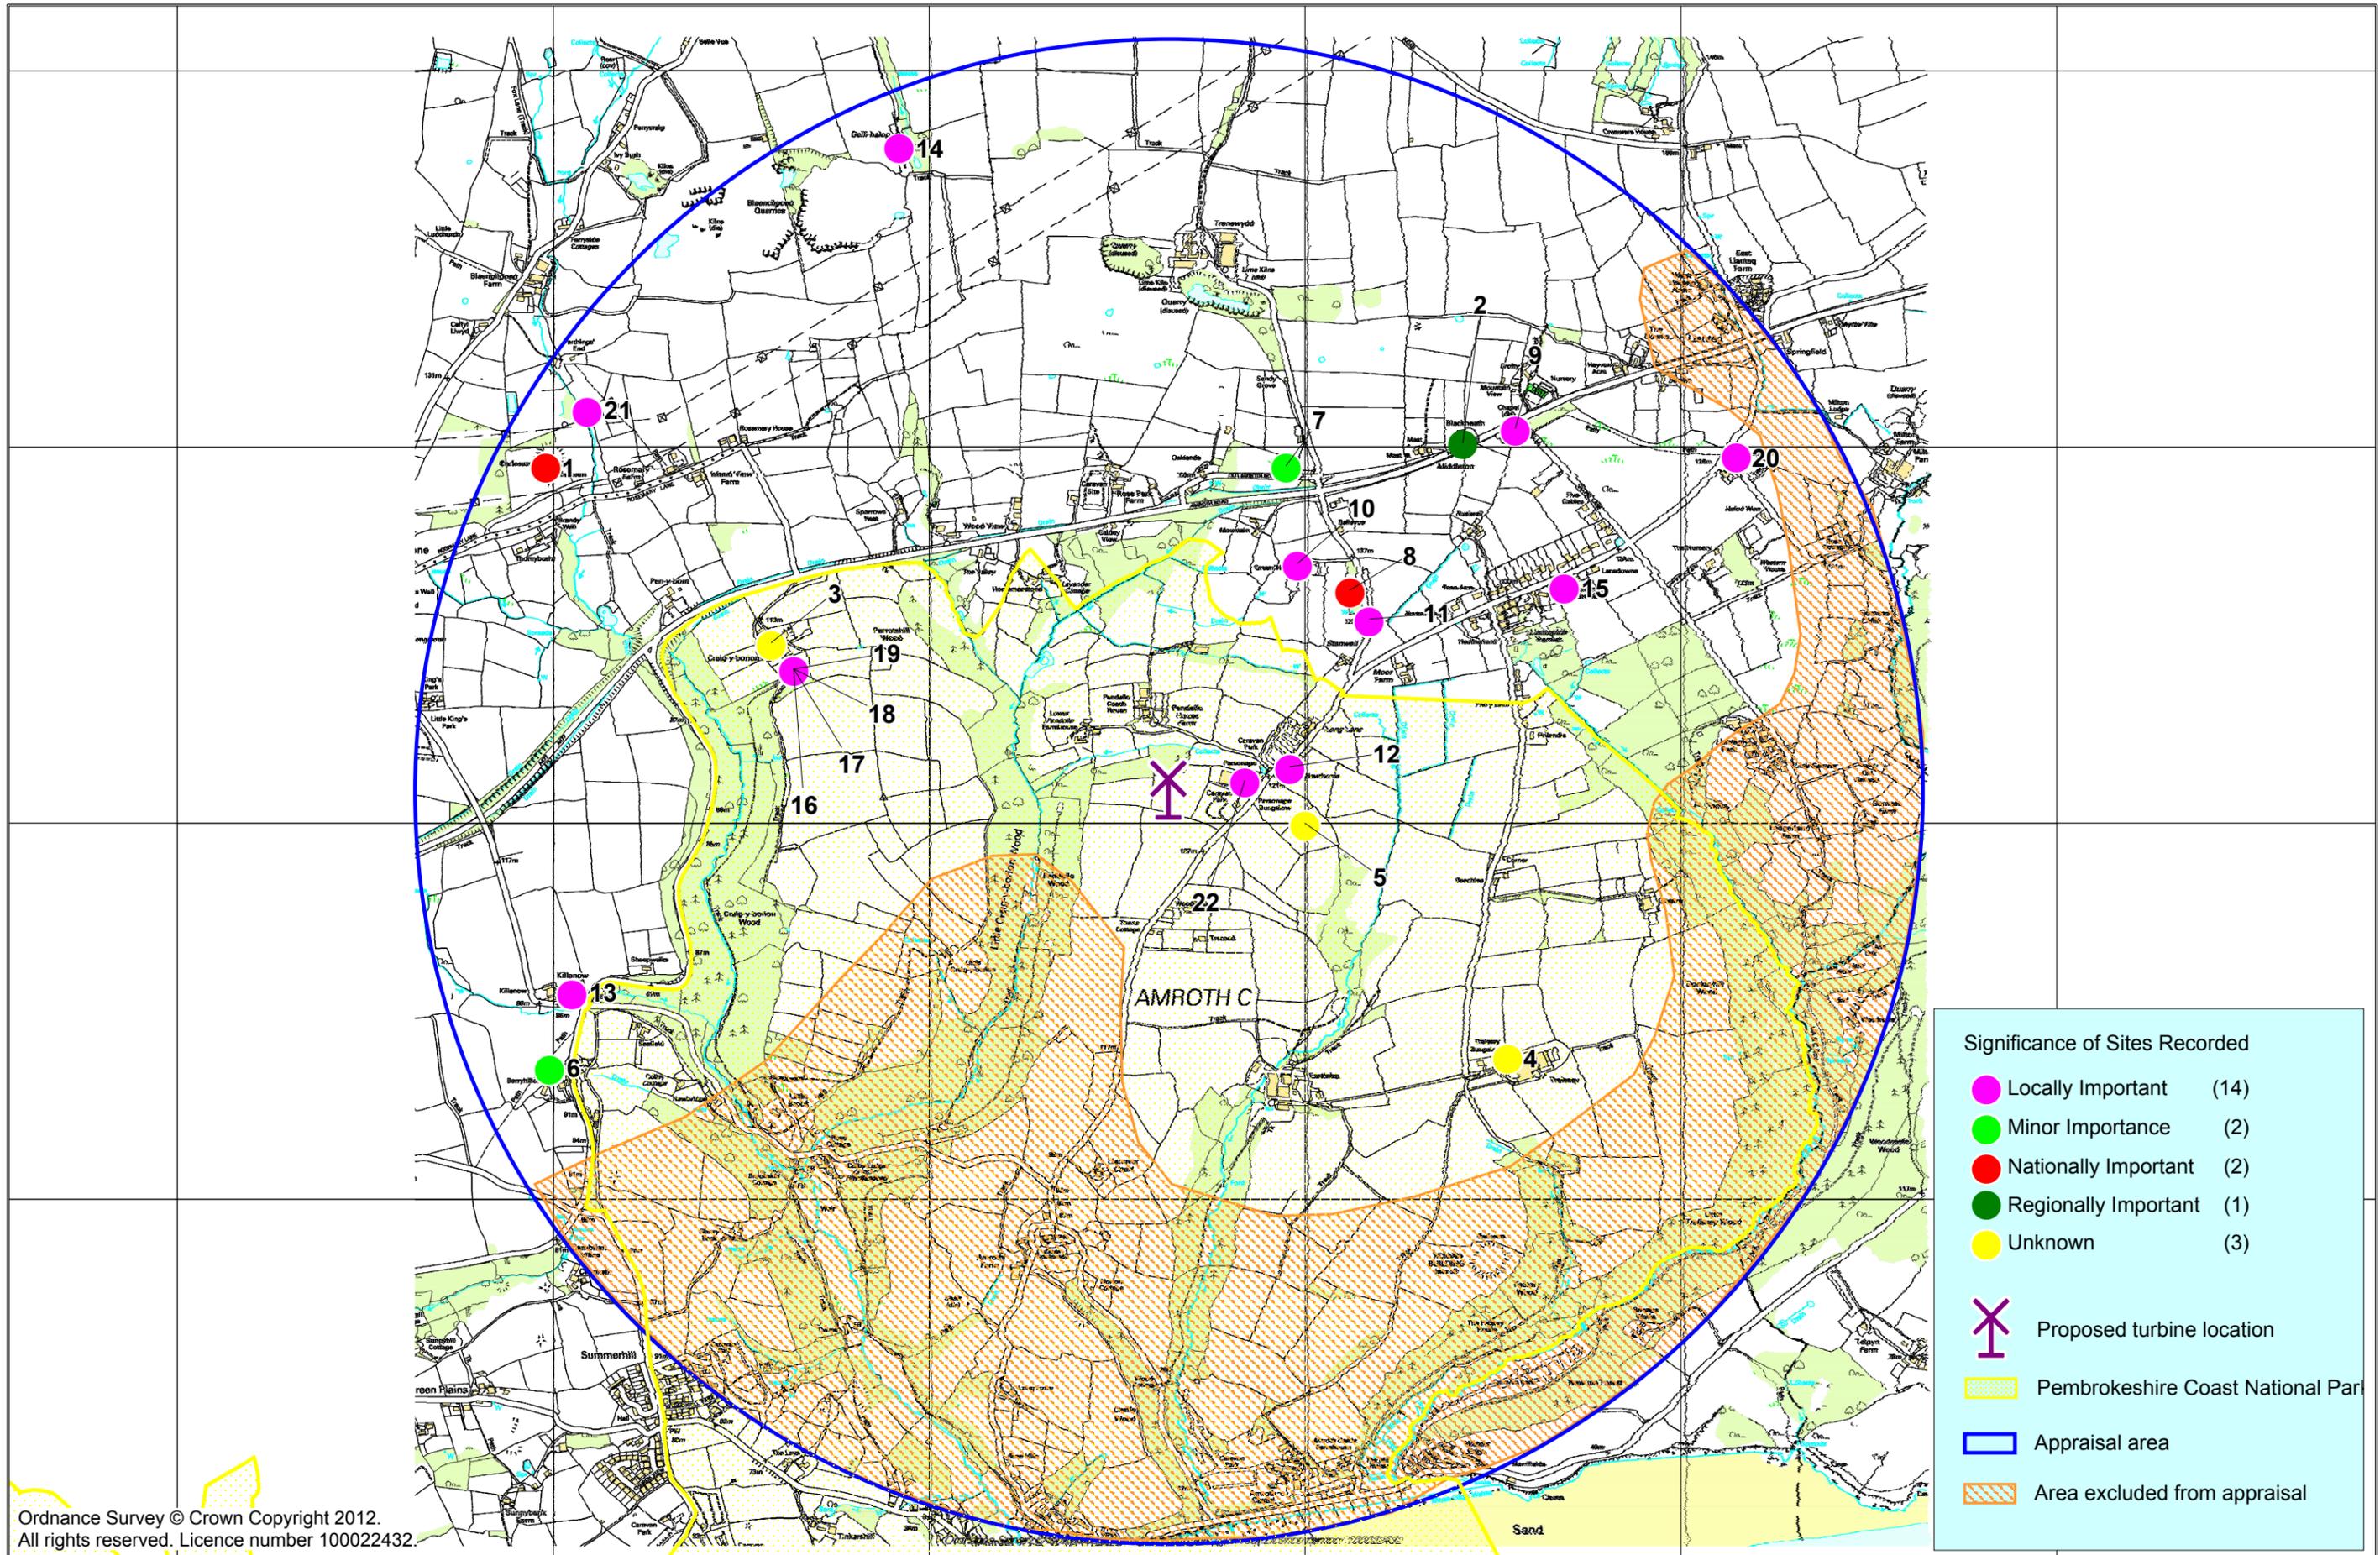
Figure 3: Sites showing significance, labelled with Project ID number

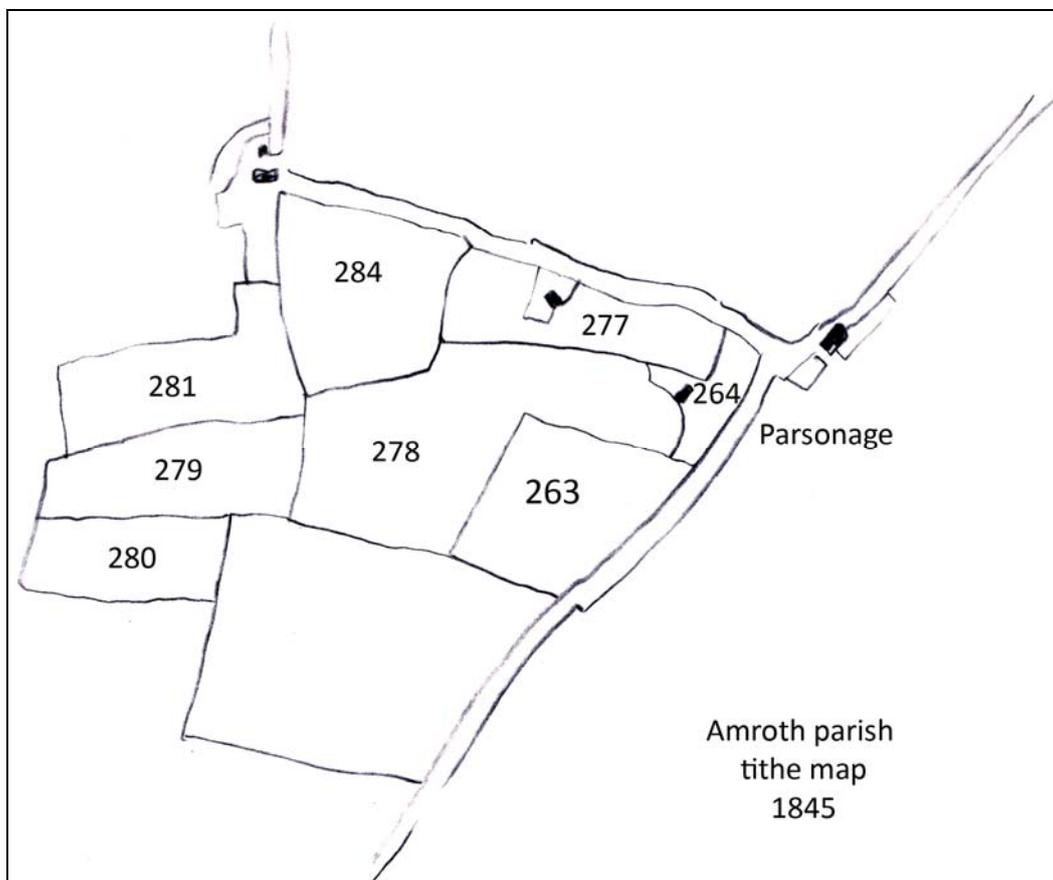
*Figure 4: Parsonage farm on the 1845 Amroth parish tithe map*

6.2 On tithe survey in 1845, the farmhouse and fields at Parsonage Farm are shown very much as there are today. The farm was recorded as being owned by the Reverend William Harries and occupied by George Davies (see Figure 4). Field parcel 278, in which the turbine will stand, was larger and included the parcel to the east towards the farmhouse which on the 1890 map, and later, is shown as separate field parcel.

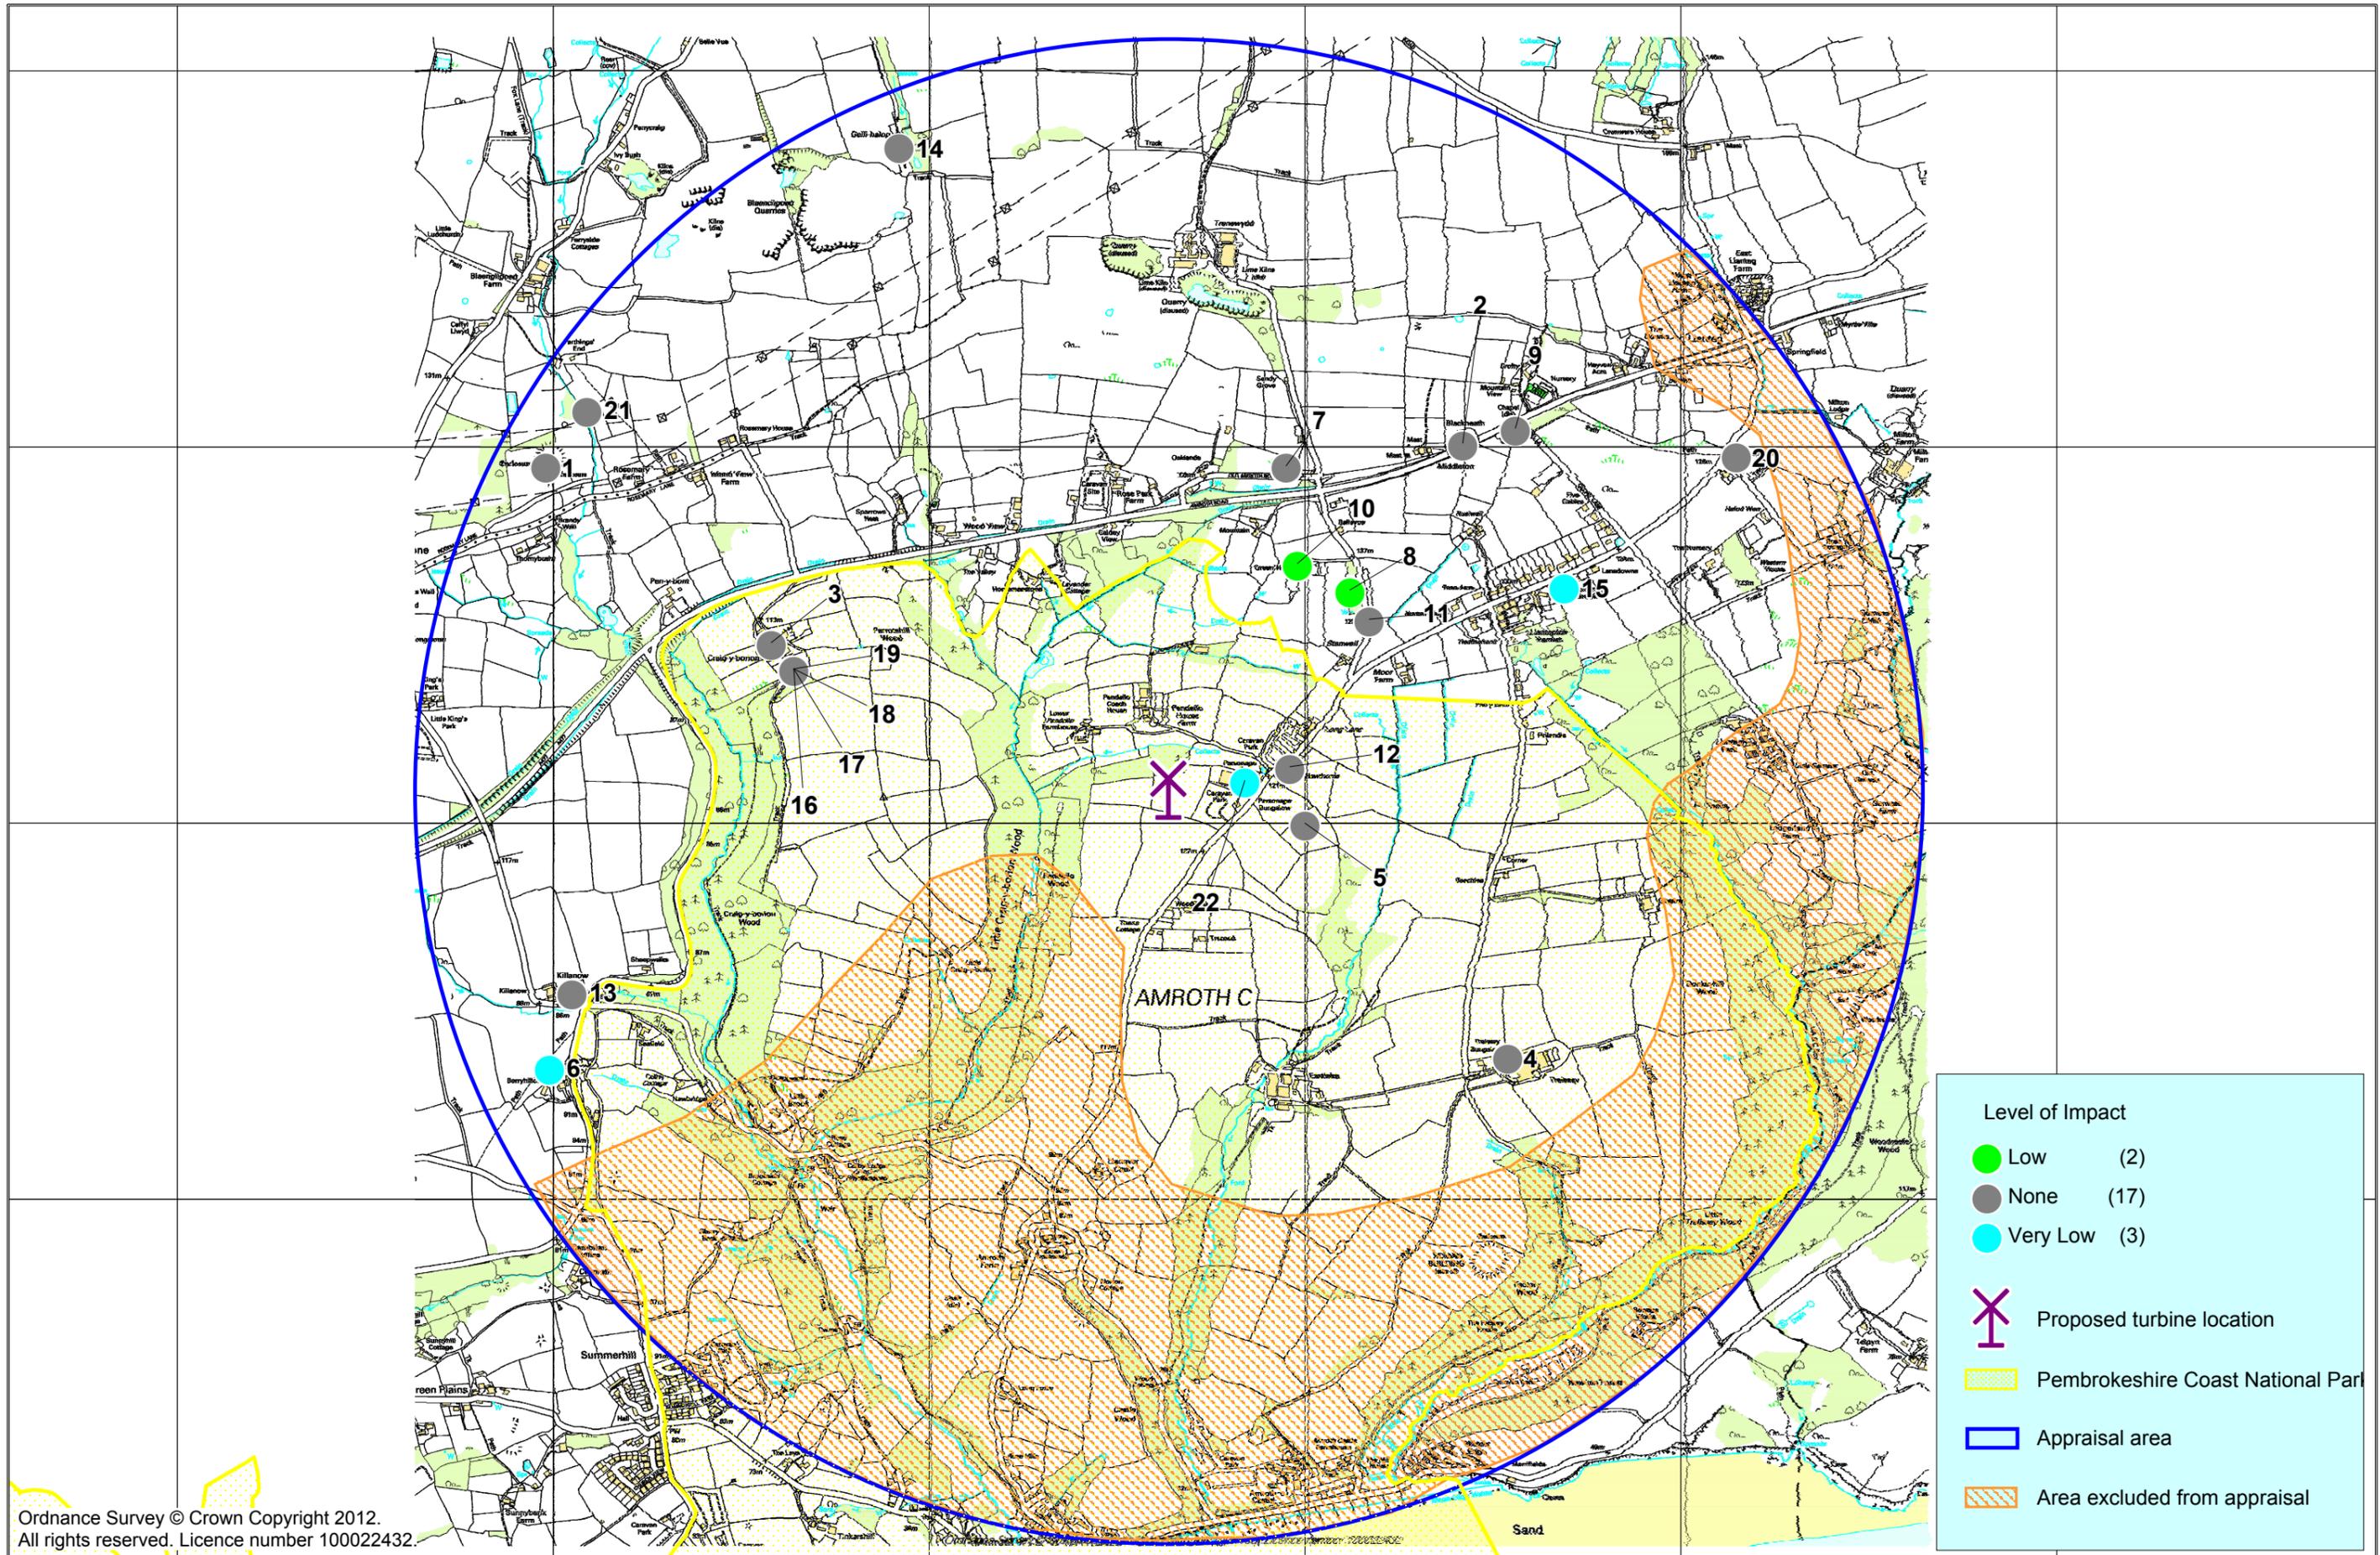
Figure 5: Sites showing impact, labelled with Project ID number

The proposed turbine location does lie within the Pembrokeshire Coast National Park. Its location is sheltered from most of the coastline and the coastal slopes by topography and trees as shown in Figure 5.
