GLASTIR ADVANCED POST VISIT ASSESSMENT

Site Name: Llanio Isaf

CRN A0037668

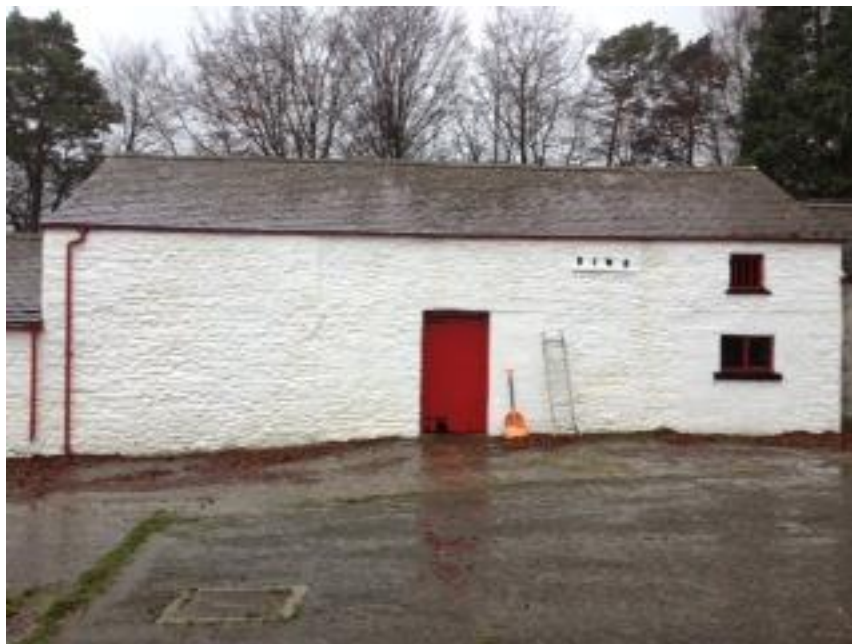
The building subject to the Glastir proposal is a dairy/cow shed. It stands to 2 stories and the roof steps down part way along its length. At the step down the exposed gable spandrel is covered with ill-fitting corrugated metal. There are two small window openings and a door in the main elevation. The building is white washed with a red painted door, window surrounds and rain water goods. The roof structure requires some work and a temporary support has already been inserted.

The building is a typical 19th century farm building being part of a wider farmstead retaining many original features. As such it is worthy of repair under Glastir. When undertaking any repairs guidance in Technical Note 680: Repair of traditional buildings needs to be followed. Specifically the colour scheme of red and white needs to be maintained.
