## Letterston School, Pembrokeshire

### Archaeological Watching Brief

**Report No. 1014**

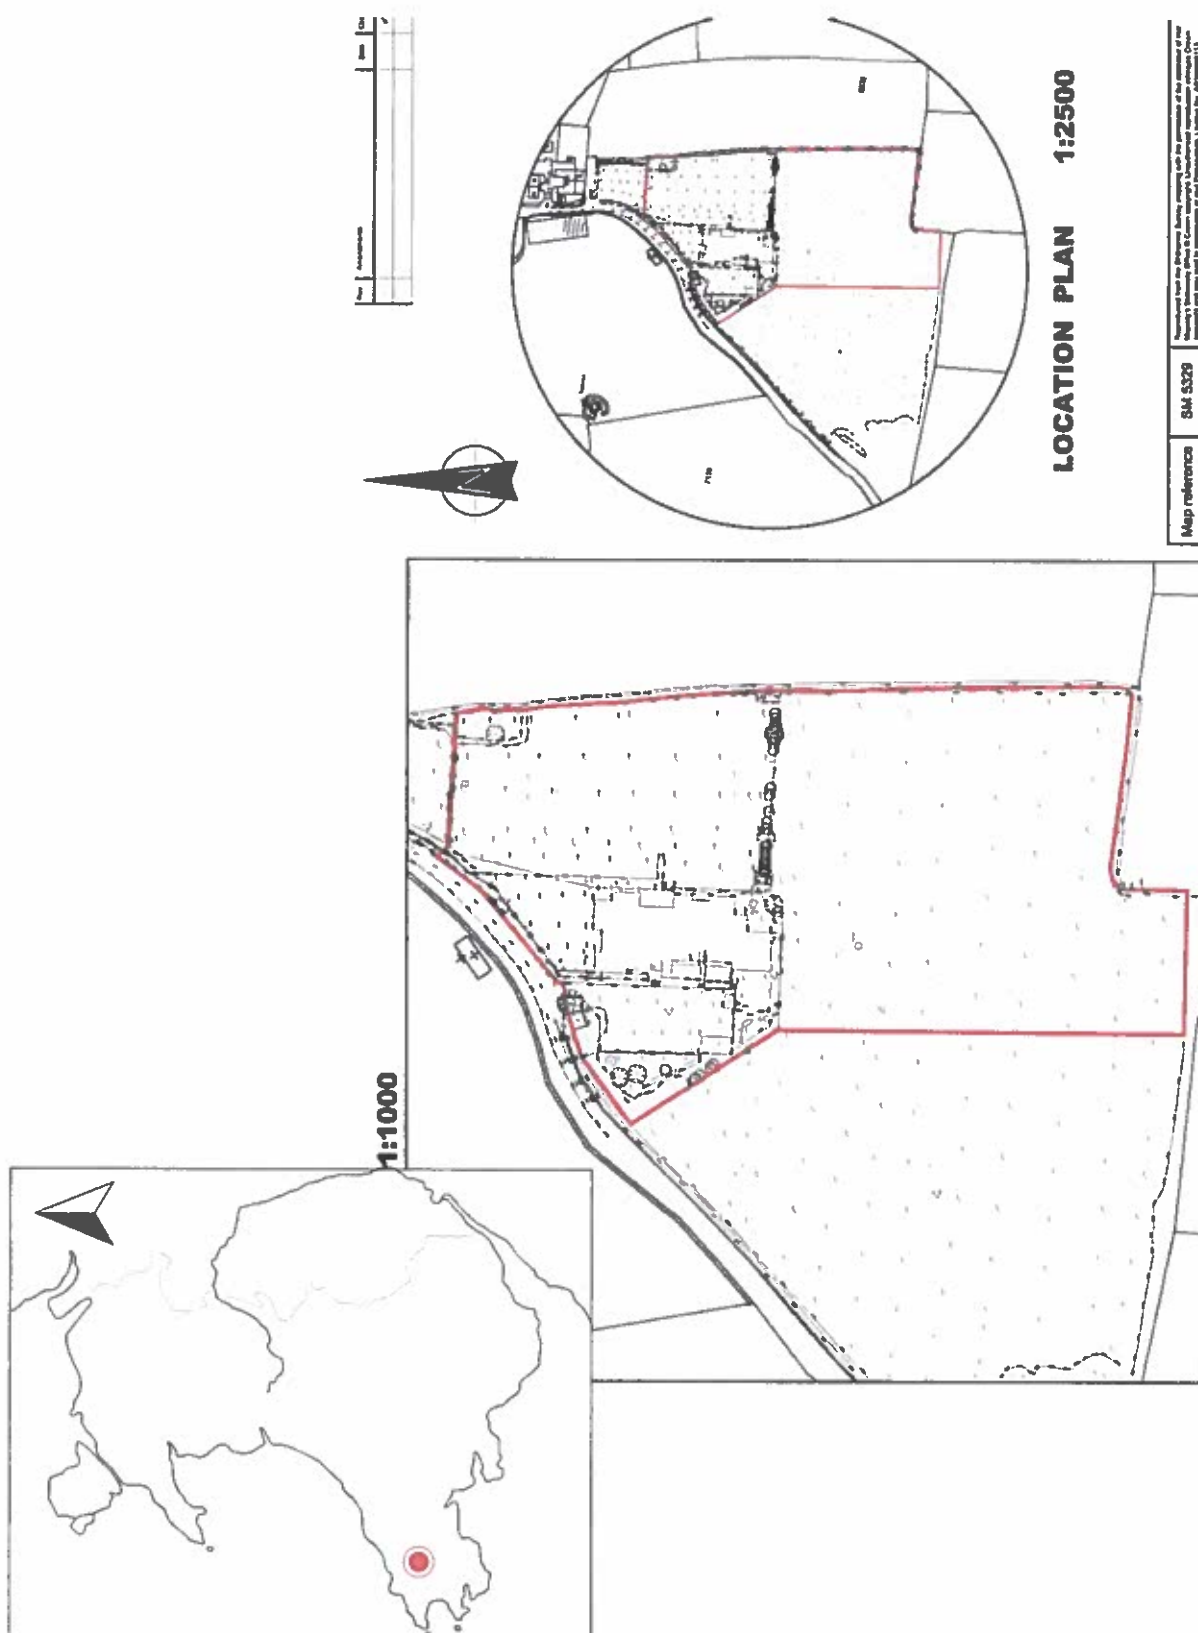
| <b>Fig. 2</b> | <b>Layout of the site showing the location of the modern features identified</b> |

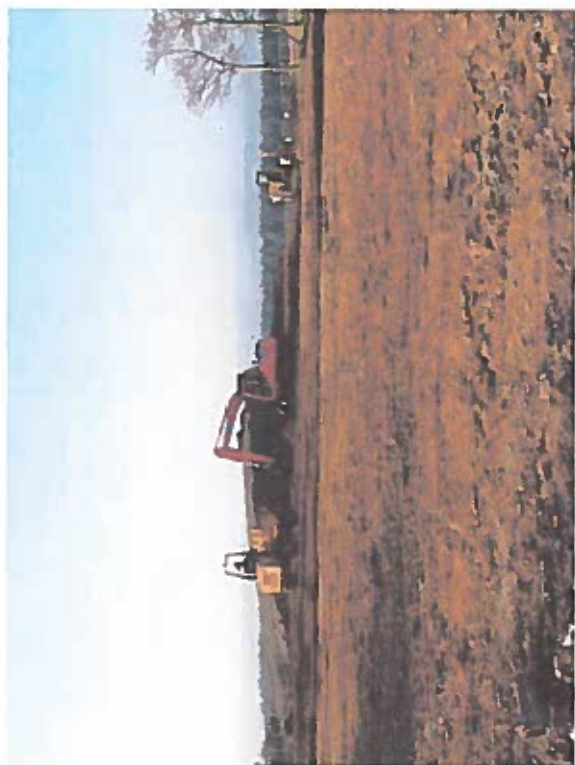
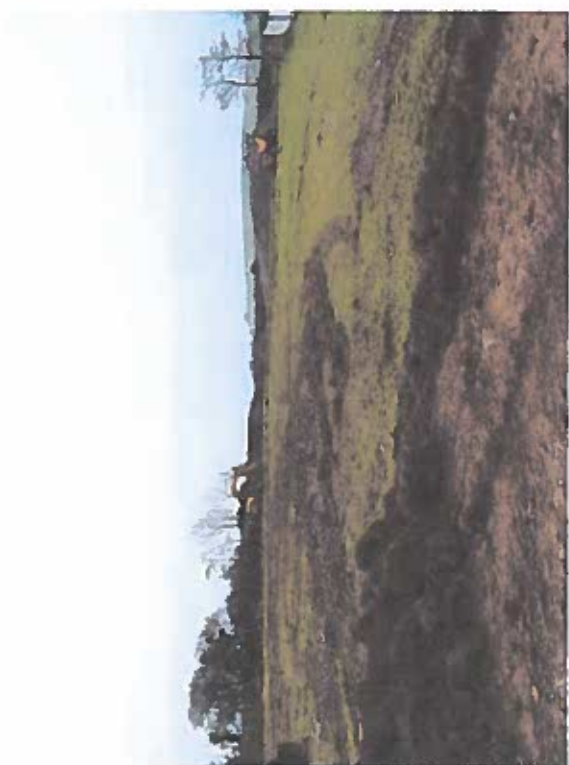
Fig. 3  
The site prior to and  
during the topsoil  
strip

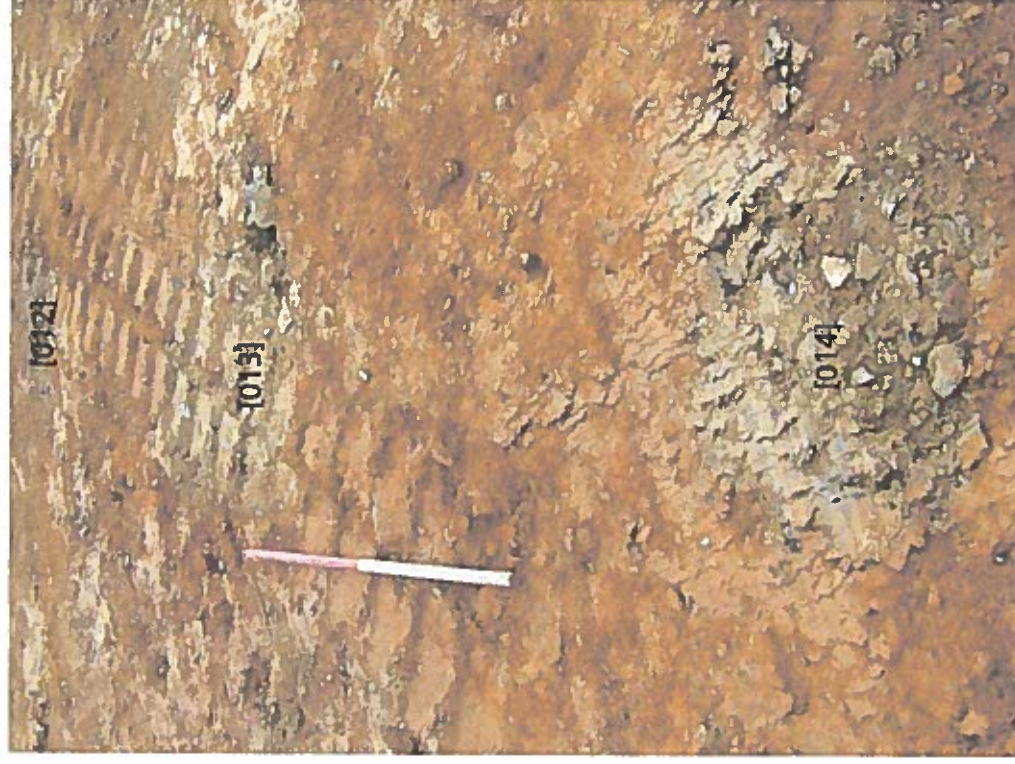
At the northern end of the site, three lines of square cuts measuring 0.5m by 0.5m were identified, [011]-[014], [019]-[023], [033] and [034]. These were spaced 1m apart and were aligned directly east/west. These cuts all contained a fill comprising mixed topsoil and natural shale. Their function is unknown but they are modern and possibly related to the drainage trench [003]. A further line of square cuts was identified at the southern end of the site, [043], which contained square concrete fence posts that were removed as part of the works.

Fig. 4  
Line of square cuts  
filled with modern  
materials at the northern  
end of the site

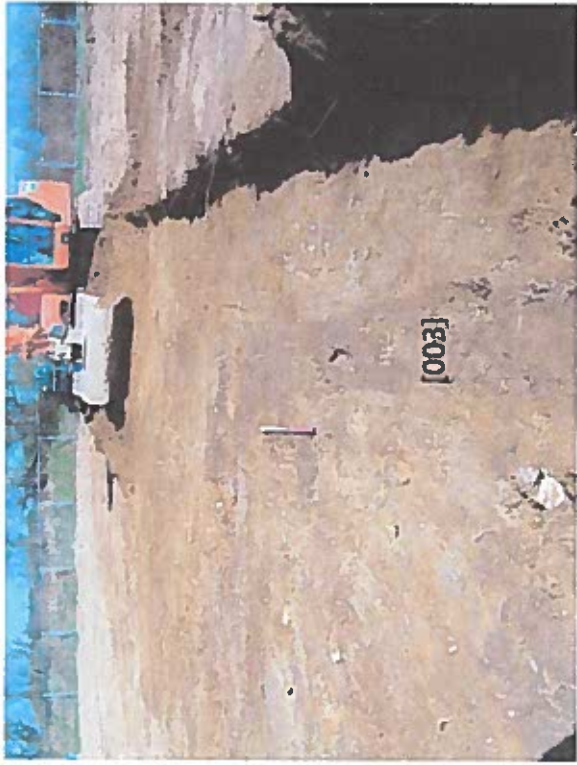
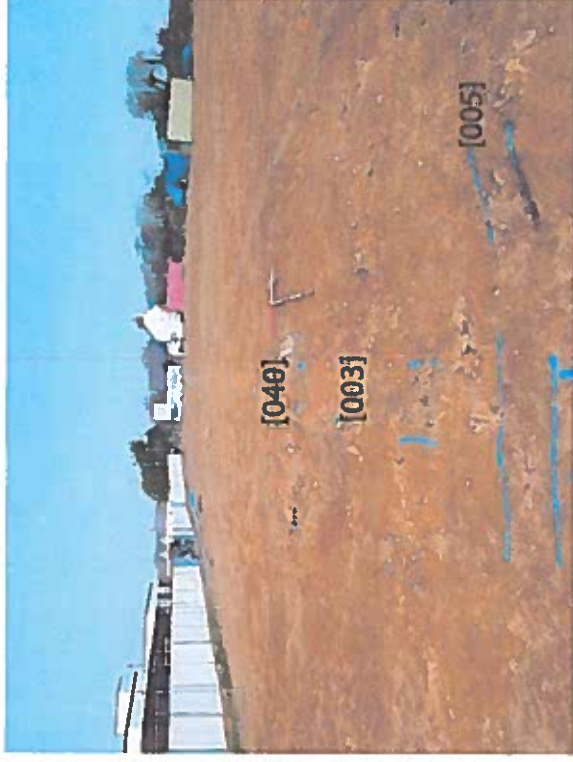
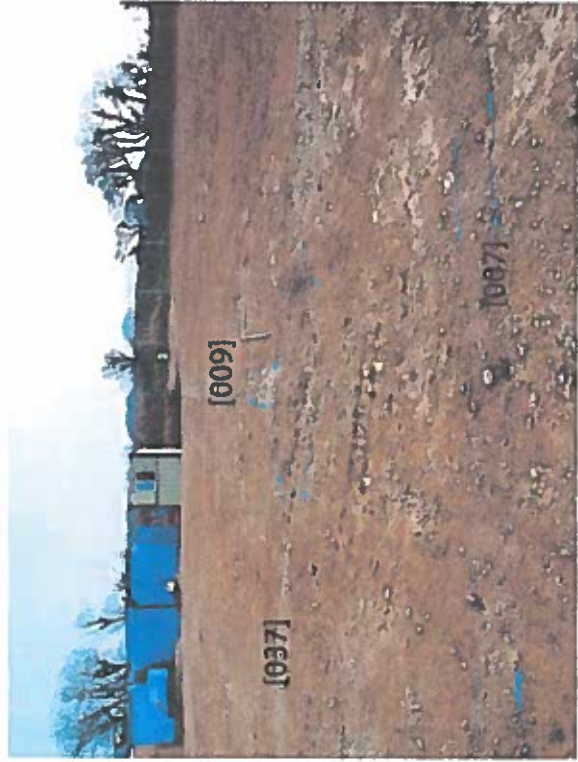
The site was criss-crossed by nineteenth/twentieth century drainage features, including 5 manholes. The main drain, [003], was identified running roughly north/south along full length of the site. It branched off to the east in two places., [009], [037]. The majority of the manholes were located on this main drain, with the remaining two, [039] and [040] located to the west of drain [003].

Fig. 5  
Modern drains and  
manholes on the site
