CANOLFAN GOFFA FFESTINIOG

Level 2/3 Building Record

Prosiect Rhif / Project No. G2459

Prepared for: NHS Wales

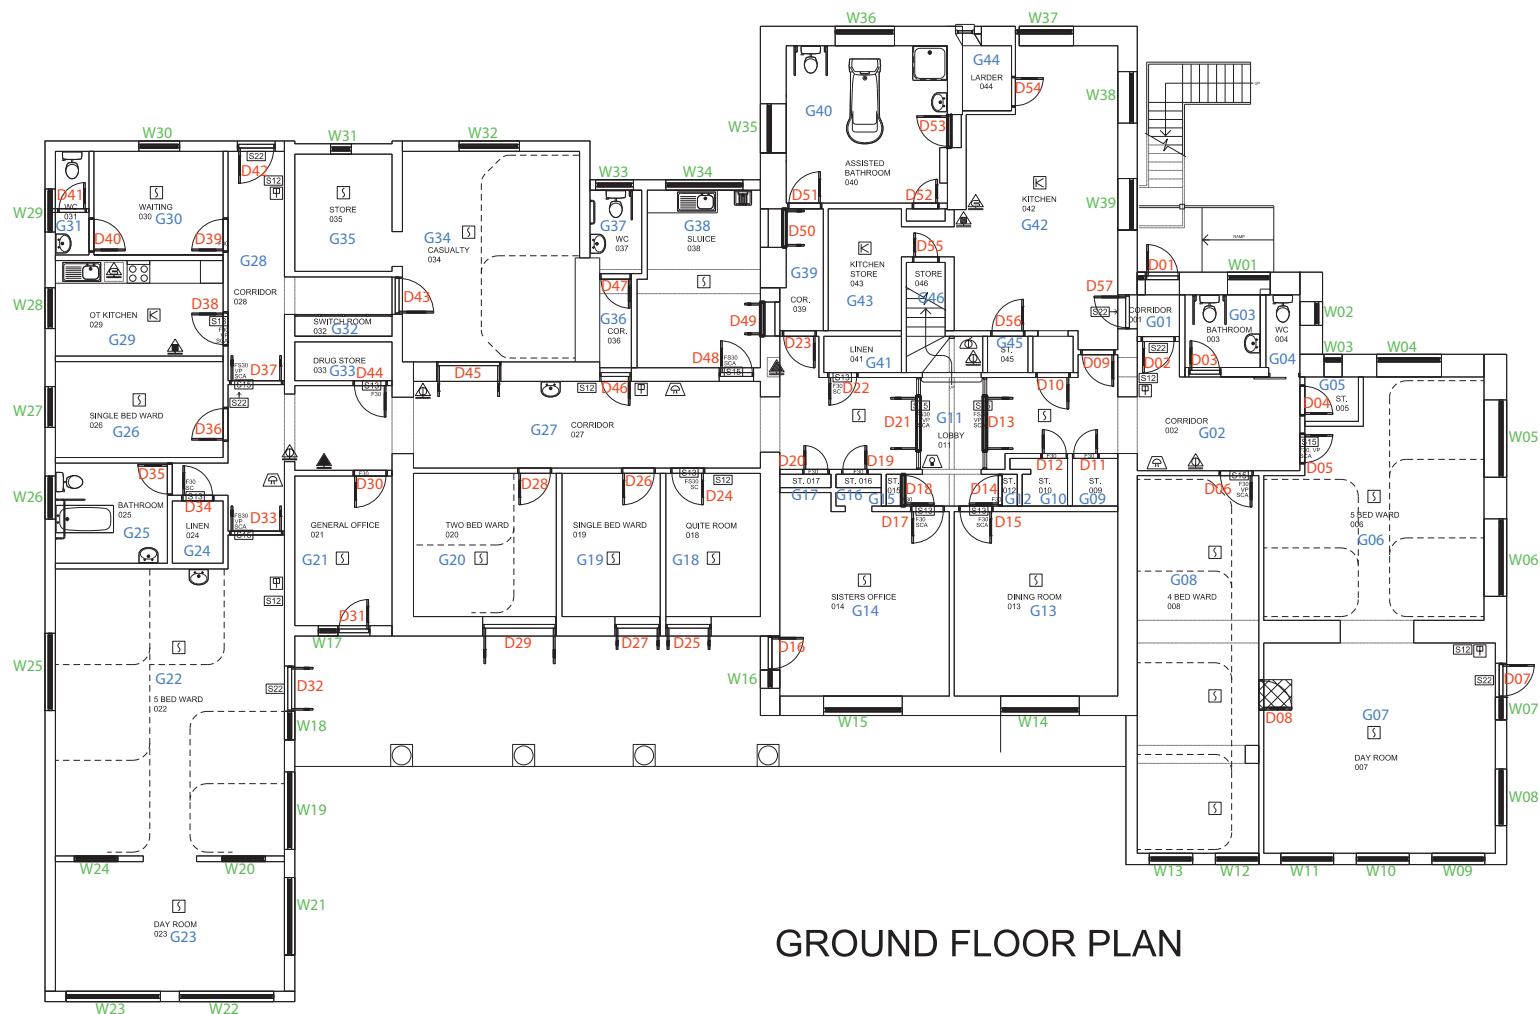
GROUND FLOOR PLAN

Figure 02: Reproduction of TACP Architects Ltd Drawing No. EX01, with Gwynedd Archaeological Trust amendments to highlight room numbers, door numbers and window numbers used for recording and reporting

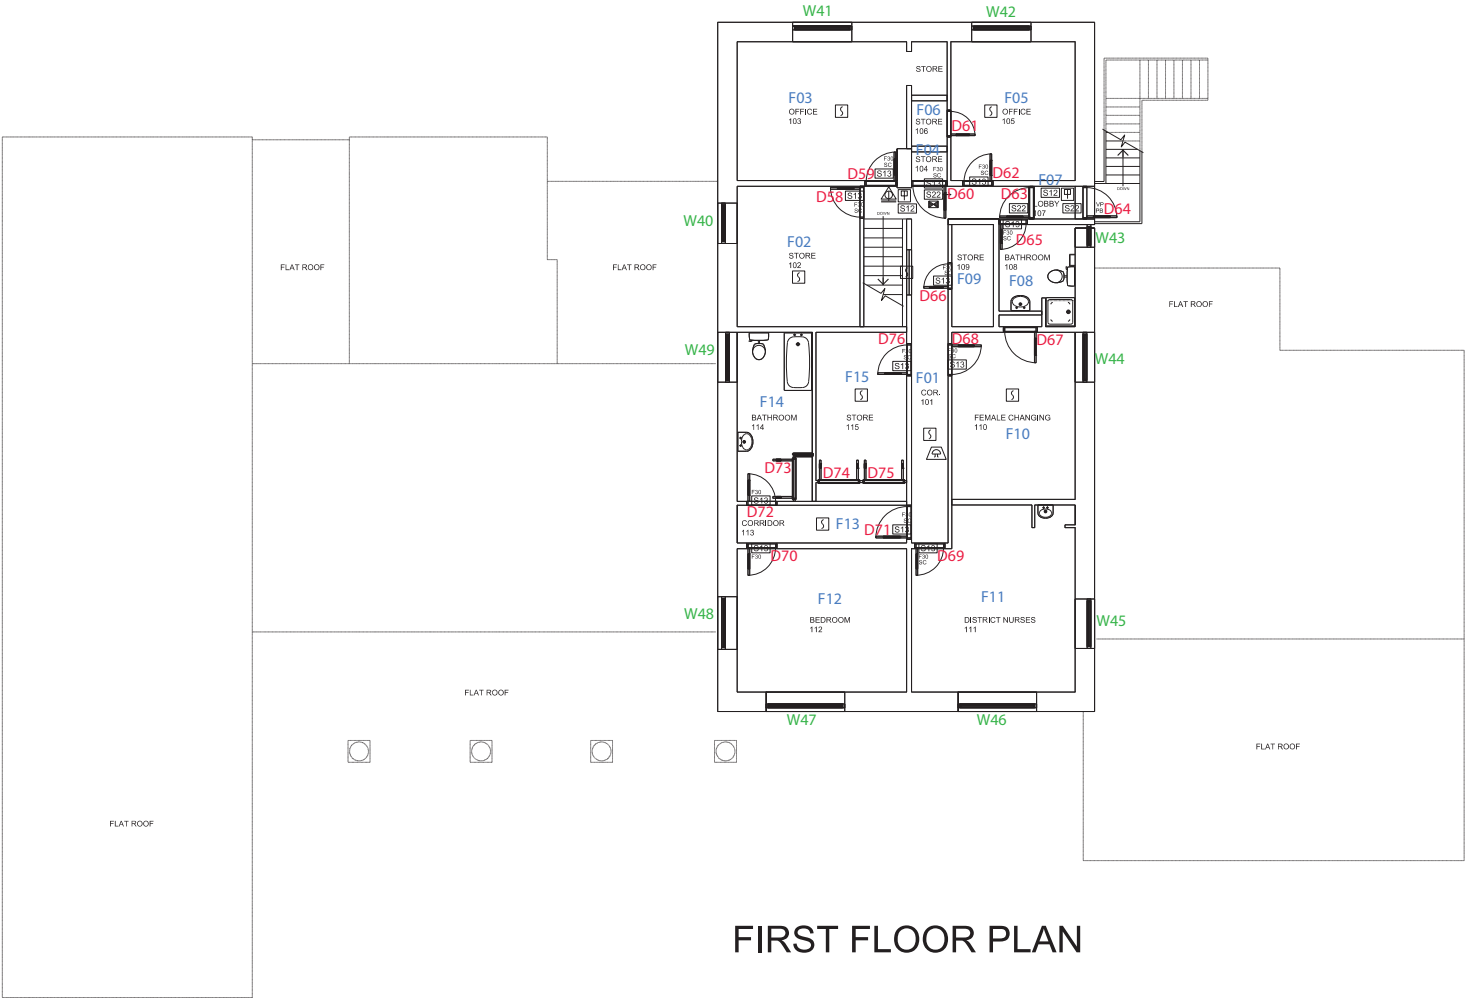
Figure 03: Reproduction of TACP Architects Ltd Drawing No. EX02, with Gwynedd Archaeological Trust amendments to highlight room numbers, door numbers and window numbers used for recording and reporting

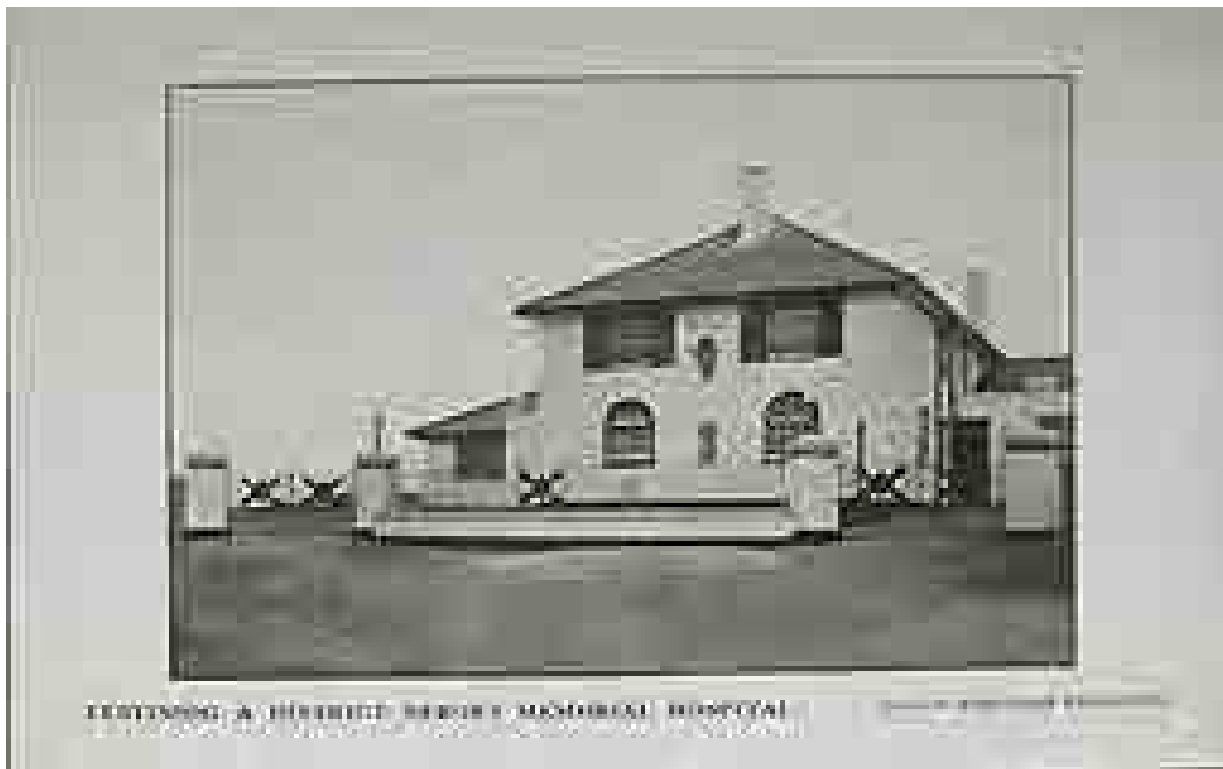
Figure 05a: Reproduction of a postcard detailing the hospital in its original form, comprising a main building and two wings. Gated access to each wing is visible along with a low front wall outside the main building. The access gates have subsequently been removed.

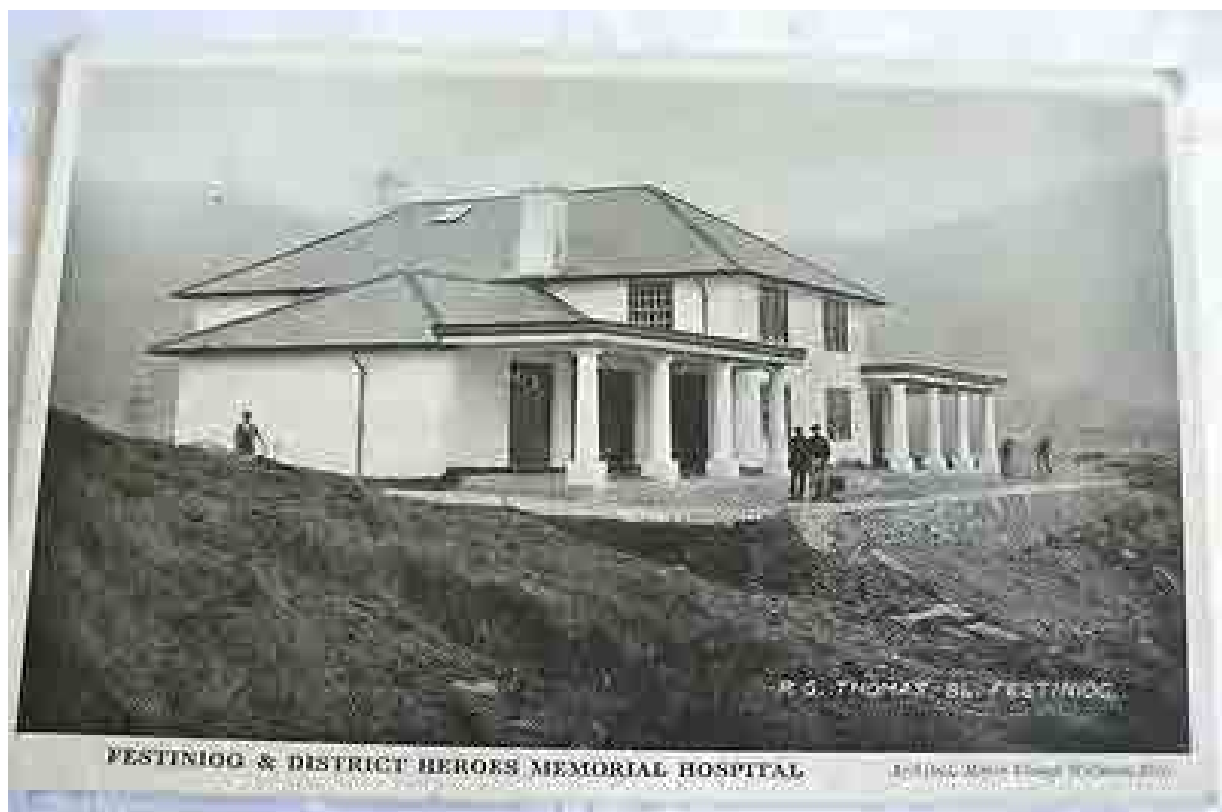
Figure 05b: Reproduction of a postcard detailing the hospital in its original form, during construction. This image details the main building and the two wings, along with the verandas at the rear of each wing. The memorial garden has not been completed at this point. The west wing (left part of image) was subsequently extended, whilst the east wing veranda was removed in the 1970s.

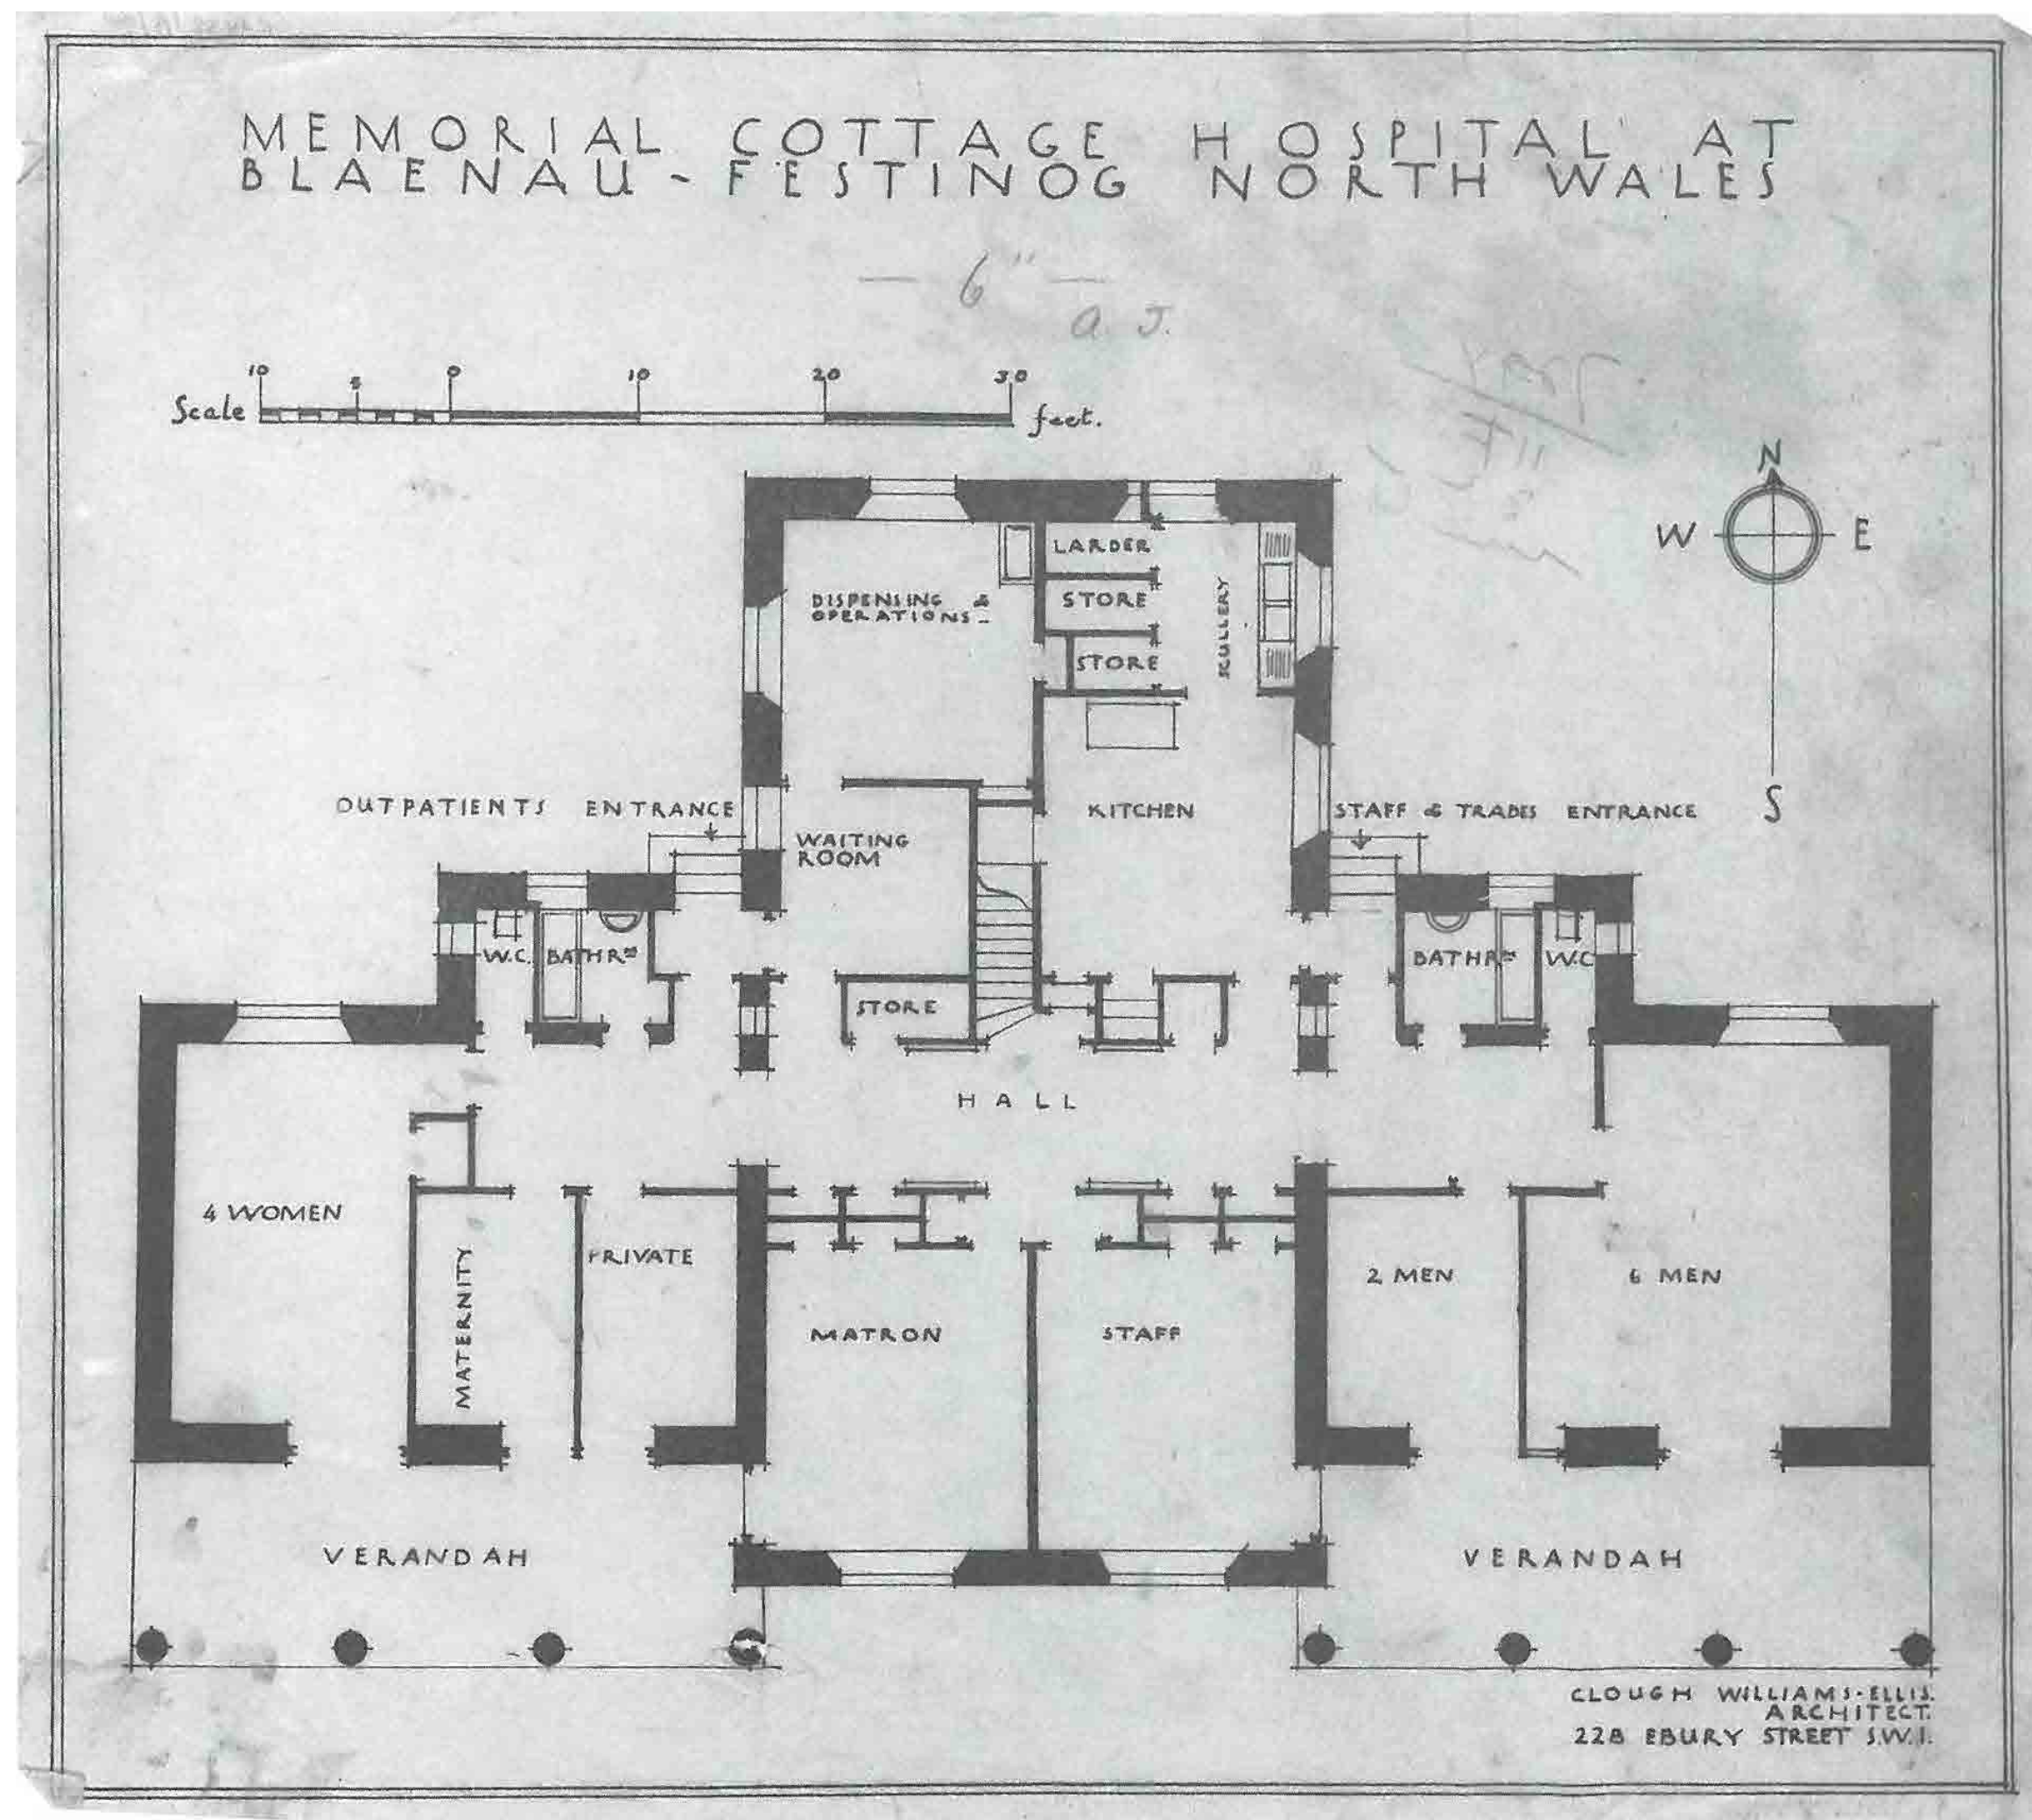
Figure 06: Reproduction of Sir Clough Williams-Ellis' design for Ffestiniog Hospital, c.1925. Produced using pen with wash on tracing paper; original size: 310mm x 340mm (Source: Haslam, R. 1996. Clough Williams Ellis, RIBA Drawings Monograph No. 2).

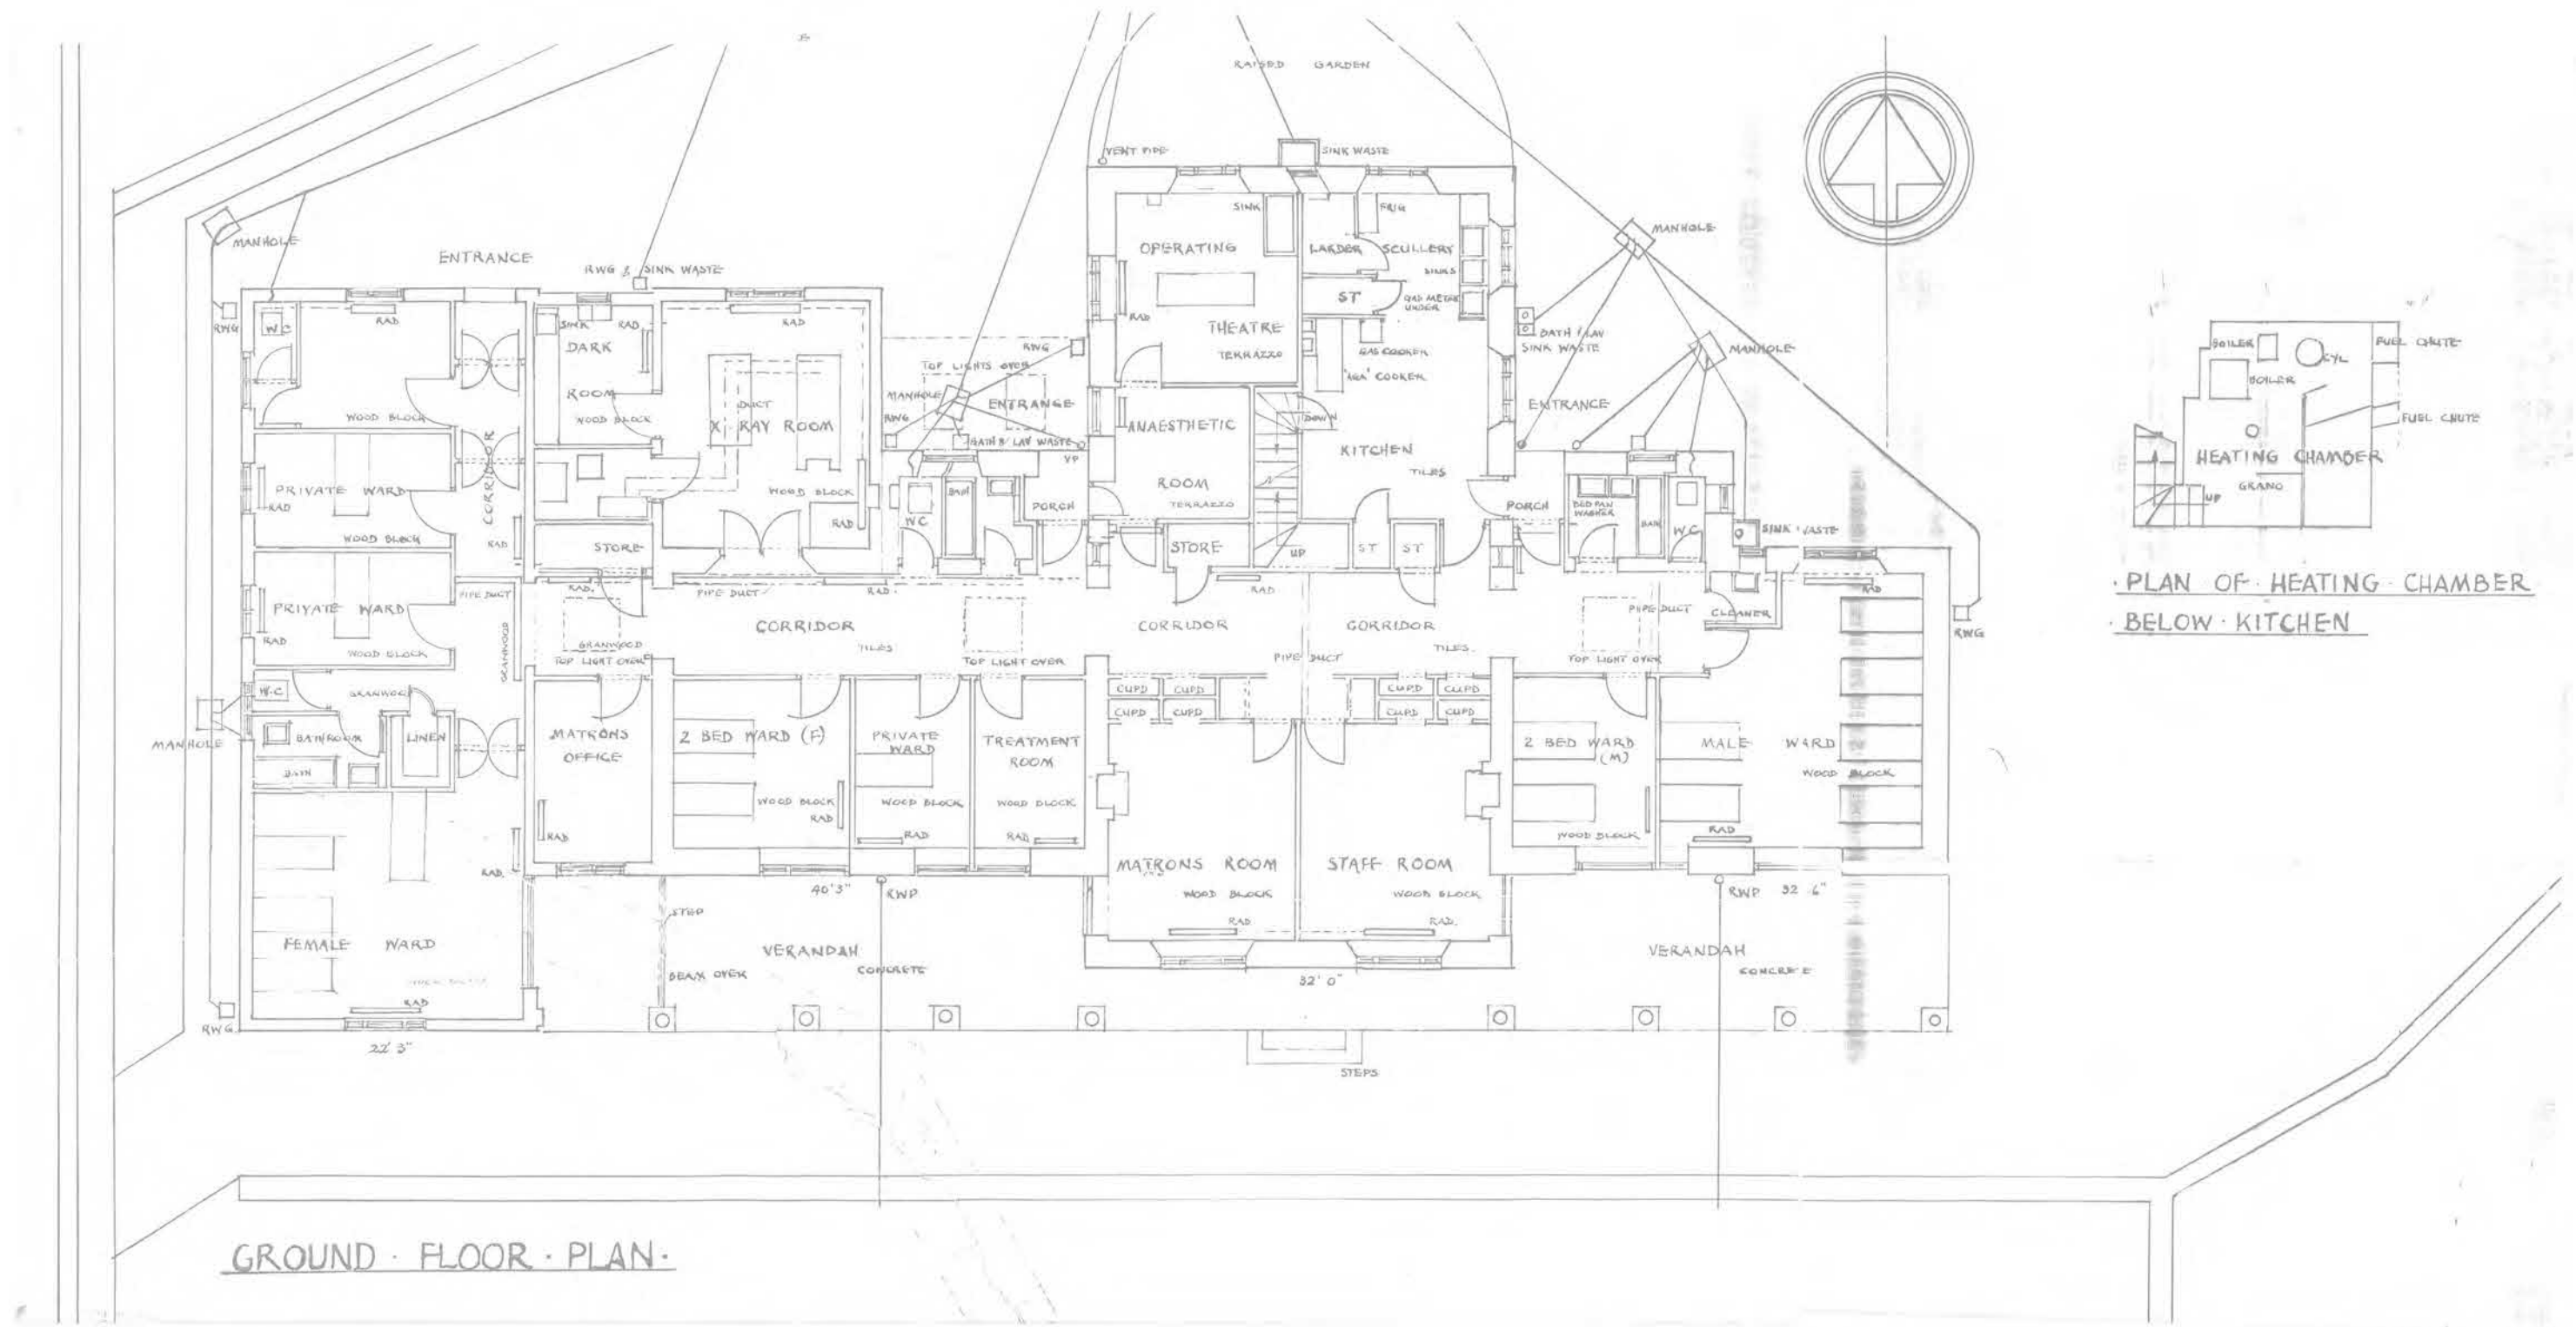
Figure 07: Reproduction of an undated plan of the hospital. The plan will have been produced before 1960, as a plan from that date includes interior changes not on this plan or on the 1925 plan. This plan includes the extension to the west wing that was designed after 1934 and saw the addition of 11 rooms that included more patient wards, the addition of an X-Ray room and the extension of the central corridor that linked the west wing to the main building. The building was further extended in the early 1970s (Source: Betsi Cadwaladr University Health Board archive 18/1).

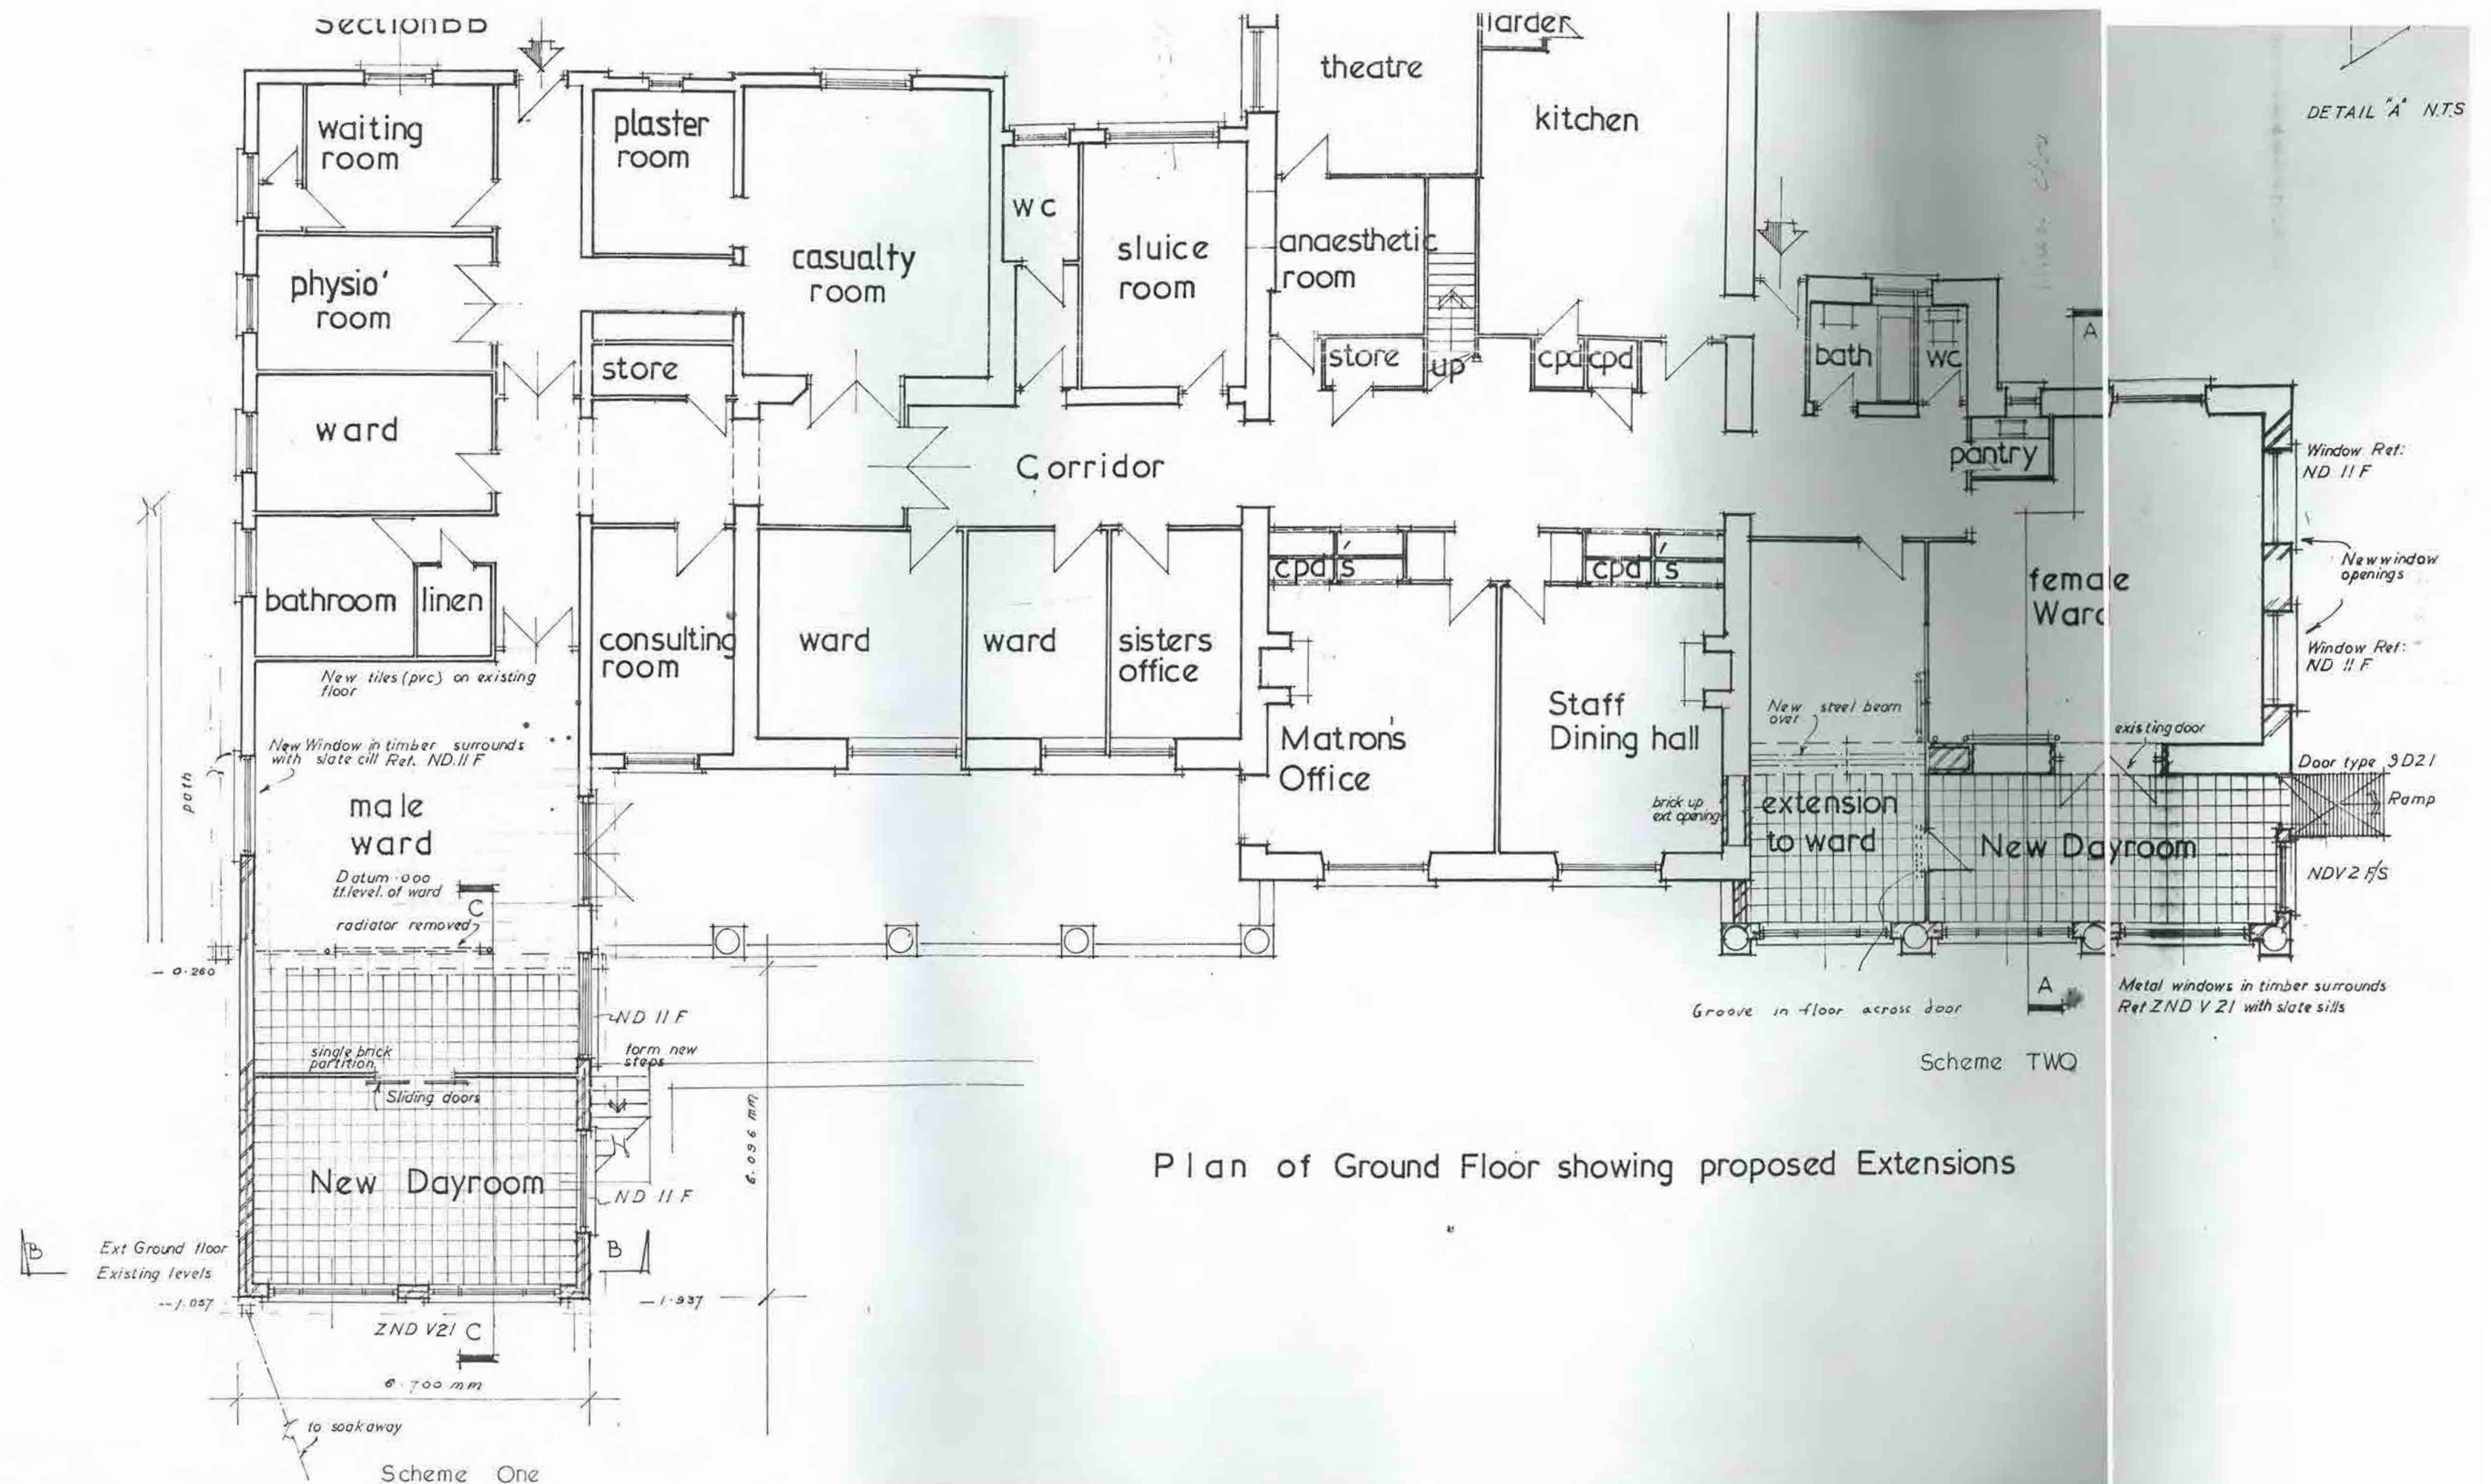
Figure 09: Partial reproduction of a 1972 plan of the hospital. The plan details proposed changes to the west and east wings, with the addition of a dayroom to the west wing and a ward extension and day room added to the east wing. The addition of the day room to the east wing necessitated the removal of the veranda, whilst new windows were also added to the existing east wing patient ward. The plan also reveals that the internal layout had changed, with the male and female wards moved to the opposing wings. (Source: Betsi Cadwaladr University Health Board archive 18/16).

The 1972 essentially matches the current layout and proportions, but room functions have changed, with the operating theatre in the building core now extant as an assisted bathroom. A physiotherapy room on the 1972 plan is now a kitchen and the sister's office in the original east wing now a "quiet room" (the sister's room having the replaced the matron's room in the building core). The east wing dayroom on the 1972 plan has been extended further south and is visible on the current plan as double the size; the ward has also been extended south. This layout has removed the east wing veranda.

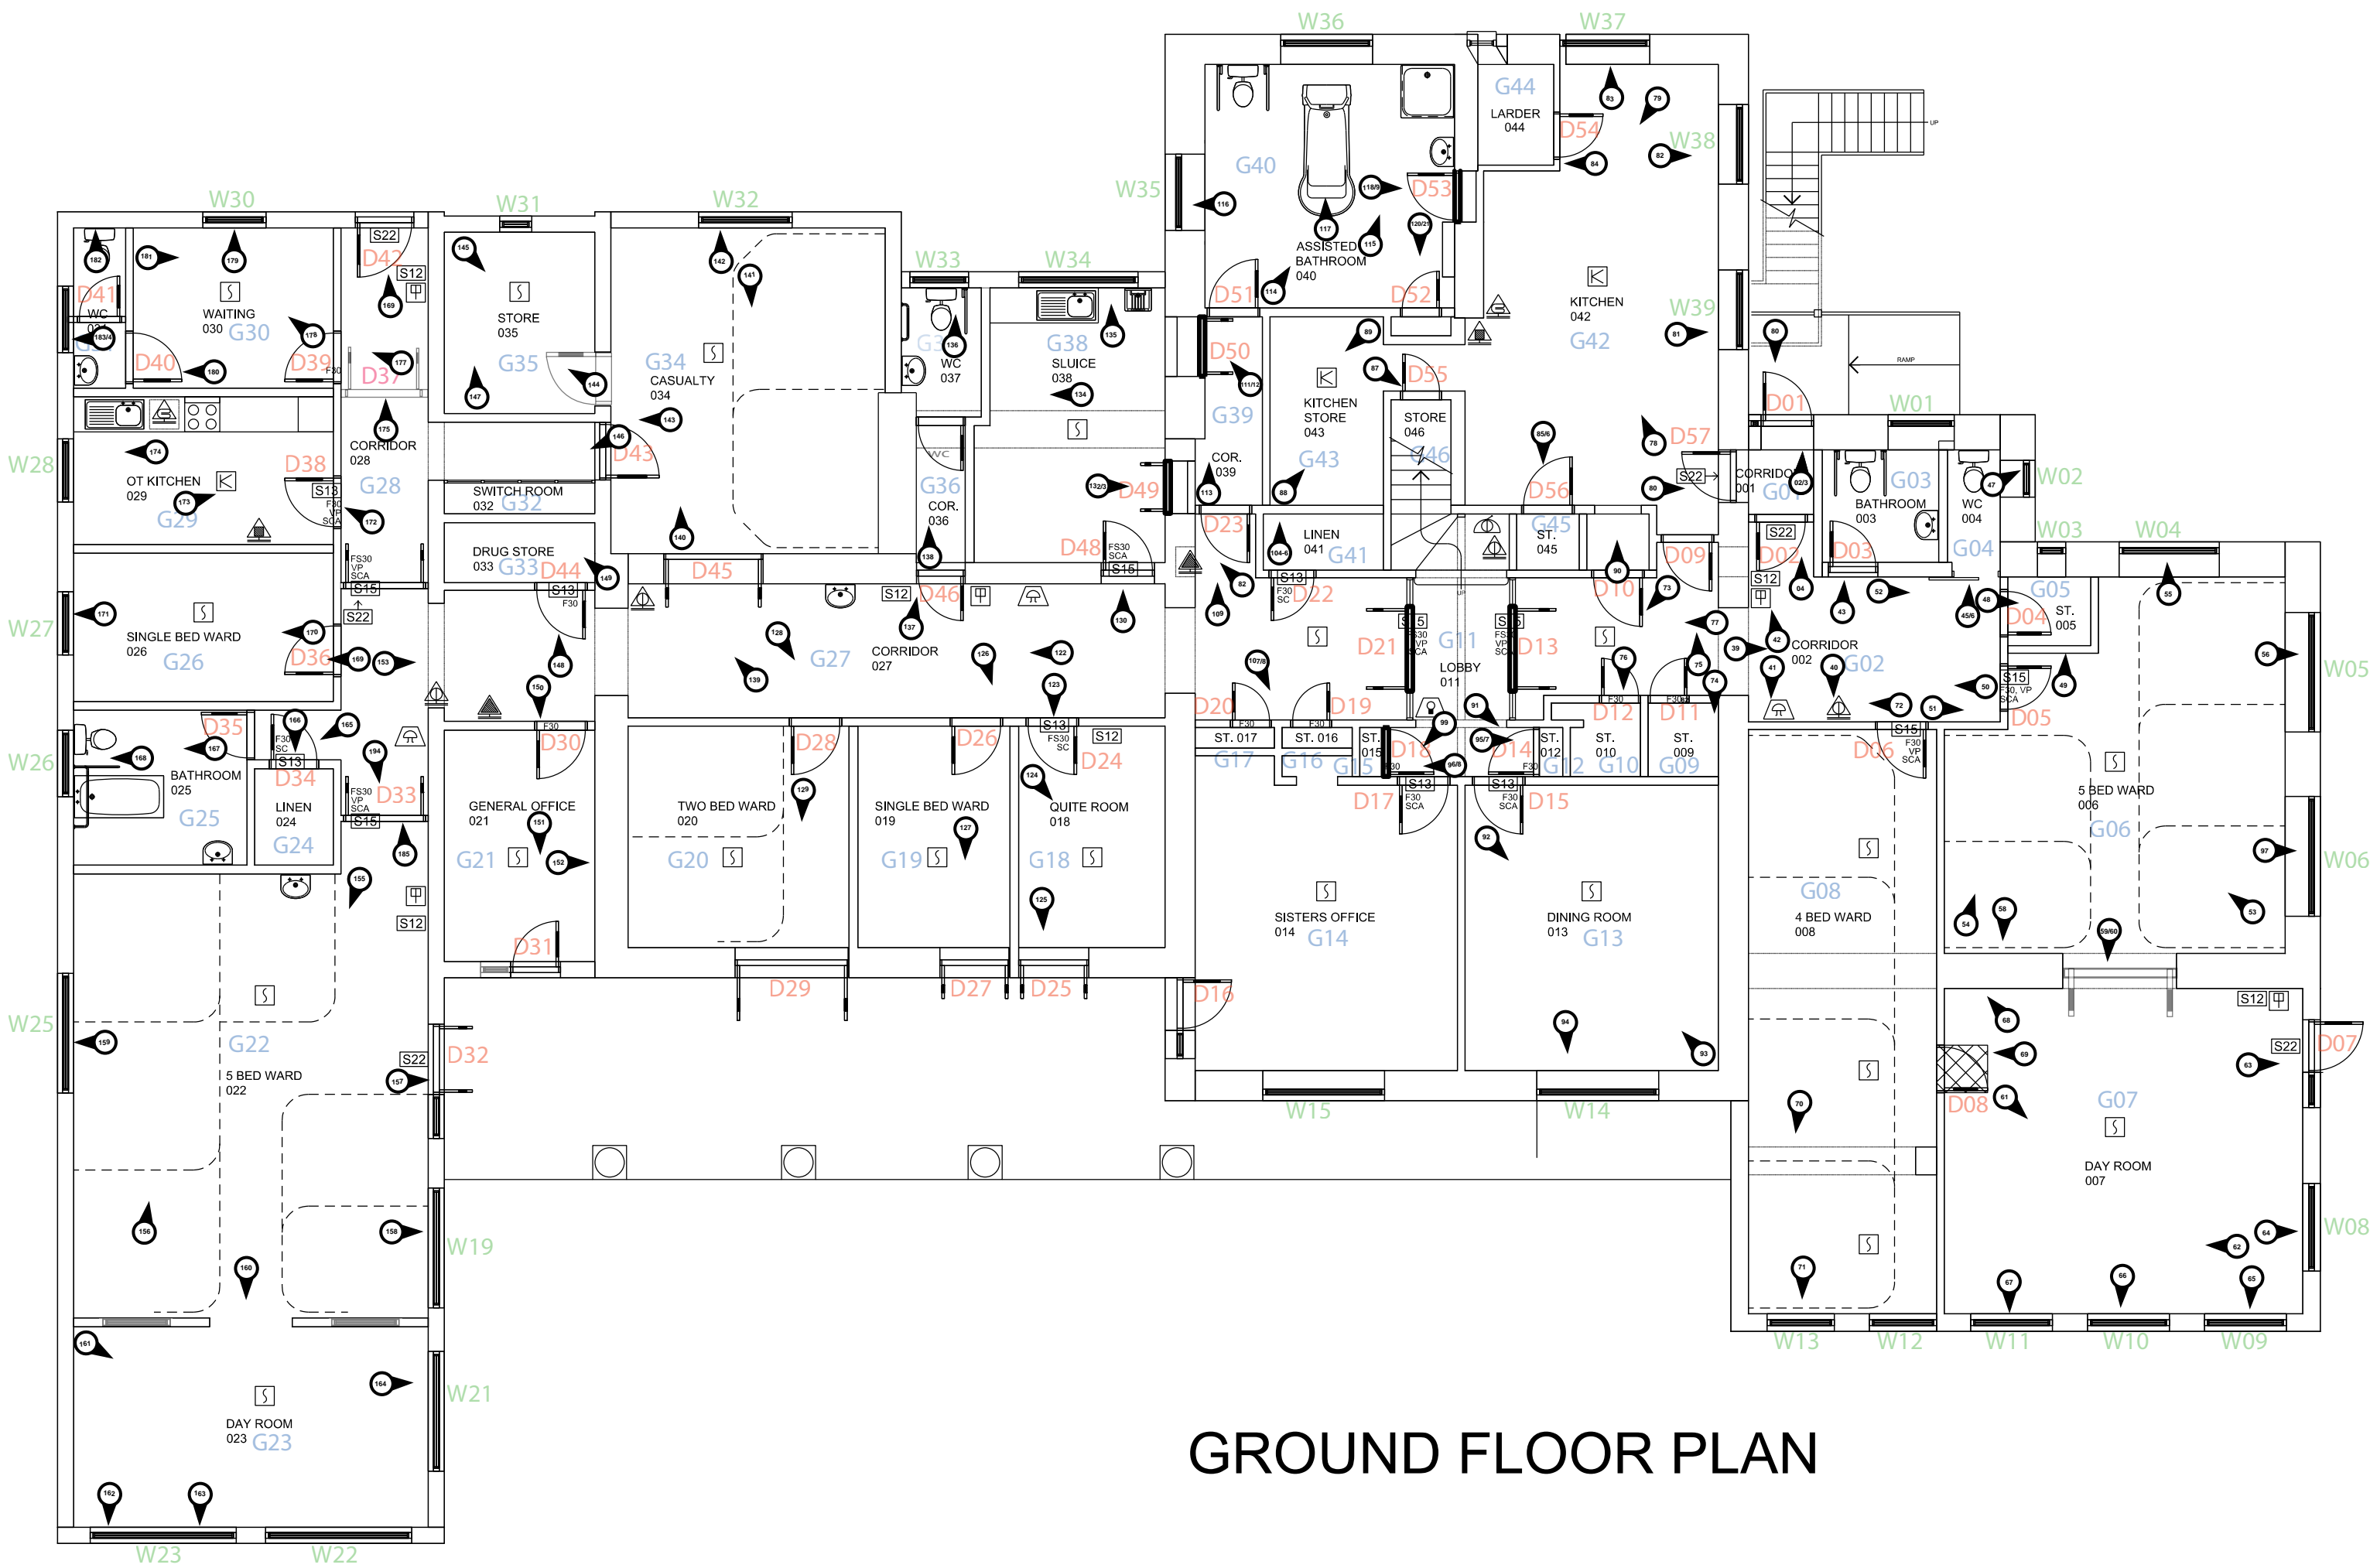
GROUND FLOOR PLAN

Figure 10: Reproduction of TACP Architects Drawing EX01, with Gwynedd Archaeological Trust amendments to highlight room numbers, door numbers and window numbers used for recording and reporting and the location of all images taken on the ground floor.
