CANOLFAN GOFFA FFESTINIOG

Level 2/3 Building Record

Prosiect Rhif / Project No. G2459

Prepared for: NHS Wales

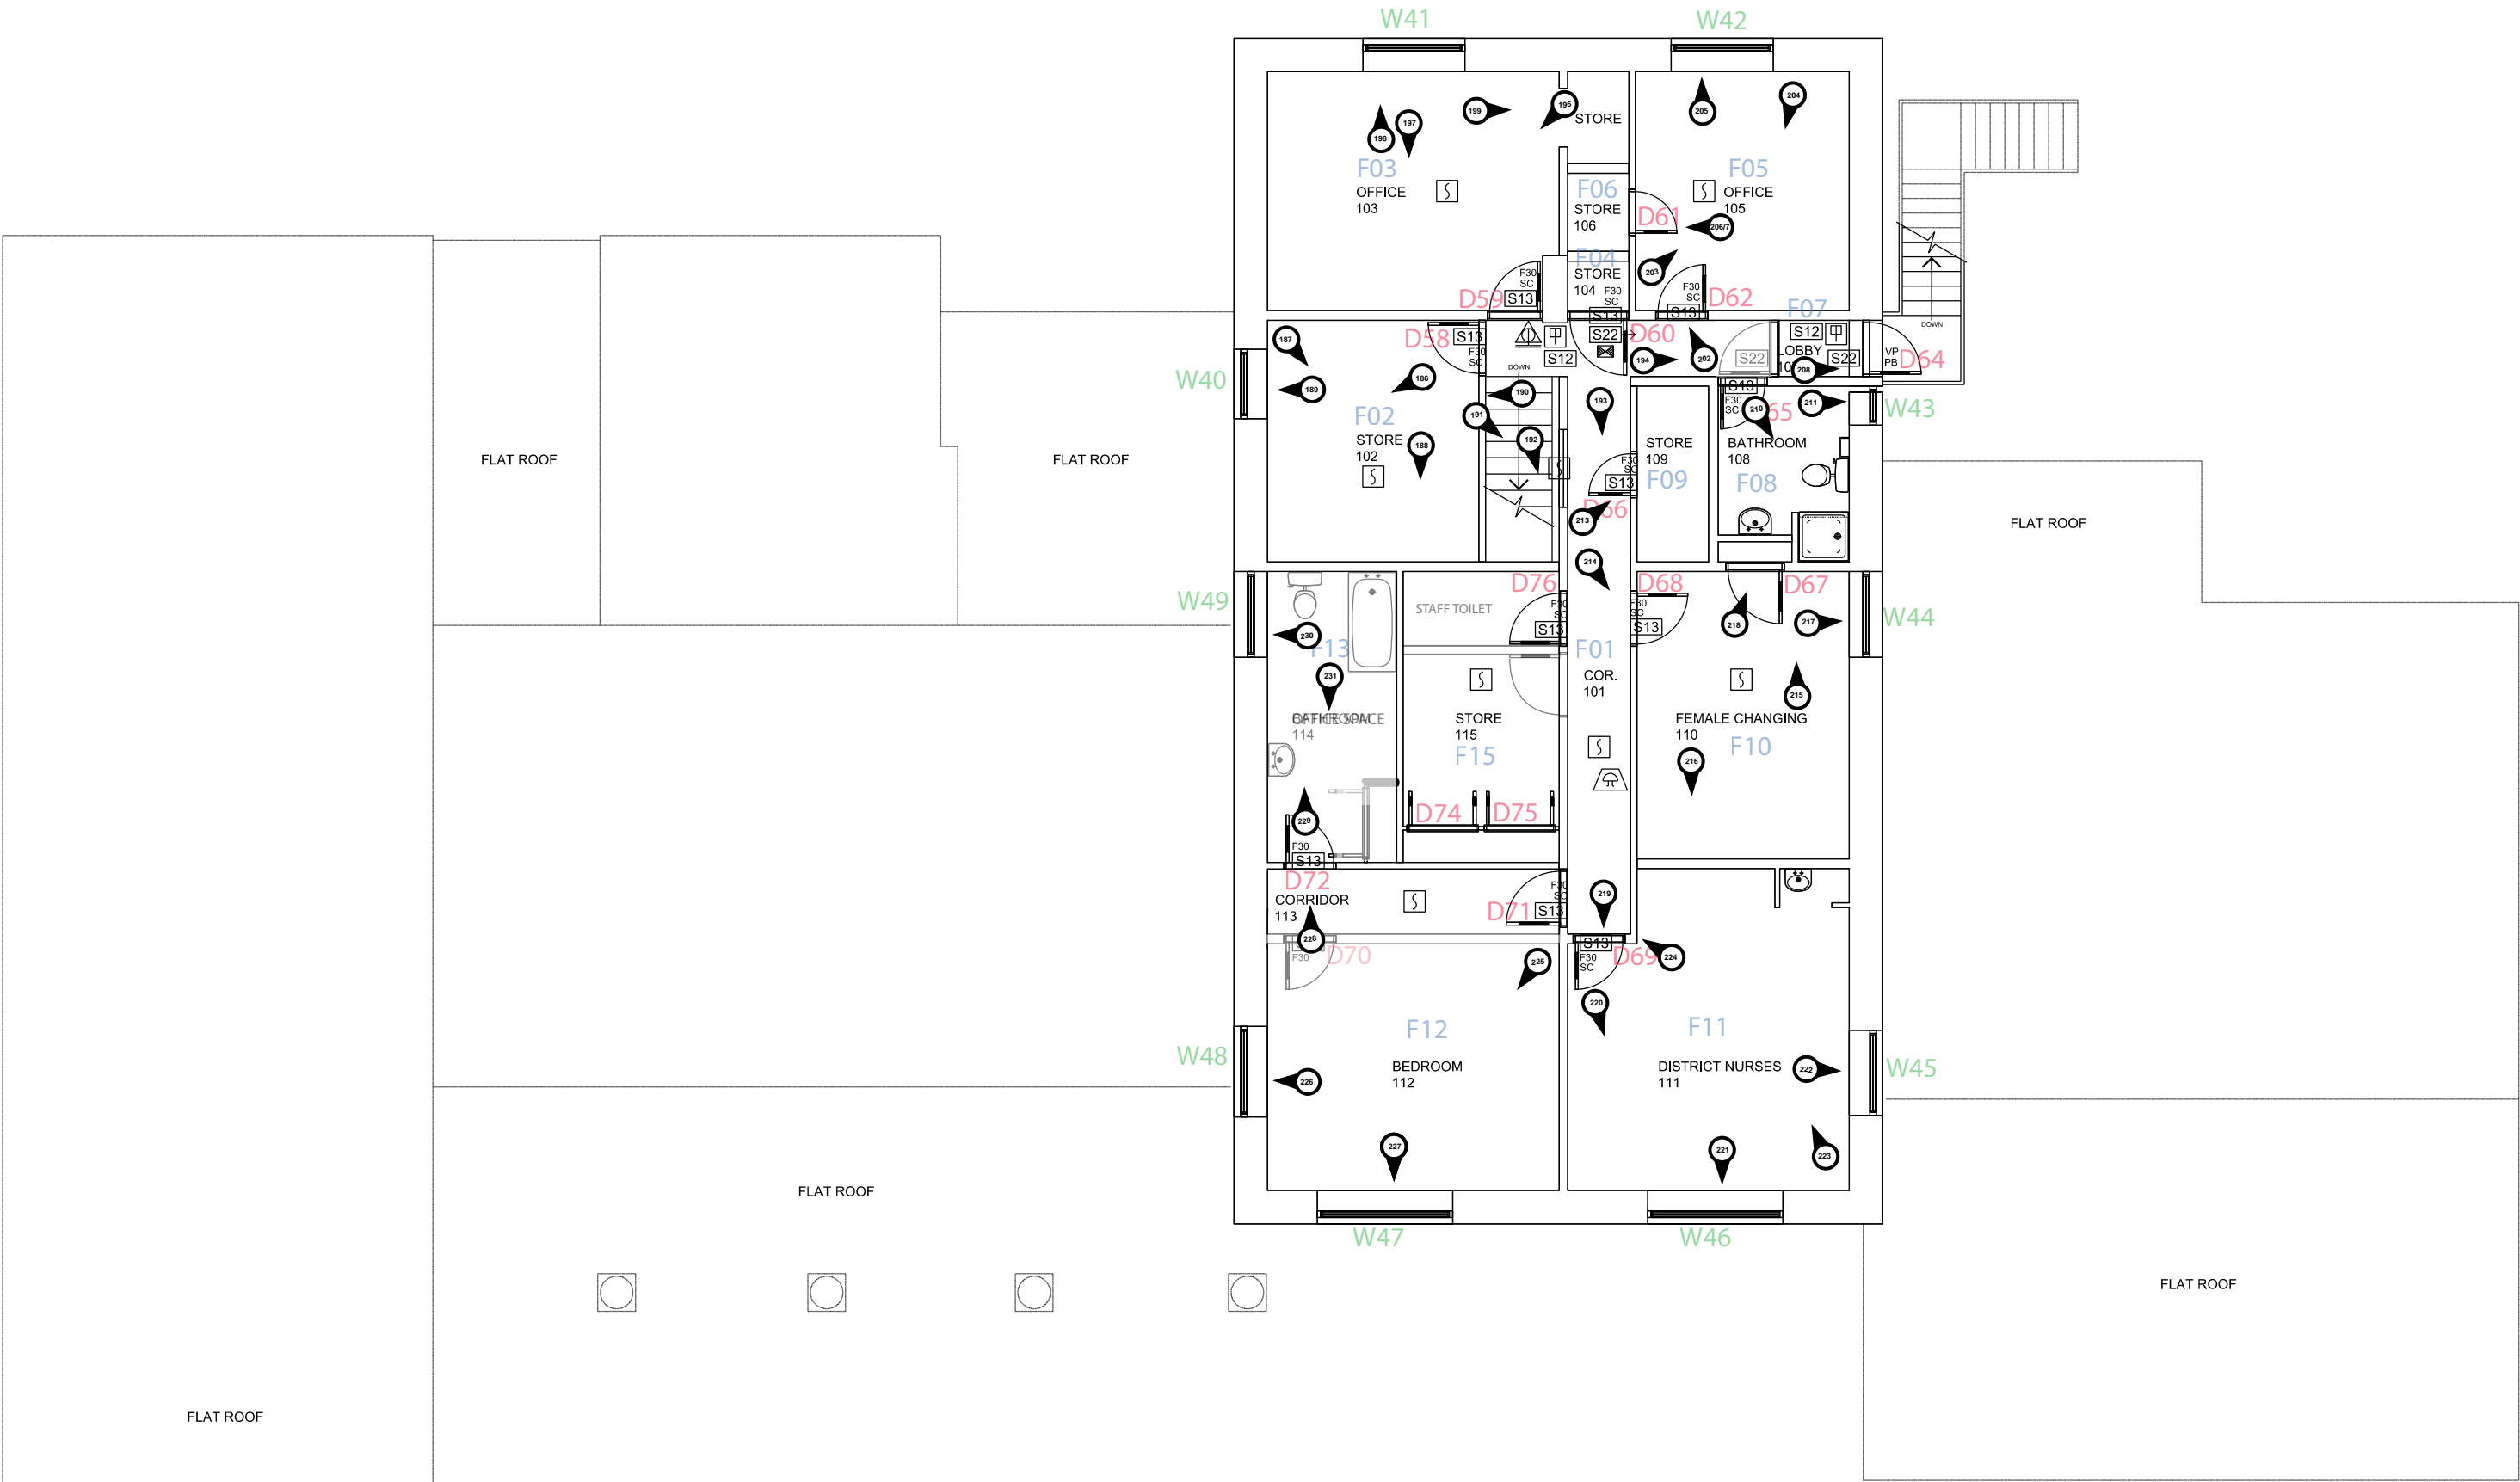
FIRST FLOOR PLAN

Figure 11: Reproduction of TACP Architects Drawing EX02, with Gwynedd Archaeological Trust amendments to highlight room numbers, door numbers and window numbers used for recording and reporting and the location of all images taken on the first floor.

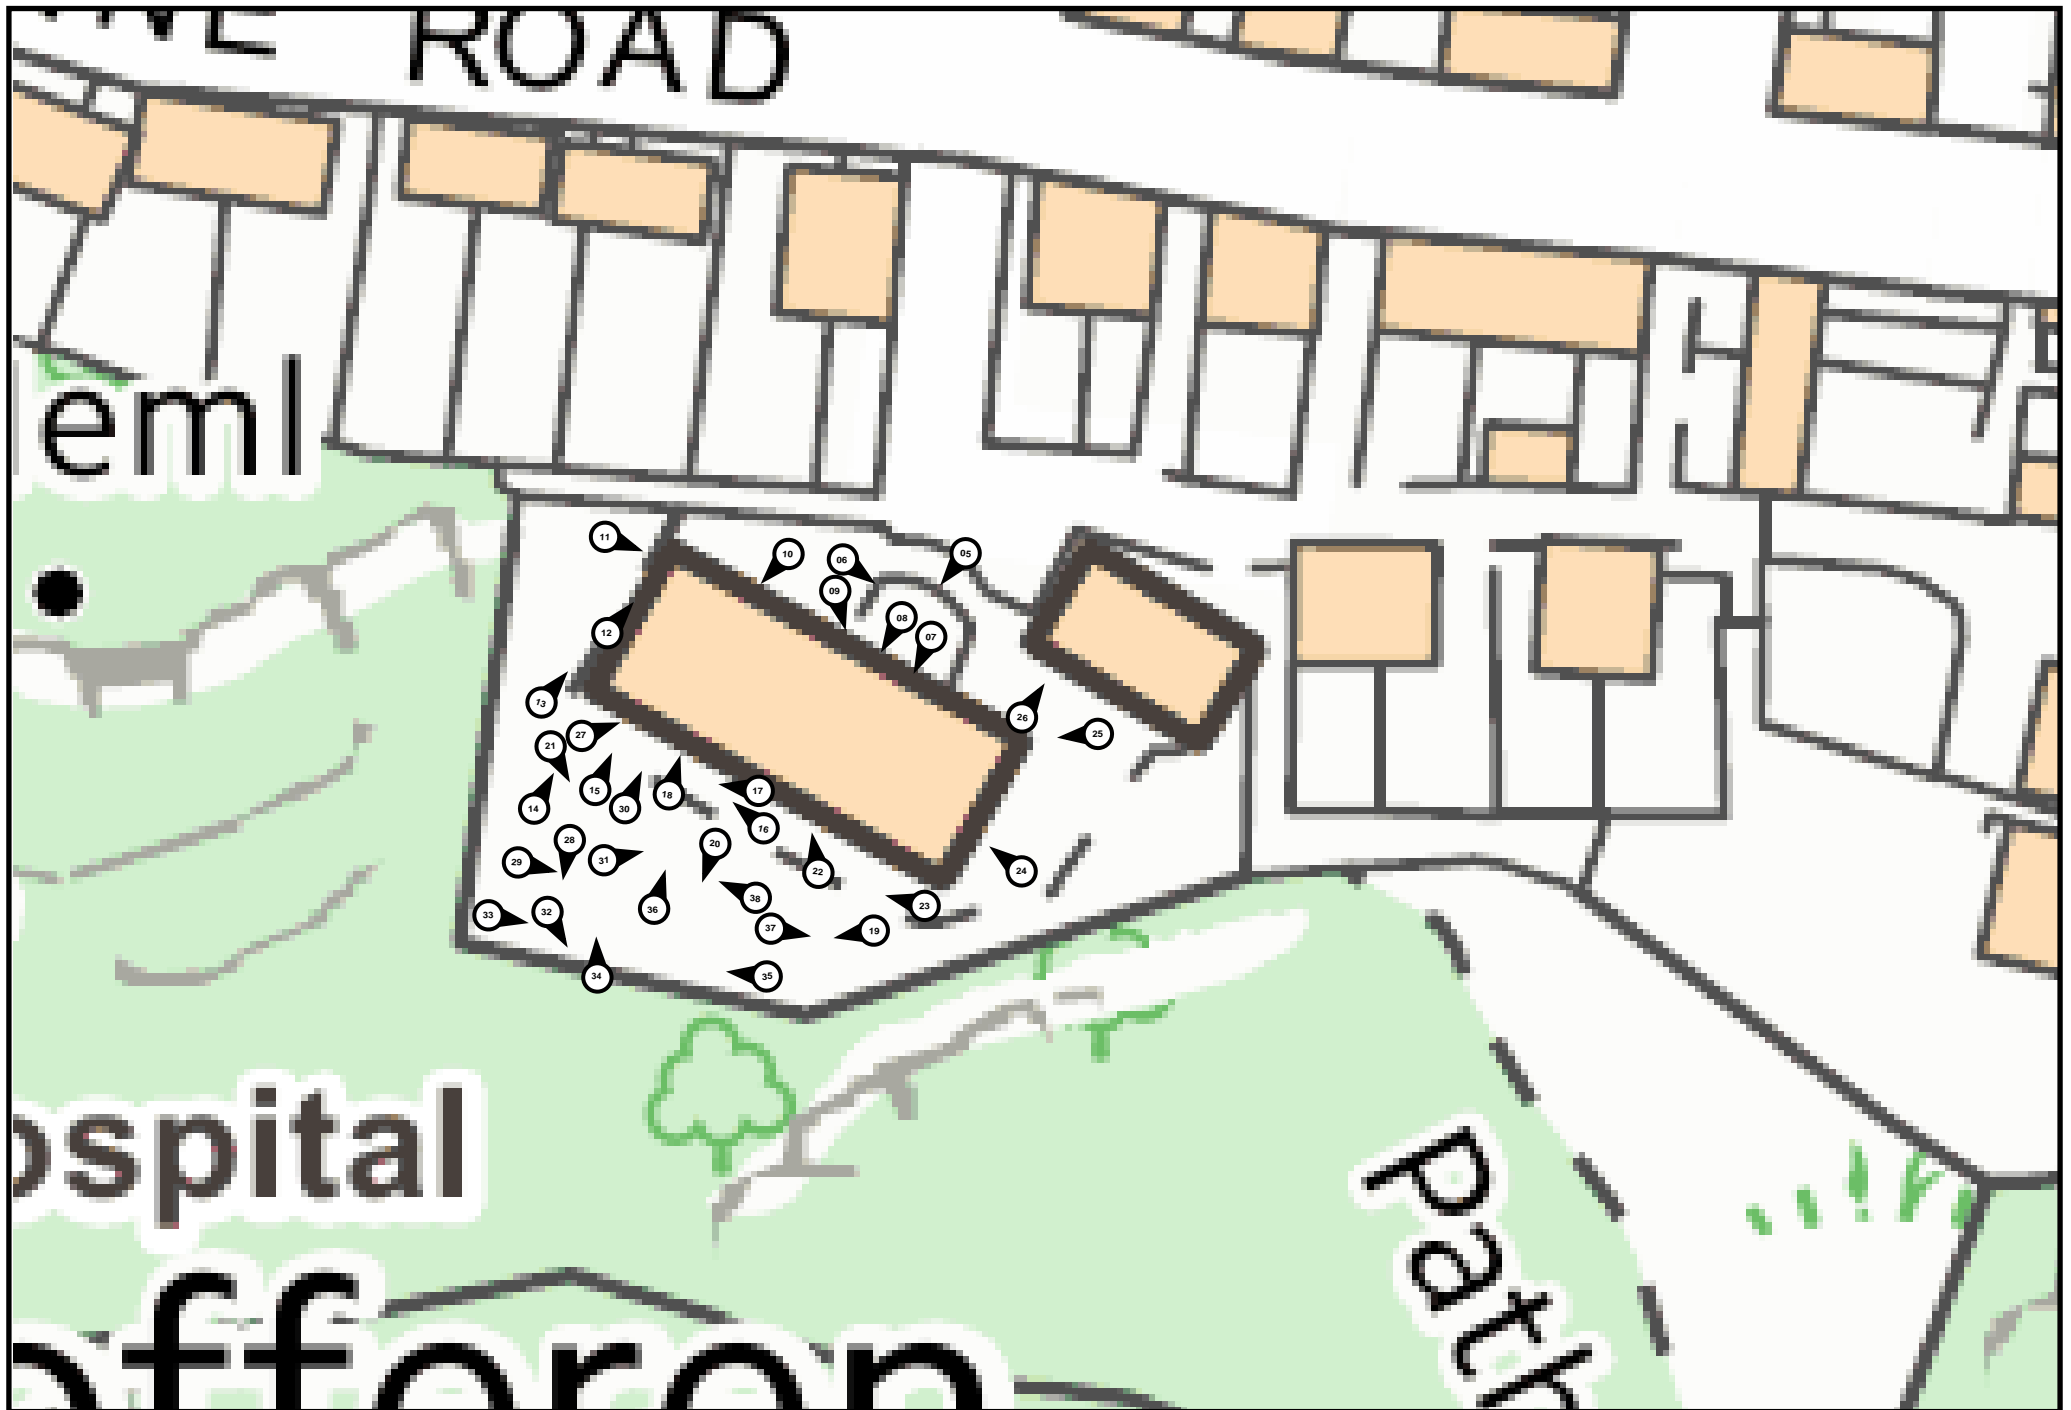
Figure 12: Location plan highlighting the location of all images taken of the exterior of the building.
Based on 1:10000 Ordnance Survey County Series Map Sheets SH74NW. SCrown Copyright. All Rights Reserved. License number AL100020895.

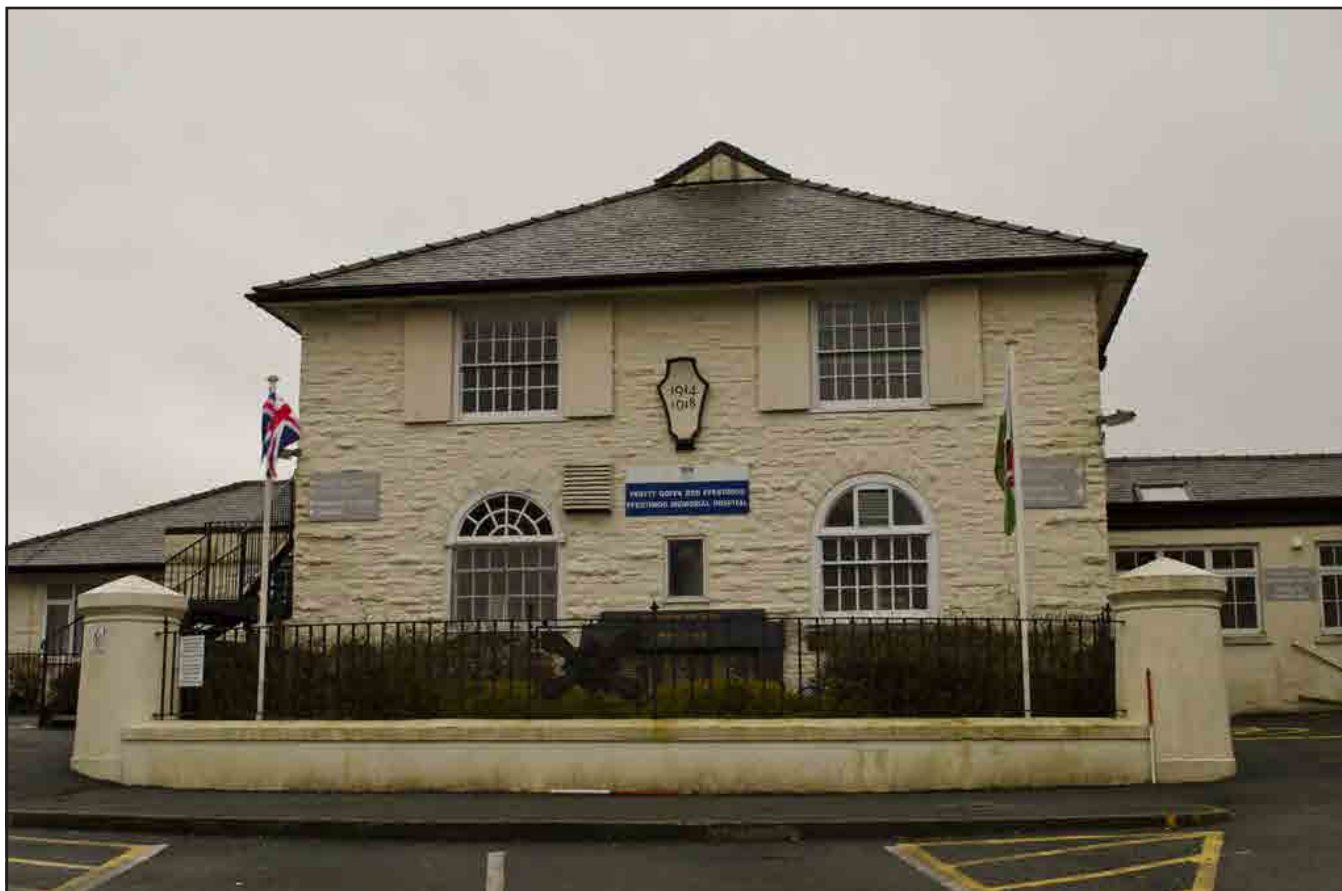
Plate 01: Front Elevation - view from the north incorporating the original building and adjoining wings (both part visible).
Scale: 2 x 1.0m (archive image: G2459_005).

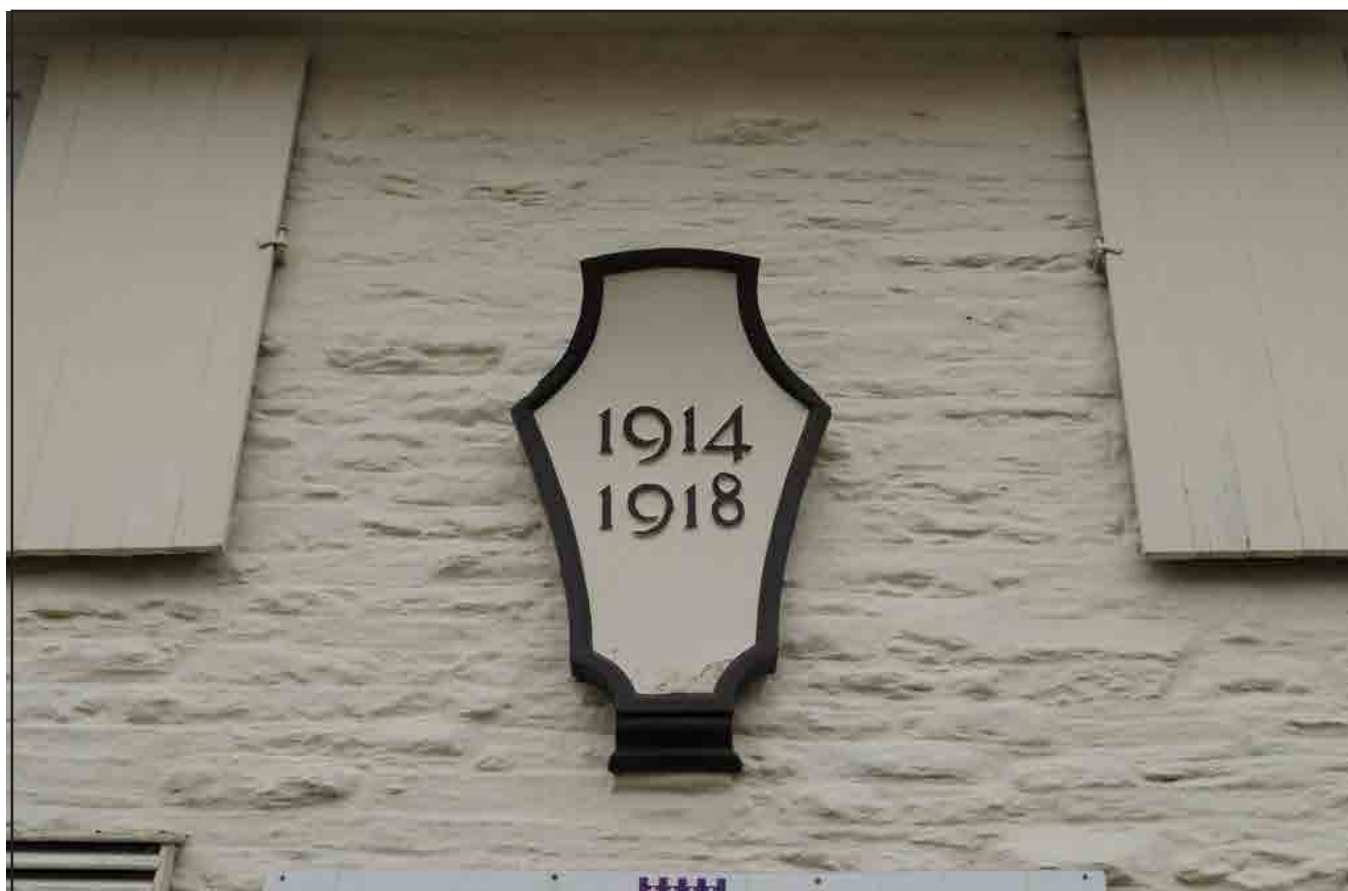
Plate 02: Front Elevation - detail of First World War memorial plaque (archive image: G2459_008).

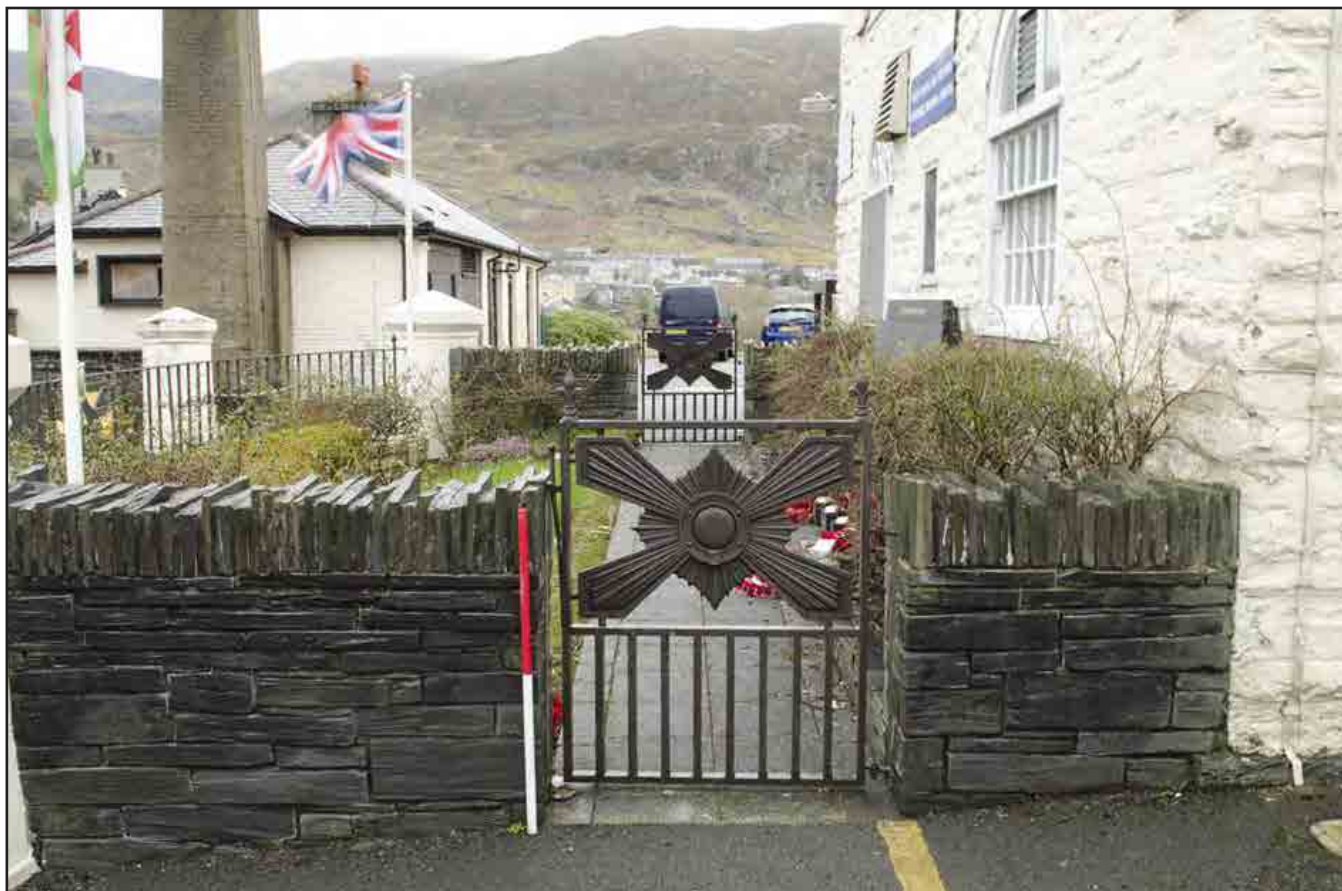
Plate 03: Front Elevation - view east of entrance into raised garden at the front of the building
Scale: 1.0m (archive image: G2459_006).

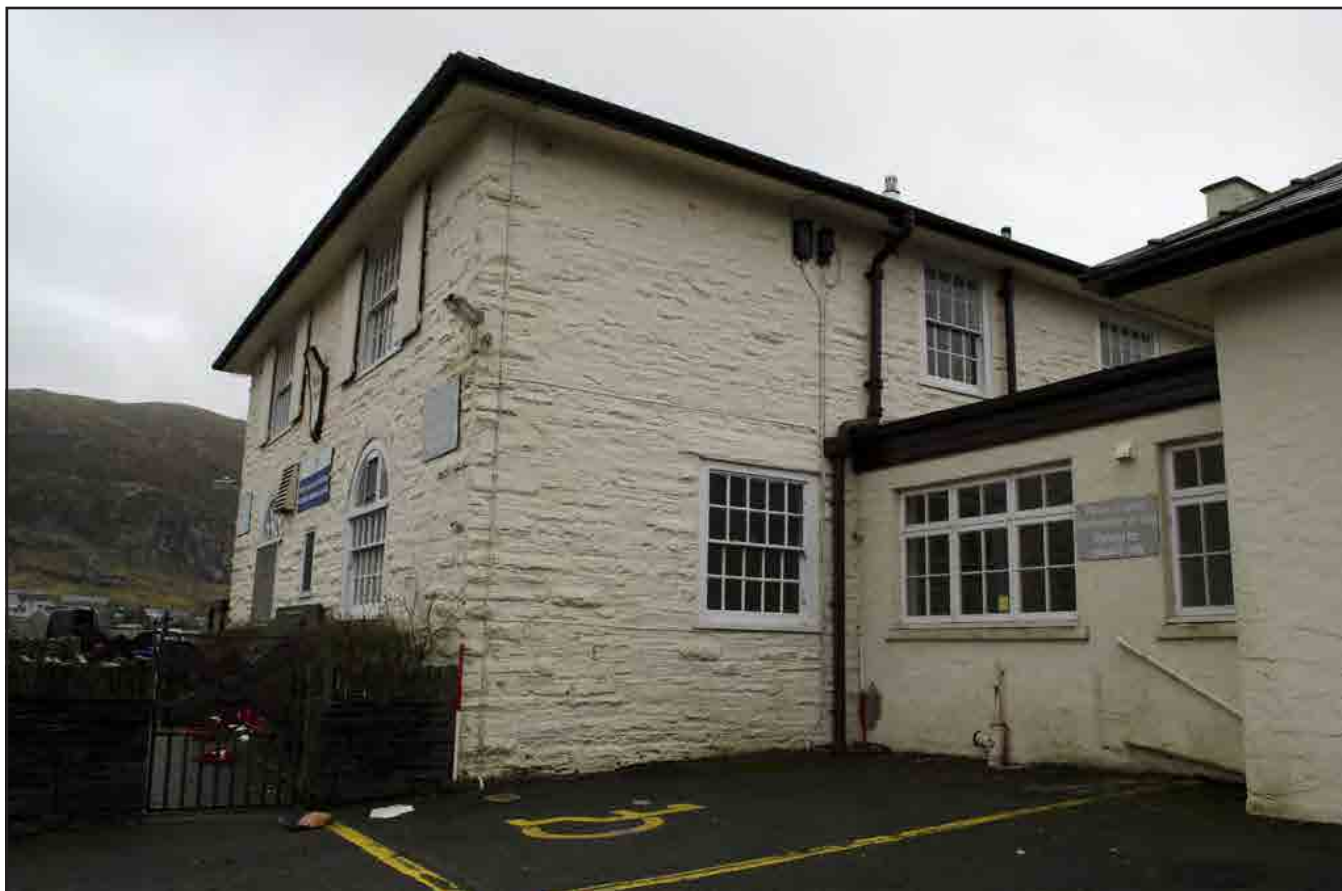
Plate 05: Front Elevation - view southeast of main building core and front of the west wing. The main building core is part of the original building, whereas the visible part of the west wing in the image are post-1925 extensions
Scale: 1.0m (archive image: G2459_009).

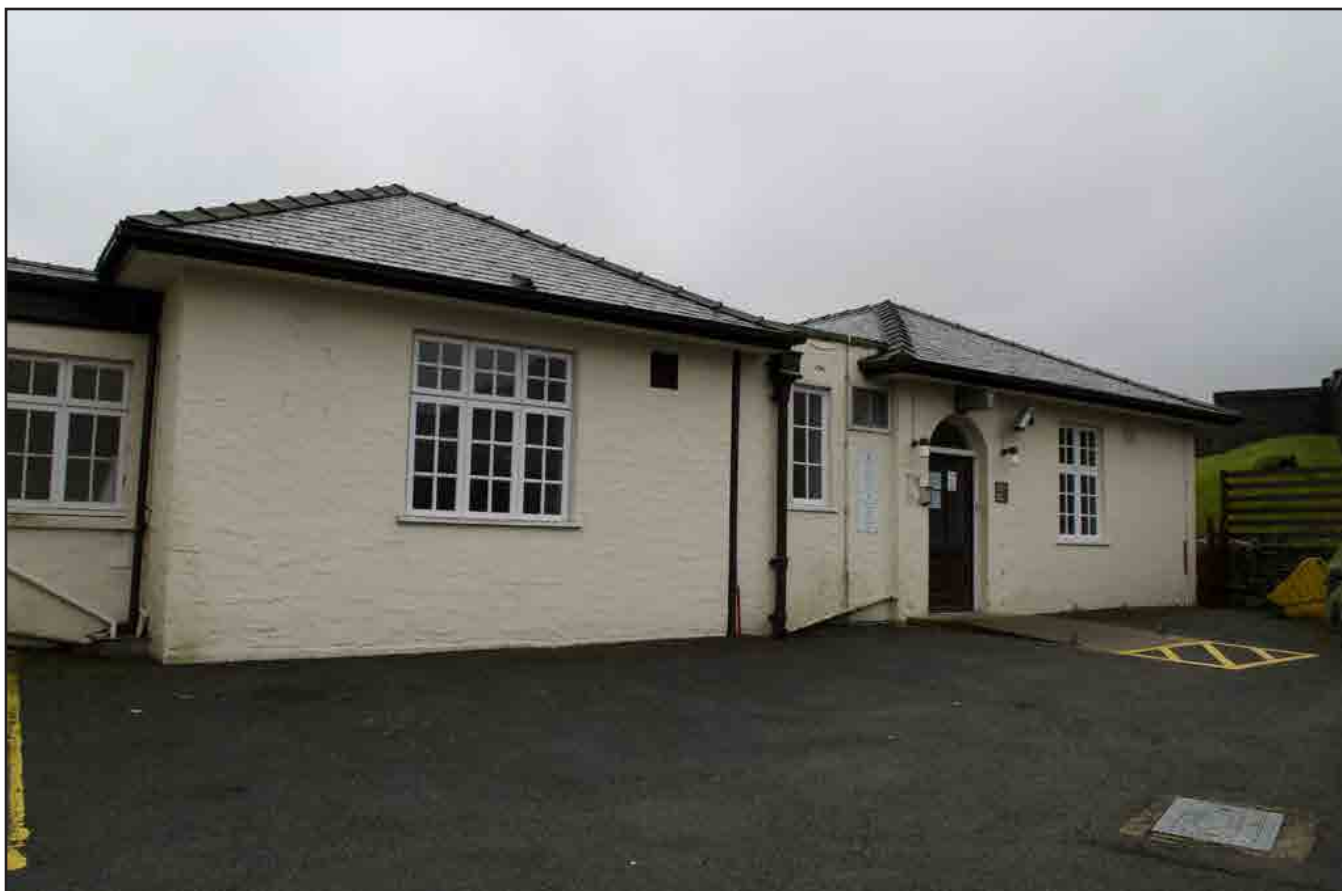
Plate 06: Side Elevation (west wing) - detail of west wing showing hip gable slate roofing. This part of the west wing is a post-1925 extension (archive image: G2459_010).

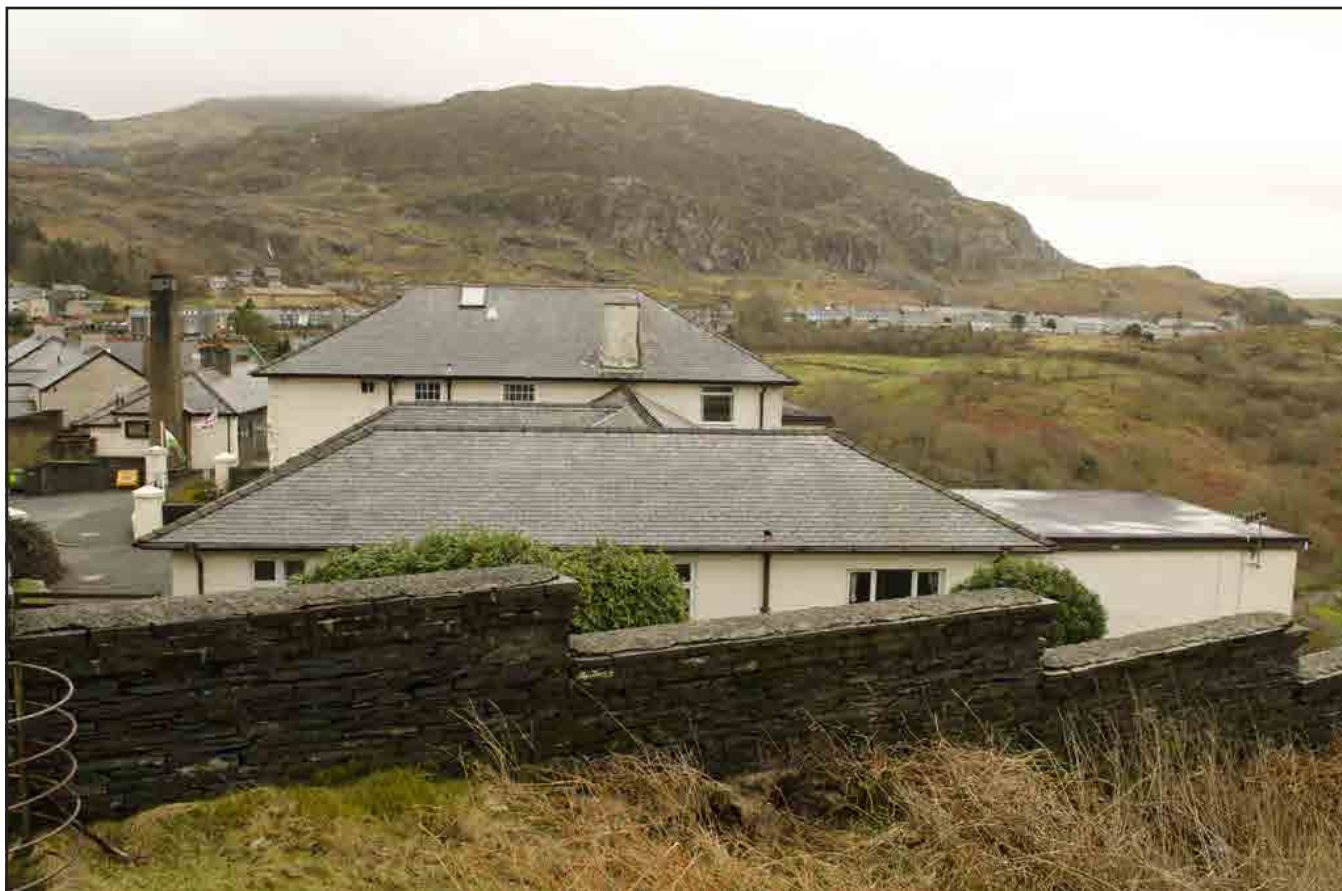
Plate 07: Side Elevation - view east of the west wing and main building core, detailing the hip gable slate roofs used for the main building and parts of the west wing, as well as the flat roofing used at the rear of the west wing. The main building core is part of the Original building, along with part of the west wing visible beneath a chimney at the centre of the image. The remaining parts of the building are extensions (archive image: G2459_011).

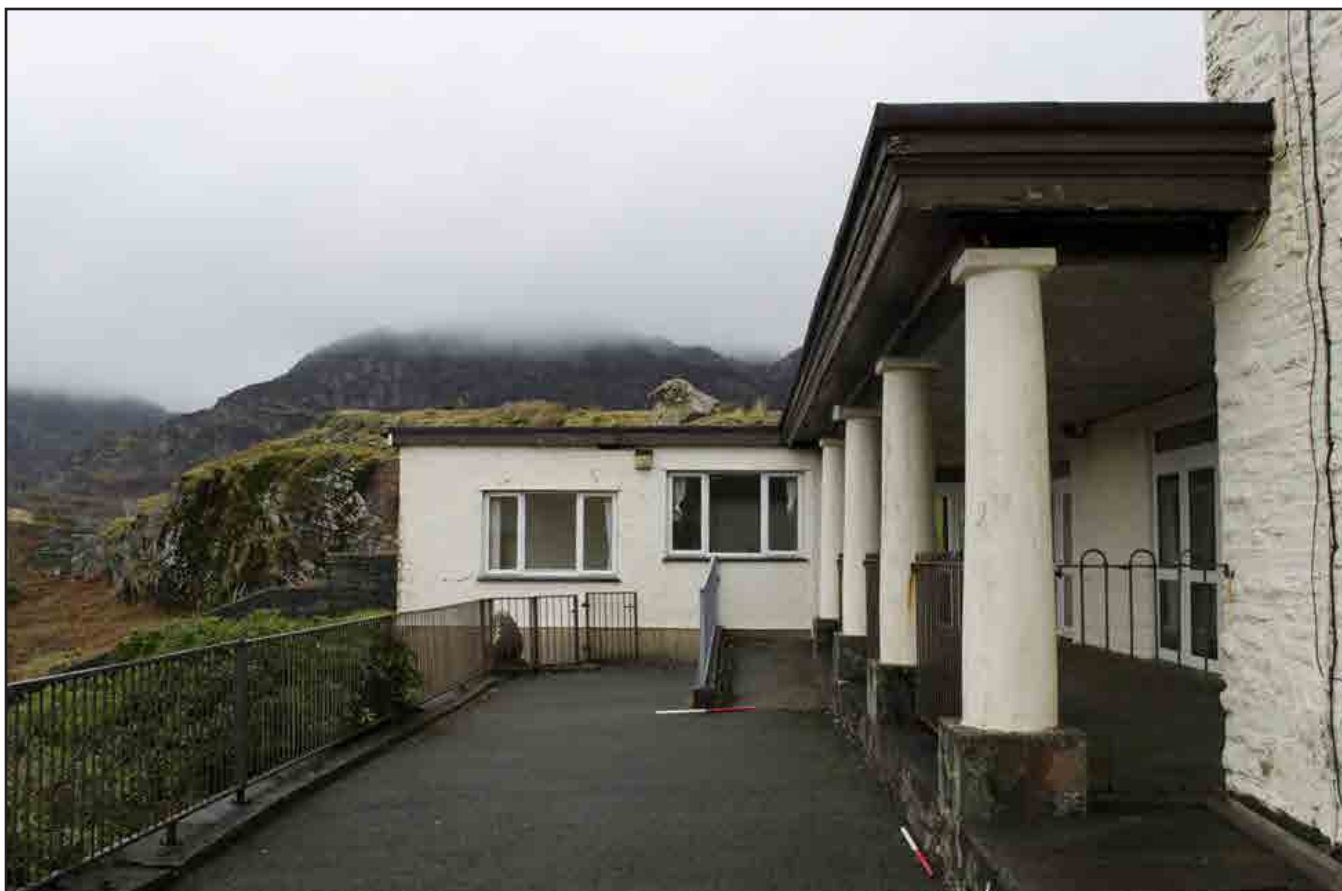
Plate 08: Side and Rear Elevations - view west of west wing. The flat roofed part of the wing is a post-1972 extension which included a dayroom. The veranda in the foreground is part of the original 1925 building although the veranda roofline was subsequently modified when the wing was extended. Scale: 2 x 1.0m (archive image: G2459_017).

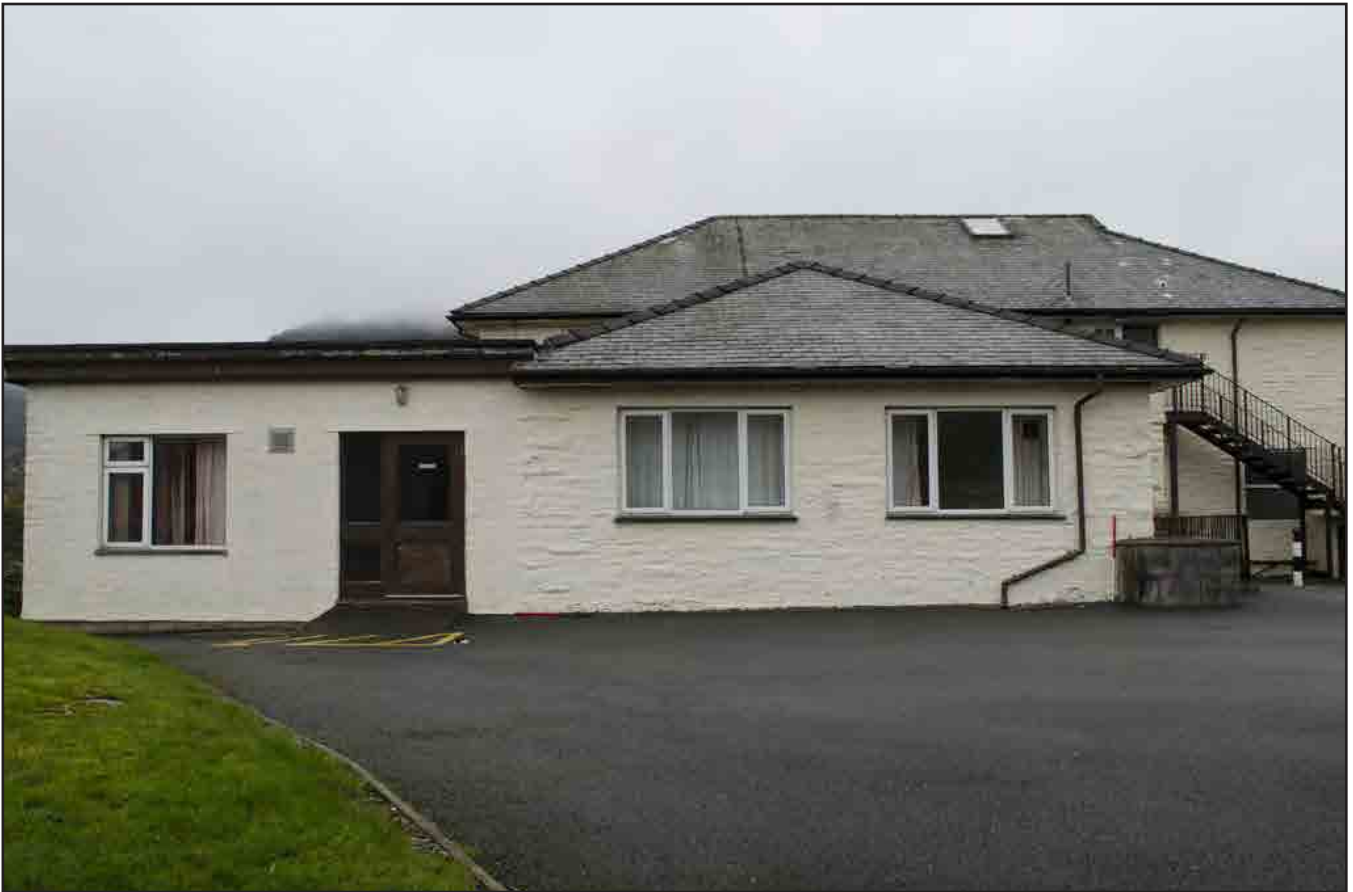
Plate 09: Side Elevation (east wing) - view west; the east wing comprised a hip gable slate roof wing that projected at a right angle to the main building and originally housed the male ward and staff entrance. The hip gable part of the wing is from the original building; the flat roof belongs to a post-1972 extension for a dayroom that removed the veranda. The windows in the original part of the wing were added during the construction of the dayroom extension. Scales: 2 x 1.0m (archive image: G2459_024).

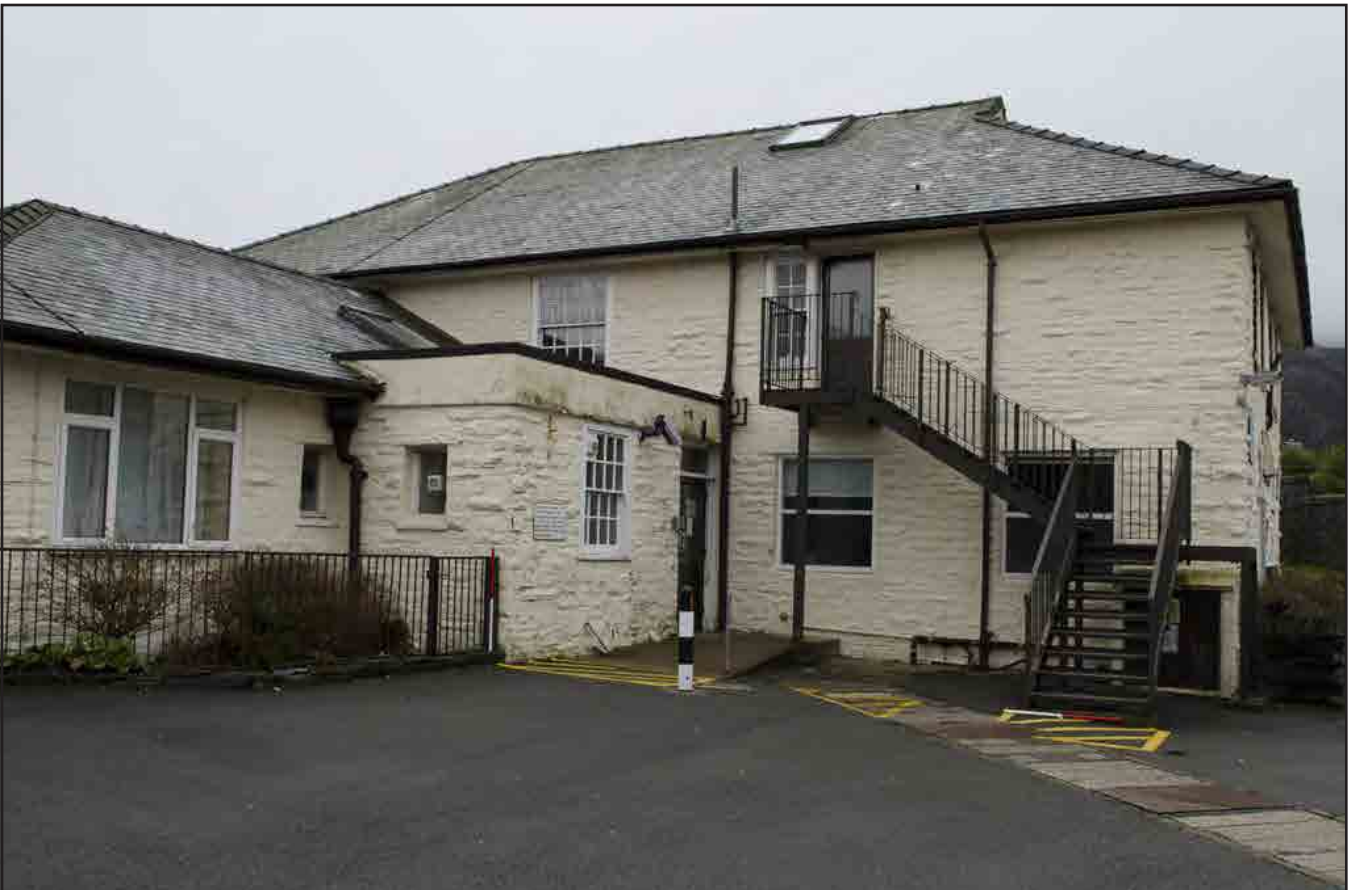
Plate 10: Side Elevation (east wing) - view southwest of wing as seen from the front of the hospital. The wing projects from the main building core. The flat roof portion of the wing is the original staff entrance, whilst the hip gable portion includes the patient wards. The windows are all in their original positions. The fire escape on the main building core is a modern addition, with the fire escape door utilising an earlier window that has been enlarged. Scale: 2 x 1.0m (archive image: G2459_025).

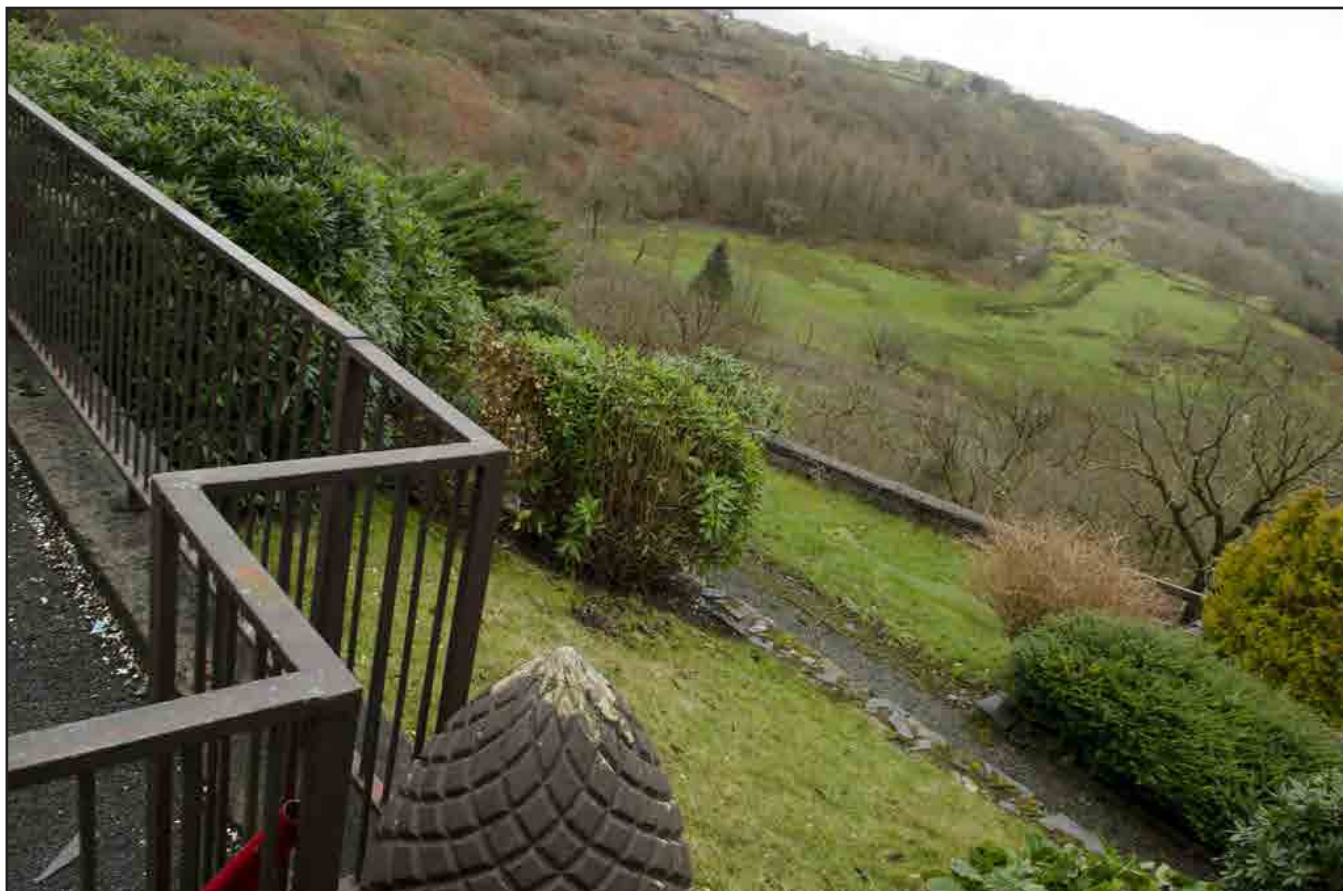
Plate 11: View south of the memorial garden located at the rear of the hospital. The garden is terraced into hillside. The view is from the west wing veranda (archive image: G2459_027).

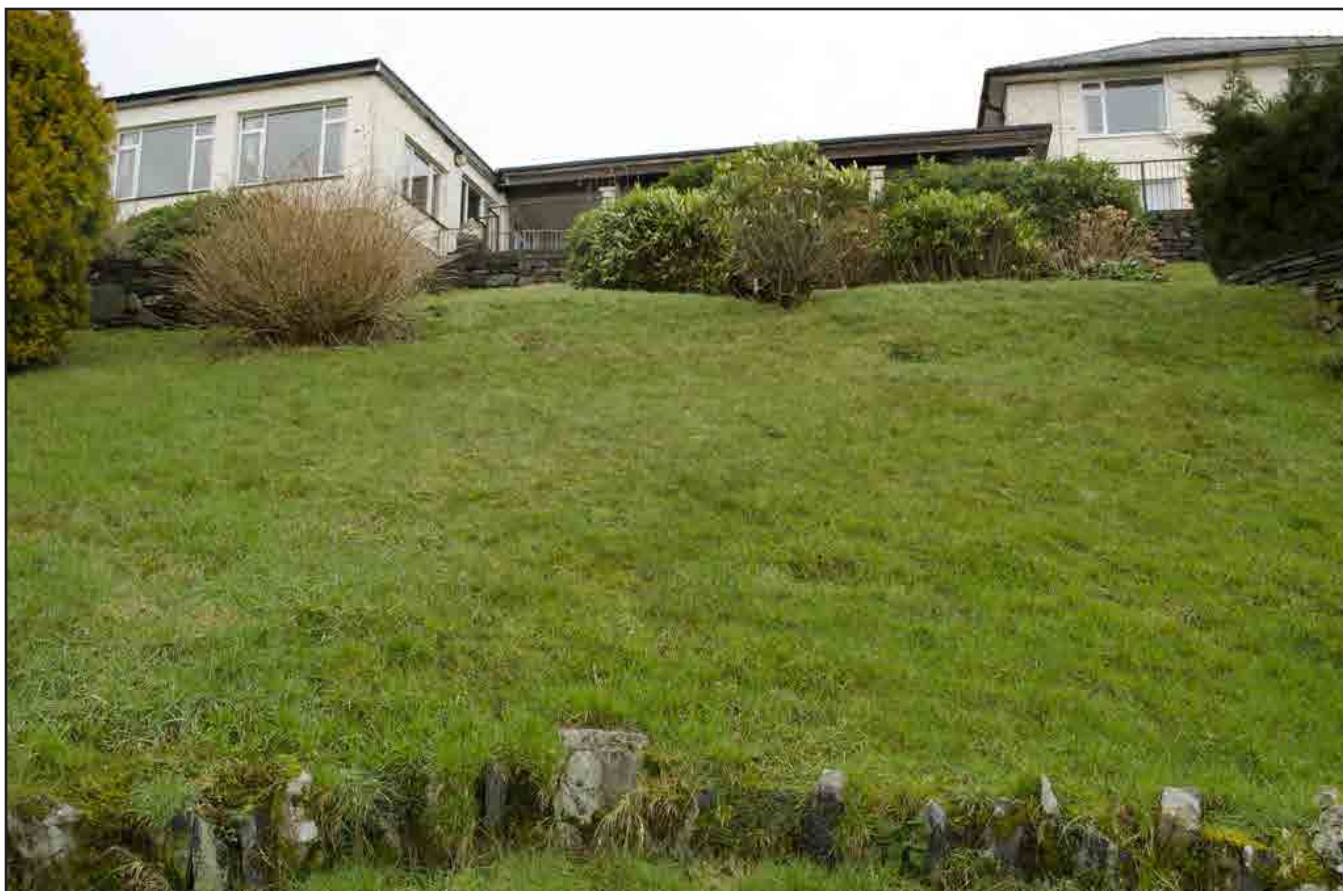
Plate 12: View north of the memorial garden located at the rear of the hospital, detailing the gradient of the slope. The west wing is visible at the top of the image, including the veranda; a retaining wall is visible at the front of the image (archive image: G2459_034).

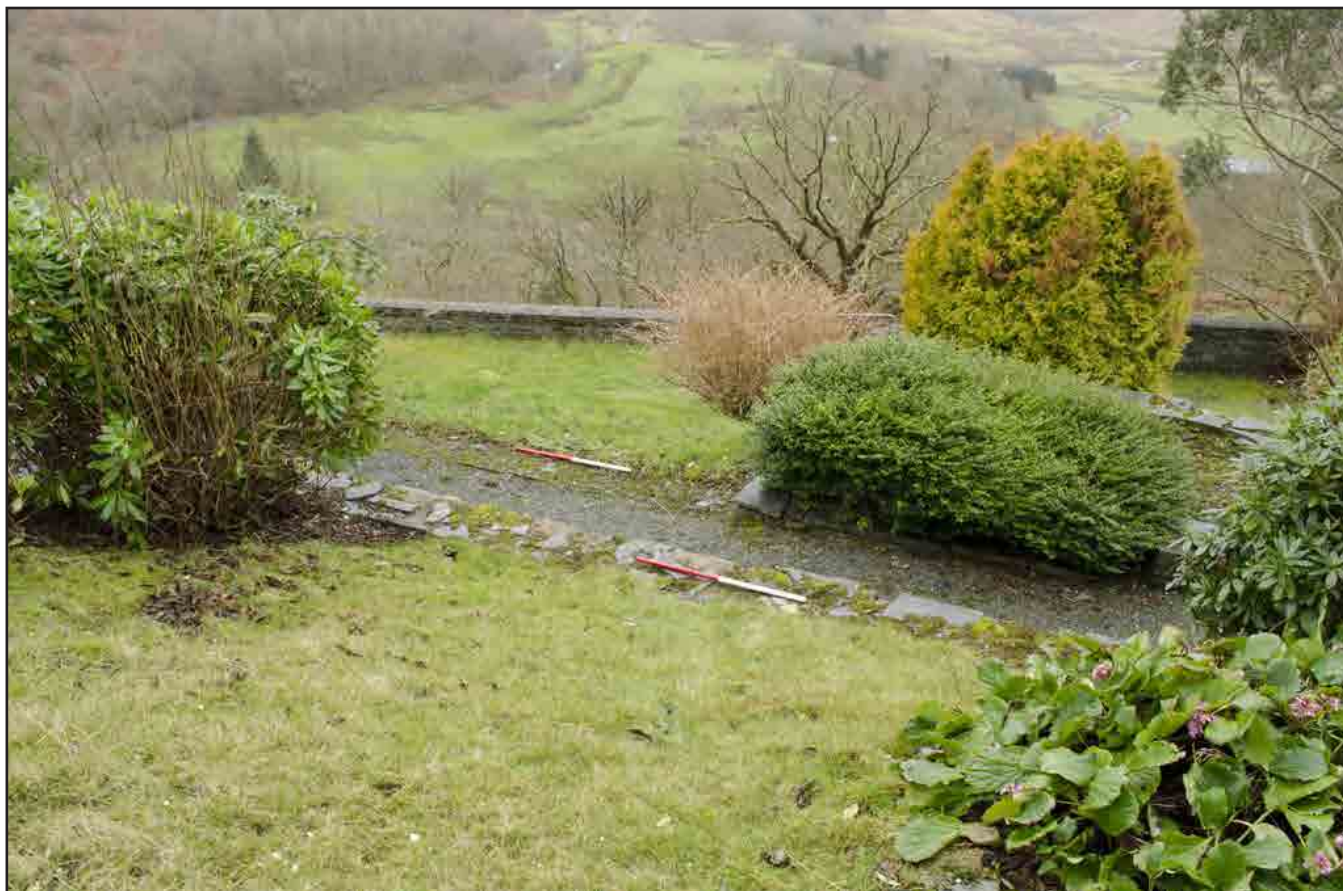
Plate 13: View south of the memorial garden detailing current condition, a pathway and a raised planting area. Scale: 2 x 1.0m (archive image: G2459_028).
