CANOLFAN GOFFA FFESTINIOG

Level 2/3 Building Record

Prosiect Rhif / Project No. G2459

Prepared for: NHS Wales

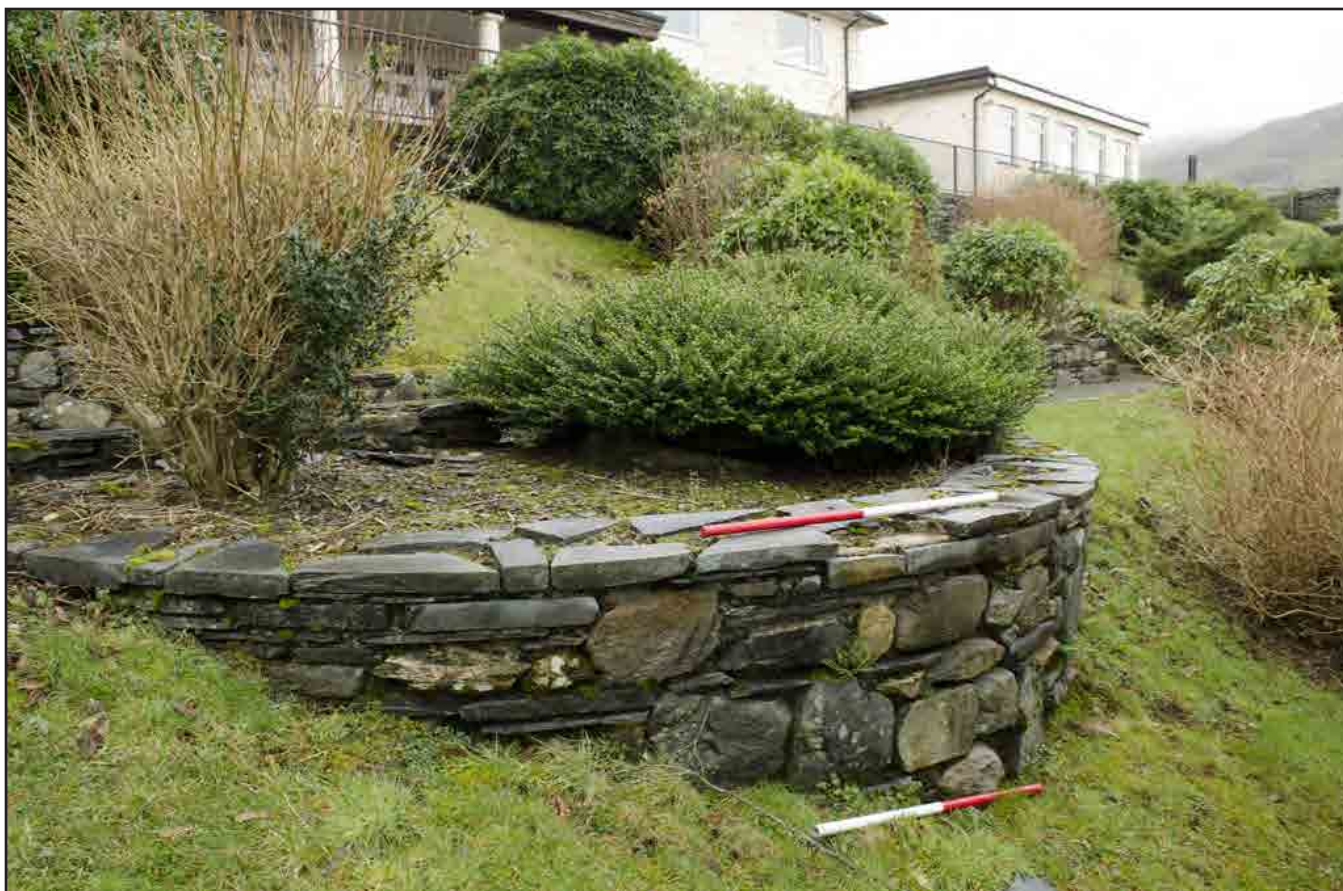
Plate 14: View east of the memorial garden detailing a raised planting area built from stone, with the west and east wings of the hospital visible in the background (archive image: G2459_031).

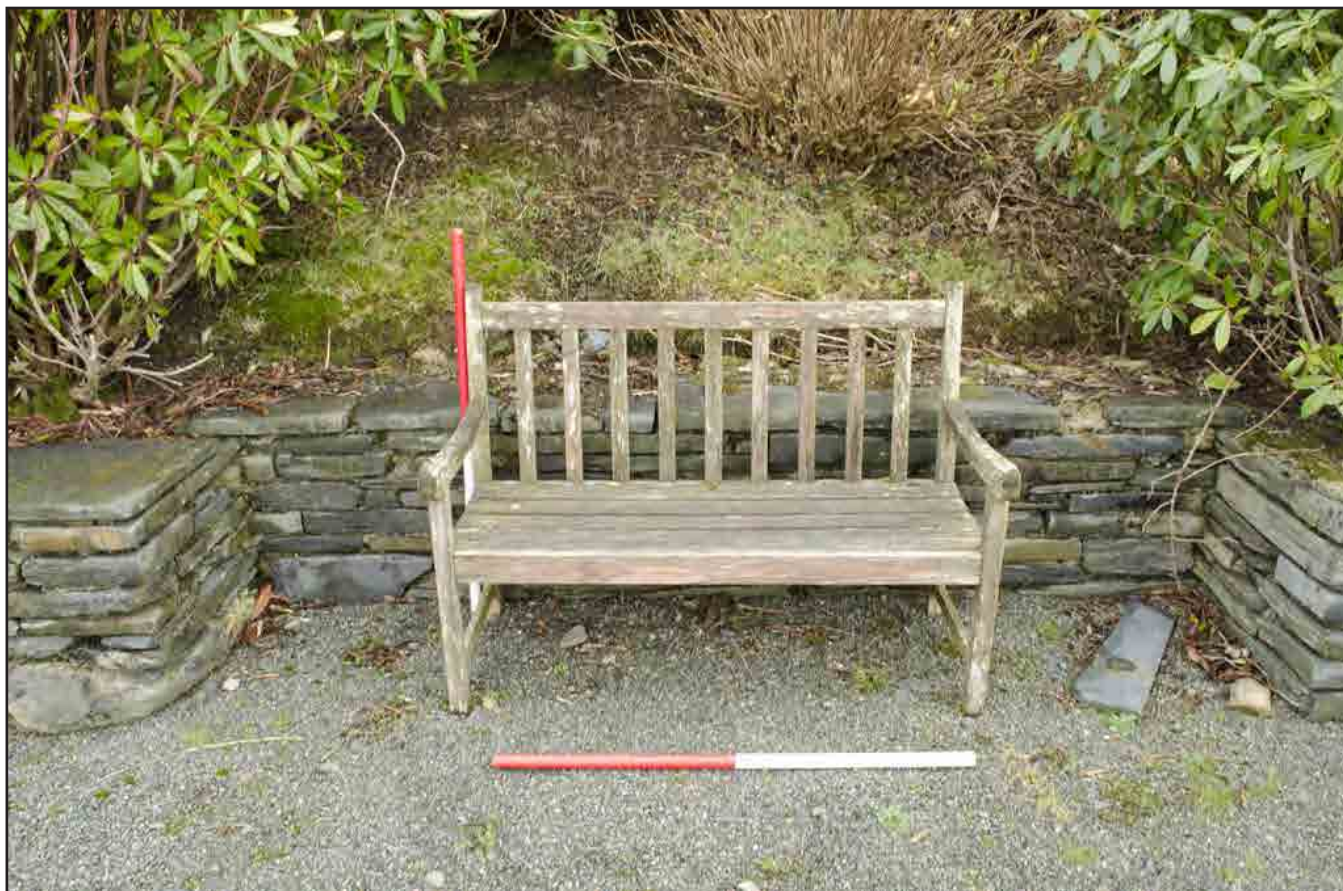
Plate 15: Detail of a wooden bench located along the middle terrace path and retaining wall. Scale: 2 x 1.0m (archive image: G2459_030).

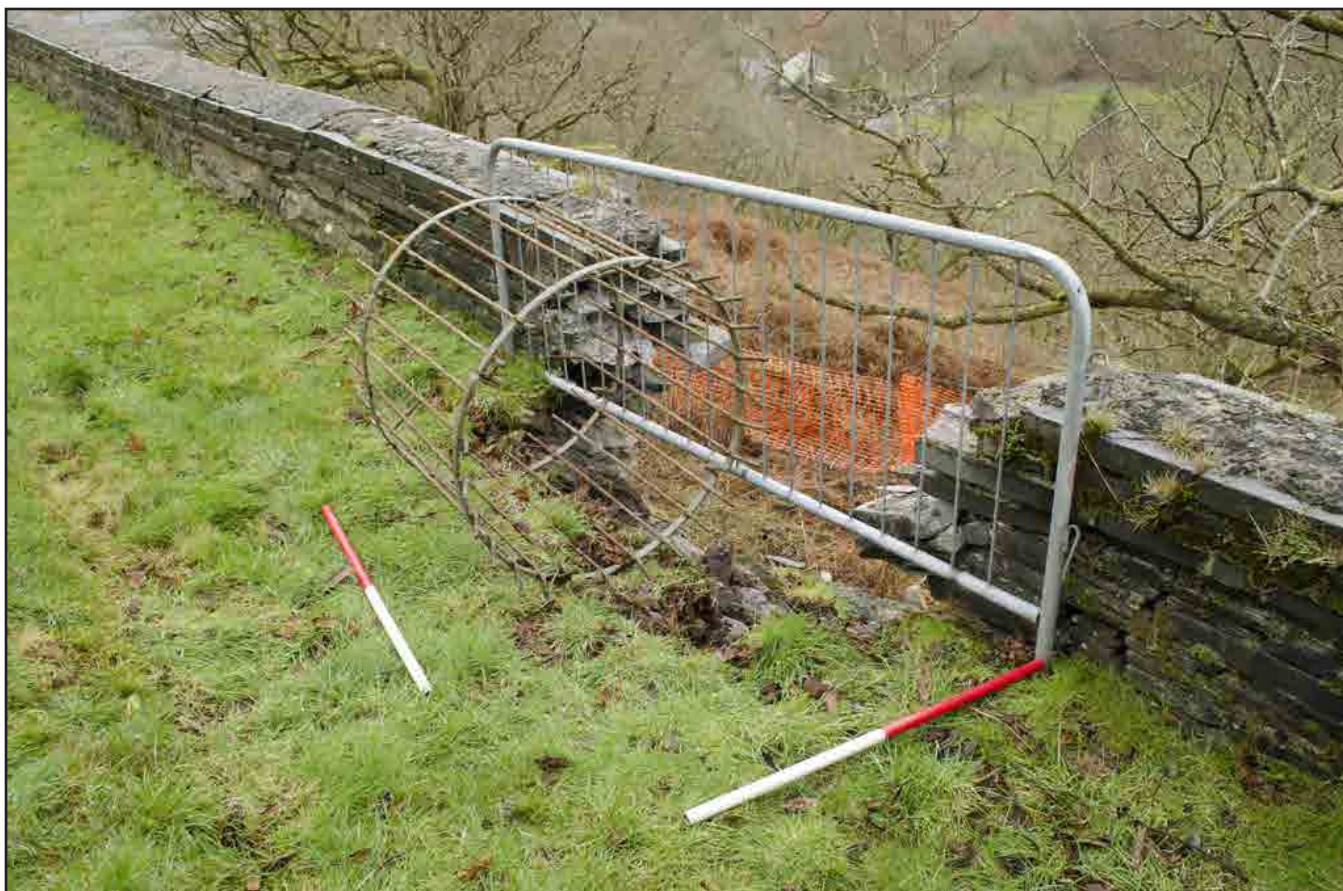
Plate 16: Detail of an existing breach in the boundary wall of the memorial garden; note the slate core of the wall. Scale: 2 x 1.0m (archive image: G2459_032).

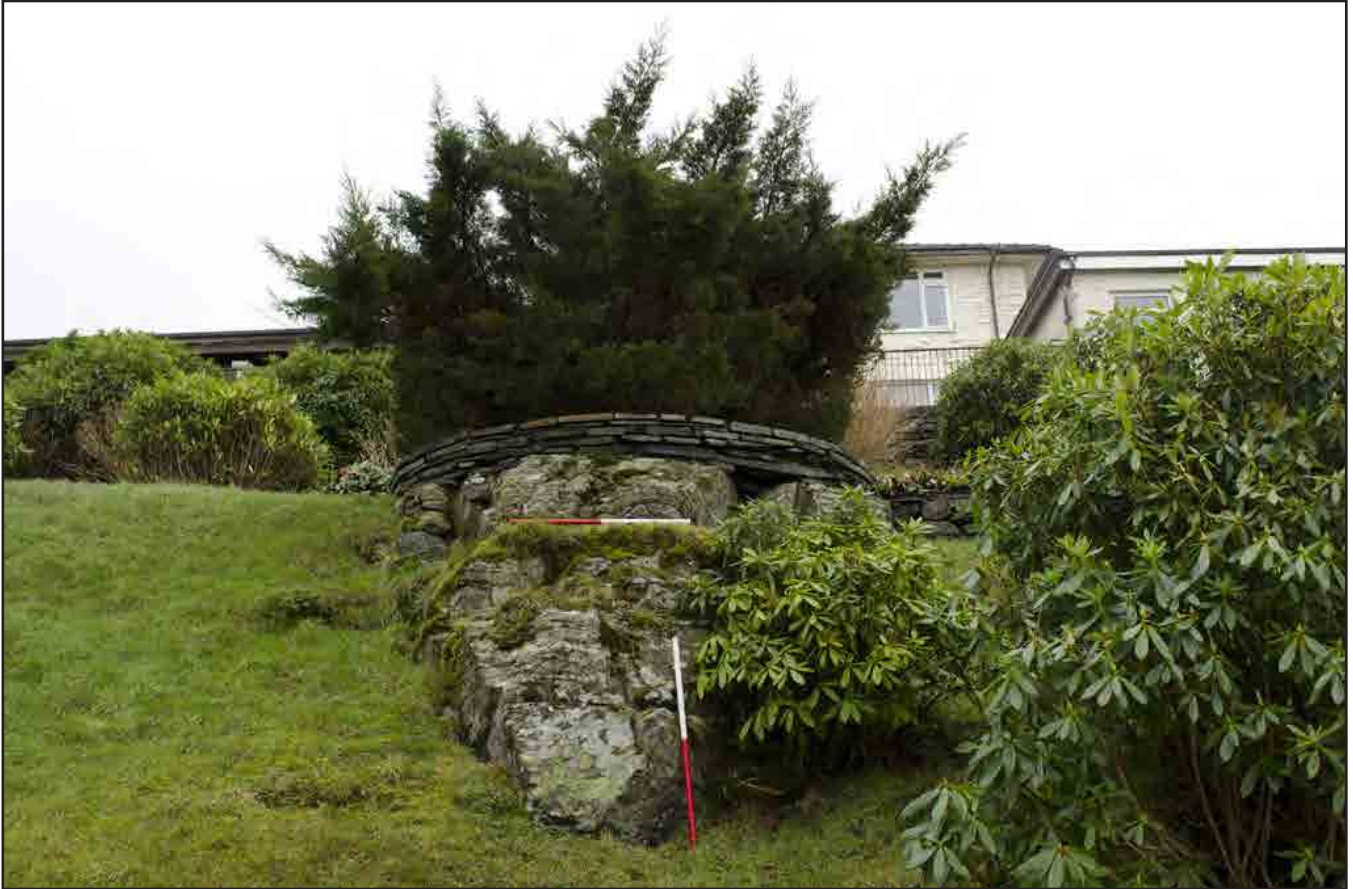
Plate 17: View north of the memorial garden detailing raised planting area built onto exposed rock. Scale: 2 x 1.0m (archive image: G2459_036).

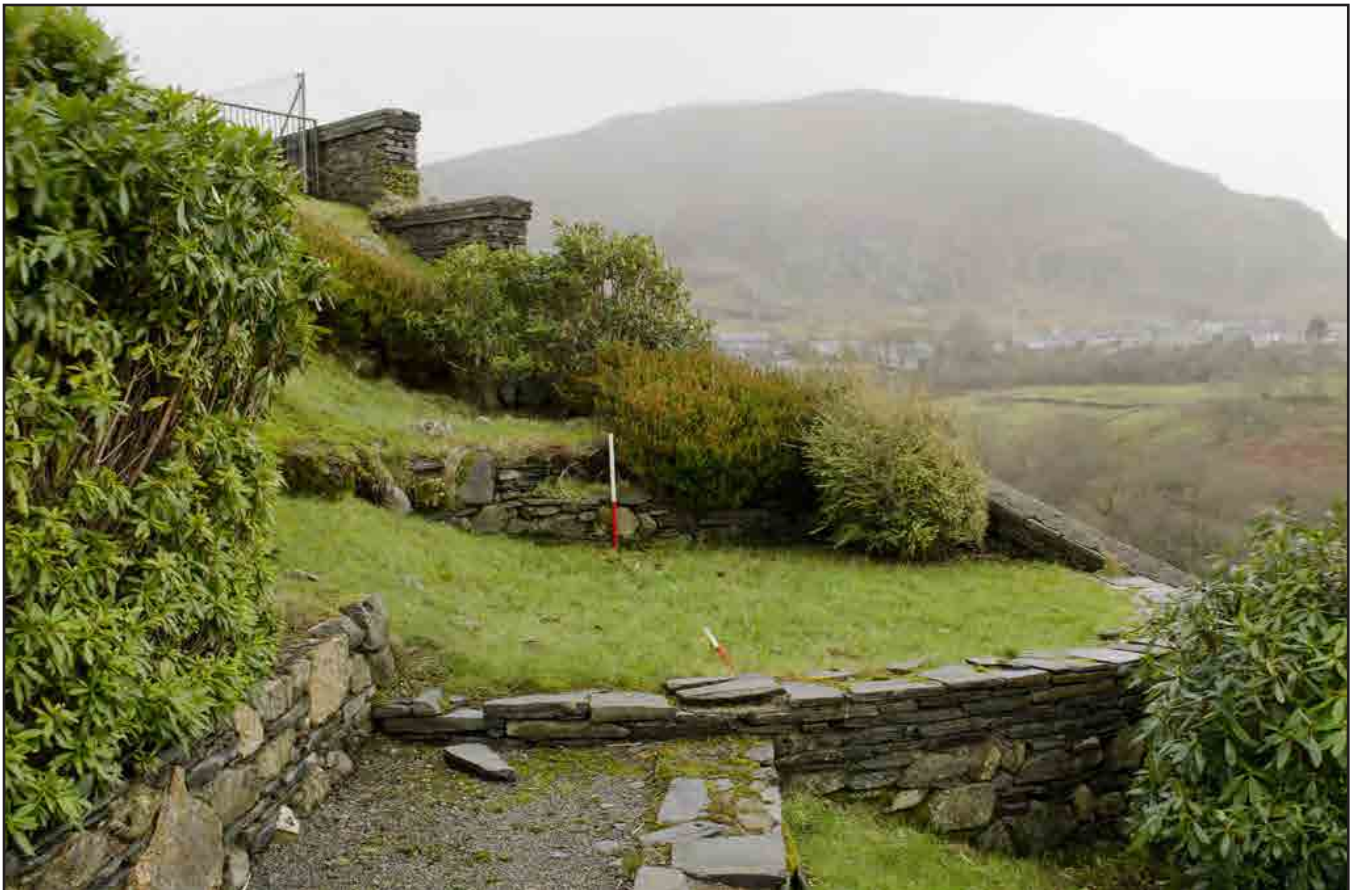
Plate 18: View east of the memorial garden detailing stone terraces and boundary wall. Scale: 2 x 1.0m (archive image: G2459_037).

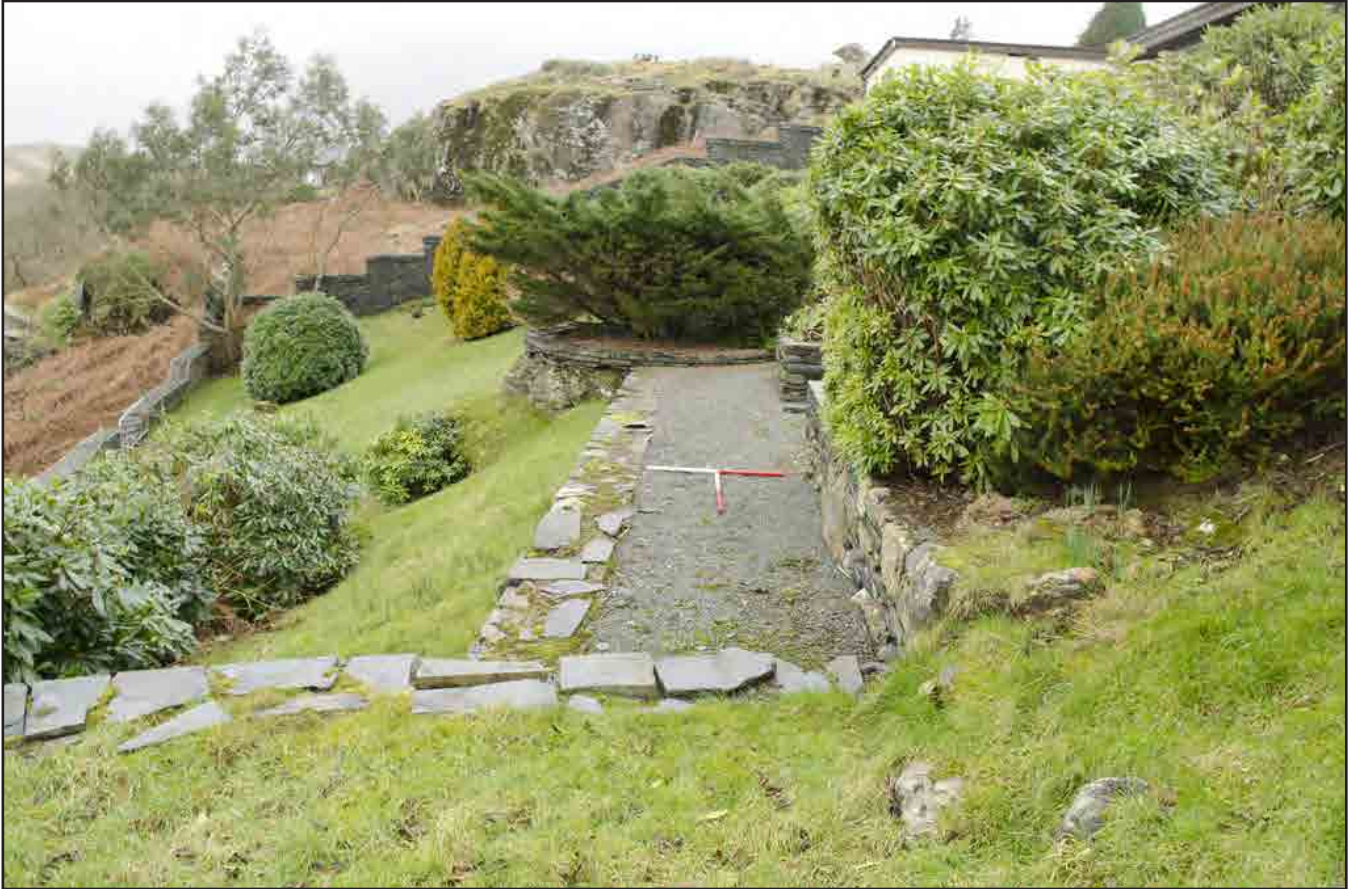
Plate 19: View west of the memorial garden detailing, pathway, raised planting area and boundary wall, with the natural landscape and hillside visible on the other side of the wall. Scale: 2 x 1.0m (archive image: G2459_038).

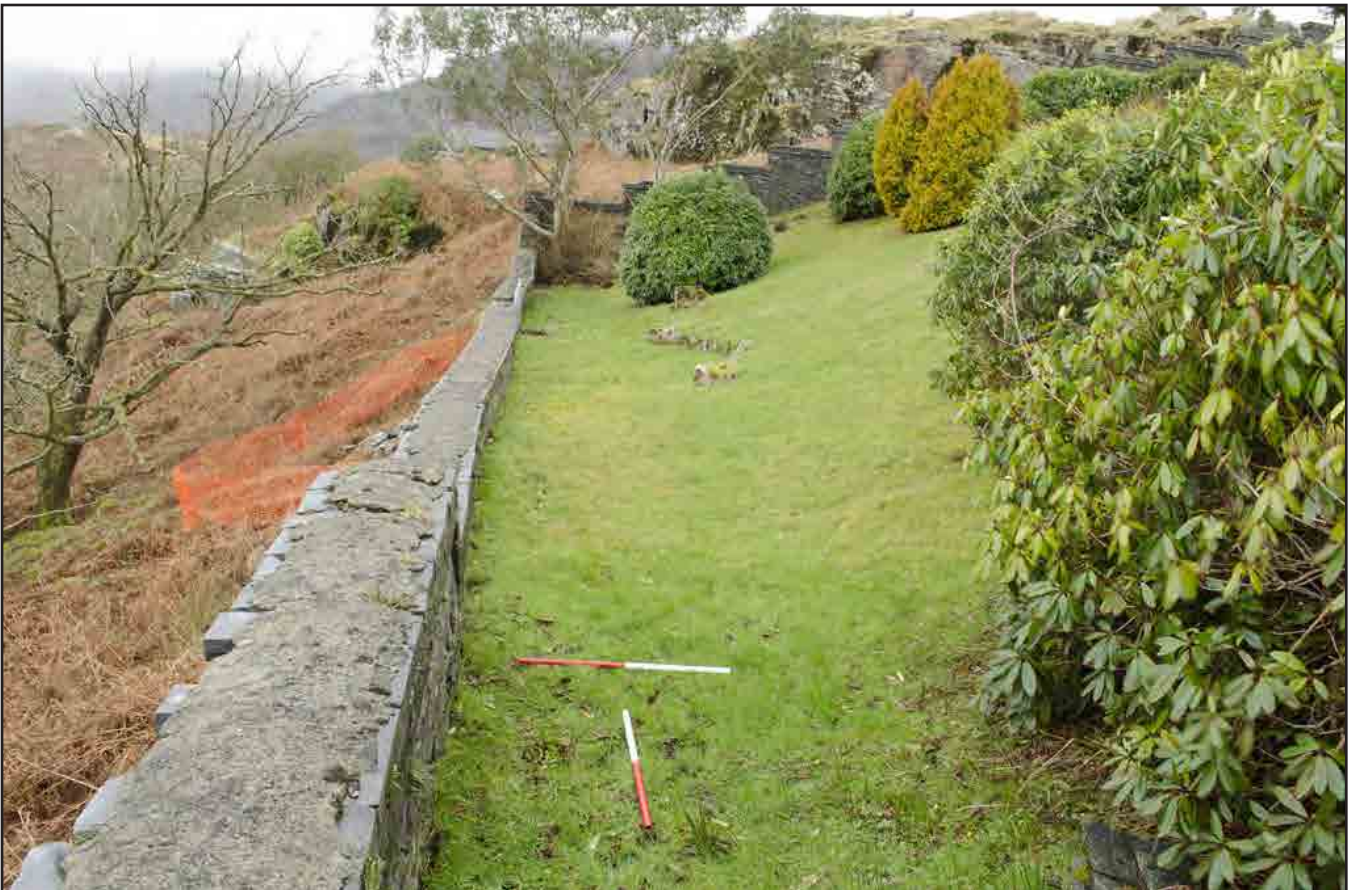
Plate 20: View west of the memorial garden detailing the boundary wall, with the natural landscape and hillside visible on the other side of the wall. Scale: 2 x 1.0m (archive image: G2459_035).

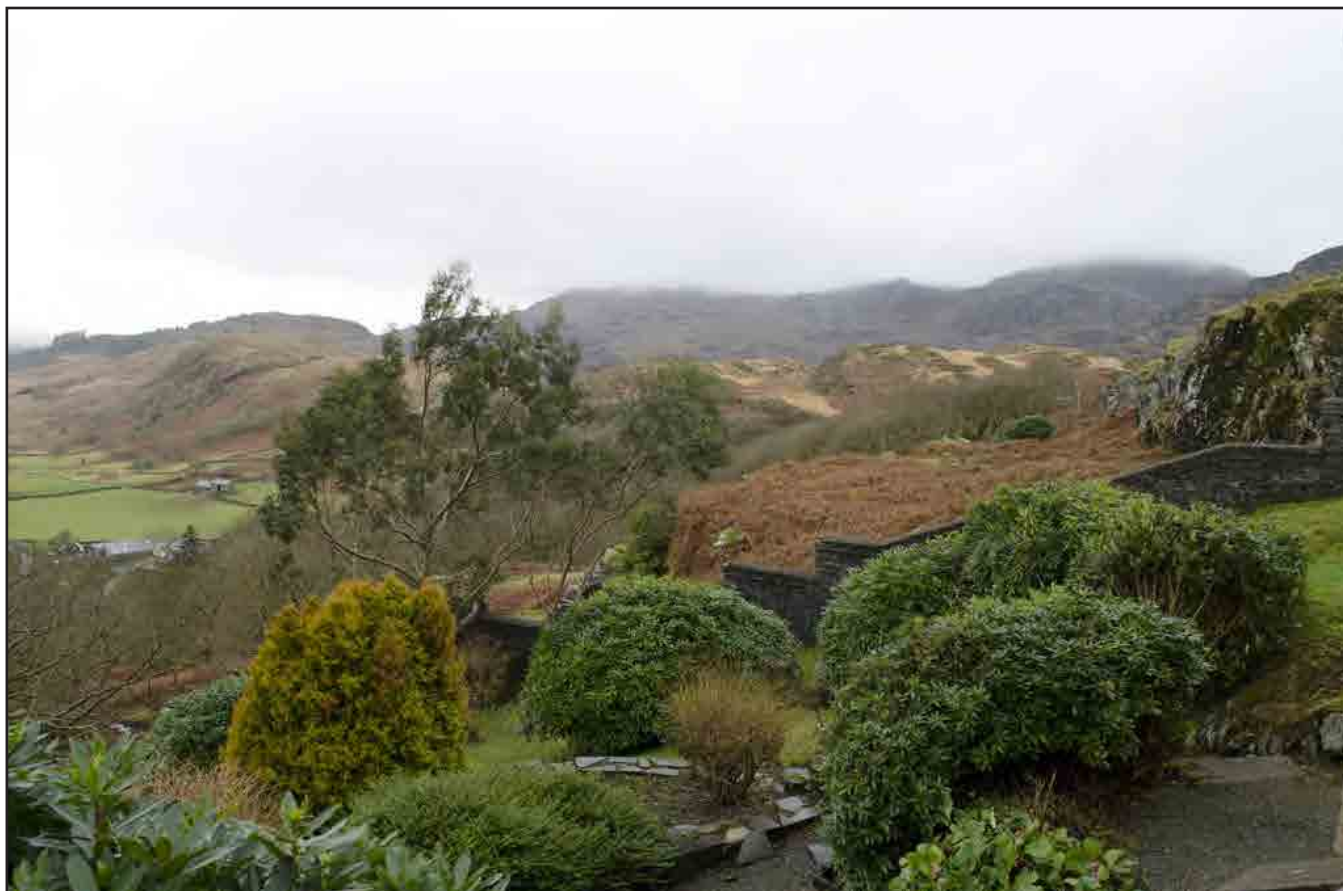
Plate 21: View east of the memorial garden detailing, pathway, raised planting area and boundary wall, with the natural landscape and hillside visible on the other side of the wall (archive image: G2459_019).

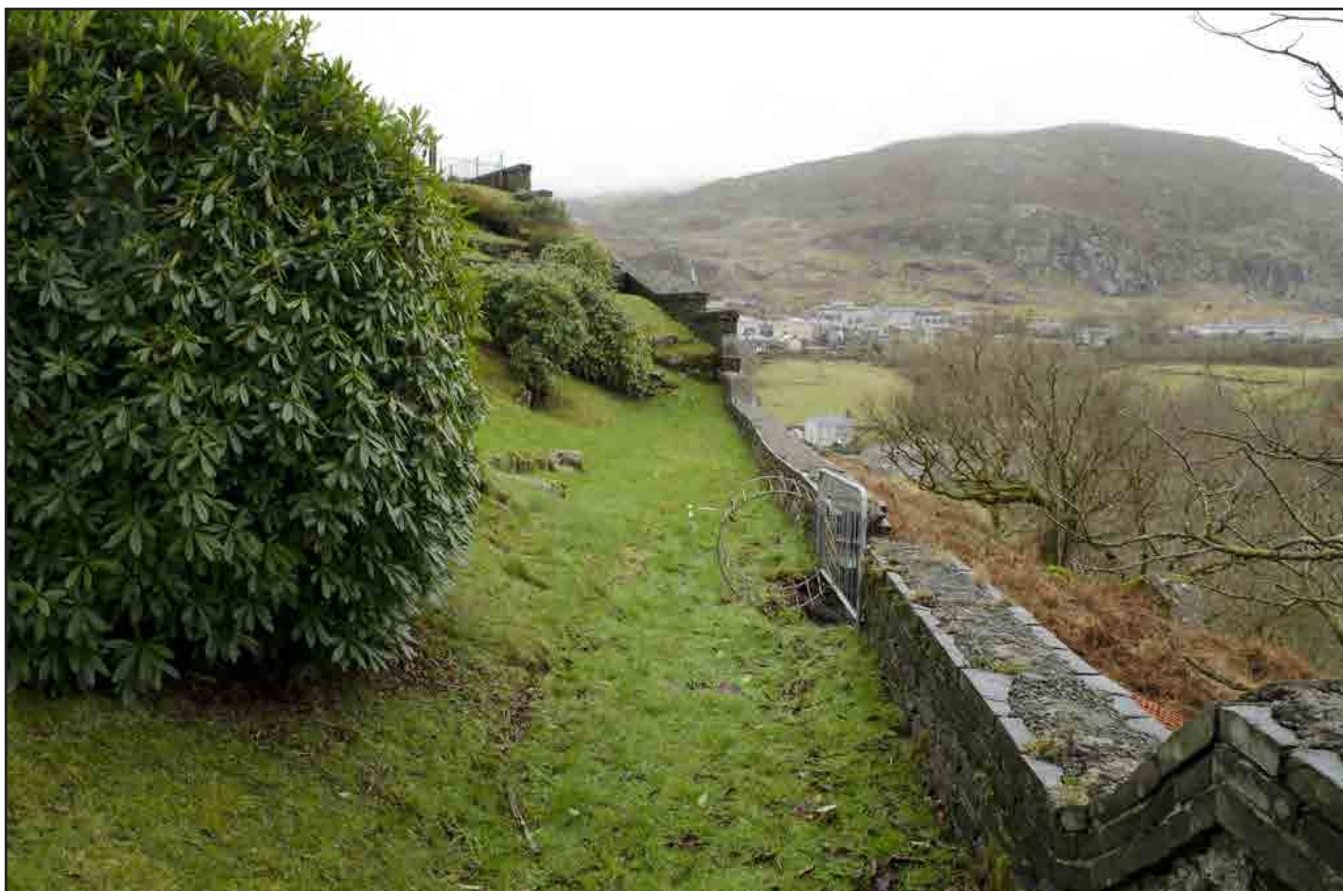
Plate 22: View west of the memorial garden detailing the boundary wall, with the natural landscape visible on the other side of the wall, along with part of Ffestiniog (archive image: G2459_033).

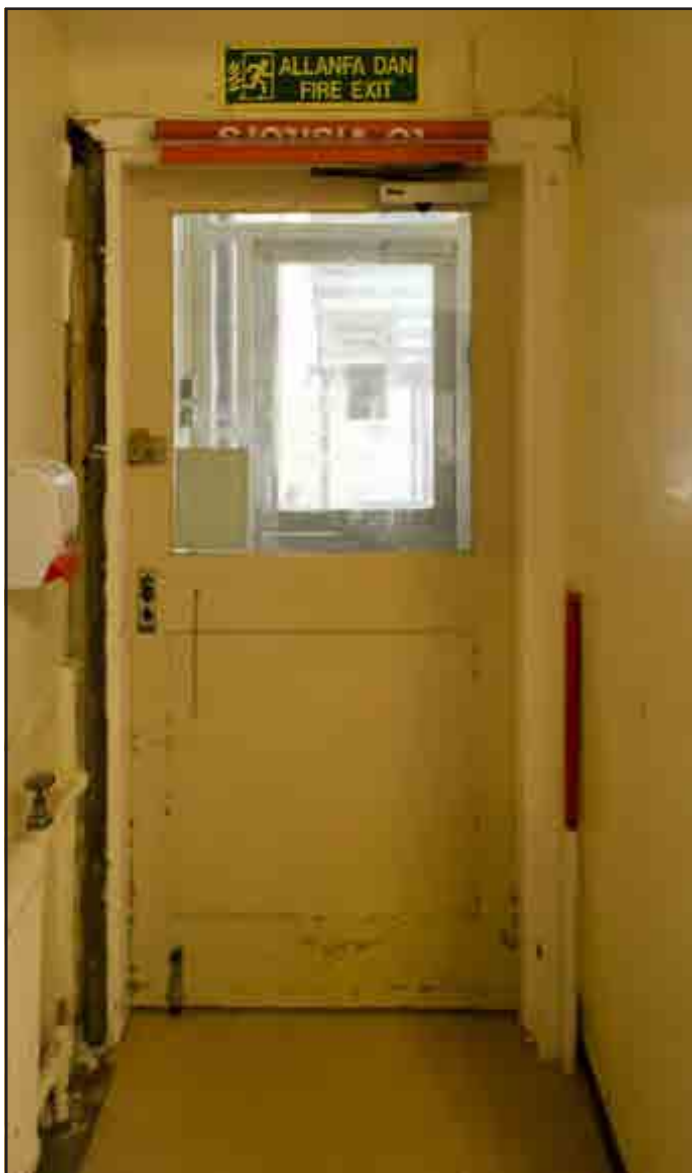
Plate 25: Internal view of door D02 within the east wing, leading to the staff and trades' entrance (archive image: G2459_004).

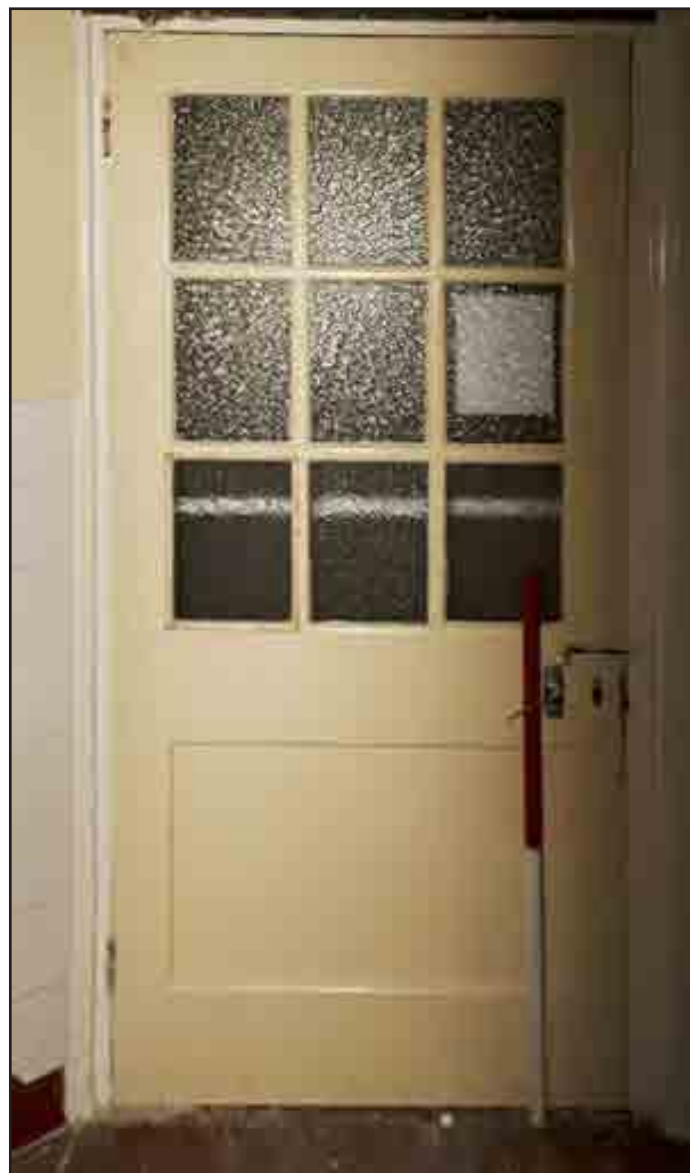
Plate 26: Internal view of door D57 within the main building core, leading from the east wing to the kitchen (archive image: G2459_080).

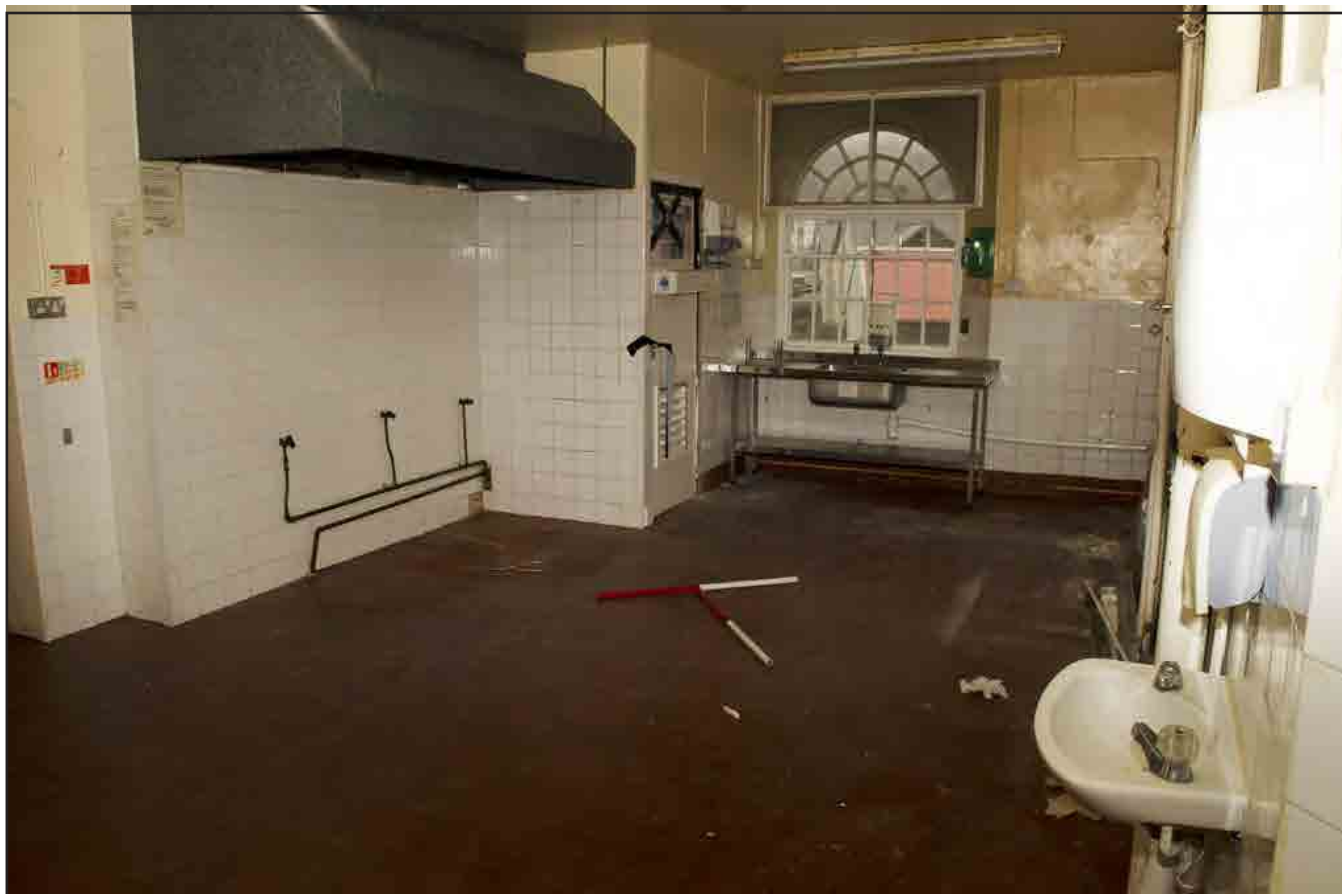
Plate 27: Main Building Core - Room G42 (Kitchen): view northwest looking towards the front of the building. Note the semi-circular window fitting which is an original feature. This room has always been a kitchen. Scale: 2 x 1.0m (archive image: G2459_078).

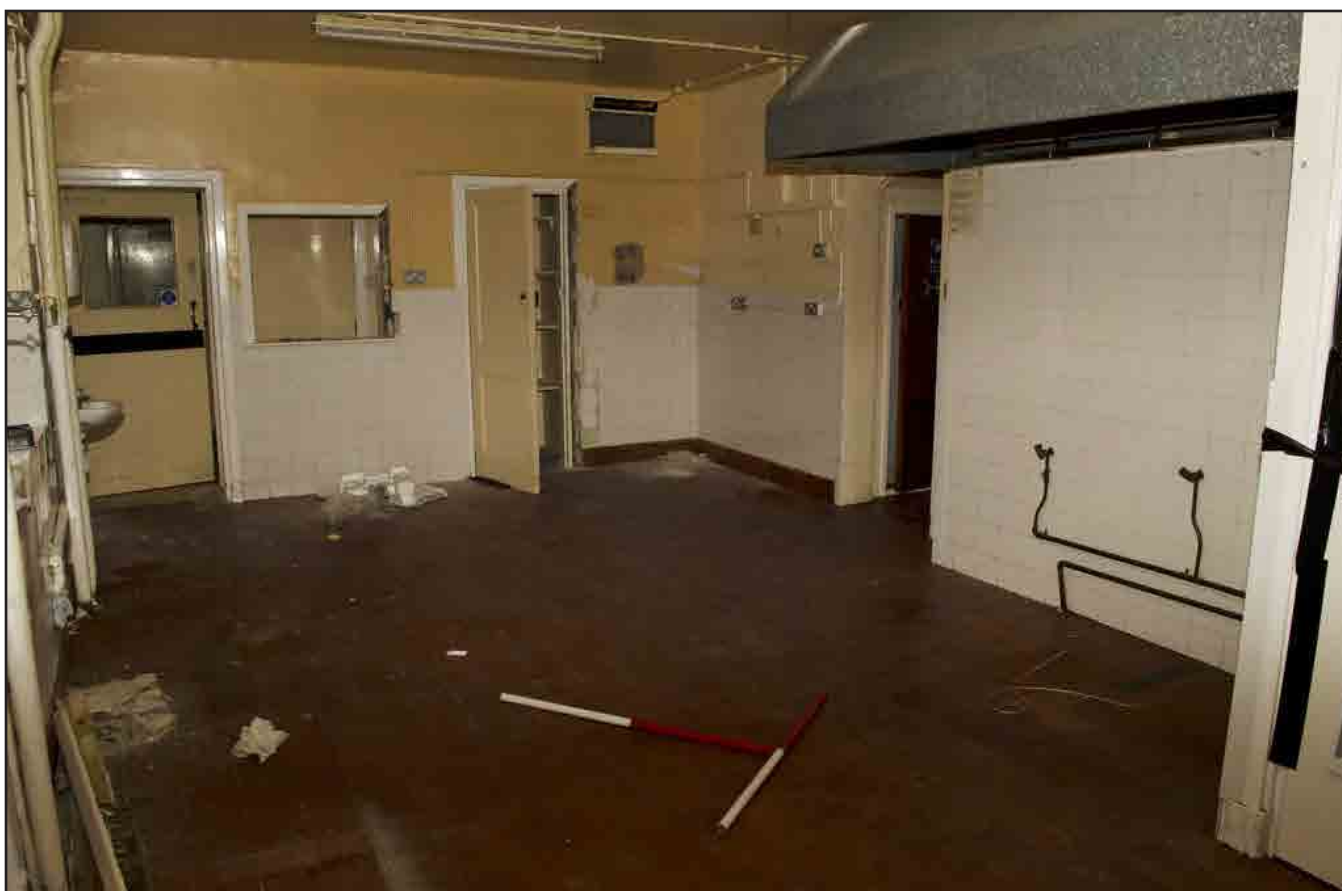
Plate 28: Main Building Core - Room G42 (Kitchen): view southeast looking towards the interior of the building. Scale: 2 x 1.0m (archive image: G2459_078).

A large rectangular room located in the original building core at the front of the building, used as a kitchen. The room is accessed from corridors G01 and G27 and provides access to kitchen store G43 (Plates 27 and 28). This room is listed as a kitchen on all plans (1925 to 2013). The pre-1960 undated plan lists a gas cooker and an *Aga* cooker as being used in the kitchen. The kitchen also included two larders and a store in one corner of the kitchen on the 1925 to 1960 plans, but this had been reduced to a single smaller larder on the 1972 plan that is still in use (room G44). As with the assisted bathroom (room G40), the angled recess on the front elevation window has been partly modified with a flush finish on one side (Plate 27).

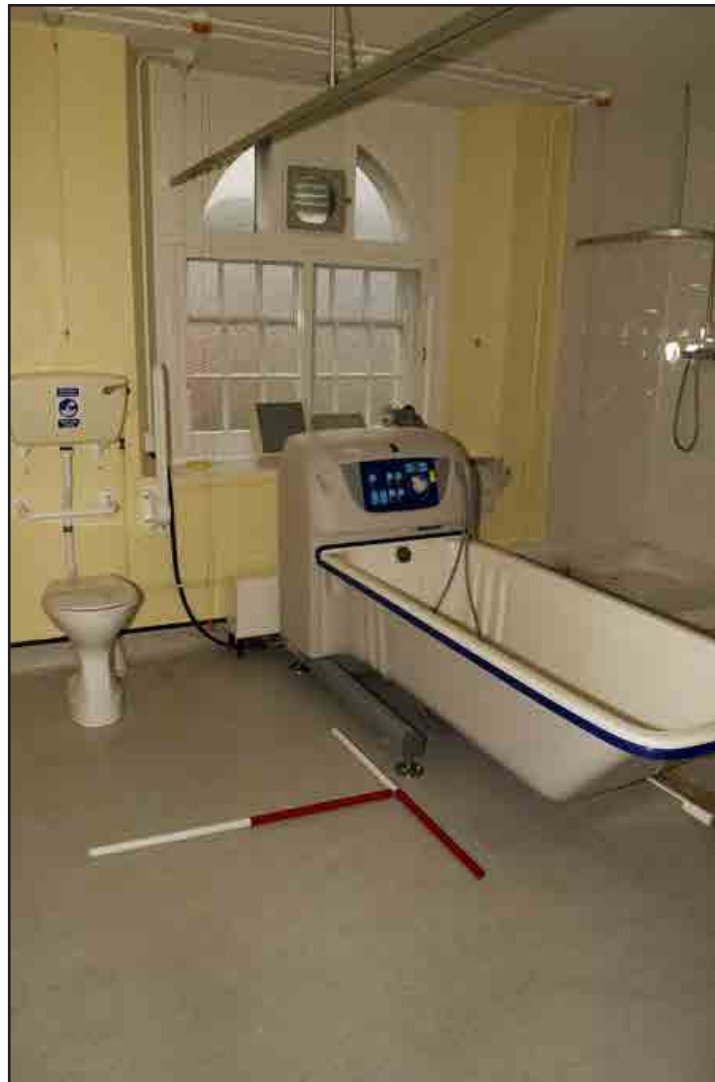
Plate 29: Main Building Core - Room G40 (Assisted Bathroom): view north looking towards the front of the building. This room was formerly the operating theatre. Scale: 2 x 1.0m (archive image: G2459_114).

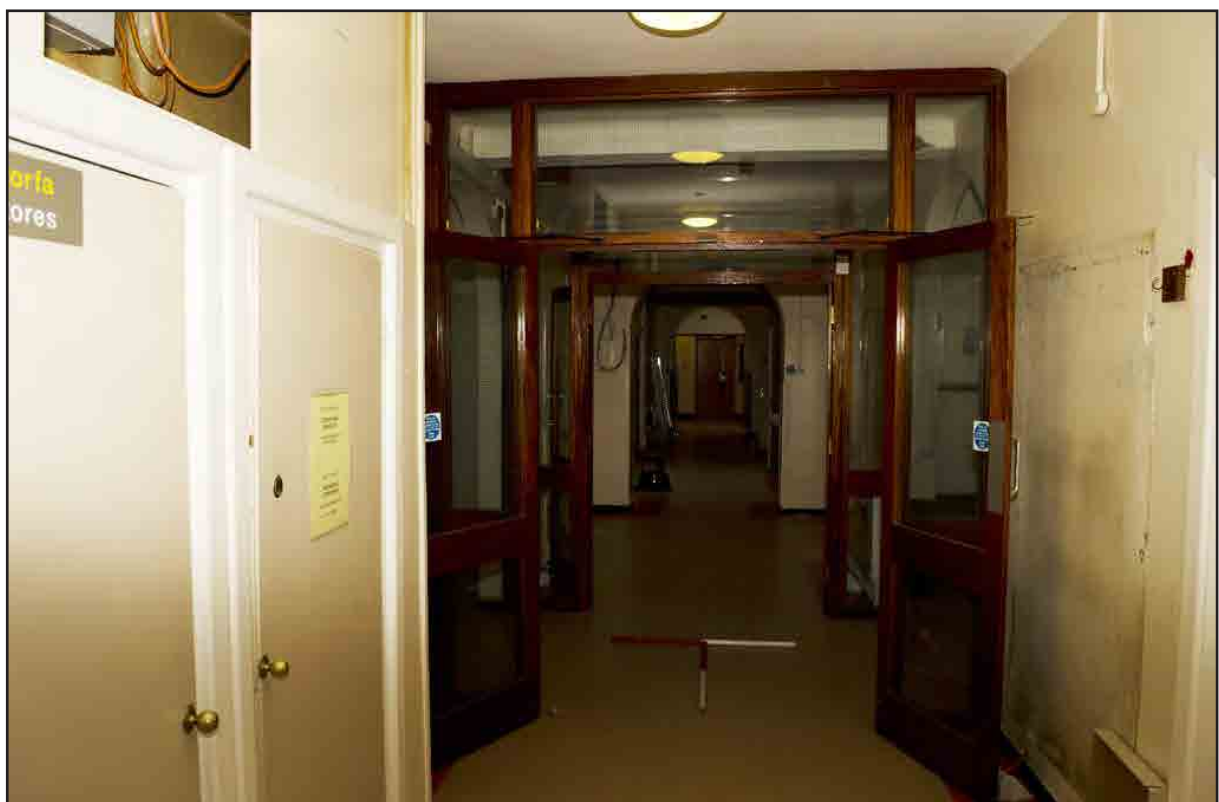
Plate 30: Main Building Core - Room G11 (corridor): view west looking along the corridor through two sets of double doors. Scale: 2 x 1.0m (archive image: G2459_077).

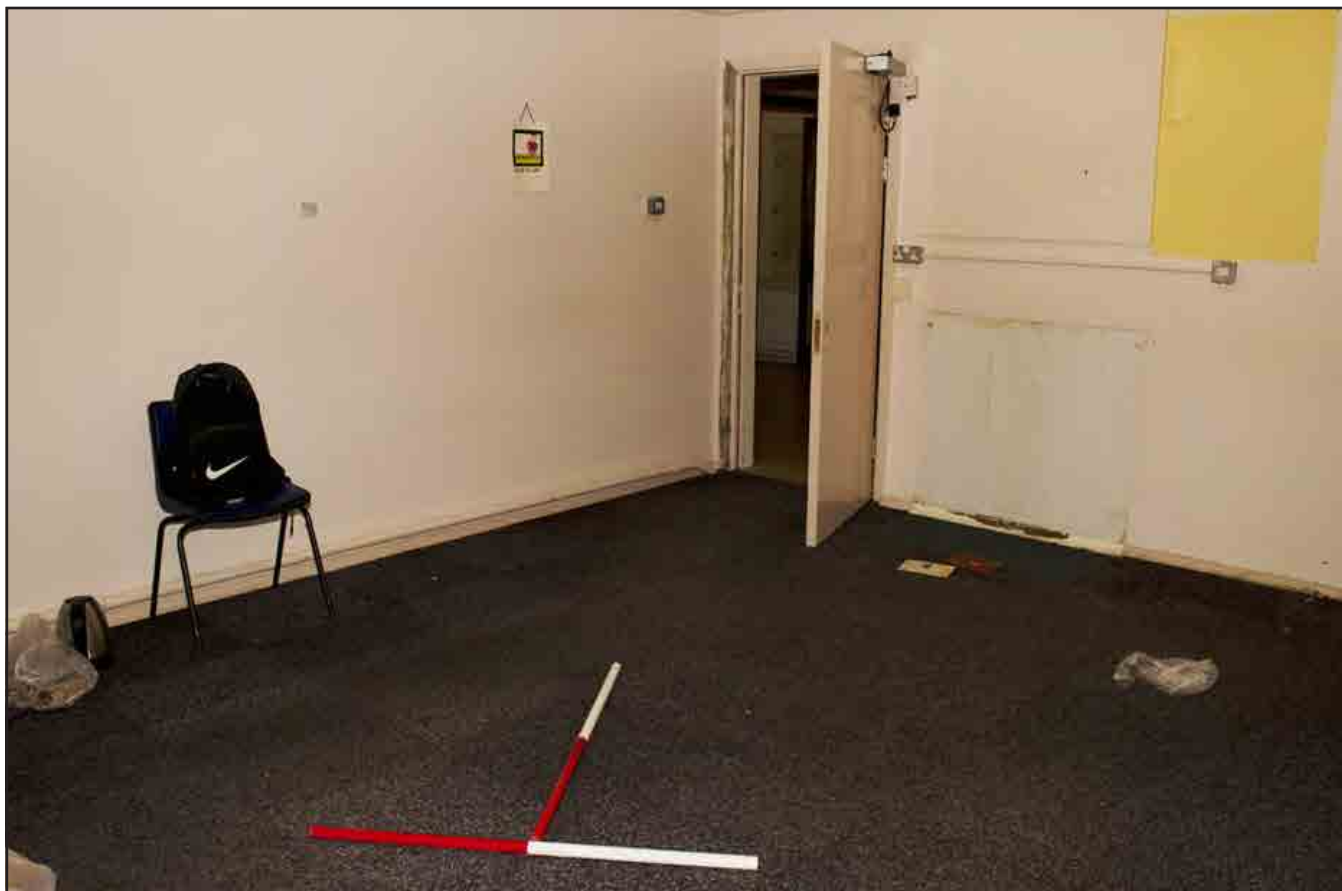
Plate 31: Main Building Core - Room G13 (Dining Room): view northwest looking towards the front of the building/room entrance. This room was originally a staff room. Scale: 2 x 1.0m (archive image: G2459_093).

A rectangular room used as a dining space; accessed from lobby G11 (via door D50; Plate 31). The room is within the original building core and is listed on the 1925 to 1960 plans as a staff room; it is listed on the 1972 plan as a staff dining room and on the 2013 plan as a dining room. The original window fittings had been replaced with uPVC; the windows look towards the landscape south of the hospital (Plate 32).

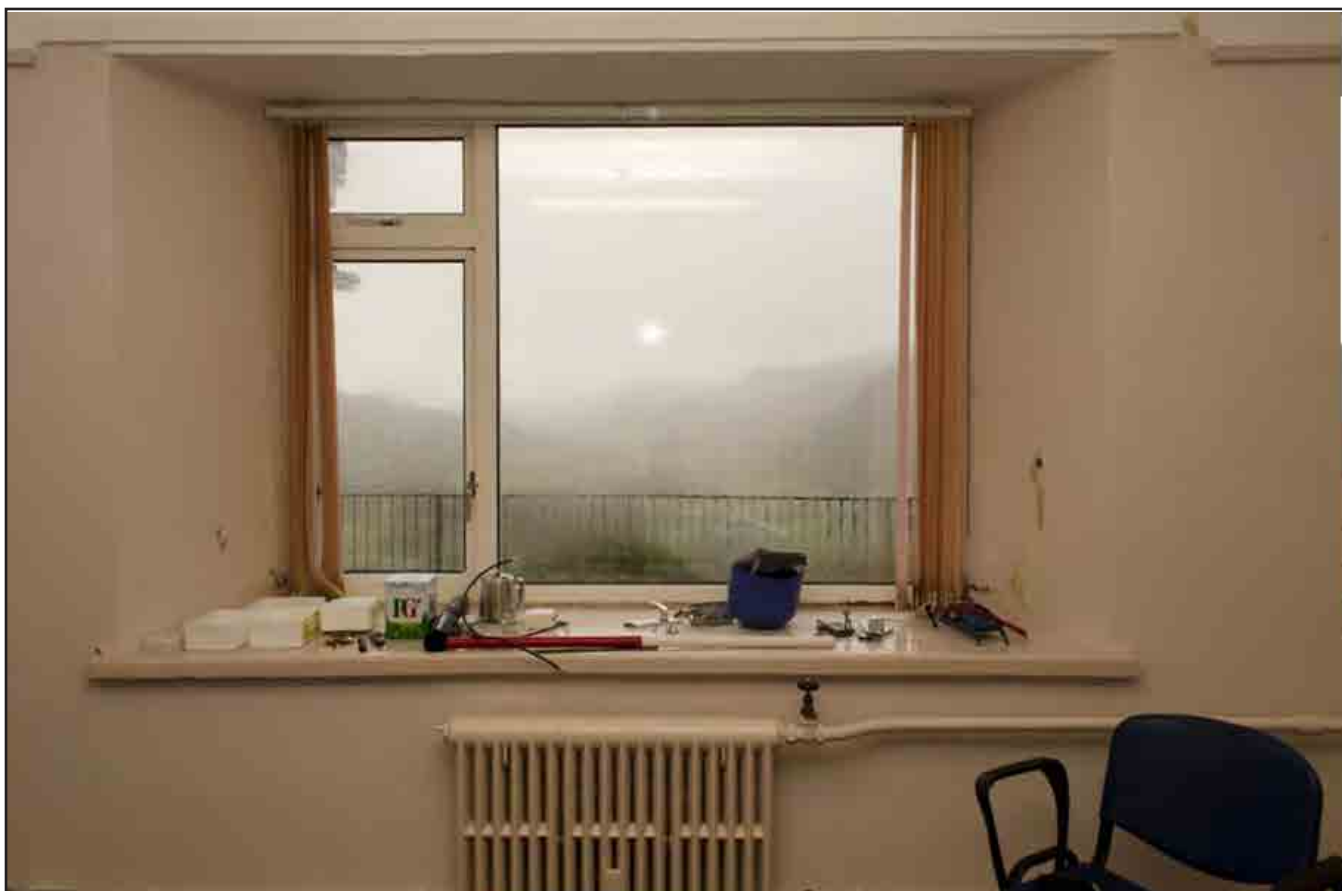
Plate 32: Main Building Core - Room G13 (Dining Room): view south looking through window W14. The window is not an original fitting. Scale: 1.0m (archive image: G2459_094).

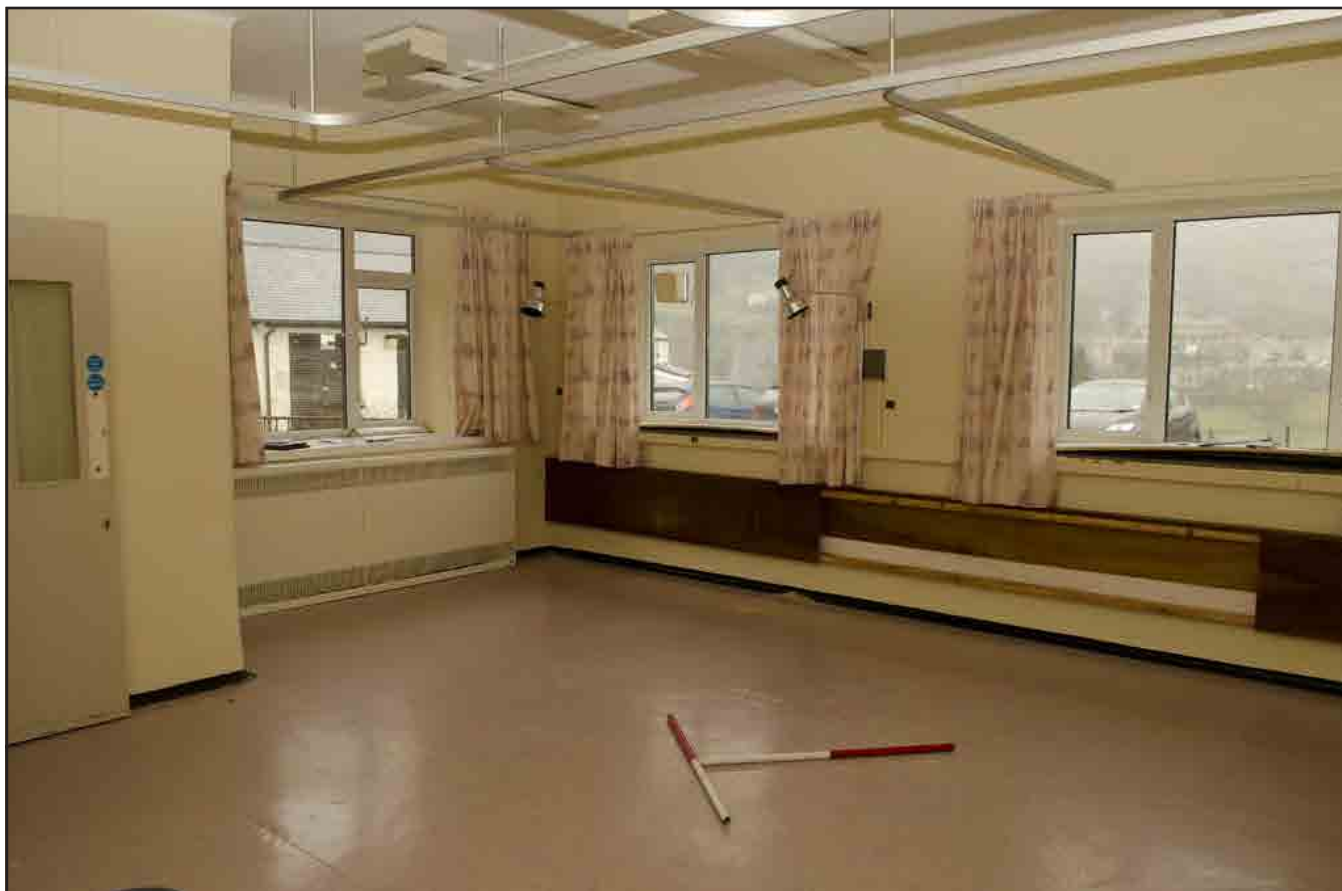
Plate 33: East Wing - Room G06 (5 Bed Ward): view southeast looking towards the rear of the building. This room has always been a patient ward and is part of the original building. Scale: 2 x 1.0m (archive image: G2459_054).

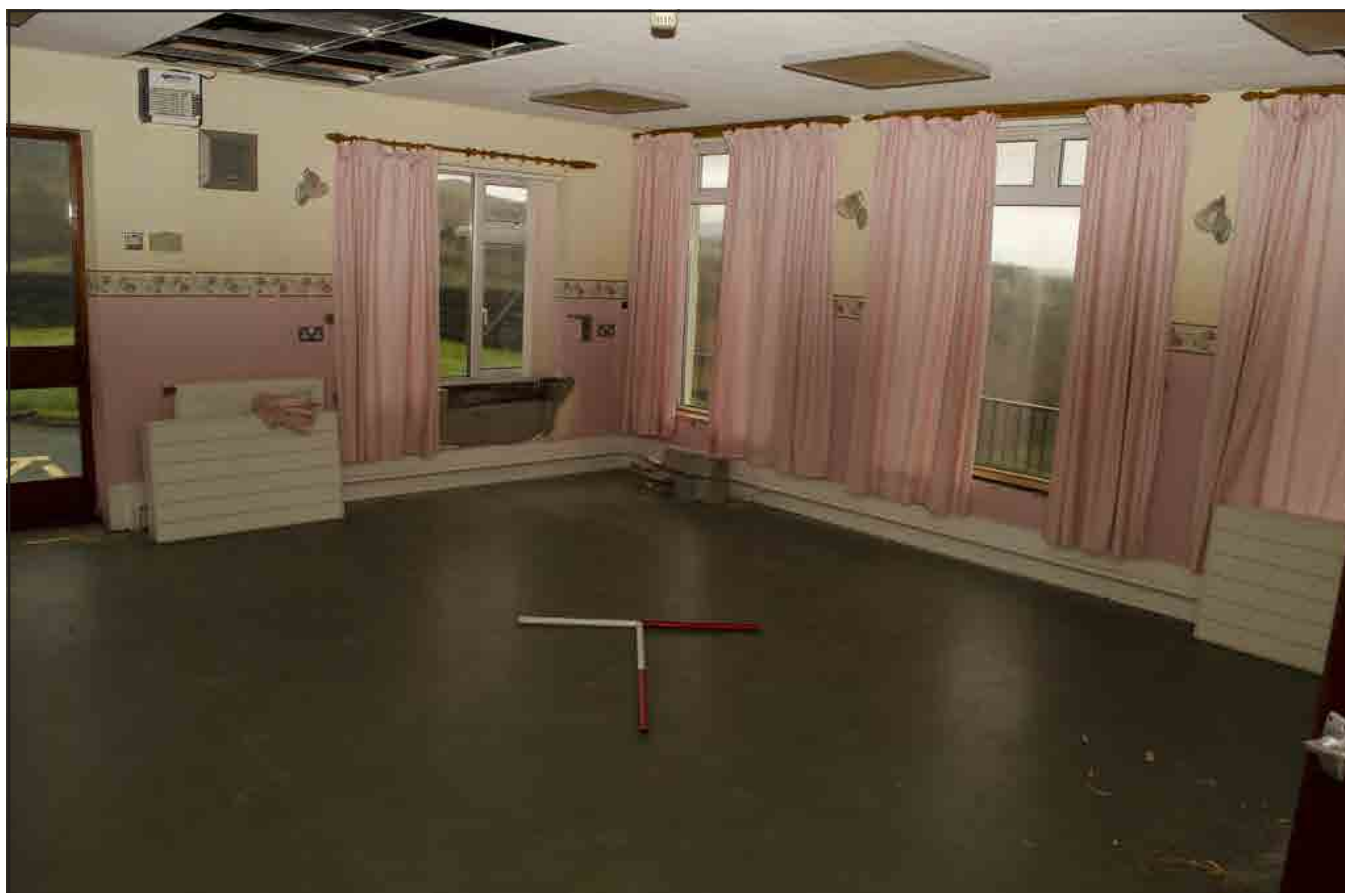
Plate 34: East Wing - Room G07 (Day Room): view southeast looking towards the rear of the building. This room was added to the wing in the early 1970s and replaced the veranda. Scale: 2 x 1.0m (archive image: G2459_061).
