CANOLFAN GOFFA FFESTINIOG

Level 2/3 Building Record

Prosiect Rhif / Project No. G2459

Prepared for: NHS Wales

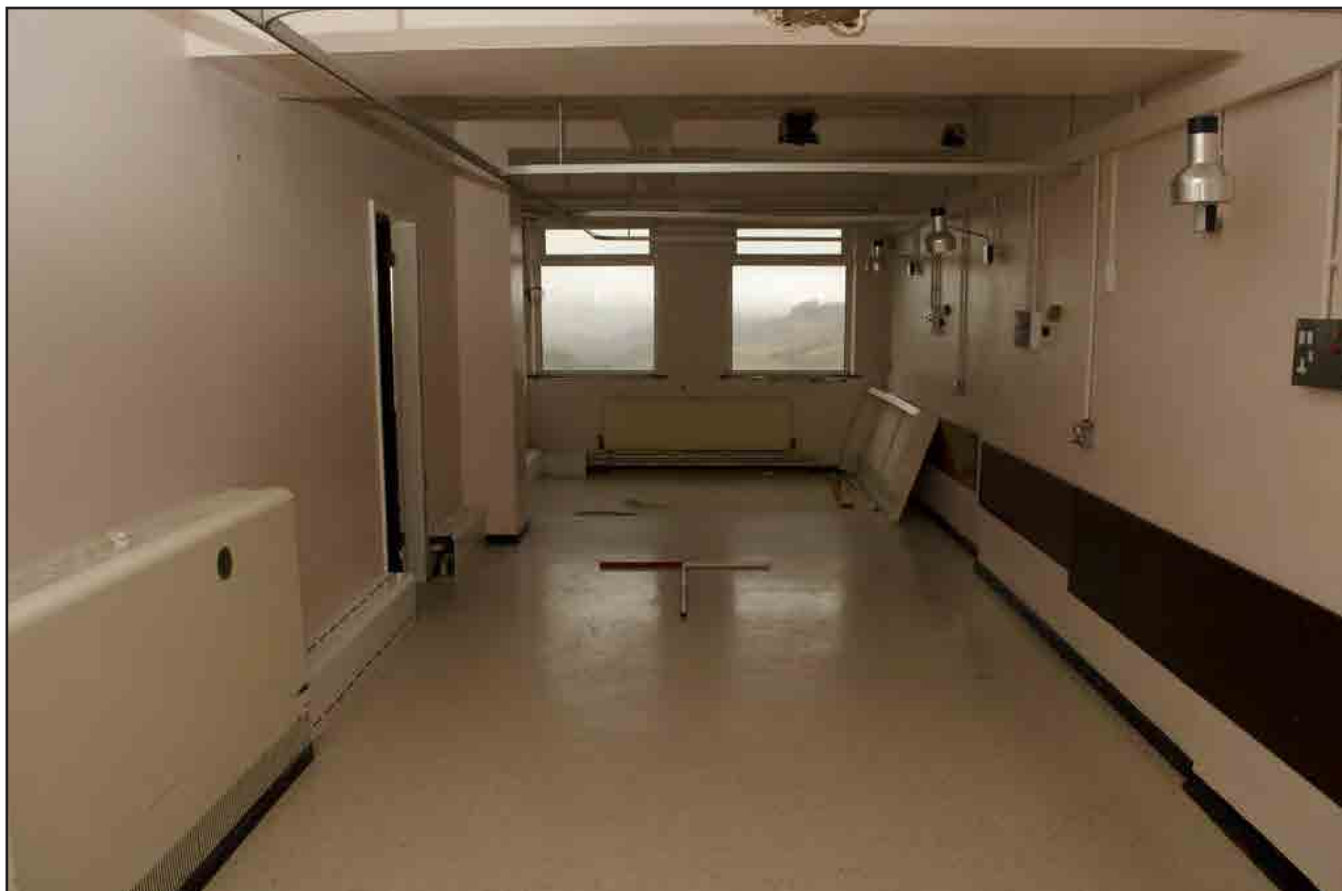
Plate 35: East Wing - Room G08 (4 Bed Ward): view south looking towards the rear of the building. This room incorporates part of the original building and a 1970s extension, with a 2 Bed Ward extended south to increase ward capacity. Scale: 2 x 1.0m (archive image: G2459_070).

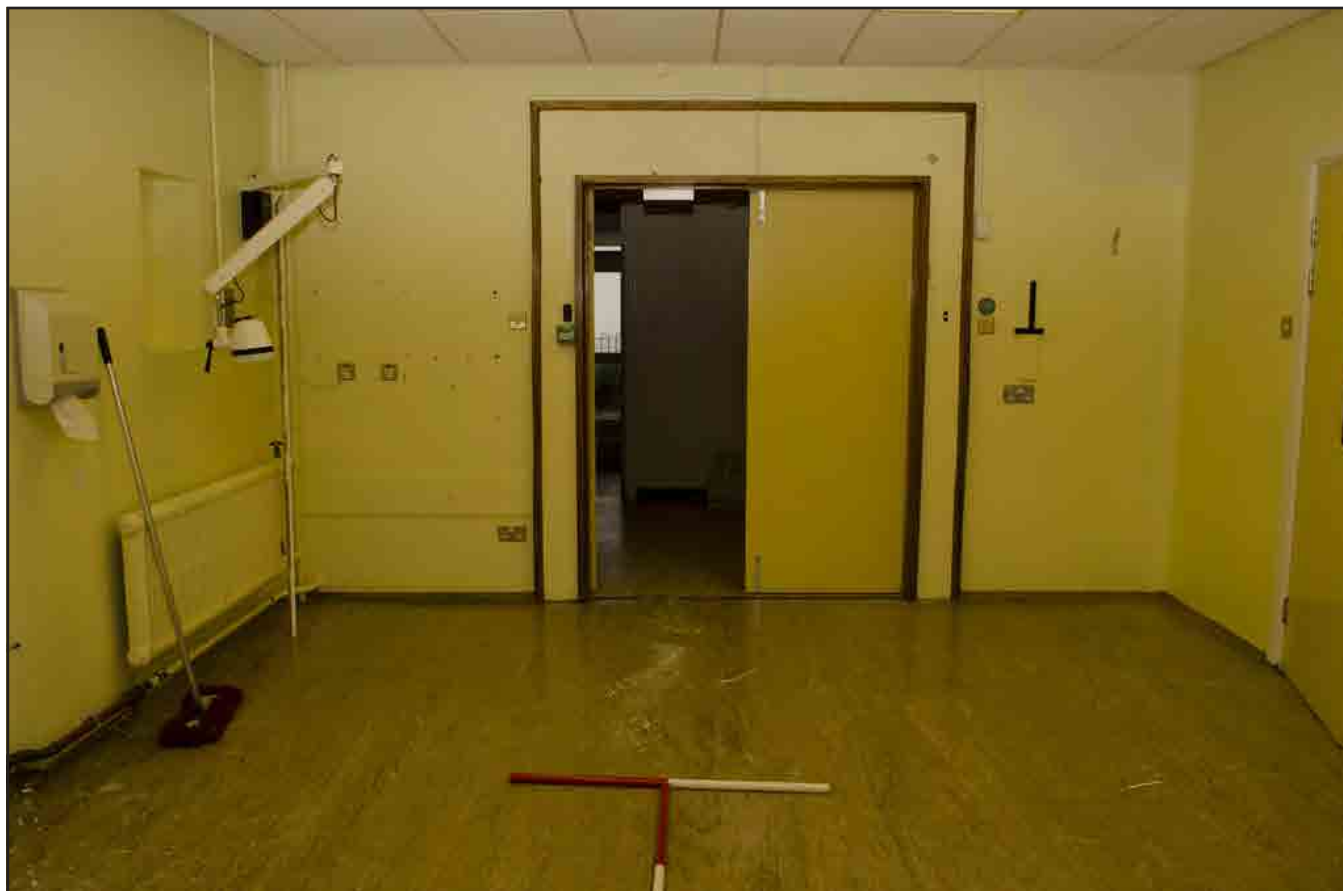
Plate 36: West Wing - Room G34 (Casualty): view south looking towards the centre of the building.
This is not an original part of the west wing but was added after 1925 as an X-Ray room, subsequently becoming a casualty room in the late 1960s/early 1970s. Scale: 2 x 1.0m (archive image: G2459_141).

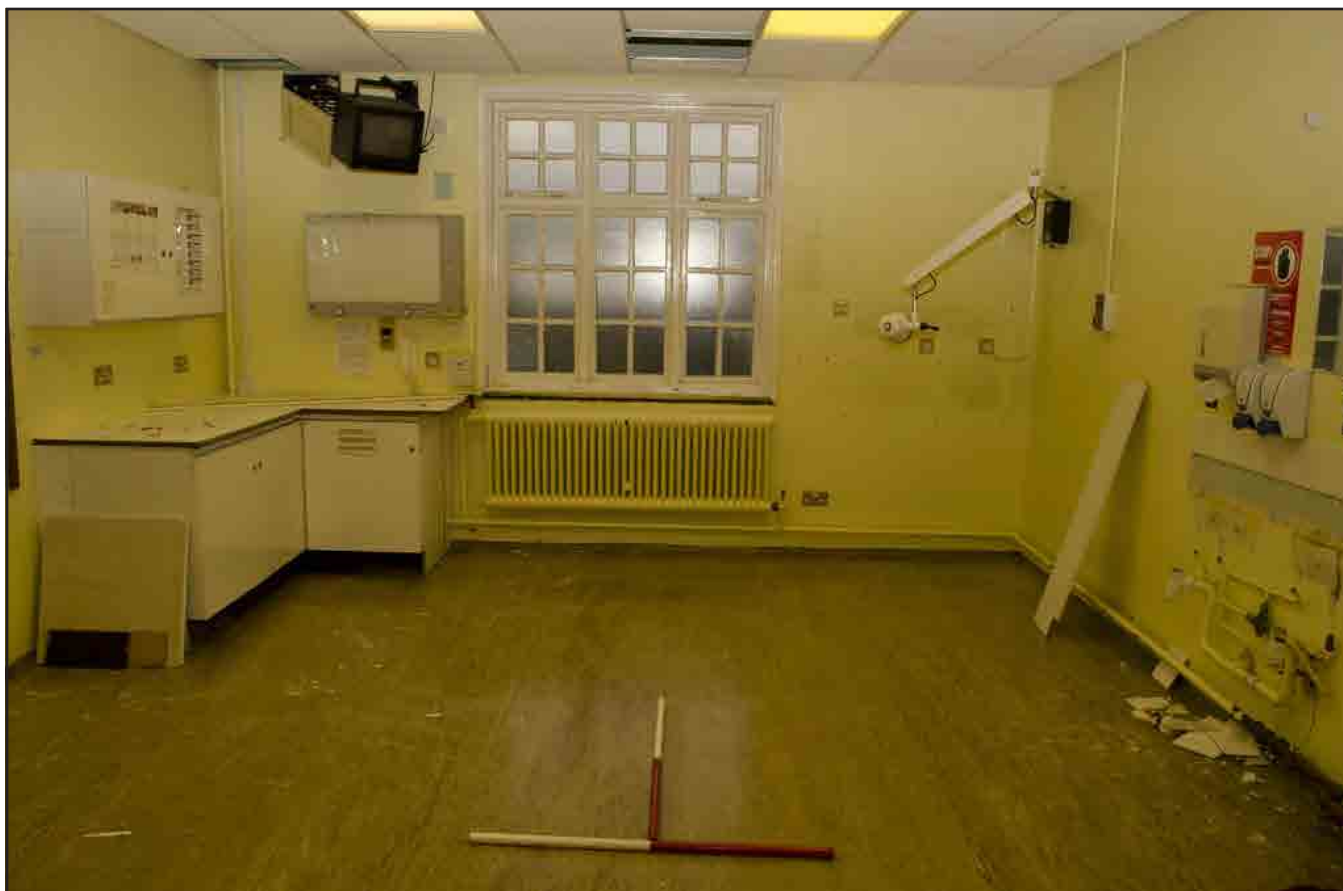
Plate 37: West Wing - Room G34 (Casualty): view north looking towards the front of the building.
Scale: 2 x 1.0m (archive image: G2459_140).

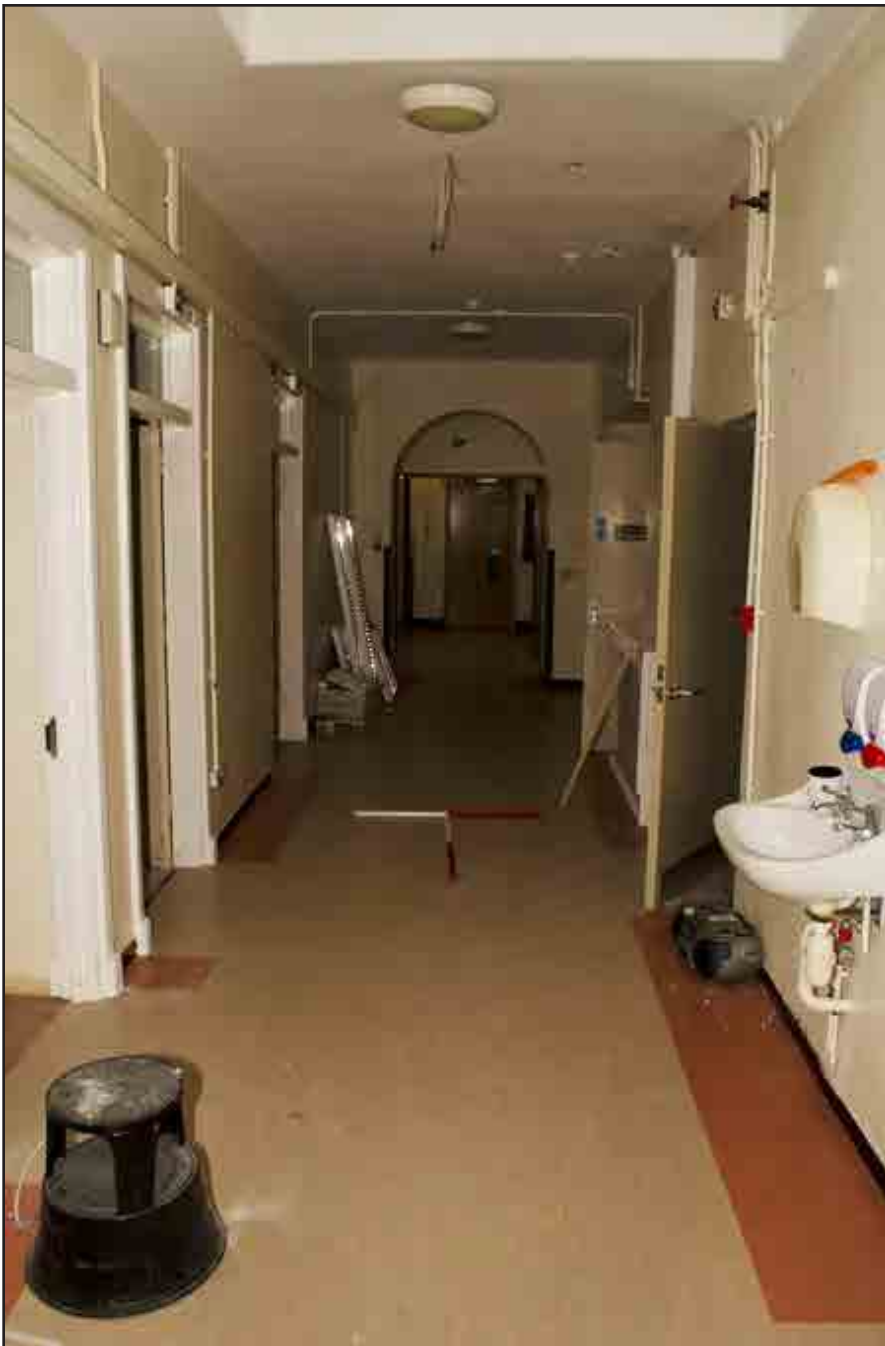
Plate 38: West Wing - Room G27 (Corridor): view west looking along the corridor. This part of the corridor is within the original part of the west wing; an extension was added after 1925 to provide access to additional rooms. Scale: 2 x 1.0m (archive image: G2459_122).

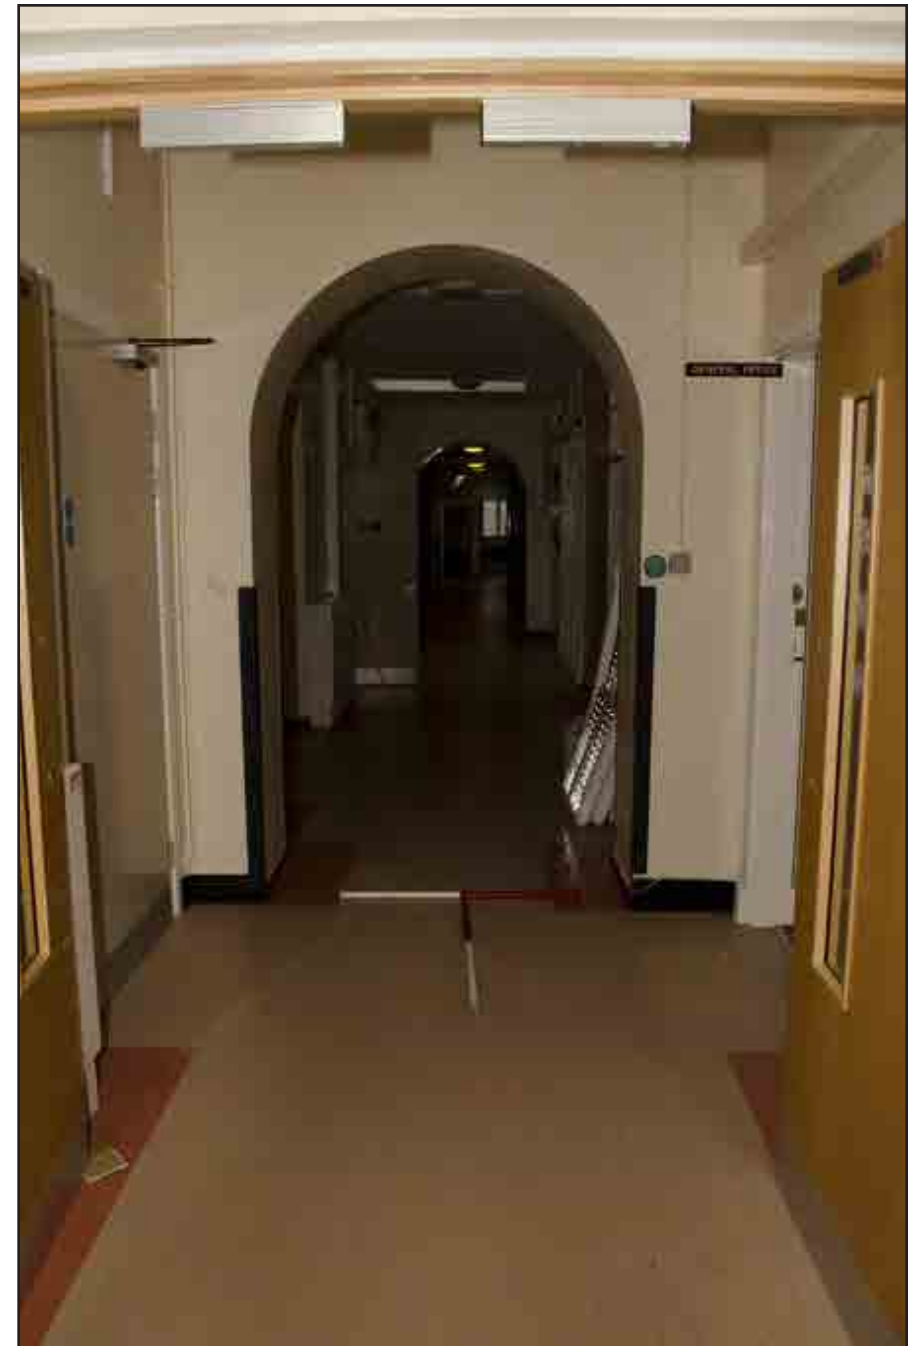
Plate 39: West Wing - Room G27 (Corridor): view east looking along the corridor. This part of the corridor is not within the original part of the west wing but is part of the post-1925 extension designed to provide access to additional rooms. Scale: 2 x 1.0m (archive image: G2459_153).

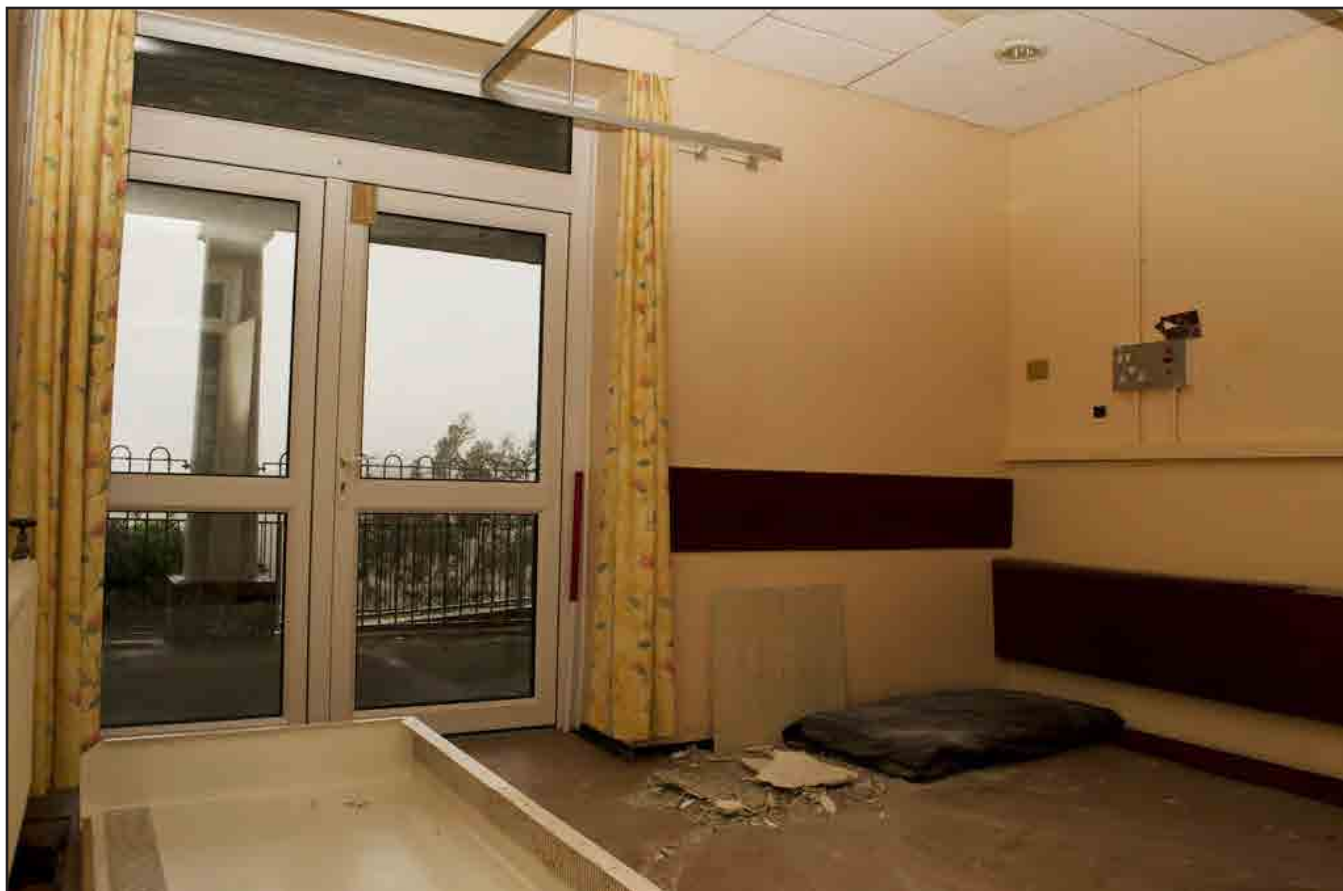
Plate 40: West Wing - Room G20 (2 Bed Ward): view south looking to the rear of the building. This room is within the original part of the west wing and has always functioned as a 2 Bed Ward. The double doors open onto the veranda; this is an original feature but the fittings have been replaced with modern uPVC. Scale: 1.0m (archive image: G2459_122).

A square shaped two bed ward that is part of the original west wing (Plate 40). The room is accessed from corridor G27. The room includes a uPVC double glaze door leading to the veranda (door D29; height: 2.46 m; width 1.92 m). The room is detailed on the 1925 plan as a 4 bed female ward; the room is larger than present and extends into what is now the access corridor (Room G27). Room still retains original radiator, of which the outer casing has been removed to reveal original Parquet flooring. The remainder has been covered with textured lino tiles. Building work has exposed original foundation would work for the first floor flooring. The room appears to have been converted into a 2 bed ward and the corridor extended across not long after, as the current layout is visible on the undated pre-1960 plan.

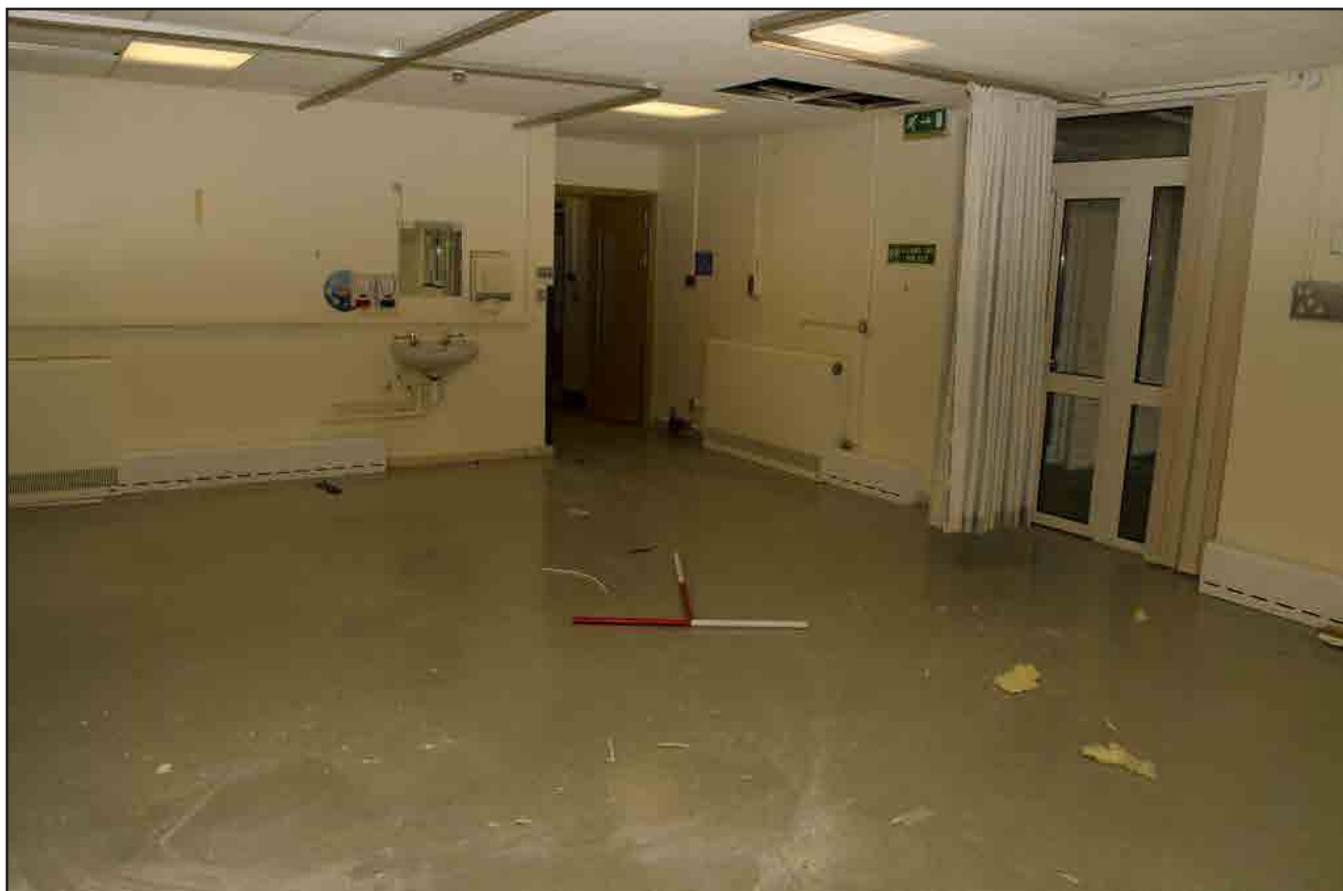
Plate 41: West Wing - Room G22 (5 Bed Ward): view south looking across the room towards the access door (via corridor G27) and access into room G23 (west wing dayroom). This room is not within the original part of the west wing but is part of the post-1925 extension; the dayroom is an additional extension built in the early 1970s. Scale: 2 x 1.0m (archive image: G2459_153).

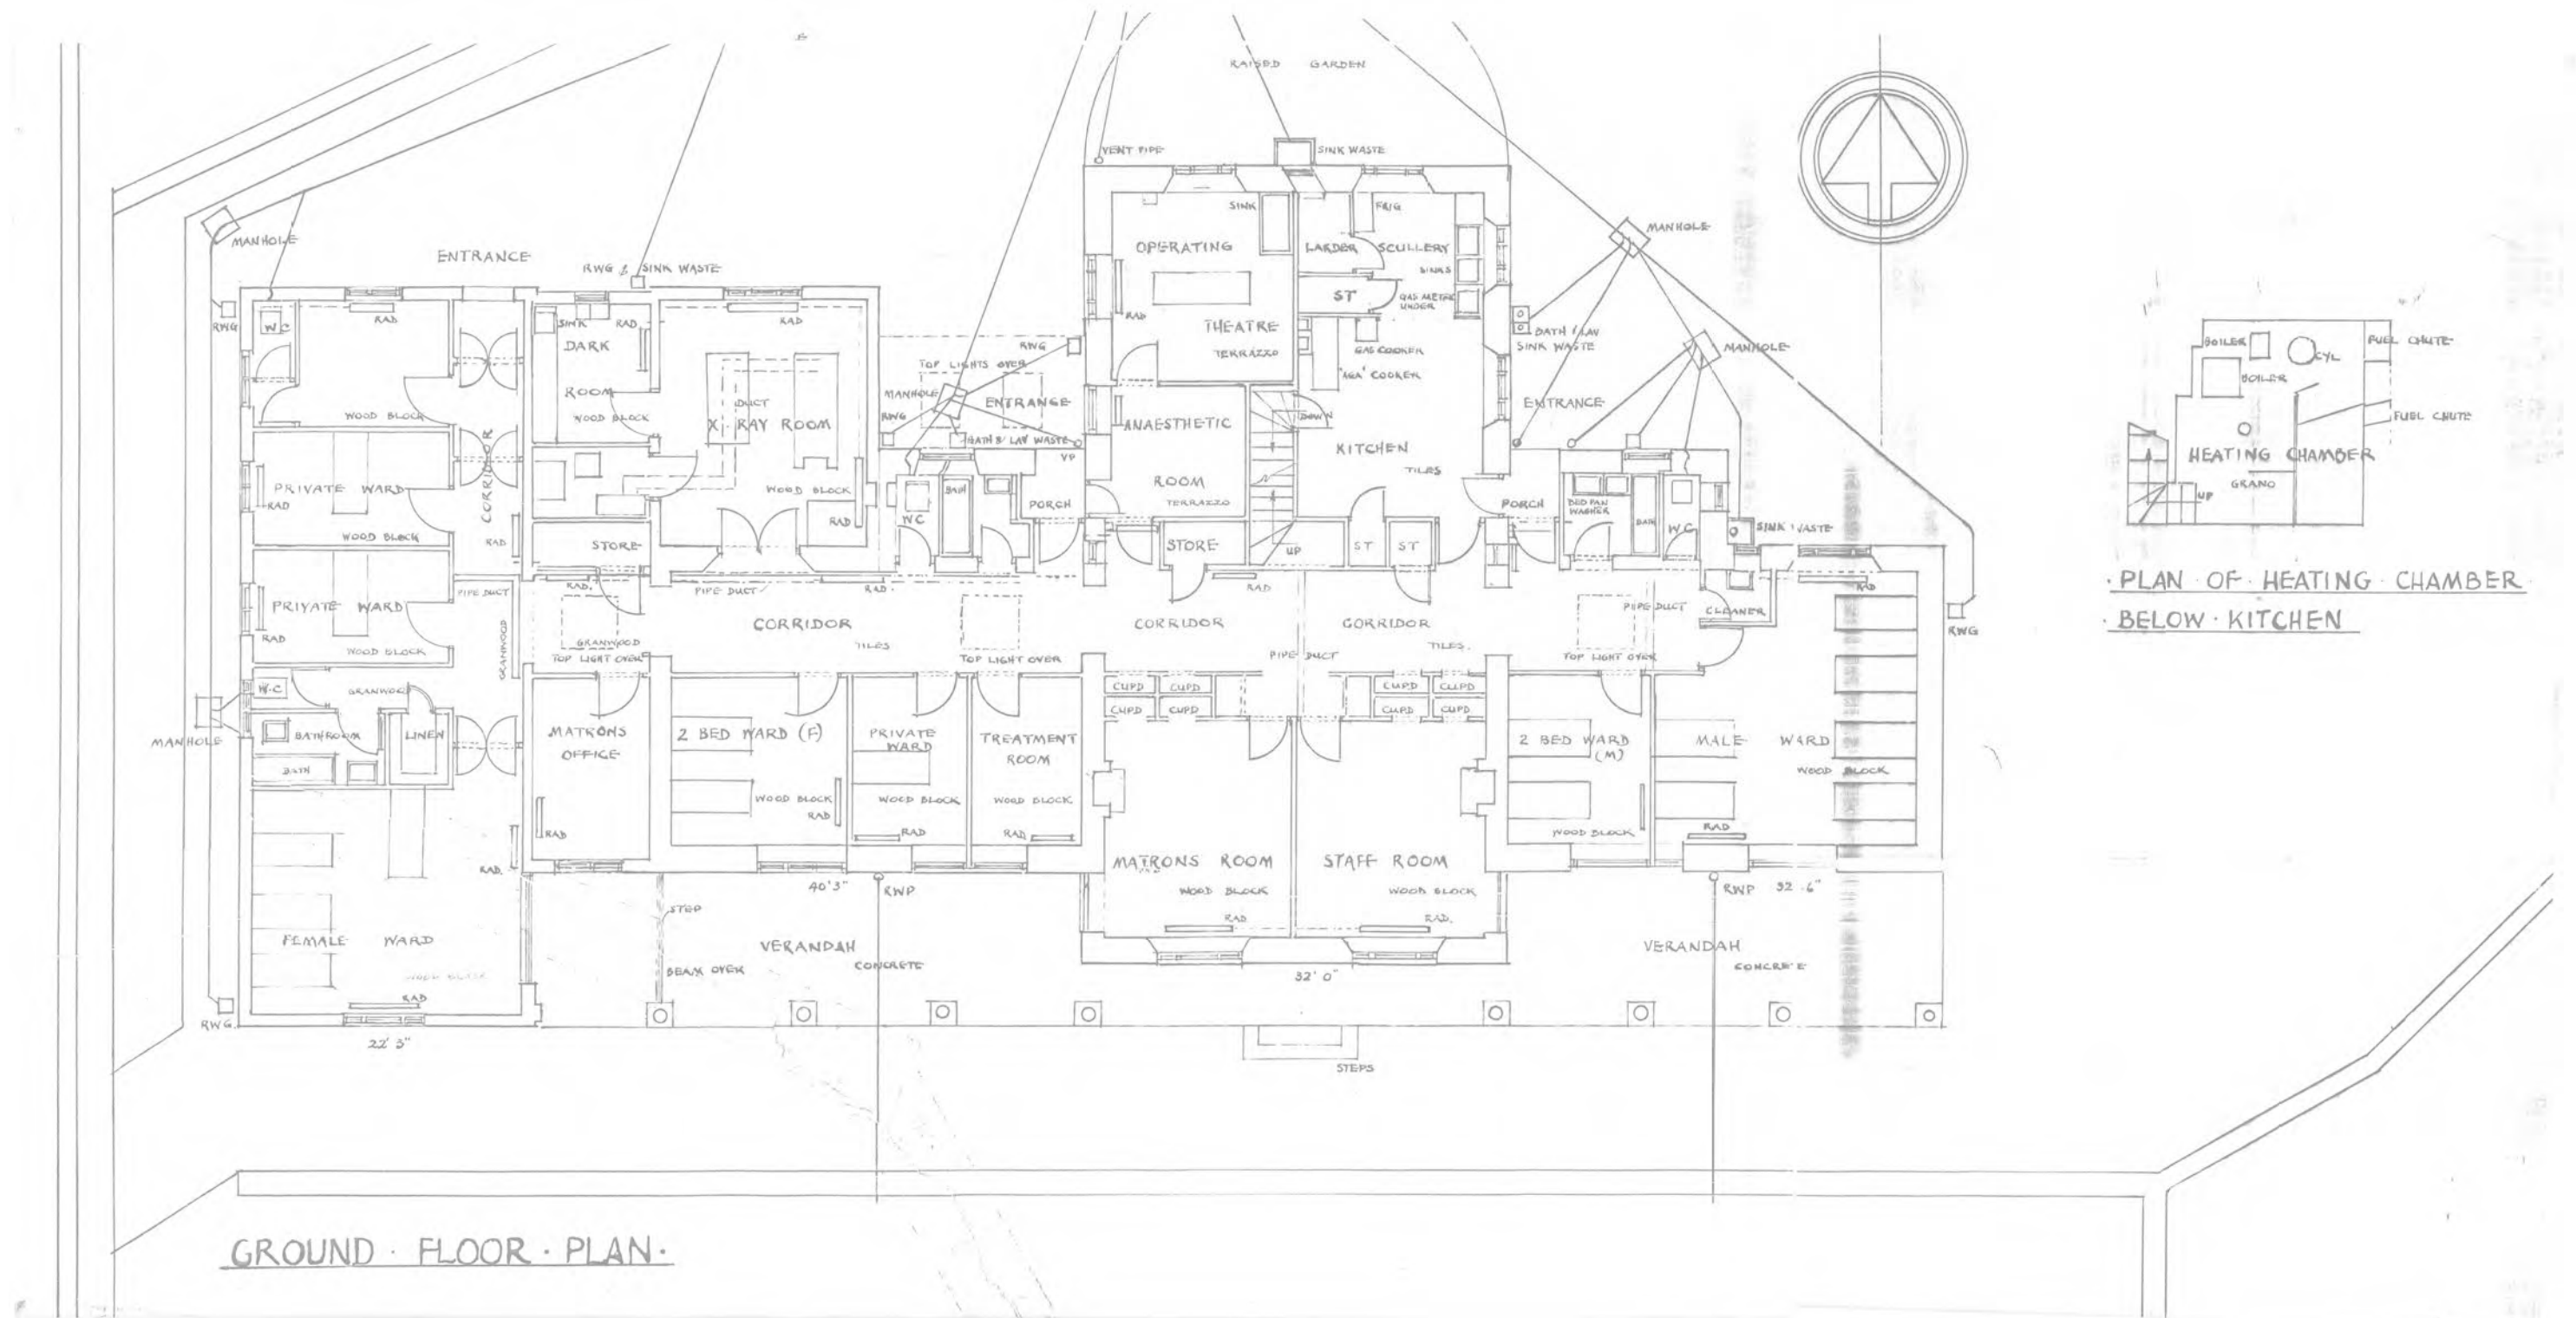
Figure 07: Reproduction of an undated plan of the hospital. The plan will have been produced before 1960, as a plan from that date includes interior changes not on this plan or on the 1925 plan. This plan includes the extension to the west wing that was designed after 1934 and saw the addition of 11 rooms that included more patient wards, the addition of an X-Ray room and the extension of the central corridor that linked the west wing to the main building. The building was further extended in the early 1970s (Source: Betsi Cadwaladr University Health Board archive 18/1).

The latest plan was produced in 2013 (TACP Architects Ltd Drawing No. EX01), which generally matches the 1972 plan. The 2013 plan was used during the building recording and it was noted that further changes had been made to the building since the production of the 2013 plan, albeit on a small scale, with certain room functions changed or partitions removed or relocated.
