# HOLYHEAD BREAKWATER

## Level 4 Building Record

Prosiect Rhif / Project No. G2489

Adroddiad Rhif / Report No.1355

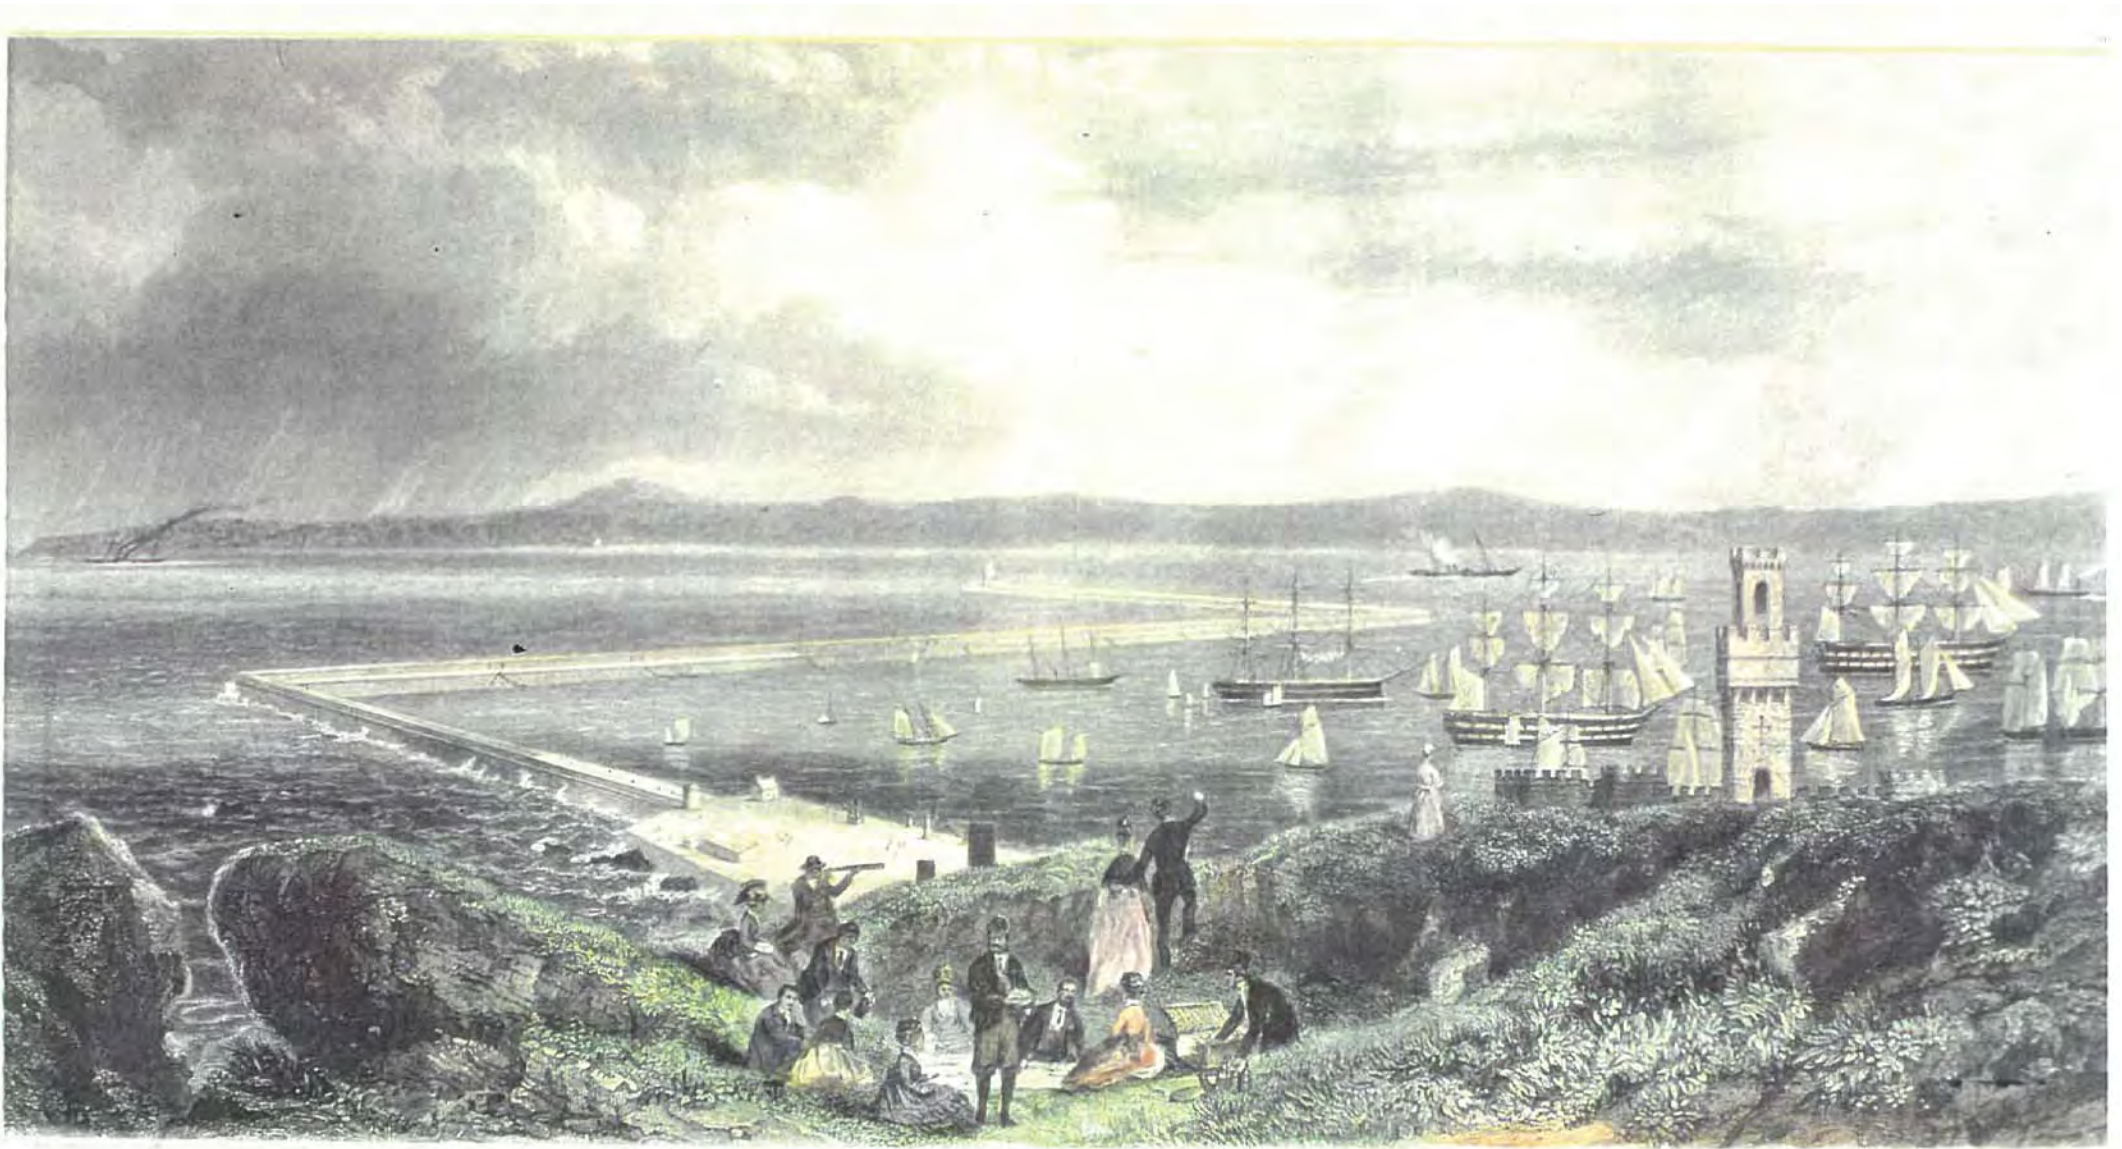
Figure 06: View of the Great Breakwater at Holyhead in 1874 shortly after its completion. Image by G.H. Andrews (NLW)

The breakwater work was completed in 1873, at a cost of £1,285,000 (Hollands 1973; Haslam *et al.* 2009; Figure 03) and the Prince of Wales performed the opening ceremonies. A watercolour painted by G.H. Andrews conveys the scene at the time (Figure 06). An inscribed plaque on the wall of the lighthouse reads:

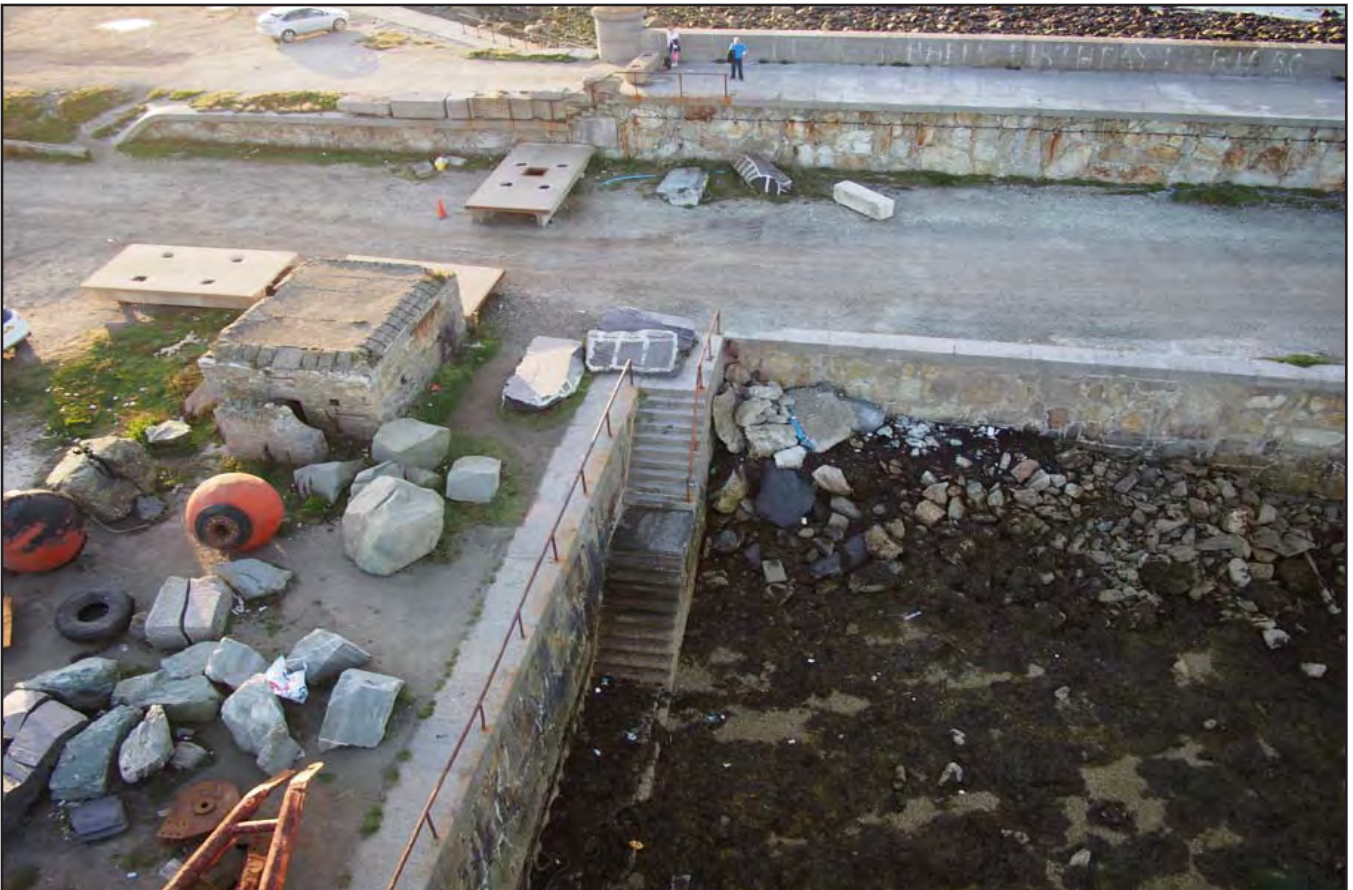
Plate 01: Holyhead Breakwater's Landsend with view of the remnants storage and working area on the portside and decorated bollard on the seaward (sourced from Civil Engineering Solutions: 20150928 Holyhead Breakwater 988.jpg).

### Plate 01:

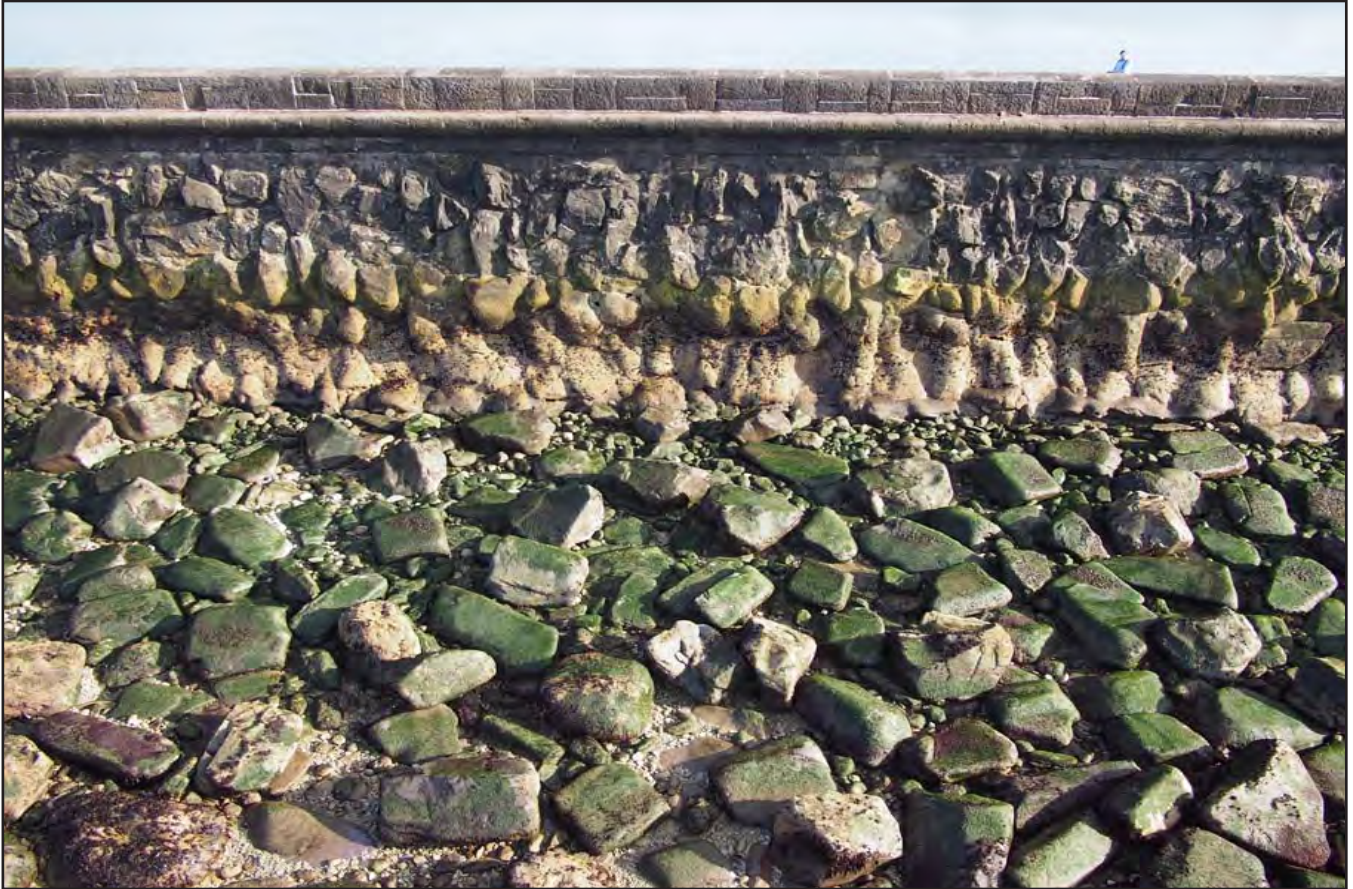
Plate 05: Seaward side view of rubble sourced from Holyhead Mountain used as supporting foundations of the parapet (sourced from Civil Engineering Solutions: 20150928 Holyhead Breakwater 186.jpg).

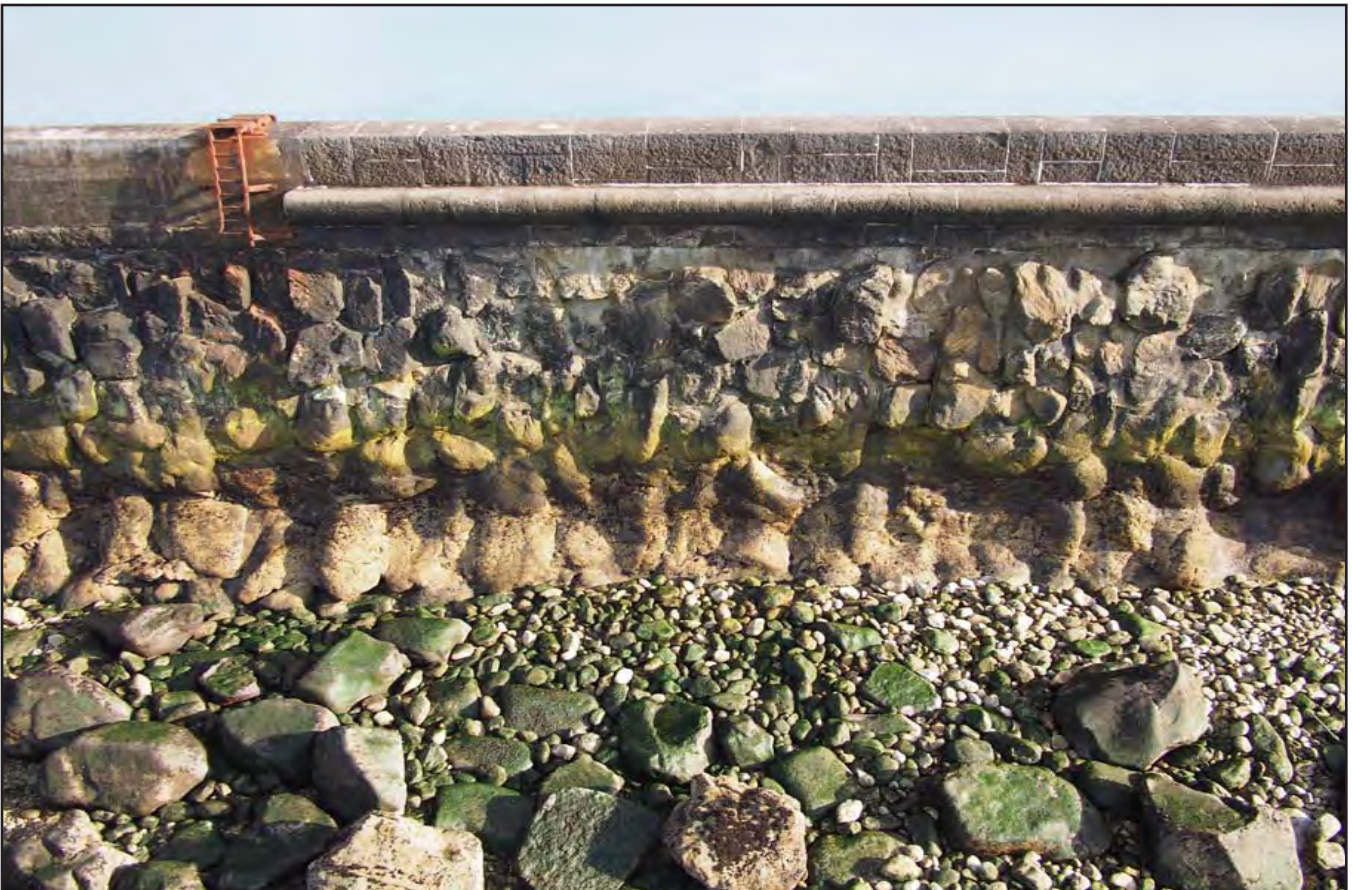
Plate 06: Seaward view of parapet with the remnants of a later addition of a ladder, possibly used in emergencies (sourced from Civil Engineering Solutions: 20150928 Holyhead Breakwater 206.jpg).

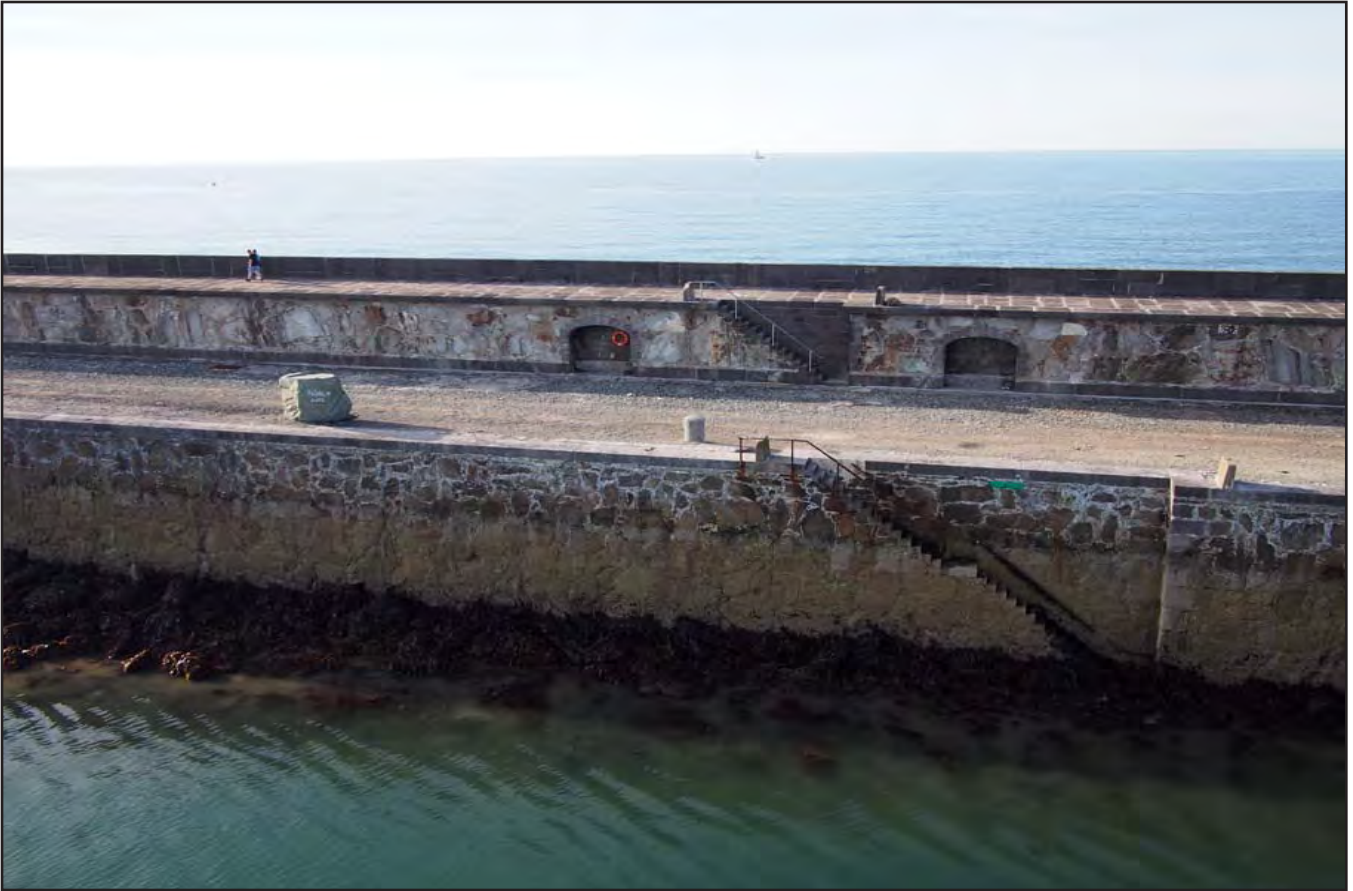
Plate 10: Portside view of mooring post, and staircases leading into the sea, and onto the parapet. Note two original alcoves with masoned seated areas possibly used for shelter during shipments (sourced from Civil Engineering Solutions: 20150928 Holyhead Breakwater 377.jpg).

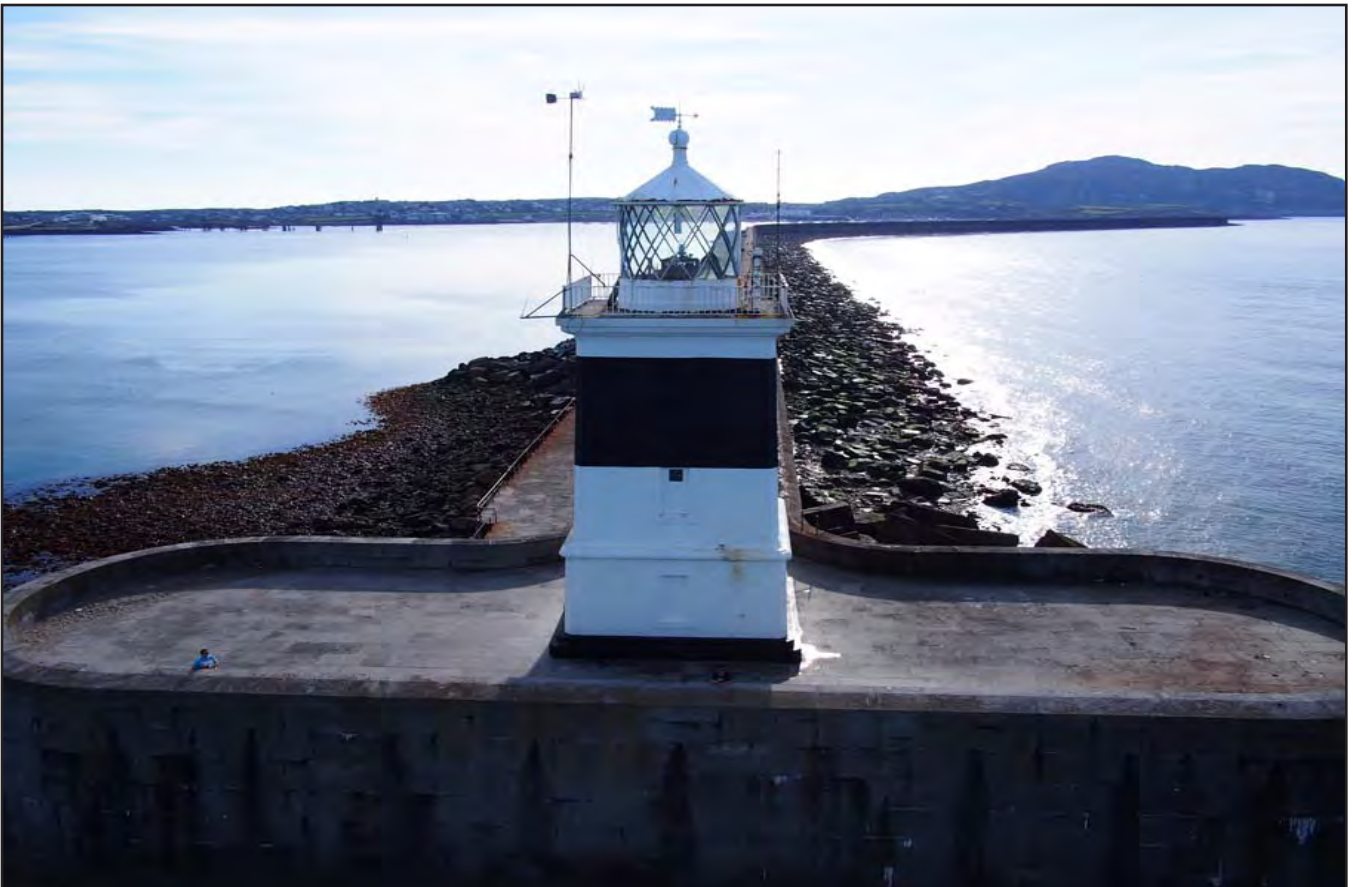
Plate 13: Aerial view of the tail end of the breakwater with the light house  
(sourced from Civil Engineering Solutions: 20150928 Holyhead Breakwater 225.jpg).

The lighthouse was built to a design by John Hawkshaw to mark the end of the Breakwater (Plates 14, 25). It was built in 1873 and was square in plan, with chamfered angles, and a stepped plinth. It has horizontal roll moulding at first floor level. There is a walkway around circular lantern, on moulded cornice supports and with iron railings. Inside there are three floors and a basement entered through the lower stage of the breakwater.

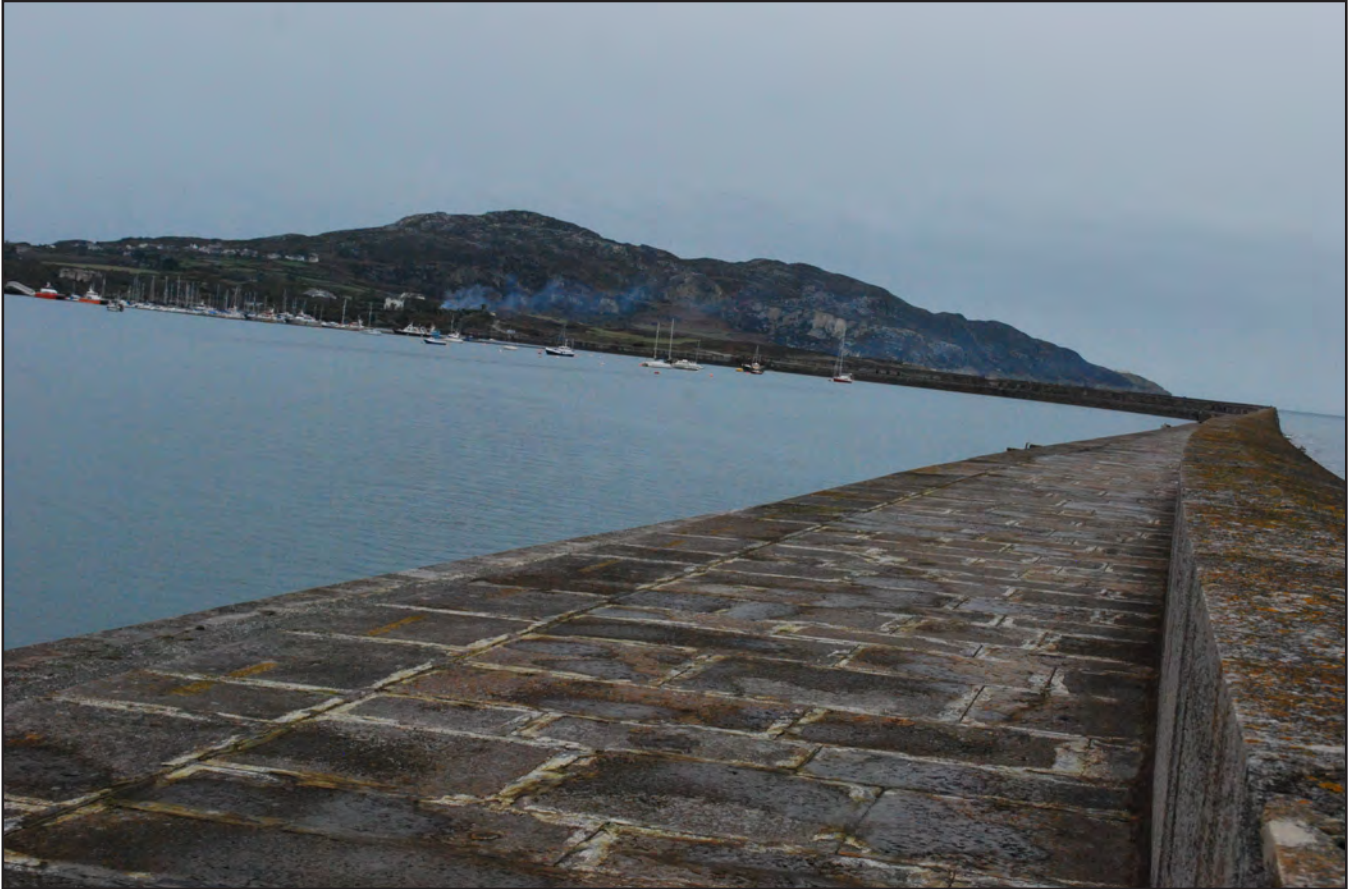
Plate 14: View of full length of breakwater showing its curve leading towards landsend at Holyhead Mountain  
(sourced from Civil Engineering Solutions: 20150928 Holyhead Breakwater 160.jpg).

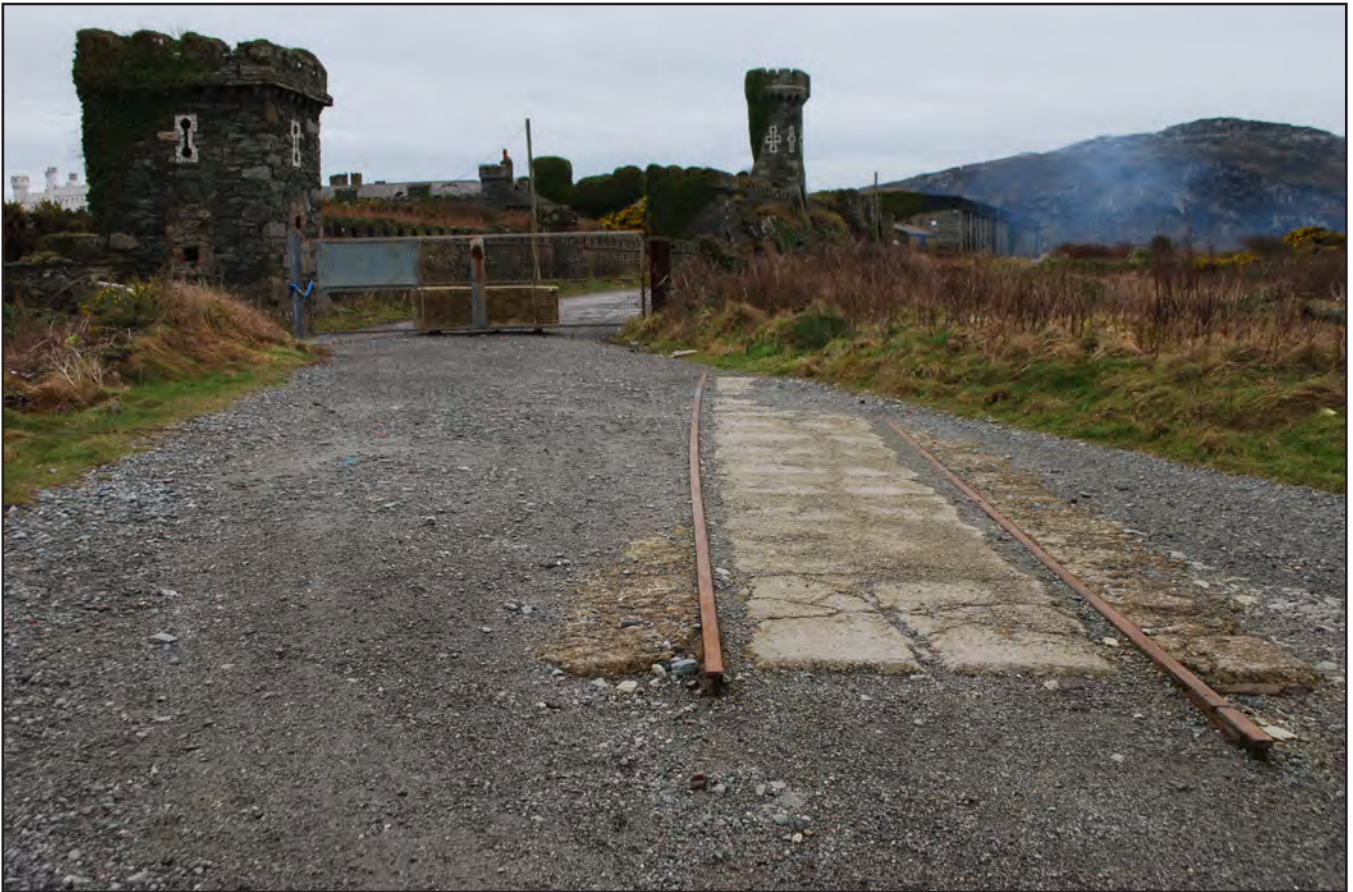
Plate 17: Holyhead Breakwater - view from northeast detailing surviving remnant of rail at landward end of hardstanding/building area (archive image: G2498\_001).

A 7ft gauge tramway was built 1848-9 to carry stones from a quarry to the proposed breakwater off Soldier's Point. An extension was also built to Salt Island, though that scheme was later abandoned. Special wagons designed by the resident engineer Dobson were used to tip stones from a timber staging to create a wide mound upon which the breakwater was subsequently built. Written records testify to their being five parallel tracks running along the staging (Davidson, *forthcoming*). The tramway continued to be used for maintenance, though in 1910, when a contract for major repair works was let to S Pearson and Son, a new standard gauge line was laid alongside, and following 1913 only this gauge was used. Rail marks visible at the end of the breakwater are 7ft in width, though sleepers which remain in situ close by (laid longitudinally not across the track) are of standard gauge width. Remains of the standard gauge rails are visible outside the Engine Shed (PRN 18110), and further north, where the track to the breakwater crosses the fence line (Plate 17; Figure 09).

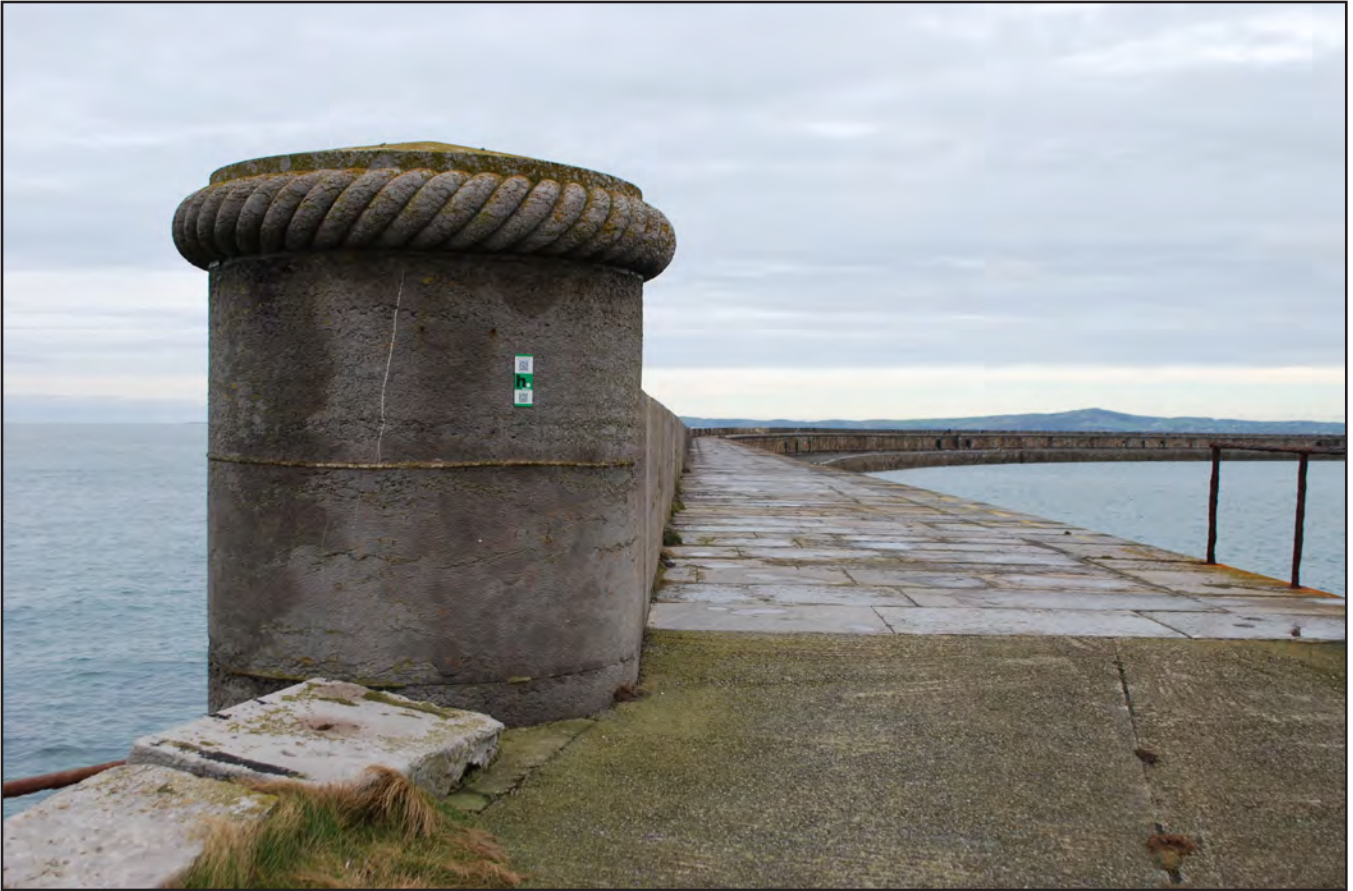
Plate 18: Holyhead Breakwater - view from southeast of large stone drum with roped design at end of the parapet (archive image: G2498\_003).

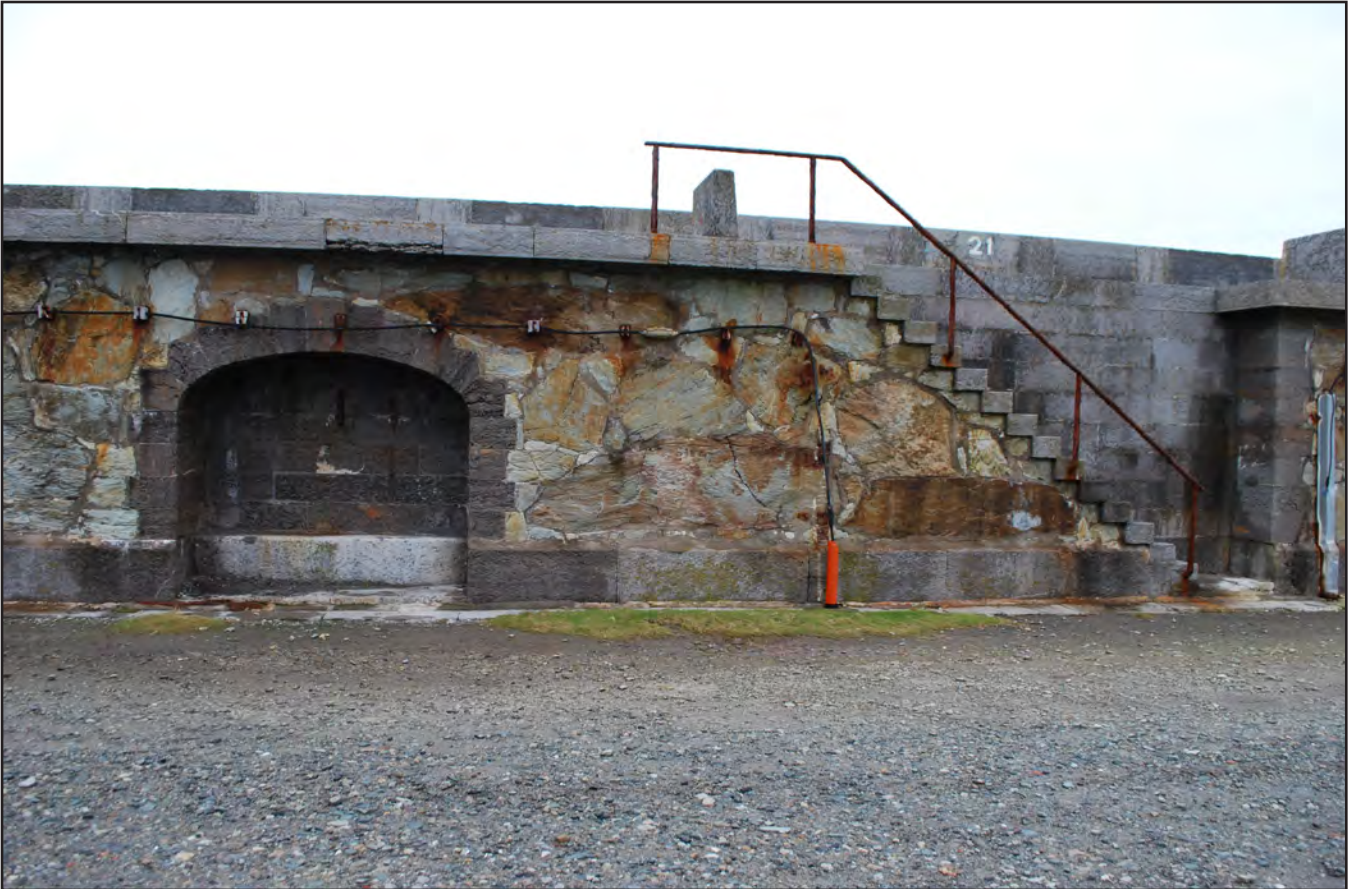
Plate 22: Holyhead Breakwater - view from south of refuge within the breakwater parapet and stairway between upper and lower levels (archive image: G2498\_015).

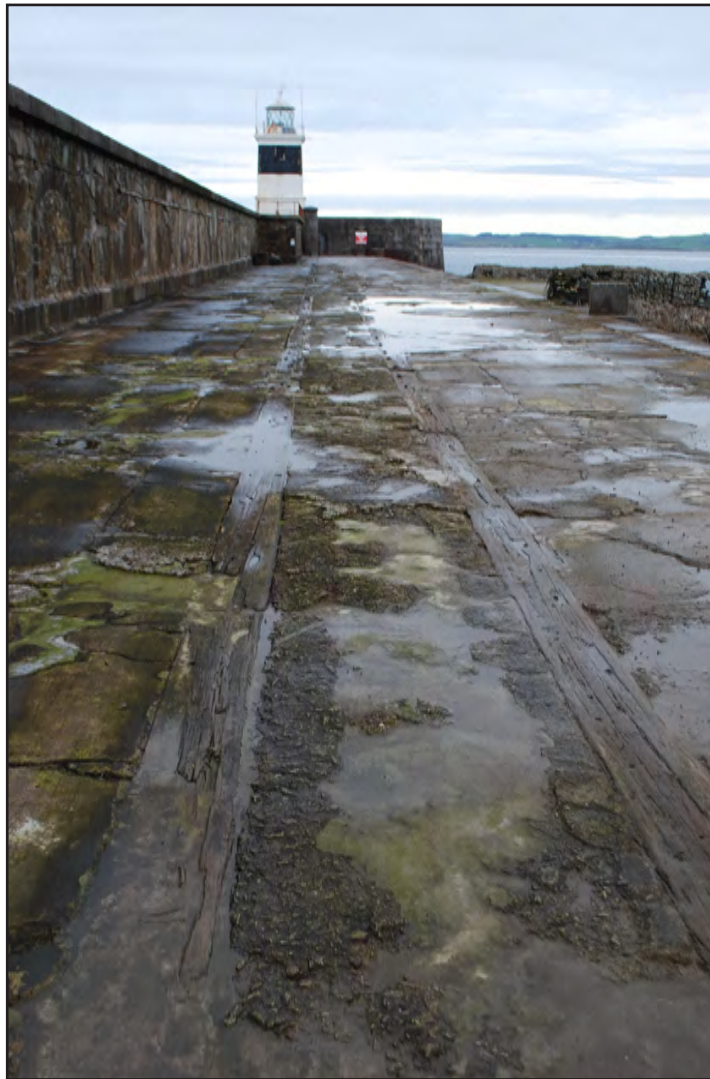
Plate 23: Holyhead Breakwater - view from west of wooden sleepers located along lower breakwater walkway near the lighthouse (archive image: G2498\_022).

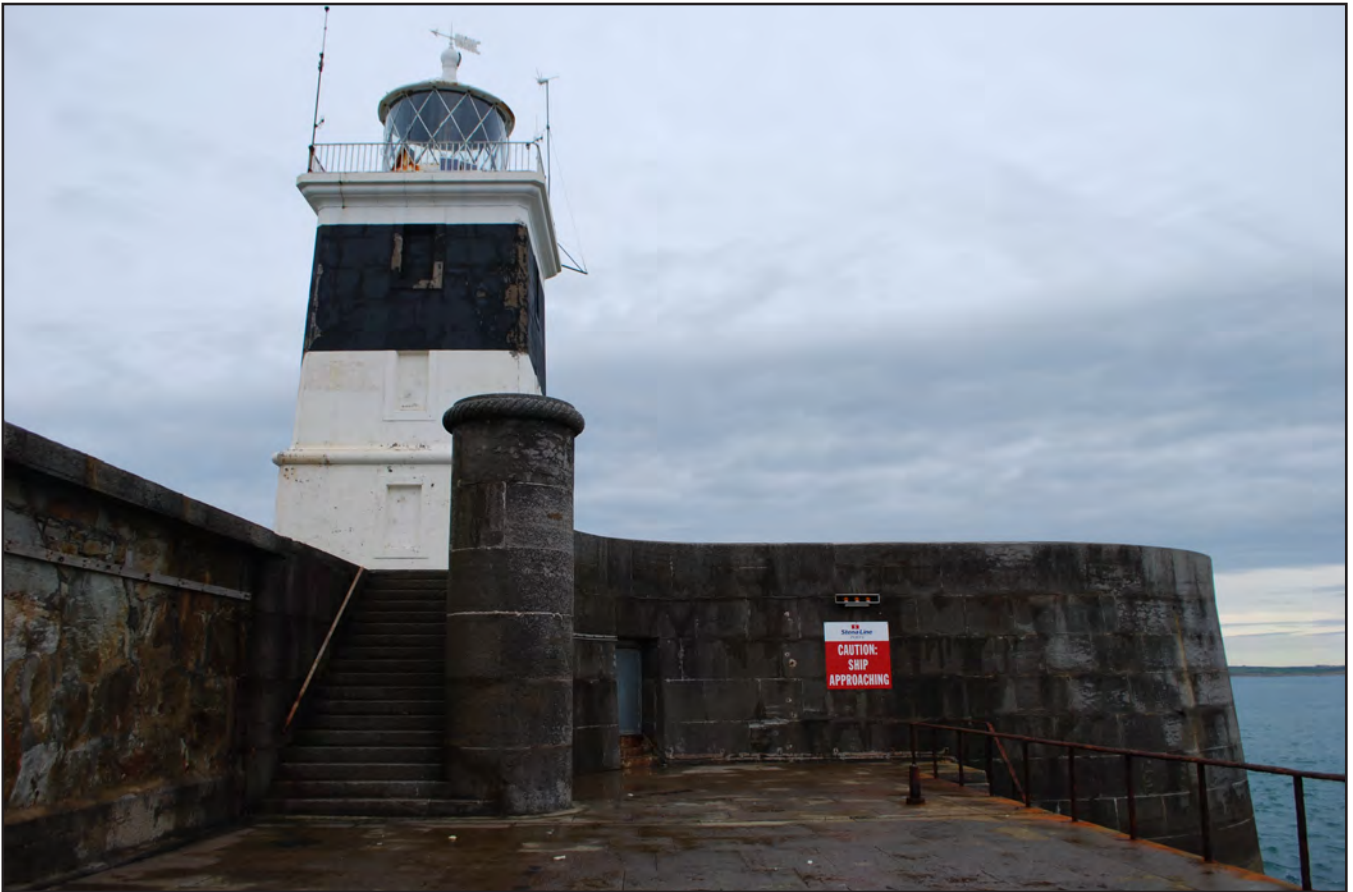
Plate 24: Holyhead Breakwater - view from southeast of upper parapet storage area and central latrines (archive image: G2498\_015).

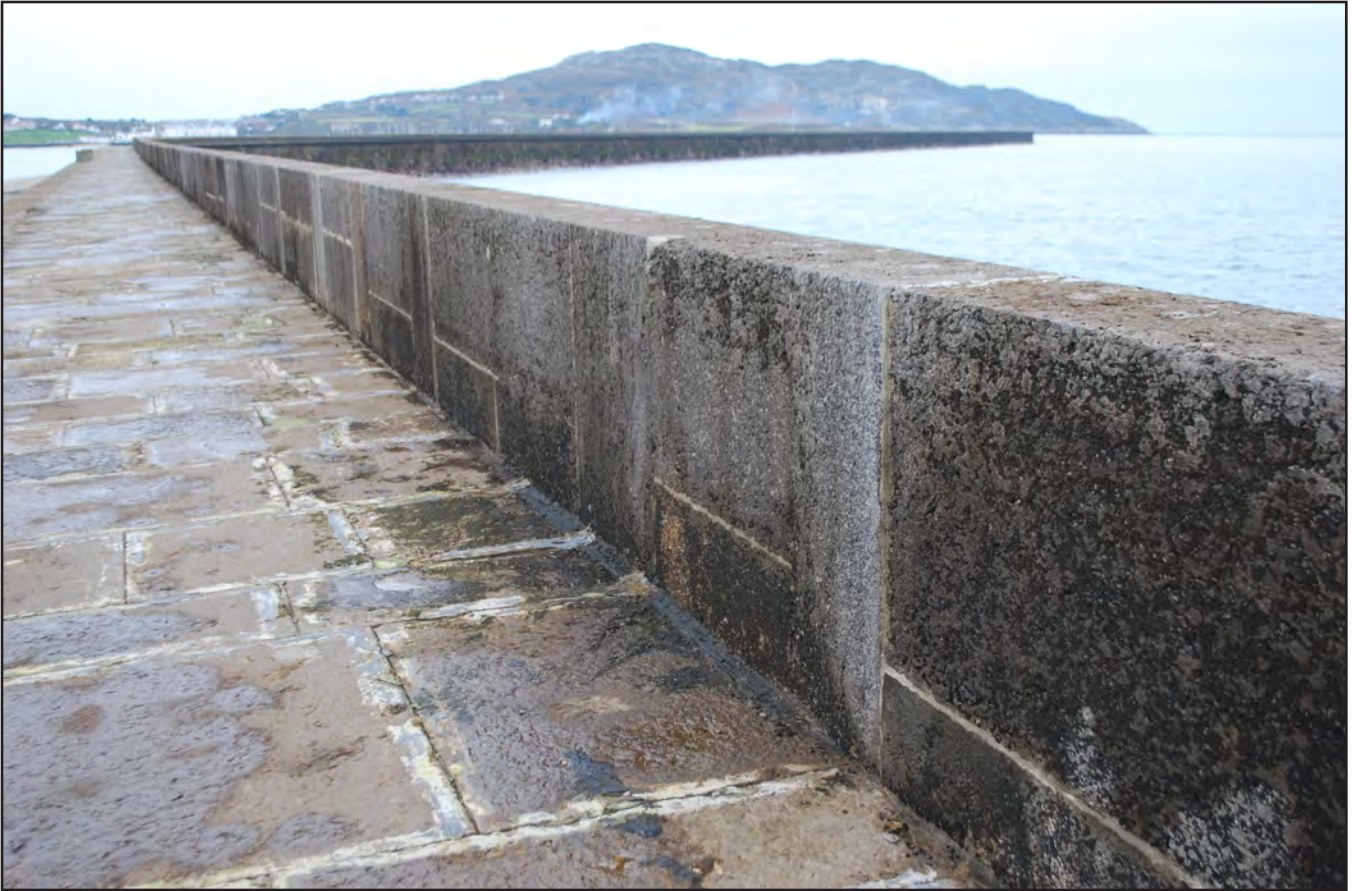
Plate 26: Holyhead Breakwater - view from southeast of parapet ashlar showing cyclopean blocks (archive image: G2498\_037)

The Great Breakwater is 2.4 miles long and is z-shaped in plan, and was constructed between 1848 and 1873. It was designed by J.M. Rendel, who was replaced by John Hawkshaw after the former's death on 21<sup>st</sup> November 1856. The resident engineer, who oversaw the day to day work on the breakwater, was John Dobson, and the contractors were J and C Rigby. The breakwater was, in engineering terms, a very significant development, and several new techniques were pioneered during its construction. The breakwater was built by dumping stone from Holyhead mountain to form a rubble mound, upon which was erected a massive wall faced with limestone blocks (Plate 26).

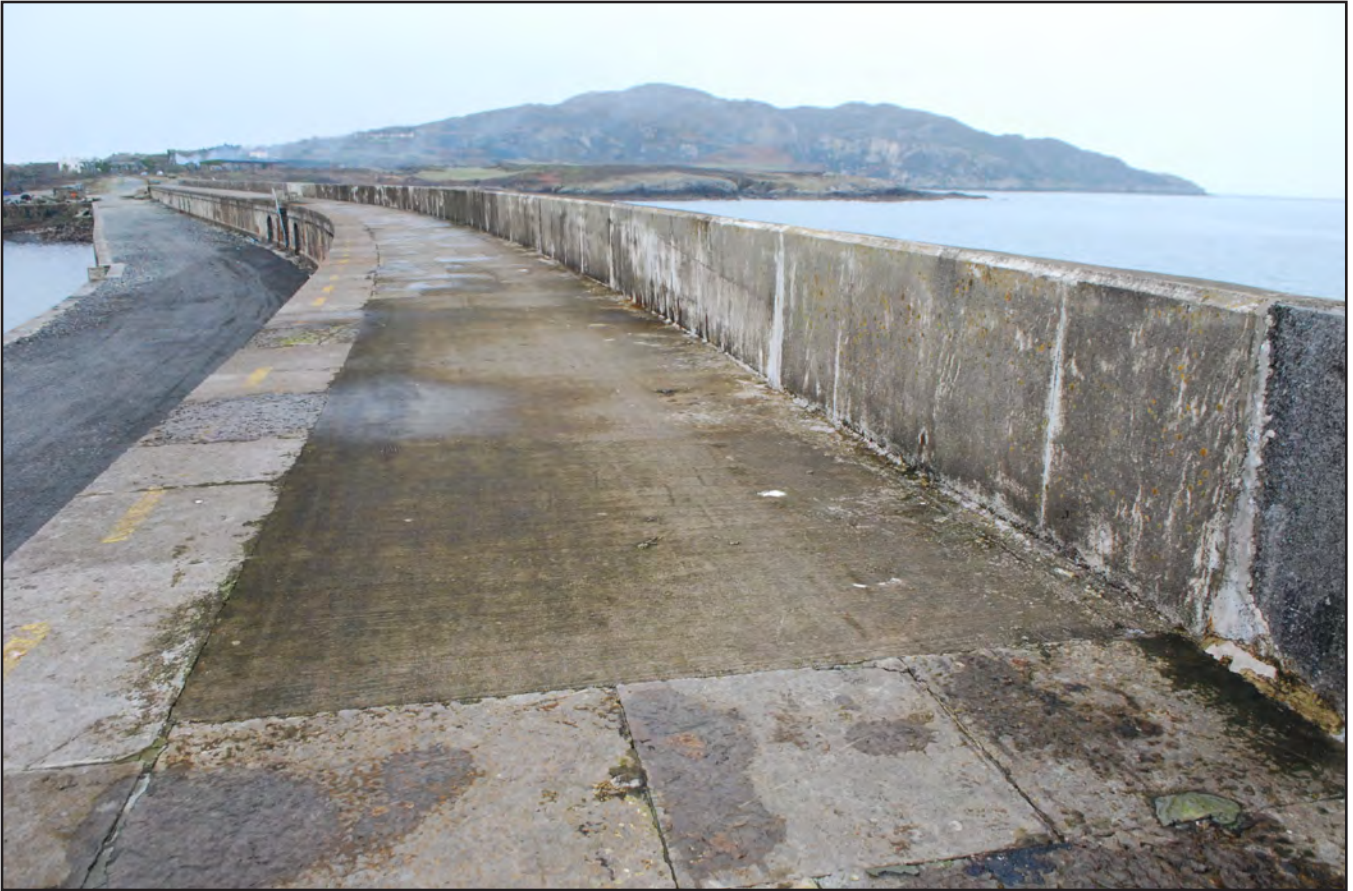
Plate 28: Holyhead Breakwater - view from east of storm damage repair to the parapet and carriageway (archive image: G2498\_046).

Work on the breakwater has been continuous since it was opened, with repairs frequently required due to damage caused by the gales that hit the coastline during winter (Plate 28). In 1878 William Williams, contractors of Holyhead, were paid £1,100 by the Treasury for repairing the foundations, and further huge amounts of rubble were deposited in 1880, 1886, 1887, 1889-1890 (National Archives, RAIL 837/23) and 1904 (National Archives, RAIL 837/30; Figure 07). In 1911 and 1913 S. Pearson and Sons, contractors of Westminster added 267,000 tons to the foundations from the quarry, and in 1914, 24 steel cases filled with concrete were placed around the north-east end of the breakwater, which remain clearly visible today (National Archives, RAIL 837/32, Figure 08; Plate 12). A ‘Breakwater Gang’

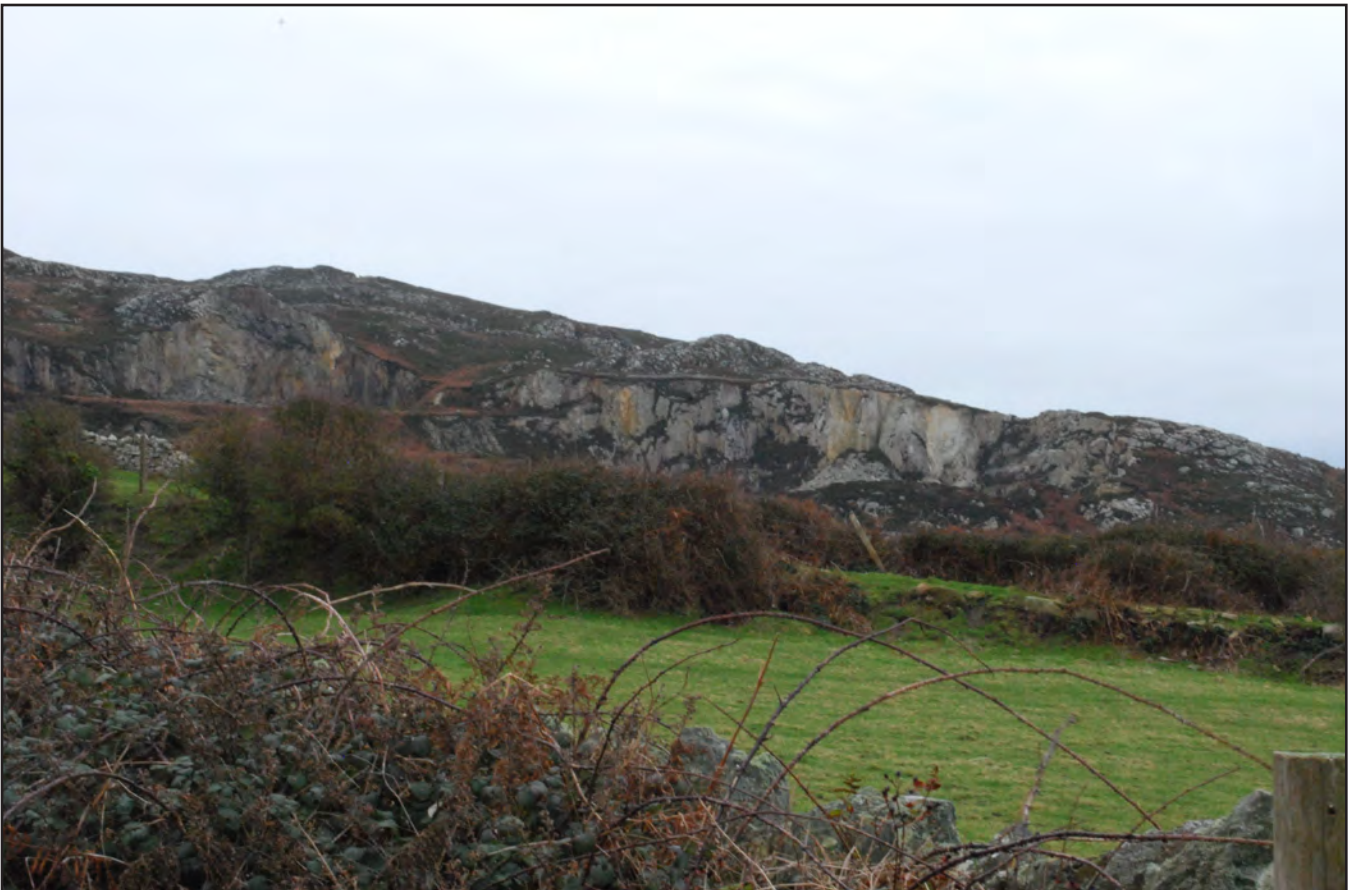
Plate 29: Holyhead Breakwater - view from north of former wharf at southwestern end of the breakwater (archive image: G2498\_050).
