CAERNARFON TOWN IMPROVEMENTS  
SECTION 3 - HIGH STREET (G1257)  
ARCHAEOLOGICAL MONITORING

**CAERNARFON TOWN IMPROVEMENTS**  
**SECTION 3 - HIGH STREET (G1257)**  
**ARCHAEOLOGICAL MONITORING**

**Gwynedd Archaeological Trust Report No. 164**

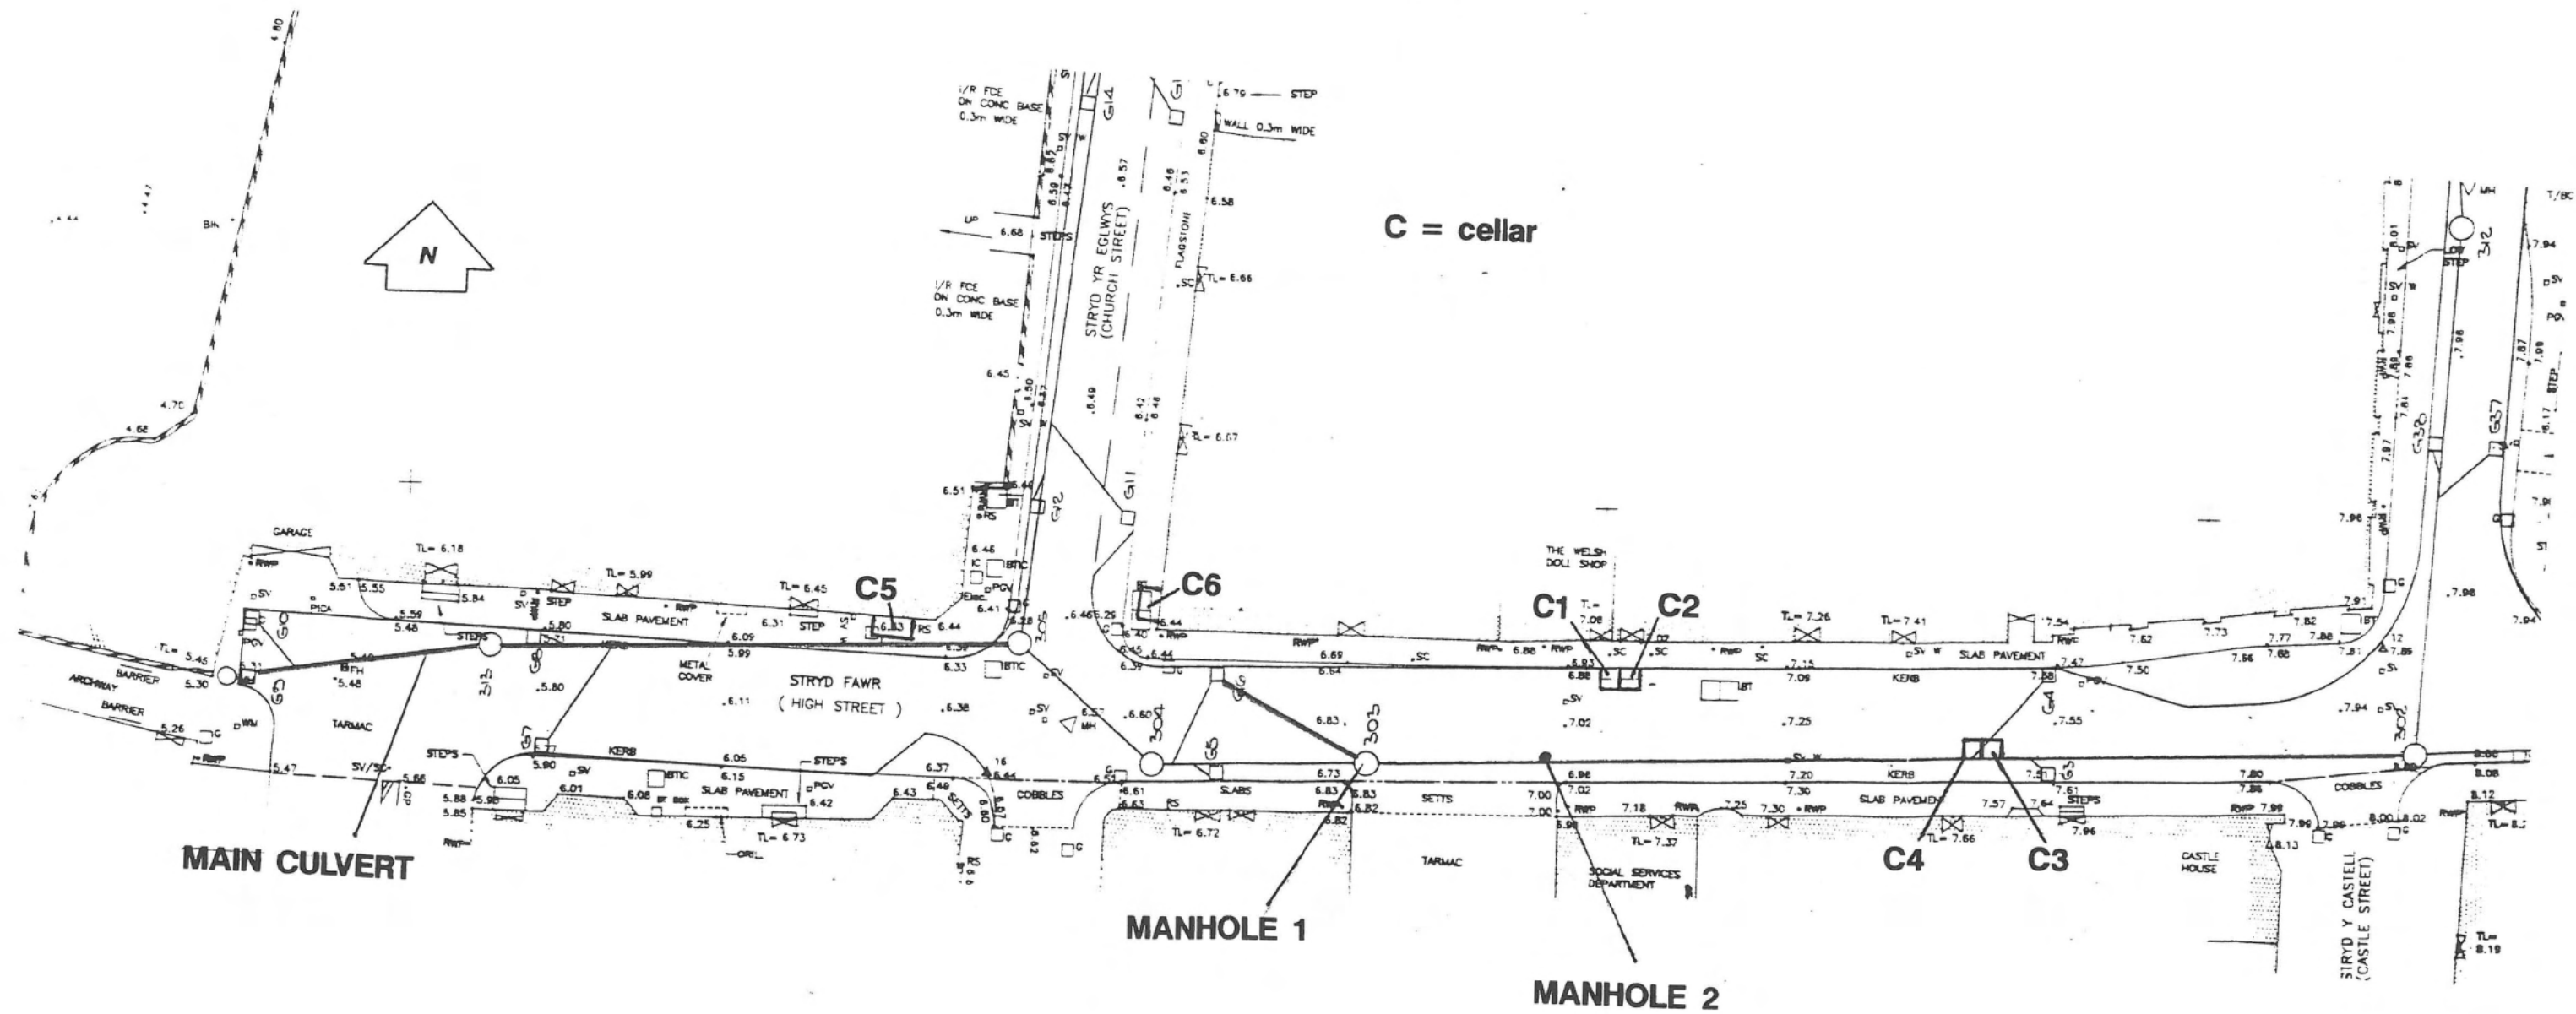
## FIG. 1

1. The excavation of manhole pits, 2. The excavation of the main culvert and connecting trenches, 3. The general removal of ground surfaces for the re-laying of all roads and pavements surfaces. This work took place between February 27th, 1995 to March 20th, 1995. The location of the main works are shown on figure 1.

This work also revealed the presence of five small cellars and the street entrance to another cellar (see figure 1). Cellars 1 and 2 were located adjacent to the northern pavement outside No.'s 7 and 9 High Street respectively. They were 1m wide and extended beneath the road by
