AFON GAIN, GANLLWYD, GWYNEDD  
ARCHAEOLOGICAL ASSESSMENT

G1439.05

REPORT 228 (DRAFT)

## HYDRO-ELECTRIC SCHEME

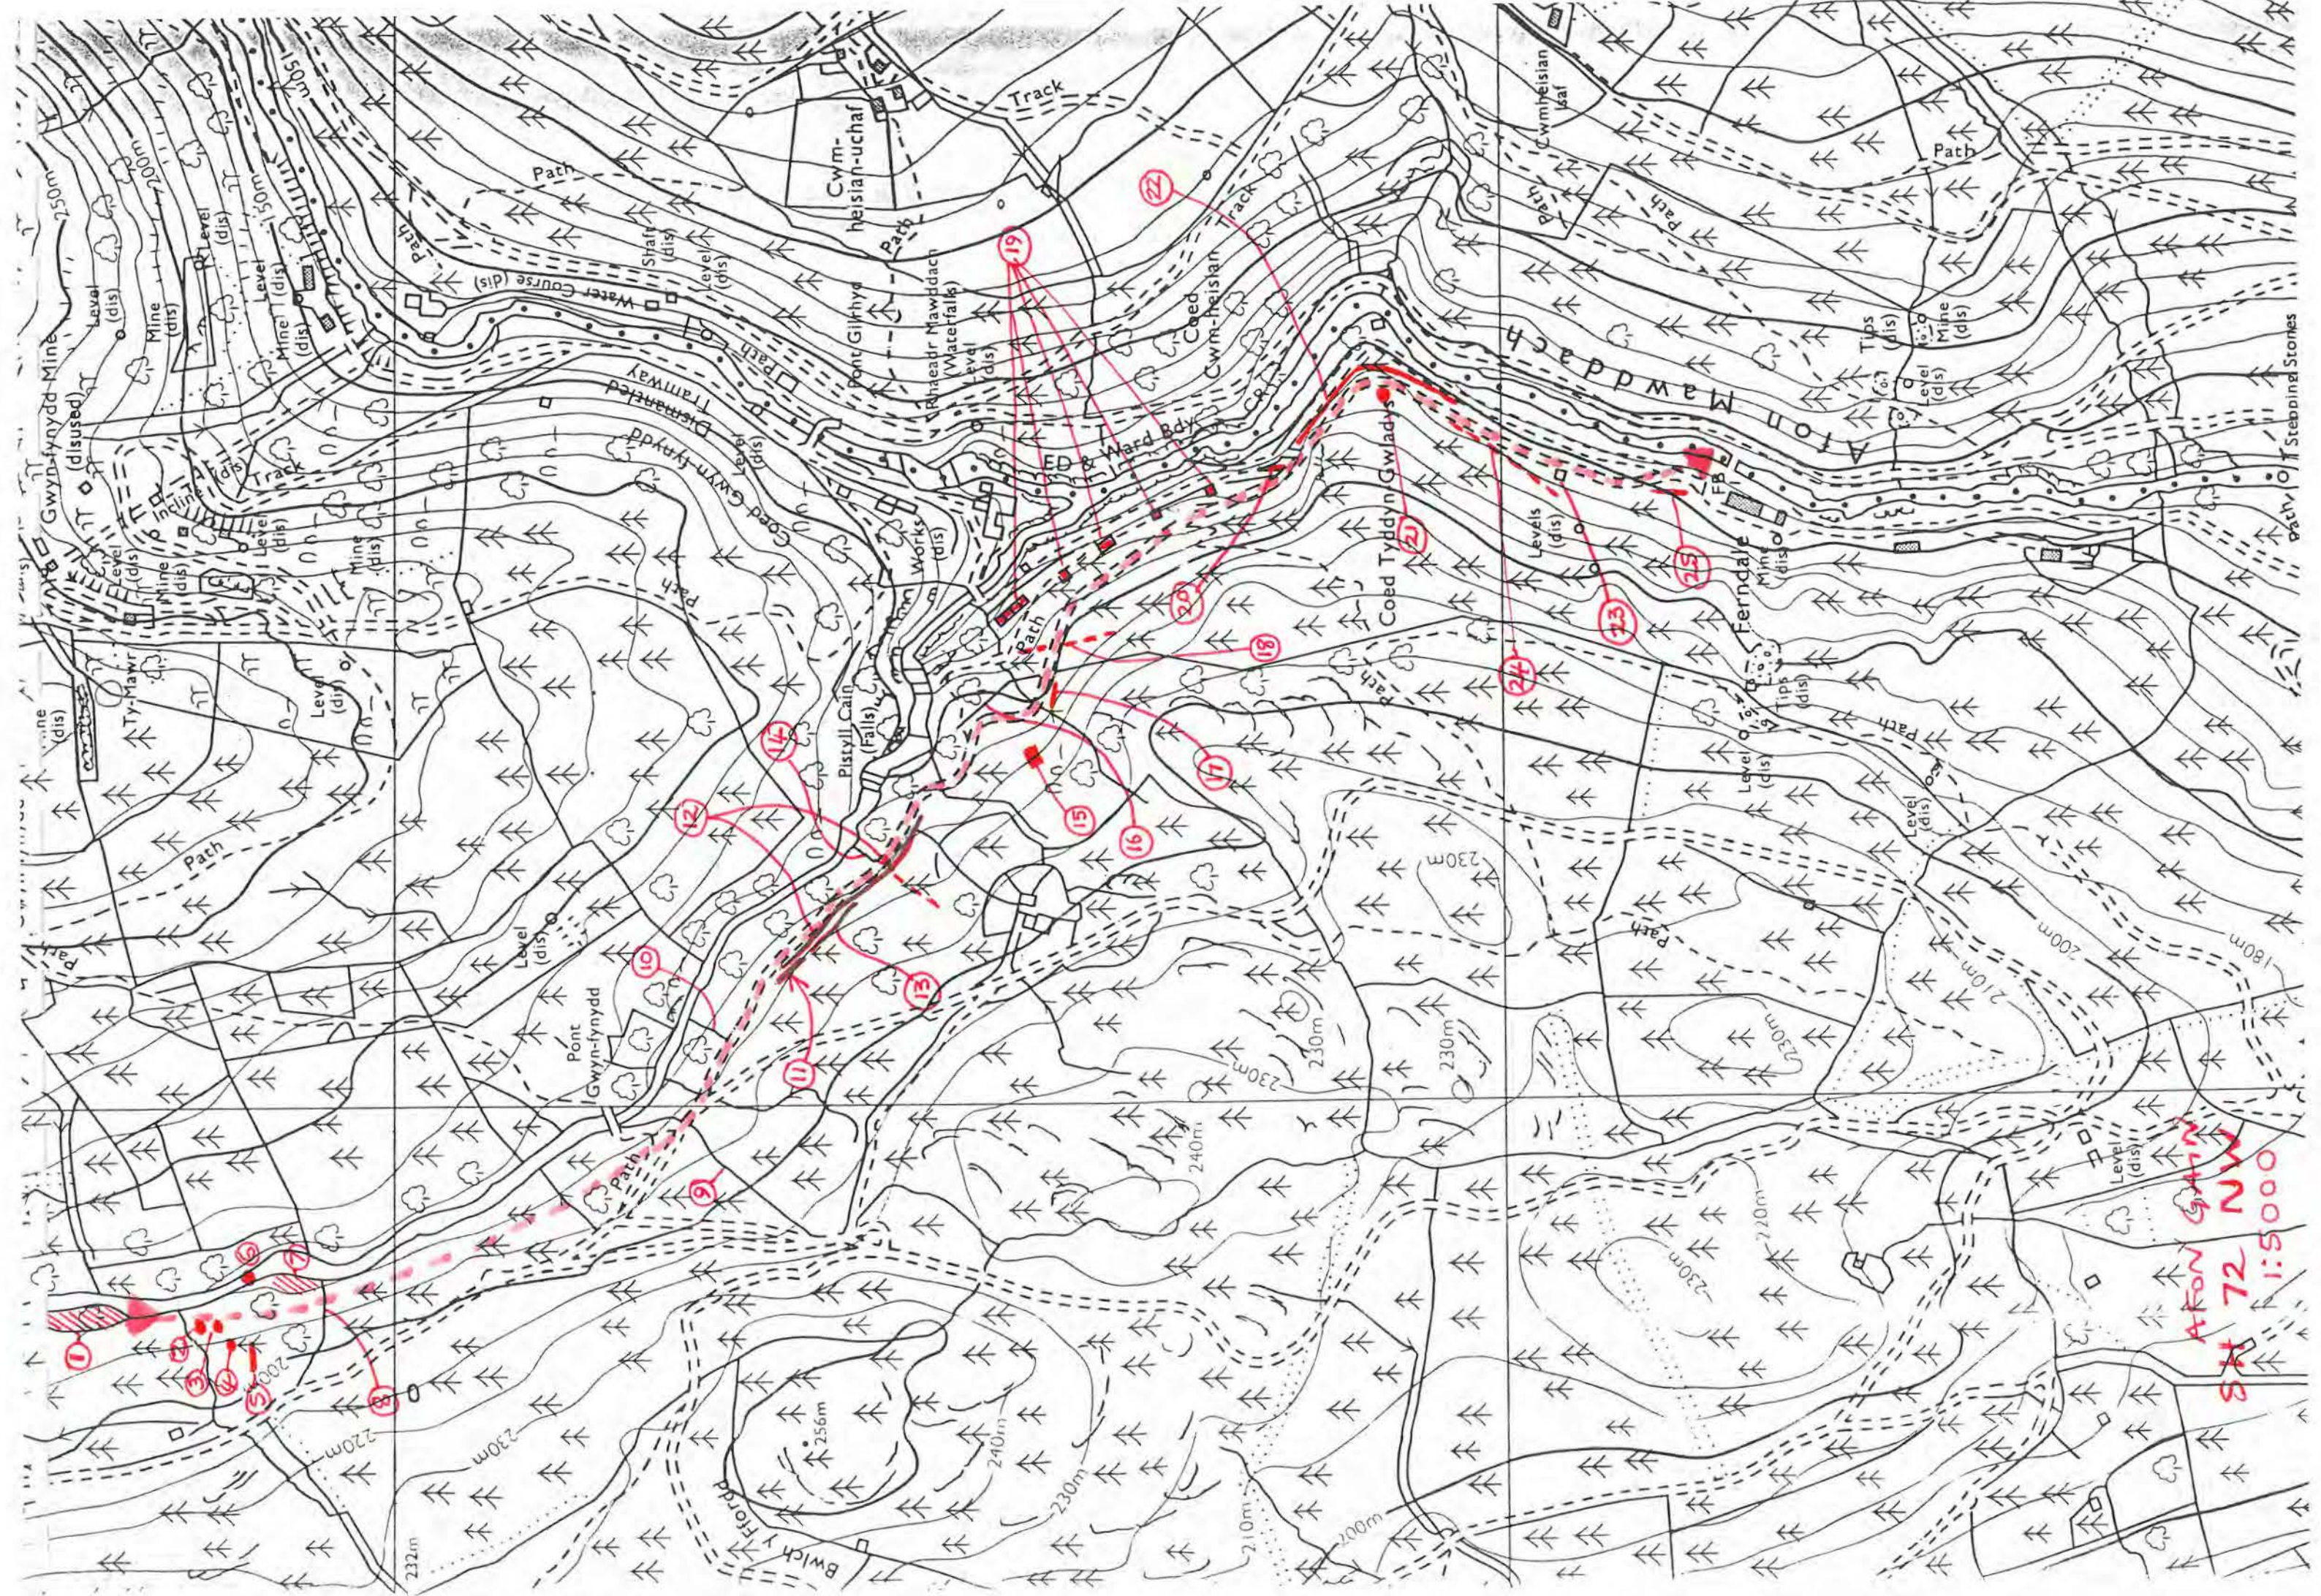
This includes the pipeline route and its immediate borders, within c. 50m on each side. All features of human activity are recorded except those deriving only from current land-use. Features are numbered in sequence from the northern, uphill end of the route downwards. The location of all the features is shown on the accompanying map (fig. 1).
