# Tudor Rose 15th and 16th century hall-house Castle Street, Beaumaris

GAT Project No. 000 prepared by David Longley for North West Wales Dendrochronology Project March 2010

This report is a record of the structural and decorative timber features at Tudor Rose, Castle Street Beaumaris and is intended to complement dendrochronological dating as part of the North West Wales Dendrochronology Project. The survey was made between 16th February and 11 March 2010.

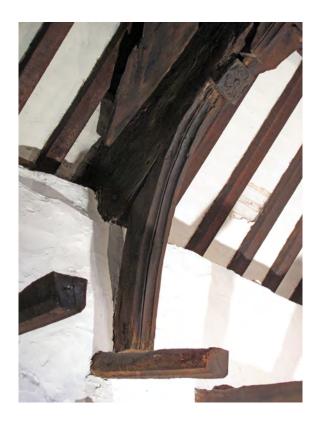
Truss 2 arched brace and first-floor joists, truncated

- The principals meet at the apex of the truss with a mortice and tenon joint and are pegged with two pegs.
- The collars are cranked beams and are supported by arched braces in the angle between the collar and principal, continuing onto the face of the walls. The braces are truncated at their base to accommodate the first floor, although, presumably, originally attached to wall posts.

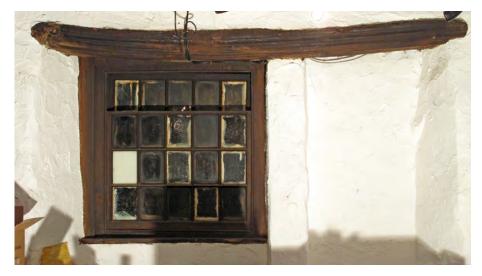
opening in west wall with elaborately decororated lintel

- The braces are attached to the collar and principles by pegged mortice and tenon joints at between six and eight pegs to the joint.
- There are openings in both the west and east walls on the ground floor which accommodate windows. Two wide, splayed, openings, facing each other in the central area of the hall may represent the doors of a cross-passage. Both openings are now blocked although a late, window in the west wall occupies a part of the original opening on the west side. The lintel over this opening carries a particularly elaborate moulding (see detail).

In the W. wall is an original window opening (now partly blocked) with a moulded wood lintel; the windows in the E. wall are modern.

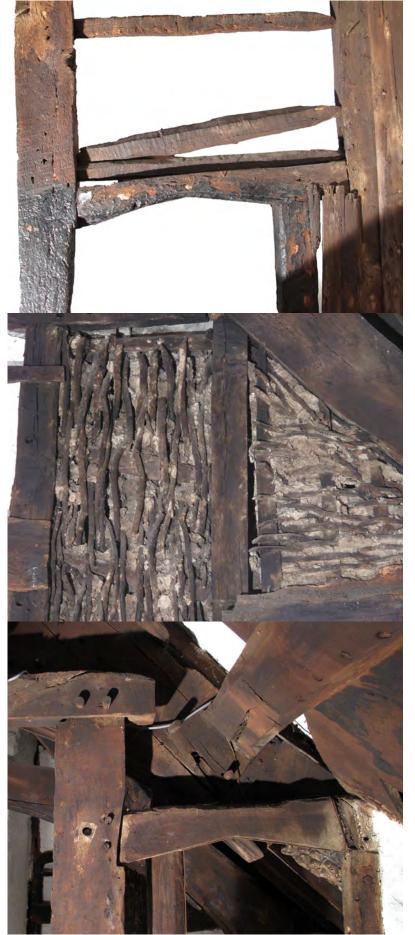
ground floor partition; false four-centred door head; staves for wattle and daub

gable truss partition; staves and wattle and daub

first floor partition; false four-centred door head and carpentry

- Following the provision of a first floor across the hall, a timber framed partition was installed almost immediately adjacent to the third truss. There are two doors, one towards the west wall and, a second, immediately up against the east wall. The panels were filled with wattle and daub. A comparable partition was installed on the ground floor less than a metre south of that on the first floor. There is a small door close to the west wall which may have provided access to a stair to the first floor. A second opening, adjacent, may have framed a second door which provided access between the hall and private rooms to the south. All of the doors where the heads survive are of false four-centred style. Good examples of staves with chisel and pointed ends survive in the ground floor partition, as well as grooved posts to take the chisel-end, and holes to take the points, around which the wattling is woven.

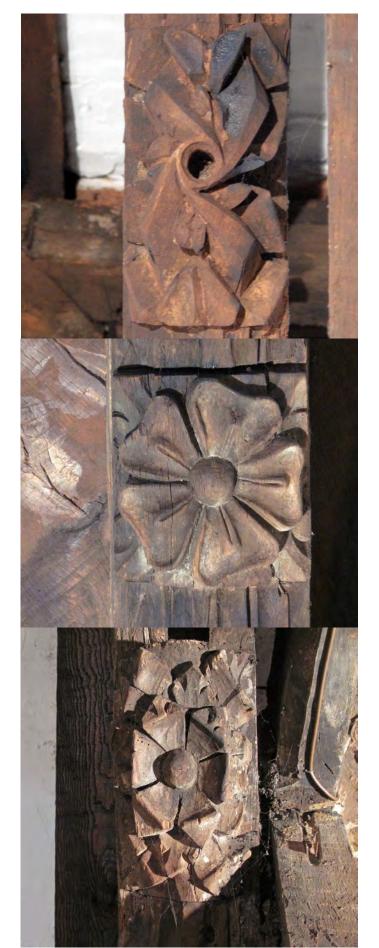
Truss 3: central foliate boss

Truss 2: west rose

Truss 3: east rose

- The two central trusses carry elaborate mouldings continuously from the wall brace to the underside of the collar, with the exception that foliage bosses have been included in the design at the base of the collar and at the junction of the two arched braces where they meet the principals (see details).

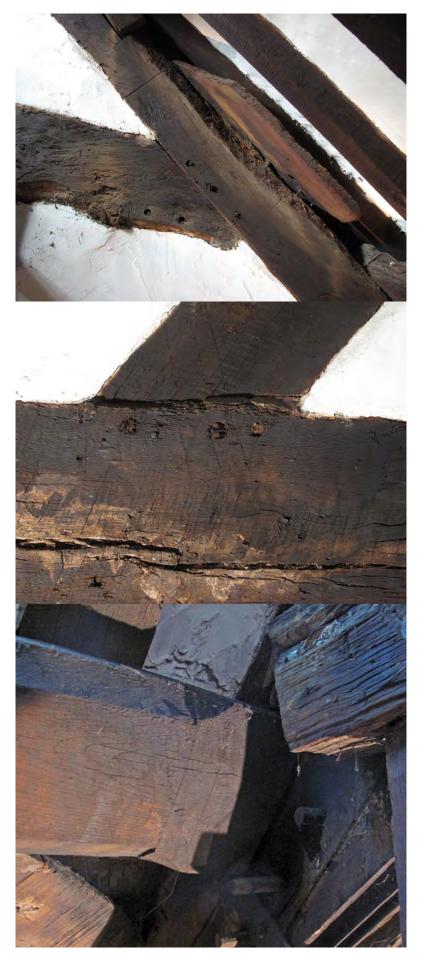
Truss 4: carpenter's marks on principal

wing truss 4: carpenter's marks on tie-beam and strut

chamfered purlin at truss 3: carpenter's marks
