**BRECON AND  
MONMOUTHSHIRE CANAL  
MONUMENTS RECORD CARD**

**Monument Number:  
MB 162  
LLANOVER**

Monument Name: Overflow between Bridges 82 and 83

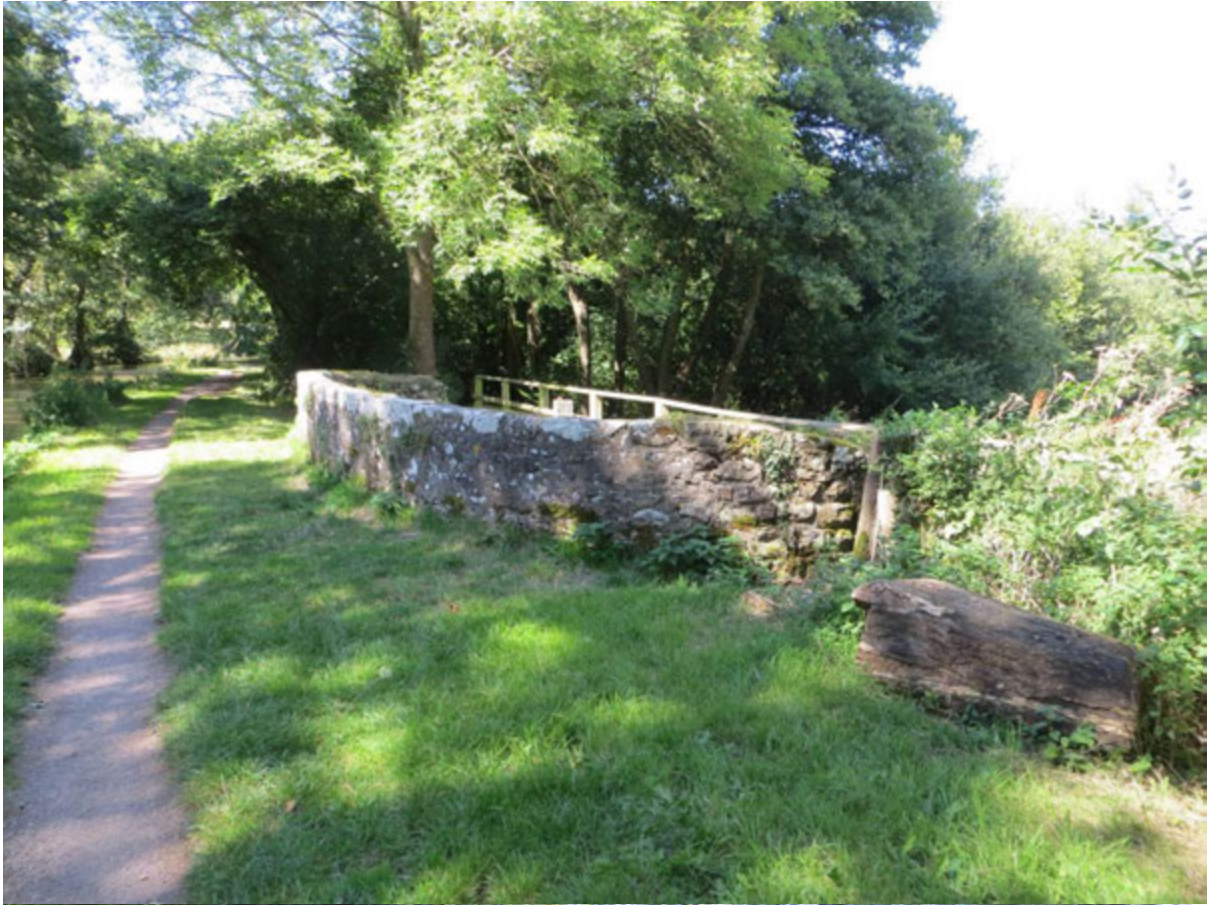
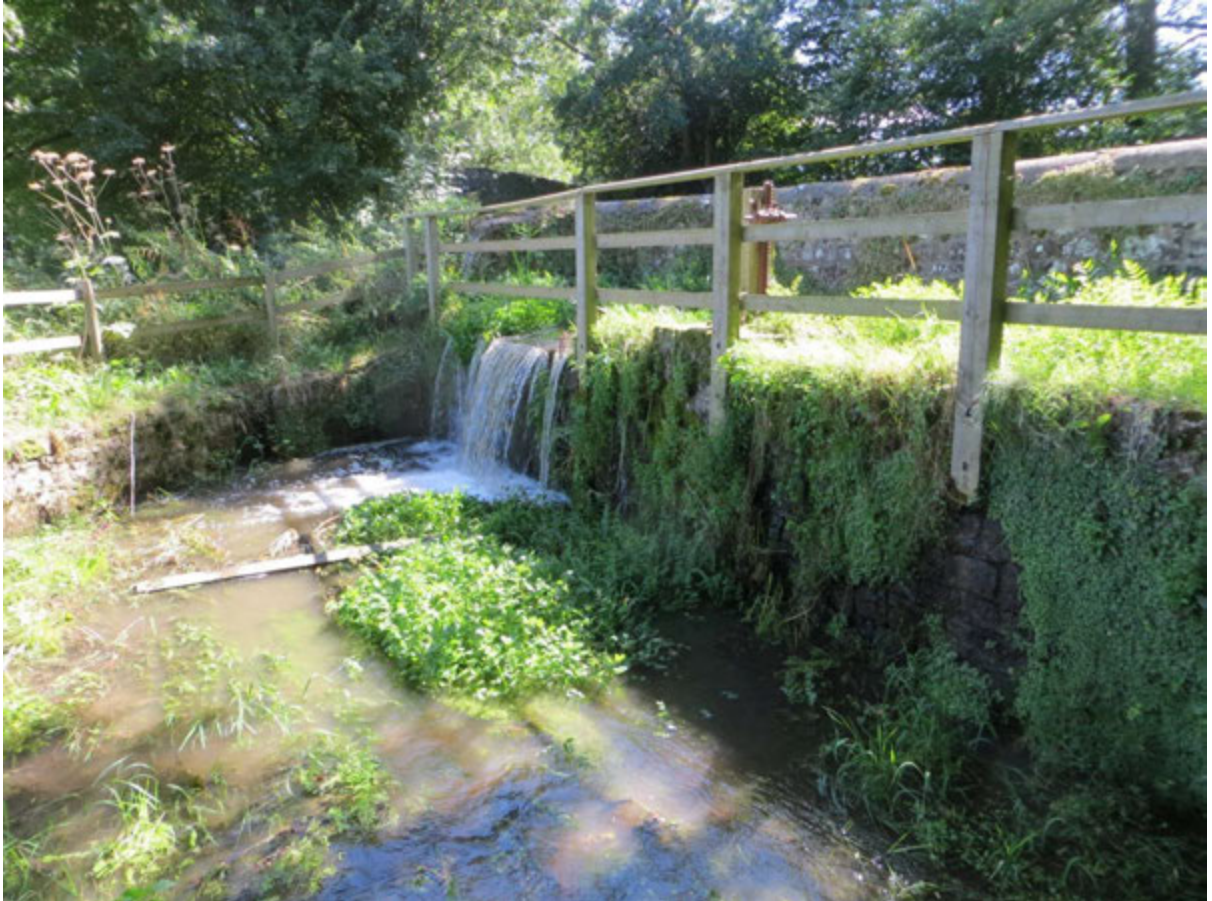
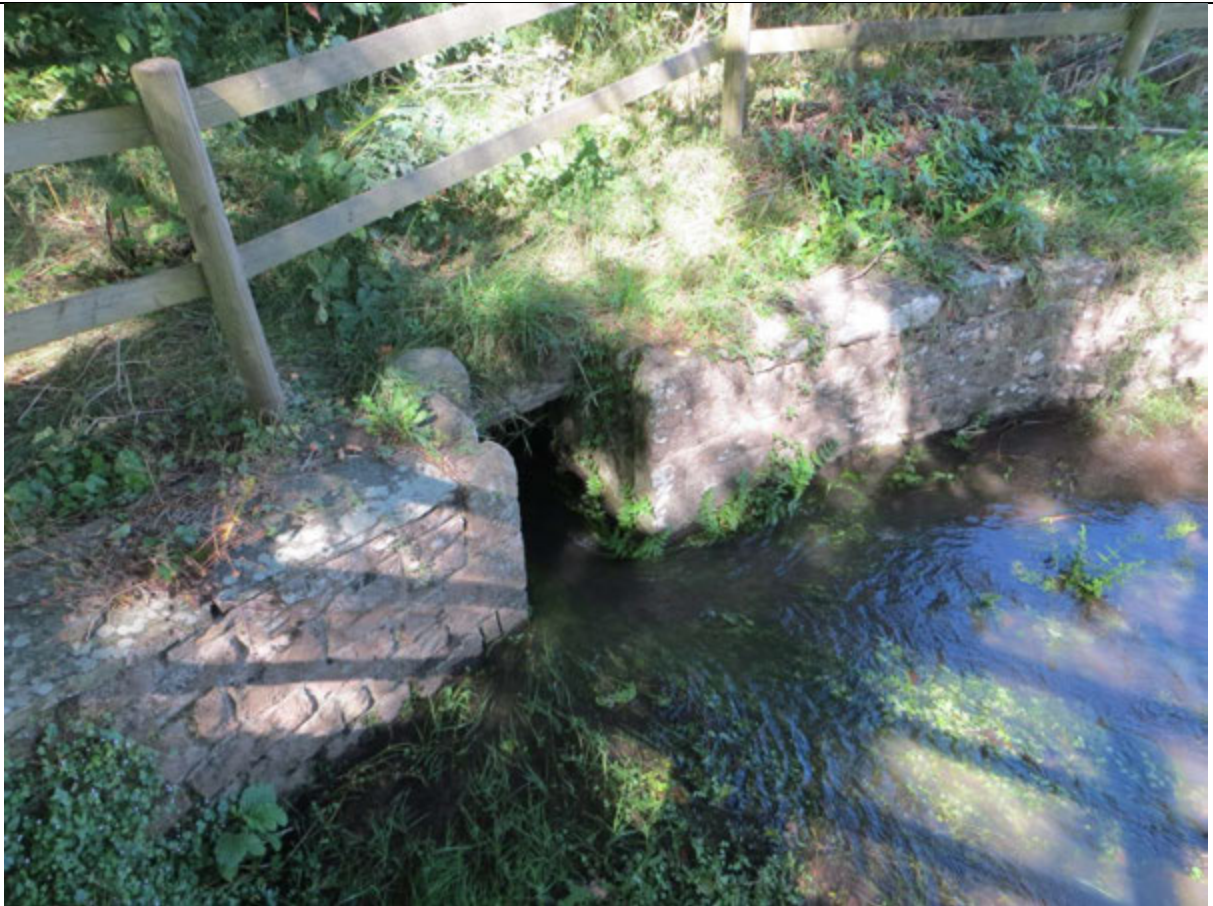
Images:

Exterior Constructed of local sandstone rubble. The overflow is in the form of a D-shaped pond backing onto the towpath. There is a low curved wall about 1m high onto the towpath and this protects a drop the walling of which contains the sluices. Low wing wall beyond surrounding the paved pond.

Condition: Good.

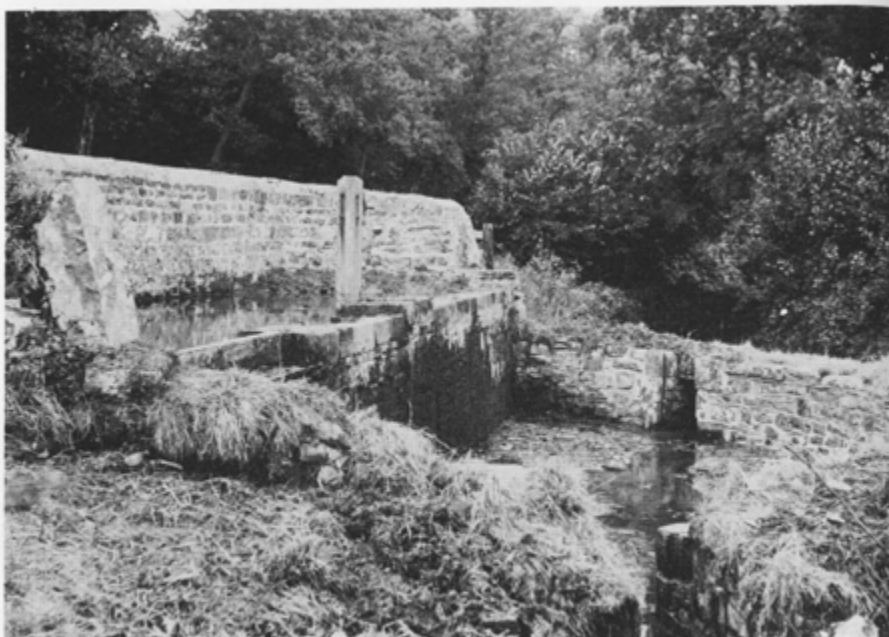
Stevens' Picture

**Plate 31** Overflow weir and drain sluice north of bridge 82. The towing path is beyond the wall and the water in the upper pond is at canal level. It is connected to the canal by a culvert under the path. Water passing over the weir or through the drain sluice leaves the lower pond via culverts in the background and foreground.
