## BRITISH WATERWAYS ARCHITECTURAL HERITAGE SURVEY

A	BW Region	M+SW	PRN	162
	Waterway	M+BC	OS Sheet	
	BW Struc No		NGR	
	Side	<input checked="" type="radio"/> TOW <input type="radio"/> OFF <input type="radio"/> CEN <input type="radio"/> OTH	Photo Neg No	12/3+4
	BW Owned	<input checked="" type="radio"/> Y <input type="radio"/> U/K <input type="radio"/> N	MMS/PMS	
B	County	GWENT	Alt Address	
	LA District	Mounmouth Torfaen		
	Parish			
	Address	SLUICE INTO POND AT.		NE OF BR. 82
C	Date Listed		SAM No	
	Grade	<input type="radio"/> I <input type="radio"/> II* <input type="radio"/> II	Protected Area	<input checked="" type="radio"/> NP <input type="radio"/> AONB <input type="radio"/> CA <input type="radio"/> SSSI
	Serial No		Structures in Item	
D	Design Integ	A <input type="radio"/> <input checked="" type="radio"/> B <input type="radio"/> C <input type="radio"/> D	Context	VIL <input type="radio"/> URB <input type="radio"/> ISO <input checked="" type="radio"/> GRO

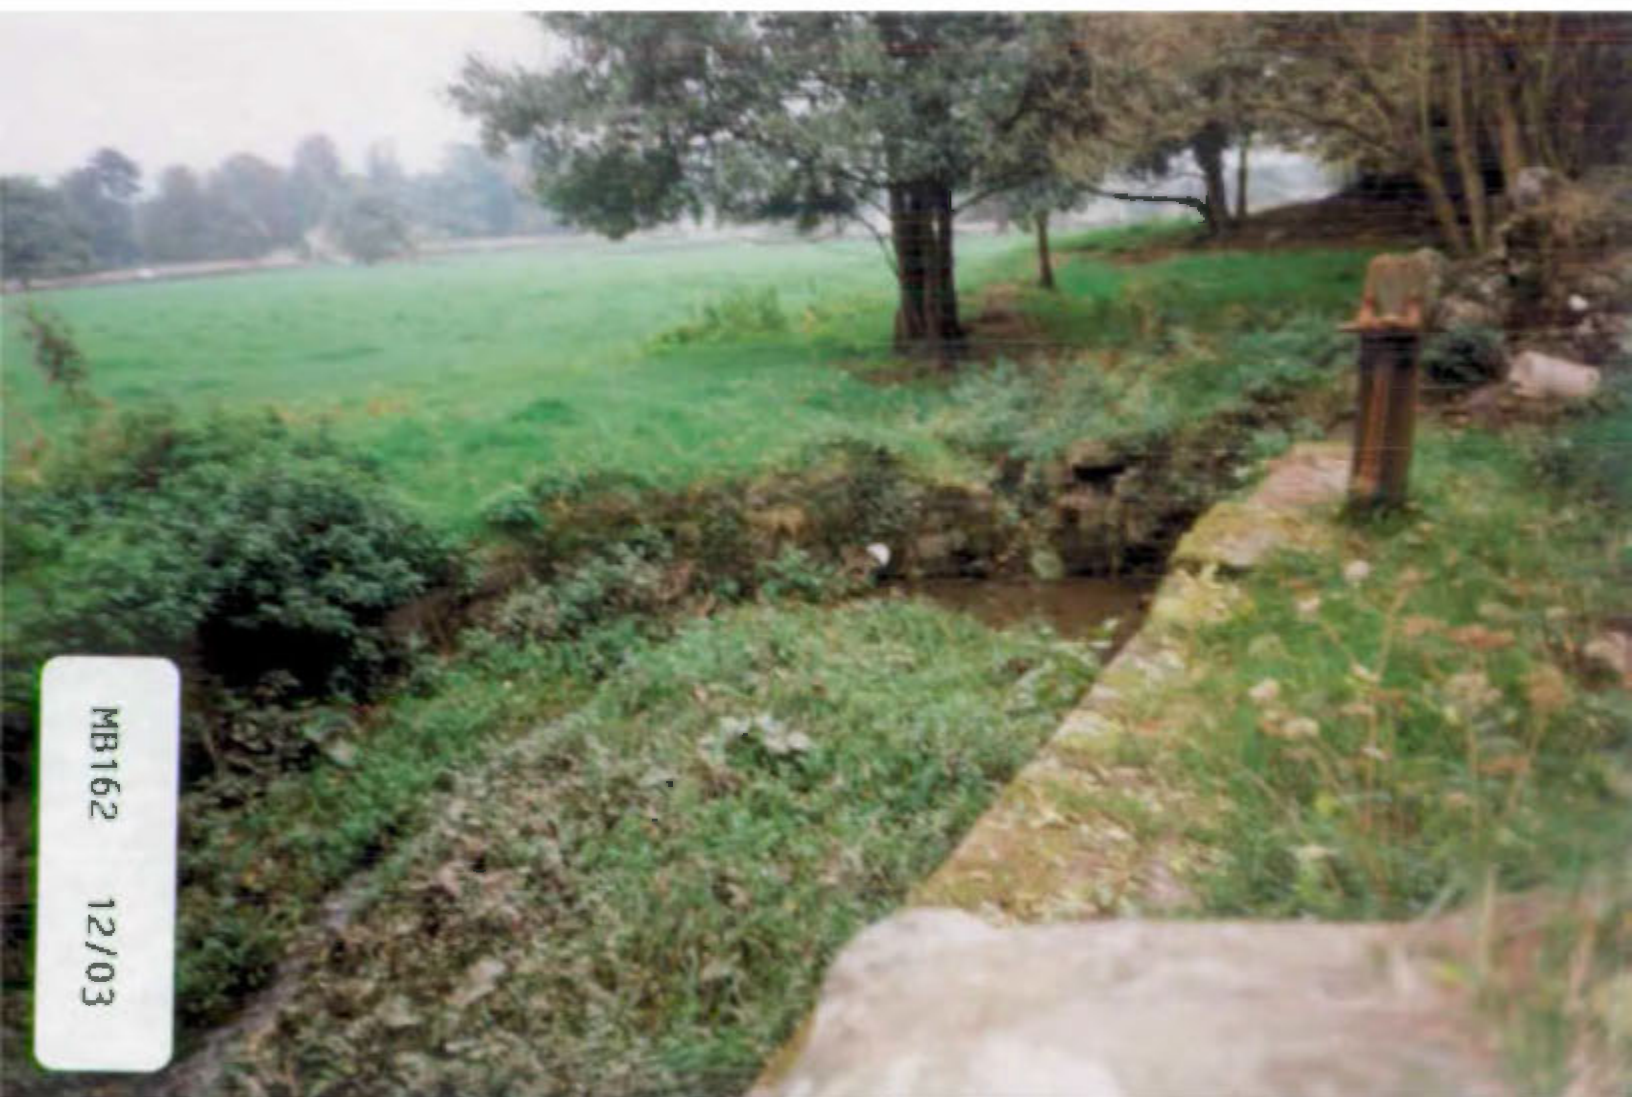
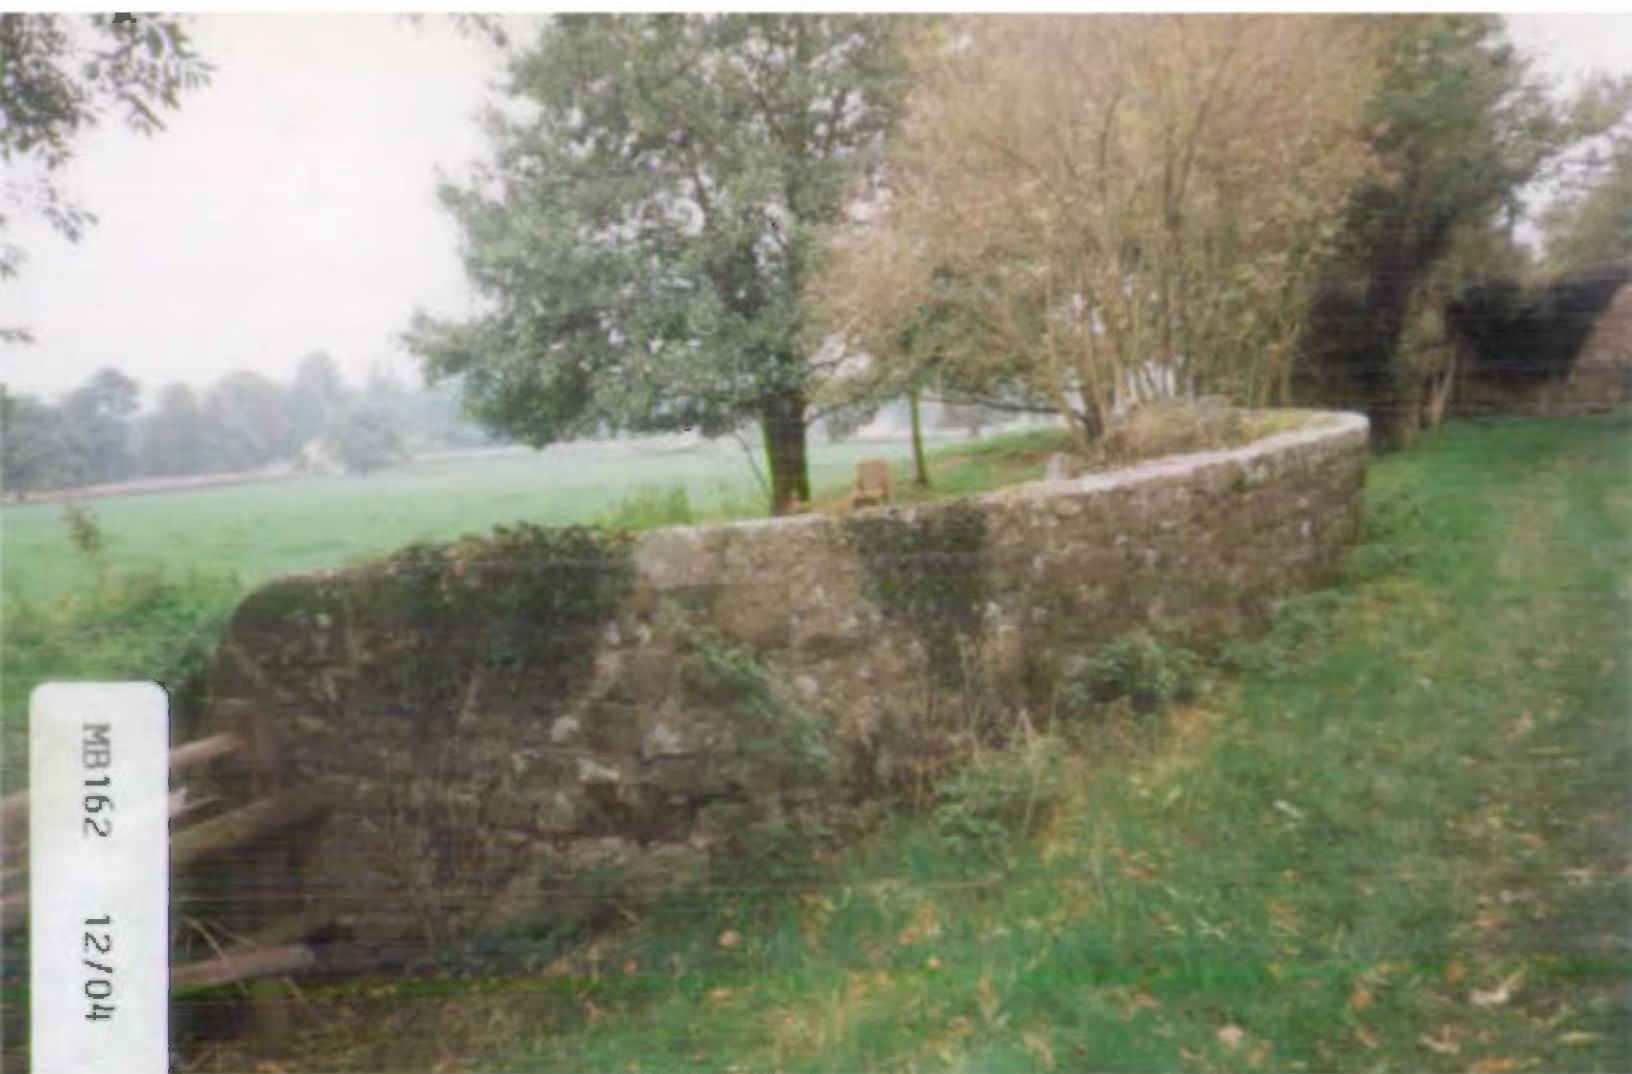
MB162 12/04

Overflow wier and drainage pond. C19 with C20 renewal. Coursed rubble stone pond walls and curved retaining wall. Pond with concrete and wooden weir across diameter. Steel paddle allows water to overflow from the canal via a culvert, and the pond drains in turn through another culvert into a nearby stream.
