BRITISH WATERWAYS ARCHITECTURAL HERITAGE SURVEY

A BW Region M + SW PRN 208

Address BR NO 52, ~~ADJACENT~~ AT PONTYMOILE JUNCTION

E Building Type ROVING BRIDGE

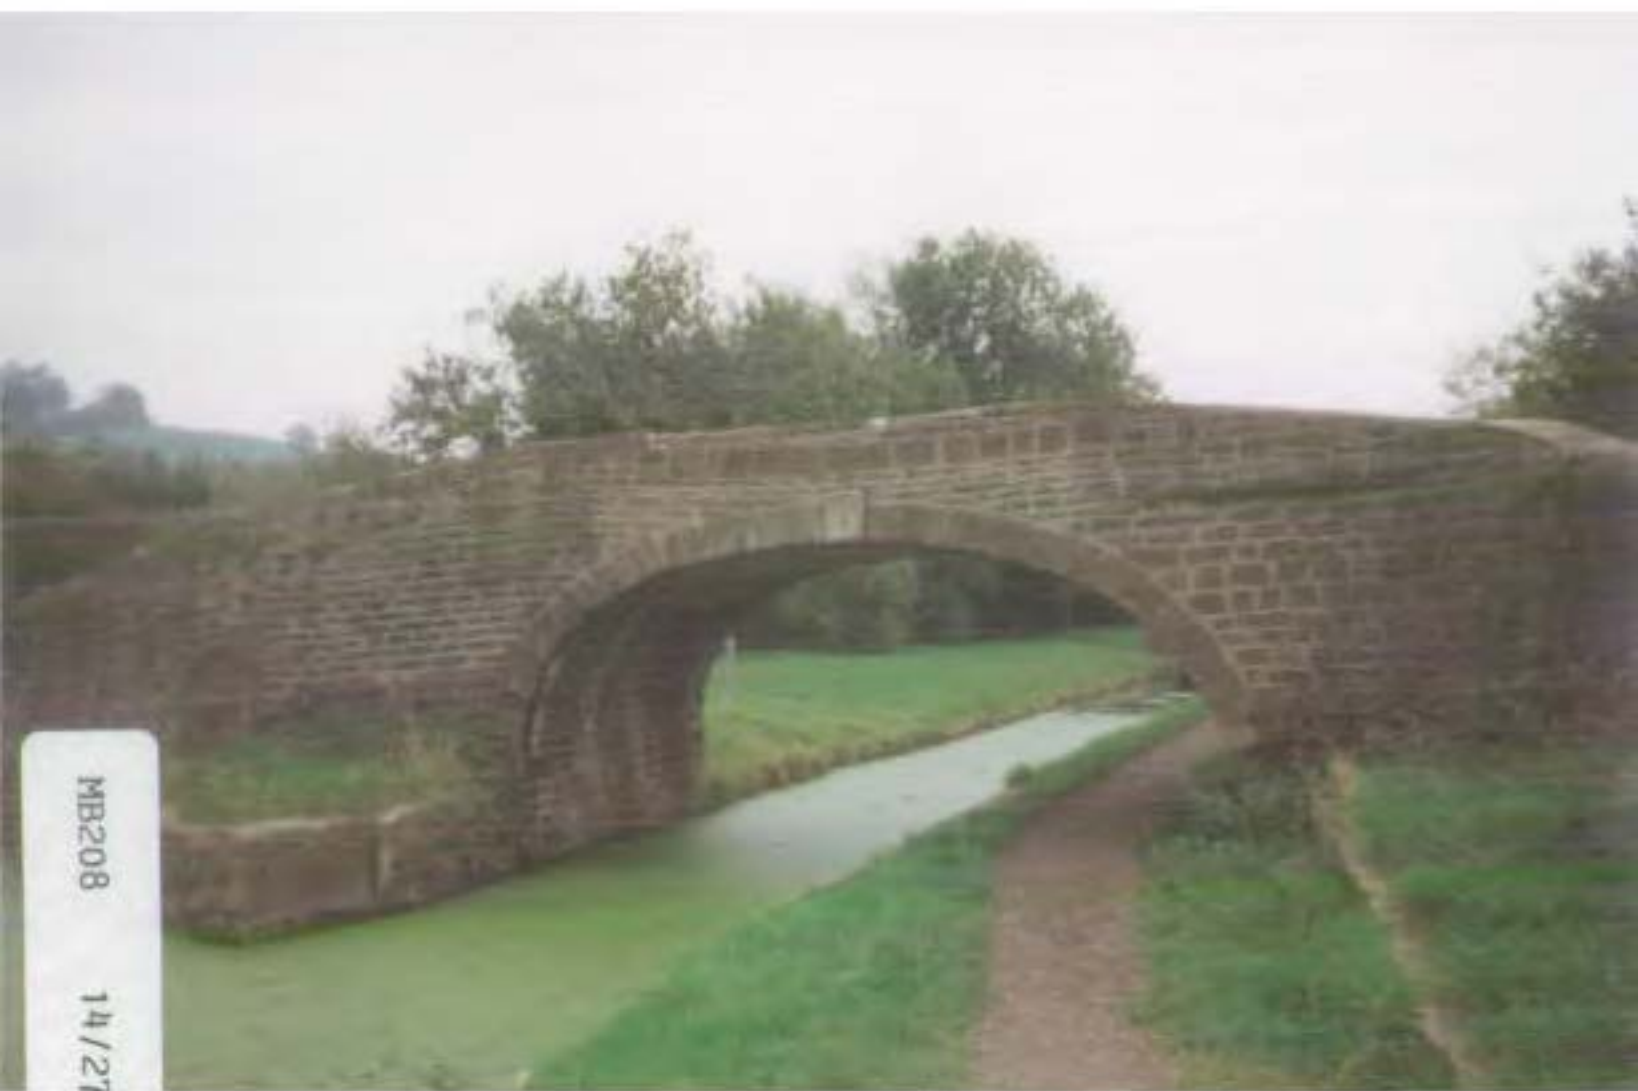
14/27

Roving bridge. c1810 with C20 rebuilding. William Crossley engineer. Coursed dressed sandstone, heavily jointed with mortar. Elliptical arch with dressed stone voussoirs and prominent keystones. Rebuilding to crown of parapet, and also to northern wingwalls, where terminating piers have been removed and walls extended. Southern facade has also been rebuilt, but retains square terminating piers. Flat stone copings to both elevations. Bridge situated at the junction of the former Brecknock and Abergavenny canal which continued to Pontypool, but no longer exists, and the main line of canal which continues to Newport, although un-navigable.
