BRITISH WATERWAYS ARCHITECTURAL HERITAGE SURVEY

A	BW Region	M + SW	PRN	174
	Waterway	M + BC	OS Sheet	
	BW Struc No	BR NO 75	NGR	
	Side	TOW OFF <u>CEN</u> OTH	Photo Neg No	12 127 - 29
	BW Owned	<u>Y</u> U/K — N	MMS/PMS	
B	County	GWENT	Alt Address	
	LA District	Minmouth Torfaen		
	Parish			
	Address	BR NO 75, JENKIN ROSSER'S BRIDGE		
C	Date Listed		SAM No	
	Grade	I II* II	Protected Area	<u>NP</u> AONB CA SSSI
	Serial No		Structures in Item	
D	Design Integ	A <u>B</u> C D	Context	VIL URB <u>ISO</u> GRO
	Setting	A <u>B</u> C D	Condition	A <u>B</u> C D
	Group Value	Y <u>N</u>	Present Use	TRACK/FOOTPATH BR
	Listable	<u>Y</u> <u>N</u>		
E	Building Type	ACCOMMODATION BRIDGE		
	Date	1) 1812 2) 3) 1919 + 1920 RENEWAL		
	Designer(s)	WILLIAM CROSSLEY		
	Materials	BR <u>ST</u> EBR CO IR ME WD		
		TI SL CTI CER AS OTH		
	S Features/ Tech Merit			
	Date Inspected	18 10 95

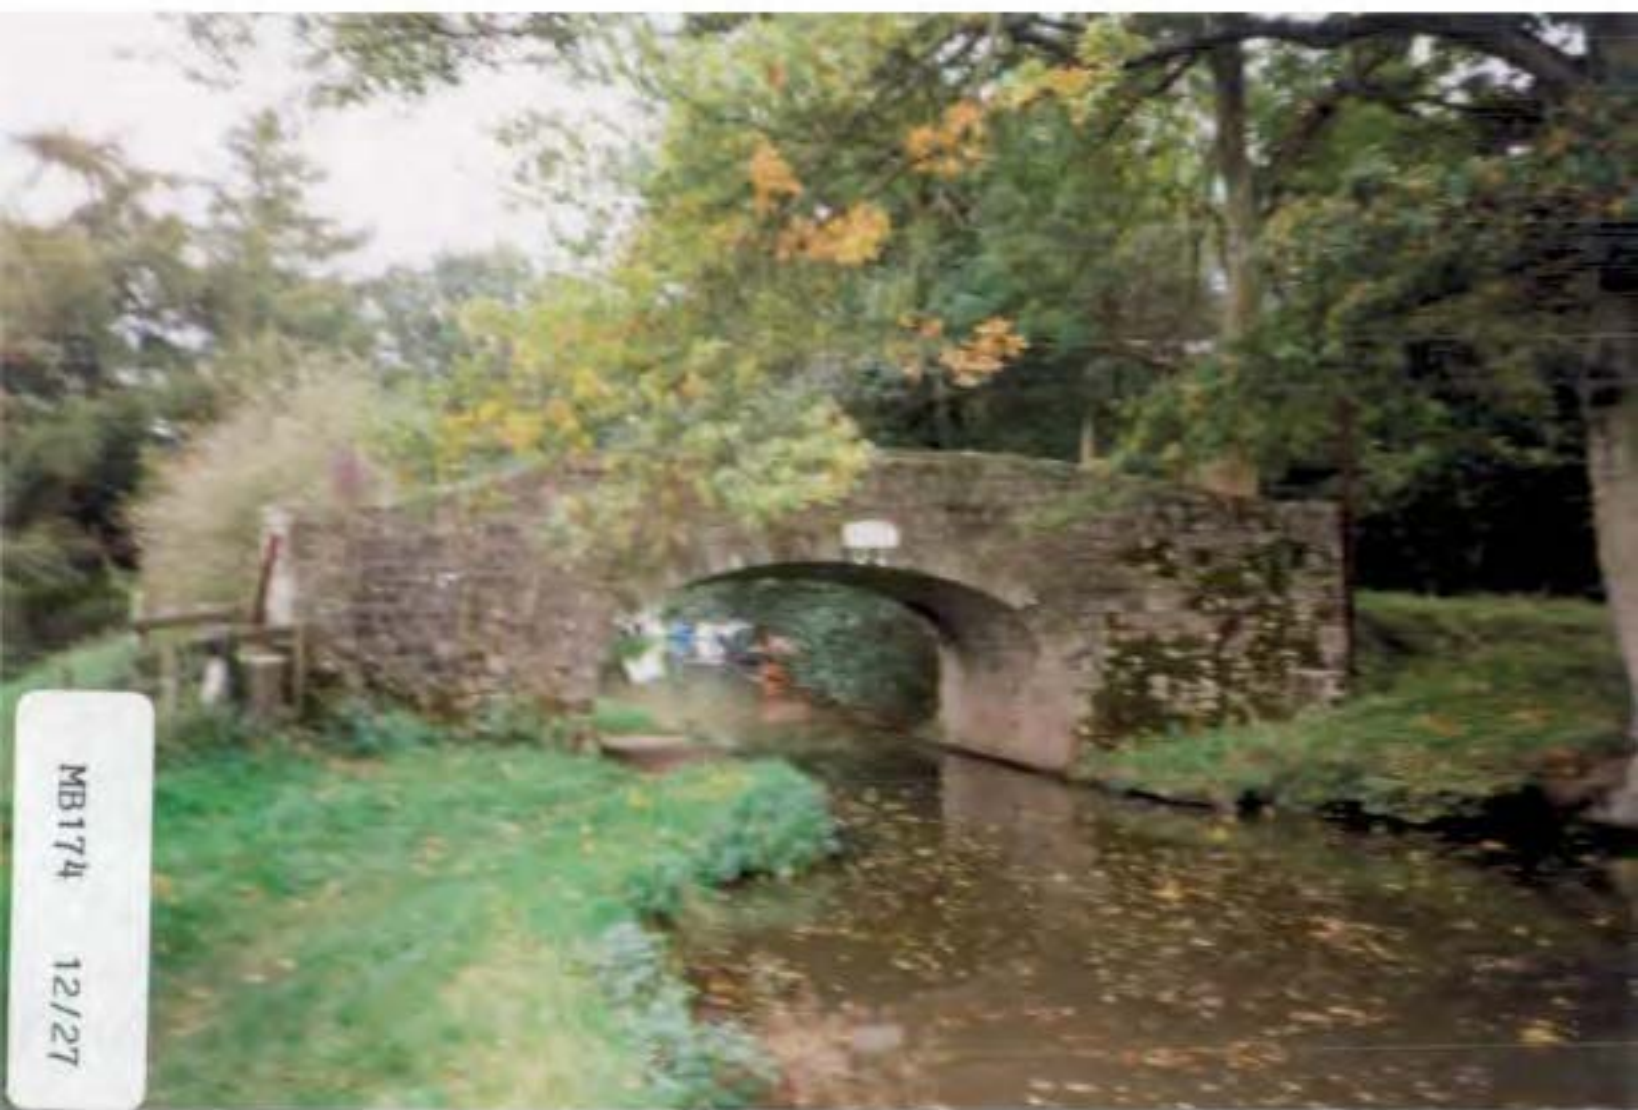
Accommodation bridge. c1812 with C20 rebuilding. William Crossley engineer. Coursed rubble sandstone. Elliptical arch with dressed stone voussoirs, replaced in places and prominent keystones. Hump-backed parapet mostly rebuilt, with uneven courses and heavy mortar jointing. Slightly protruding terminating piers. Flat and rubble stone copings. Slab stone stile with LC20 stone steps to the north.
