BRITISH WATERWAYS ARCHITECTURAL HERITAGE SURVEY

Address ~~CROES Y PANT BR~~, NO. 66 BROOK FARM BRIDGE

E Building Type ~~PUBLIC ROAD BRIDGE~~ ACCOMMODATION BR

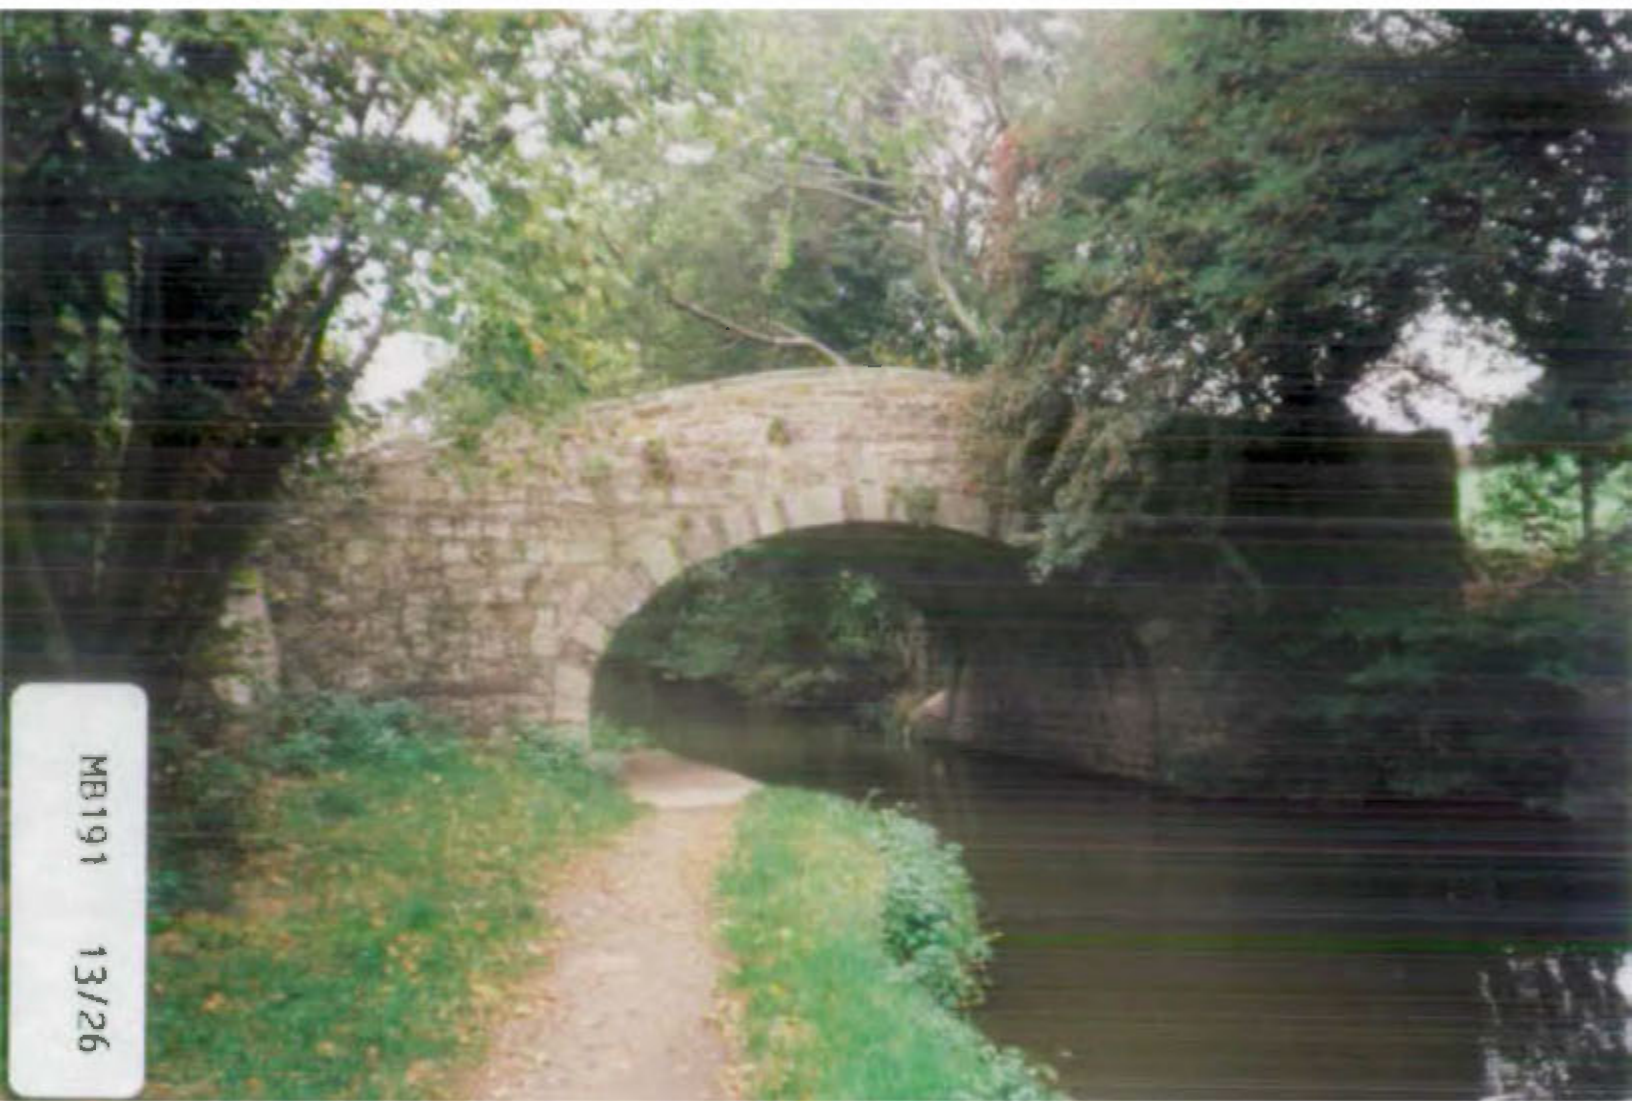
MB191 13/26

Accommodation bridge. c1812 with C20 rebuilding. William Crossley engineer. Coursed rubble sandstone. Elliptical arch with dressed stone voussoirs and prominent keystones. Hump-backed parapet has been rebuilt and has flat copings, mostly replaced. Slightly protruding rebuilt terminating piers. Stone slab stile on towside set in LC20 stone frame.
