| | BRITISH WATERWAYS ARCHITECTURAL HERITAGE SURVEY MB | | | | | | | |
| | Address | BR NO. 56 | , SQVIRES | BRIDGE. | | | • | |
| E | Building Type | Accomm | OVATION 1 | BRIDGE | | | | |

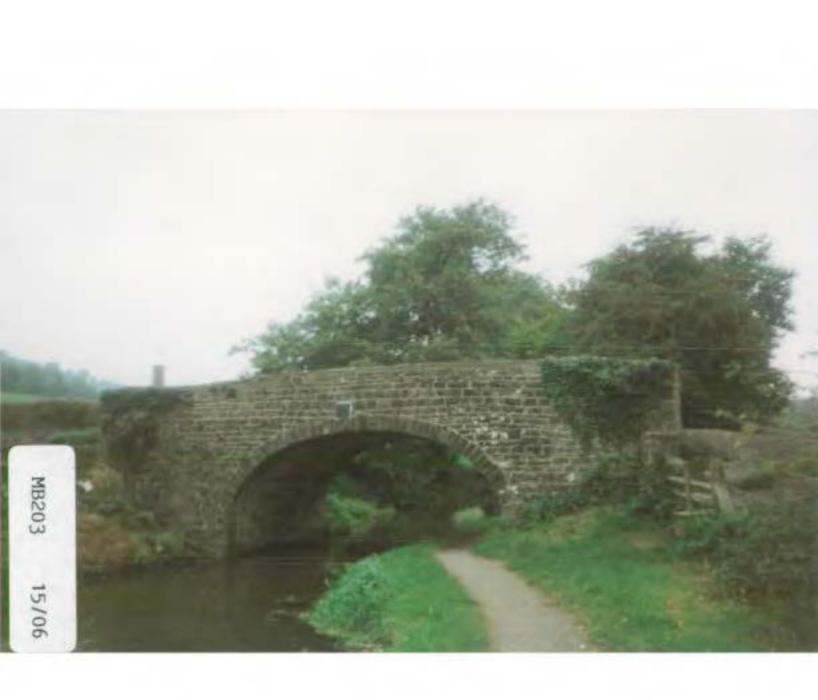
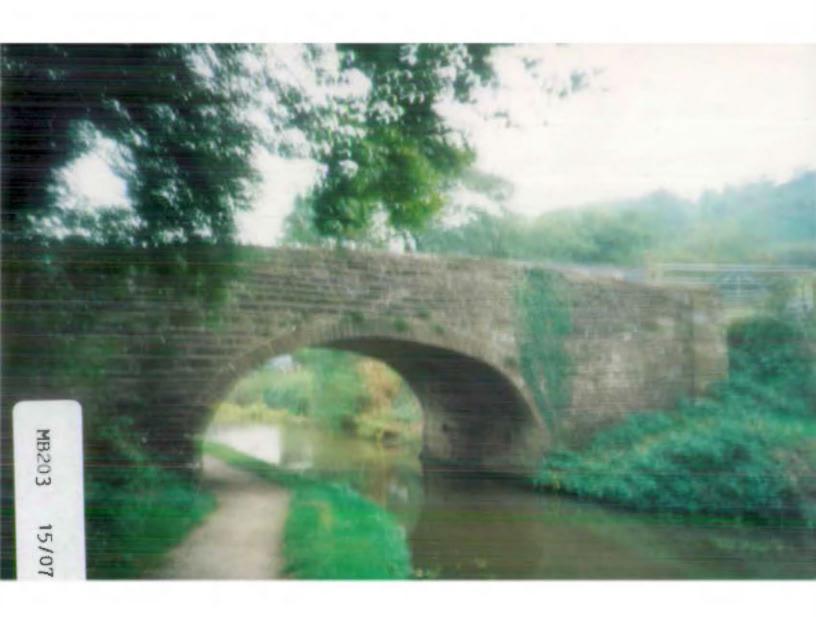
Accommodation bridge. c1812 with C20 rebuilding. William Crossley engineer. Coursed rubble sandstone. Elliptical arch with dressed stone voussoirs and prominent keystones. Both elevations have been rebuilt, with heavy mortar jointing. Flat copings to parapet. Slightly protruding square terminating piers.
