BRITISH WATERWAYS ARCHITECTURAL HERITAGE SURVEY

A	BW Region	M+SJ	PRN	122
	Waterway	M+B	OS Sheet	
	BW Struc No	Br 102	NGR	
	Side	TOW OFF <input checked="" type="radio"/> CEN OTH	Photo Neg No	06/34,35,36
	BW Owned	<input checked="" type="radio"/> Y U/K N	MMS/PMS

E	Building Type	Road bridge + stile		
	Date	1)	2) 1800-1805	3)
	Designer(s)	Thomas Dadford		
	Materials	BR <input checked="" type="radio"/> ST EBR CO IR ME WD		
		TI SL CTI CER AS OTH		
	S Features/ Tech Merit	Iron rib reinforcement to underside of arch		
	Date Inspected	22	06	95

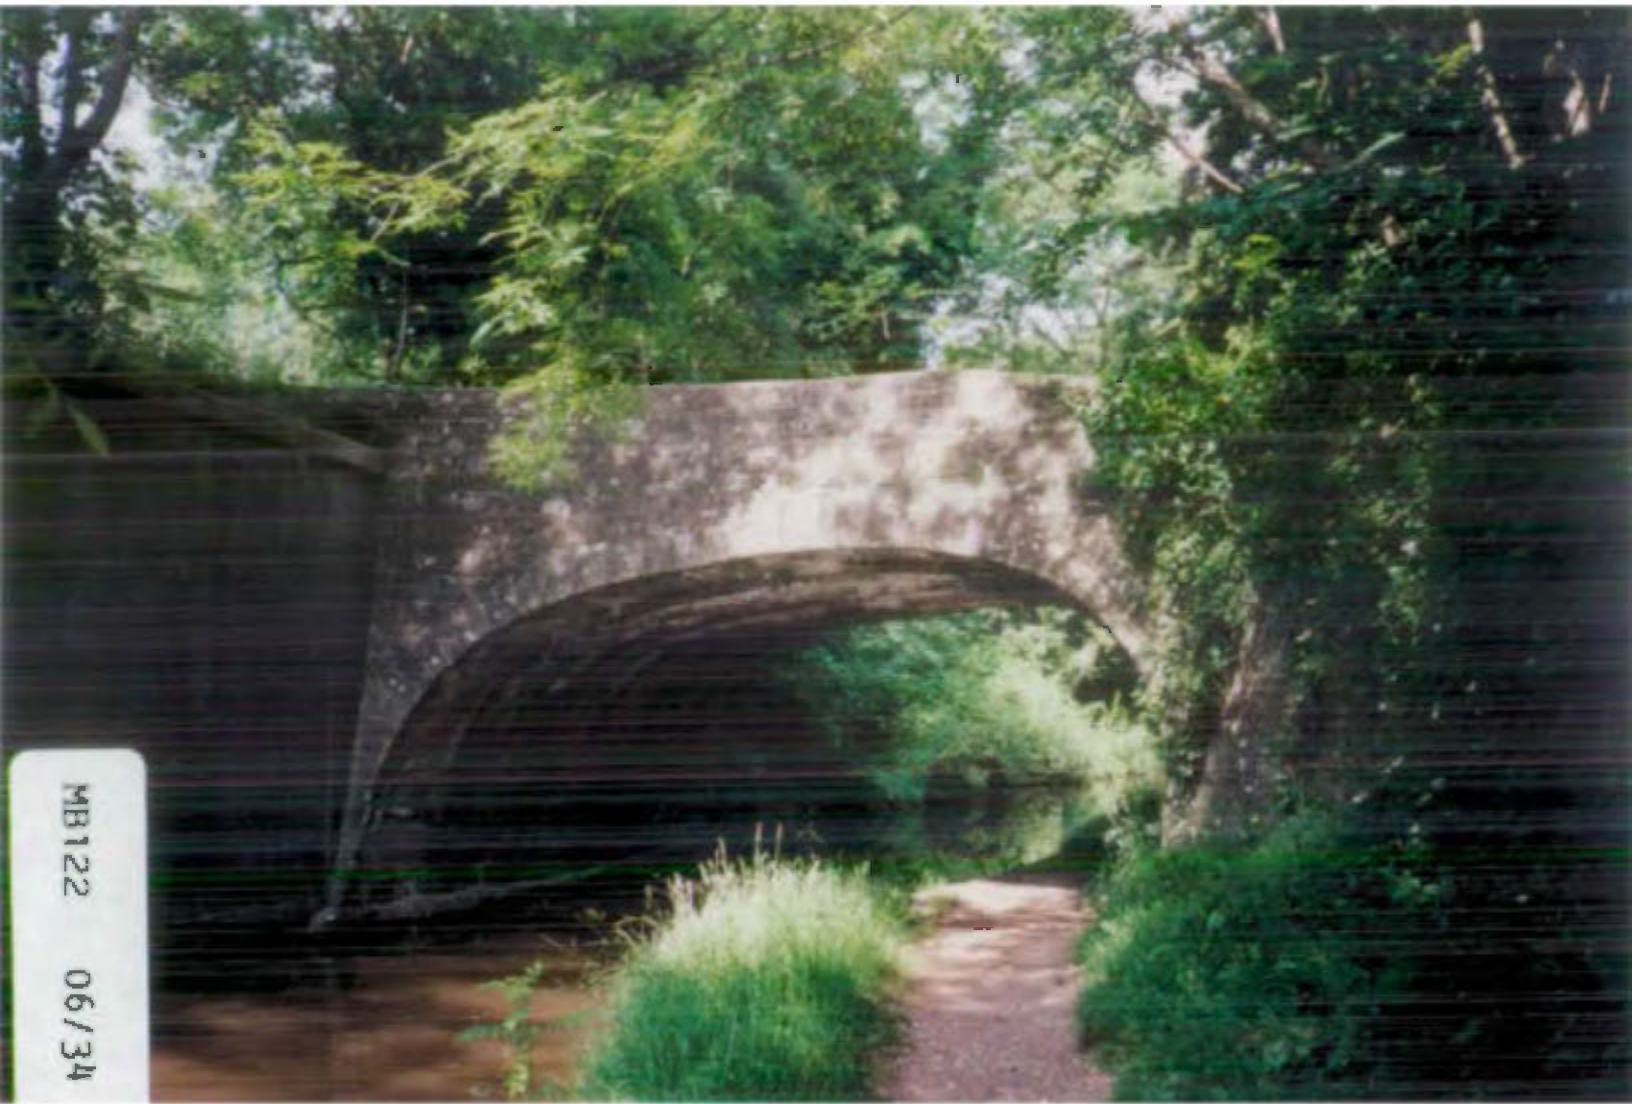
06/34

Road bridge (now footbridge). 1800-1805. Red sandstone rough
ribbed arch (deformed) bridge. Iron ribs ~~on~~ surface
fixed to underside of arch for reinforcement.
