## BRITISH WATERWAYS ARCHITECTURAL HERITAGE SURVEY

B	County	GWENT	Alt Address	
	LA District	Mammoth Torfaen		
	Parish			
	Address	ELM COTTAGE, ADJACENT WEST SIDE BR 65, MAMMILAD

E	Building Type	CANAL COTTAGE								
	Date	1)		2)		3)	LC19			
	Designer(s)									
	Materials	<input checked="" type="radio"/> BR	<input checked="" type="radio"/> ST	EBR	CO	IR	ME	<input checked="" type="radio"/> WD		
		<input checked="" type="radio"/> TI	SL	CTI	CER	AS	OTH			
	S Features/ Tech Merit									
	Date Inspected	18	10	95

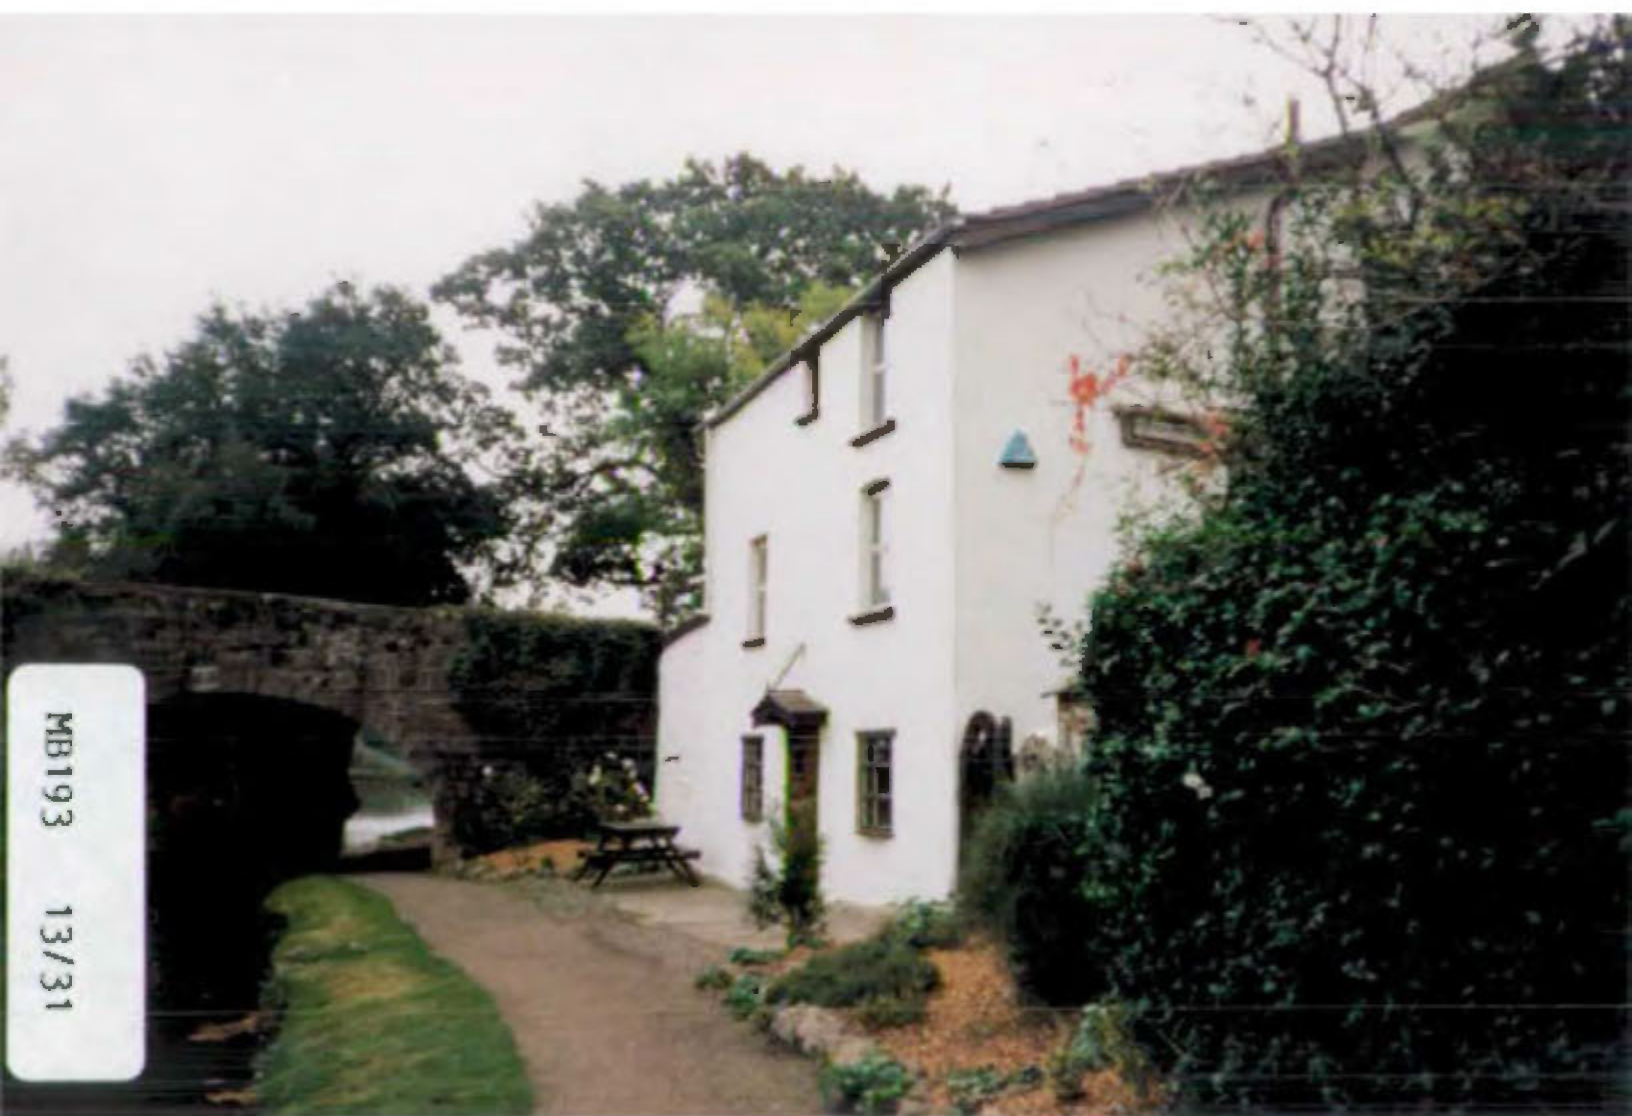
MB193 13/31

Canal cottage. LC19. Brick, rendered and painted white. Pitched tiled roof. Rectangular plan, shorter end onto canal. Three storeys. Front elevation onto canal. LC20 central doorway with porch. Ground floor LC20 nine-pane bow windows, one each side of entrance. Two replacement sash windows to first storey, and right hand sash only to second floor, with small central lookout window. Rubble stone outshut to east of house.
