TY'N-Y-COED, LLANWRDA, CARMARTHENSHIRE ARCHAEOLOGICAL BUILDING RECORDING

REPORT NO. 2020-22
PROJECT RECORD NO. 121729

February 2020

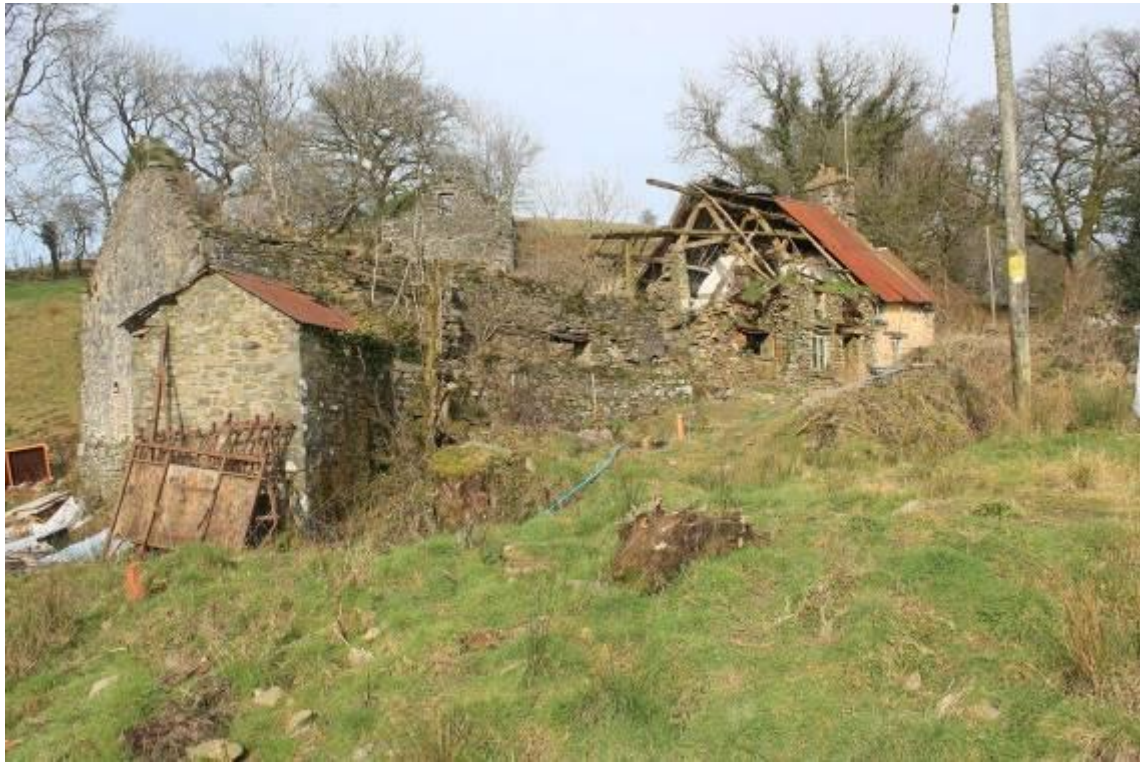
Photo 3: View north: oblique shot of byre and house

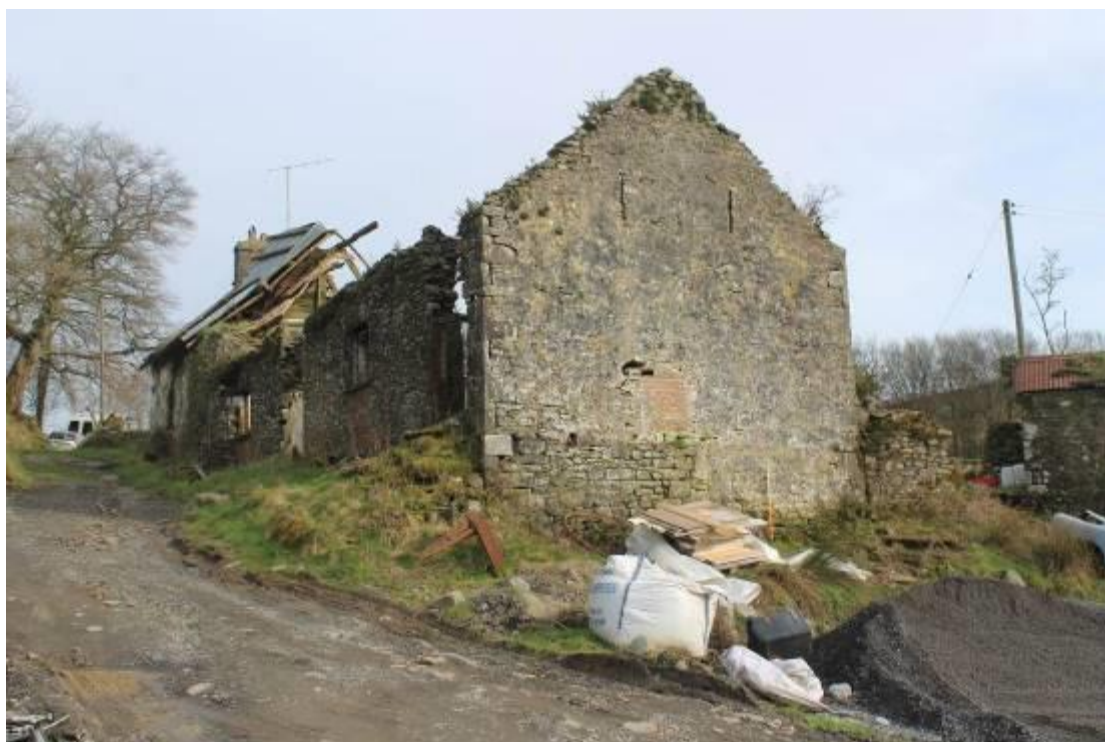
Photo 5: Southwest corner of byre. 1m scale

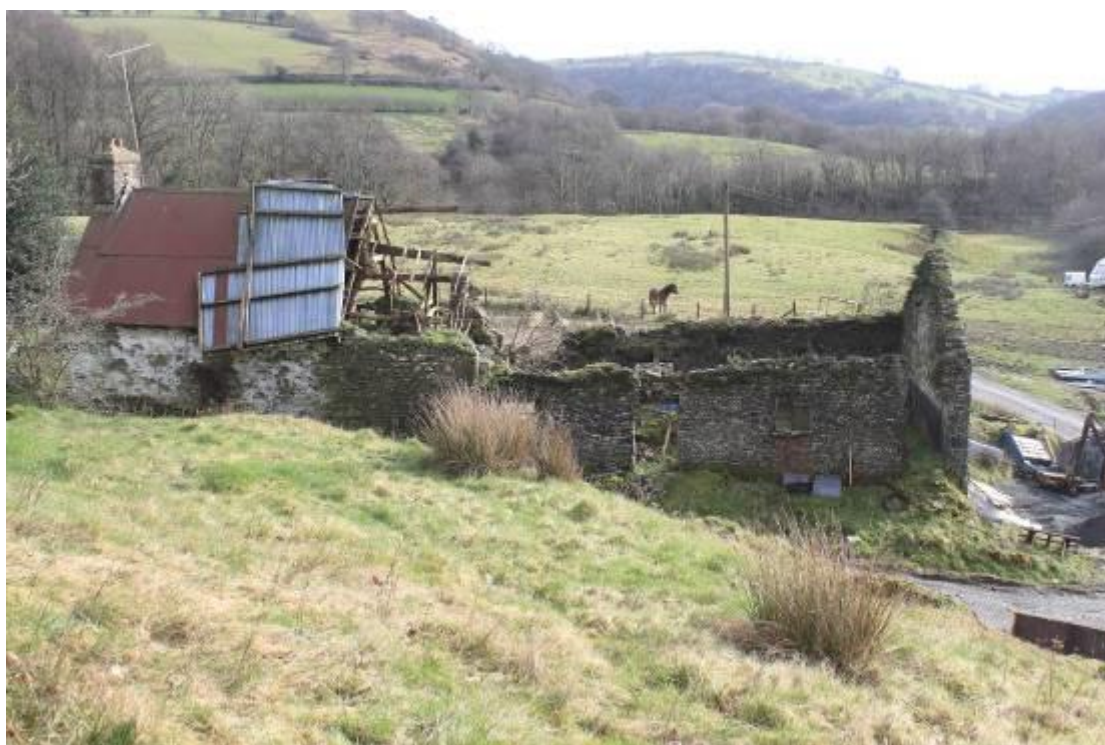
Photo 6: West facing elevation of house and byre

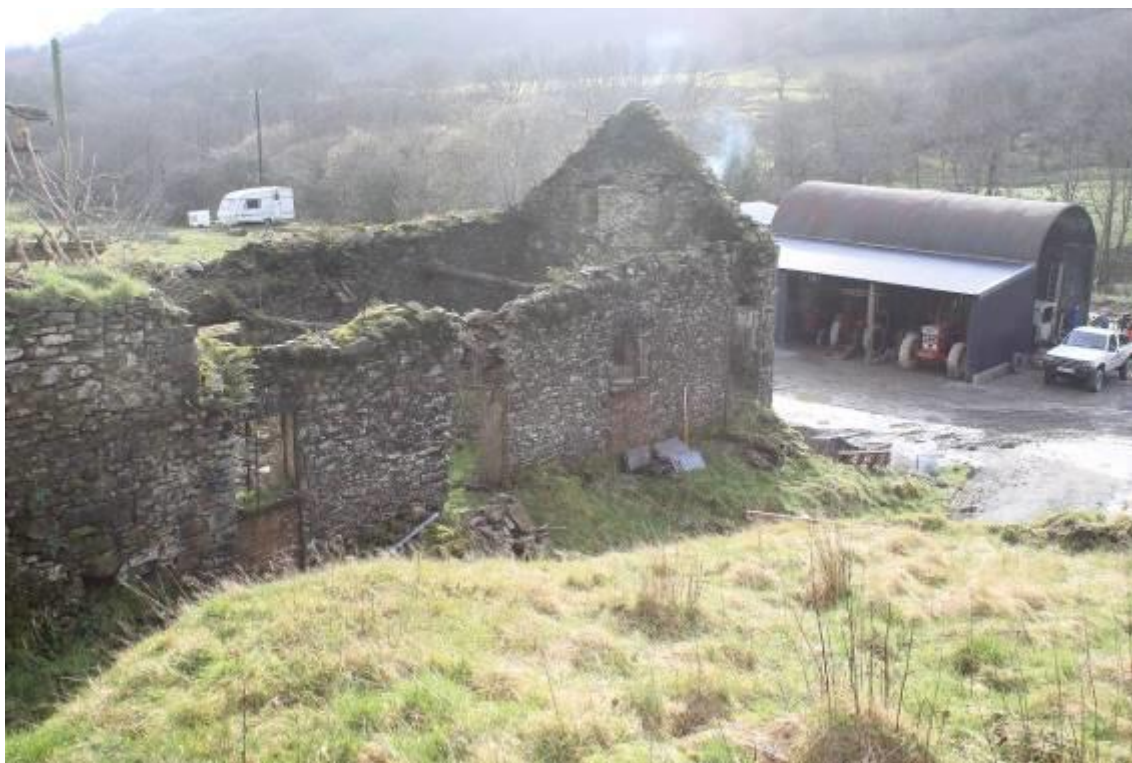
Photo 7: Oblique shot of west wall of byre

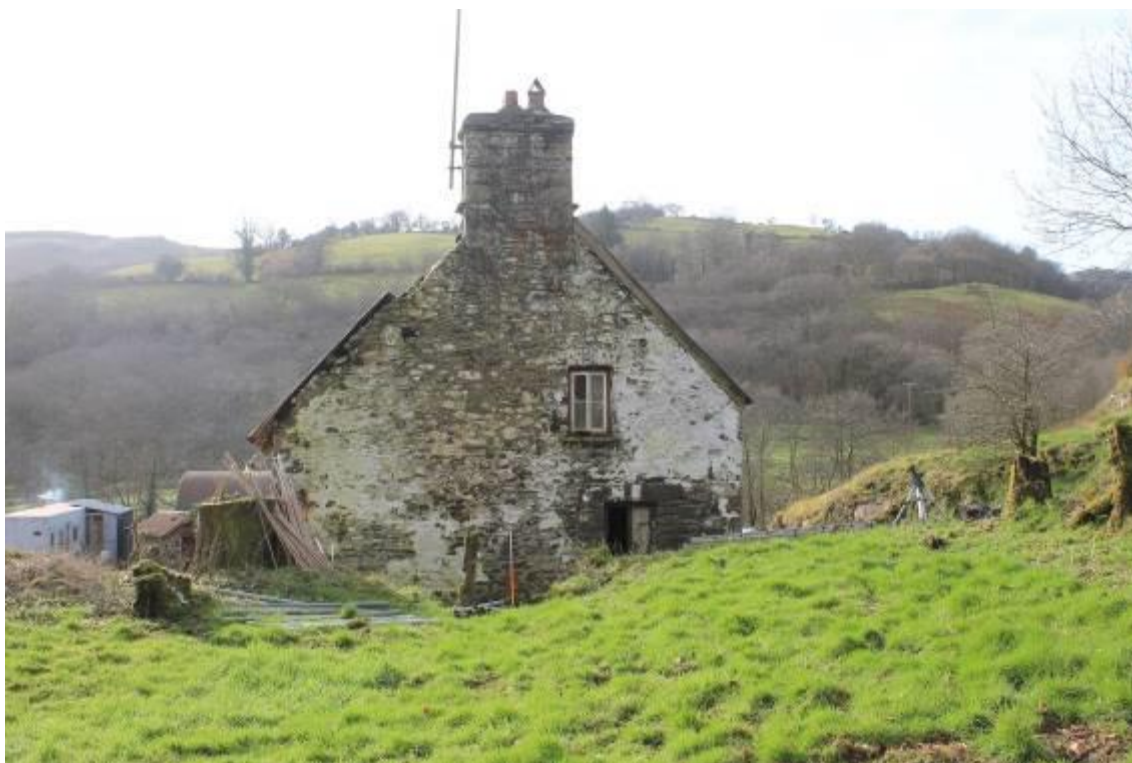
Photo 9: North elevation of house. 1m scale

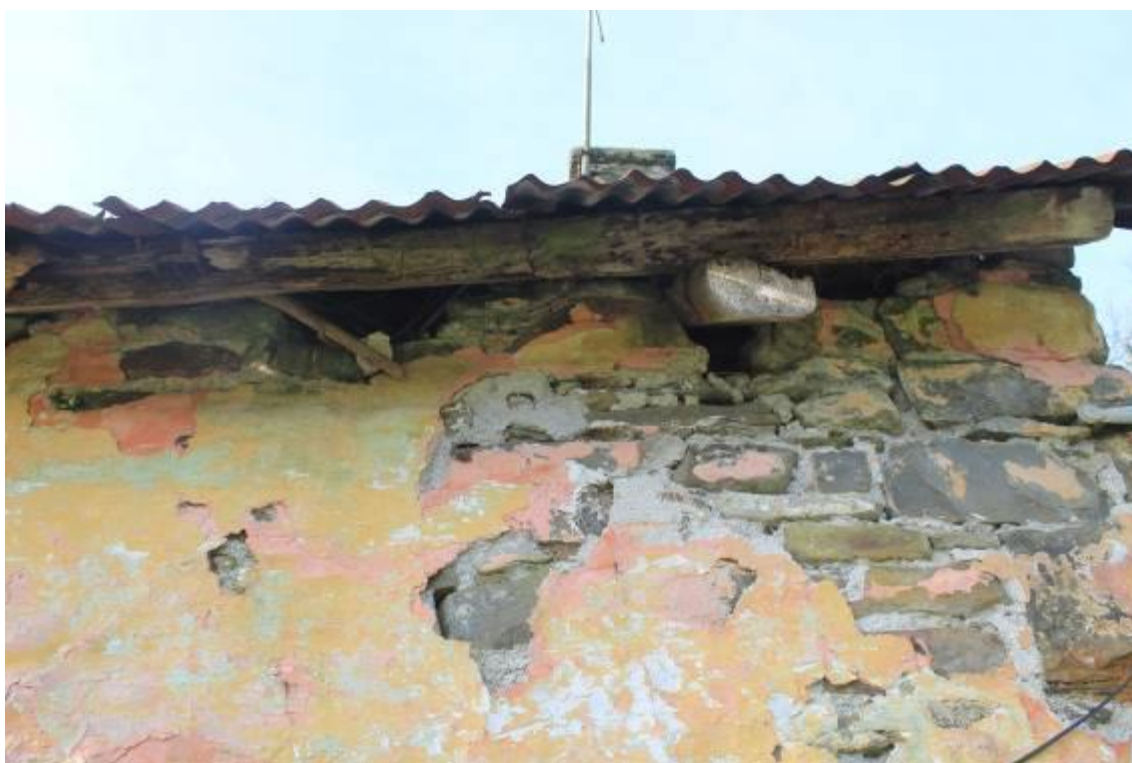
Photo 10: Wooden soffit at northeast corner of house

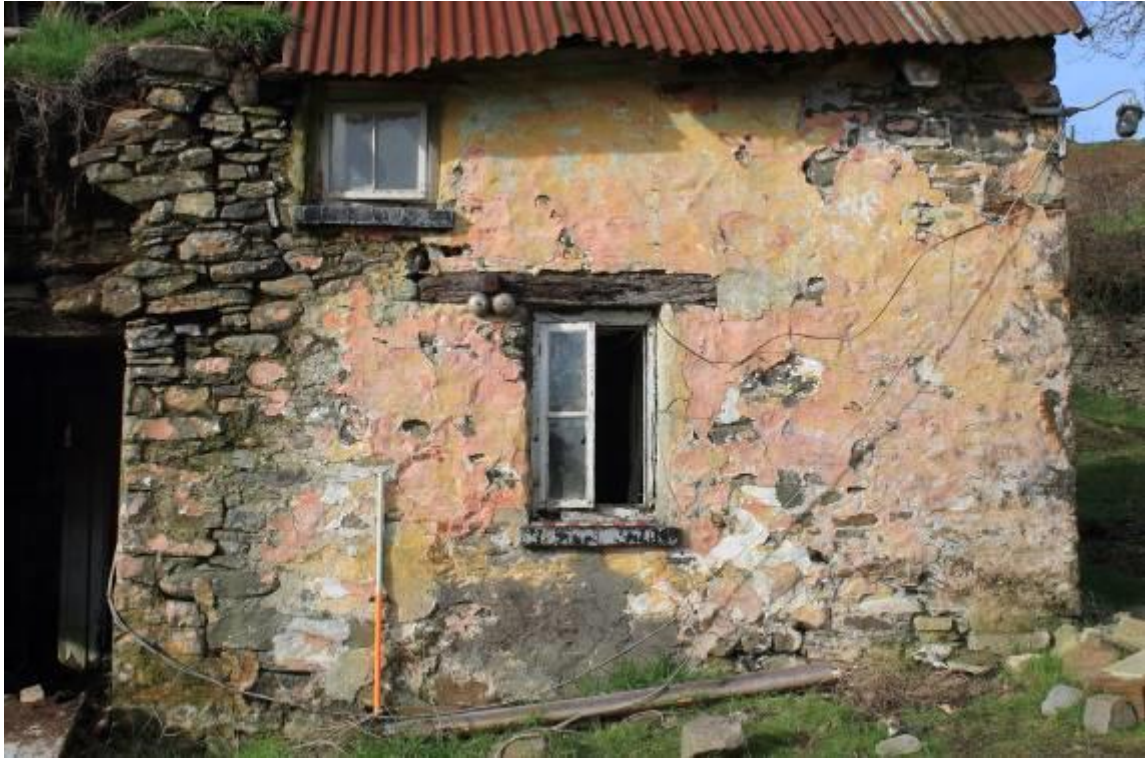
Photo 11: Detail of house façade north of doorway. 1m scale

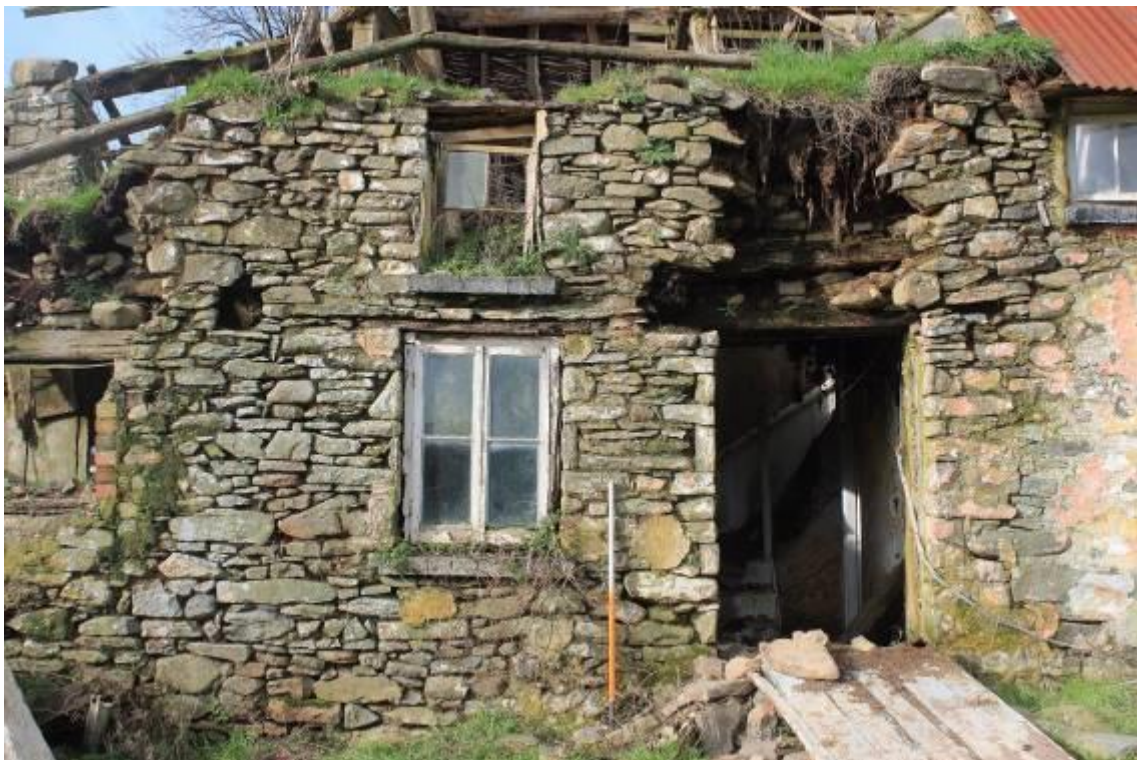
Photo 12: Detail of house façade south of doorway. 1m scale

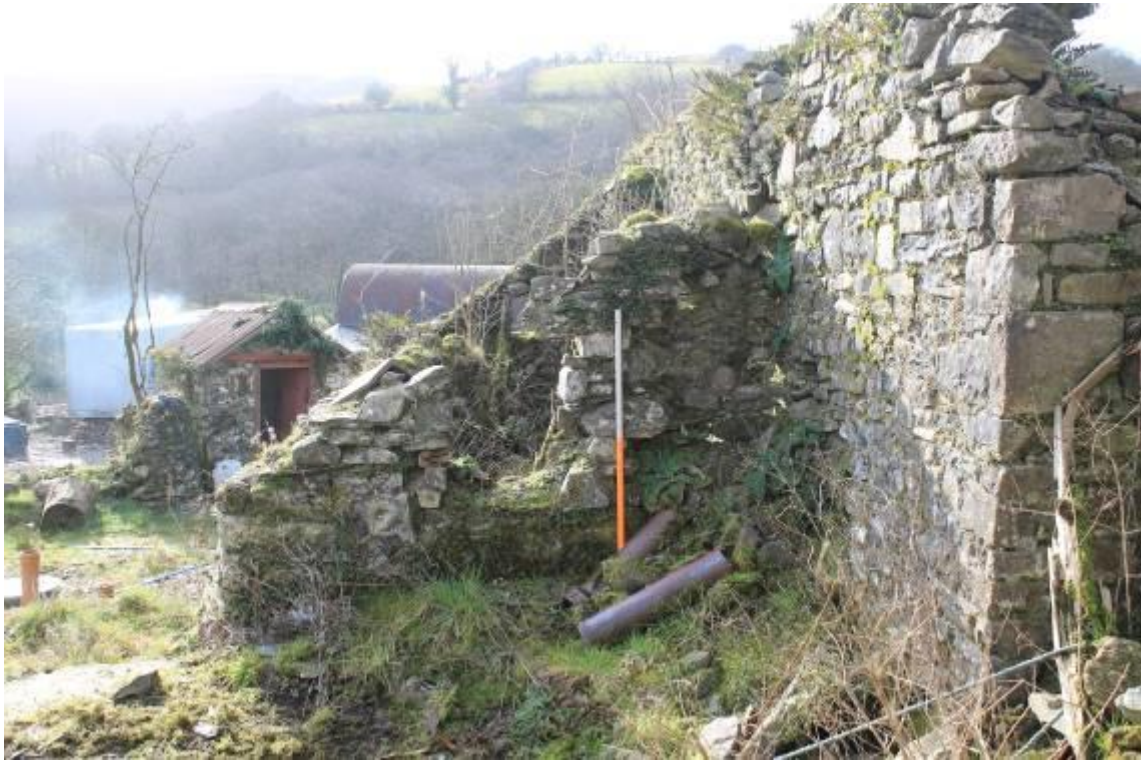
Photo 15: View south towards lean-to. The tŷ bach can be seen in the background. 1m scale

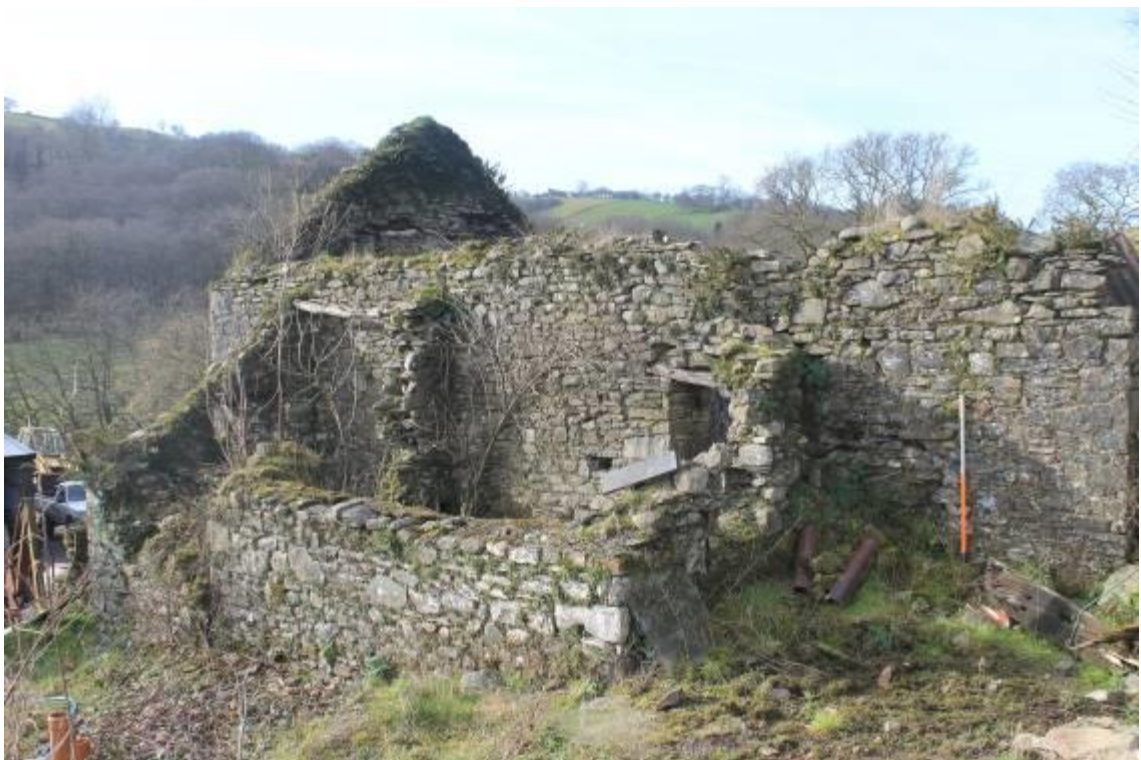
Photo 16: View southwest towards lean-to (byre in background). 1m scale

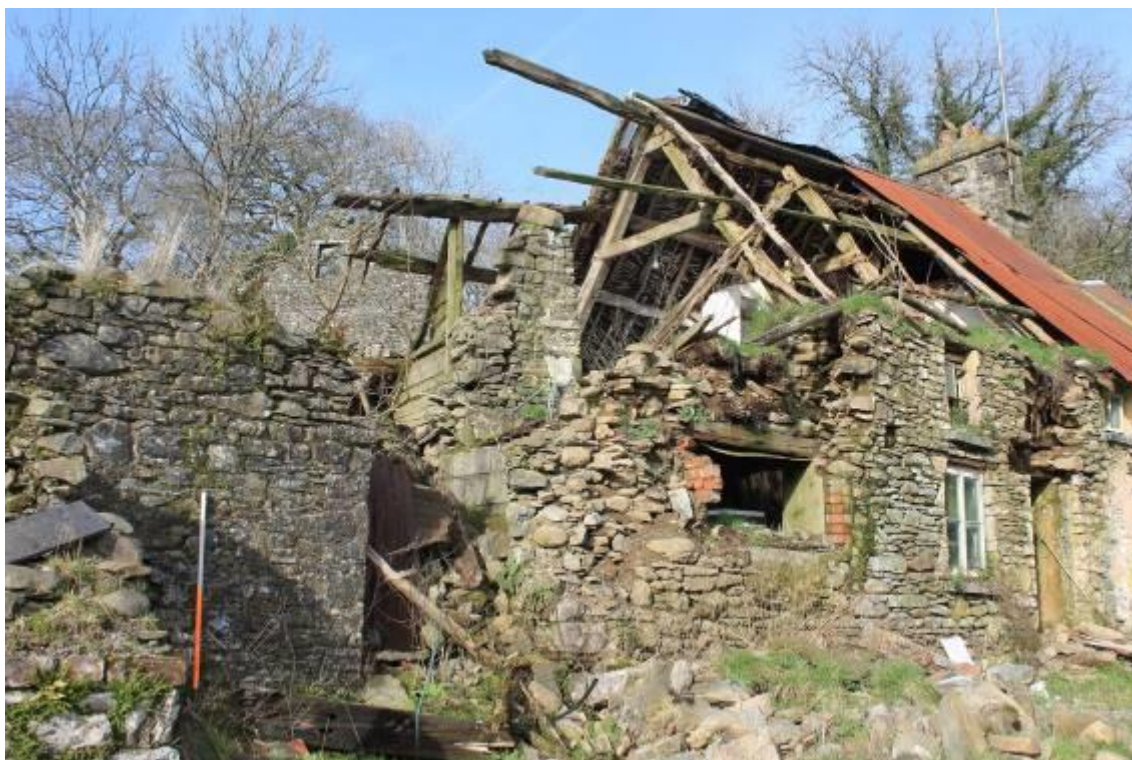
Photo 17: View north towards collapsed south end of house and exposed roof timbers. 1m scale

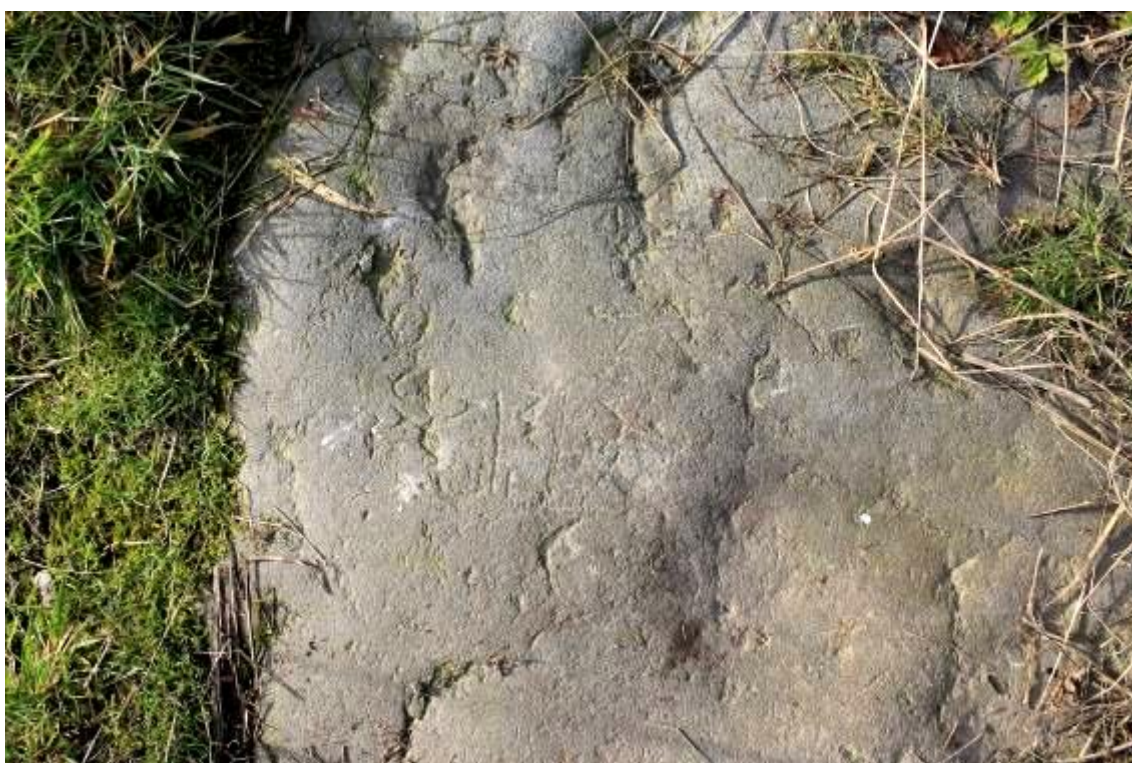
Photo 18: Graffiti incised in stone beside lean-to

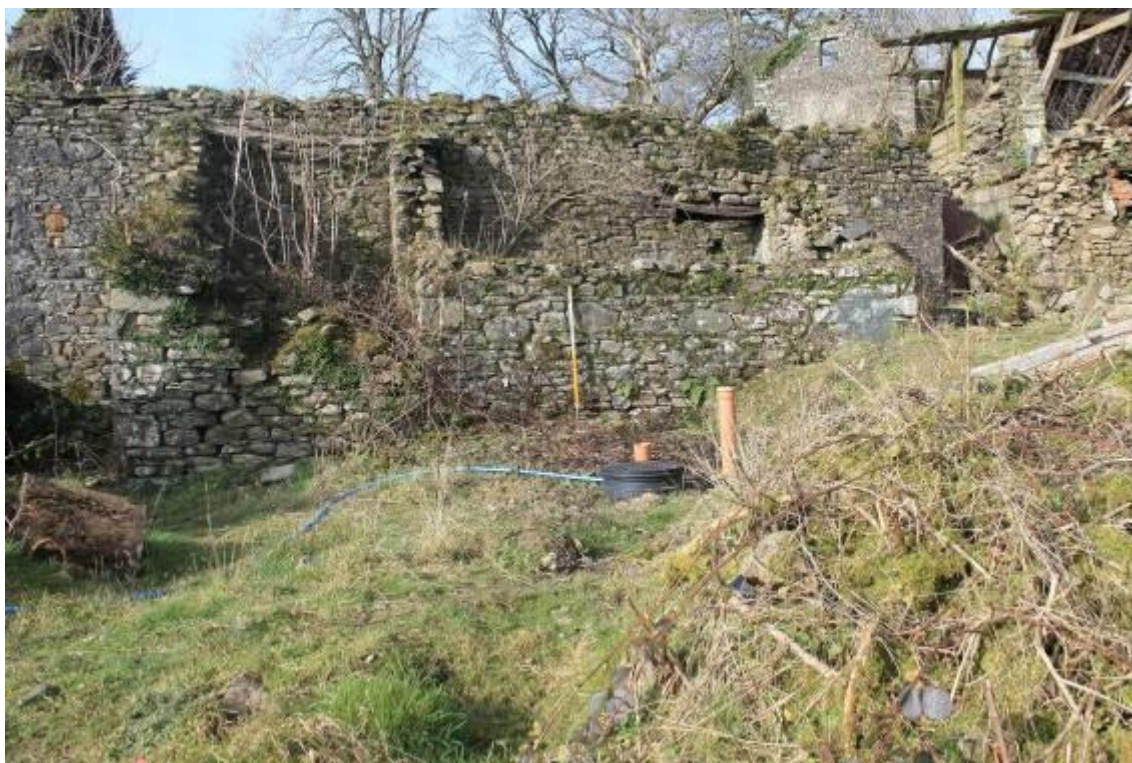
Photo 19: View west towards lean-to and byre. 1m scale

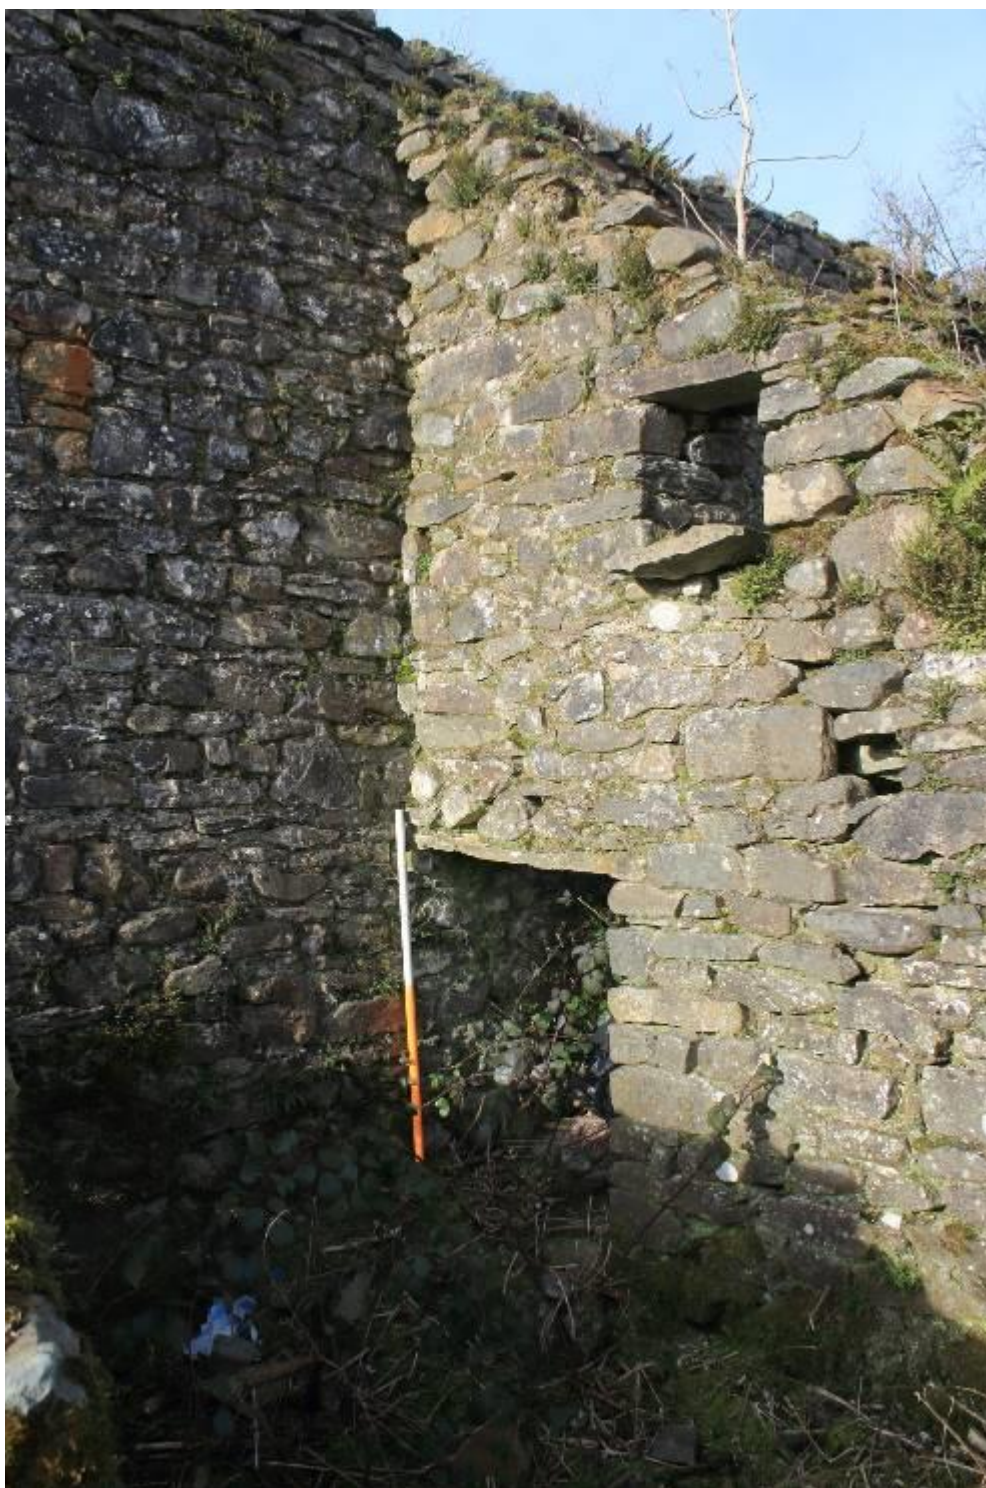
Photo 20 View north; entrance to pig-sty at south end of lean-to. 1m scale

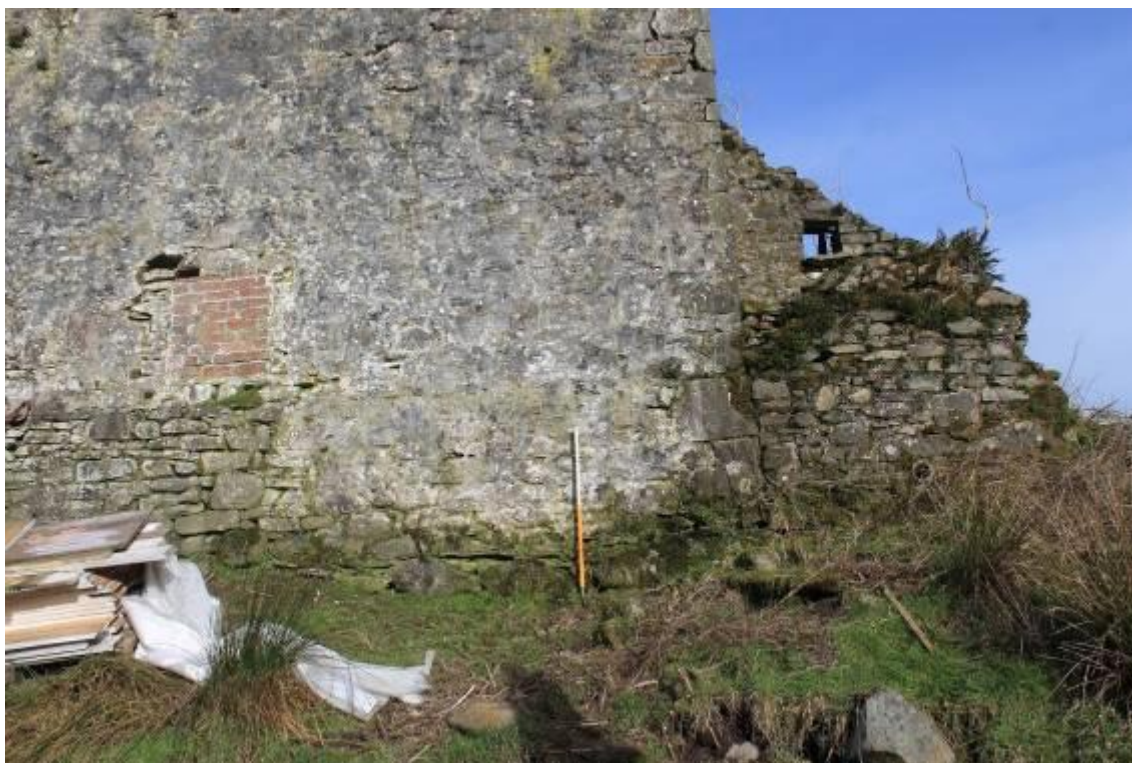
Photo 21: Southeast corner of byre (also showing southern elevation of lean-to).
1m scale

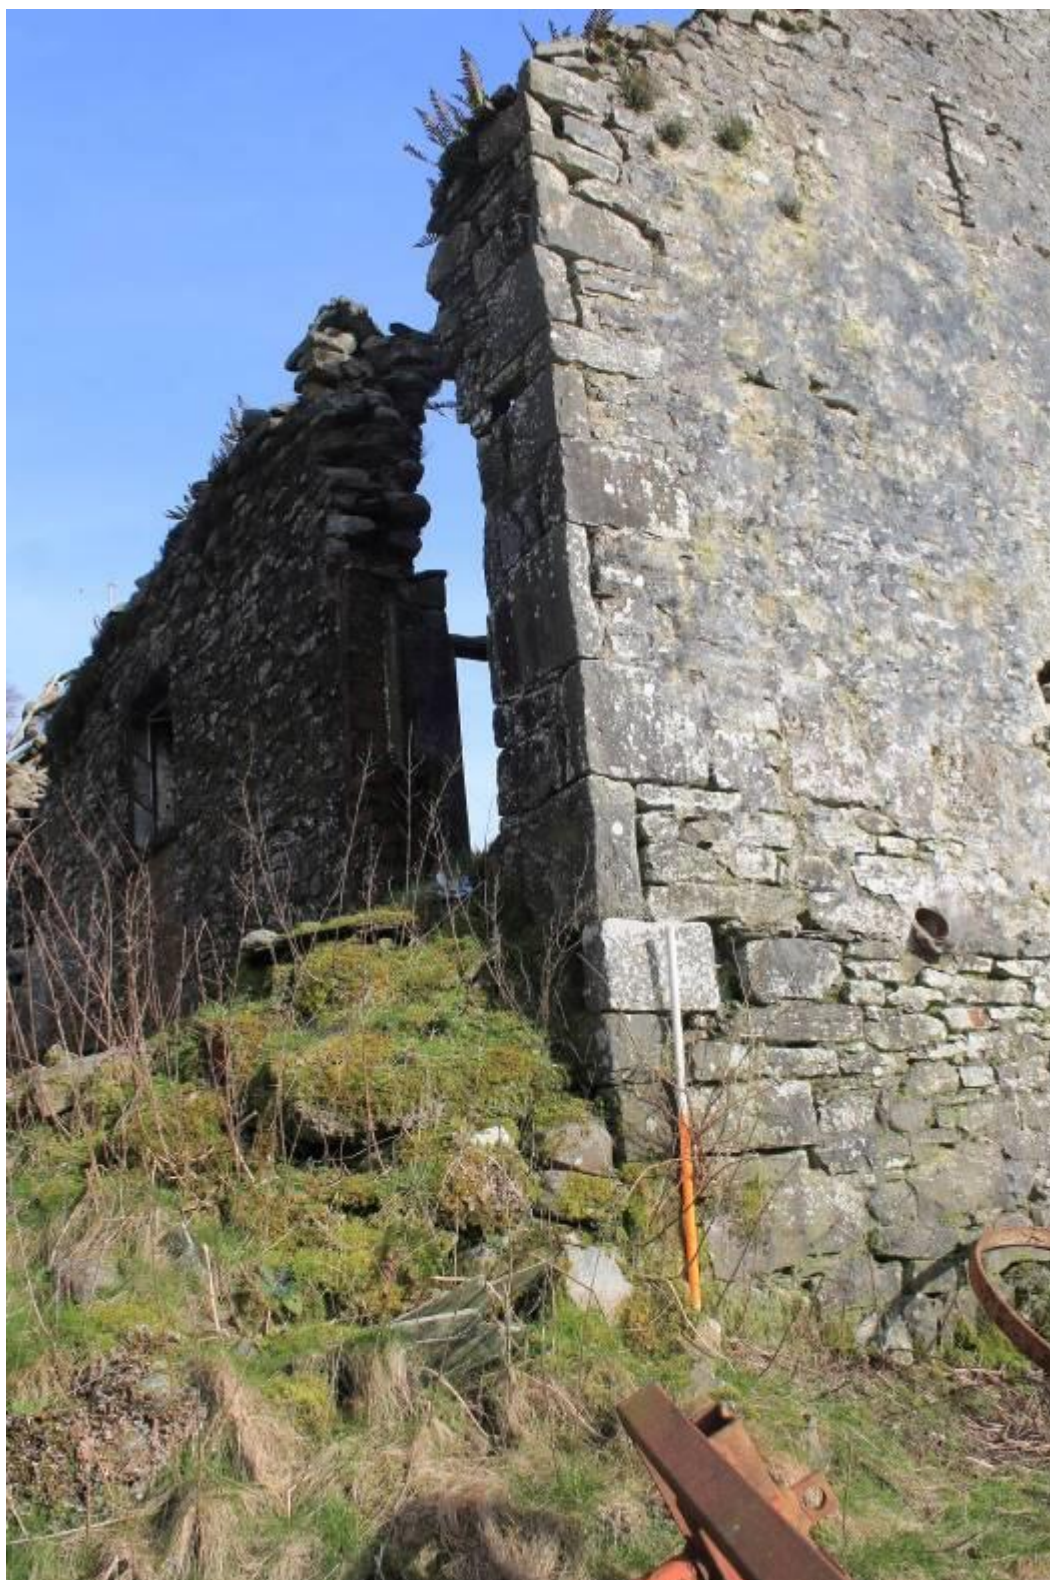
Photo 22: Quoins at southwest corner of byre. 1m scale

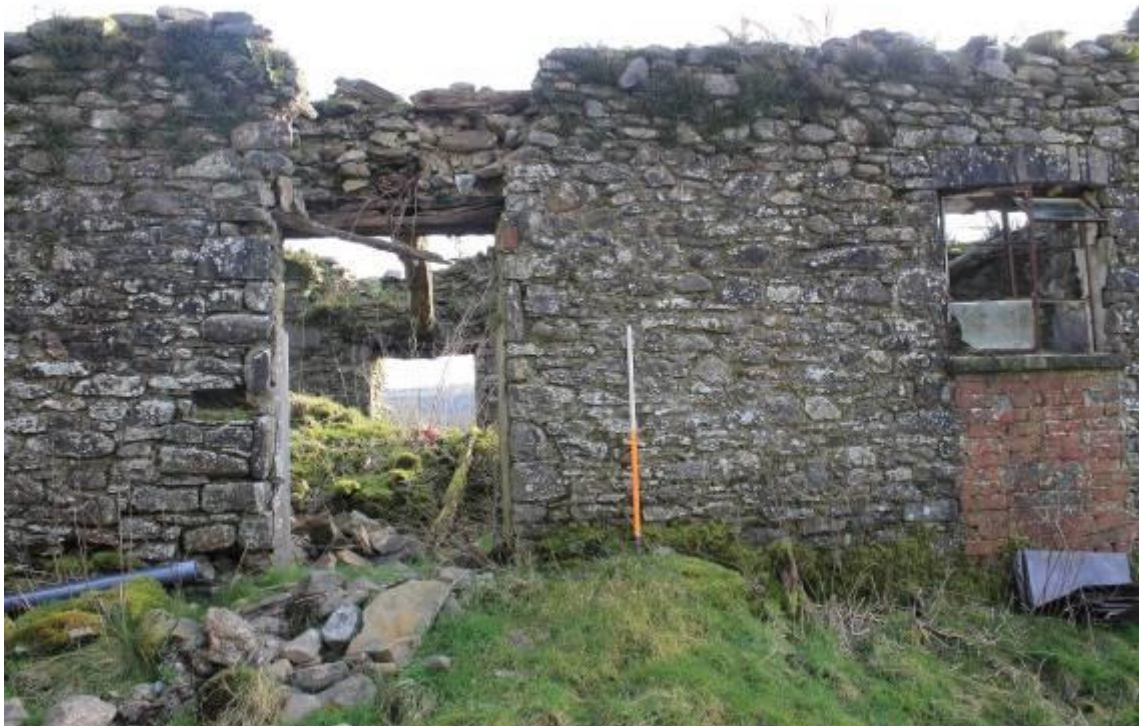
Photo 24: Entrance (with timber lintel) in west wall of byre. 1m scale

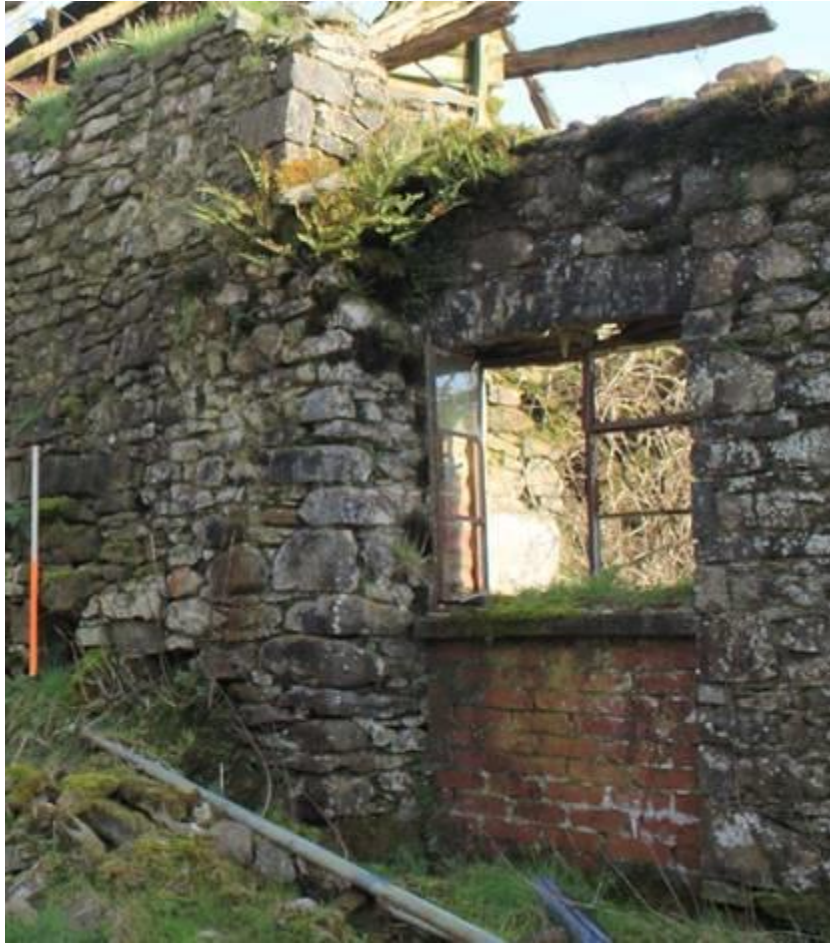
Photo 25: Detail of blocked entrance to former cross-passageway in west wall of byre. 1m scale

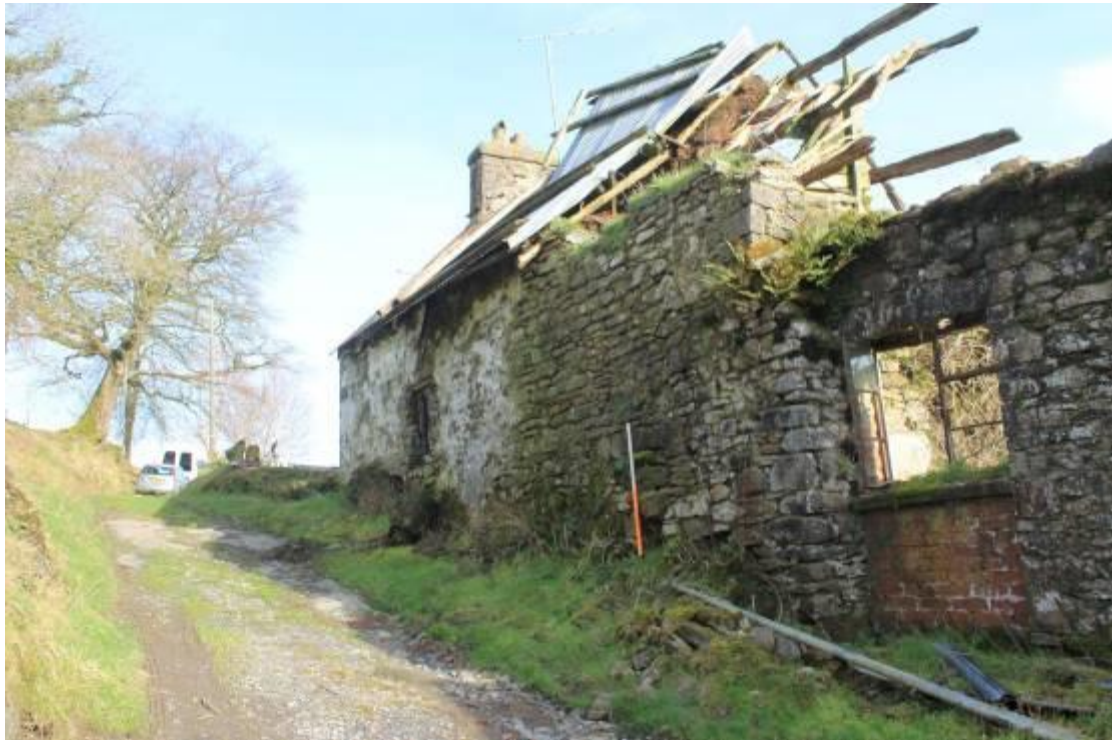
Photo 26: Oblique view of west wall of house and north end of byre. 1m scale

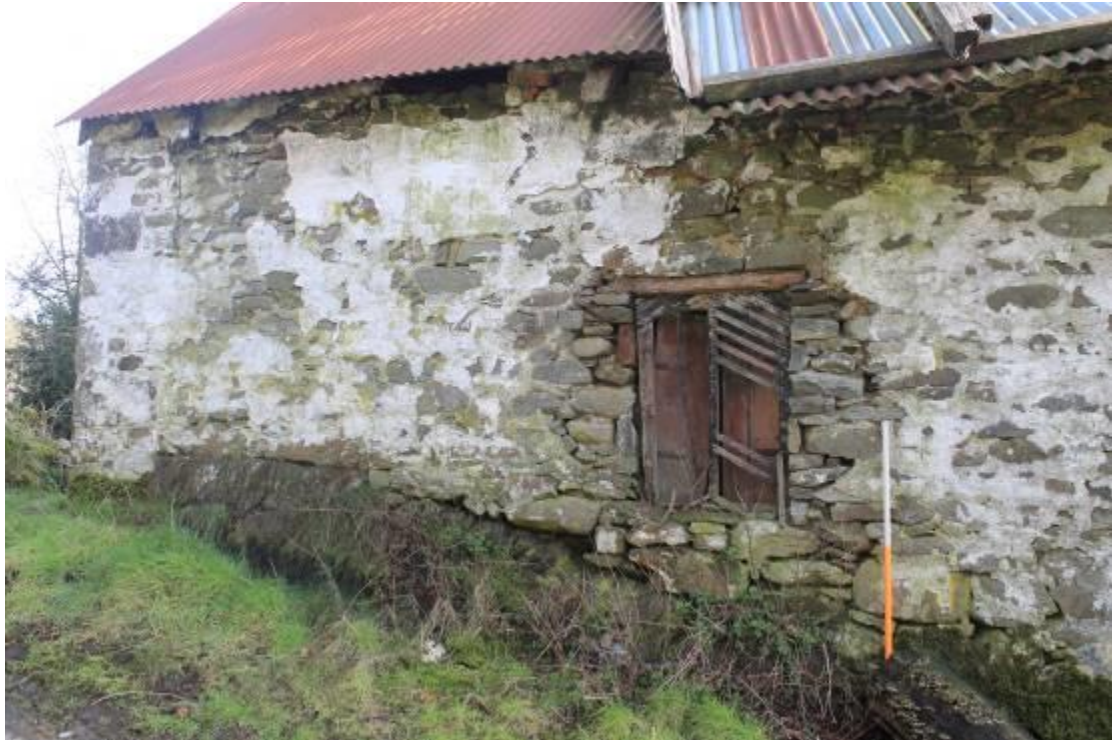
- 3.6 The difference in levels between the external bedrock and the internal dairy floor suggests that the dairy floor has been terraced into the bedrock to create a cooler room temperature. The height of the bedrock in relation to the west window can be seen in Photos 28, 29 and 32. Inside the dairy a small area of bedrock (0.65m higher than the floor) can be seen below the window in the north wall (Photo 60).

Photo 28: West wall of house (note rising bedrock). 1m scale

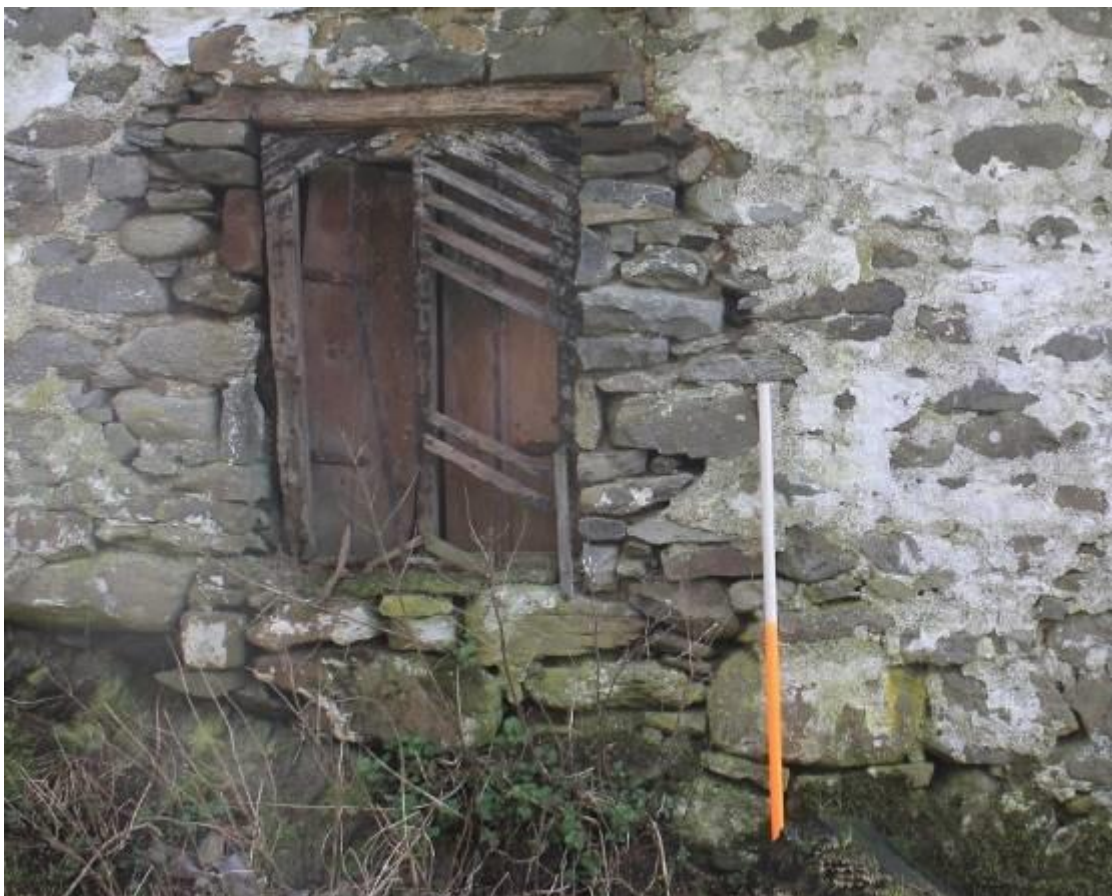
Photo 29: Shuttered window (located in dairy) in west wall of house. 1m scale

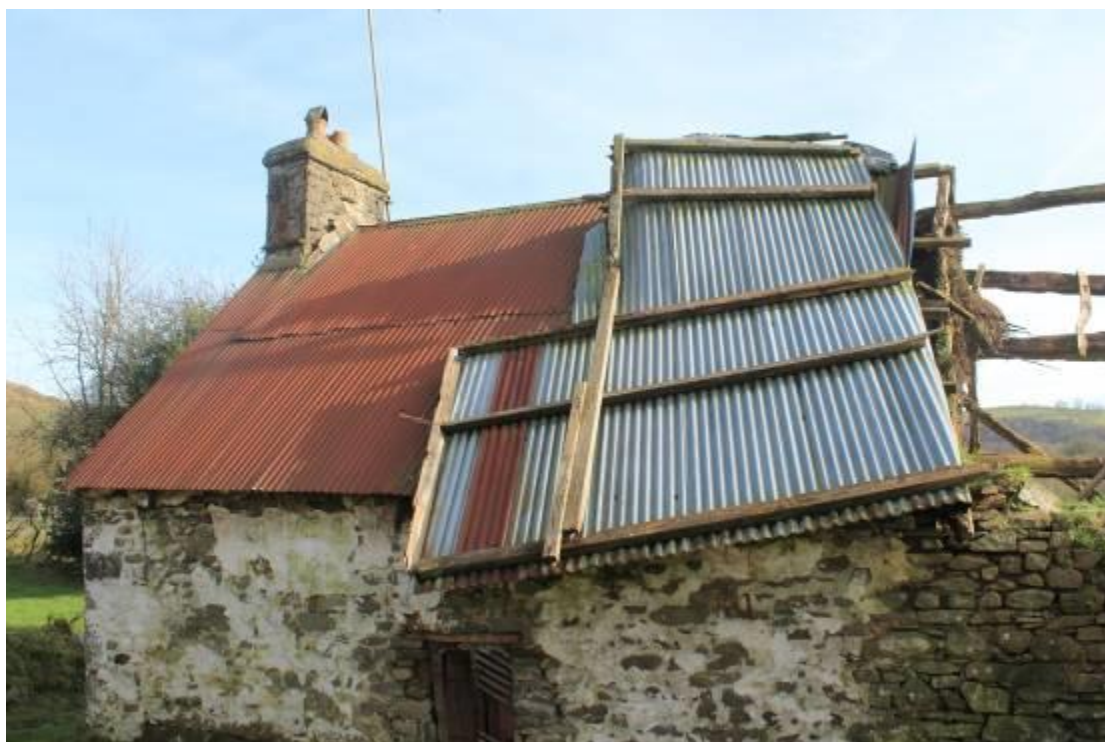
Photo 30: Detail of corrugated-iron roof on west side of house

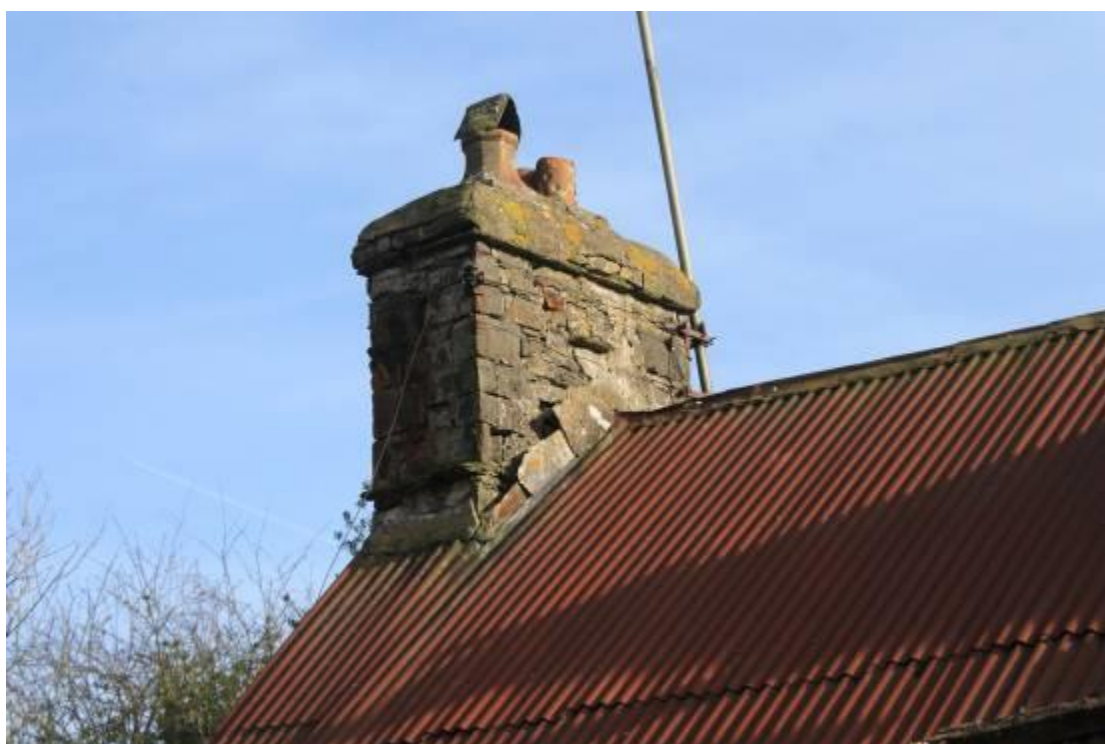
Photo 31: Detail shot of chimney

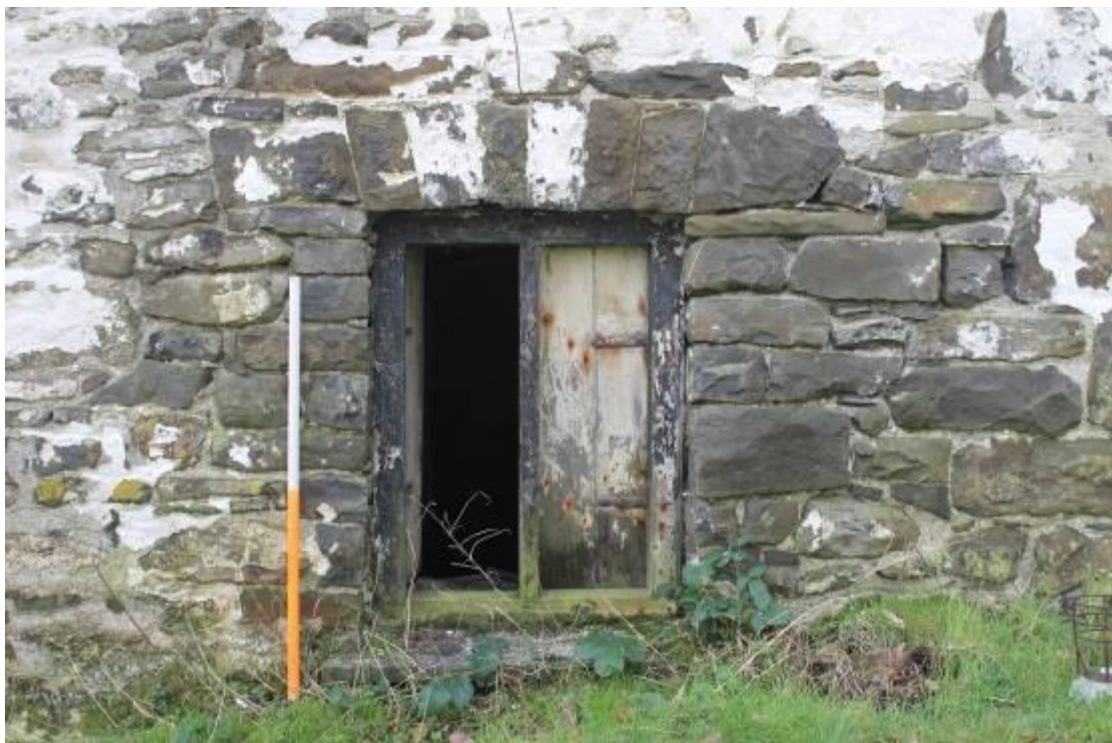
Photo 33: Shuttered window with stone voussoirs (located in dairy) in north wall of house. 1m scale

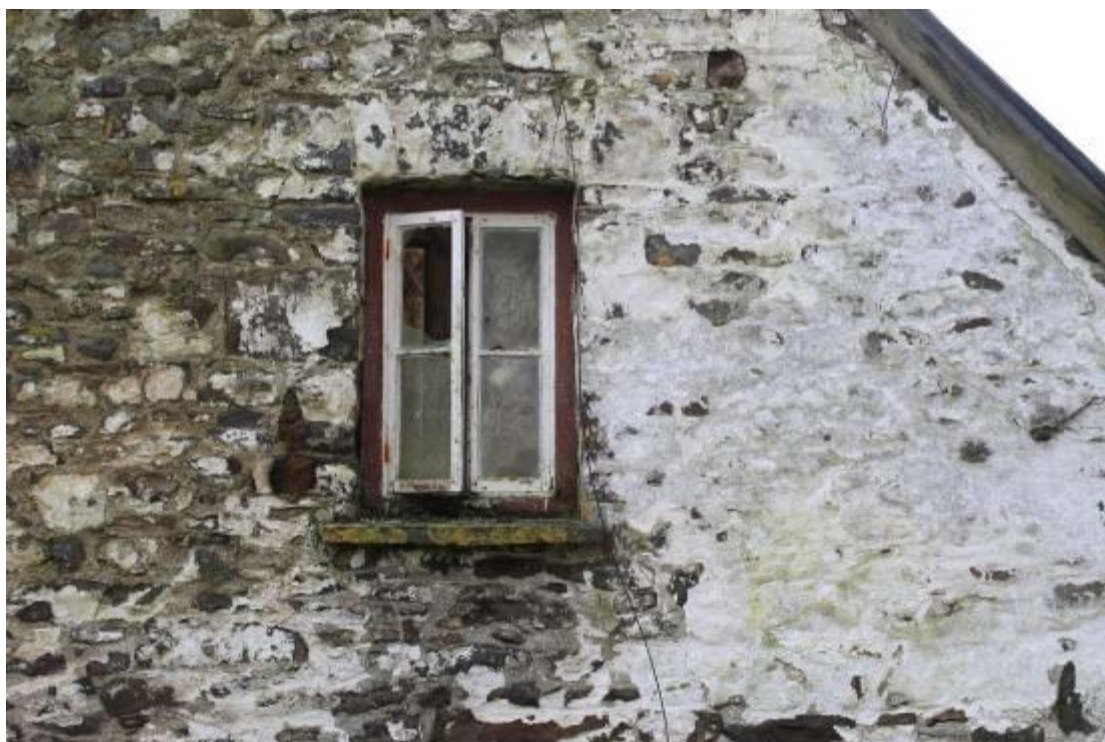
Photo 34: First floor bedroom window with stone voussoirs
