TY'N-Y-COED, LLANWRDA, CARMARTHENSHIRE ARCHAEOLOGICAL BUILDING RECORDING

REPORT NO. 2020-22
PROJECT RECORD NO. 121729

February 2020

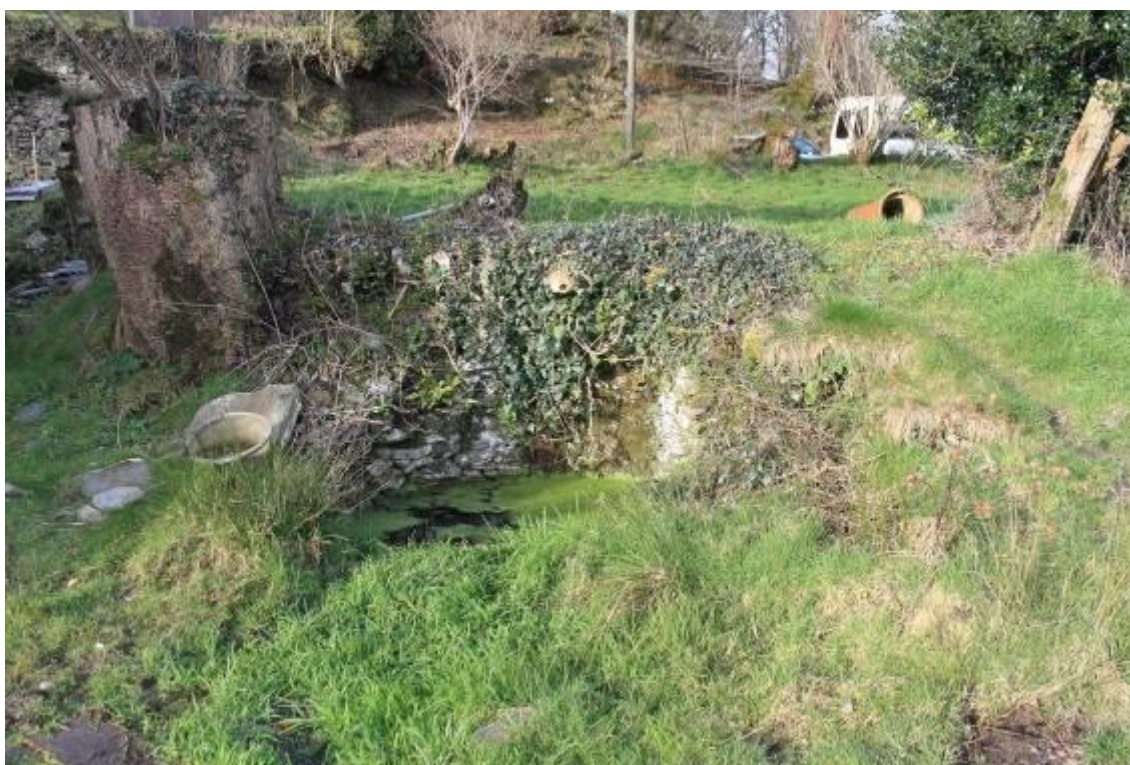
Photo 35: Stone-lined well at north end of house

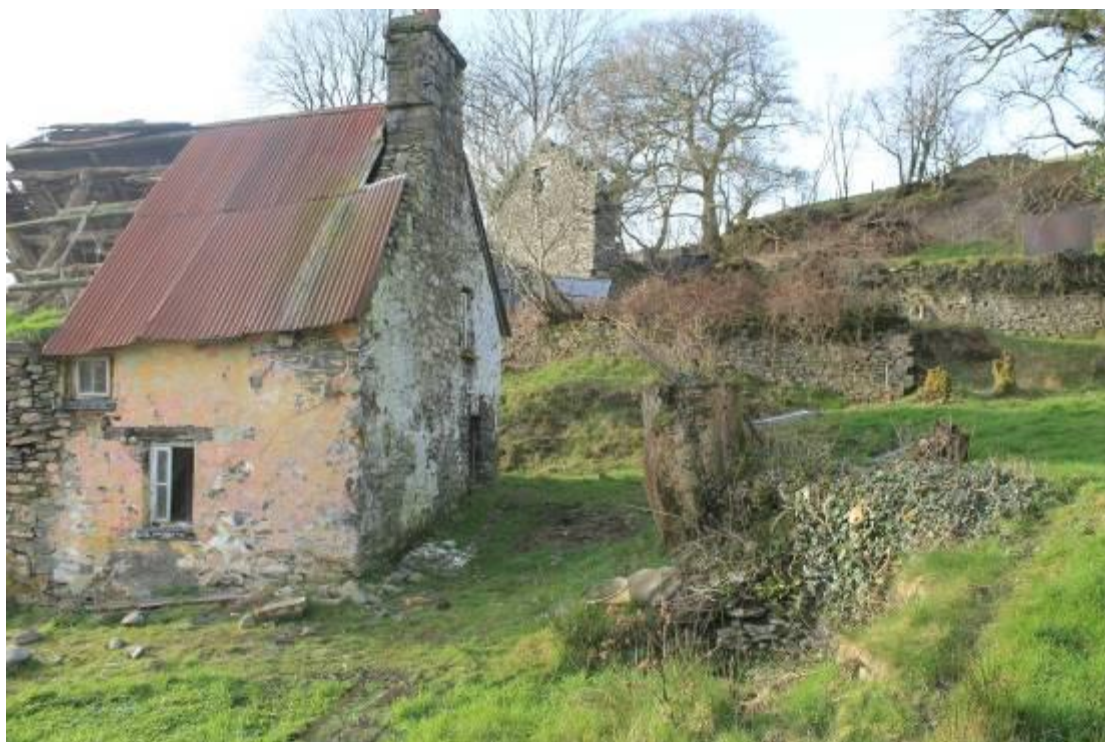
Photo 36: Stone-lined well and north end of house. The ruinous barn can be seen in background.

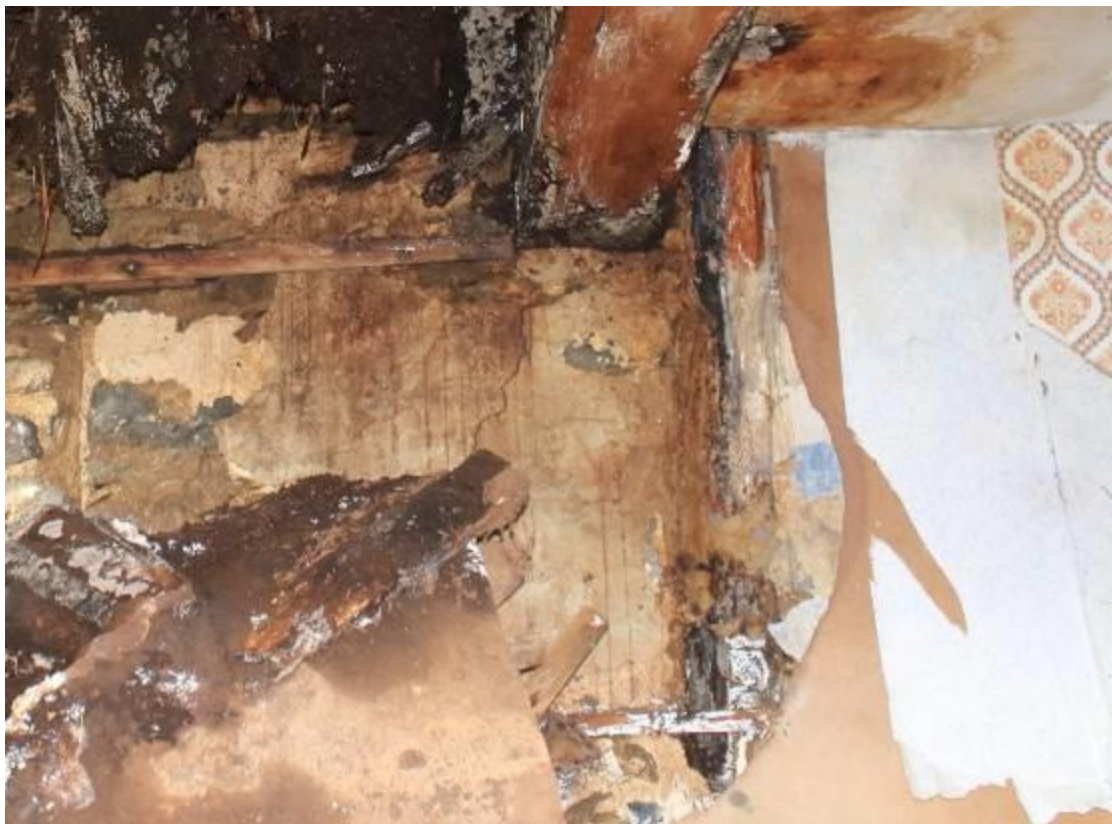
Photo 52 Close-up of foot of scarfed cruck in west wall of hall

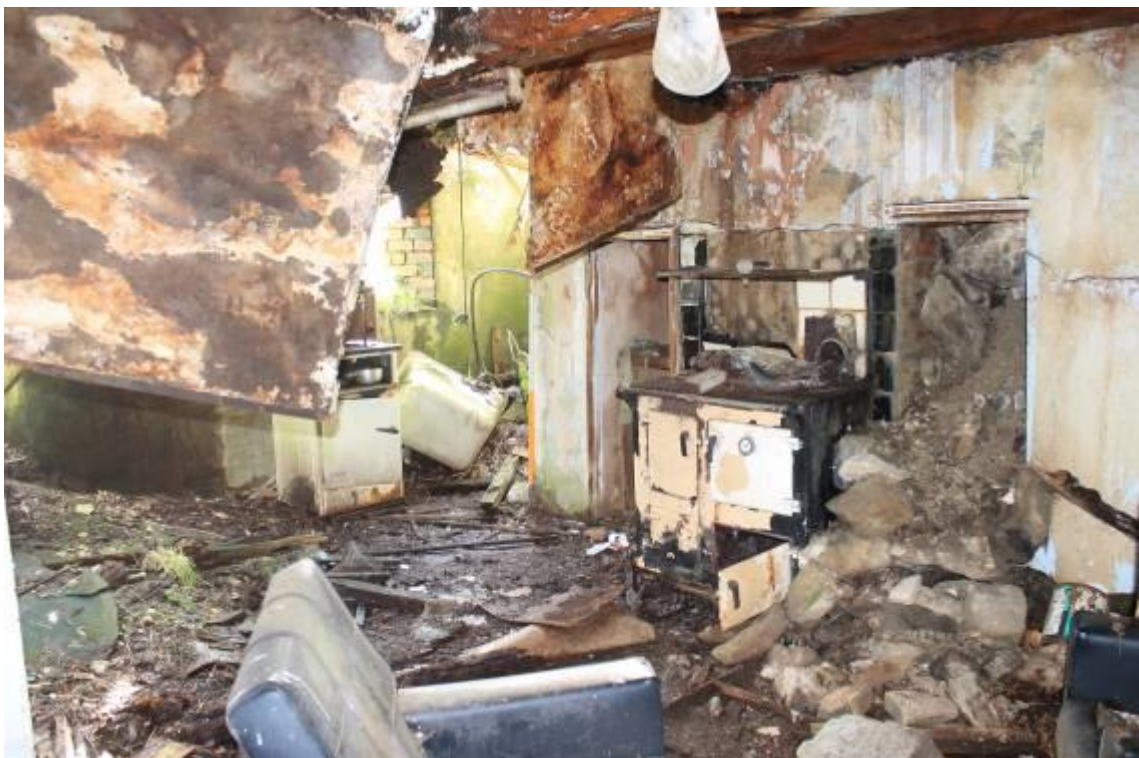
Photo 54: View southeast towards fireplace in south wall of hall; recess to cross-passage can be seen on the left

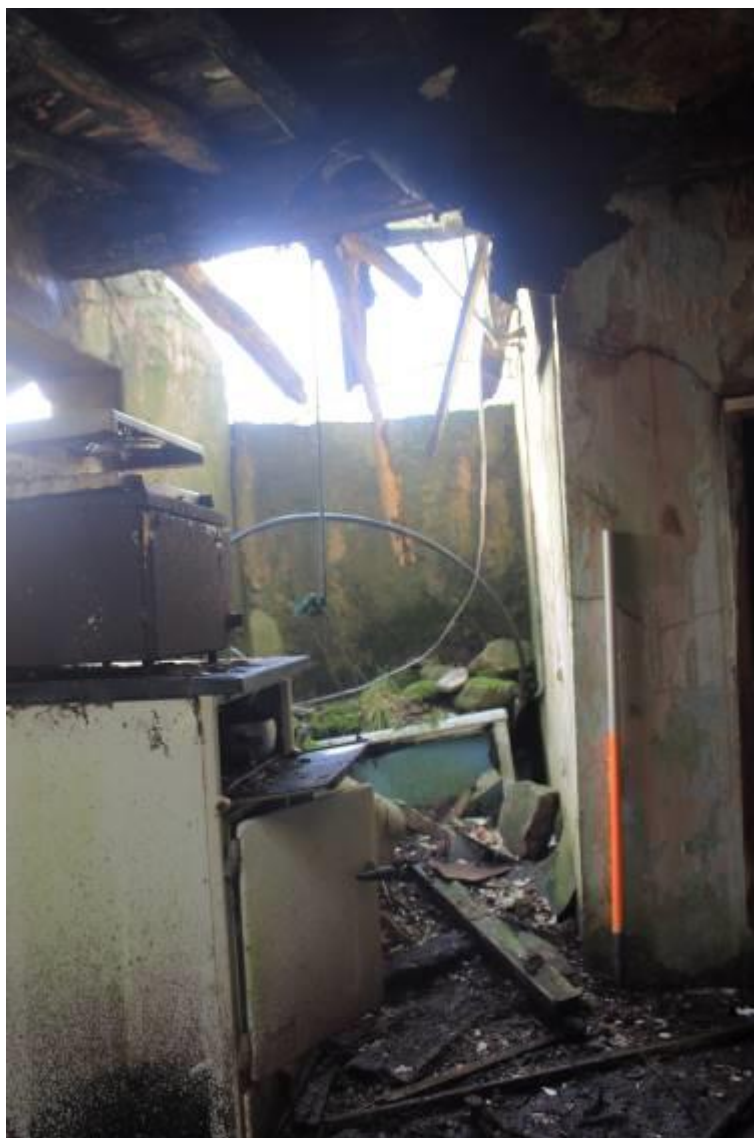
Photo 55: Passage in south wall of hall leading to cross-passage (blocked).

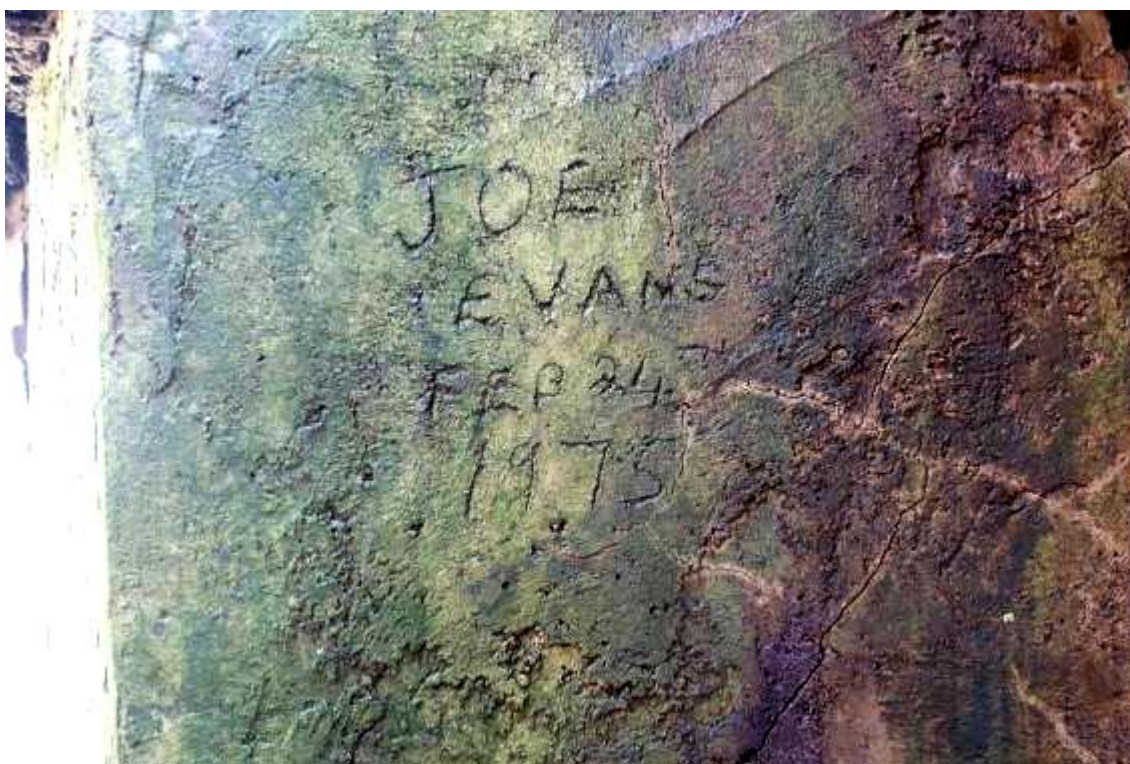
Photo 57: Graffiti incised into east wall of hall

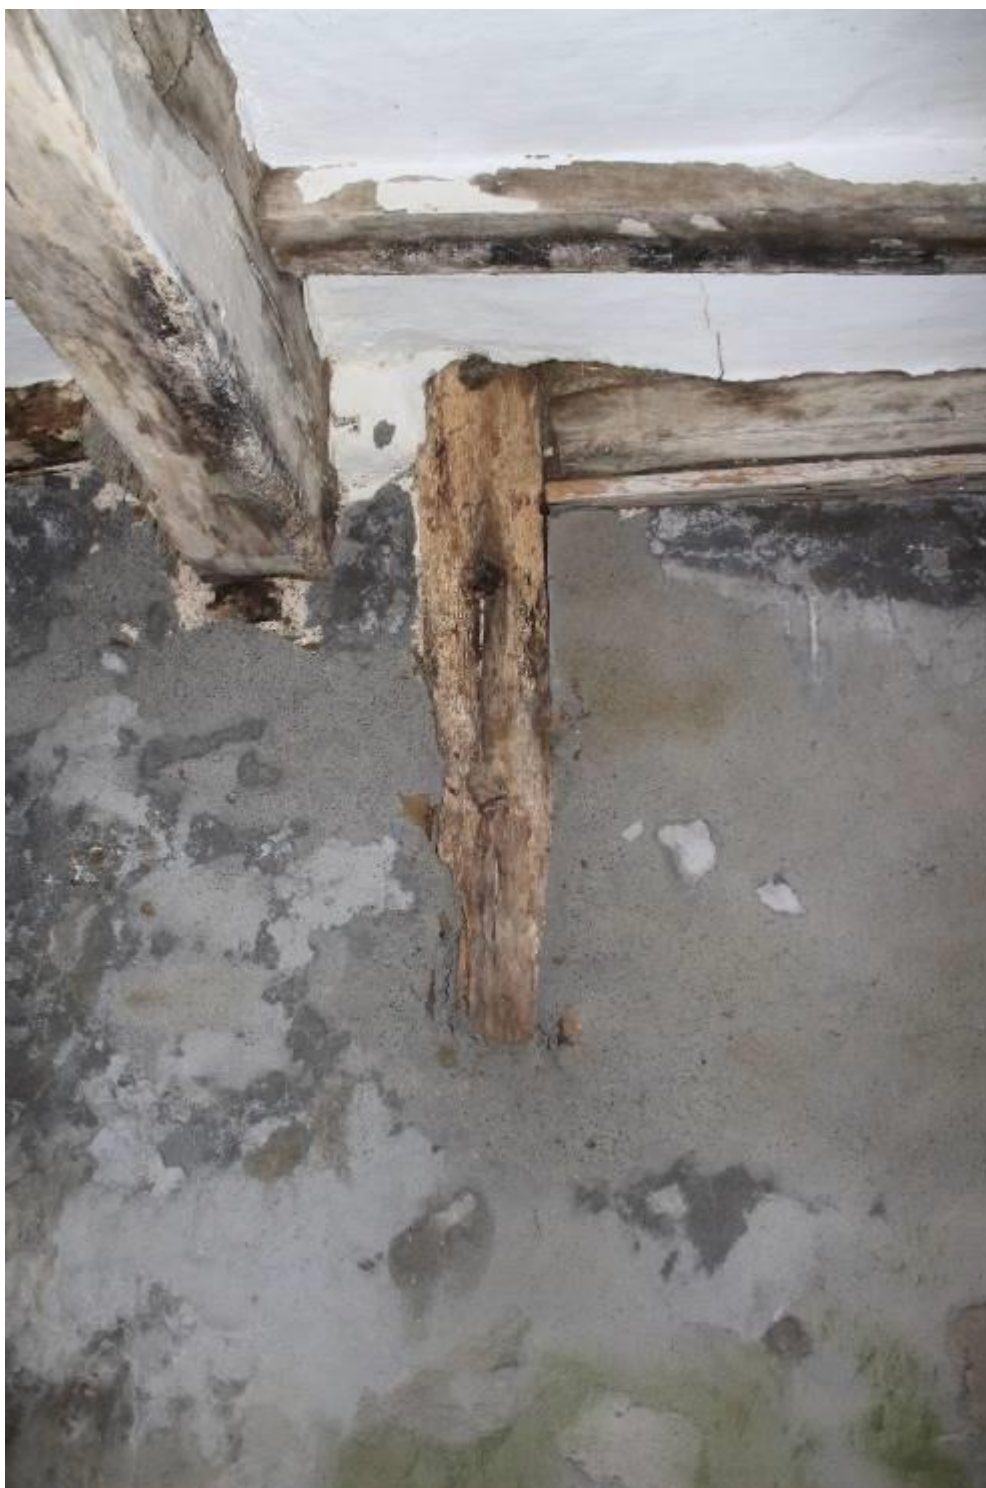
Photo 62: Scarfed cruck in west wall of dairy (north of window)

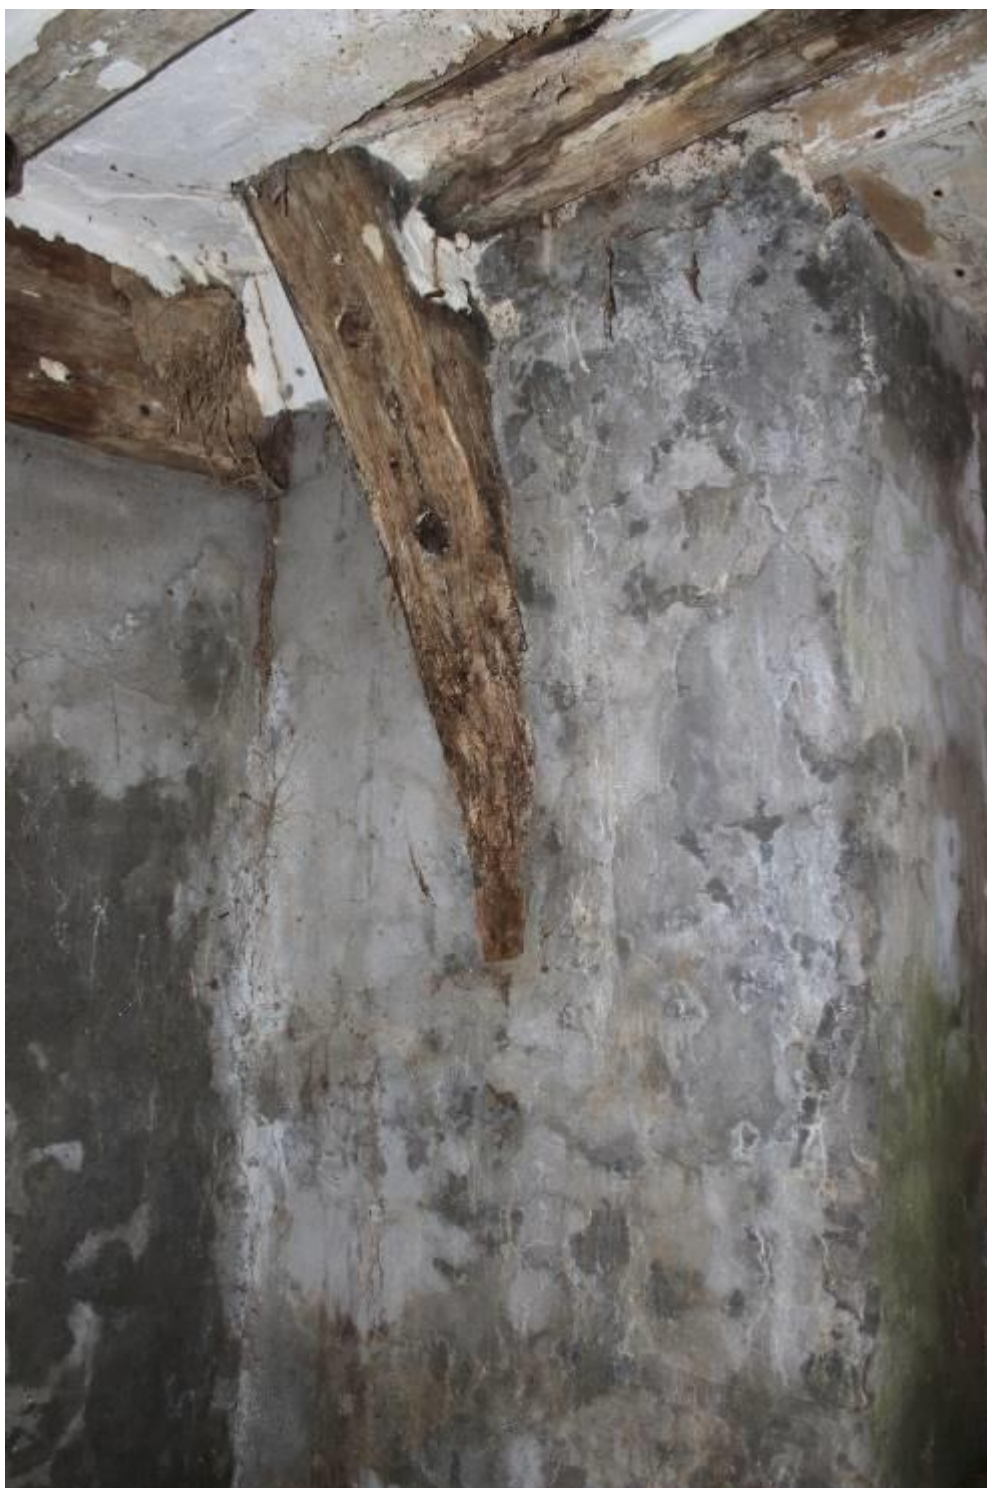
Photo 65: Scarfed cruck in west wall of dairy (south of window)

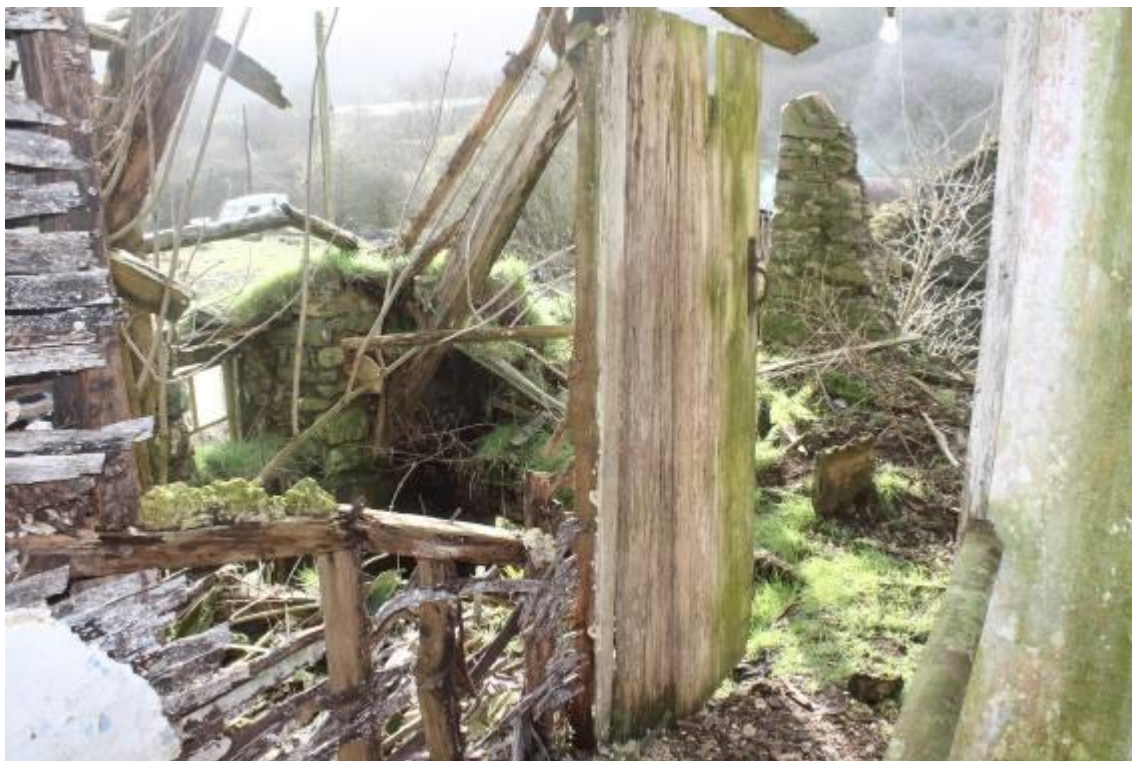
Photo 72: View from top of stair looking south at collapsed south end of house

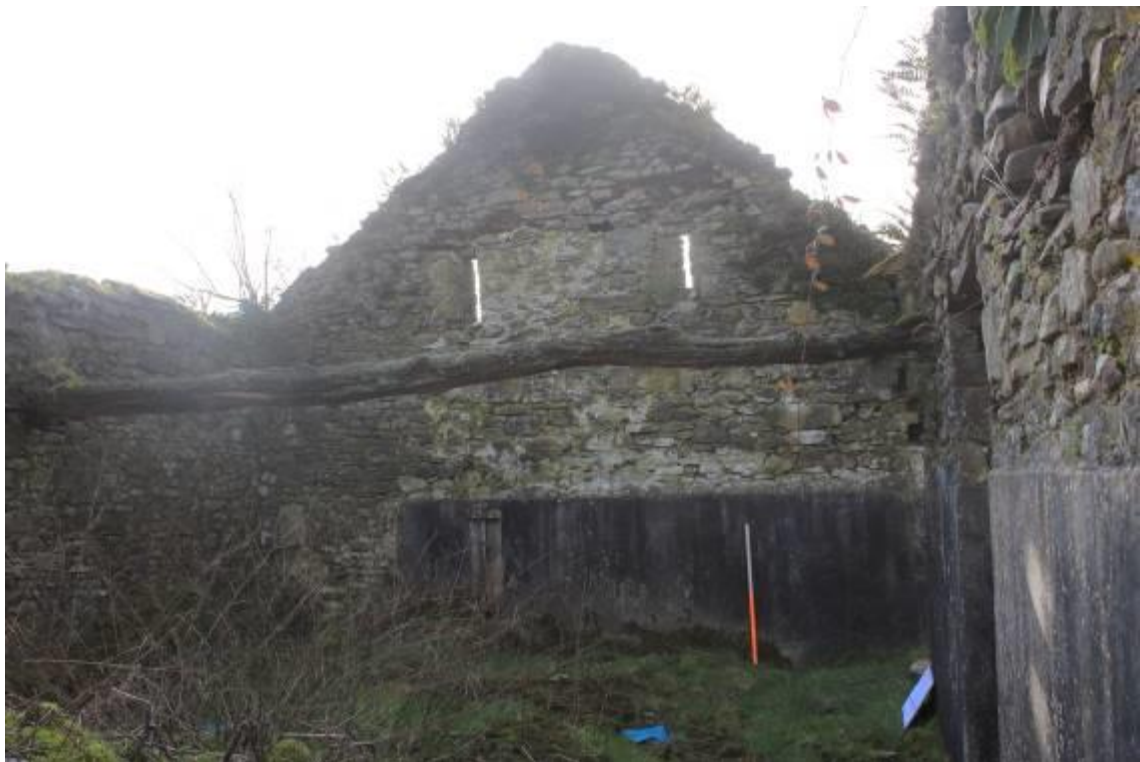
Photo 78: South gable of byre showing loops and crossbeam
