# PUMP HOUSE, NORTH DOCK, LLANELLI: STANDING BUILDING RECORDING

RHIF YR ADRODDIAD / REPORT NO. 2008/101  
RHIF Y PROSIECT / PROJECT RECORD NO. 94417

*The pump house is a grade II listed building (CADW reference 24/a/61(1)) and to comply with recommendations made by the Local Planning Authority, Dyfed Archaeological Trust Field Services were commissioned by James Allen Consultancy to undertake a programme of photographic standing building recording prior to any development work at the building.*

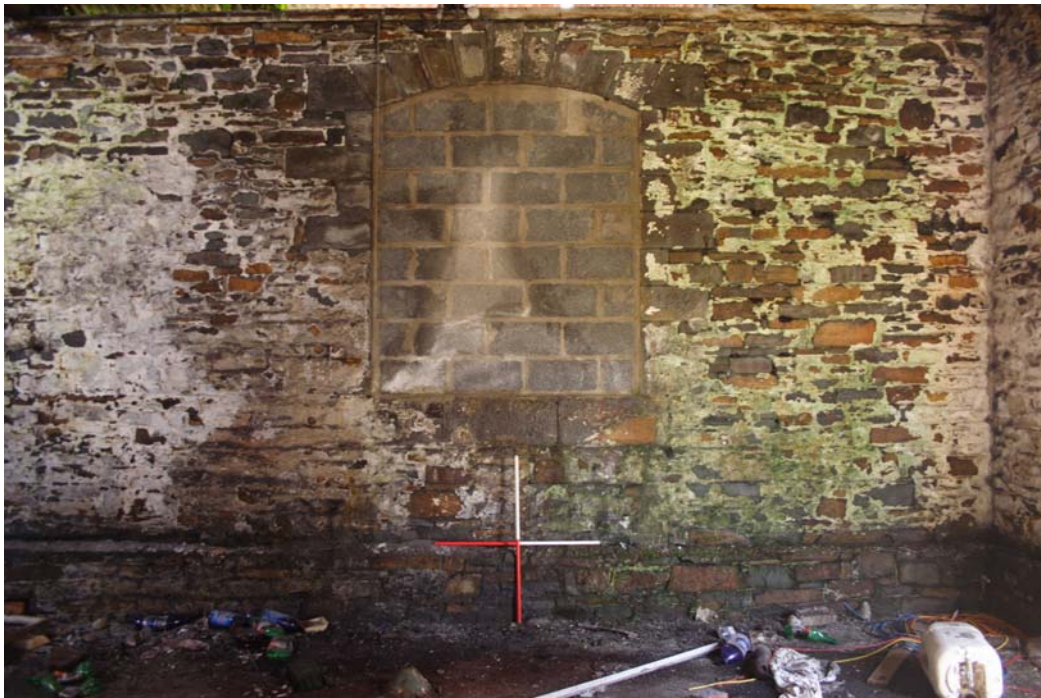
3942: Engine house. Southernmost blocked external window

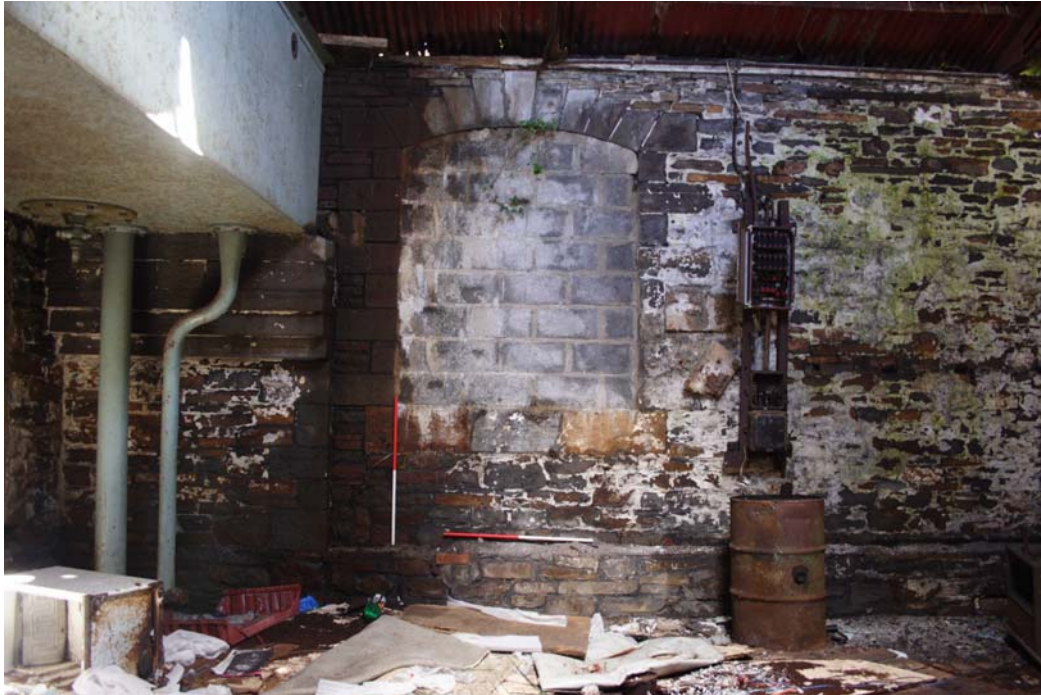
3943: Engine house. Northernmost blocked external window

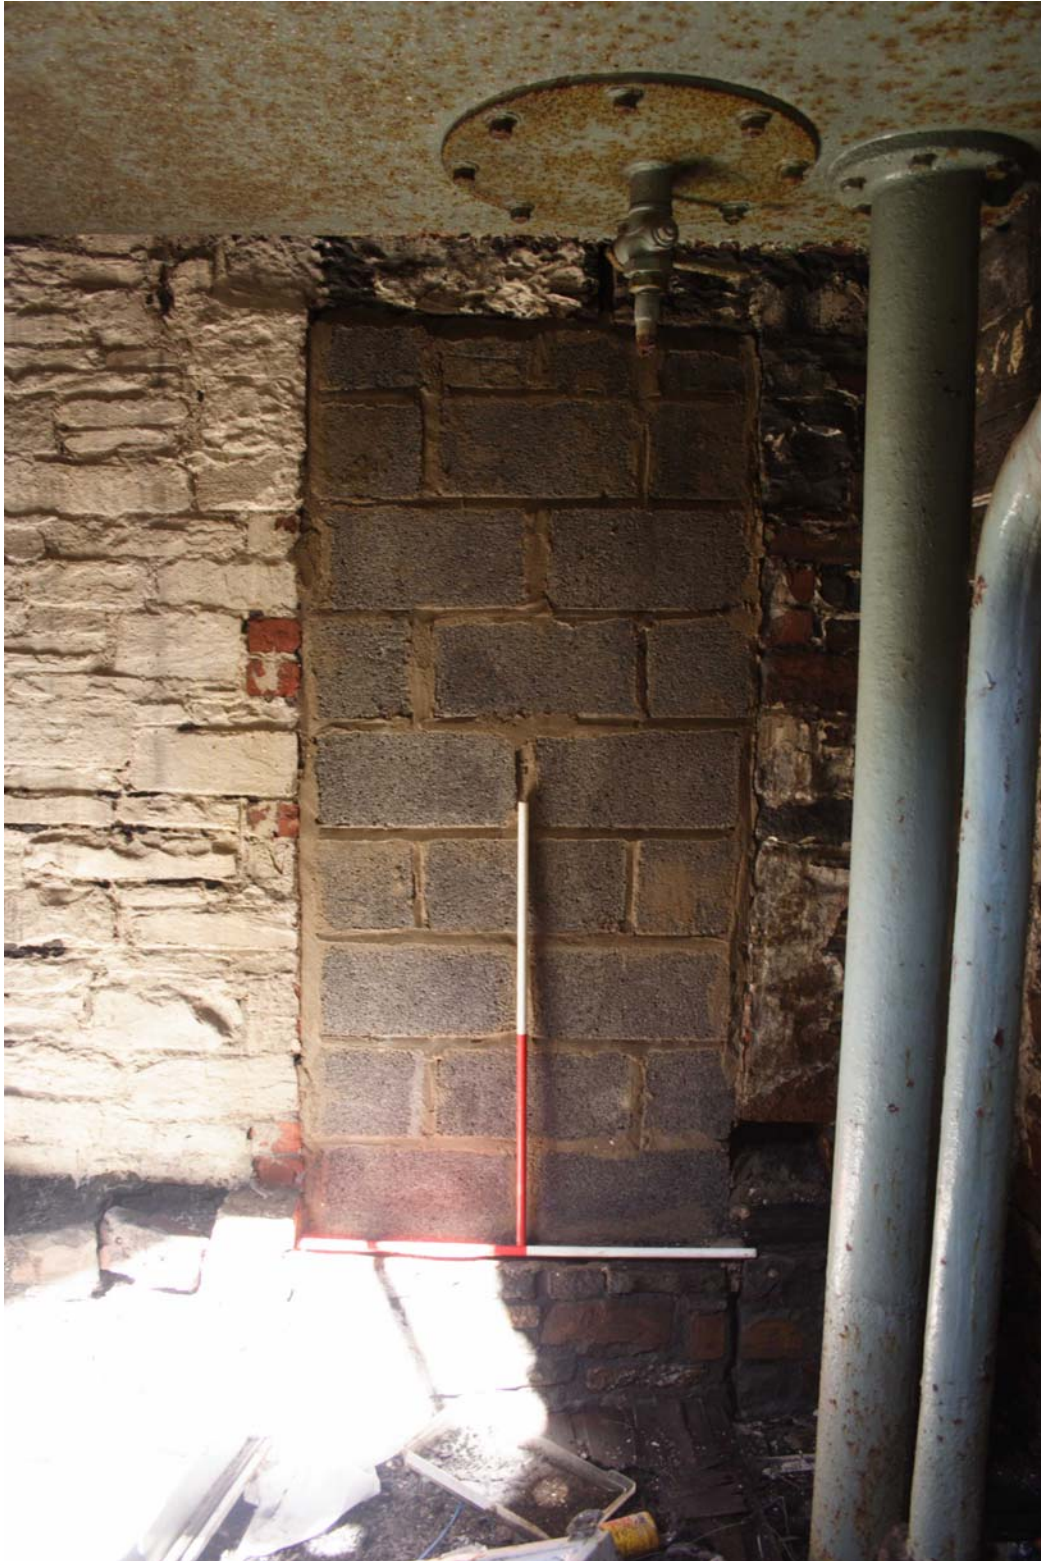
3944: Engine house. Blocked doorway to metal shed

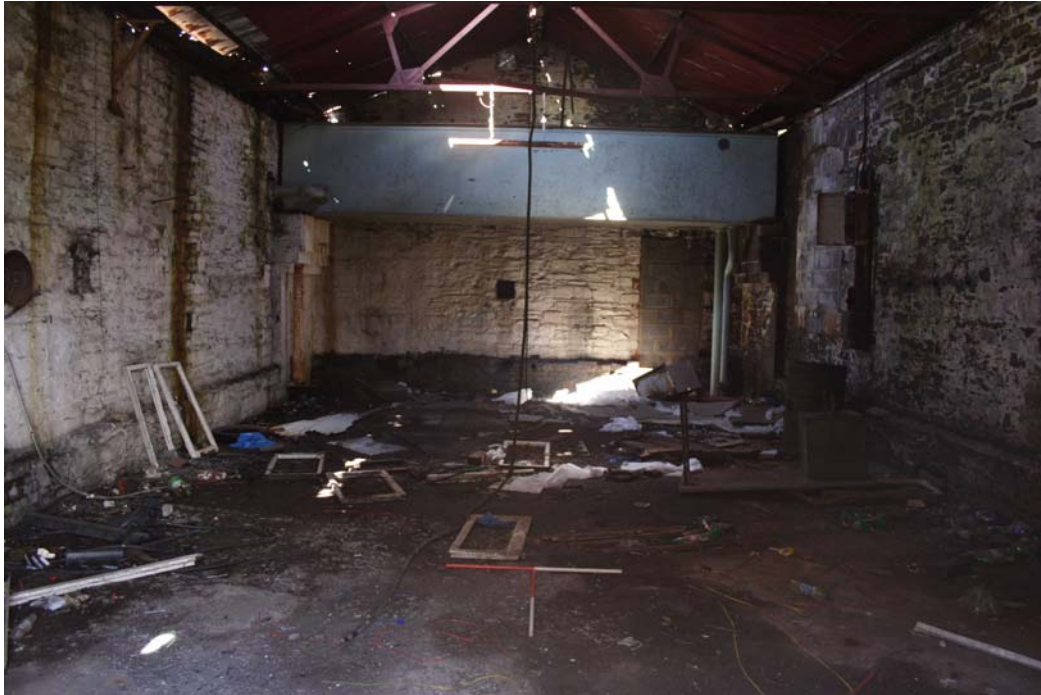
Internally the engine house measured c.13m x c.7m and was dominated by a large cast iron water tank that occupied the whole width of the northern end of the room. The tank was raised to near roof height and was supported on its eastern end by dressed stone corbelling. Whilst on the west it was supported by a cast iron column and further corbelling. It was possible to view that the cast iron pipe noted in the pump room and boiler house terminated at the tank which suggested it provided the water supply. A pair of additional pipes were present on the underside of the eastern part of the tank, these went into the floor.

3945: Engine house. Cast iron water tank and gable end

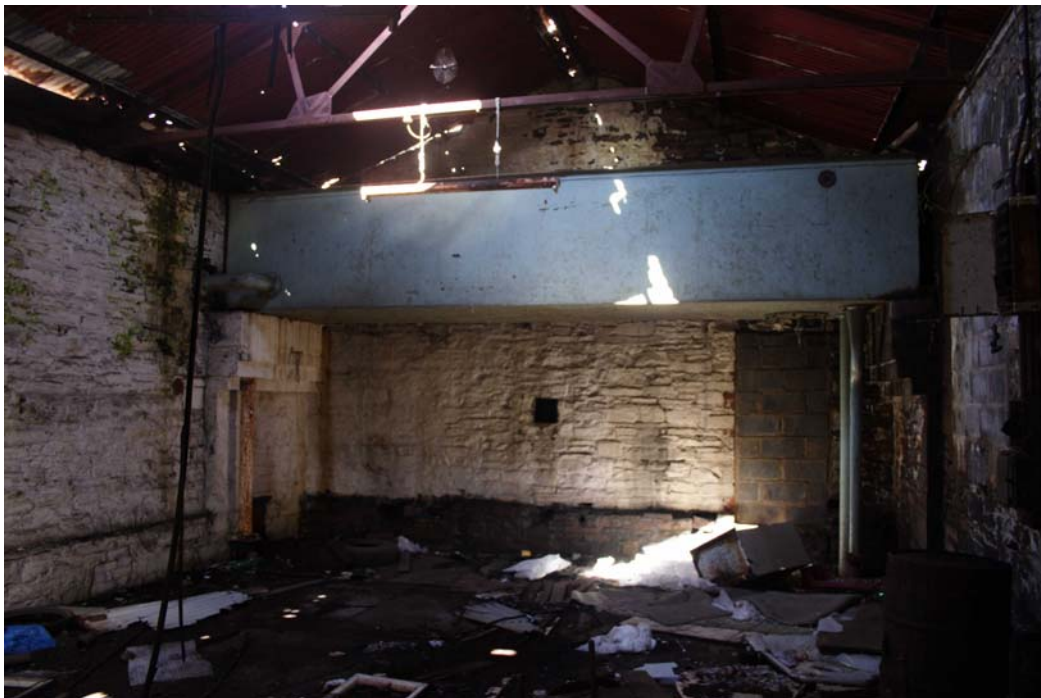
Plate 3946: Engine house. Cast iron water tank

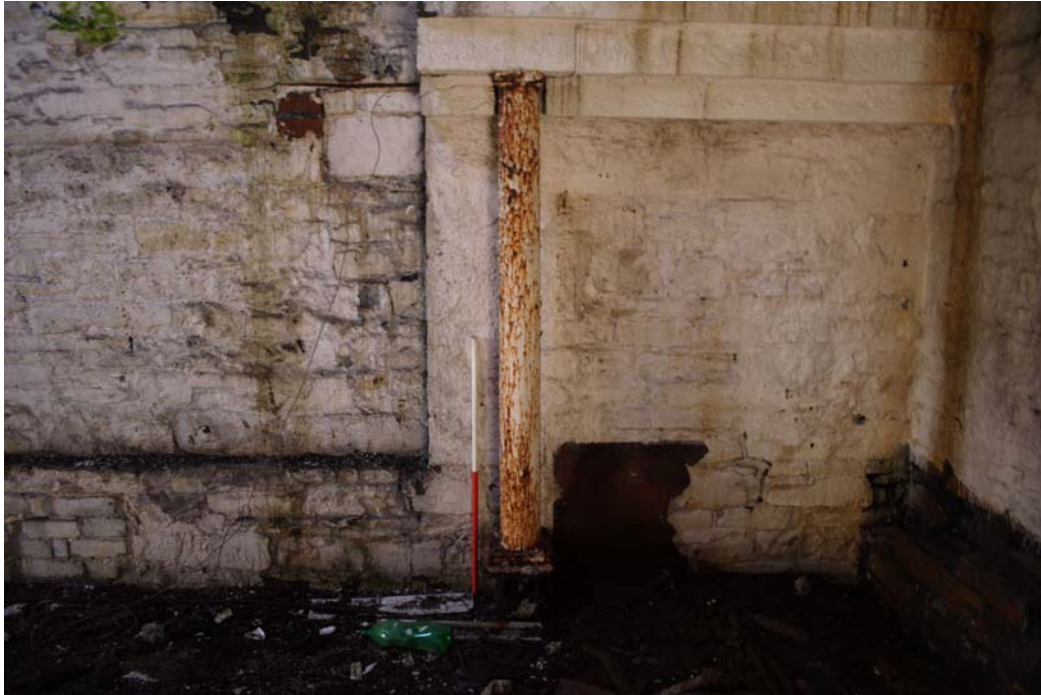
3947: Engine house. Cast iron supporting column beneath water tank

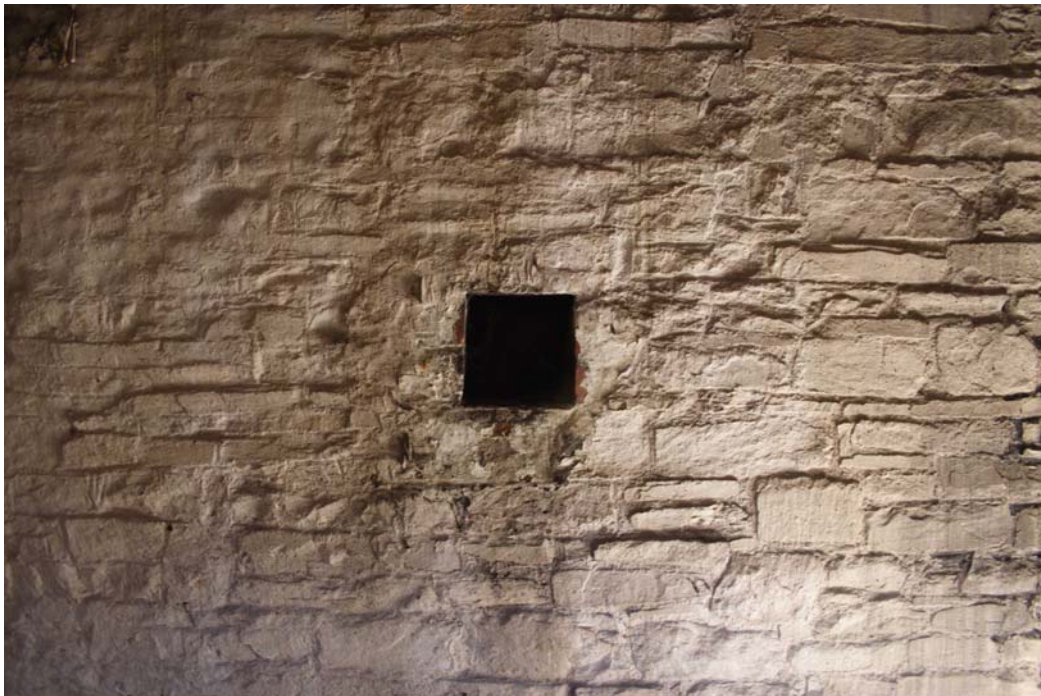
3948: Engine house. Possible viewing opening to accumulator tower

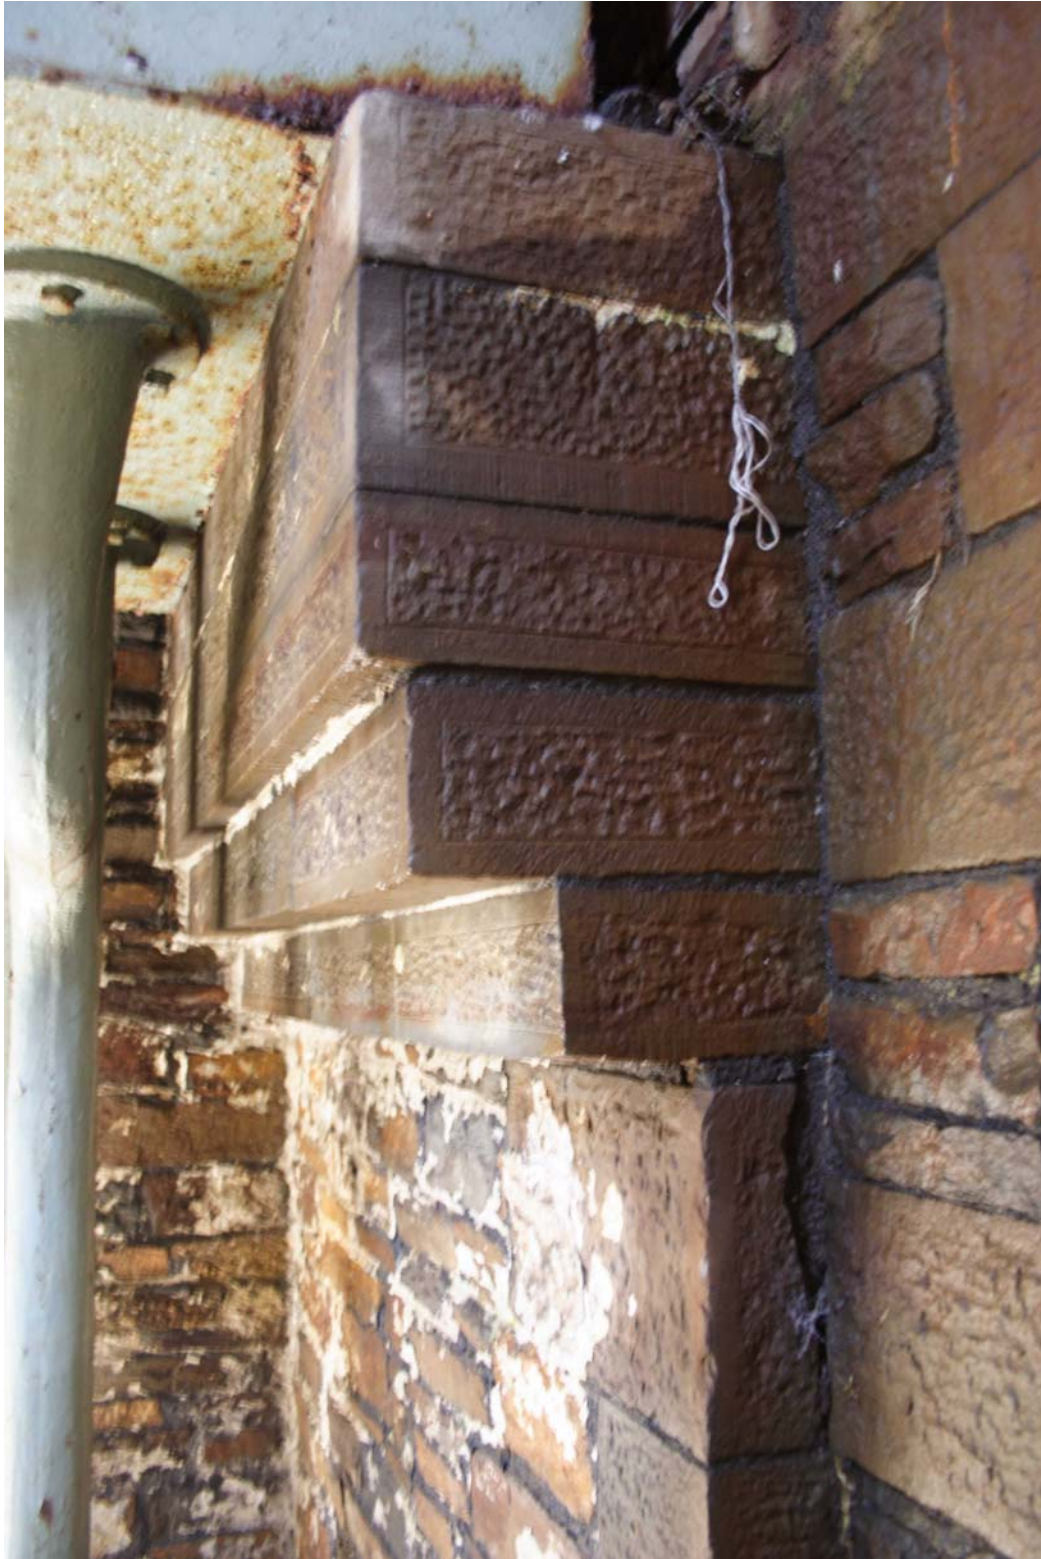
3949: Engine house. Dressed sandstone corbelling beneath water tank

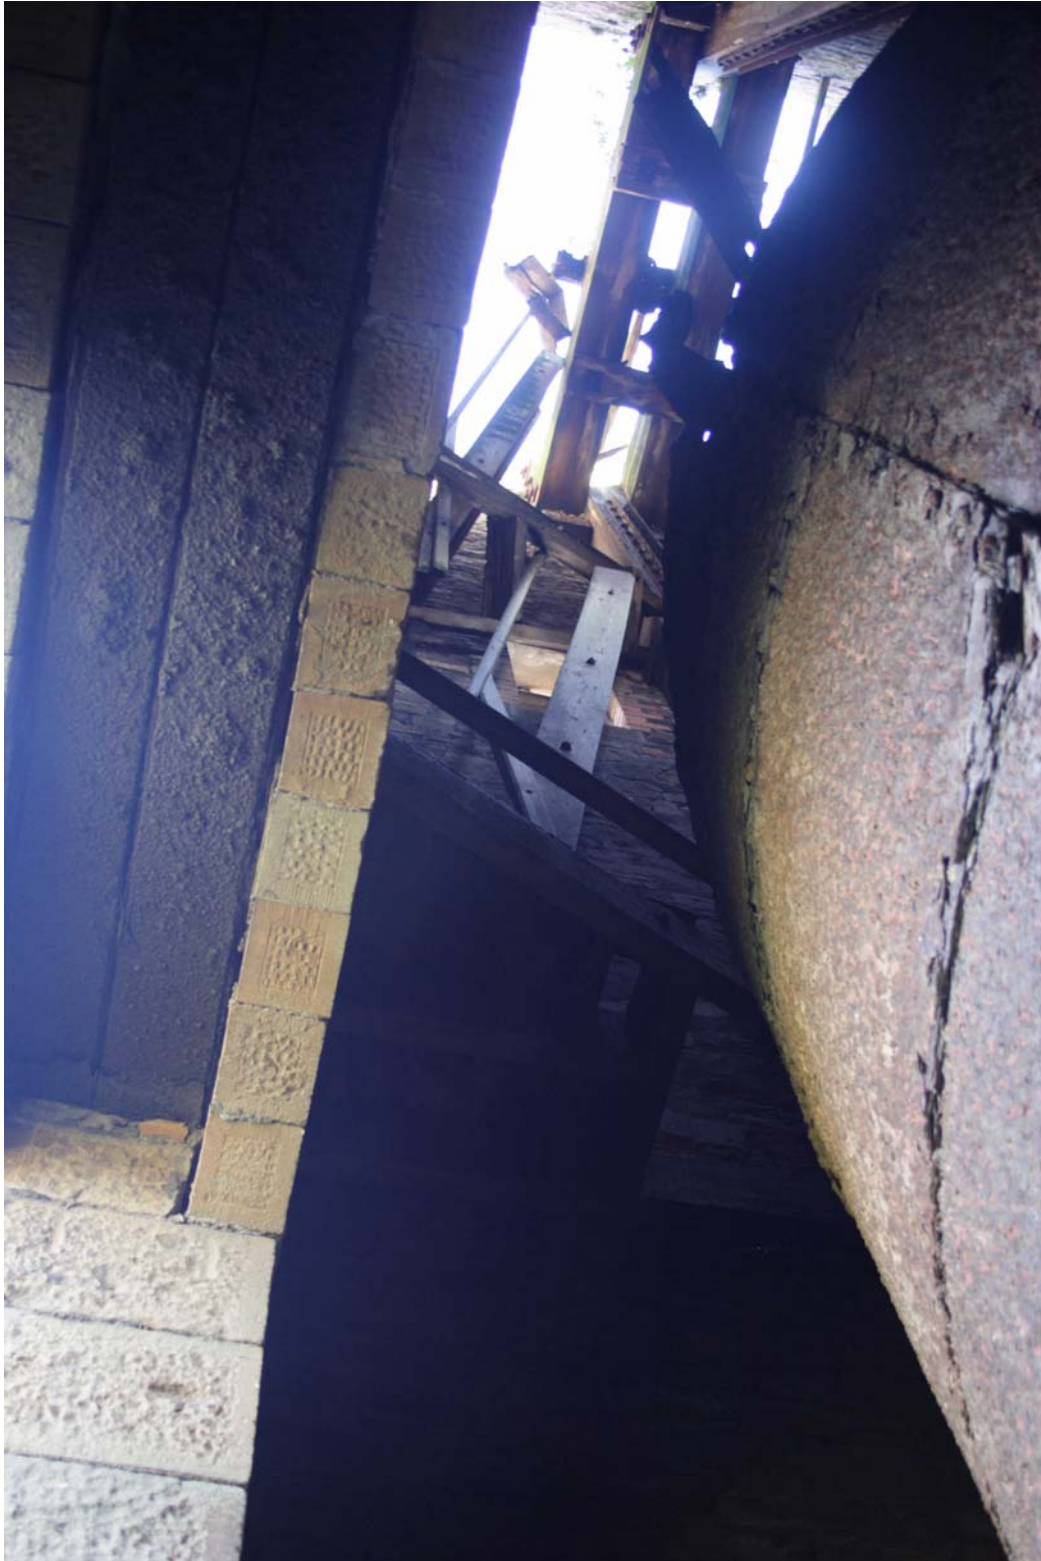
3954: Accumulator tower. Fixed ladders to access upper levels

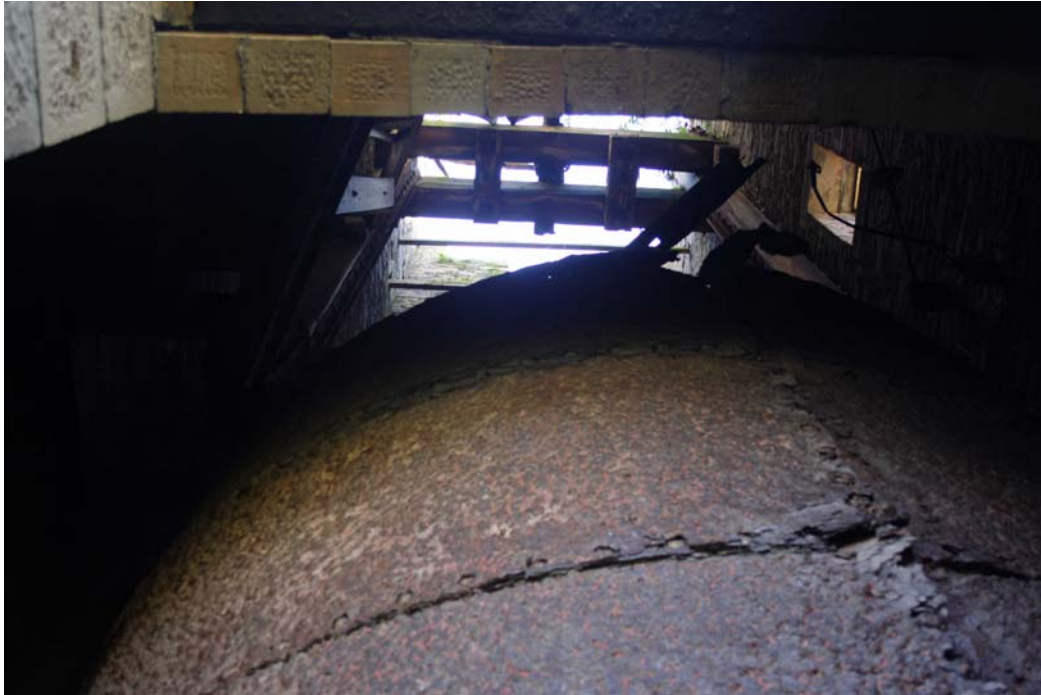
Access to the c.4m square tower was through a tall doorway piercing the northern wall that still retained its timber roller door. It was impossible to view the whole interior of the tower as the hydraulic cylinder and debris filled the space. The cylinder was constructed of riveted cast iron plates and was very heavily degraded with possibly only 50% of the structure remaining.

To the east and west of the cylinder a pair of timber guide rails, with iron teeth were present that once guided the weight used to compress the water held in the cylinder to provide power. The weight would have been raised by the engine housed in the room to the south. A timber framework was noted to be attached to the guide rails and would have once been used to house the weight.

3956: Accumulator tower. Guide rails and frame to hold weight. Collapsed cylinder below

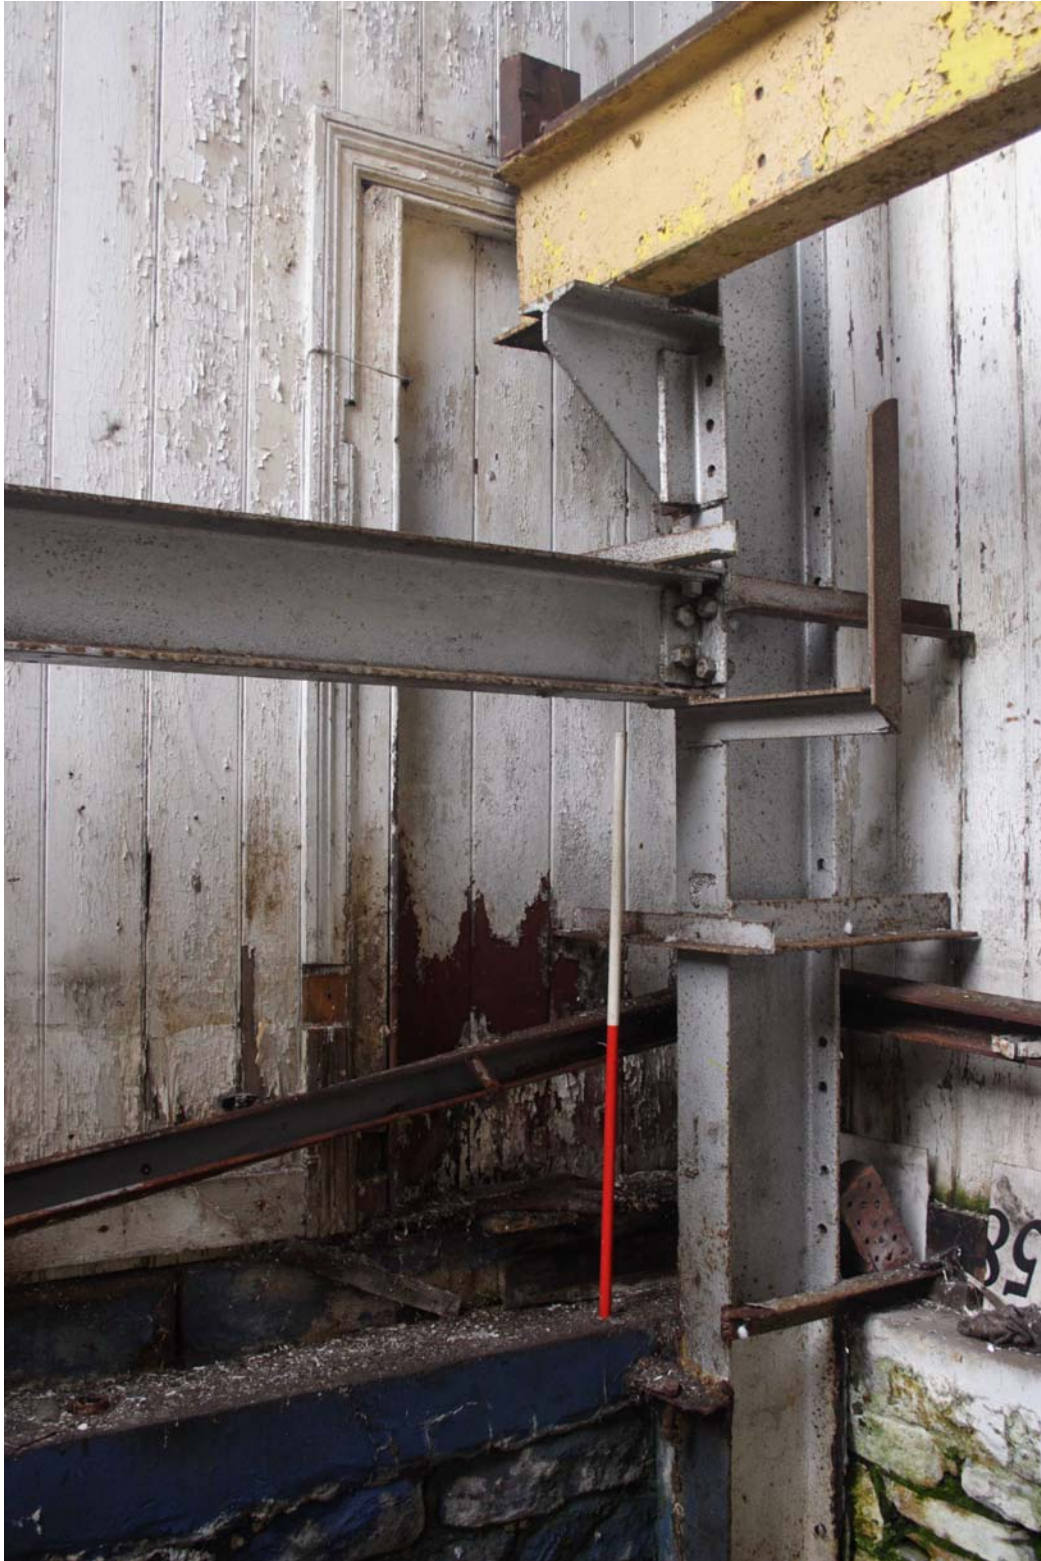
3966: Metal shed. Blocked doorway to engine house

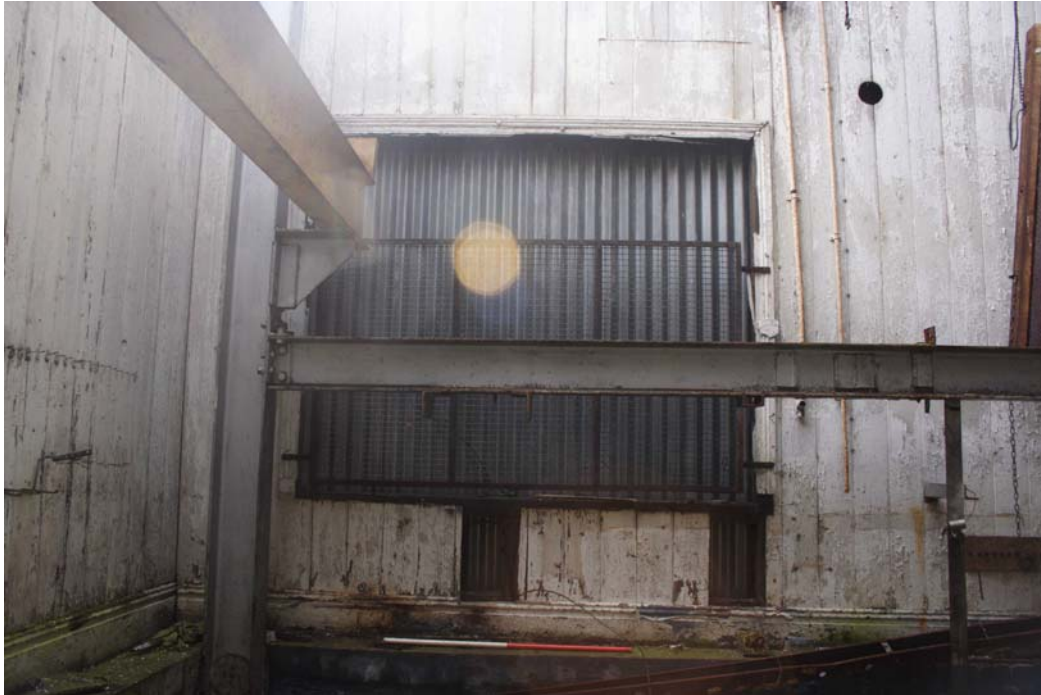
3967: Metal shed. Blocked window and original timber lining.

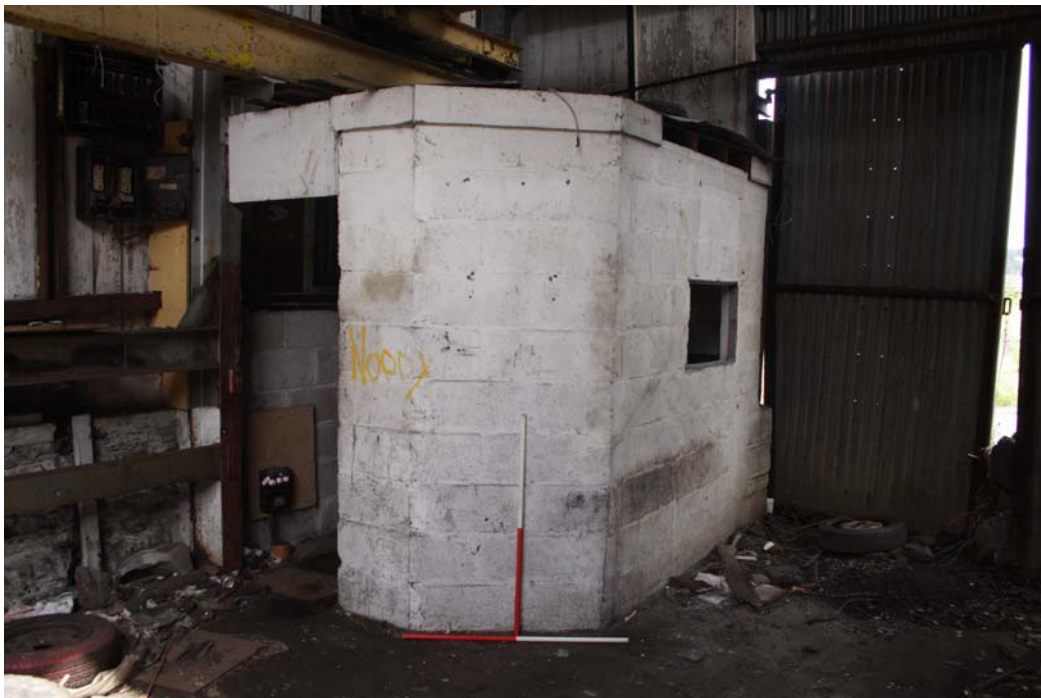
In the southeast corner of the shed a concrete block office had been constructed and a hoist system was present running the length of the shed. These relate to the J W Motors car repair workshop that once occupied the shed before relocating to Trostre in 2000.

3972: Metal shed. Later concrete block workshop office

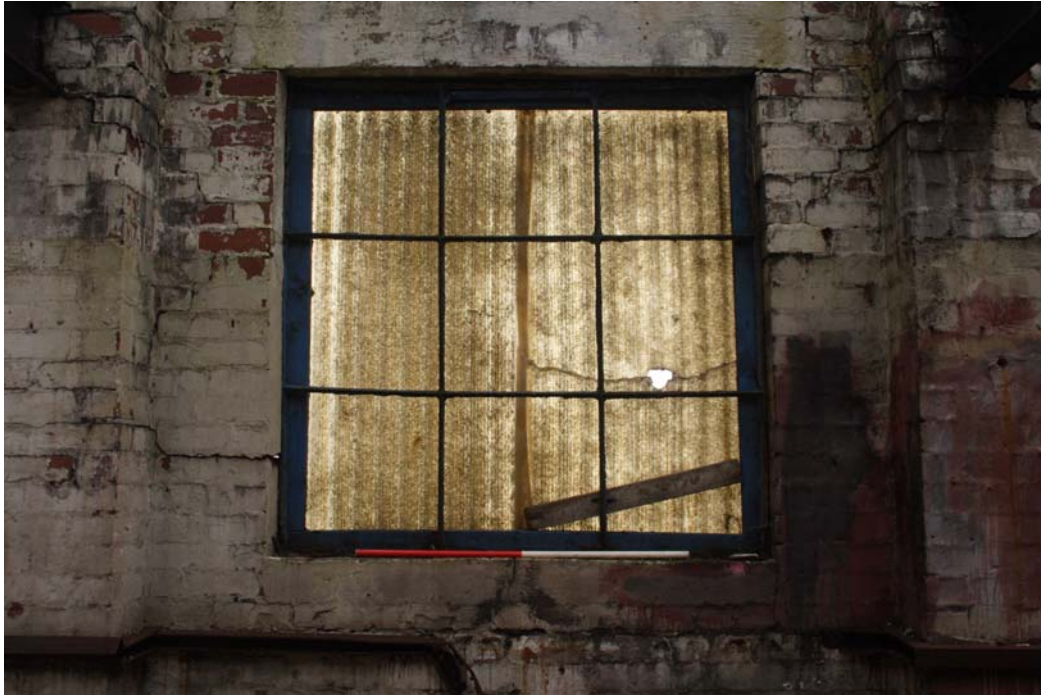
3979: Brick addition. Northernmost window internal

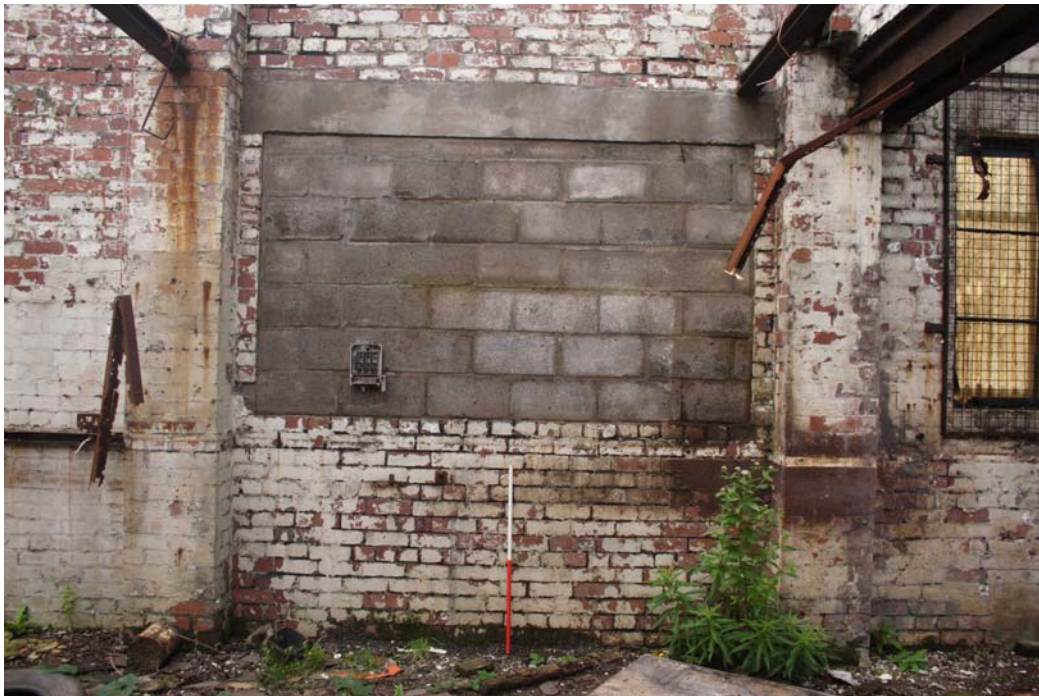
3982: Brick addition. Blocked window internal

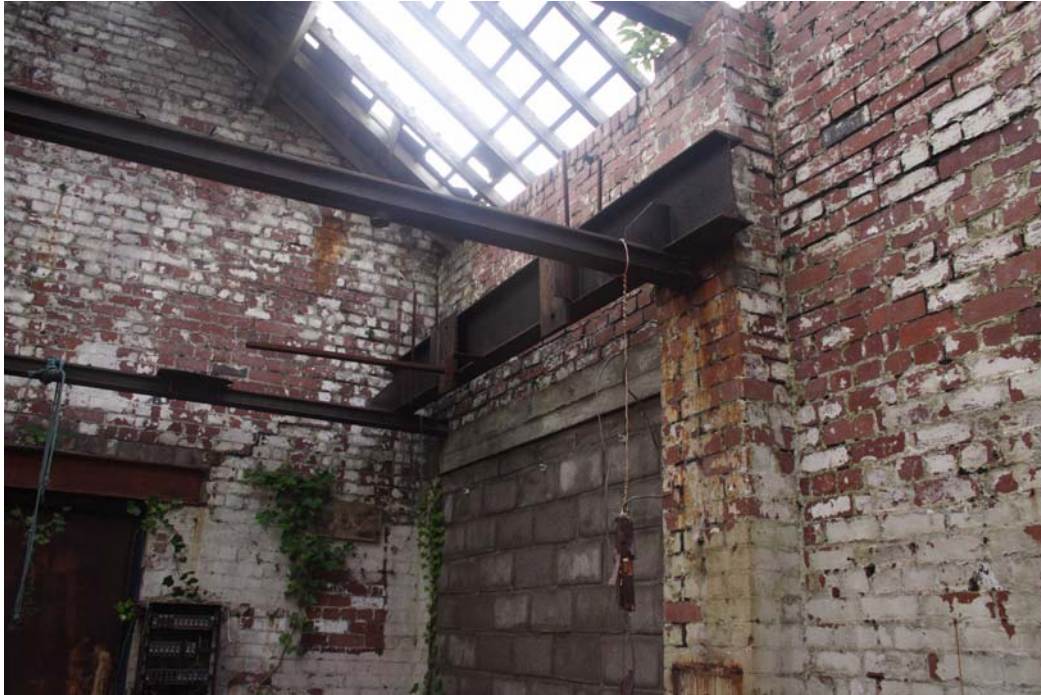
3983: Brick addition. Railway line reused as cross beam
