BOULSTON MANOR, PEMBROKESHIRE: BUILDING RECORDING

RHIF YR ADRODDIAD / REPORT NO. 2012/27
RHIF Y PROSIECT / PROJECT RECORD NO. 102767

Mawrth 2012
March 2012

P Poucher & H Wilson

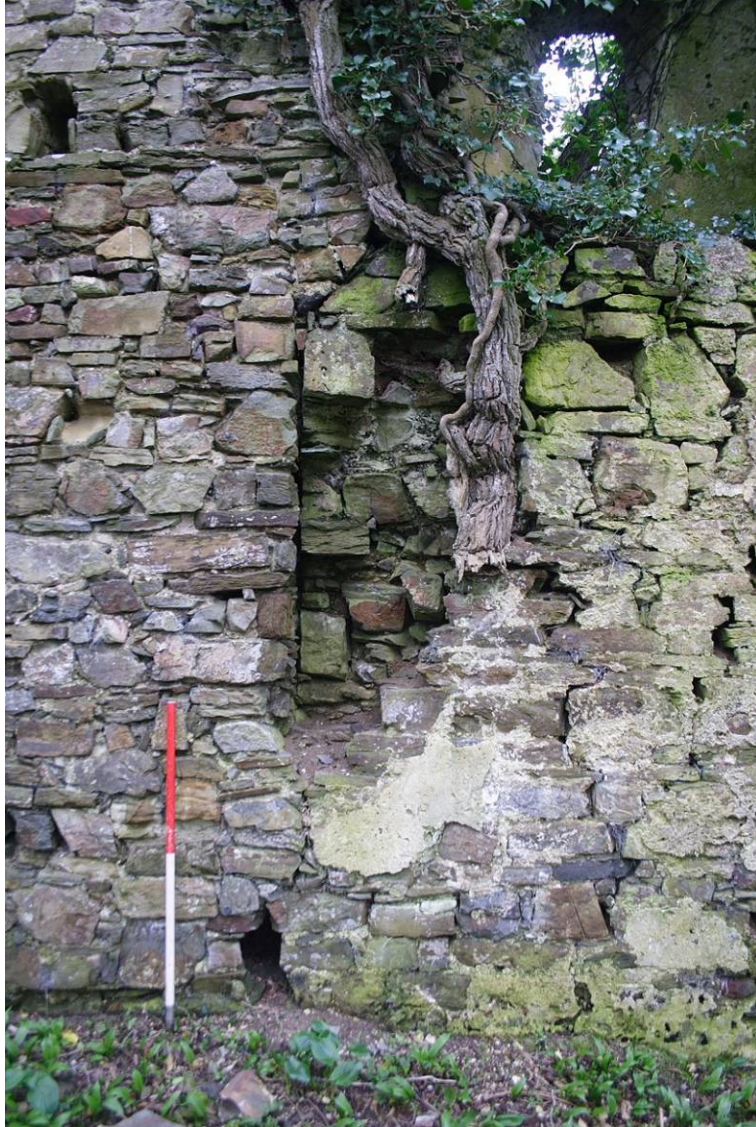
Photo 7: Close up of join in the western face. 1m scale.

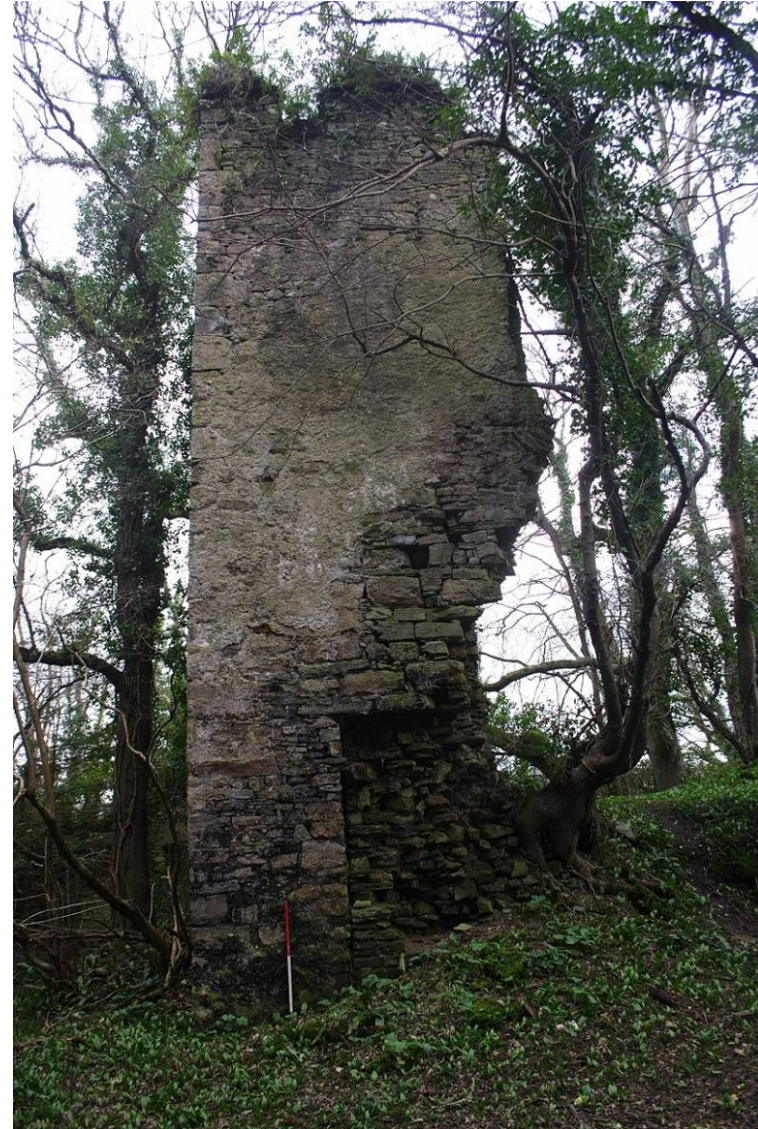
The eastern tower was a stair tower, impressions and some footings for the stairs remain (photo 11). The tower is 8.7m by 3.2m in area and four storeys high. The north and south tower walls have been built around and over (incorporating) the earlier undercroft walls (photo 10), the southern of these earlier wall segments being thicker and higher, almost to second floor level. The internal (west) tower wall has been built directly on top of the east wall of the undercroft. The stonework of the earlier walls generally consisted of smaller lime mortared rubble. The remainder of the tower is built of mortared random rubble and is still largely rendered.

Photo 10: Northern face of Eastern Tower, clearly showing earlier segment of walling. 1m scale.

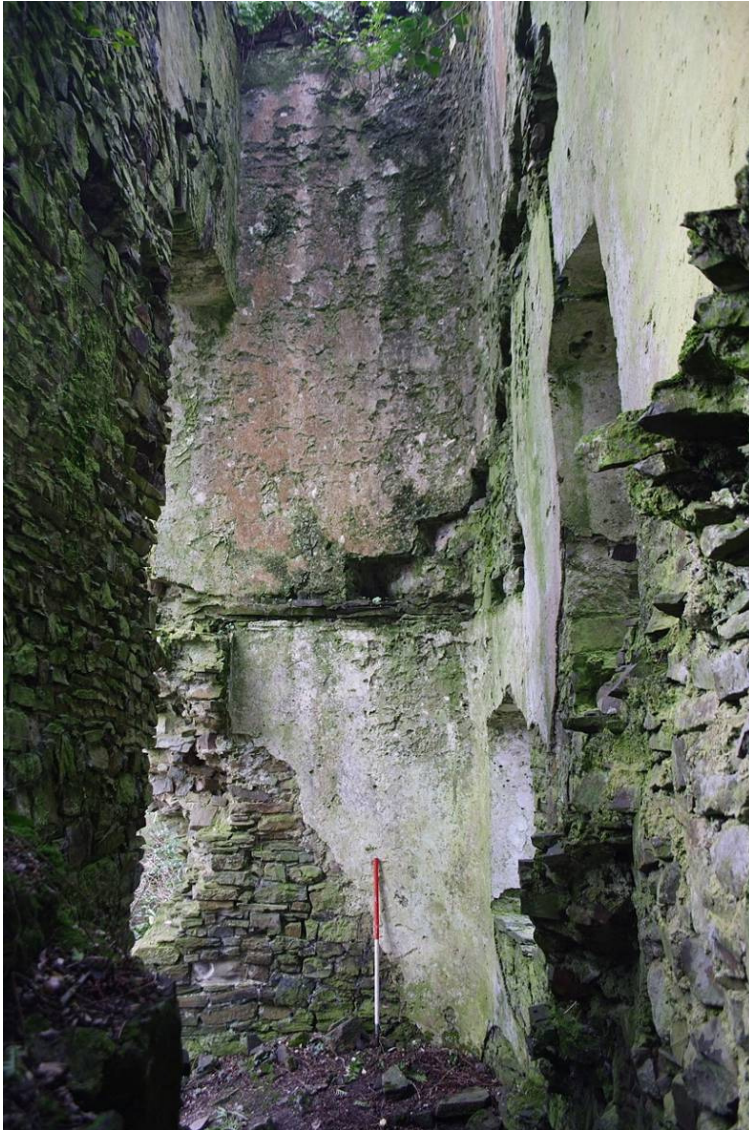
The interior of the staircase tower is rendered in smooth white plaster on all but the western side (photos 11 & 12). At second floor level this appears to have been painted pink/red (photo 13). The internal northeast corner is rounded the full height of the tower.

Photo 13: Interior of Eastern Tower showing pinker internal render on 2nd floor. 1m scale.

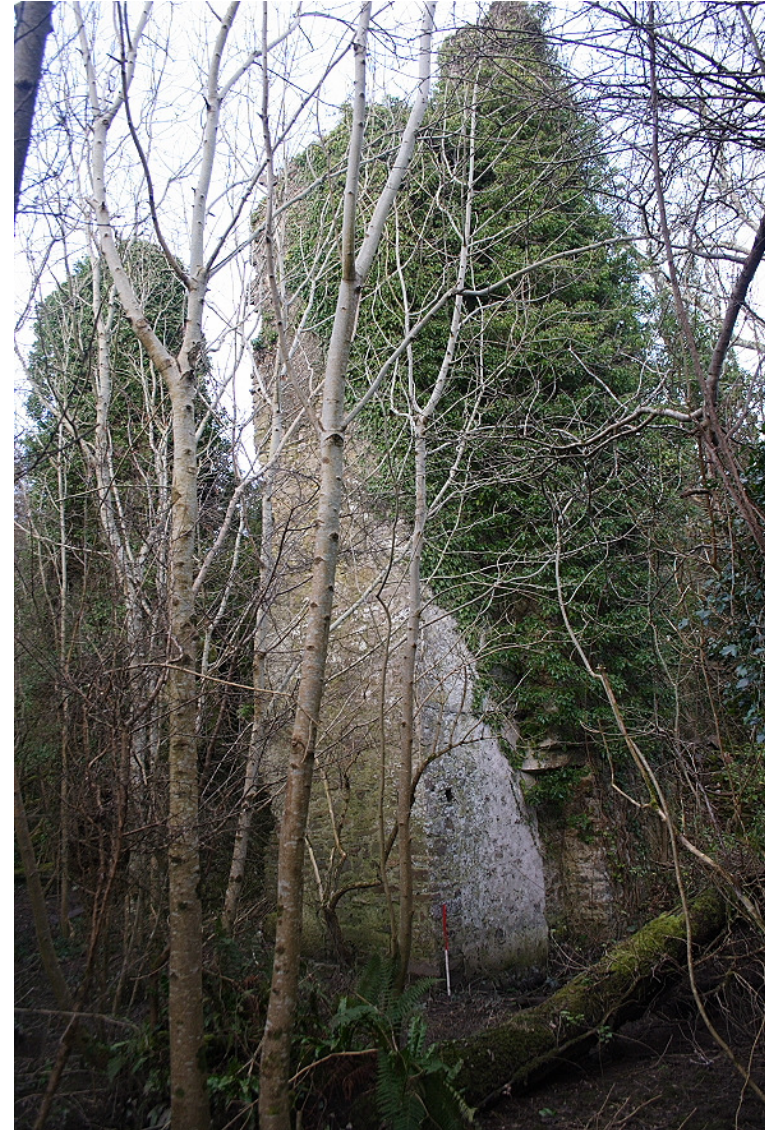
At the west end of the main hall the corners and most of the gable wall of a tower survives, with a large opening in the gable wall running the full height of the tower (photos 14 & 15). It is built in a similar style of lime-mortared random rubble and partially rendered externally, plastered internally. This tower survives to a similar 4-storey height, 7.3m north - south and c.6.2m east - west.

Photo 14: General view of Western Tower, looking northeast. 1m scale.

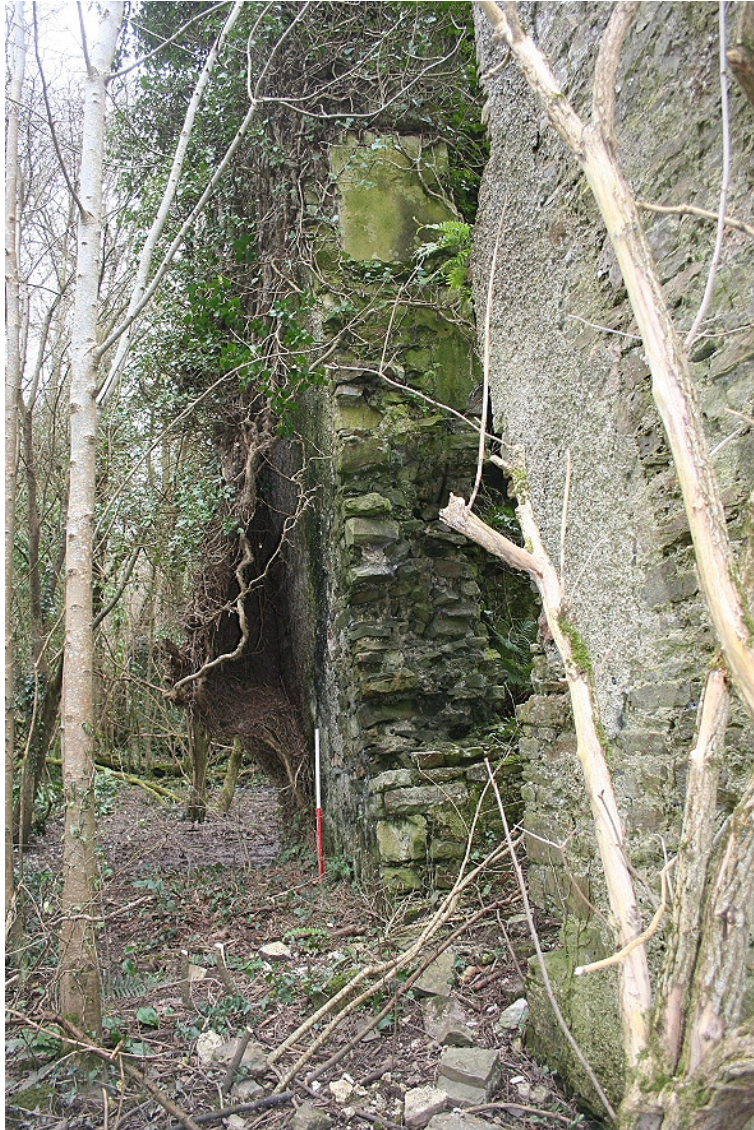
Photo 17: Looking north along the western wall of the Western Tower, showing the outward lean. 1m scale.

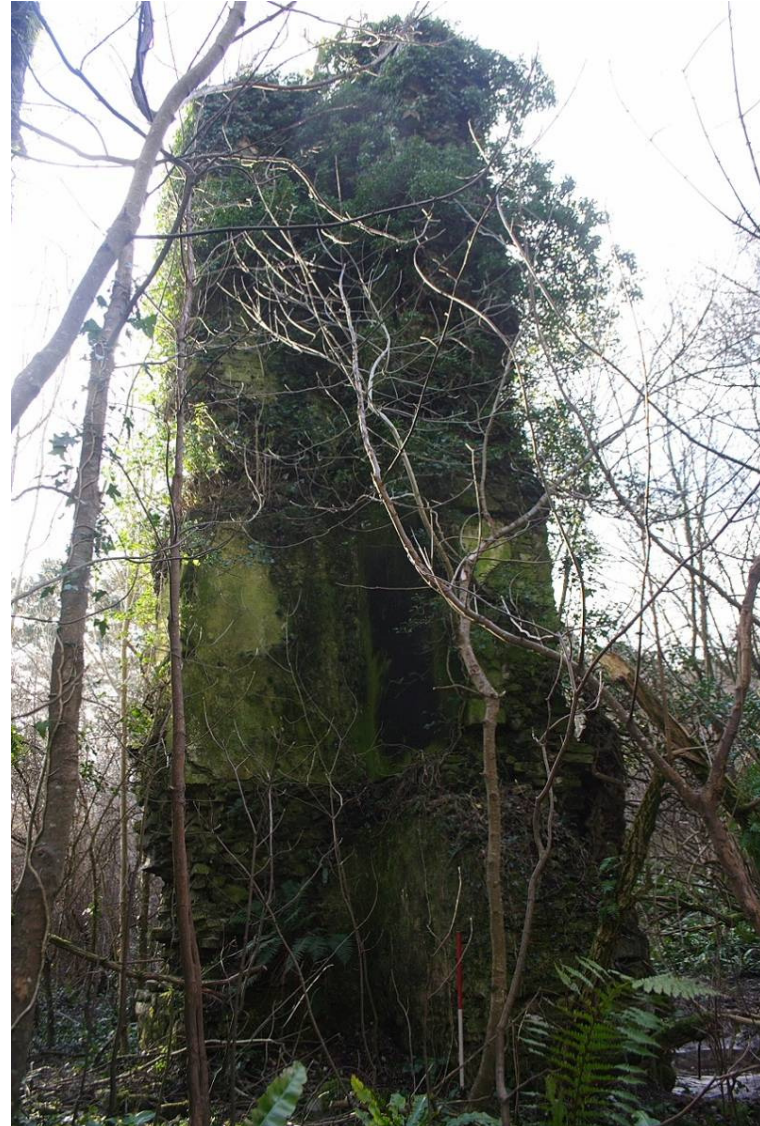
The north wall ends abruptly after 3.4m, presumably at a ground floor doorway (photo 20). There is evidence of further windows above this doorway in the floors above. A very thick growth of ivy now covers the northern face of this wall. A stream is culverted under this wall (photo 21), exiting under the southern wall (photo 22), presumably to flush internal garderobes. This has clearly become partially blocked and pools around the base of the tower (photos 21 & 23). There is evidence of a former lean-to on the external face of the tower above the point where the culvert exits (photo 24).

Photo 20: Interior of the northern part of the Western Tower, also showing the rendered side of a window in the western wall at 1st floor level. 1m scale.

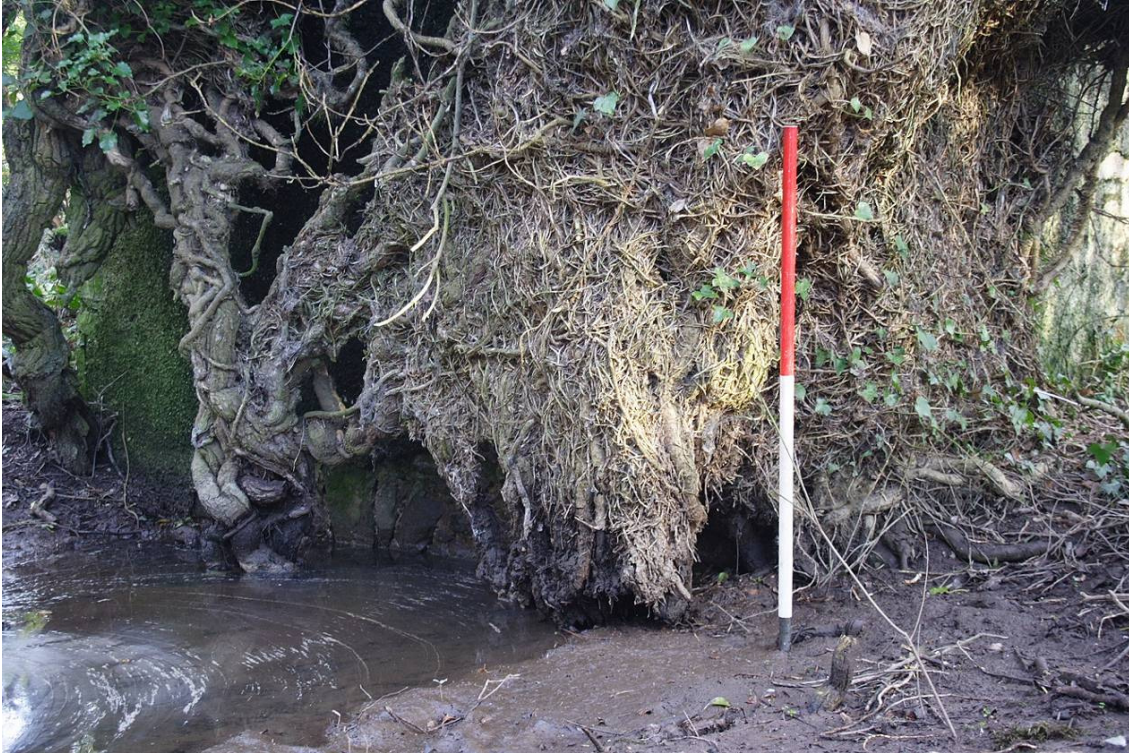
Photo 21: Stream pooling around the northern side of the Western Tower, also showing thick growth of ivy. 1m scale.

Care should be taken in the removal of vegetation such as ivy on the walls to avoid pulling out loose masonry and mortar.

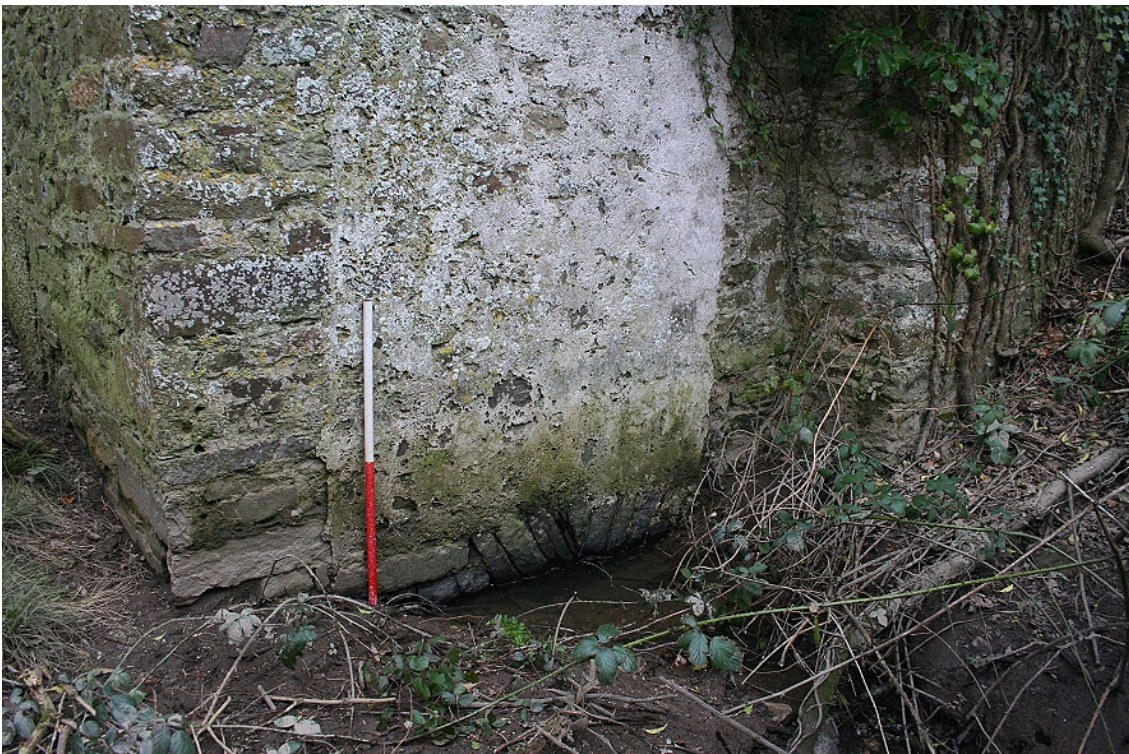
Photo 22: Stream emerging from the culvert on the south side of the Western Tower. 1m scale.

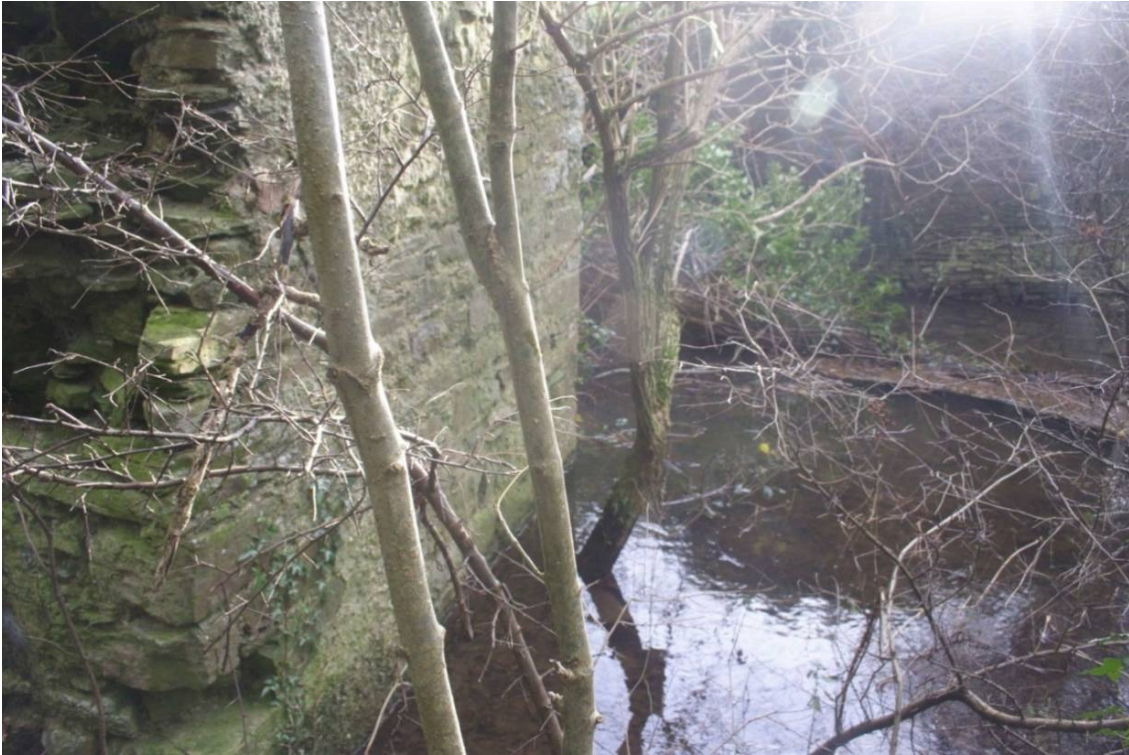
Photo 23: Water collecting around the base of the Western Tower during period of wet weather.

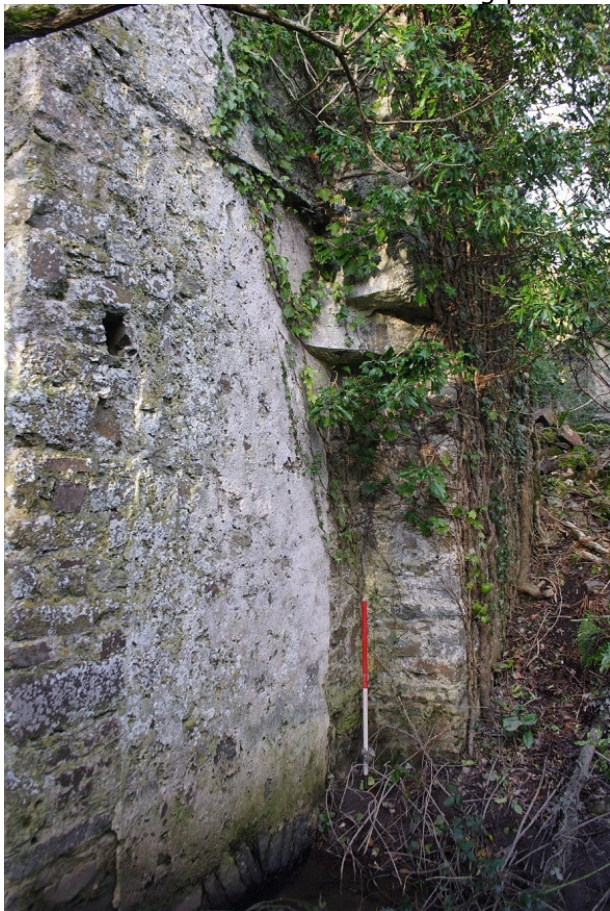
Photo 24: Southern face of the Western Tower, showing the top of the stream culvert, evidence of the former lean-to structure and protruding chimney stack. 1m scale.

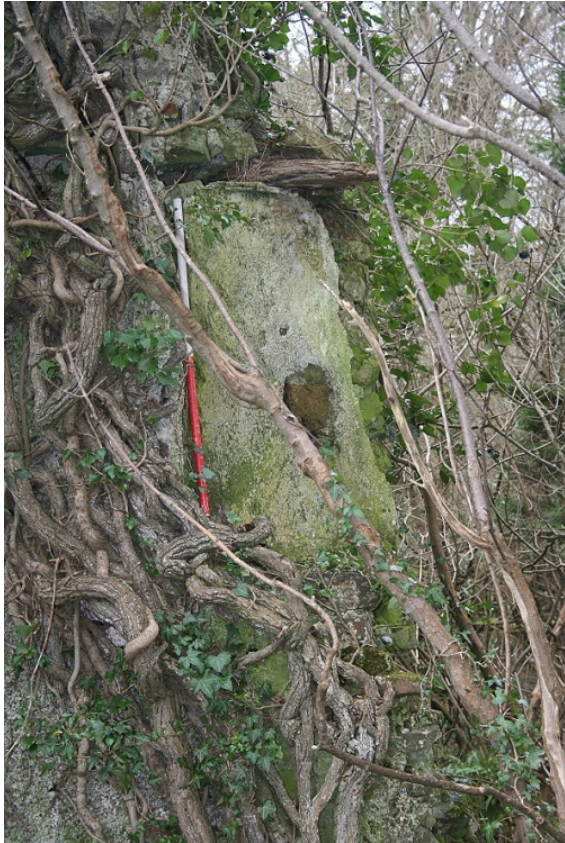
Photo 25: 1st floor window remains in the southern wall of the Western Tower, also showing surviving timber lintel. 1m scale.

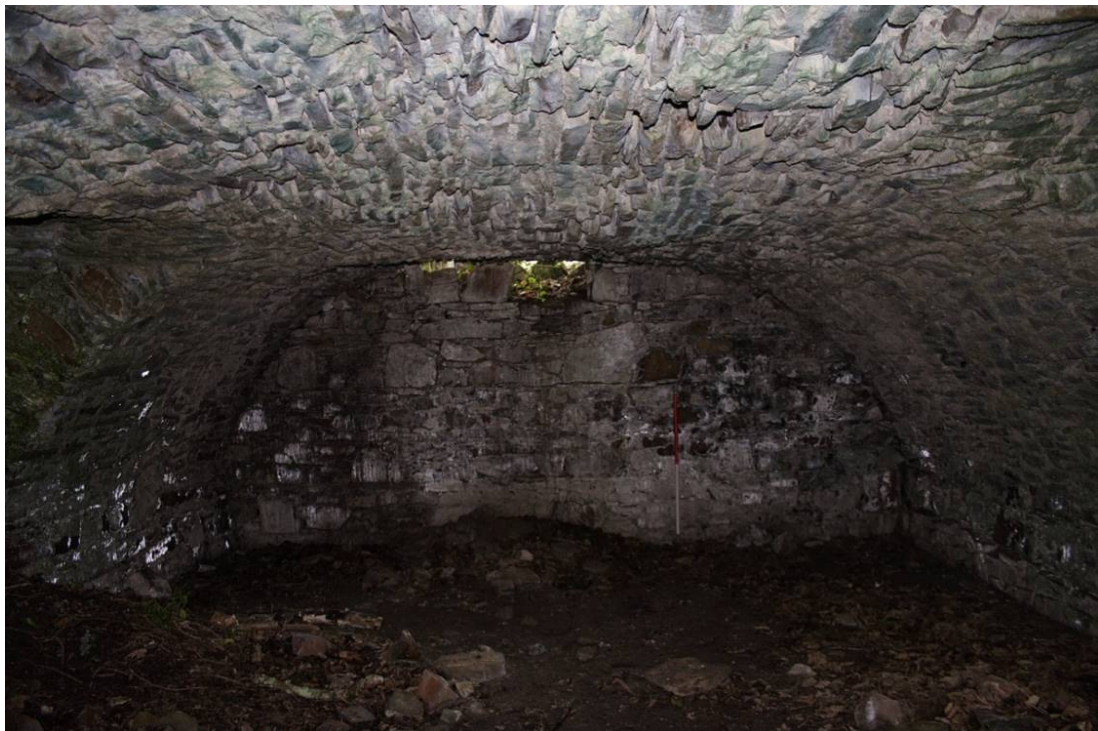
Photo 32: The interior of the undercroft looking west, showing the collapse in the ceiling and upper courses of the western wall. 1m scale.

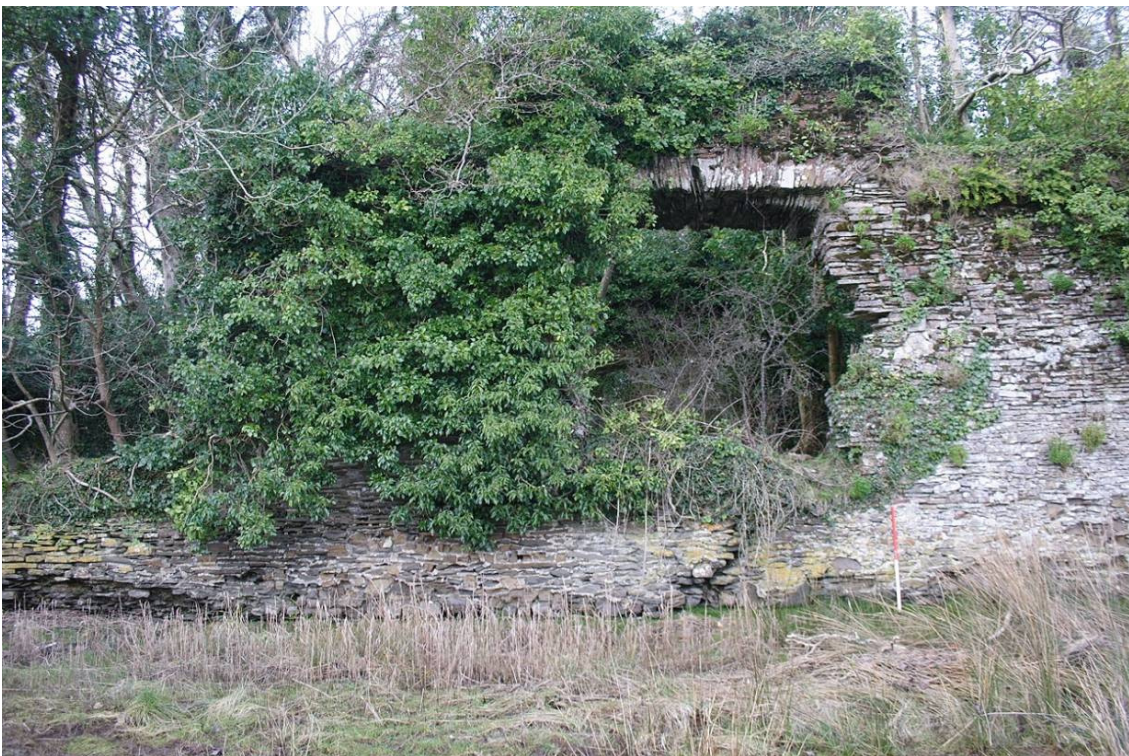
Photo 38: Main entrance into the Garden Enclosure viewed from the rivers edge. 1m scale.

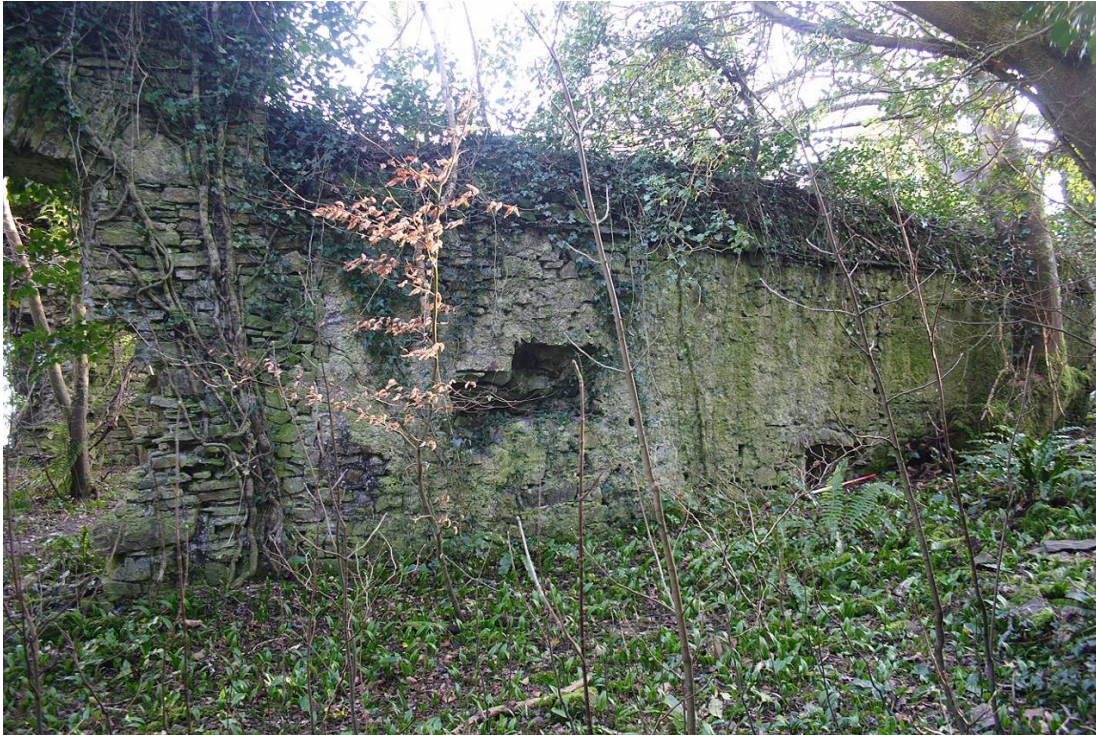
Photo 39: Northern wall of the Garden Enclosure, viewed from the north. 1m scale laid in front of the 'aumbry'.

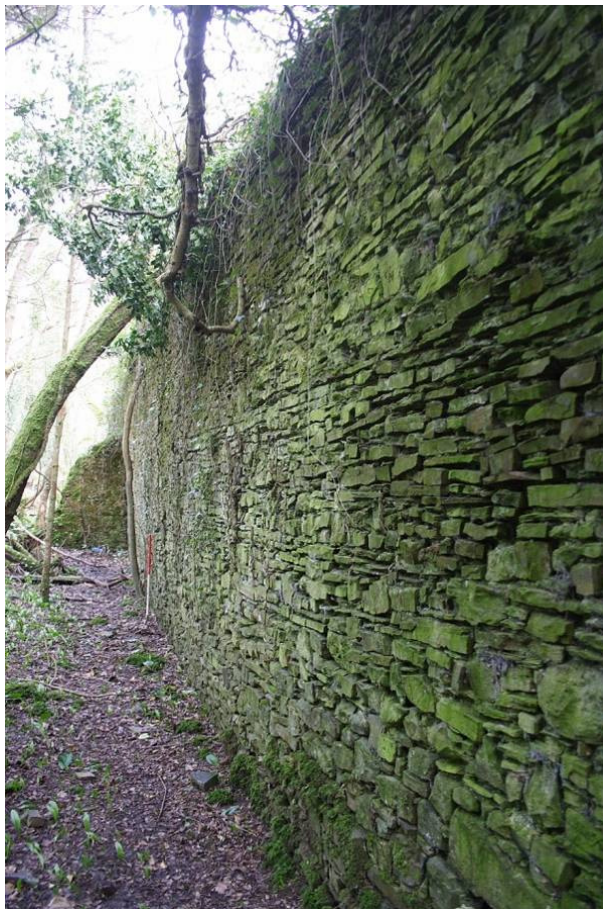
Photo 40: Northern wall of the Garden Enclosure looking southeast. Buttress visible to the left. 1m scale.

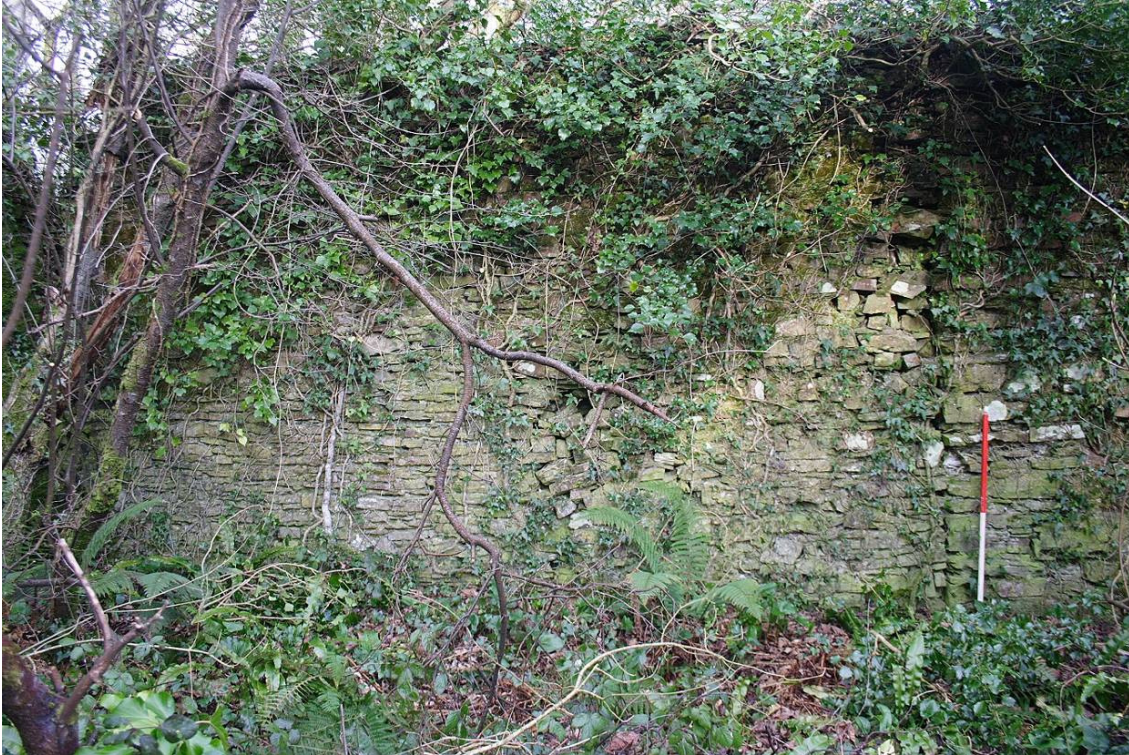
Photo 41: Interior of the eastern wall of the Garden Enclosure, showing the vertical joint of a possible entranceway. 1m scale.

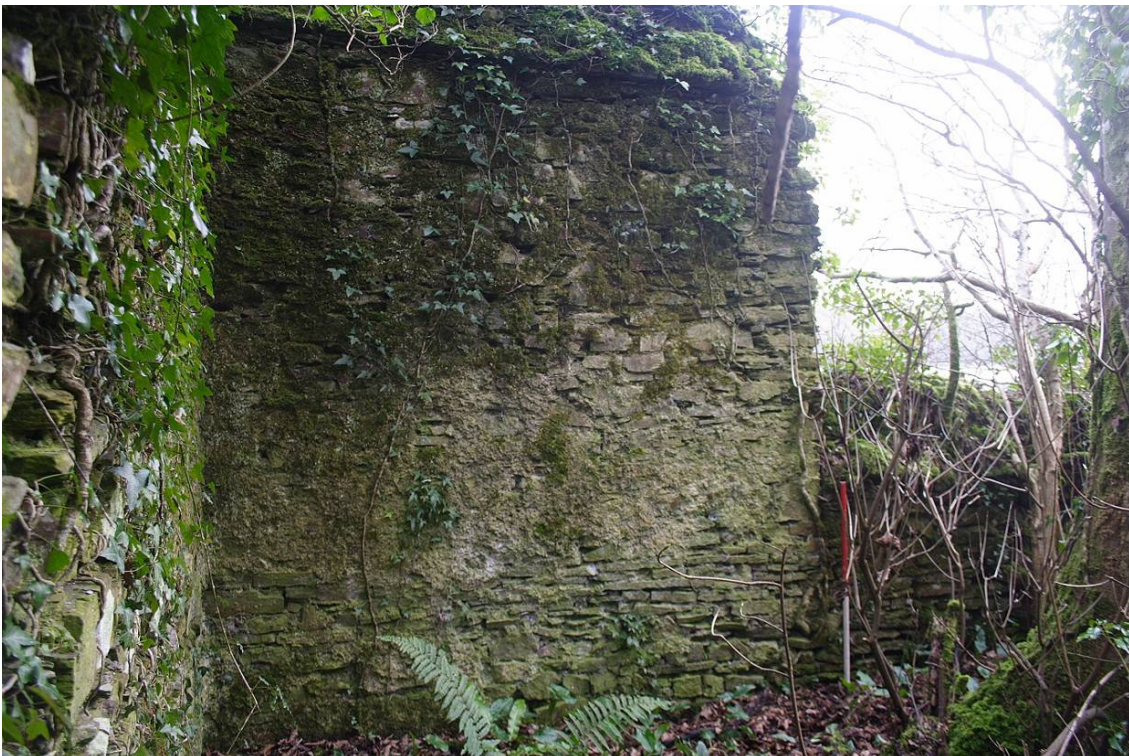
Photo 42: Interior of the southern wall at the southeast corner of the Garden Enclosure. Straight vertical joint visible to the left of the 1m scale.

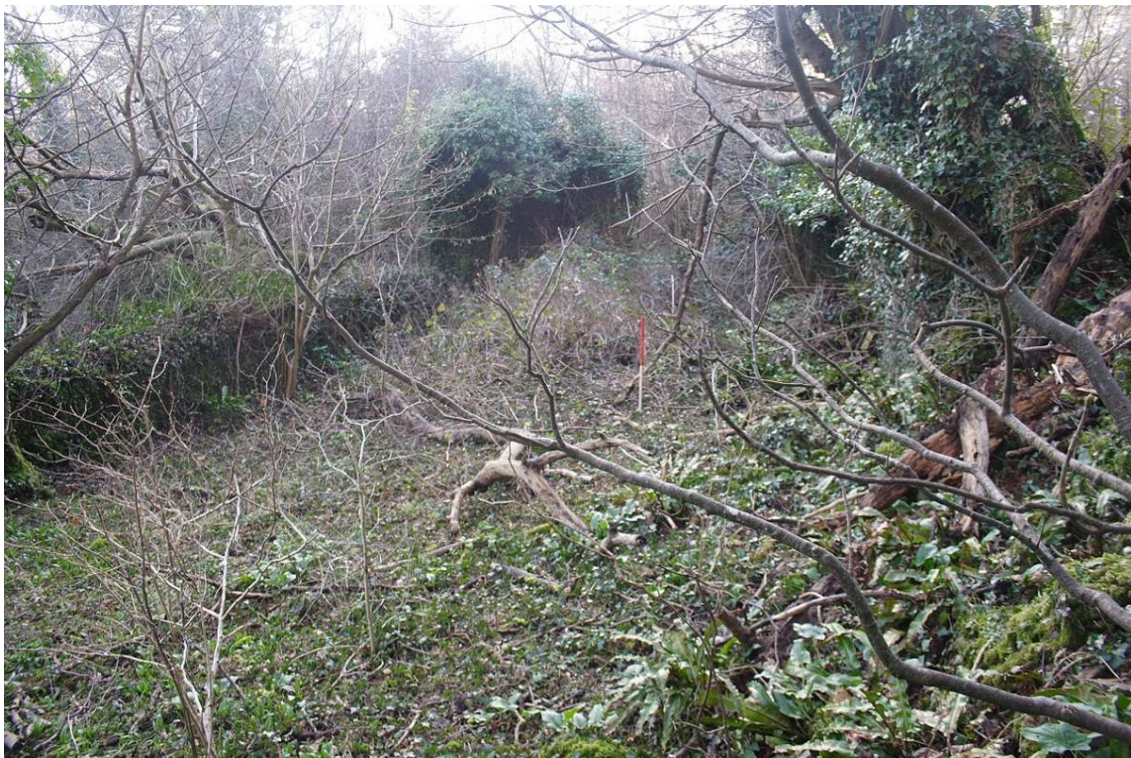
Photo 44: Interior of the Southwest Enclosure, looking southwest. 1m scale.

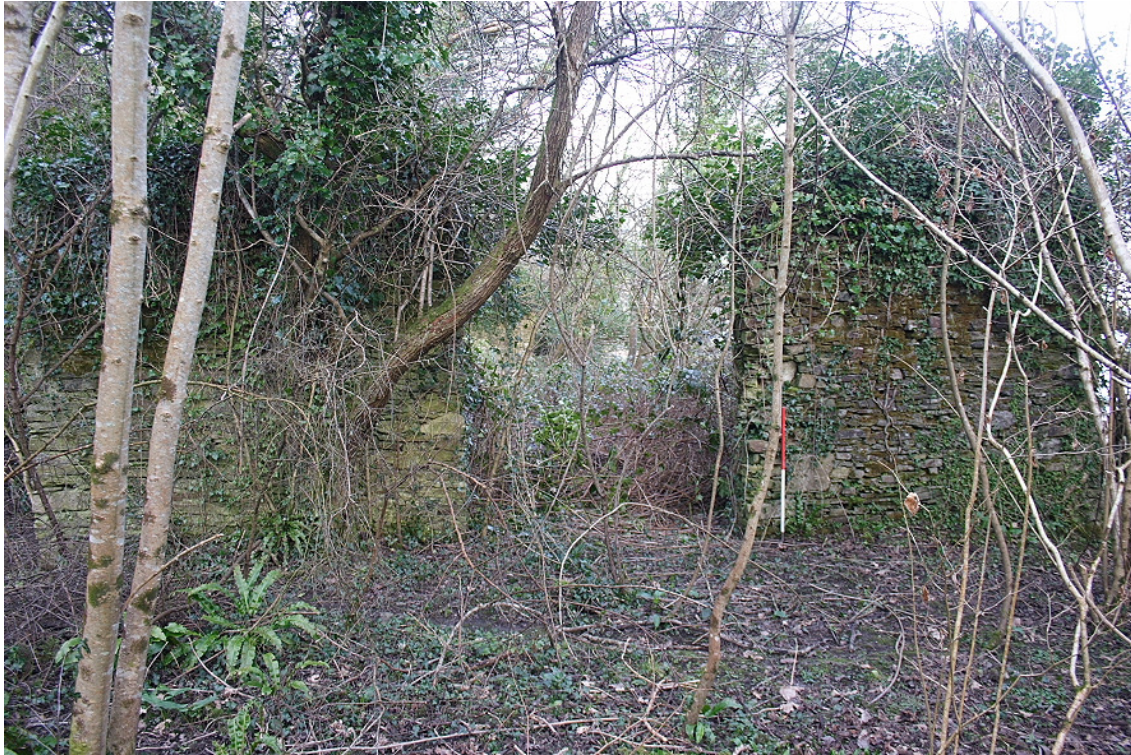
Photo 45: Entranceway through the western wall of the Southwest Enclosure. 1m scale.

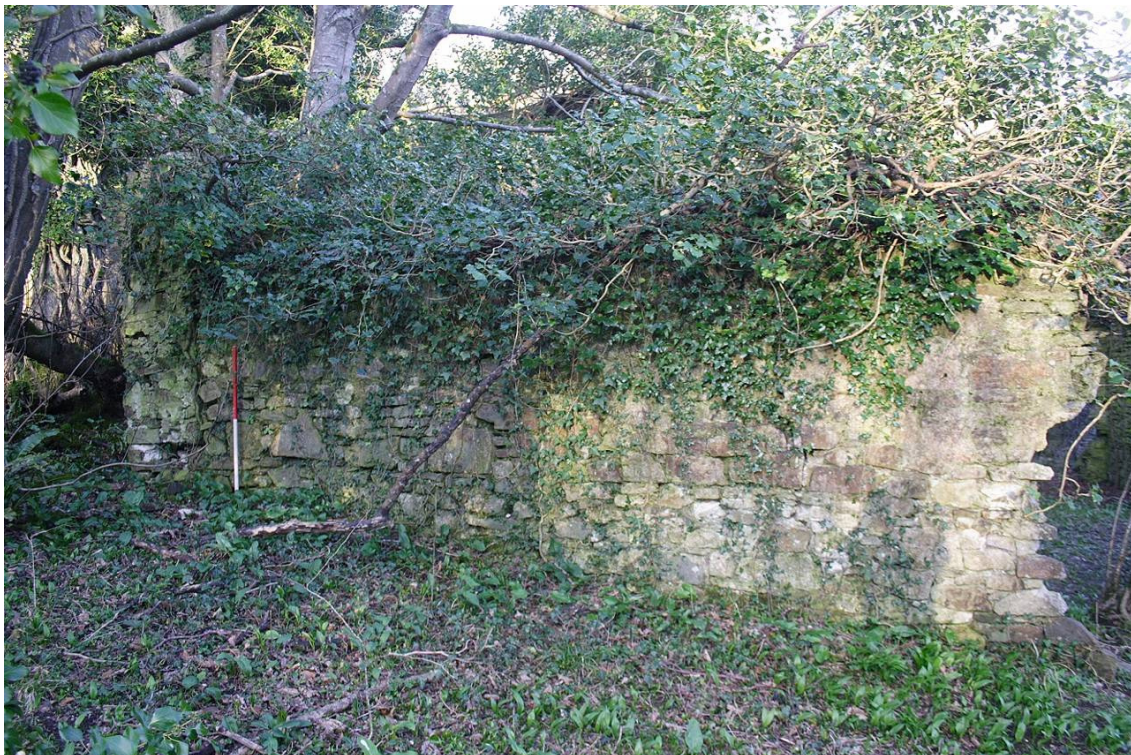
Photo 46: View looking east at the eastern wall of the Southwest Enclosure. 1m scale.

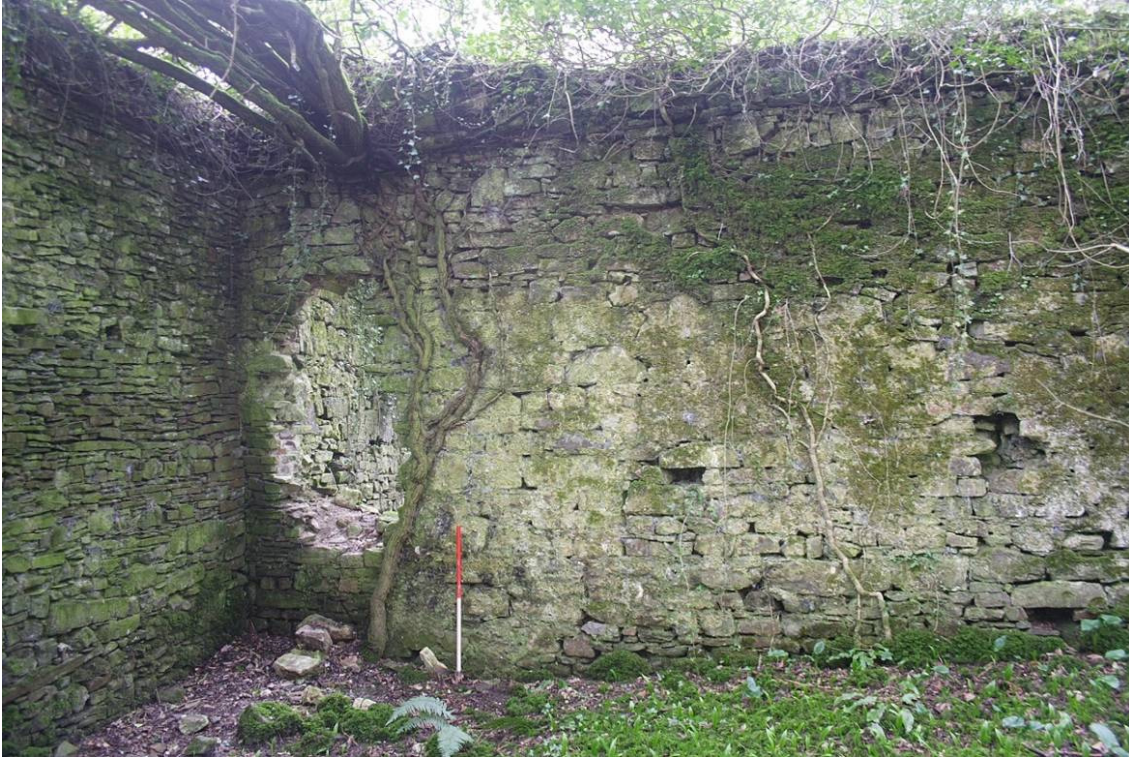
Photo 47: Looking west at the eastern wall of the Northeast Enclosure. 1m scale.

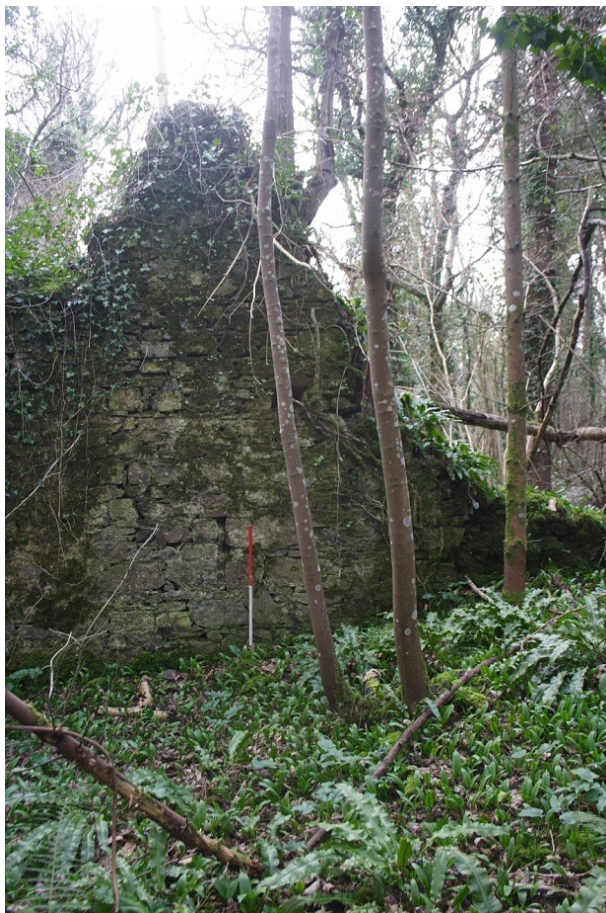
Photo 48: Northern end of the eastern wall of the Northeast Enclosure. Blocked loophole visible to the left of the 1m scale.

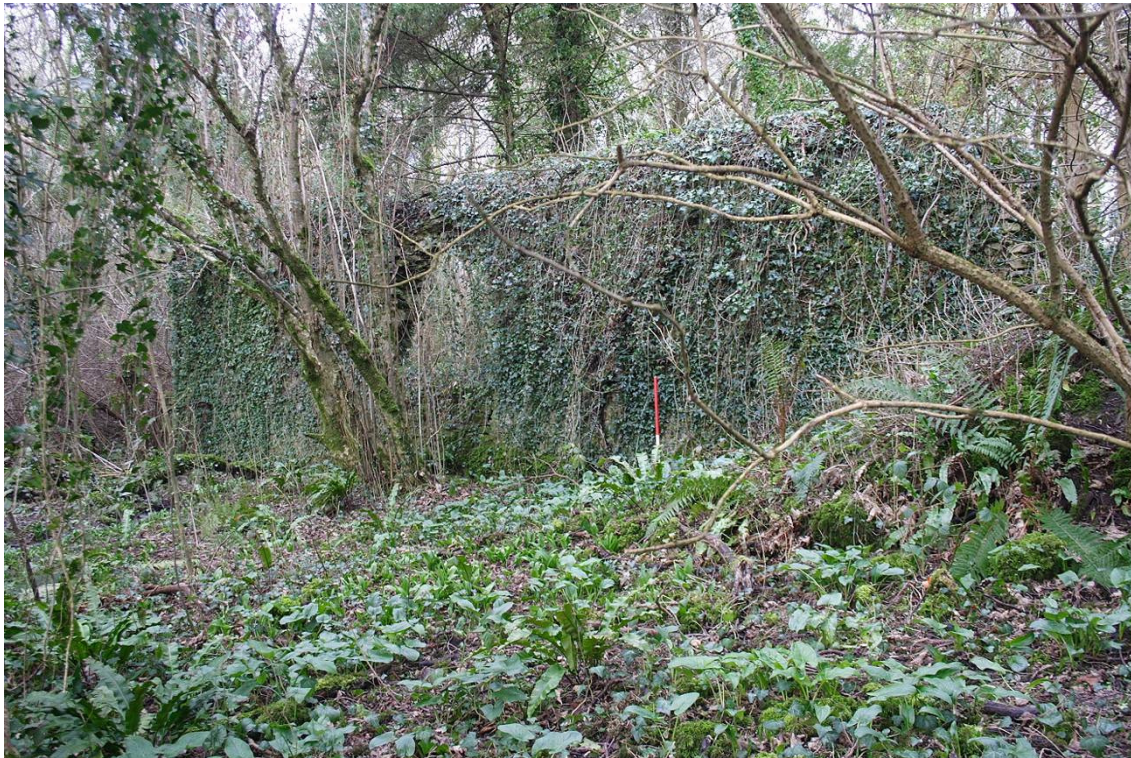
Photo 49: Eastern wall of the Northwest Enclosure, looking northeast. 1m scale.

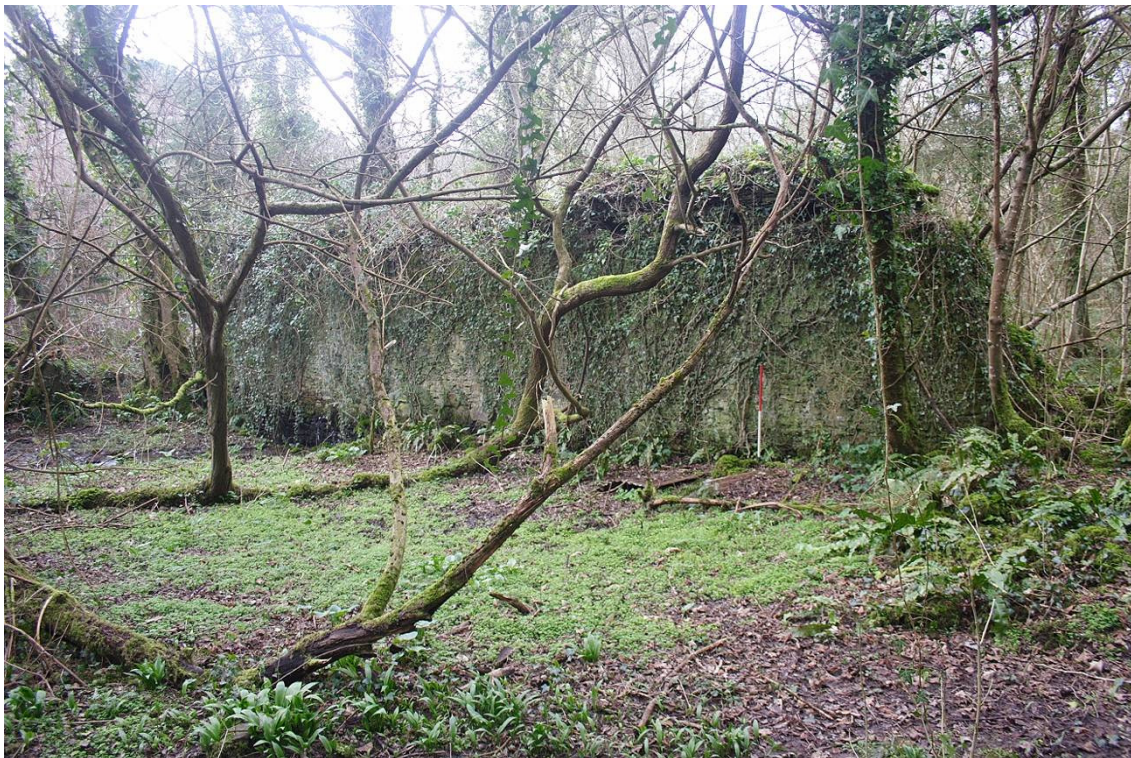
Photo 50: Northern wall of the Northwest Enclosure, looking northwest. 1m scale.

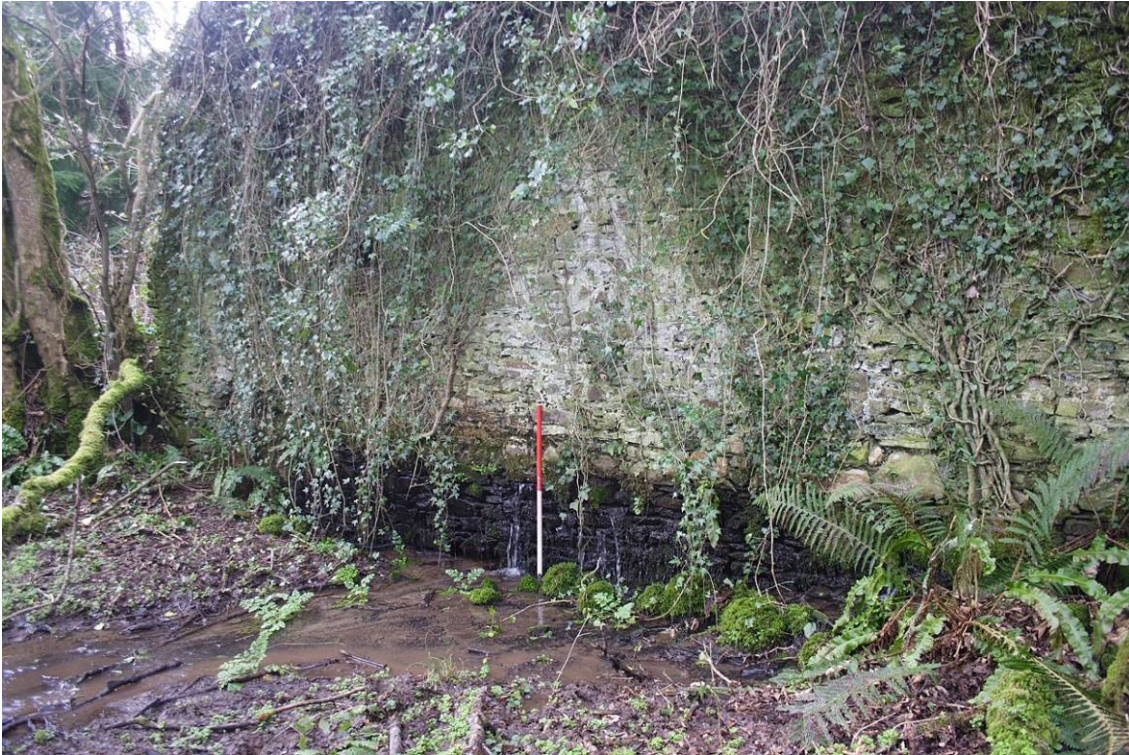
Photo 51: Water seeping through the northern wall of the Northwest Enclosure. 1m scale.

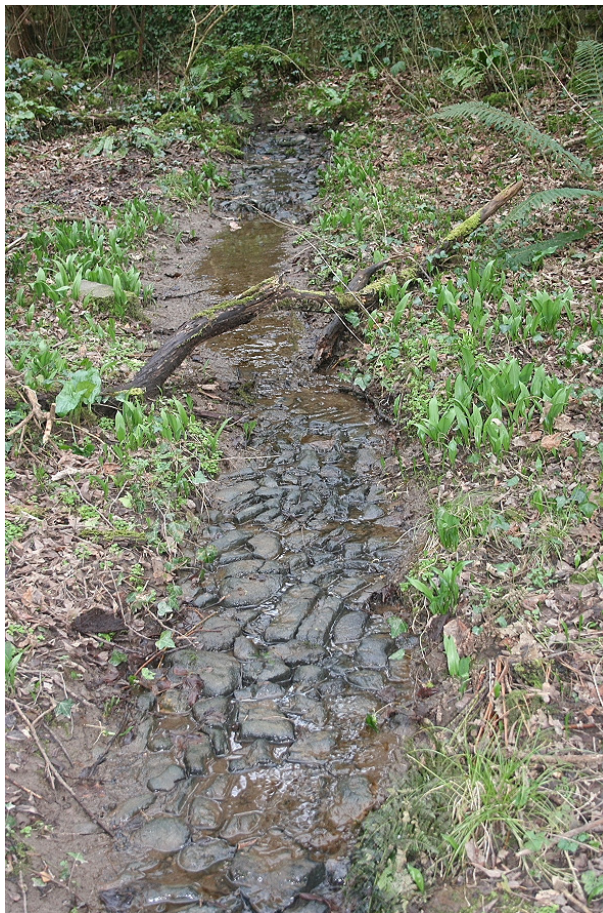
Photo 52: Cobbled surface uncovered in the Northwest Enclosure.

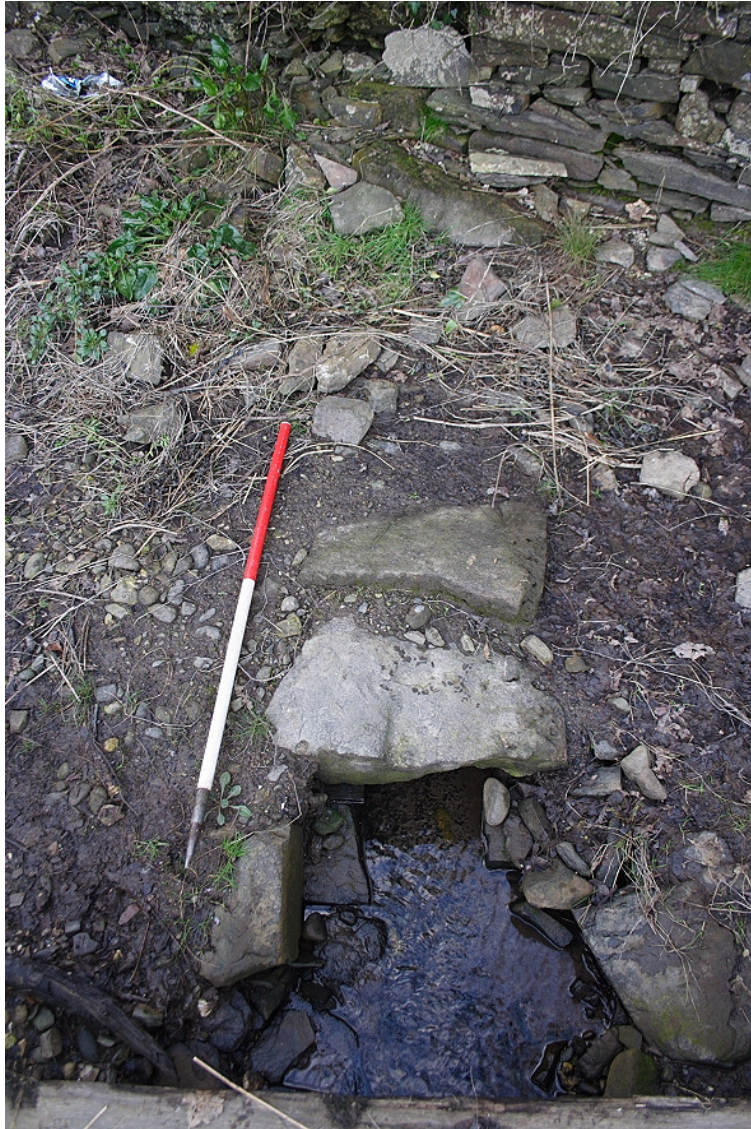
Photo 53: Culverted stream running out from underneath the Southwest Enclosure, looking north. 1m scale.
