BOULSTON MANOR, PEMBROKESHIRE: BUILDING RECORDING

RHIF YR ADRODDIAD / REPORT NO. 2012/27
RHIF Y PROSIECT / PROJECT RECORD NO. 102767

Mawrth 2012
March 2012

P Poucher & H Wilson

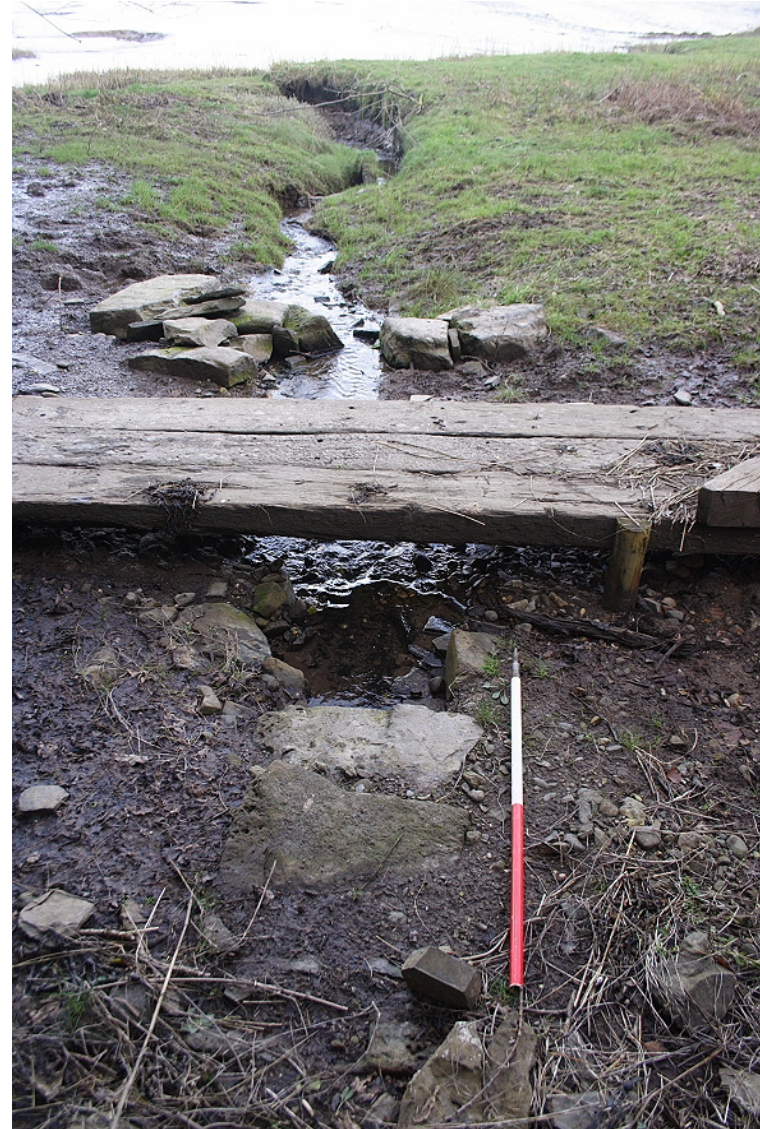
Photo 54: Stream running out into the river. 1m scale.

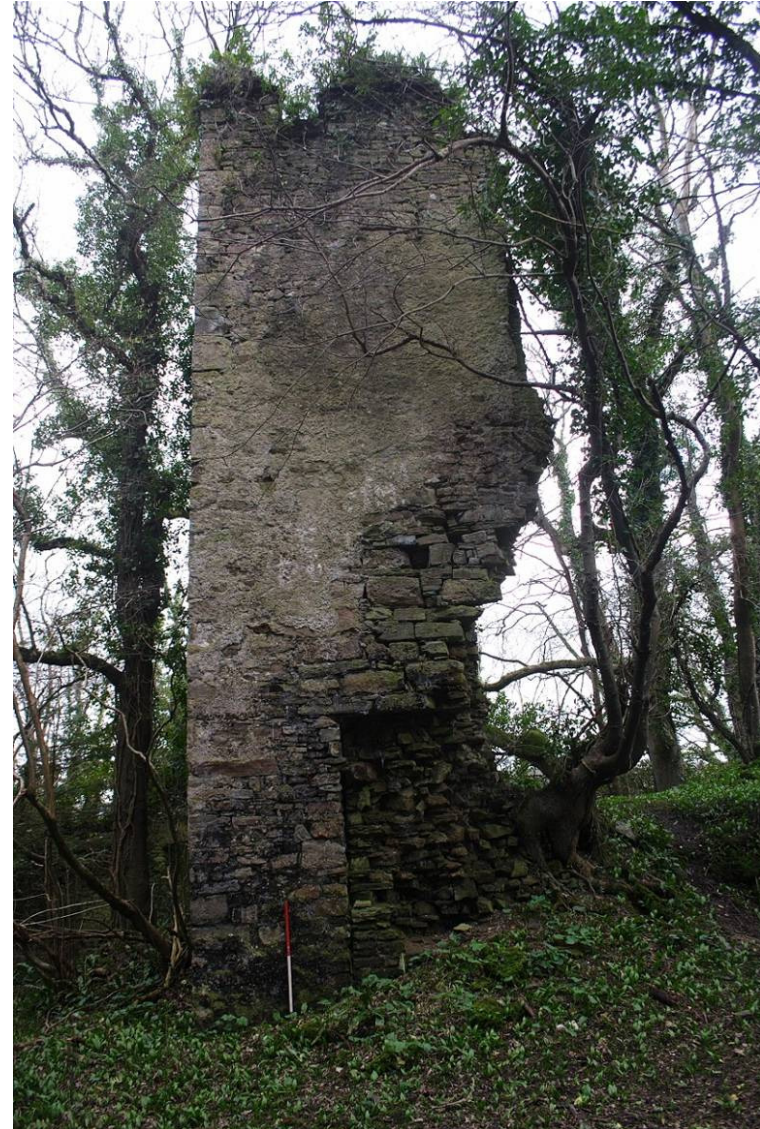
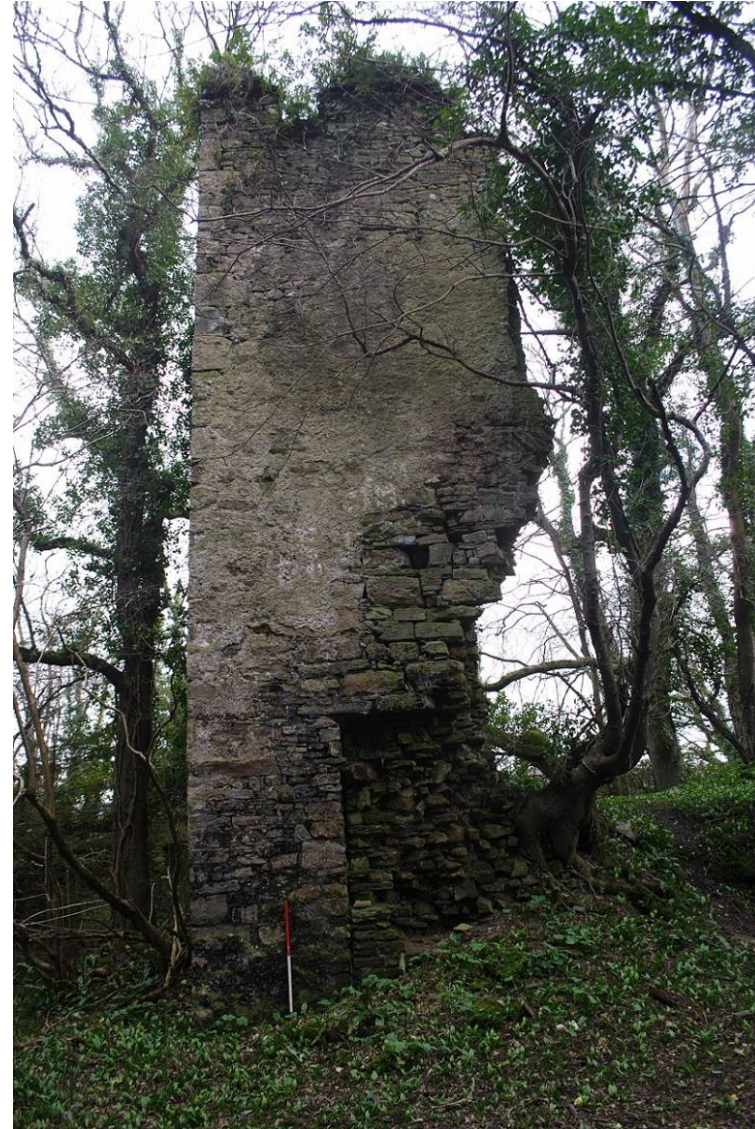
Photo 9: Closer view of the collapsed archway and vertical crack above. 1m scale.

There is a ground floor arch, presumably for an entranceway, in the centre of the east gable tower wall, just visible above the build-up of rubble and soil (photo 9). The top of the arch has collapsed, which has caused stonework immediately above to fall in, and a large crack has opened the full height of the tower. This entrance opens into a narrow space 0.8m wide, and opposite a blocked narrow splayed opening in the undercroft wall.

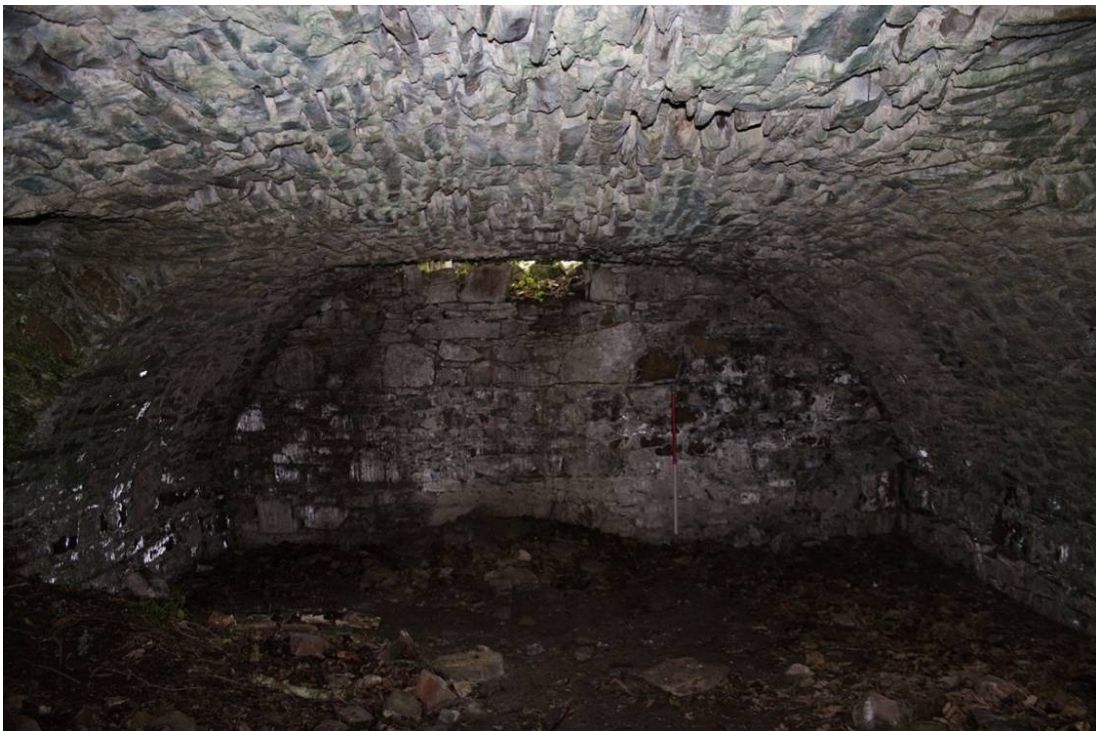
Photo 32: The interior of the undercroft looking west, showing the collapse in the ceiling and upper courses of the western wall. 1m scale.

Under the eastern half of the main hall is a vaulted undercroft at lower ground floor level. This is thought to be the earliest part of the structure, and may be medieval in date. Clearly the eastern tower has been built onto and above this earlier structure (photo 26). The structure is 11m long by 7.3m, enclosing an area 8.3m by 4.9m. The walls are of semi-coursed lime-mortared random rubble with a vaulted ceiling showing signs of partial subsidence to the west (photo 32). Stones have also come away from the top of the west gable wall, now open to the exterior.

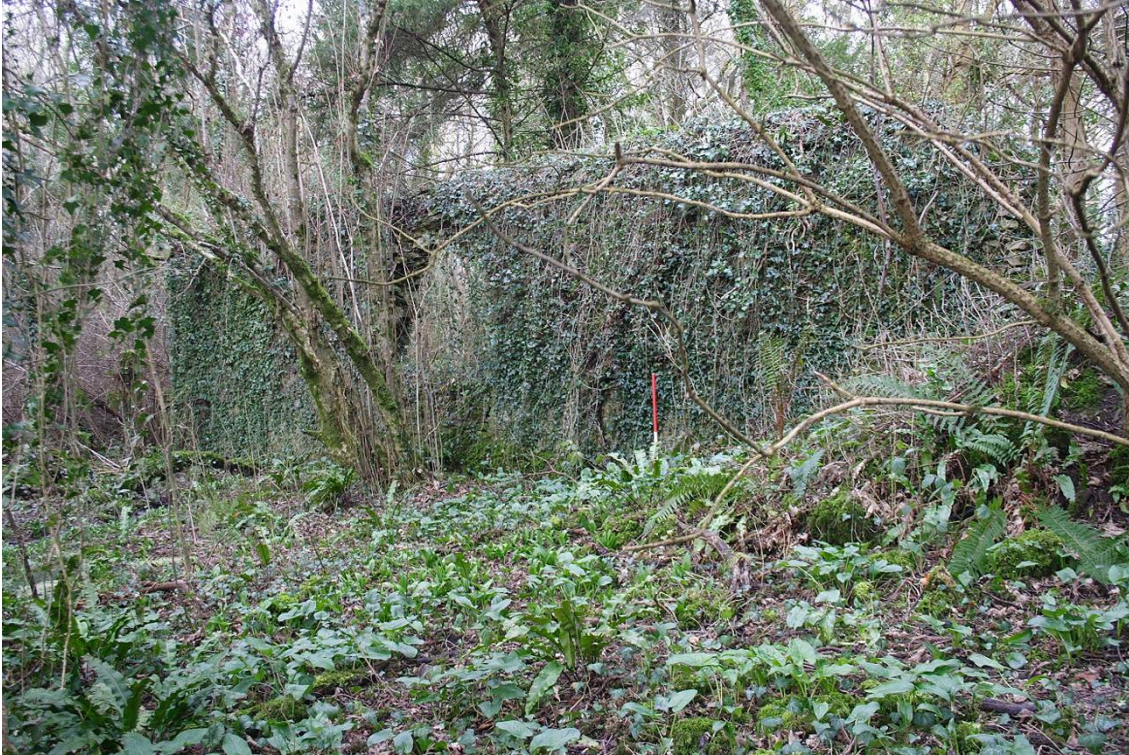
Photo 49: Eastern wall of the Northwest Enclosure, looking northeast. 1m scale.

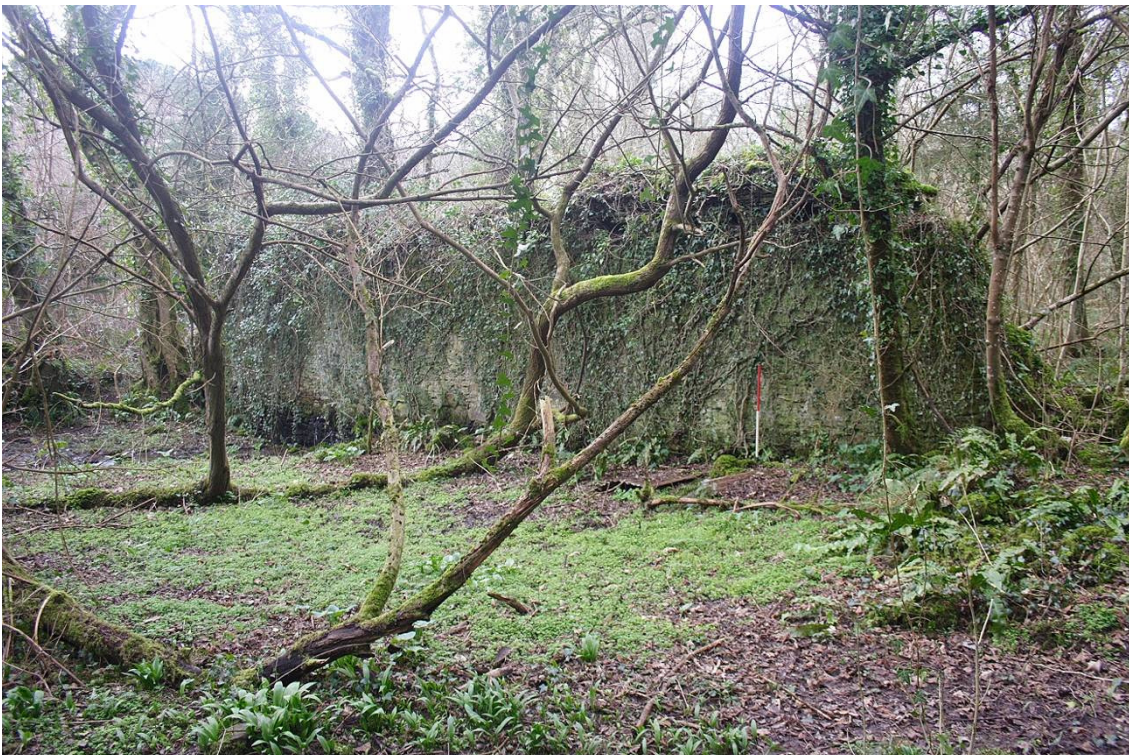
Photo 50: Northern wall of the Northwest Enclosure, looking northwest. 1m scale.

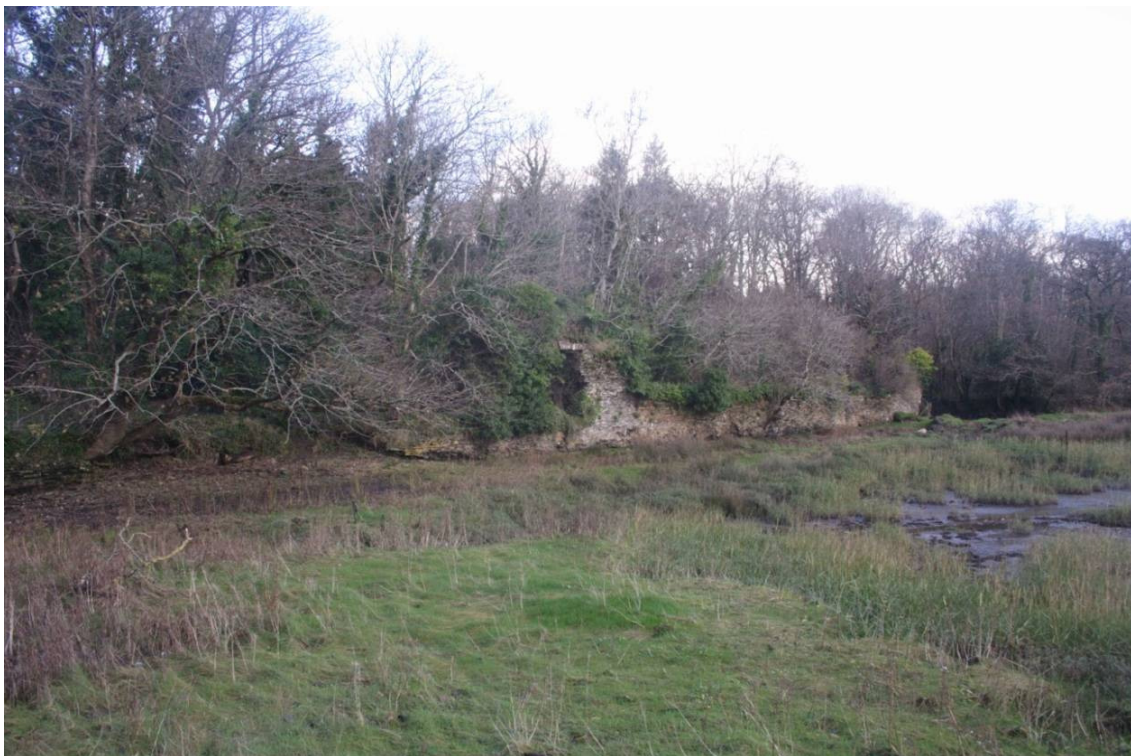
Photo 34: Looking northeast at the southern wall of the Garden Enclosure.

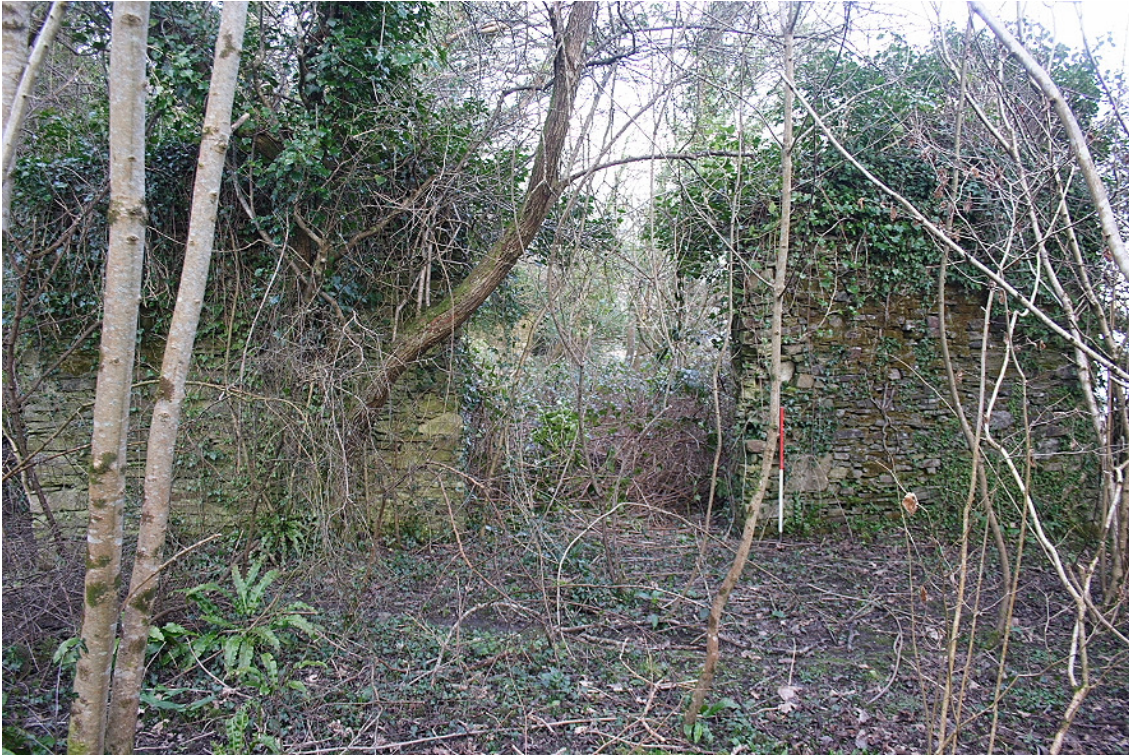
Photo 45: Entranceway through the western wall of the Southwest Enclosure. 1m scale.

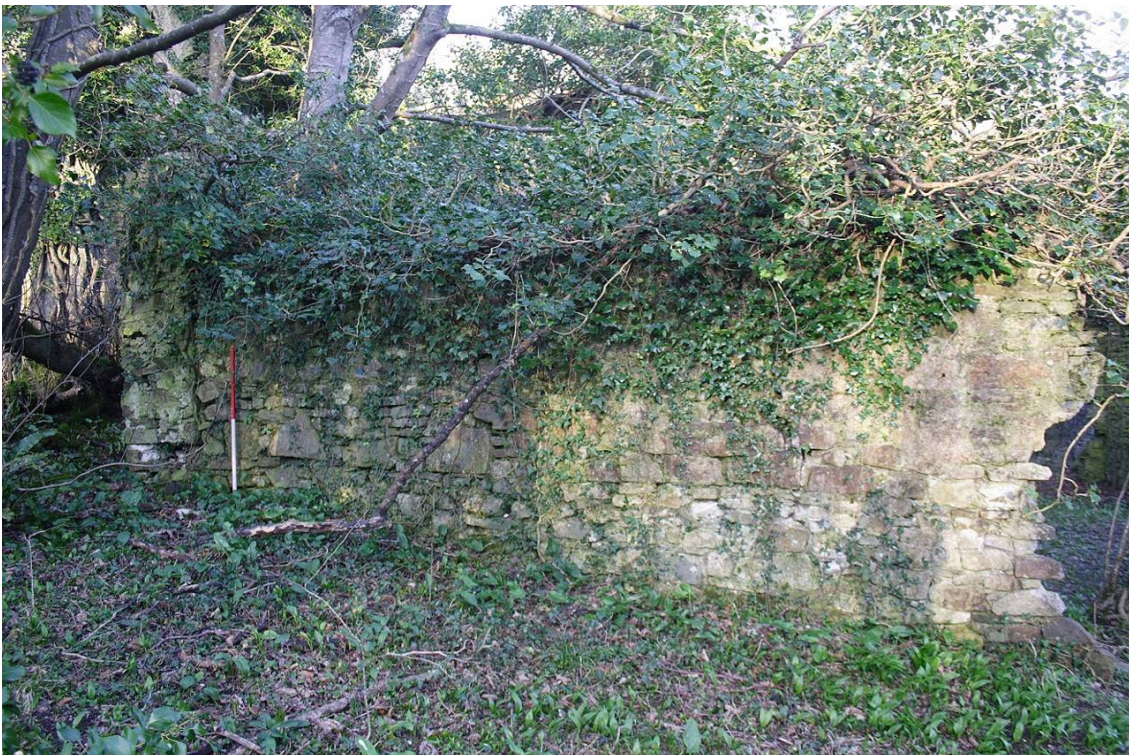
Photo 46: View looking east at the eastern wall of the Southwest Enclosure. 1m scale.
