**Canolfan yr Urdd,
Pentre Efan, Velindre,
Crymych, Pembrokeshire, SA41 3XE**

**Archaeological Building Investigation & Recording
and Watching Brief**

HRSWales
Report No: 246

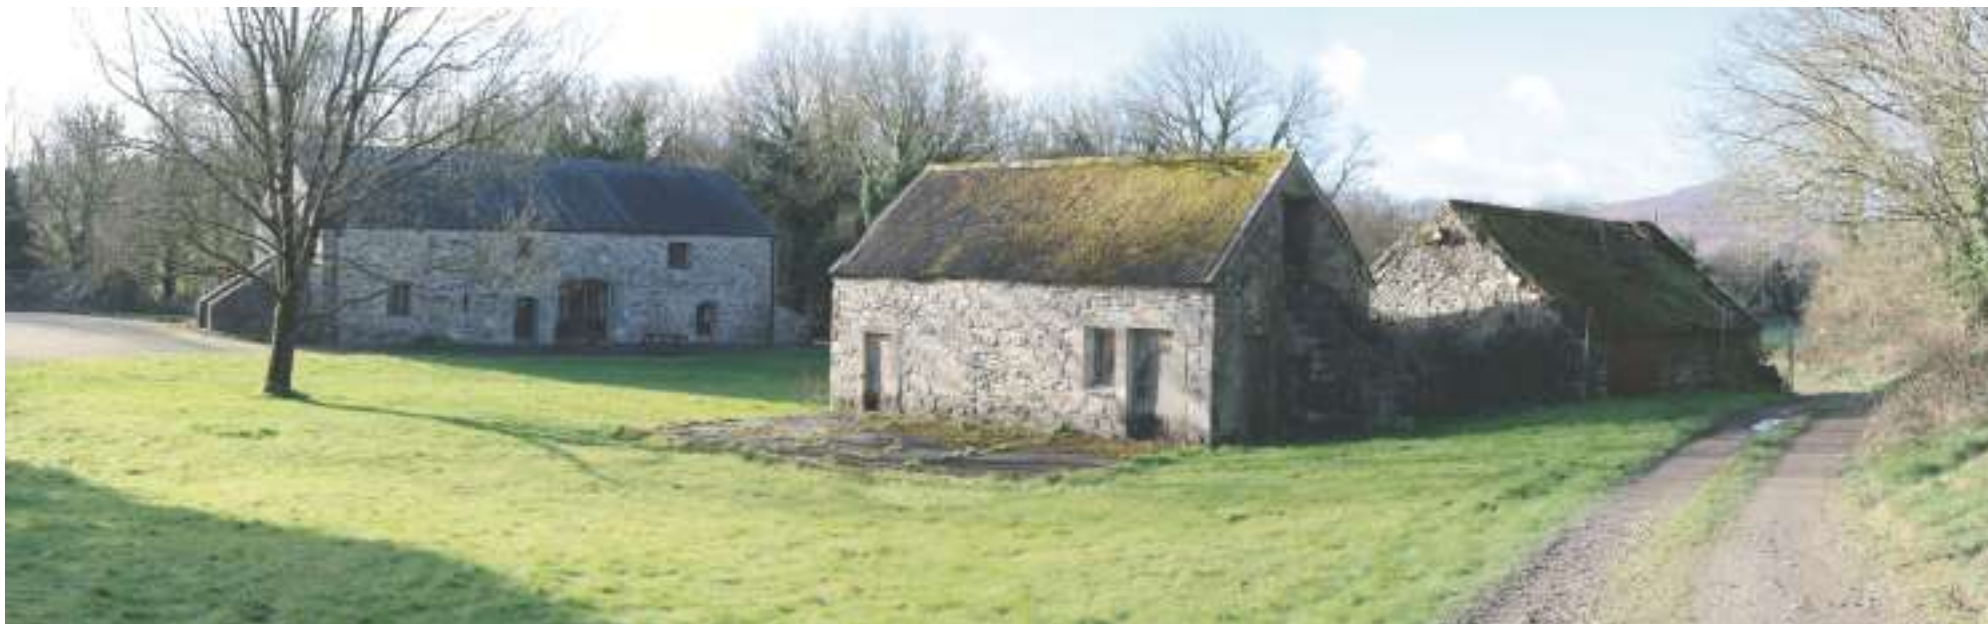
Plate 01. Canolfan yr Urdd Pentre Ifan - Gatehouse/Stables, Milking Parlour and Cart Shed. Looking SW.

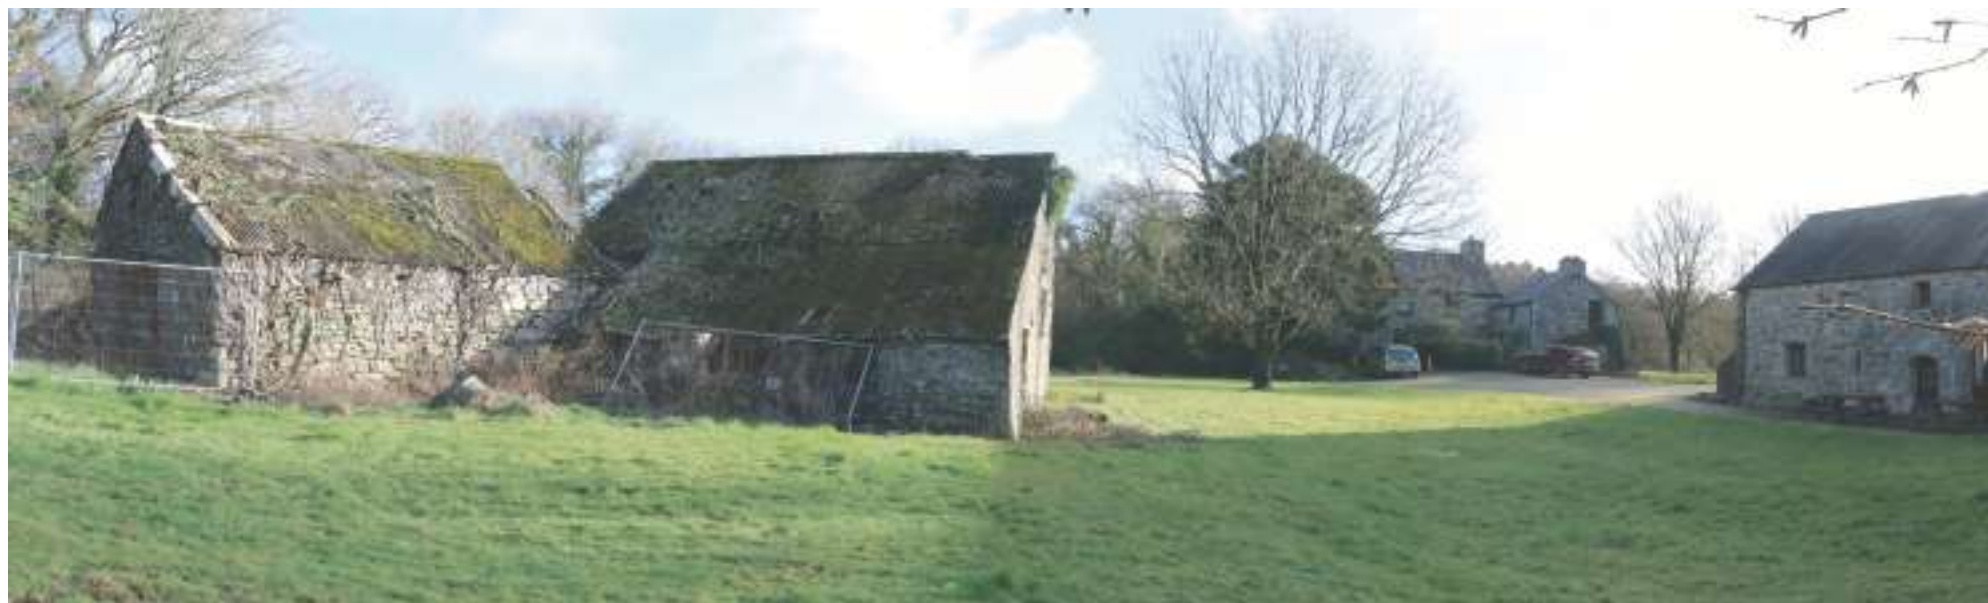
Plate 02. Canolfan yr Urdd Pentre Ifan - Pentre Ifan Farmhouse, Gatehouse/Stables, Milking Parlour and Cart Shed. Looking E.

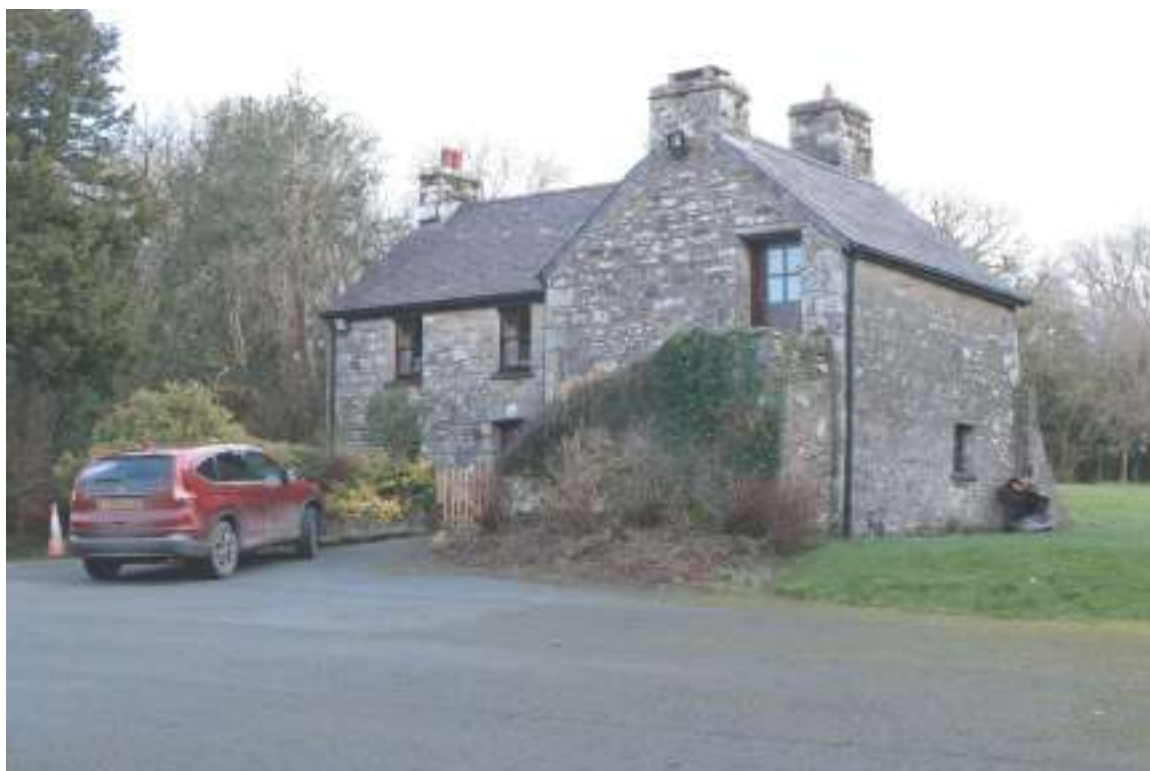
Plate 03. Canolfan yr Urdd Pentre Ifan - Pentre Ifan Farmhouse. Looking E.

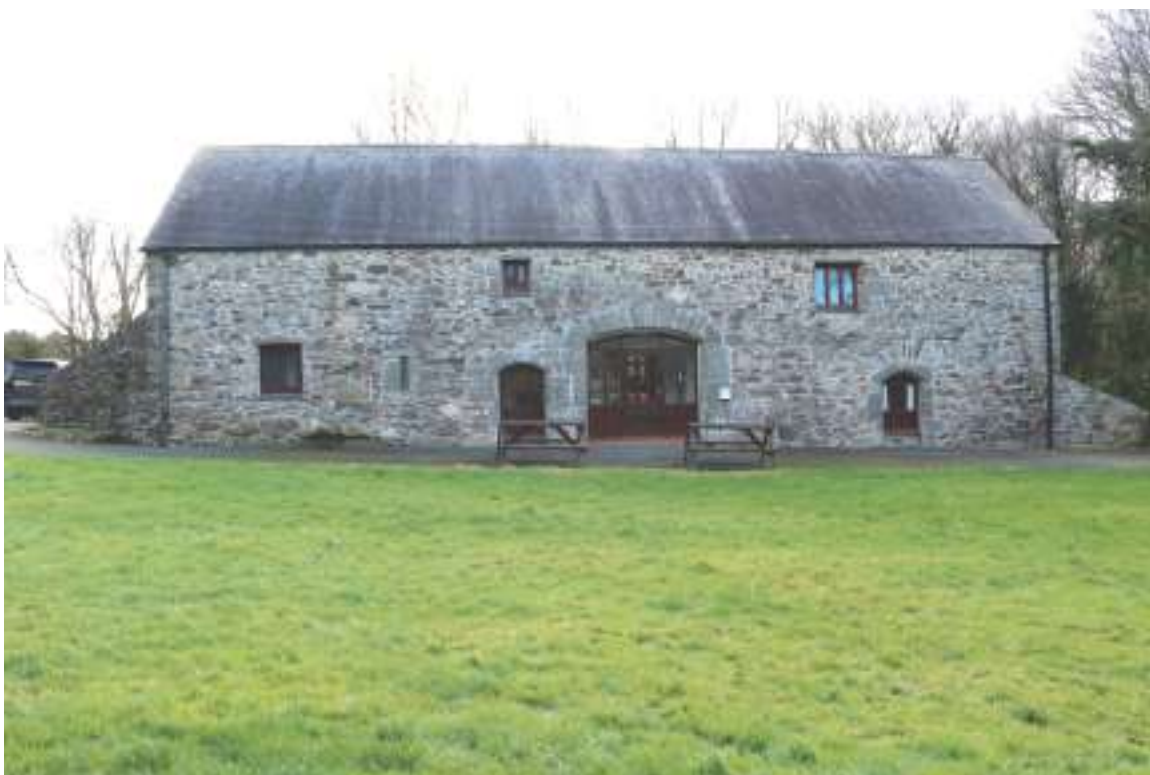
Plate 04. Canolfan yr Urdd Pentre Ifan - Gatehouse/Stables. Looking S.

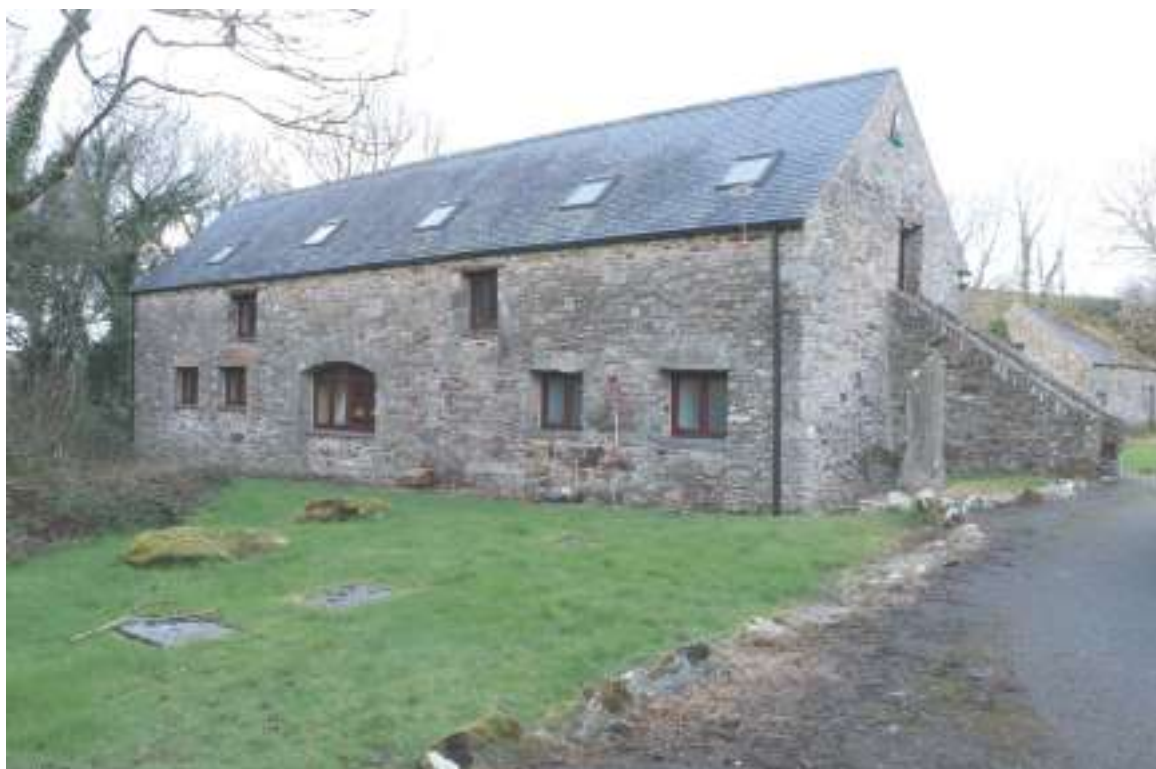
Plate 05. Canolfan yr Urdd, Pentre Ifan - Rear of Gatehouse/Stables. Looking NW.

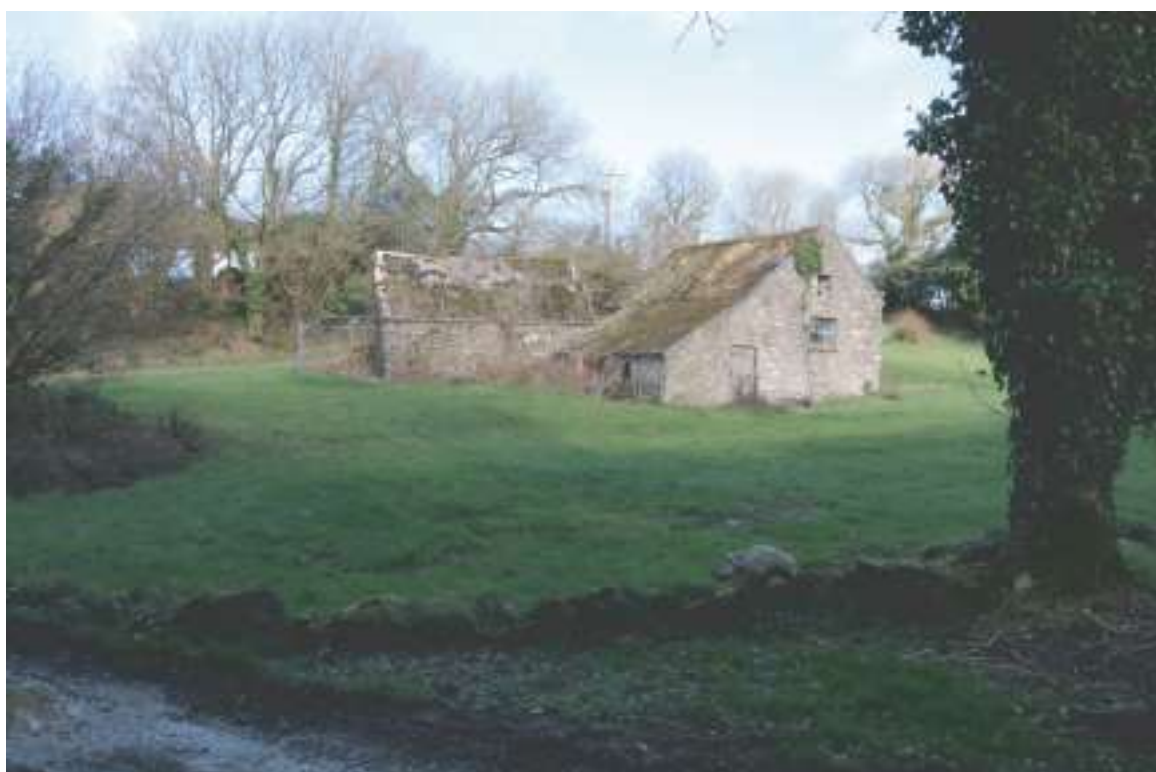
Plate 06. Canolfan yr Urdd, Pentre Ifan - Milking Parlour and Cart Shed. Looking N.

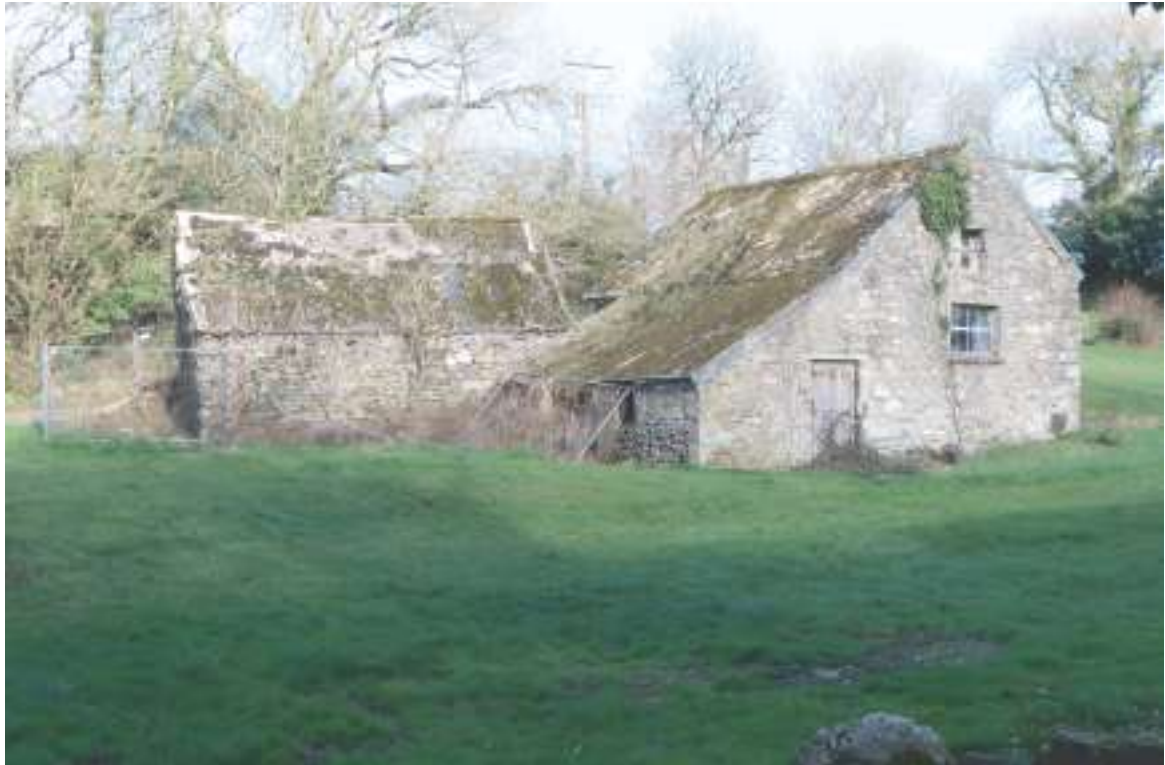
Plate 07. Canolfan yr Urdd, Pentre Ifan - Milking Parlour and Cart Shed. Looking N.

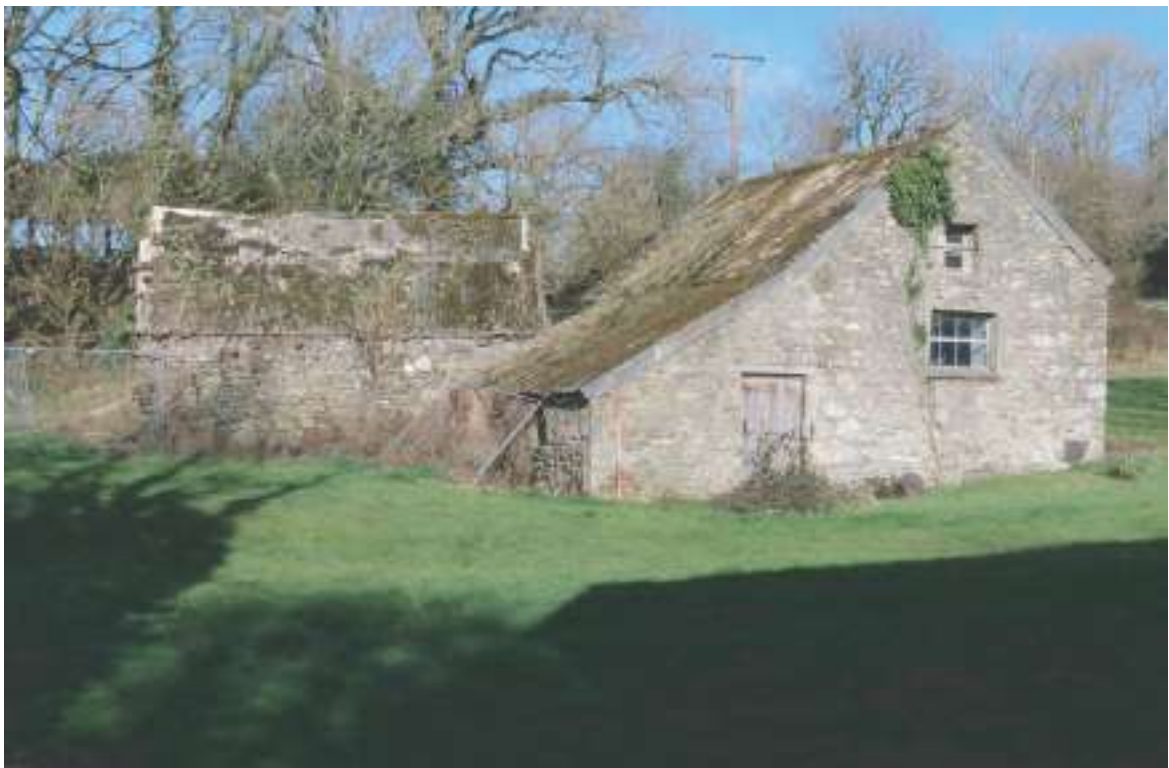
Plate 08. Canolfan yr Urdd, Pentre Ifan - Milking Parlour and Cart Shed. Looking N.

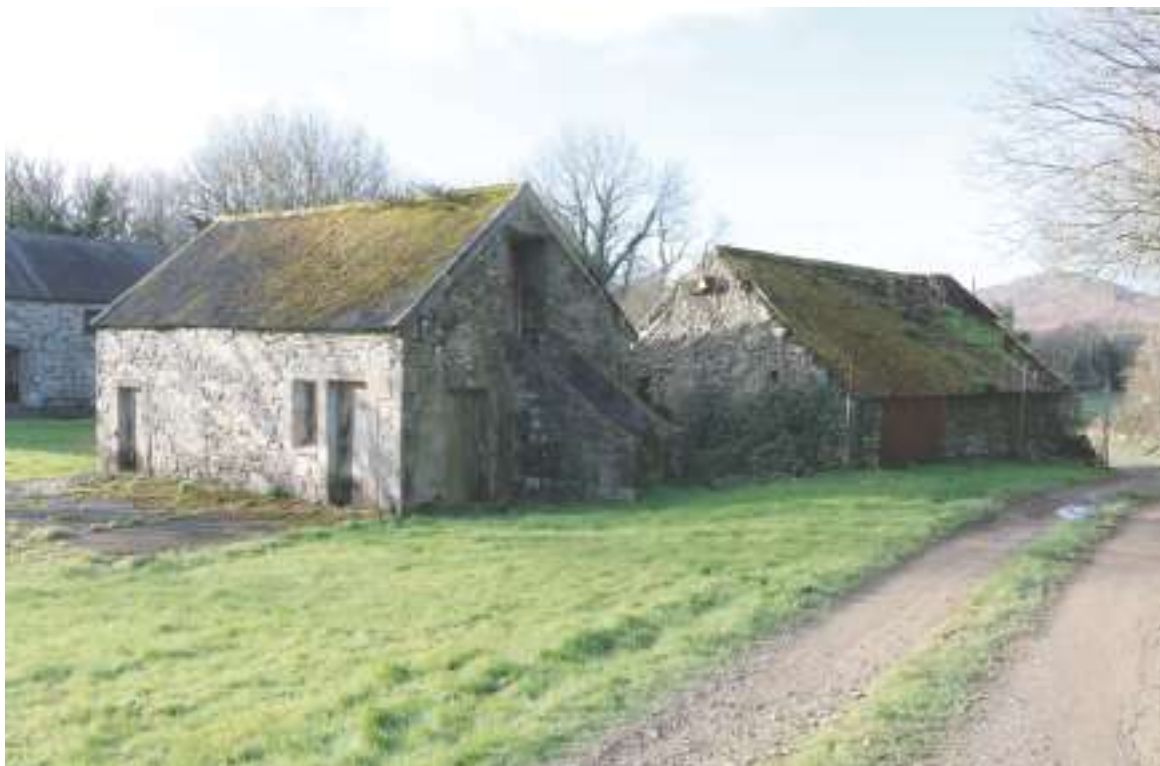
Plate 09. Canolfan yr Urdd, Pentre Ifan - Milking Parlour and Cart Shed. Looking SW.

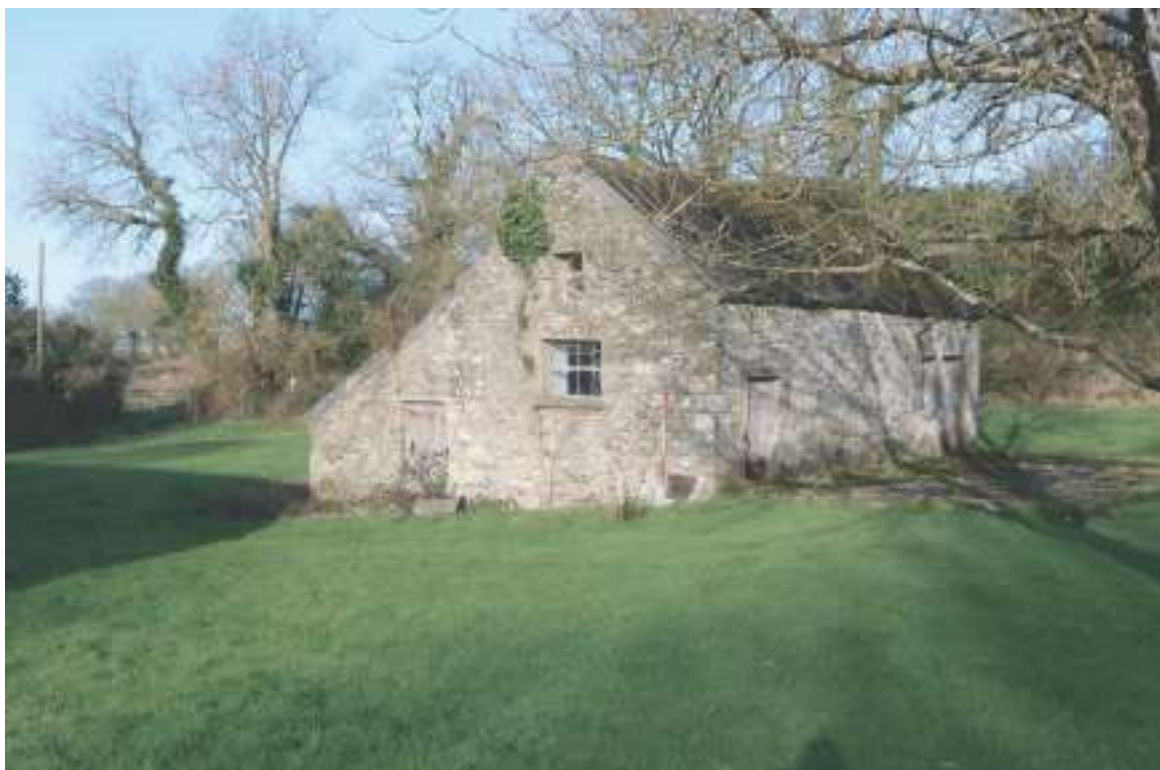
Plate 10. Canolfan yr Urdd, Pentre Ifan - Milking Parlour. Oblique view of south and east facing elevations. Looking NW.

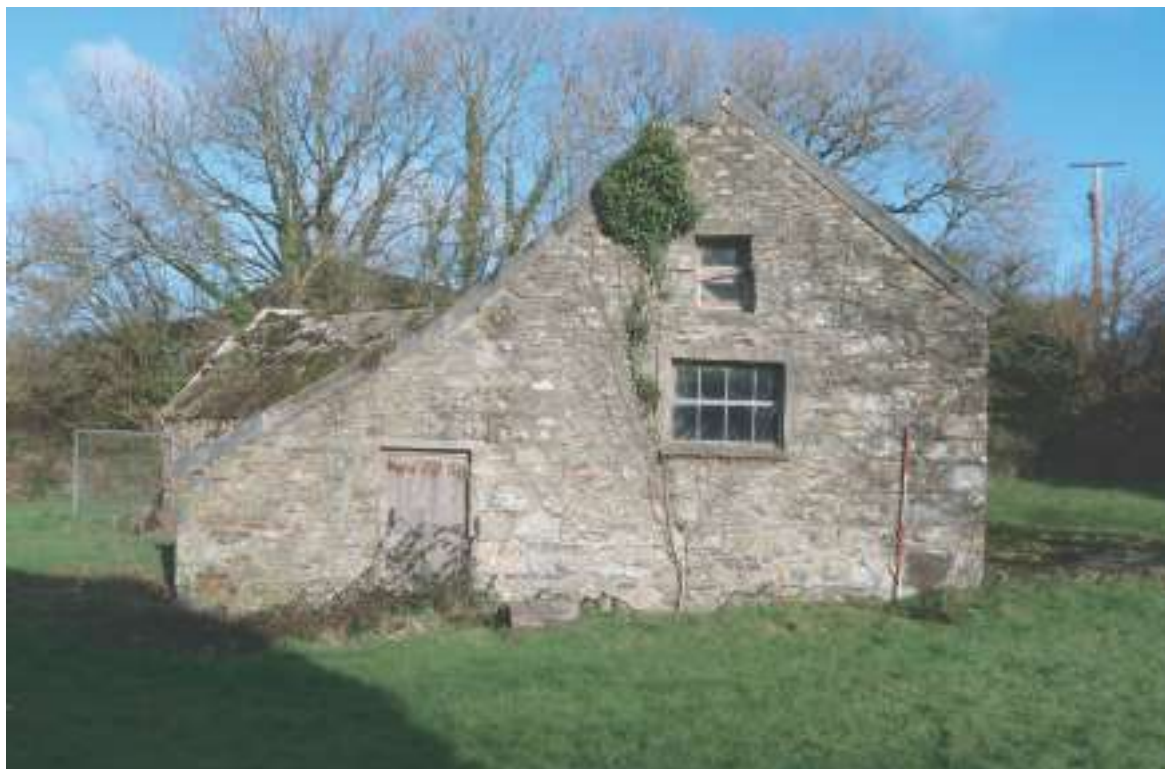
Plate 11. Canolfan yr Urdd, Pentre Ifan - Milking Parlour. South facing elevation. Looking N.

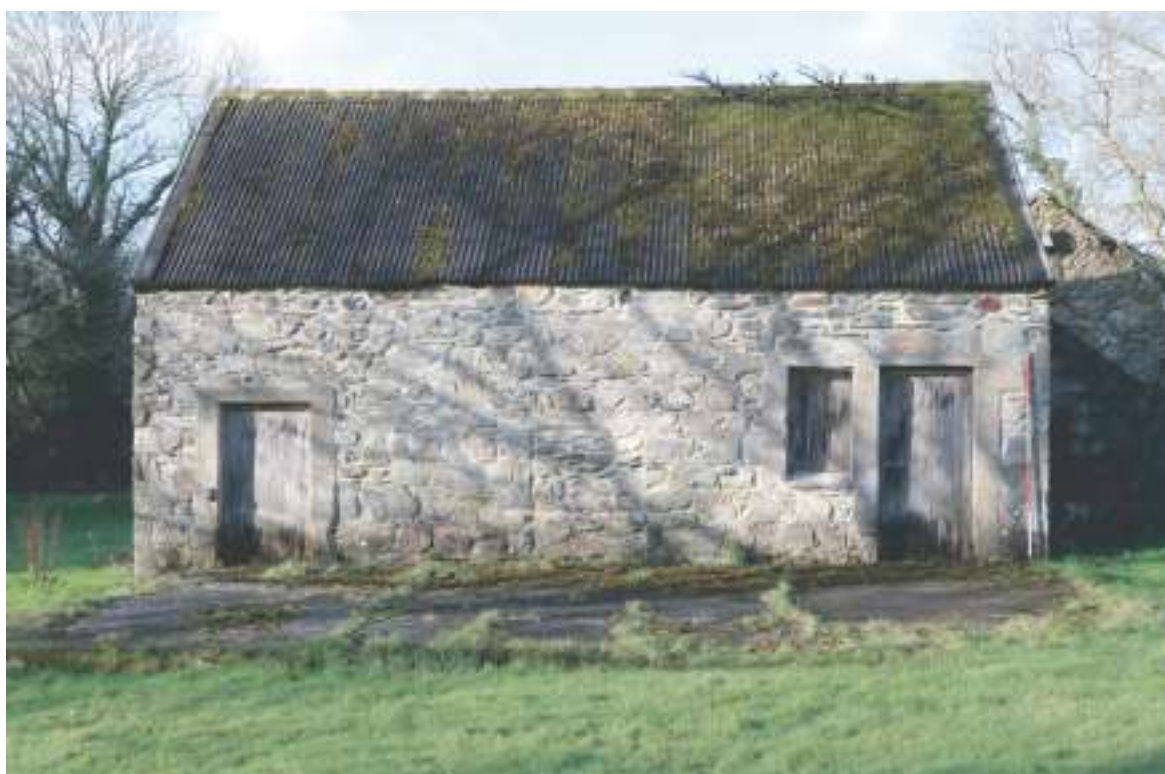
Plate 12. Canolfan yr Urdd, Pentre Ifan - Milking Parlour. East facing elevation. Looking W.

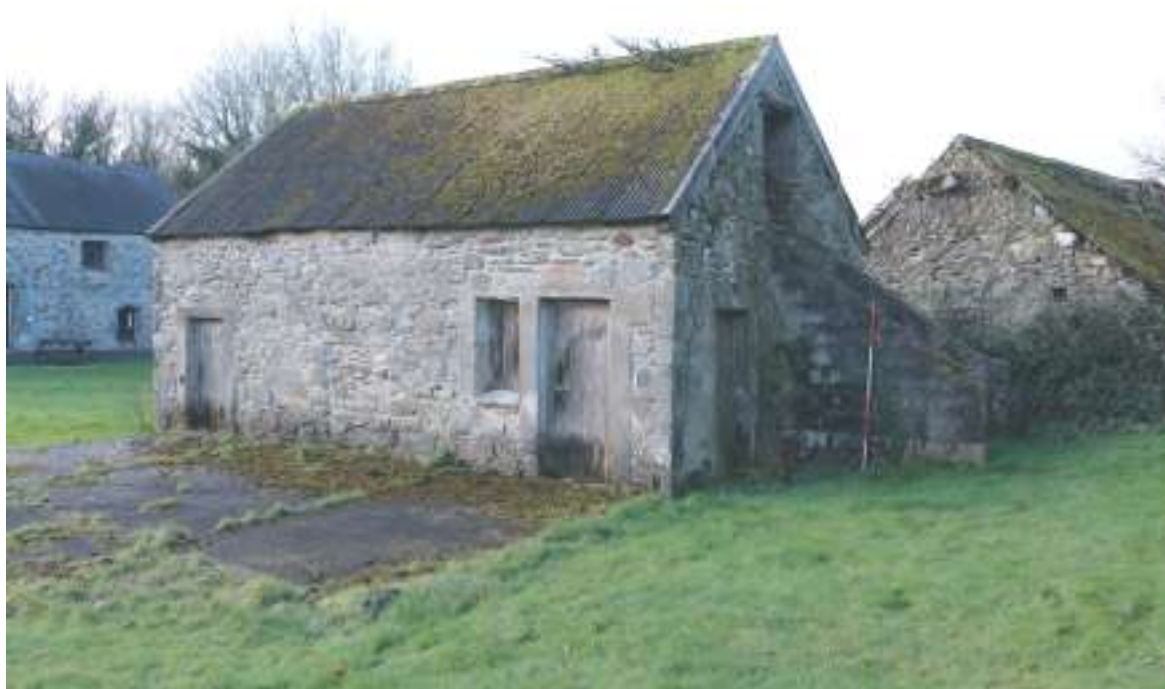
Plate 14. Canolfan yr Urdd, Pentre Ifan - Milking Parlour. Oblique view of east and north facing elevations. Looking SW.

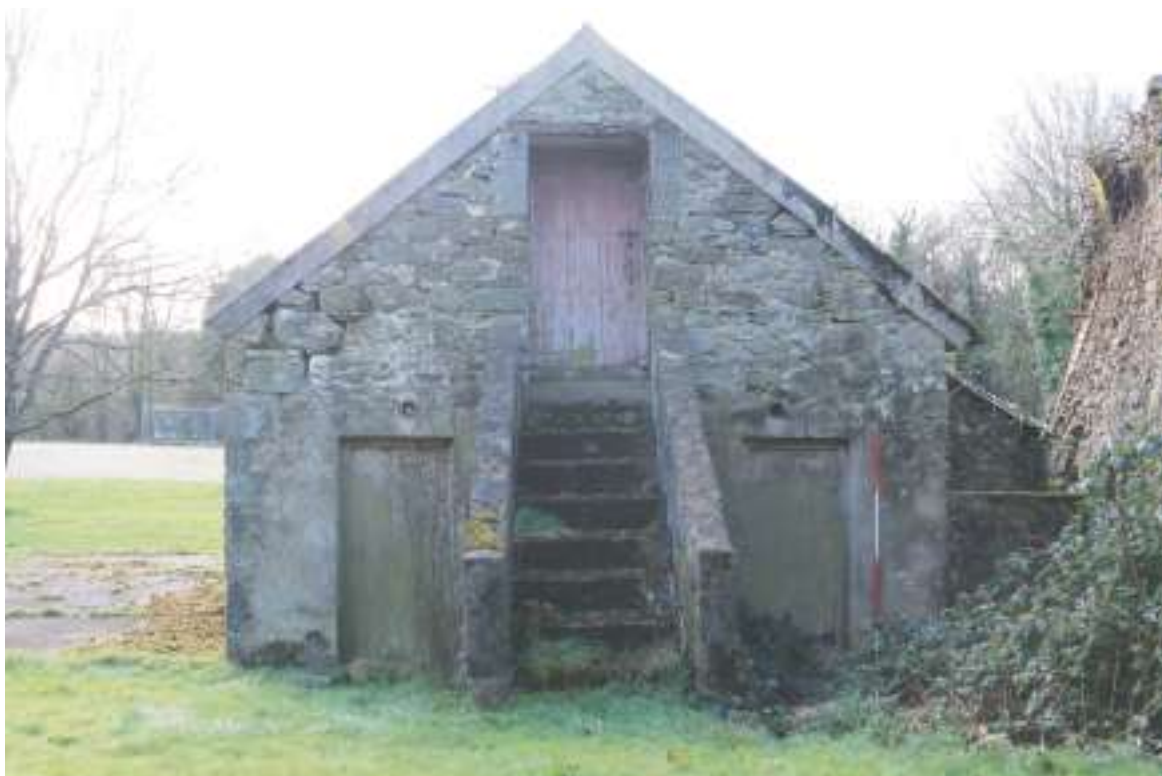
Plate 15. Canolfan yr Urdd, Pentre Ifan - Milking Parlour north facing elevation. Looking S.

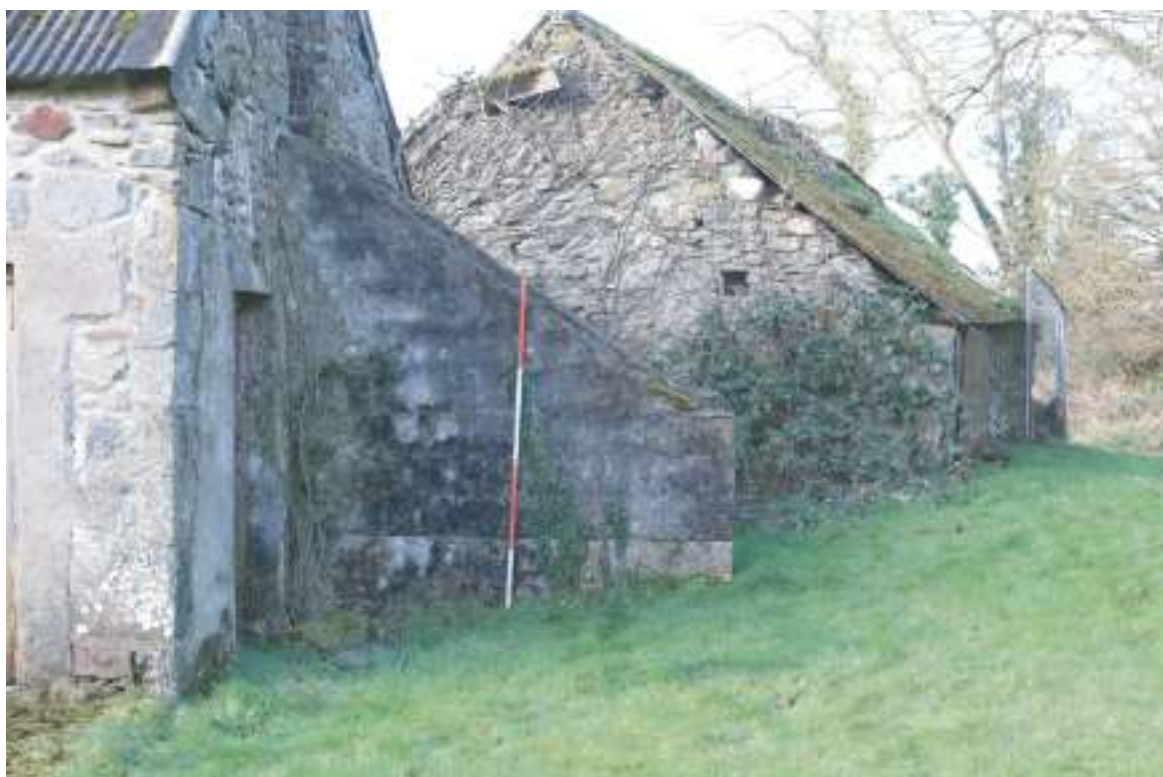
- 5.11 The upper floor of the Milking Parlour is access via a flight of cement covered concrete block steps against the north facing side elevation. The roof space has been boarded with pine floor boards, probably inserted in the mid 20th Century when the building was converted into a milking parlour. The corrugated roof is supported by four equally spaced timber 'A' frames. Each of these 'A' frames are constructed from pine and appear to be 20th Century replacements. However, the timber cross braces on the two 'A' frames on the southern side appear to be of oak and their curved form suggest that they are very likely the original 18th Century cross braces that have been re-used. Both these cross braces have been fixed to the main frames using large iron nails rather than pegged joints. The other two 'A' frames at the northern end of the building have only had short support braces nailed to their main frame at roof height. However, iron staining does suggest that the original cross braces were also reused on the frames at some time, but obviously failed and were removed at some time in the not too distant past.

Plate 16. Canolfan yr Urdd, Pentre Ifan - Modern steps upto loft on northern elevation of Milking Parlour. Looking W.

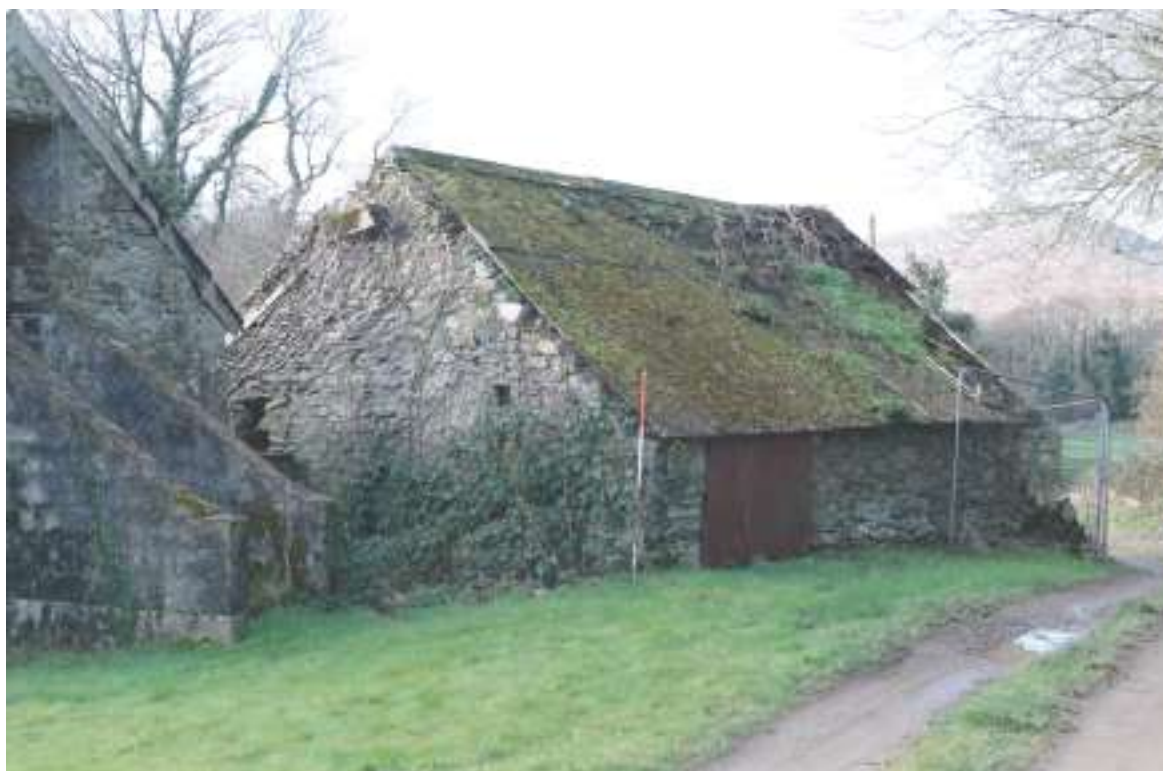
Plate 17. Canolfan yr Urdd, Pentre Ifan - Cart Shed. Oblique view of east and north facing elevations. Looking westward.

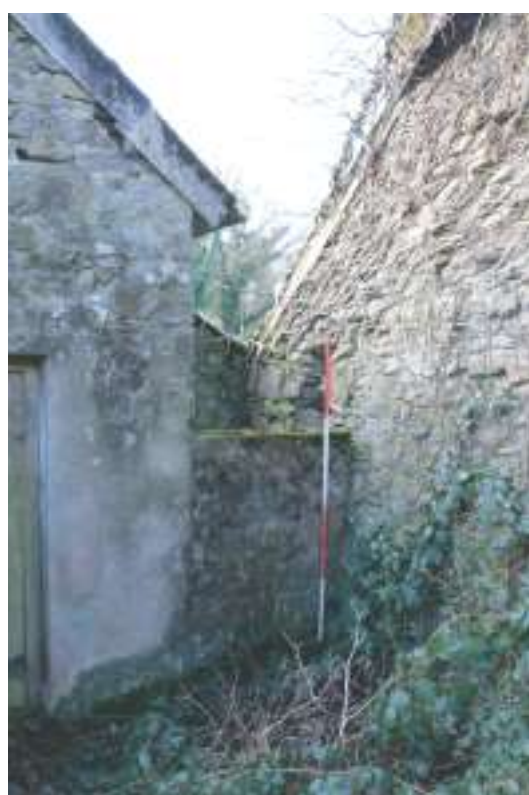
Plate 18. Canolfan yr Urdd, Pentre Ifan - Area between Milking Parlour and Cart Shed. Looking SW.

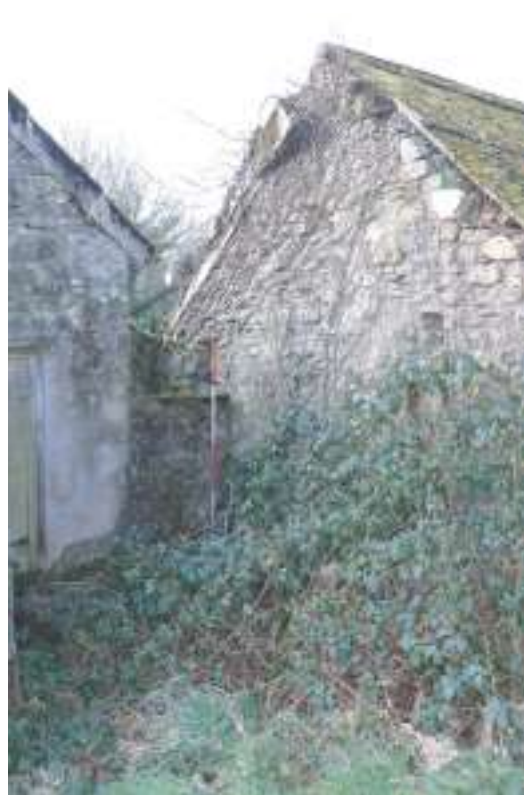
Plate 19. Canolfan yr Urdd, Pentre Ifan - Area between Milking Parlour and Cart Shed. Looking SW.

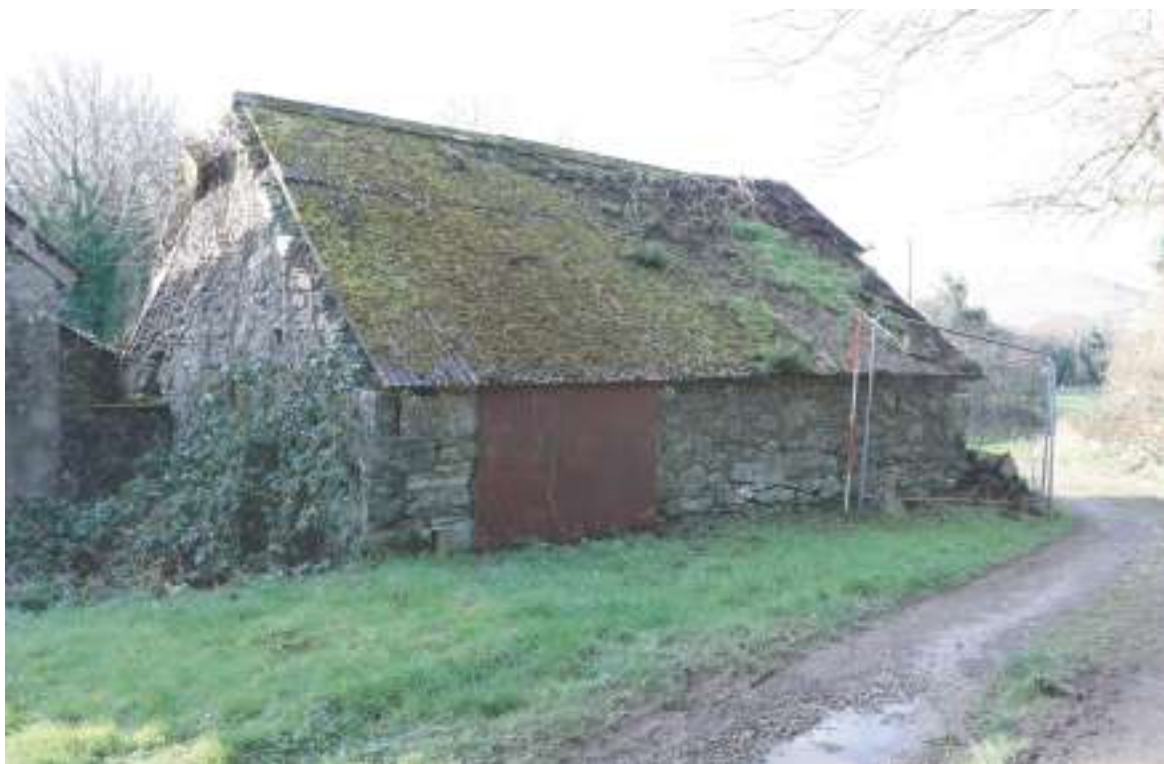
Plate 20. Canolfan yr Urdd, Pentre Ifan - Cart Shed. Oblique view of north facing elevation. Looking SW.

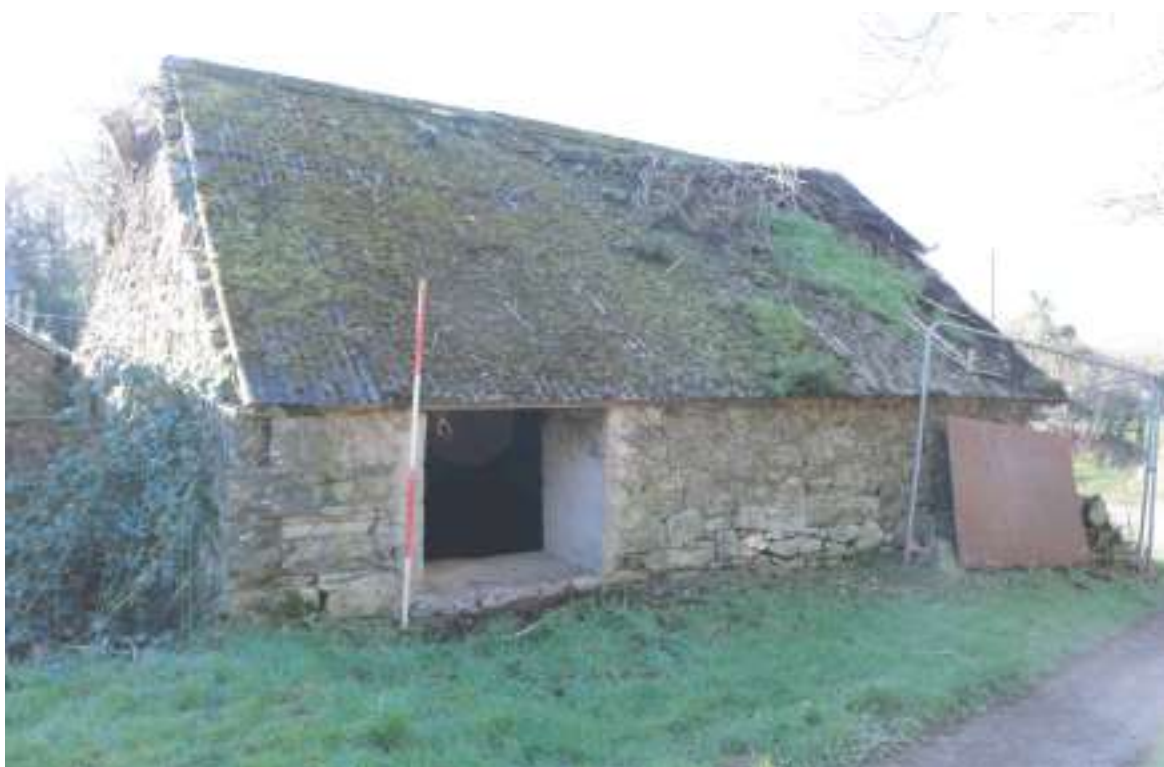
Plate 21. Canolfan yr Urdd, Pentre Ifan - Cart Shed. View of north facing elevation. Looking SW.

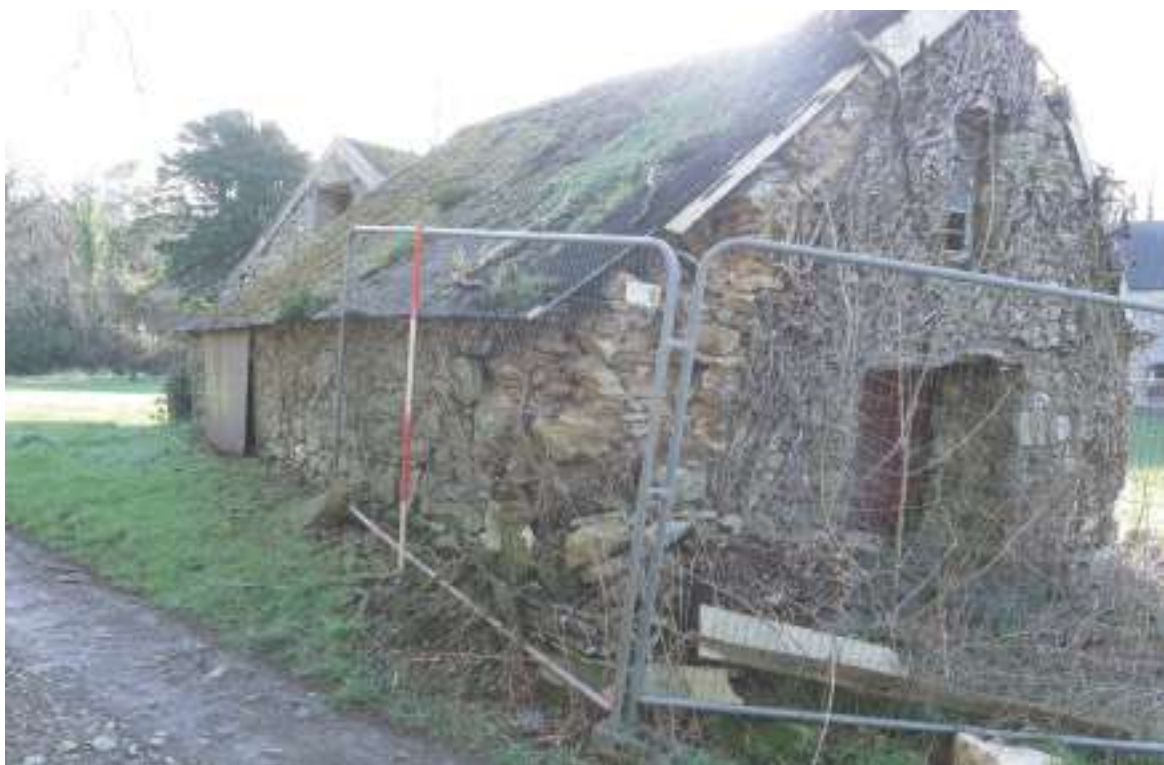
Plate 22. Canolfan yr Urdd, Pentre Ifan - Cart Shed. Oblique view of north and west facing elevations. Looking Eastwards.

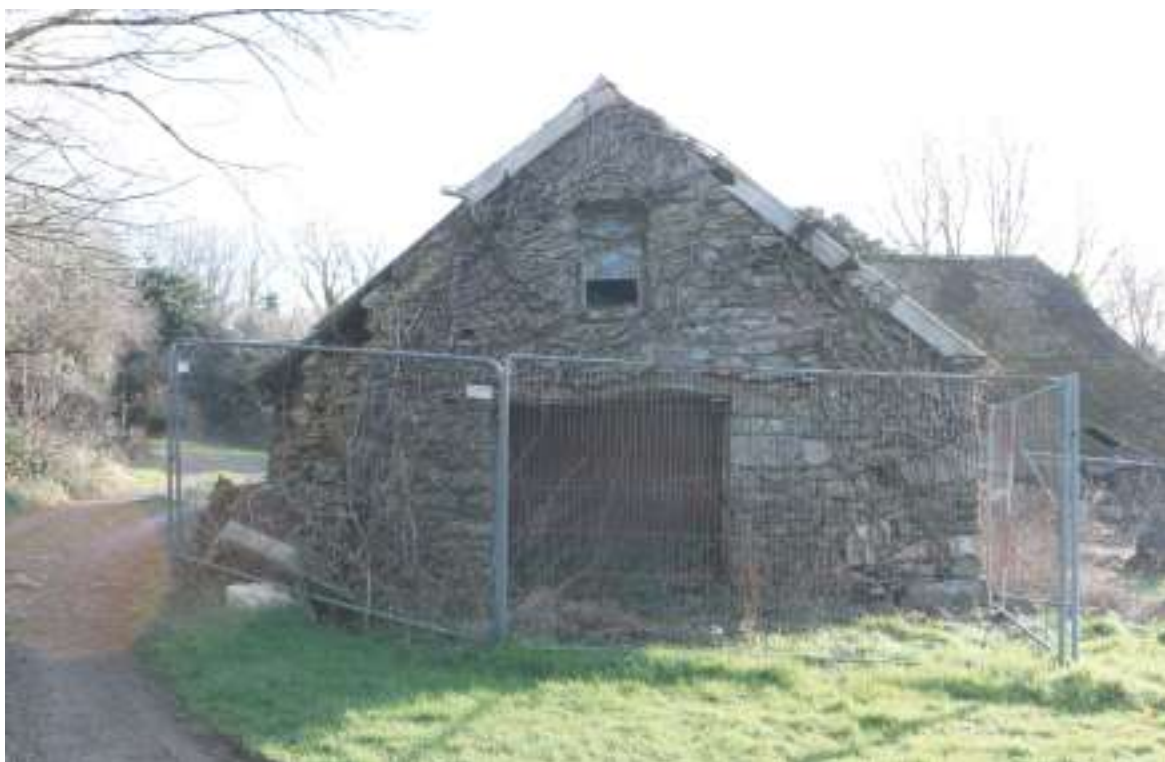
- 5.12 The west facing elevation of the Cart House faces the public access track with views of an opposing field gate with Carn Ingli Mountain in the background. This elevation served as the main entrance to the Cart House and is characterised with a double entrance held open by a large oak lintel, now in a precarious state. Above the entrance is a small window, further suggesting that there was once a loft space in the building originally. Because of dense ivy cover, which has been penetrating the stonework and mud for some considerable time, this elevation was deemed structurally unsafe, with much of the northern side collapsed and missing and the southern side also not long from suffering the same fate. At the time of the building investigation the front west facing elevation was fenced off with *heras*

Plate 23. Canolfan yr Urdd, Pentre Ifan - Cart Shed. View of west facing elevation. Looking E.

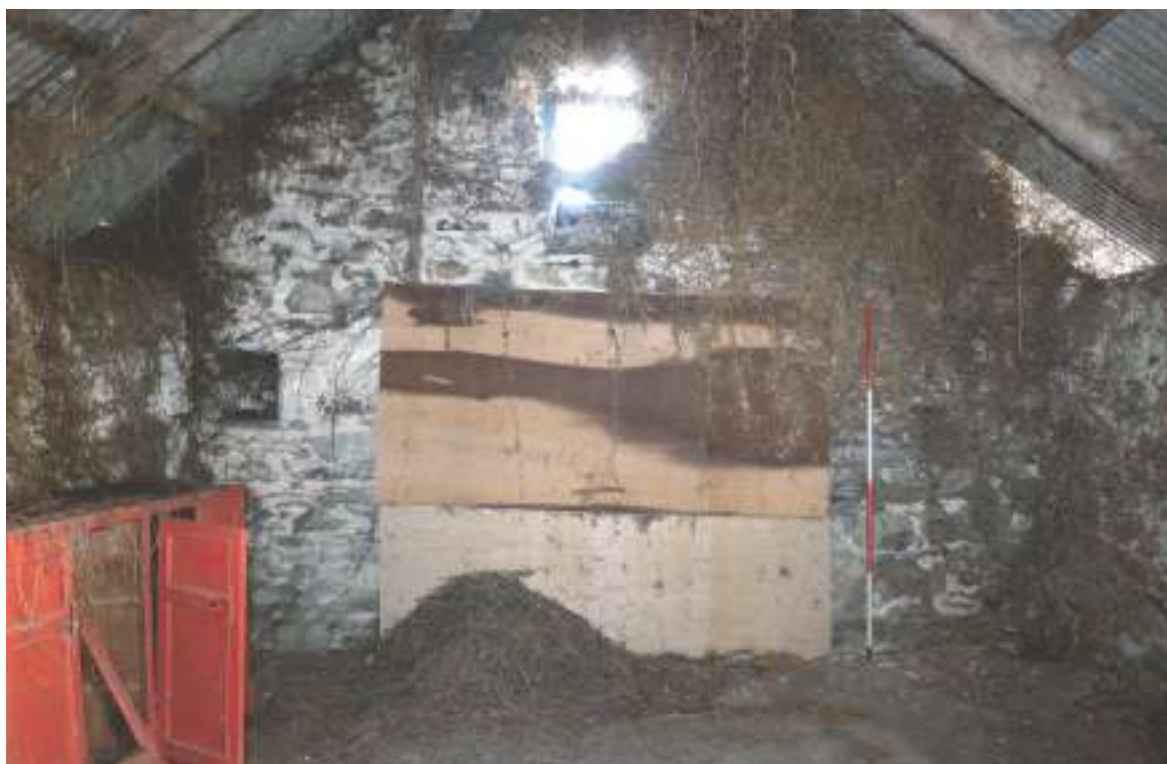
Plate 25. Canolfan yr Urdd, Pentre Ifan - Cart Shed. Interior view of east facing elevation. Looking W.

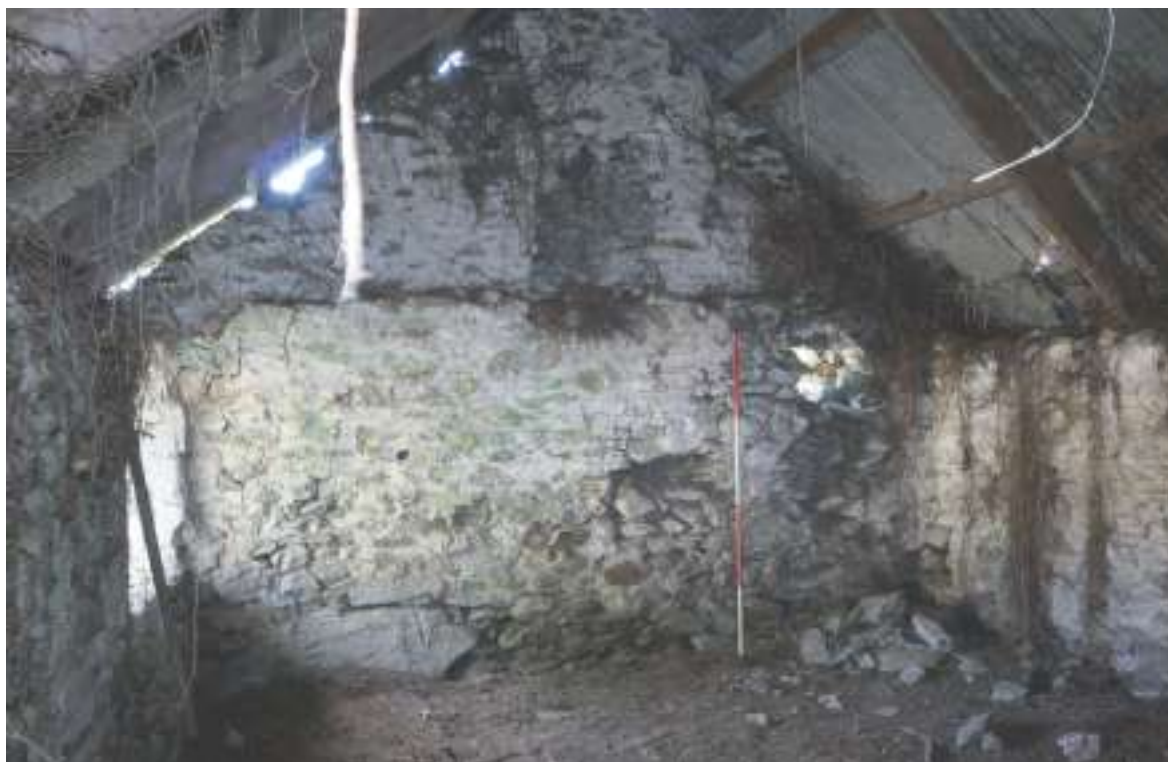
Plate 26. Canolfan yr Urdd, Pentre Ifan - Cart Shed. Interior west facing elevation. Looking E.

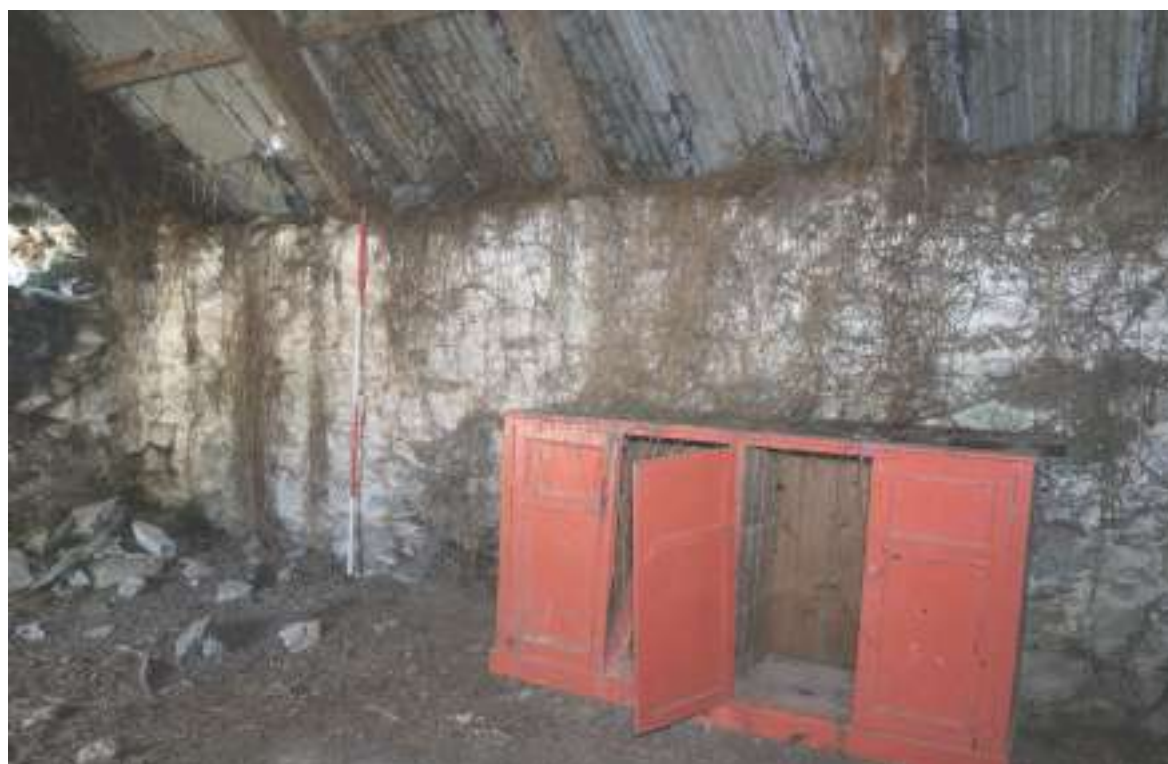
Plate 27. Canolfan yr Urdd, Pentre Ifan - Cart Shed. Interior view of north facing elevation. Looking SE.
