**Canolfan yr Urdd,
Pentre Efan, Velindre,
Crymych, Pembrokeshire, SA41 3XE**

**Archaeological Building Investigation & Recording
and Watching Brief**

HRSWales
Report No: 246

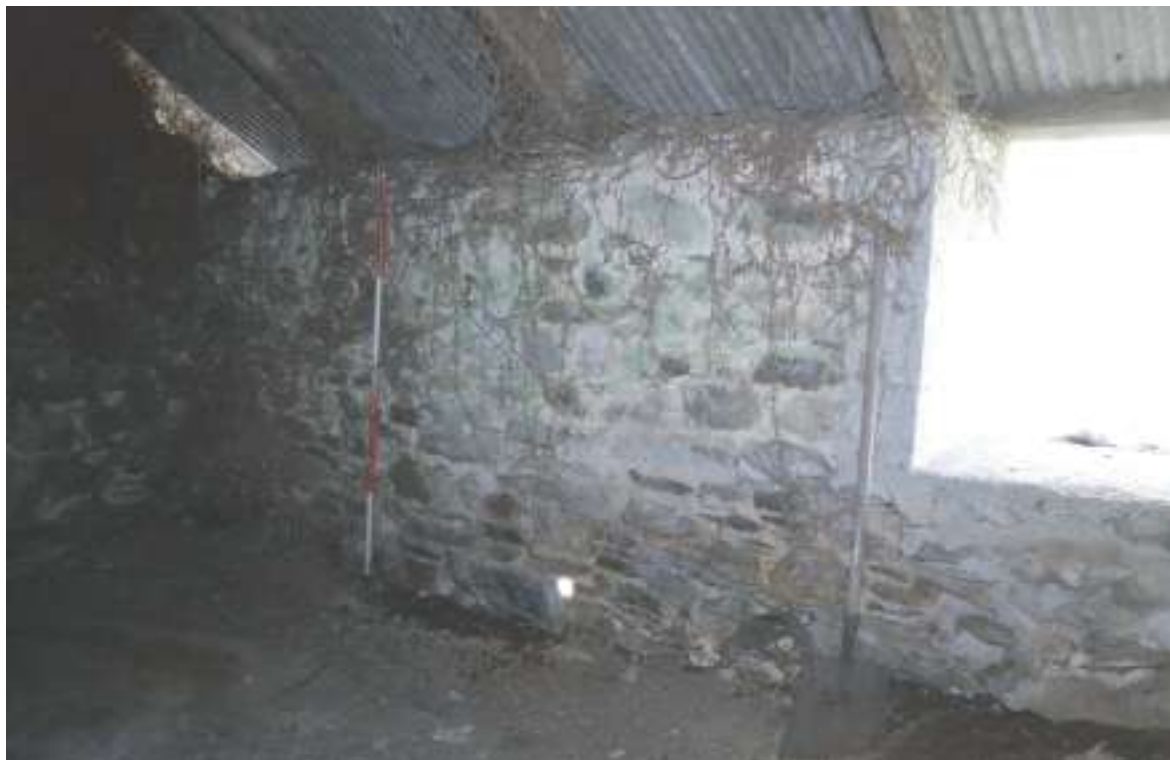
Plate 28. Canolfan yr Urdd, Pentre Ifan - Cart Shed. Interior south facing elevation. Looking NW.

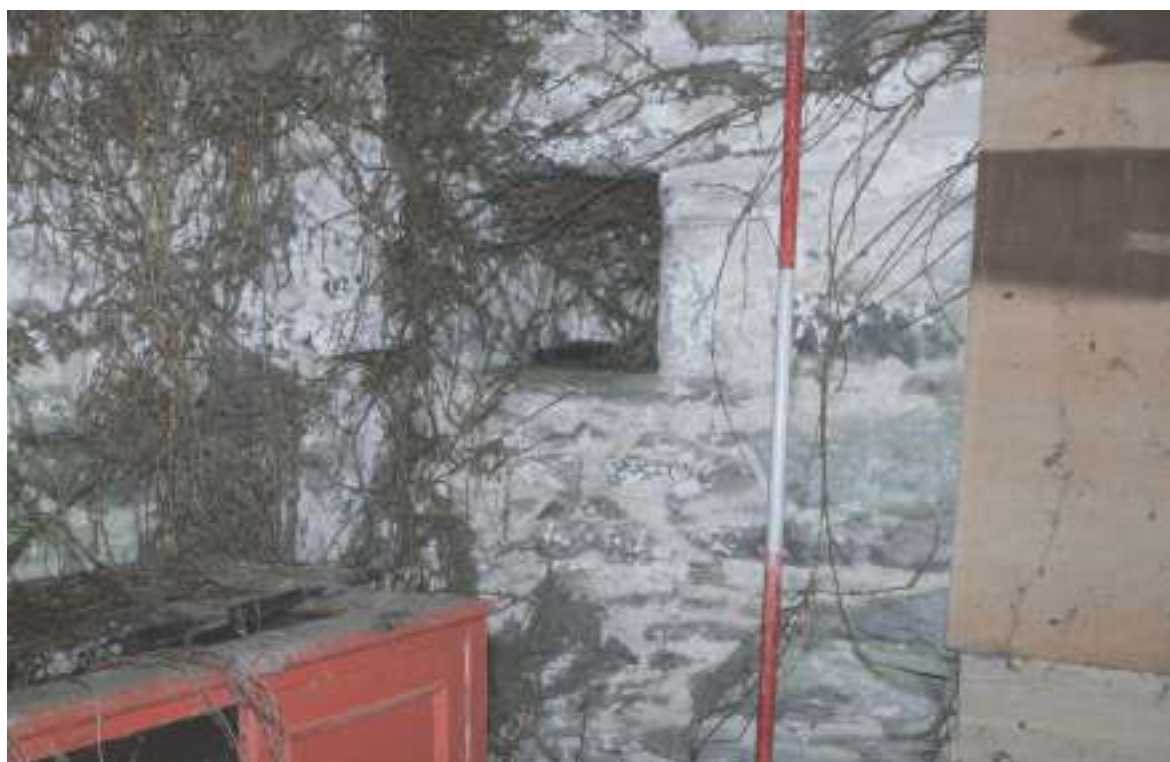
Plate 29. Canolfan yr Urdd, Pentre Ifan - Cart Shed. Interior view of 'cubby hole' in east facing elevation. Looking westwards.

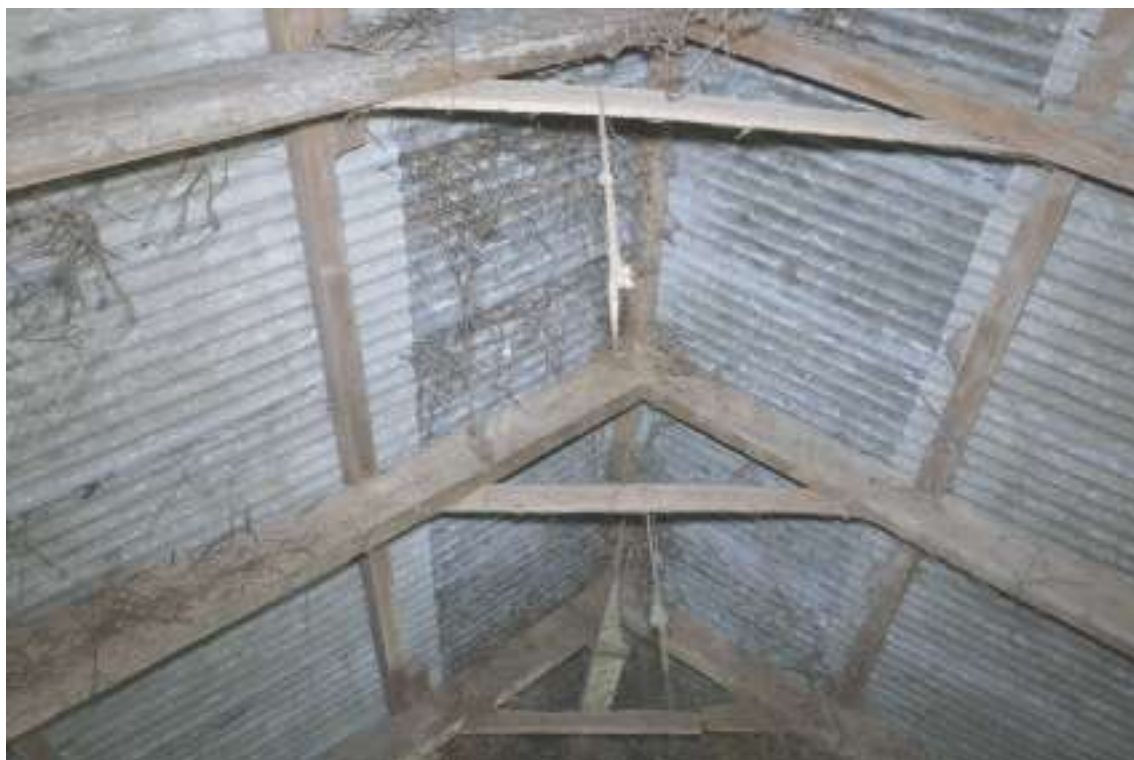
Plate 30. Canolfan yr Urdd, Pentre Ifan - Cart Shed. View of modern roofing timbers and corrugated asbestos roof. Looking W.

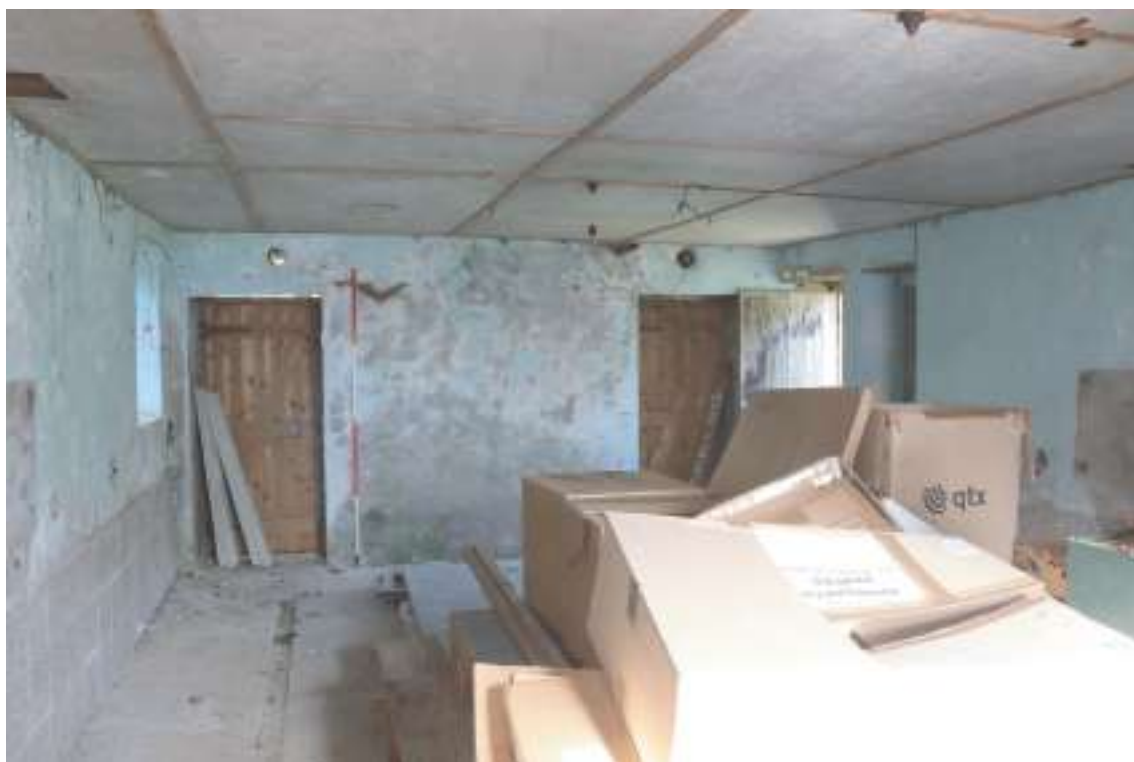
Plate 31. Canolfan yr Urdd, Pentre Ifan - Milking Parlour. Interior south facing elevation. Looking N.

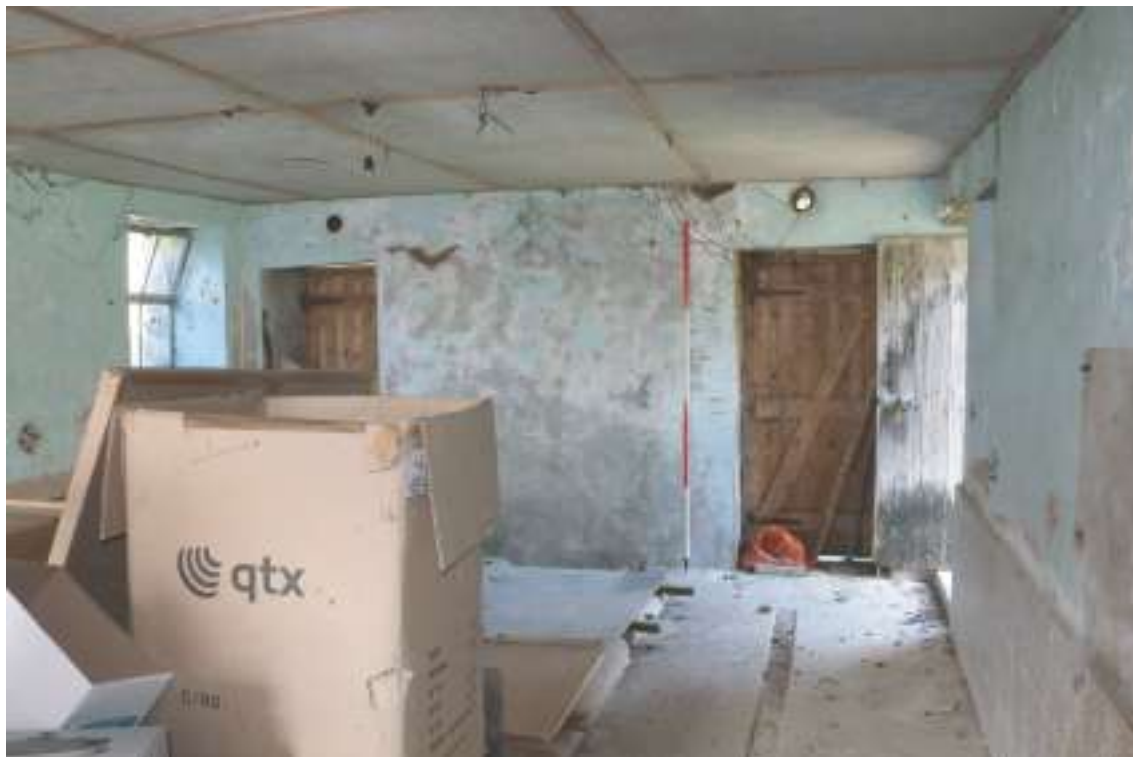
Plate 32. Canolfan yr Urdd, Pentre Ifan - Milking Parlour. Interior south facing elevation. Looking N.

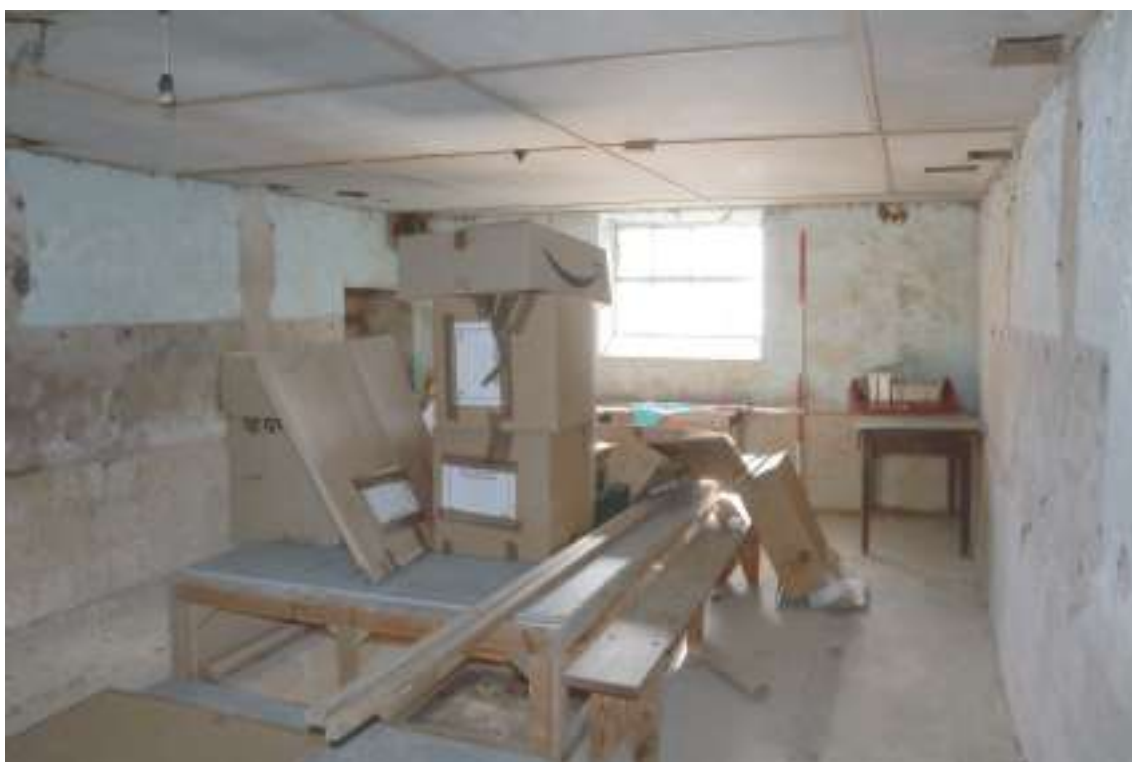
Plate 33. Canolfan yr Urdd, Pentre Ifan - Milking Parlour. Interior north facing elevation. Looking S.

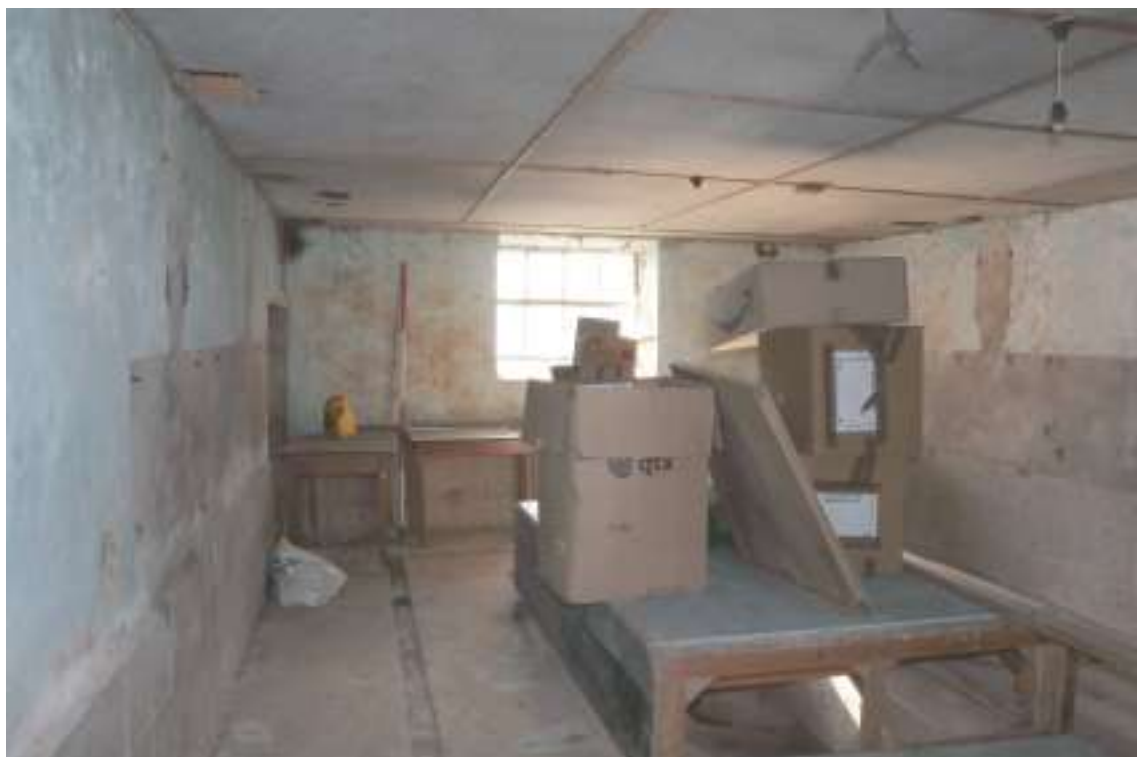
Plate 34. Canolfan yr Urdd, Pentre Ifan - Milking Parlour. Interior north facing elevation. Looking S.

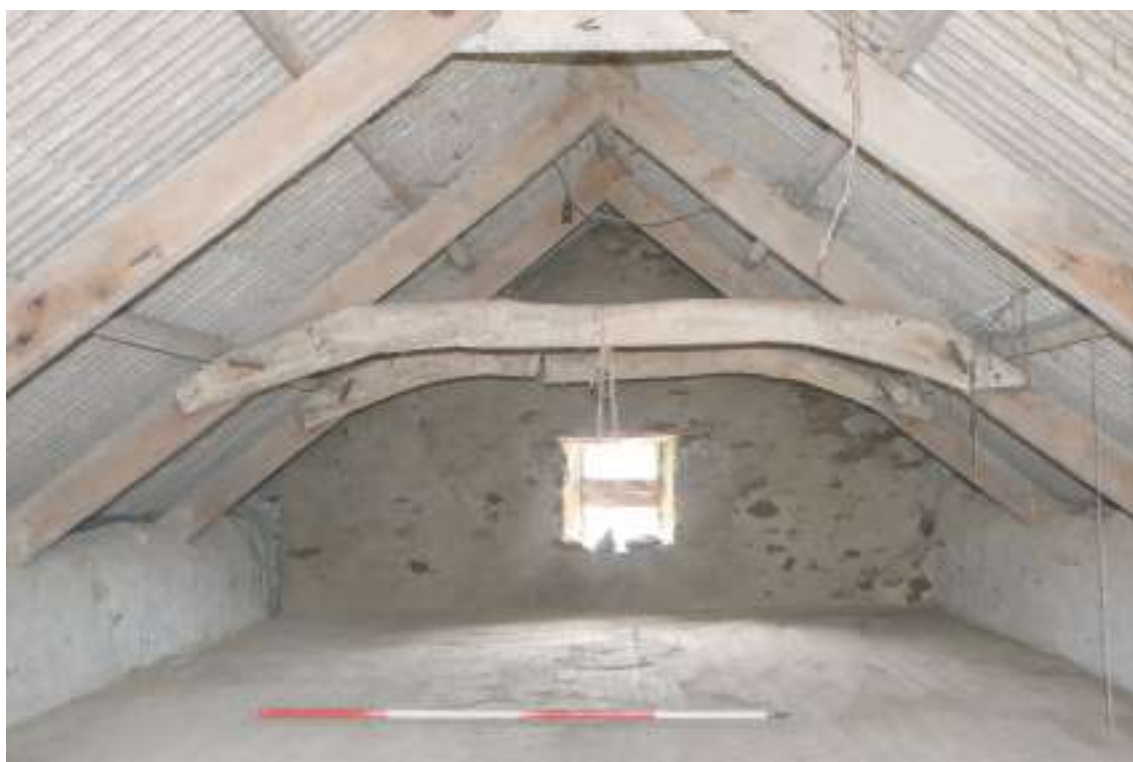
Plate 35. Canolfan yr Urdd, Pentre Ifan - Milking Parlour. Interior north facing elevation in loft space. Looking S.

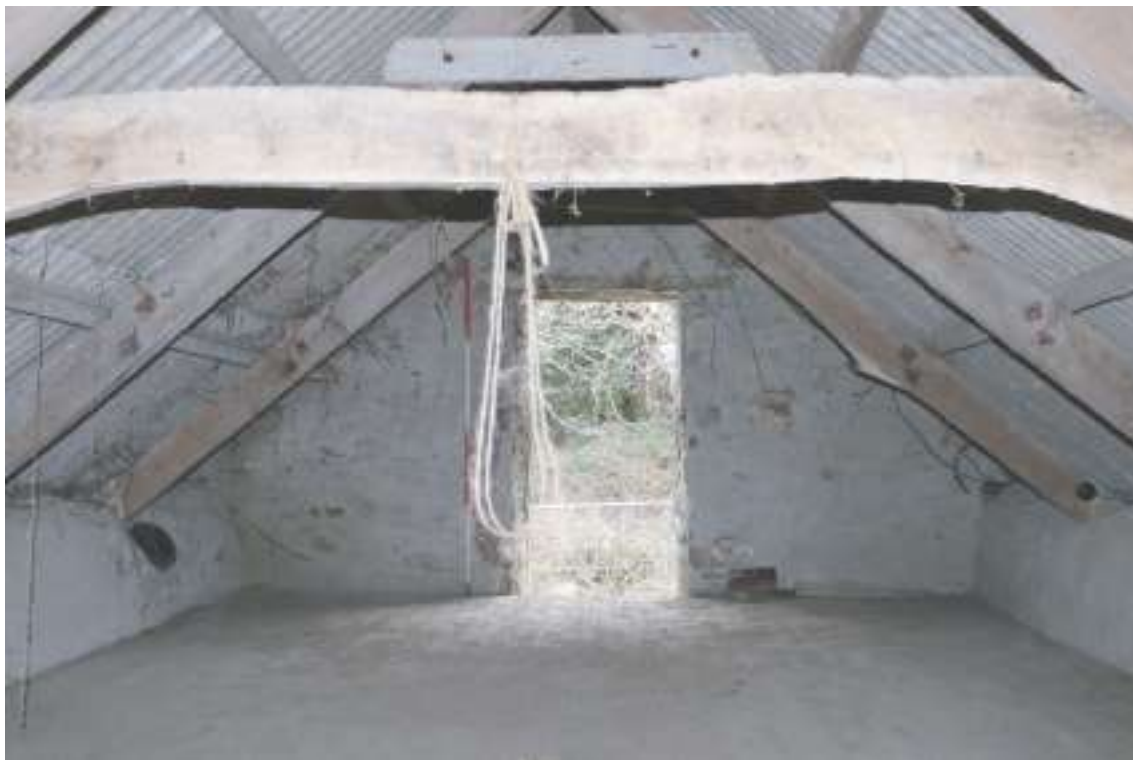
Plate 36. Canolfan yr Urdd, Pentre Ifan - Milking Parlour. Interior south facing elevation in loft area. Looking N.

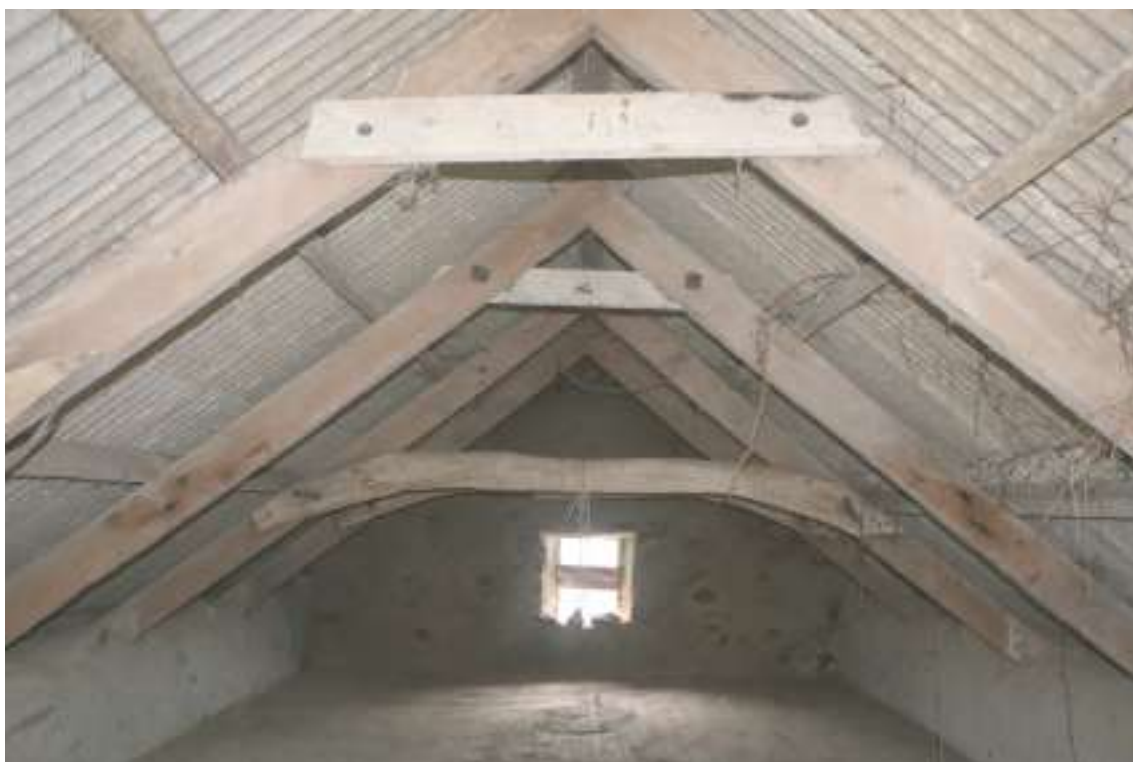
Plate 37. Canolfan yr Urdd, Pentre Ifan - Milking Parlour. View of roofing timbers. Looking S.

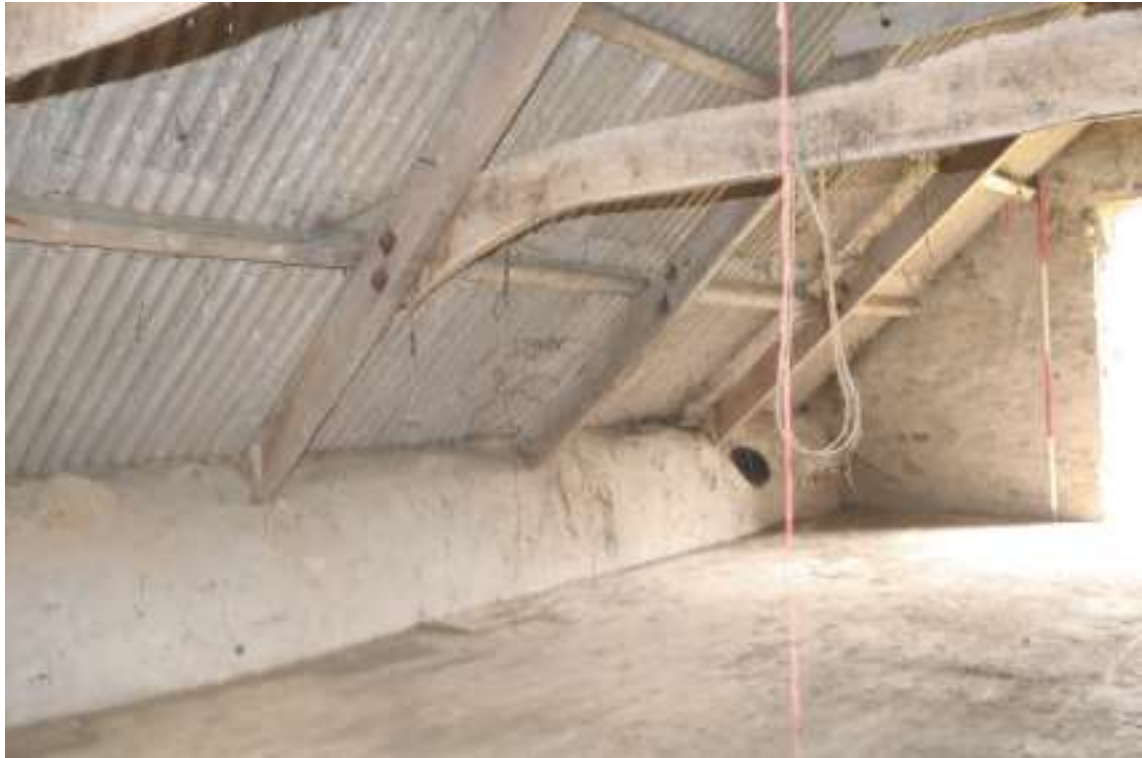
Plate 38. Canolfan yr Urdd, Pentre Ifan - Milking Parlour. View of east facing internal elevation in loft space. Looking NW.

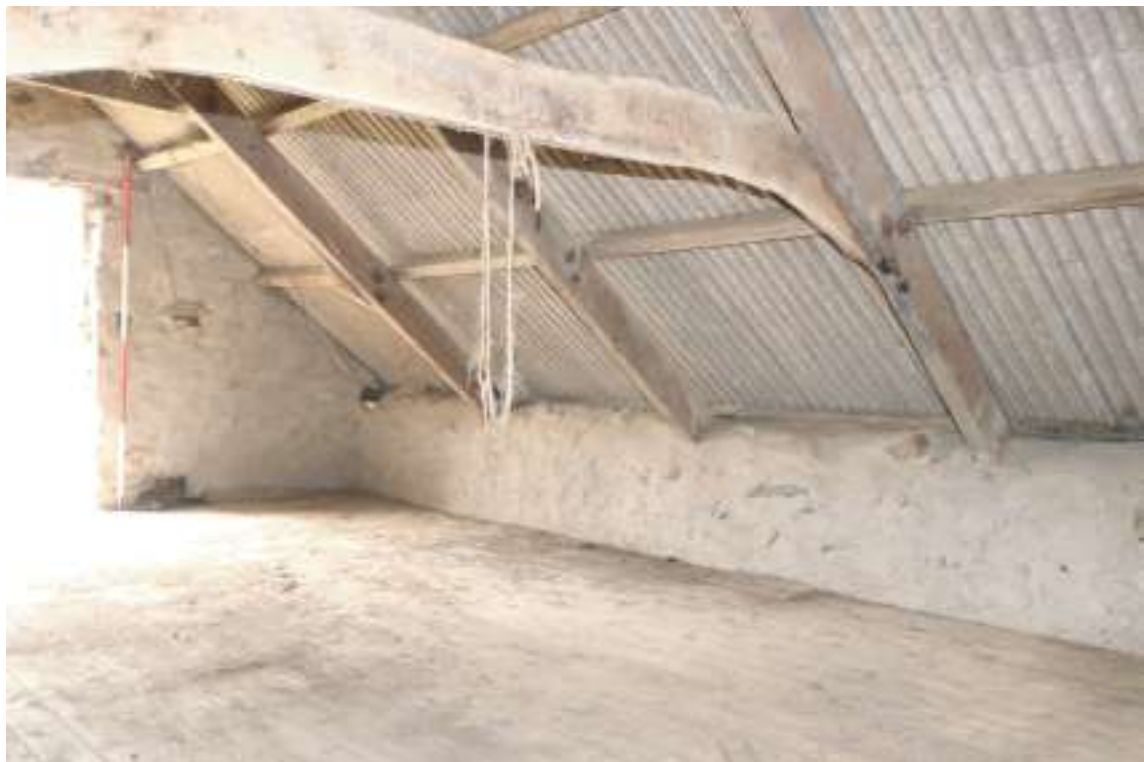
Plate 39. Canolfan yr Urdd, Pentre Ifan - Milking Parlour. View of west facing internal elevation in loft space. Looking NE.

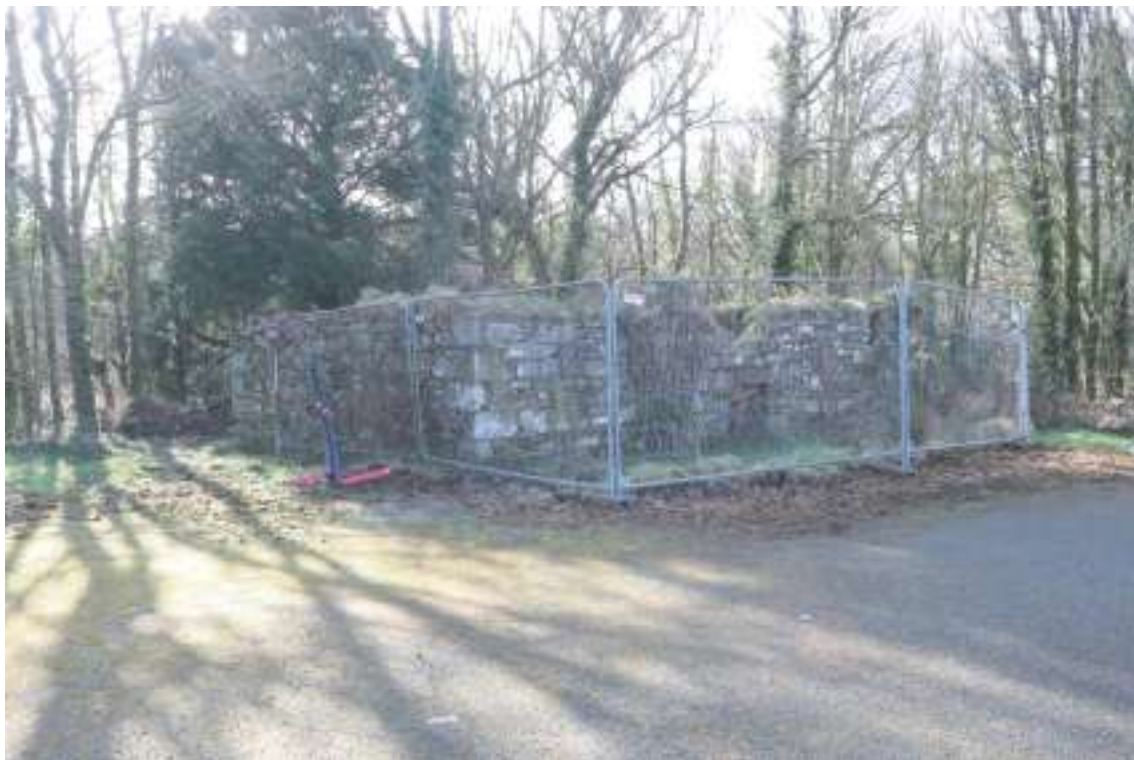
5.20 At the time of the site visit, the north facing elevation of the Corn Mill is protected with *Heras* fencing due to the unsafe condition of the building as a whole. The lower section of this elevation appears to be

5.24 The east facing elevation is constructed from bare stone with large quoin stones at each corner. In general this side elevation is in fair condition, although two structural cracks are evident toward the northern end. No features are present in this elevation.

Plate 40. Canolfan yr Urdd, Pentre Ifan - Corn Mill. North and East facing elevations. Looking SW.

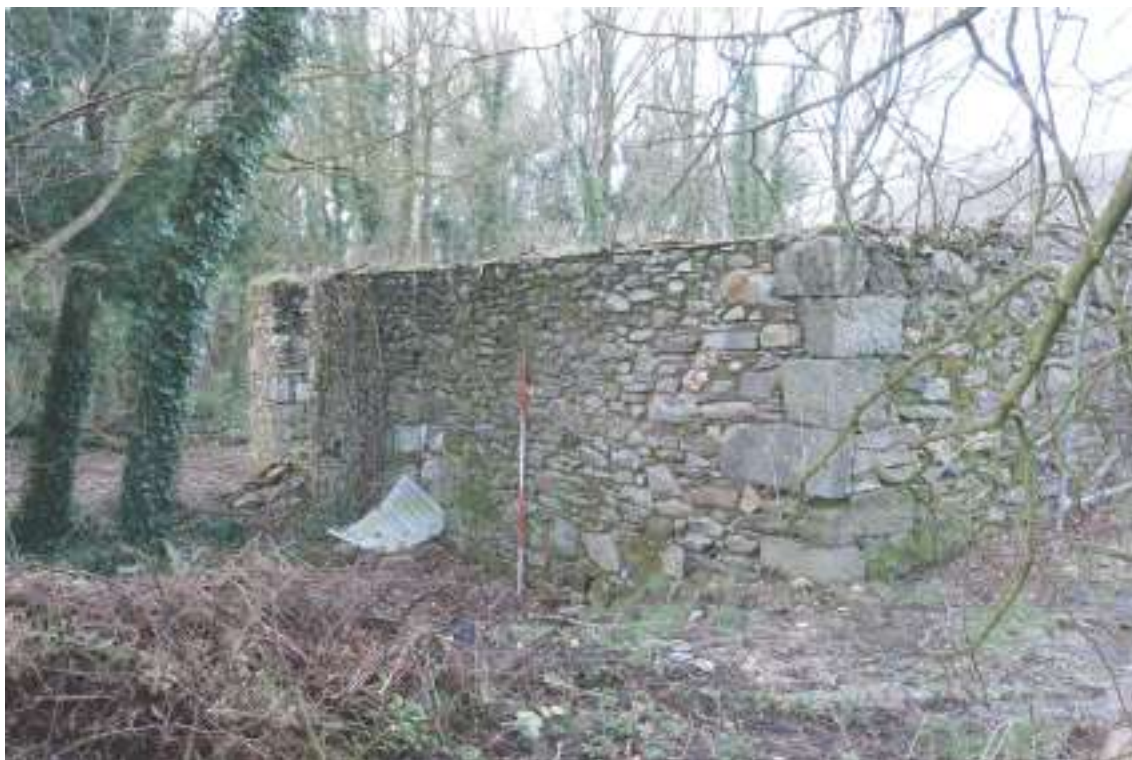
Plate 42. Canolfan yr Urdd, Pentre Ifan - Corn Mill. South and East facing elevations. Looking NW.

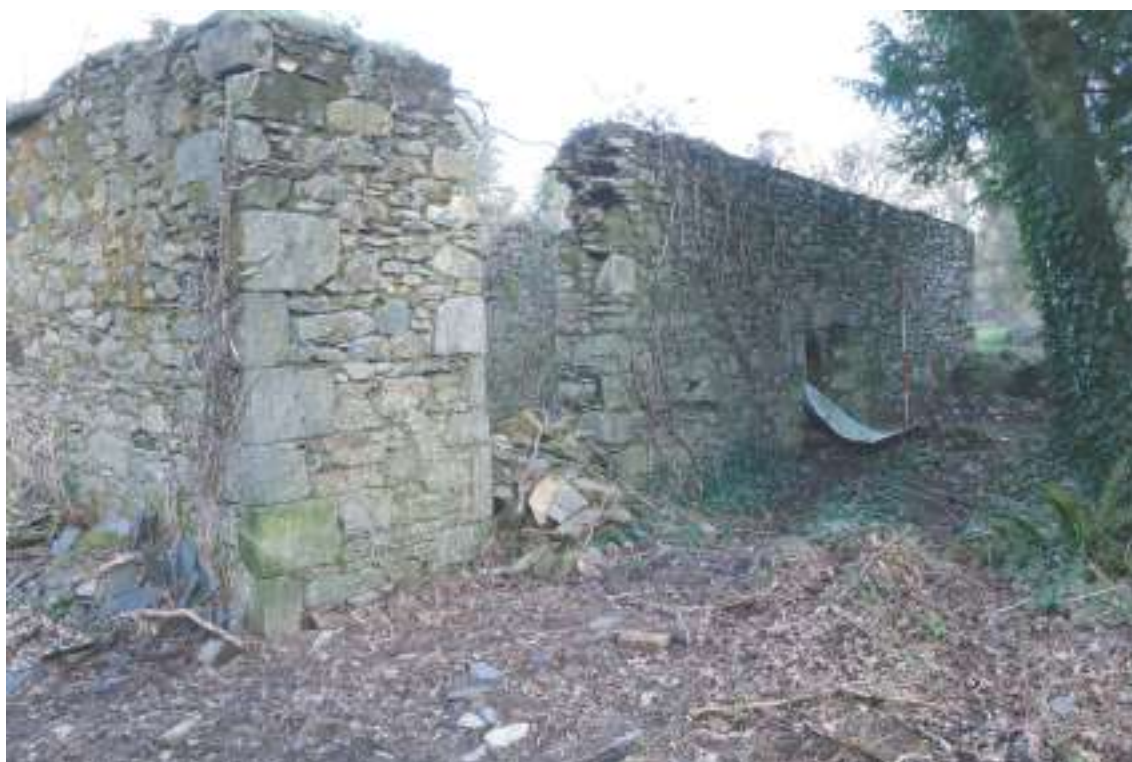
Plate 43. Canolfan yr Urdd, Pentre Ifan - Corn Mill. South facing elevation. Looking E.

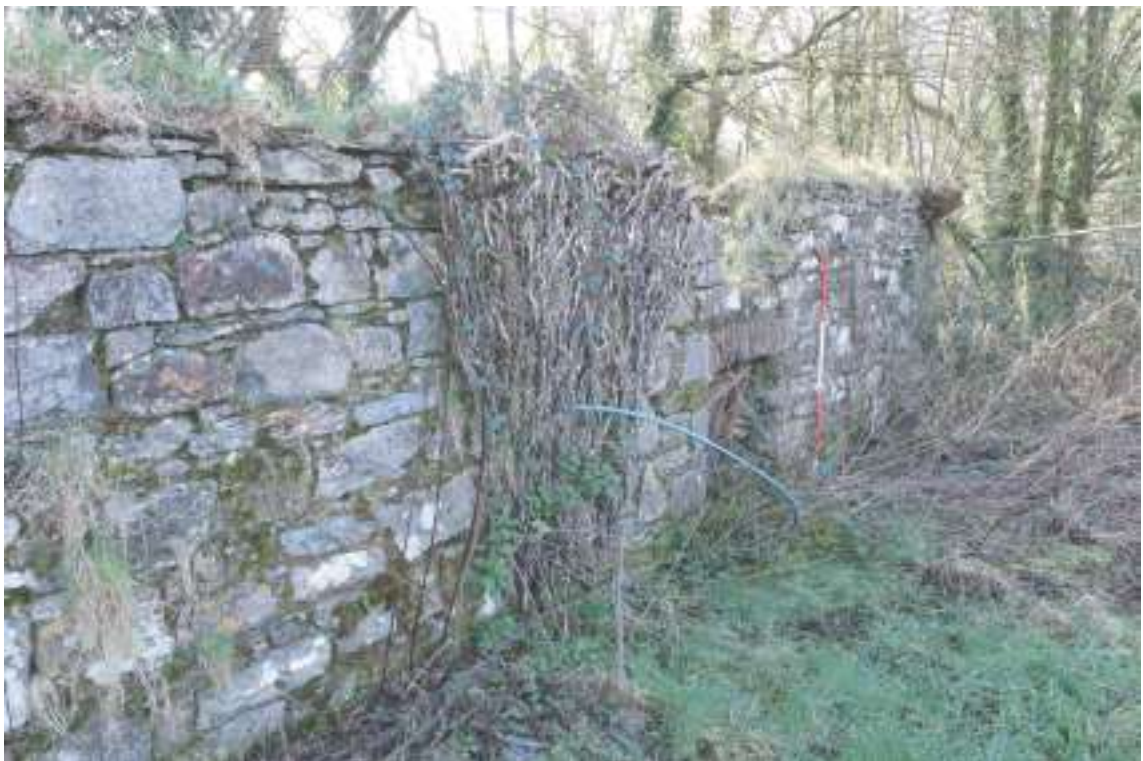
Plate 45. Canolfan yr Urdd, Pentre Ifan - Corn Mill. West end of north facing elevation. Looking SW.

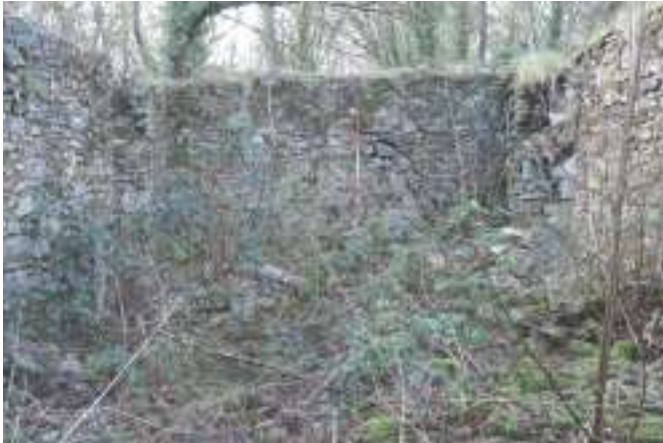
Plate 46. Canolfan yr Urdd, Pentre Ifan - Corn Mill. Interior east facing elevation. Looking W.

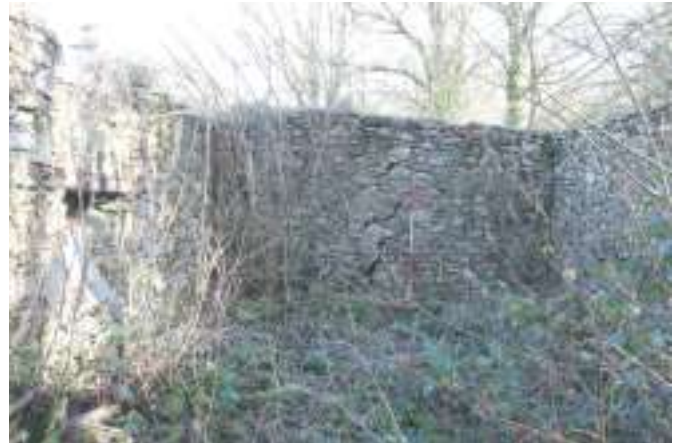
Plate 47. Canolfan yr Urdd, Pentre Ifan - Corn Mill. Interior west facing elevation. Looking E.

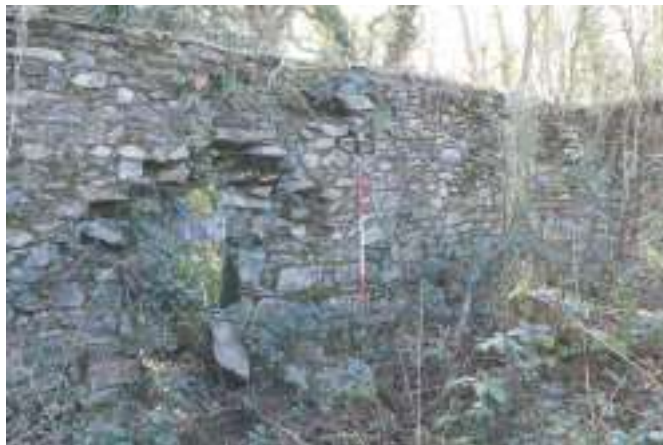
Plate 48. Canolfan yr Urdd, Pentre Ifan - Corn Mill. Interior north facing elevation. Looking SW.

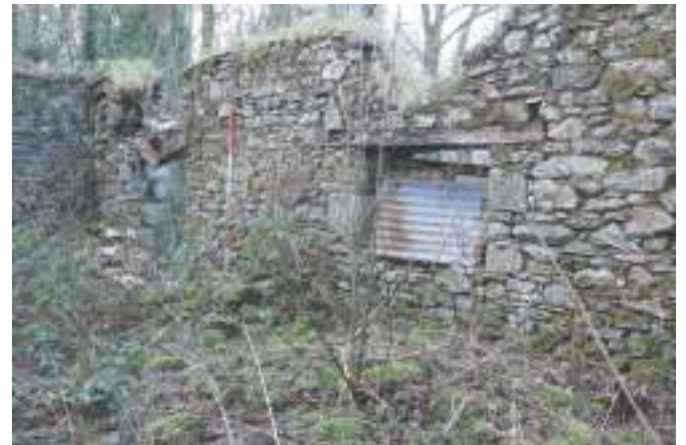
Plate 49. Canolfan yr Urdd, Pentre Ifan - Corn Mill. Interior south facing elevation. Looking NW.

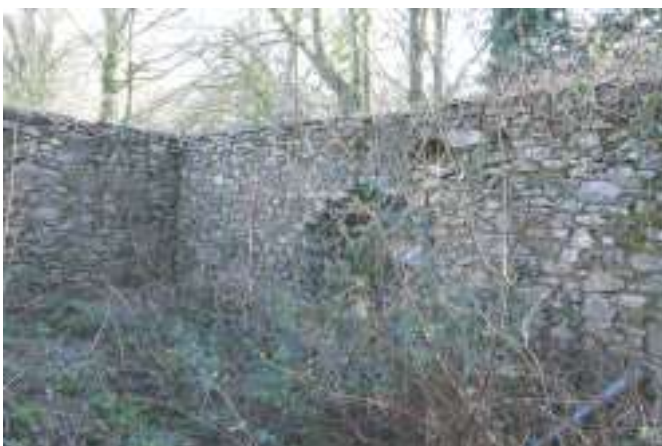
Plate 50. Canolfan yr Urdd, Pentre Ifan - Corn Mill. Interior north facing elevation. Looking SE.

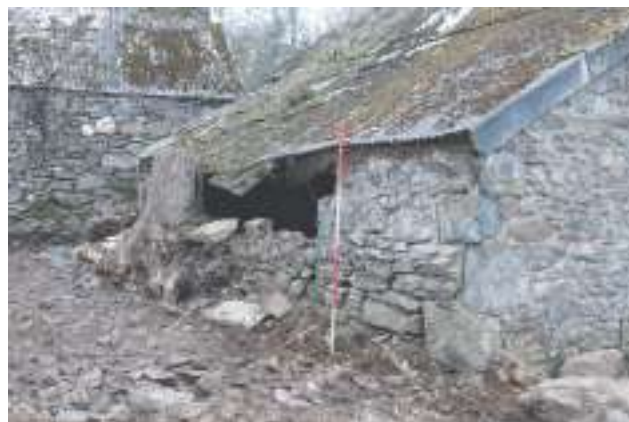
Plate 84. Canolfan yr Urdd, Pentre Ifan - Milking Parlour. View of tree stump compromising west wall following ground work. Looking N

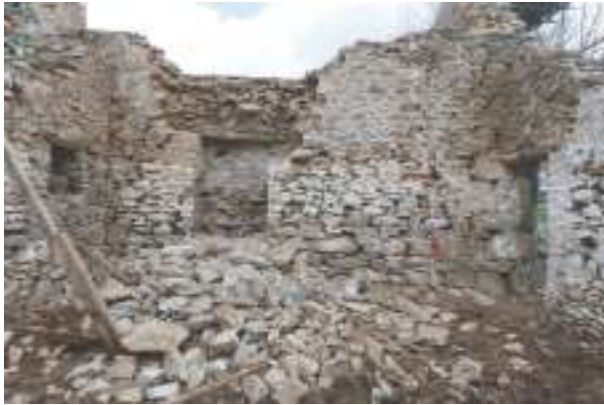
Plate 90. Canolfan yr Urdd, Pentre Ifan - Milking Parlour. West wall of Milking Parlour following removal of collapsed extension west wall. Looking E.

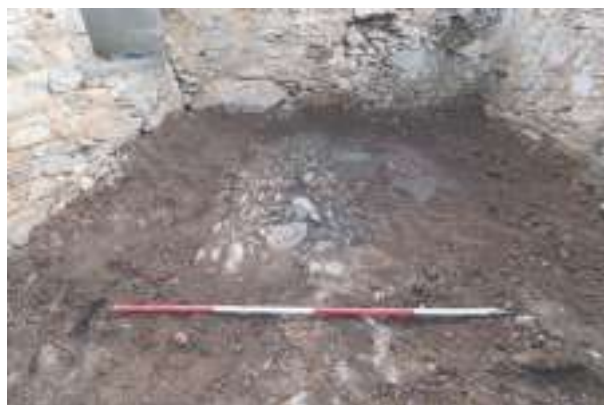
Plate 96. Canolfan yr Urdd, Pentre Ifan - Cart Shed. View of remains of exposed cobbled surface. Looking E.

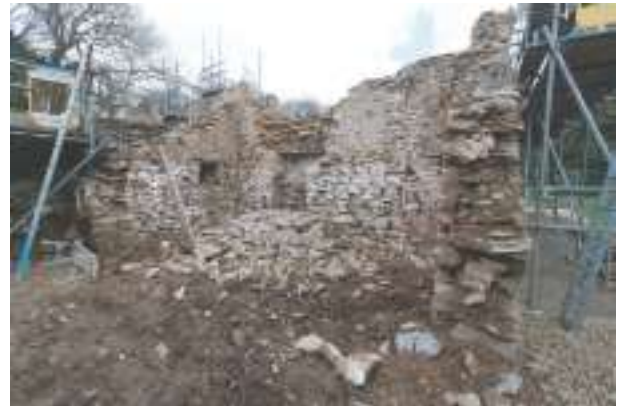
Plate 91. Canolfan yr Urdd, Pentre Ifan - Milking Parlour. Oblique view of Parlour extension following removal of roof and extension west wall. Looking NE.

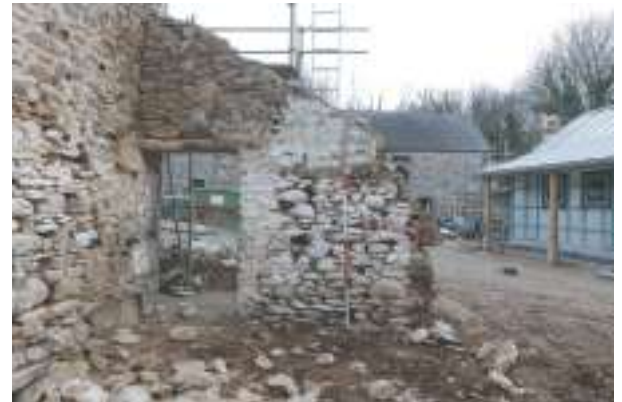
Plate 93. Canolfan yr Urdd, Pentre Ifan - Milking Parlour. View of north facing internal elevation of extension to Milking Parlour. Looking S.

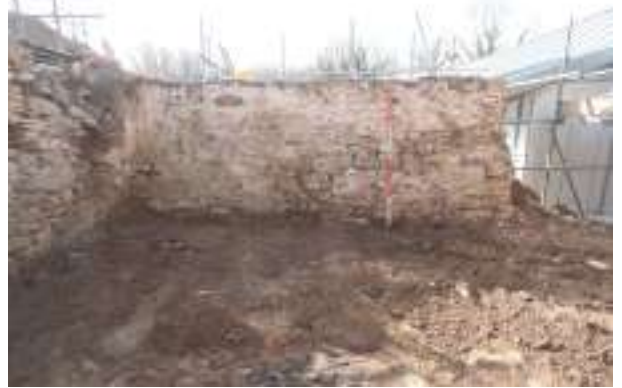
Plate 95. Canolfan yr Urdd, Pentre Ifan - Cart Shed. View of north facing internal elevation of Cart Shed. Looking S.

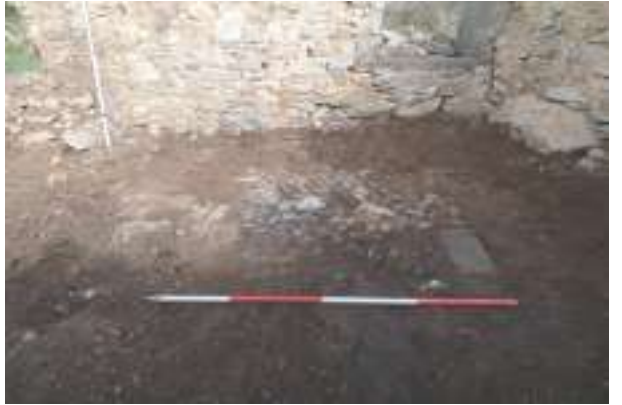
Plate 97. Canolfan yr Urdd, Pentre Ifan - Cart Shed. View of remains of exposed cobbled surface. Looking N.

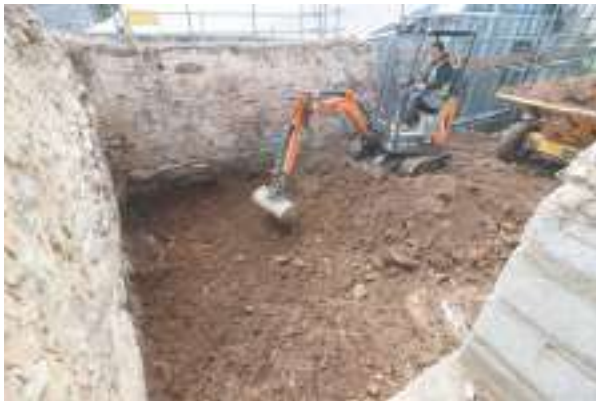
Plate 98. Canolfan yr Urdd, Pentre Ifan - Cart Shed. Working shot during ground reduction. Looking SW.

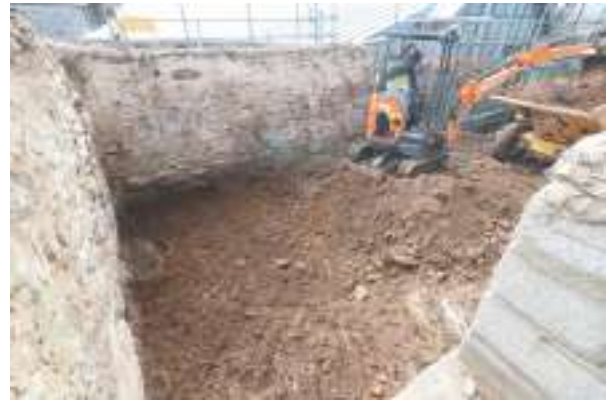
Plate 98. Canolfan yr Urdd, Pentre Ifan - Cart Shed. Working shot during ground reduction. Looking SW.

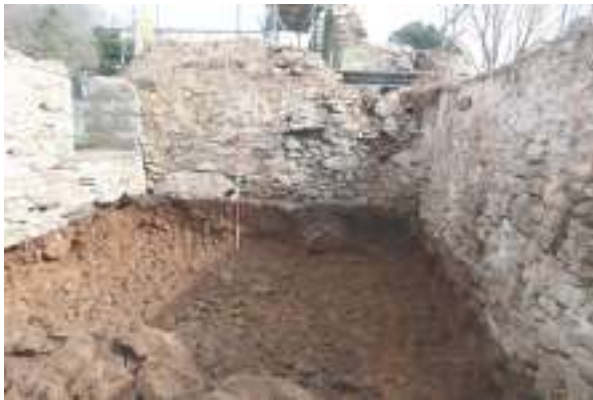
Plate 100. Canolfan yr Urdd, Pentre Ifan - Cart Shed. West facing internal elevation following ground reduction work. Looking E.

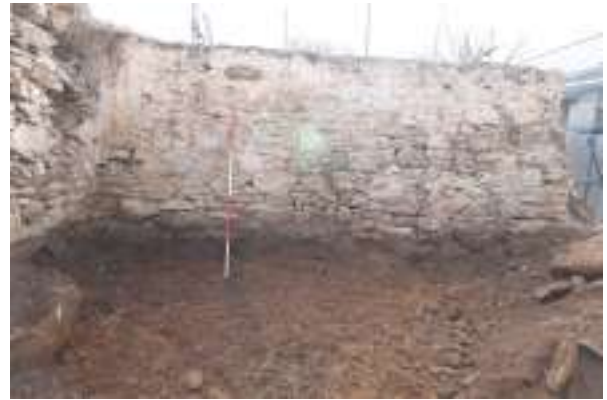
Plate 101. Canolfan yr Urdd, Pentre Ifan - Cart Shed. North facing internal elevation following ground reduction work. Looking S.

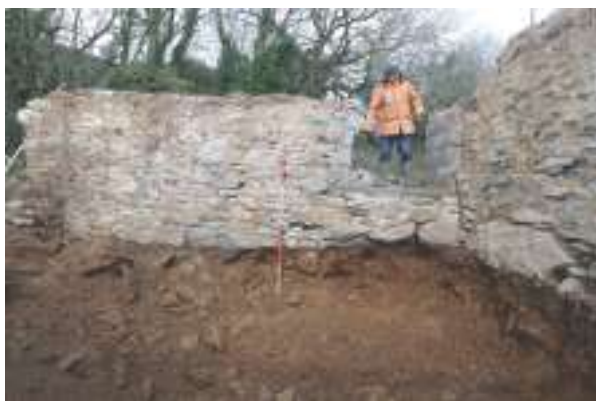
Plate 102. Canolfan yr Urdd, Pentre Ifan - Cart Shed. South facing internal elevation following ground reduction work. Looking N

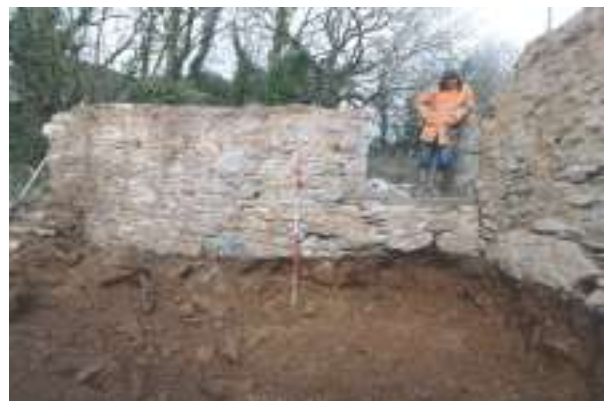
Plate 103. Canolfan yr Urdd, Pentre Ifan - Cart Shed. South facing internal elevation following ground reduction work. Looking N.

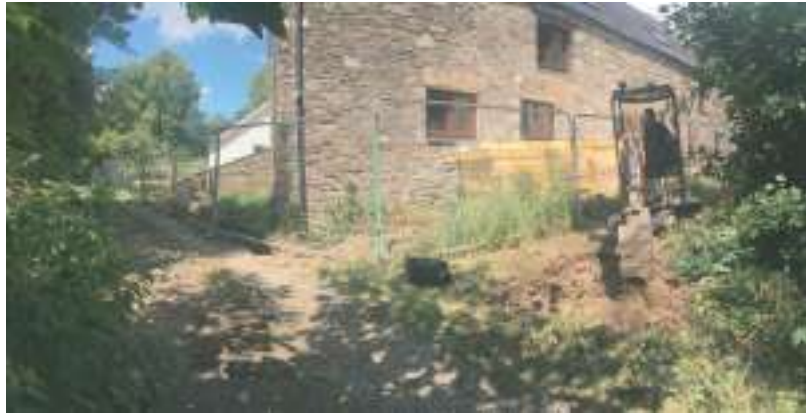
Plate 104. Canolfan yr Urdd, Pentre Ifan - Working shot during cutting of drainage trench at rear of Stables/Gatehouse. Looking N - NE.

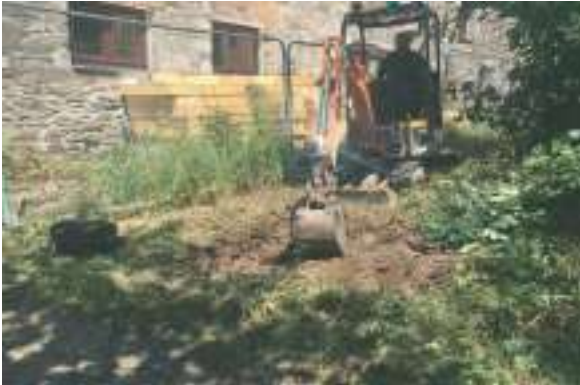
Plate 105. Canolfan yr Urdd, Pentre Ifan - Working shot during cutting of drainage trench at rear of Stables/Gatehouse. Looking NE

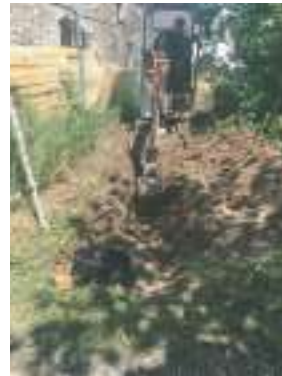
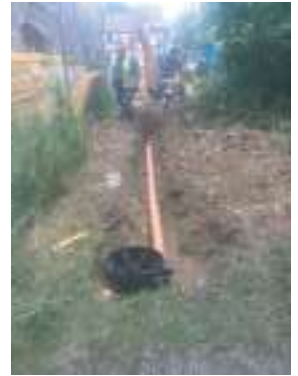
Plate 106. Canolfan yr Urdd, Pentre Ifan - Working shots during cutting of drainage trench at rear of Stables/Gatehouse. Looking E

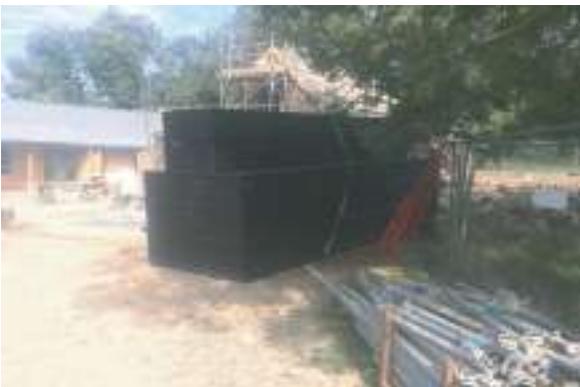
Plate 107. Canolfan yr Urdd, Pentre Ifan - View of proposed Sewage treatment plant prior to insertion. Looking NW.

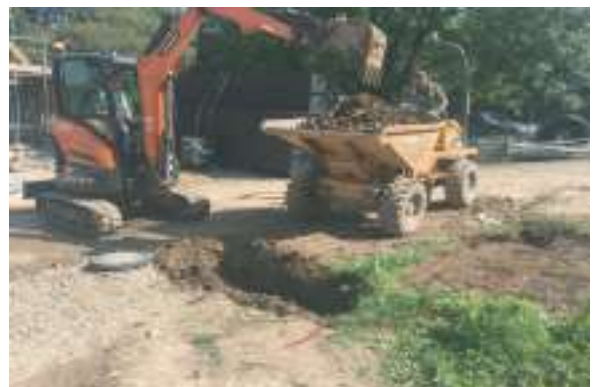
Plate 108. Canolfan yr Urdd, Pentre Ifan - Working shot during excavation of trench for Sewage Treatment Plant. Looking NE.

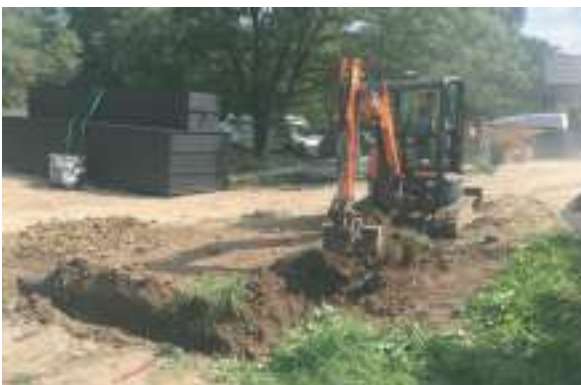
Plate 109. Canolfan yr Urdd, Pentre Ifan - Working shot during excavation of trench for Sewage Treatment Plant. Looking NE.

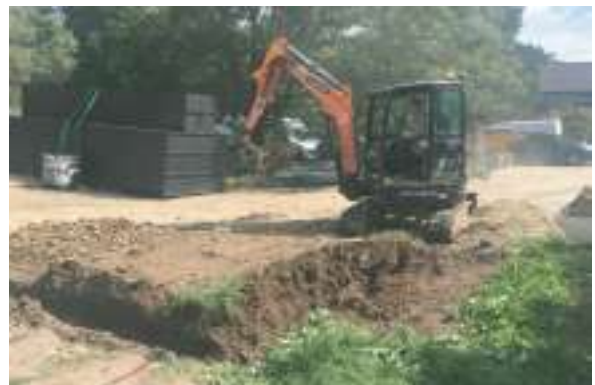
Plate 110. Canolfan yr Urdd, Pentre Ifan - Working shot during excavation of trench for Sewage Treatment Plant. Looking NE.

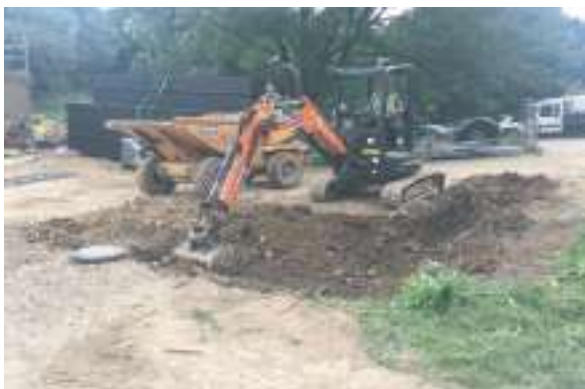
Plate 111. Canolfan yr Urdd, Pentre Ifan - Working shot during cutting of sewage treatment plant trench. Looking NE.

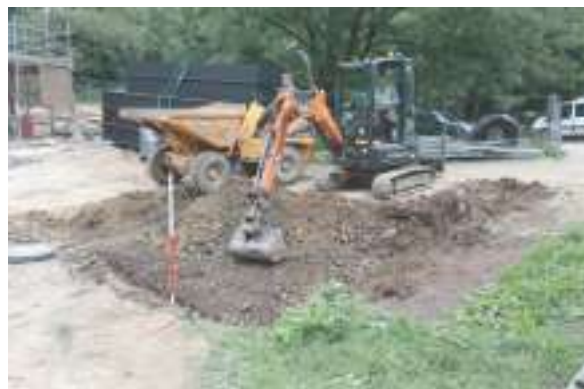
Plate 112. Canolfan yr Urdd, Pentre Ifan - Working shot during cutting of sewage treatment plant trench. Looking NE.

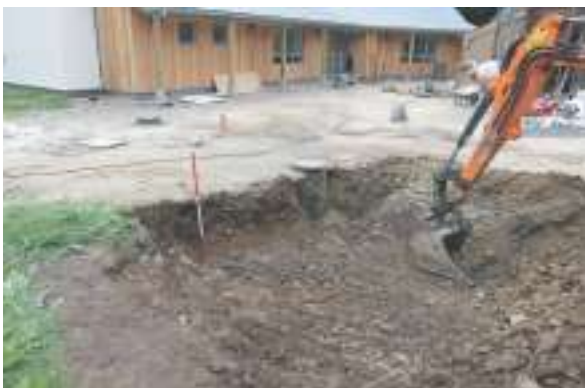
Plate 113. Canolfan yr Urdd, Pentre Ifan - Working shot during cutting of sewage treatment plant trench. Looking NW.

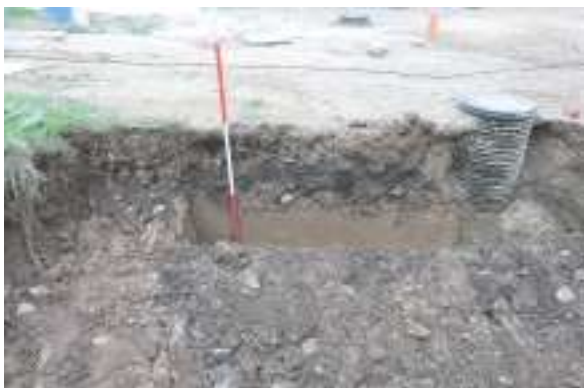
Plate 114. Canolfan yr Urdd, Pentre Ifan - View of east facing section of sewage treatment plant trench. Looking W.

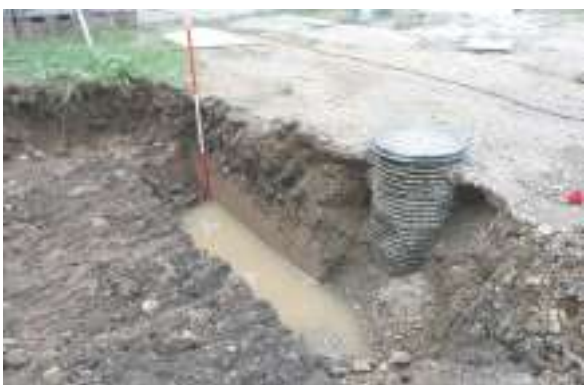
Plate 115. Canolfan yr Urdd, Pentre Ifan - Olique view of east facing section of sewage treatment plant trench. Looking SW.
