**Canolfan yr Urdd,
Pentre Efan, Velindre,
Crymych, Pembrokeshire, SA41 3XE**

**Archaeological Building Investigation & Recording
and Watching Brief**

HRSWales
Report No: 246

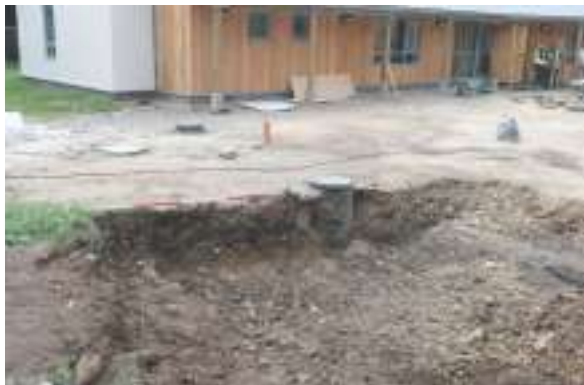
Plate 116. Canolfan yr Urdd, Pentre Ifan - Olique view of east facing section of sewage treatment plant trench. Looking NW.

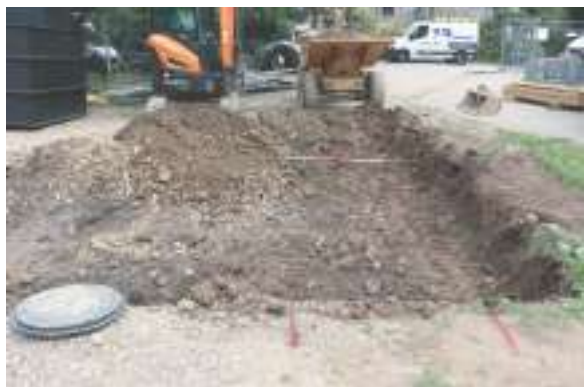
Plate 117. Canolfan yr Urdd, Pentre Ifan - View of excavated area down to natural on south side of sewage treatment plant trench. Looking E.

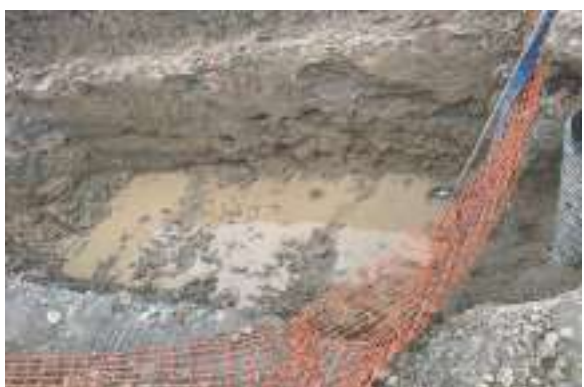
Plate 118. Canolfan yr Urdd, Pentre Ifan - View of north facing section following completion of sewage treatment plant trench. Looking SE.

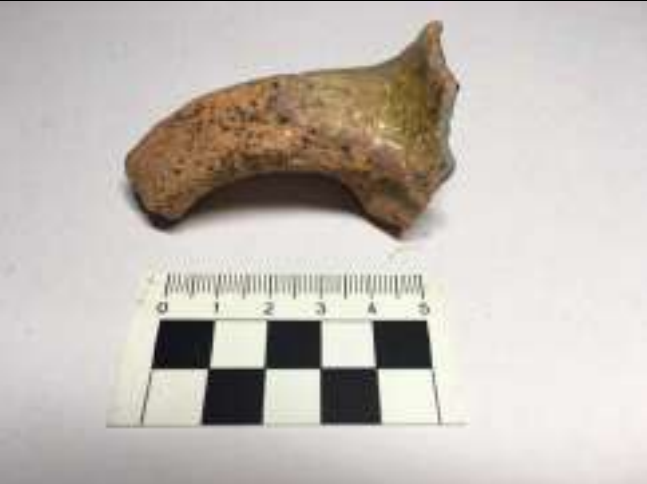
- Pottery -					
Context	Find Type	No. of pieces	Fabric Type	Date Range	Weight (grams)
103	Pottery fragment (Jug rim and handle)	1	Yellow/olive glaze with pink and grey fabric. Glazed interior.	15 th – 16th Century	48gms

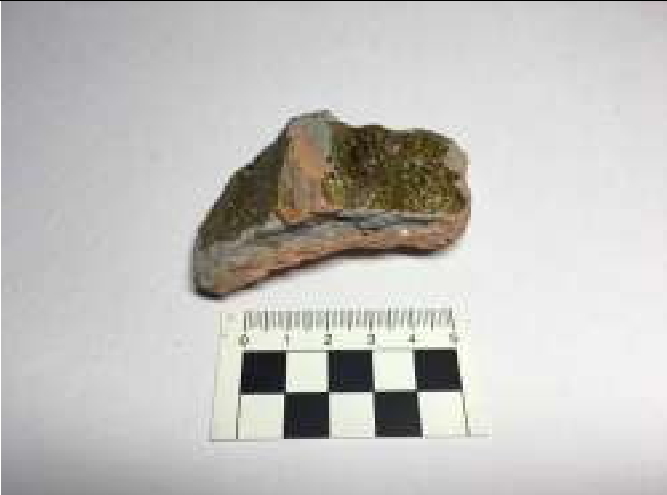
103	Fragment of roof ridge tile	1	Green/olive glaze with pink and grey fabric. Glazed on outside only	15 th – 16th Century	50gms
