HERITAGE IMPACT STATEMENT

WORK CARRIED OUT AT THE HEN TY FFERM,
PENRALLT, LOGIN, WHITLAND, CARMARTHENSHIRE,
SA34 0TL

MR G R & MRS J LEWIS

MARCH 2019

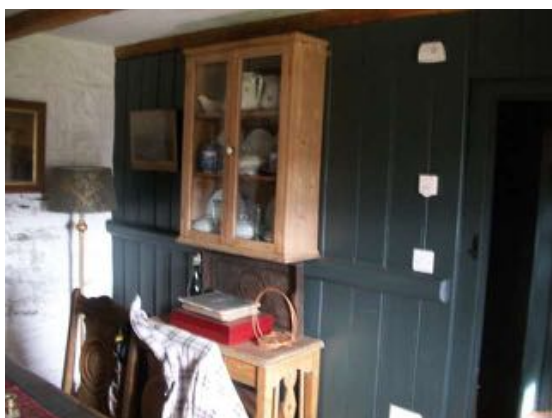
Above: Existing partition cleaned and redecorated

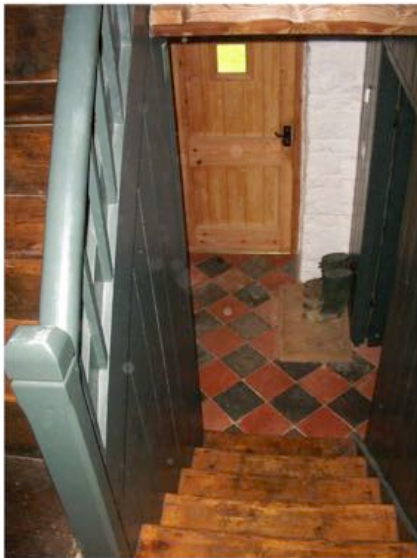
Above: As built varnished and painter joinery finishes to stairwell

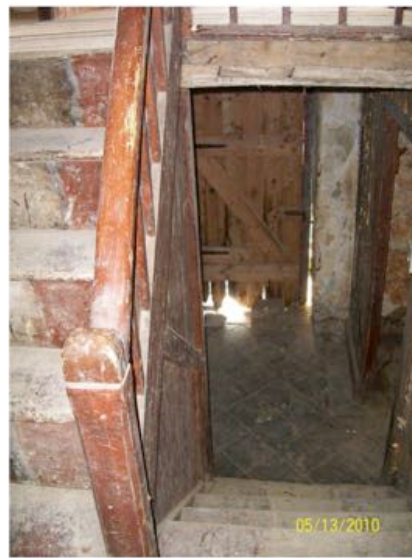
Above: Existing paint and varnished joinery finishes to stairwell

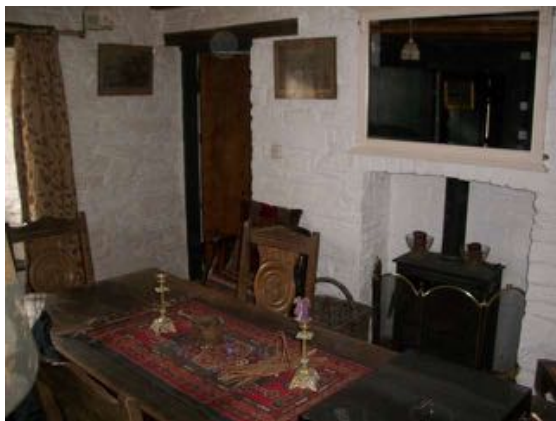
Above: Limewash finish over stone and painted joinery

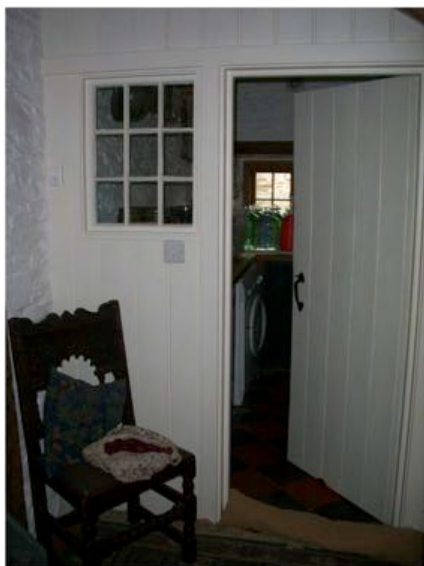
Above: New utility room partition reusing the window and boarding opposite in painted finish

The consented plans showed the removal of the eastern partition to the slating area with the room reduced in size to create a new shower room in the ground floor of the lean-to. This partition had character however with vertical boarding and internal window. The applicant salvaged this partition and relocated to the new utility room at the west end of the lean-to, conserving original fabric.

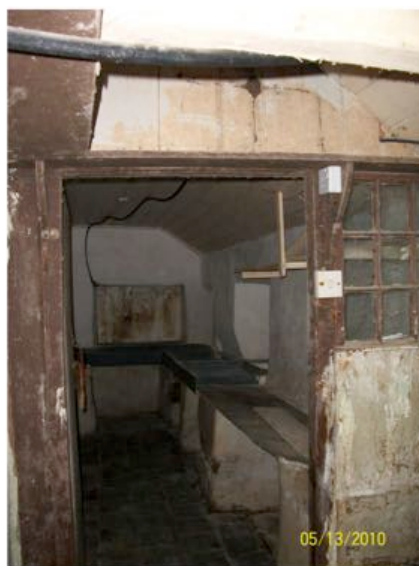
Above: Former salting room with painted vertical boarding and window

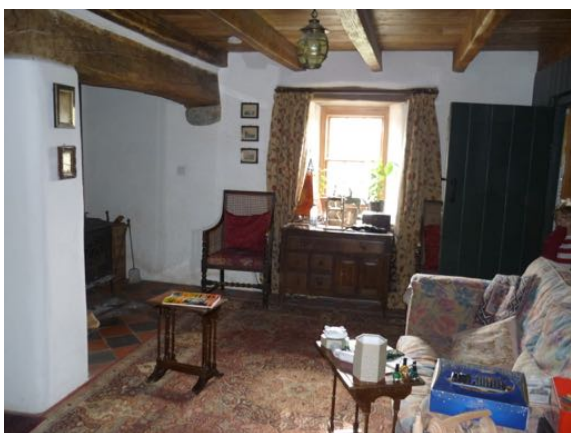
Above: Limewash over lime plaster

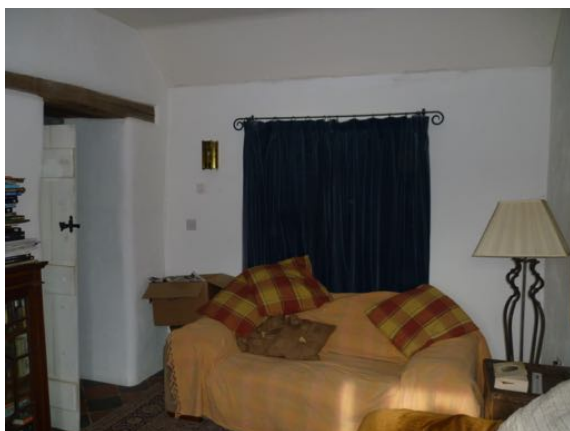
Above: New study with limewashed plaster in eastern extension

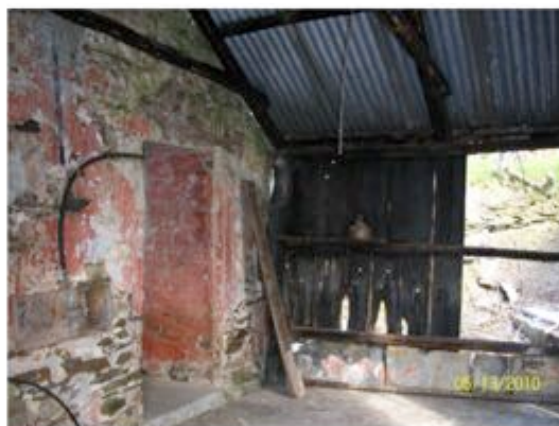
Above: Existing eastern extension with partial limewash to stone

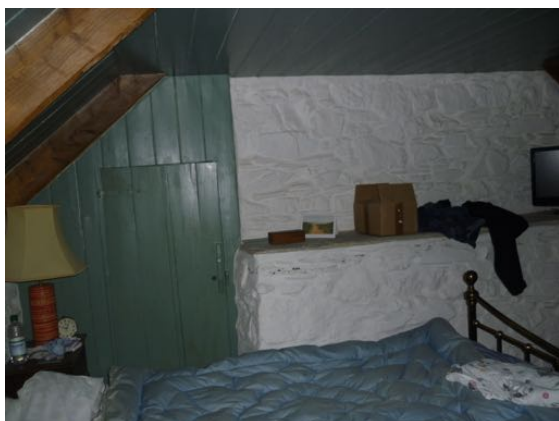
Above: Original boarding to cupboard door refitted and decorated in bedroom with limewash to stone

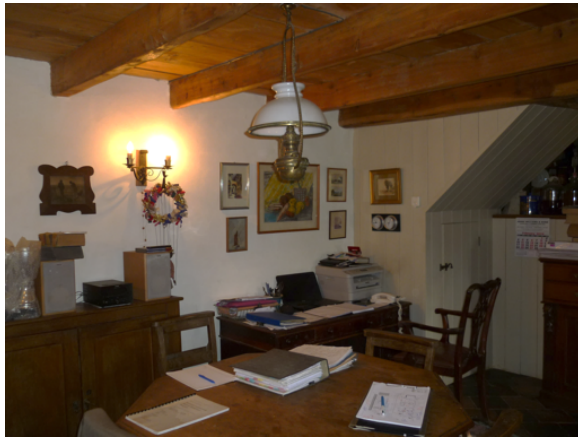
Above: New kitchen finishes with limewash over lime plaster and painted boarding to new staircase soffit within former stable

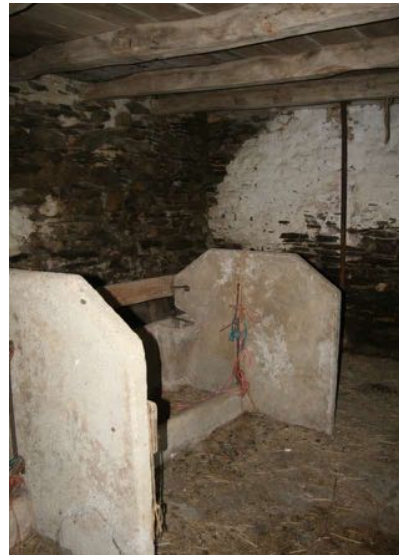
Above: Existing stable with partial limewash and exposed stone finishes

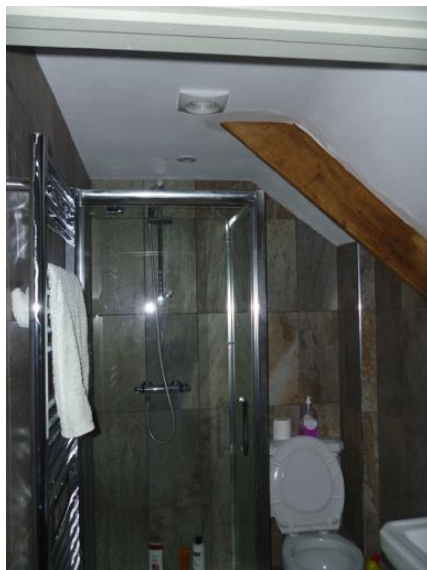
Above: New ensuite finished with wall tiling behind shower to west bedroom

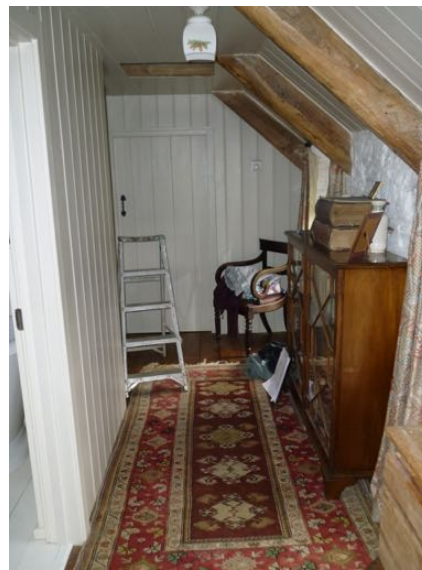
Above: New painted timber boarding to new partitions on first floor hallway

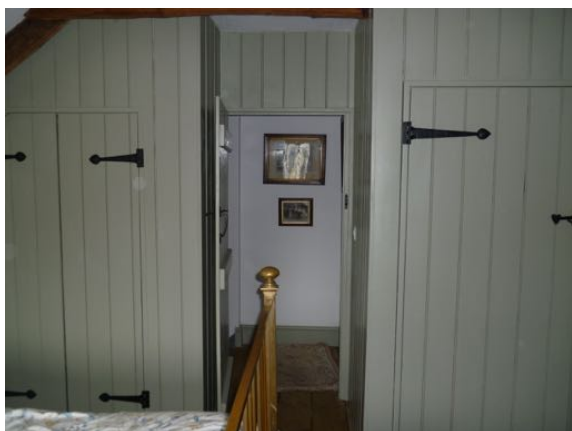
Above: New painted timber boarding to new partitions to west bedroom

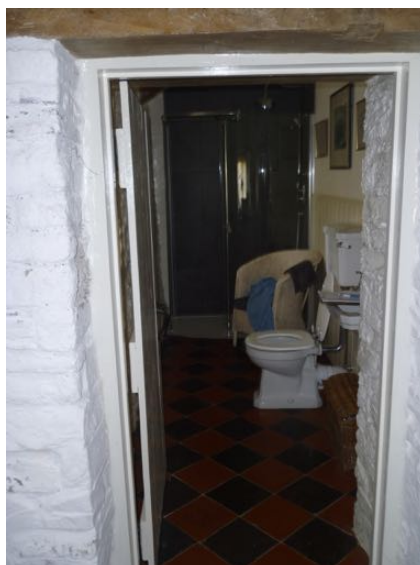
Above: New limewash to stone and localised tiling behind shower to lean-to shower room

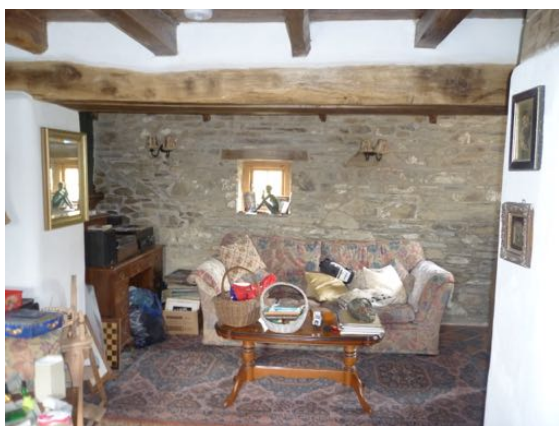
Above: Localised area of exposed stonework pointed in lime to north wall of lean-to area now within sitting room

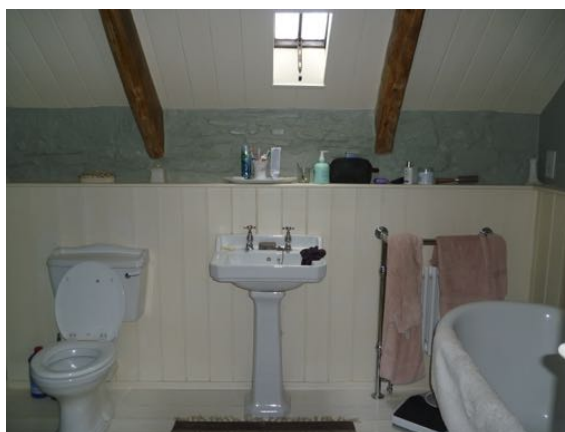
Above: Partial limewash and painted vertical timber wainscoting with first floor bathroom

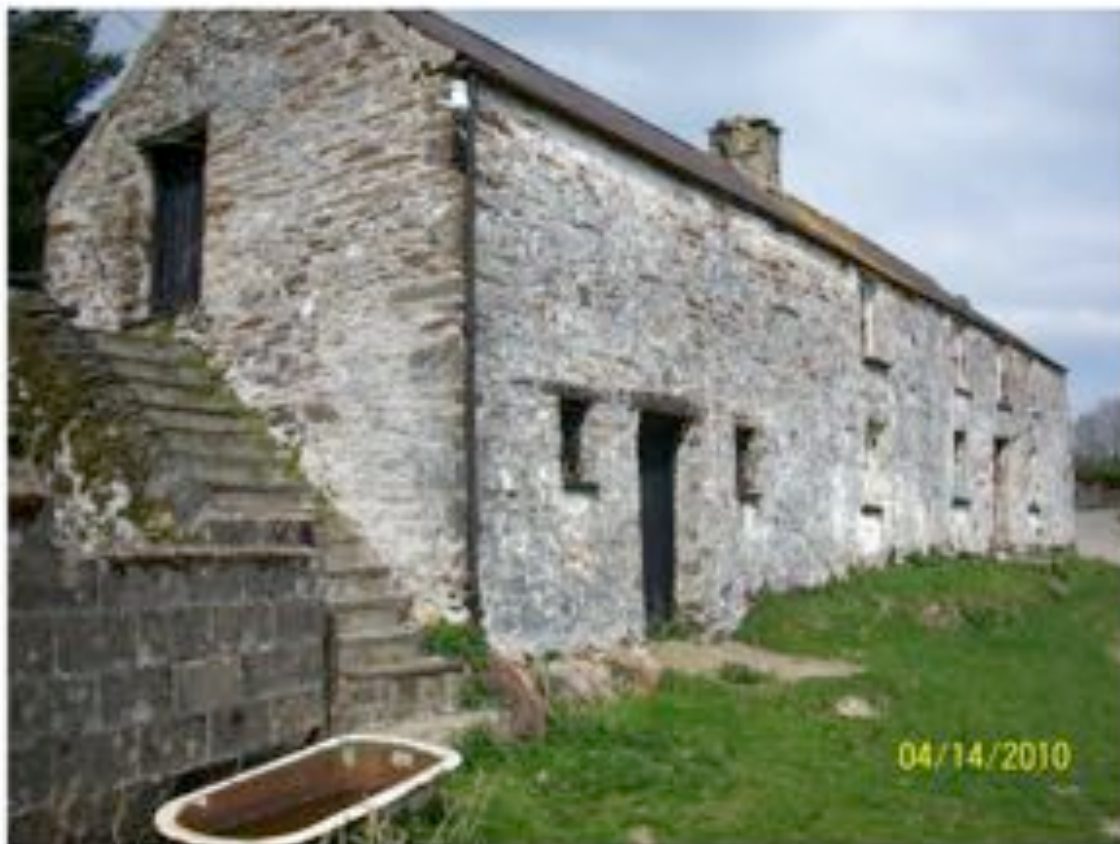
Below: South and west elevations taken before the works in 2010 with visible stonework even in the more sheltered areas of the stable in particular. Note: see photographs of the north and east elevations in the next section of this document on windows, doors and shutter.

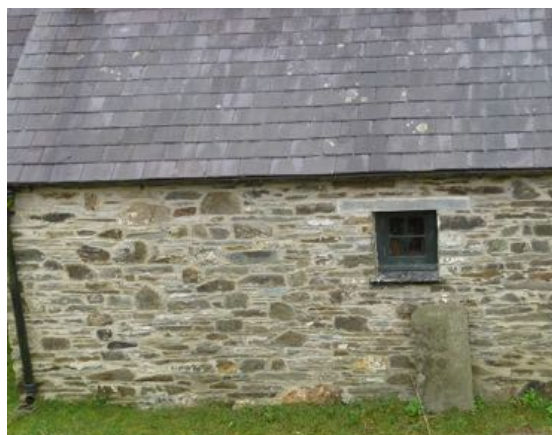
The house is situated on steeply sloping bank with the ground level to the north almost level with the eaves level of the lean-to. In accordance with the approved plans, the bank was lowered and a land drain introduced. Surface water had historically collected along the north wall of the lean-to and pooled towards the east end. During dry periods, water emerged from under the floor exiting at the southern side of the house. Loose stone visible above the higher ground level had already been noted in the structural report and following excavation a small section of detached stone outer skin was exposed. The roof was temporarily supported whilst the area was rebuilt locally using the salvaged stone and lime mortar.

Above: same rebuilt area upon completion

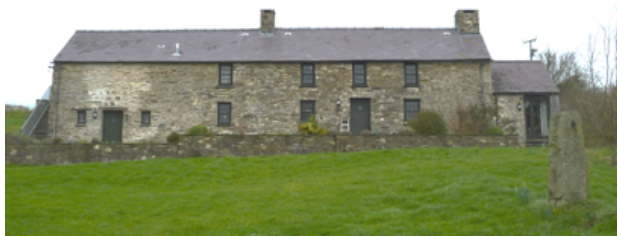
Left: View of the house from the from south but within the property boundary with simple squared outline of the chimneys retained and traditional detail conserved. The smoke holes and lead work are not apparent but the addition of chimney pots would be noticeable from afar due to the change in roof line. Although the height of the chimneys had to be estimated due to lack of primary evidence, their proportions are in keeping with the house and other historical examples.

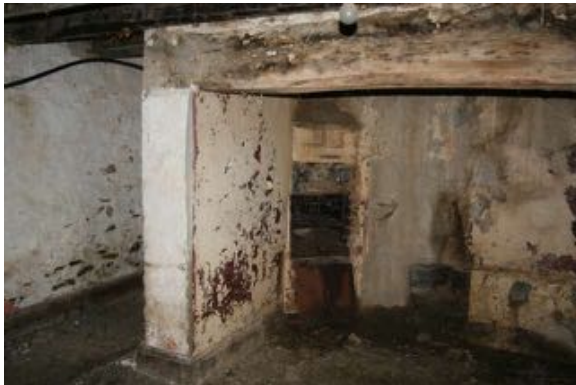
Chimneys below roof level were in fair condition with rebuilding work concentrated above roof level. Minor repairs were undertaken to the east inglenook where a hole had been knocked through to accommodate pipework from an old Rayburn. Small pieces of brick and cement mortar were removed with the hole repaired with salvaged stone and lime mortar. A wire brush was used to remove tar and soot from the stonework. A timber beam that was once used to cure meat was left insitu and other than cleaning and replastering, no works were necessary to the for the bread oven.

Above: east inglenook before

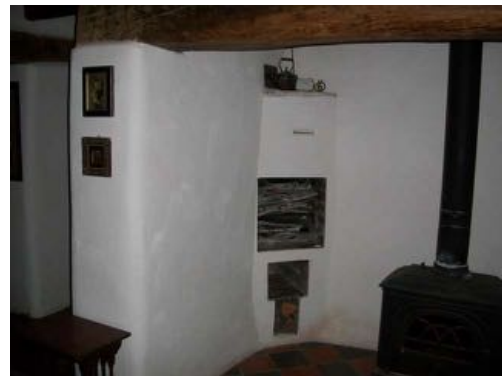
Above: east inglenook after

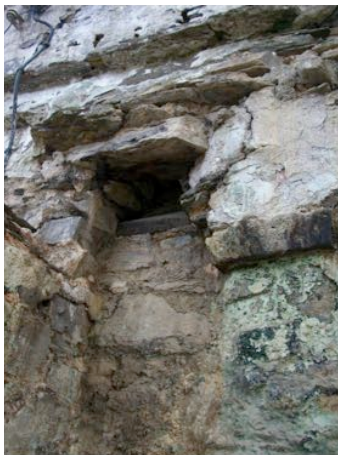
Above: old flue before

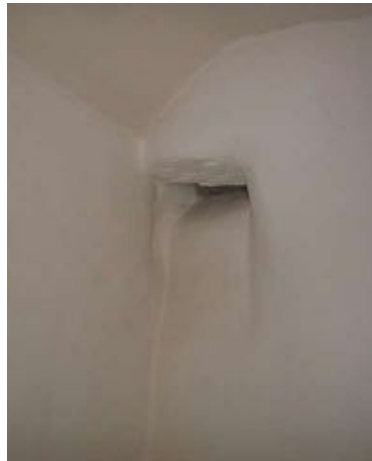
Above: old flue after

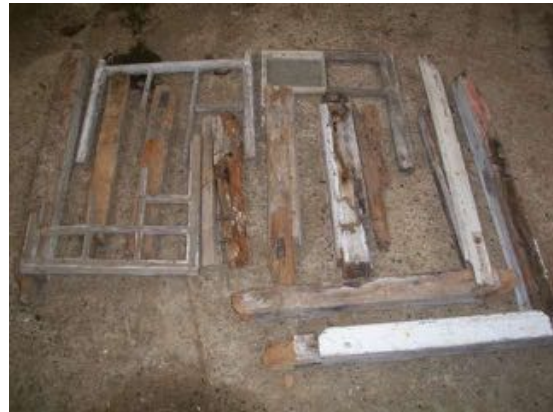
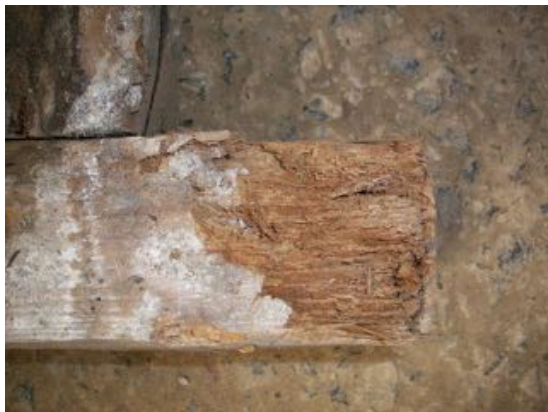
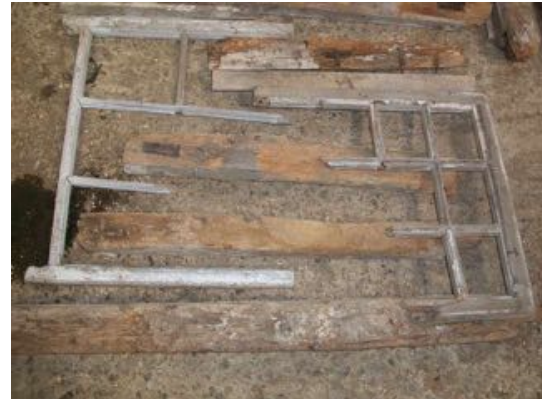
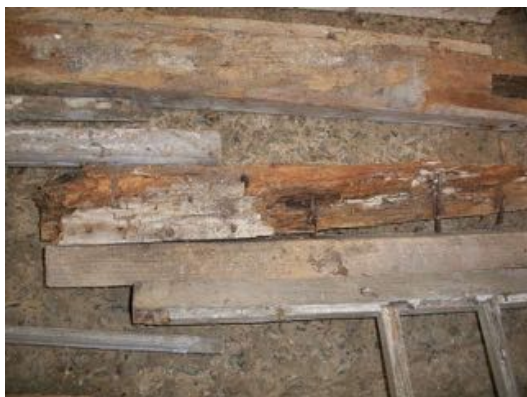
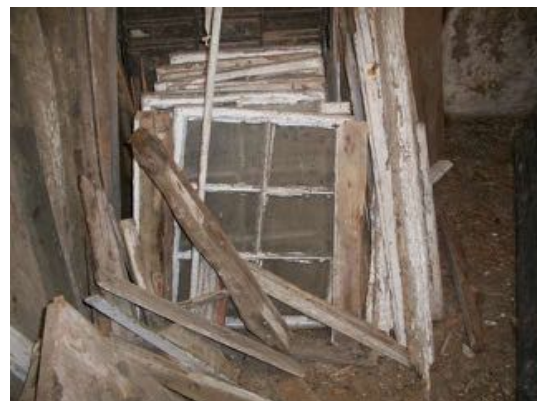
The applicant removed the windows and doors carefully but the joinery was generally in very poor condition. Salvageable sections were retained and the applicant sent a few samples sent to joinery firms in attempt to obtain a quotation for repair. Despite approaching three joinery firms, none of them felt there was sufficient good timber to justify repair. The applicant's agent prepared detailed drawings including minor changes to the local authority and believed these had therefore been agreed.

Upon discovering that conditions no.5 and 6 had not been discharged however, the applicant has re-submitted the drawings for retrospective approval. In addition, Helen Rice (planning officer at Carmarthenshire County Council) inspected the remaining fragments of window in spring 2017 and images of these are shown opposite and below.

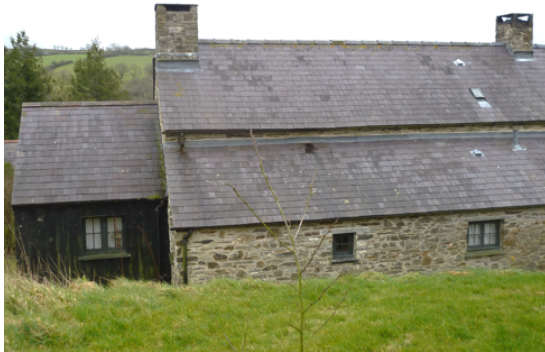
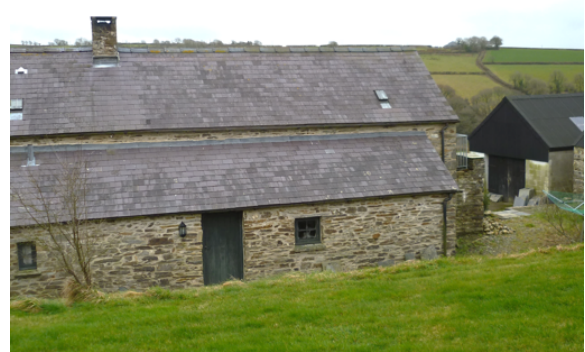
On the northern elevation, the central window in the former slating room was shown as a four pane casement but the actual opening was narrower than shown. This meant that the window panes would have been very narrow and so it was reduced to single pane width to maintain consistency with the other windows. The original window opening has been conserved. The other central window to the salting room had a simple frame with chicken wire only with wooden internal shutters. These too were in poor condition with salvaged sections set aside.

Above: As built photographs of the north elevation east end (left) and west end (right)

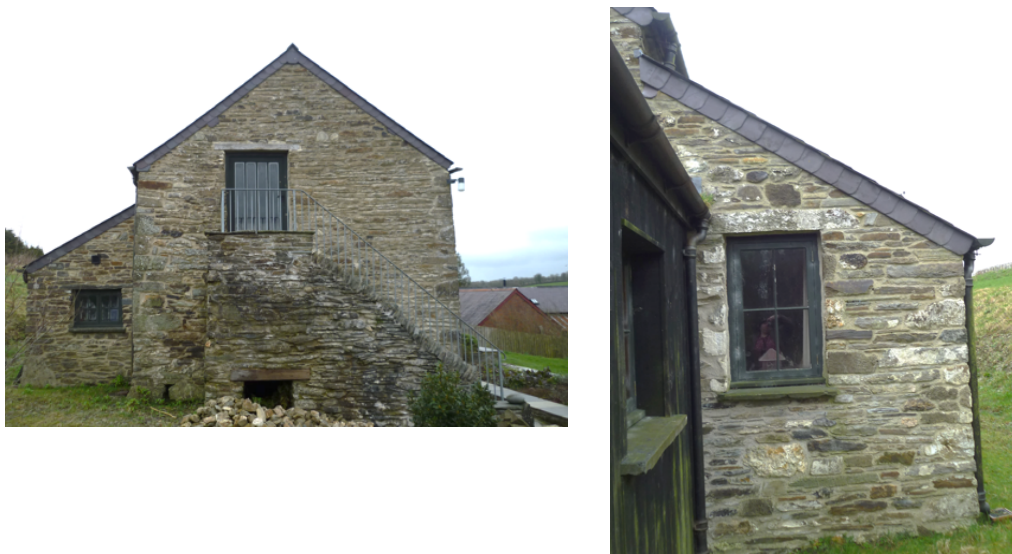
The proposed new window to the west elevation was not constructed as there was some concern over weakening that corner of the building as a number of openings had already been made into the stone walls connecting the south and north walls with comments made regarding this in the 2004 structural report. The stable openings have therefore been conserved with no new openings made.

The proposed window to the east elevation appeared to be a new opening as it was wider with pair of casements. The original opening was retained however with a resulting narrower window comprising four pane casement fitted.

Above: As built photograph consented east (right) and west (left) elevations

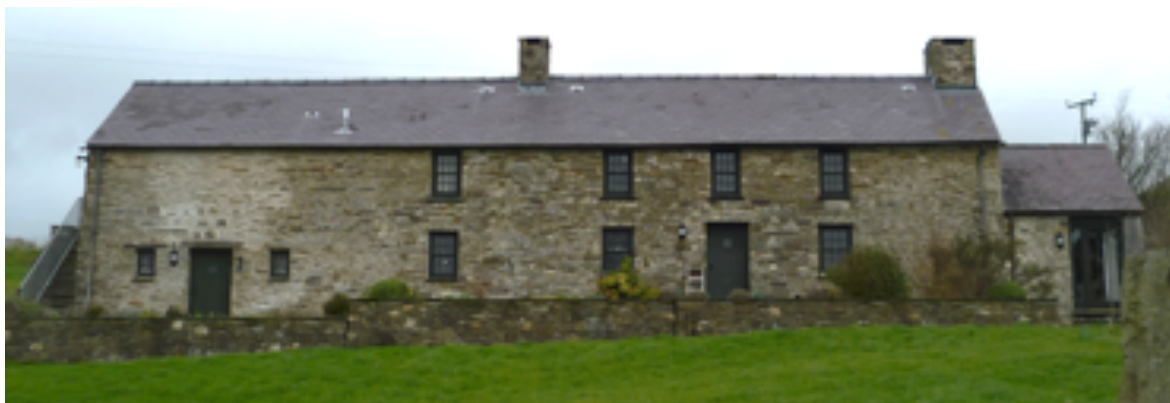
The glazed doors to the south elevation of the eastern extension were narrow and therefore a slightly wider door and fixed side light were fitted. Both the side light and door had long narrow glass panels as consented however so that it reads as a boarded door to retain agricultural character.

The consented plans showed a fully boarded door to the stable and four paneled door to the house. Fully boarded doors with small glazed vision panels have been fitted to both doors instead. The four paneled door was felt inappropriate since it contrasted with the utilitarian detailing of the other existing doors. Changes to the internal floor level meant that additional steps were added near the stable door and in order to avoid potential collision in the landing area, visibility between exterior and interior was desirable. Given that both southern doors had originally matched one another, the house door was also changed and this also had the benefit of providing additional light at the bottom of the stairwell.

Above: As built photograph of south elevation

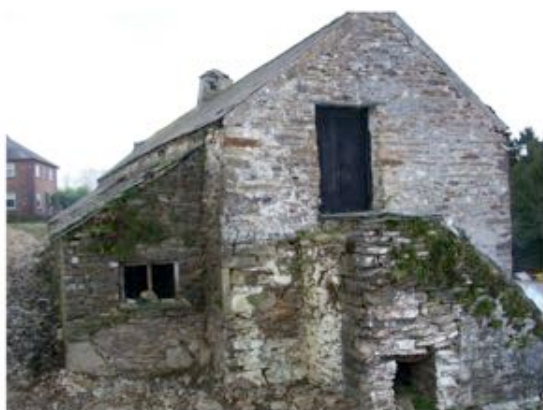
Left: Pre-development west elevation to lean-to and stable with open frame to lean-to window and fully boarded door

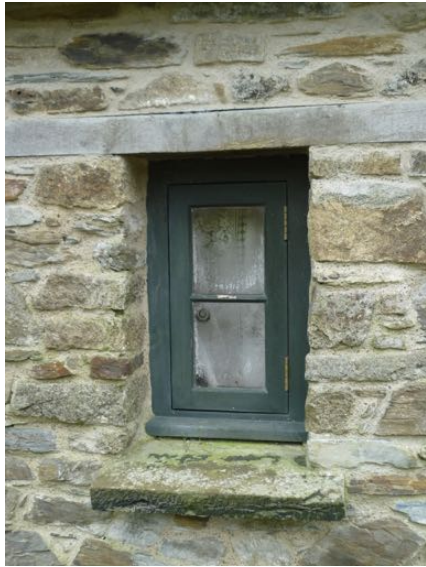
Above: New shower room window to north elevation of lean-to with glazing reduced to two panes to fit original opening (former salting room)

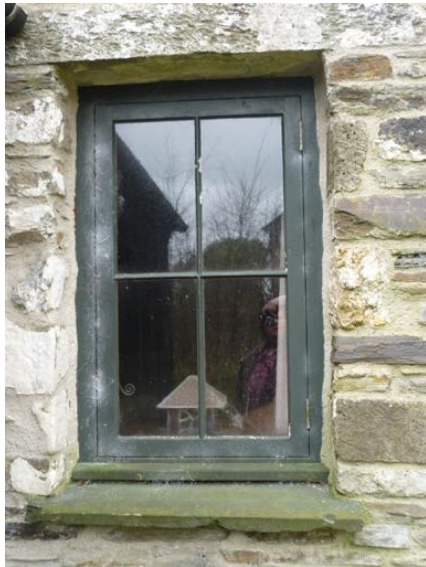
Above: New sitting room window to east elevation of lean-to with window reduced to single casement and four panes to fit original opening

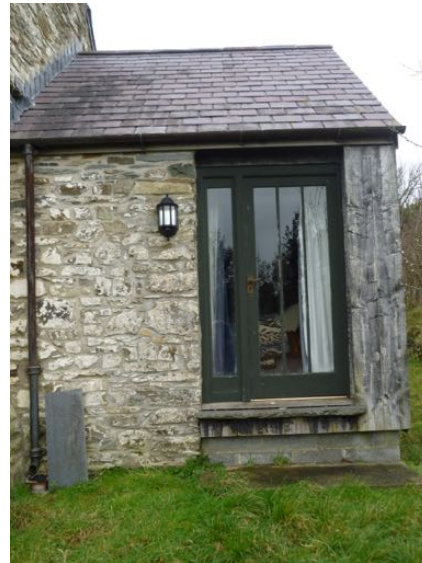
Above: New study room glazed door to south elevation of east extension. Consented pair of doors changed to single door with fixed side light

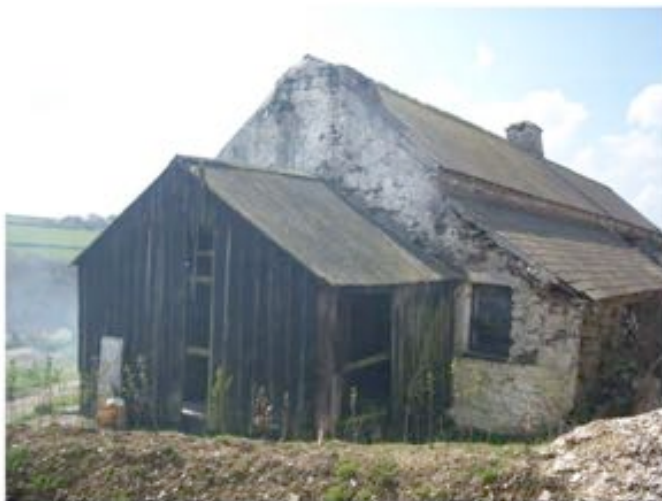
Above: Pre-development east elevation to lean-to and east extension showing narrower window opening which has been retained

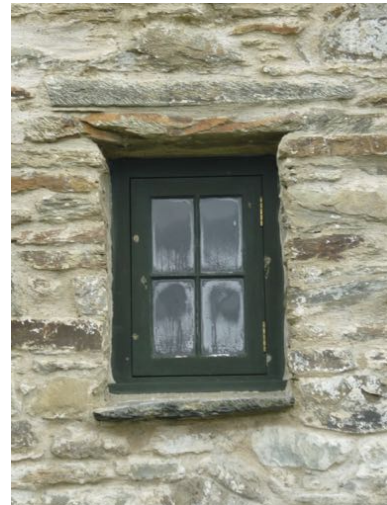
Above: New kitchen window to south elevation of former stable (two in total). Consented single panel changed to four panes.

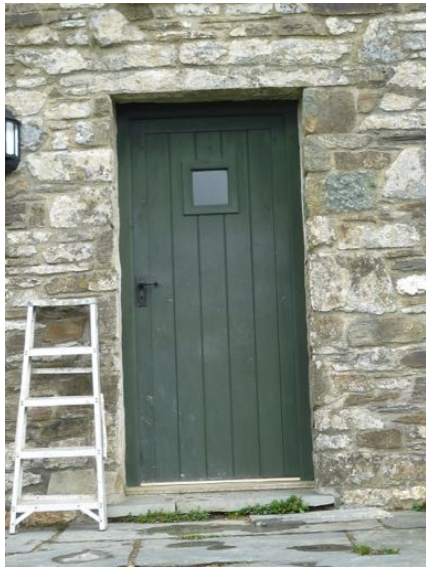
Above: New house entrance door to south elevation (stable door similar). Consented four panel door changed to boarded door to matching existing. Small glazed vision panel added.

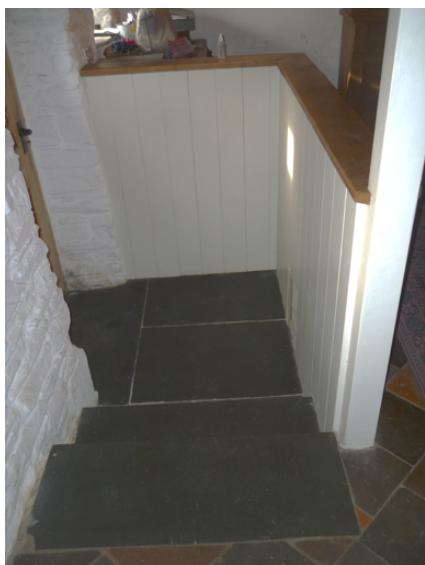
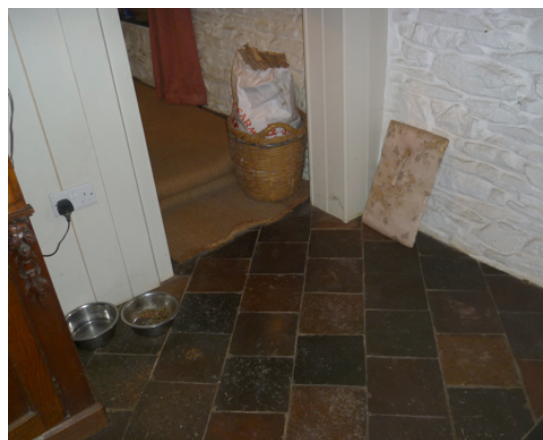
The consented drawings indicated a couple of steps but the actual change in floor levels had not been accurately recorded and additional steps were required to make the difference. The base of the south wall was also visible in places and following excavation of trials holes, it was evident that underpinning would be required to construct the stable floor on one level. It was therefore decided that the stable area would be construction in two levels to avoid underpinning with the extra internal steps located near the stable door. The floor level in the eastern extension was also raised to match that of the house to avoid underpinning. The house floor including lean-to remains as one level area as the existing layout.

Above: Steps at change in level to stable floor

Left: Steps at stable door

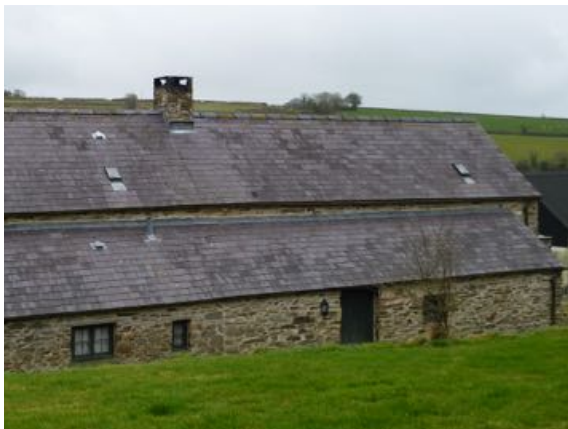
The consented scheme included the introduction of 2no. new roof lights to the rear roof slope. The applicant was able to source second hand Victorian cast iron roof lights which were fitted. Excessive condensation occurs on the single glazing however which drips onto the room below. This is particularly undesirable in western bedroom as the water drips directly onto the bed. The applicant therefore proposes to replace the roof lights with a modern reproduction which has double glazing but it made of cast iron and sits flush with the roof plane. The roof light is the smallest version available and the position will not change with appearance as that originally consented. Had the applicant not sourced a second hand roof light, they would have fitted this reproduction anyway and therefore the alteration is negligible.

Above: Rear (north) roof light with current salvaged roof lights

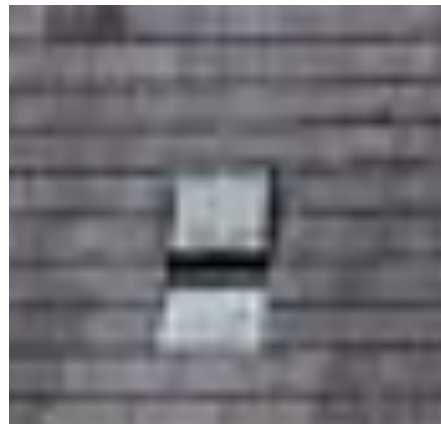
Above: Close up of current salvaged roof light

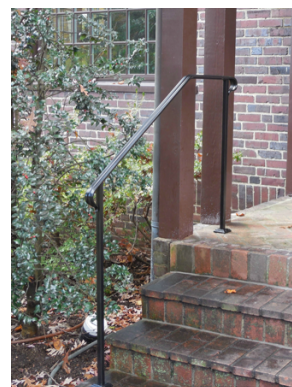
- D) Cast iron handrail only: Although a handrail would be an improvement, the gap below could still be an issue, particular for the applicant's grandchildren who could squeeze through. Very few steps of this nature historically had any sort of handrail and were usually fitted to the main wall of the building, not on posts. The use of cast iron confuses and misleads when there is little past precedent for such a detail. The guarding is however easily reversible with minimal fixings.

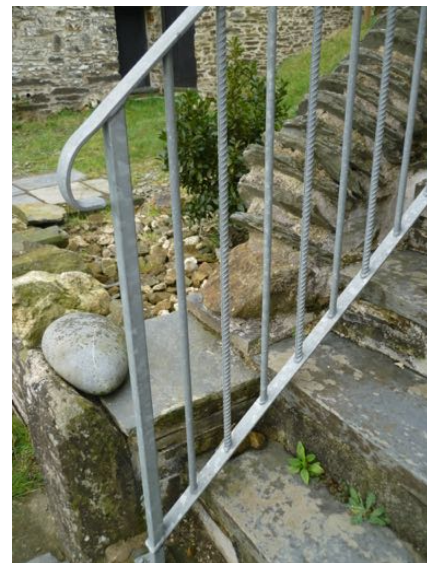
- F) Galvanised steel balustrade: The galvanized finish would provide greater durability. Use of traditional sections such as flat bar and solid round bar in small sections provide a transparency which will allow light into the room despite regular bar spacings needed to reduce risk of fall. The fixings are minimal and easily reversible. The overall design reads as a later addition but it is simple and utilitarian using materials readily available locally and therefore is more in keeping with the original vernacular architectural language than any of the other options. This is enhanced by the use of ribbed concrete reinforcement bars as rural folk recycled and made enterprising decisions based upon their skill and materials available to them.

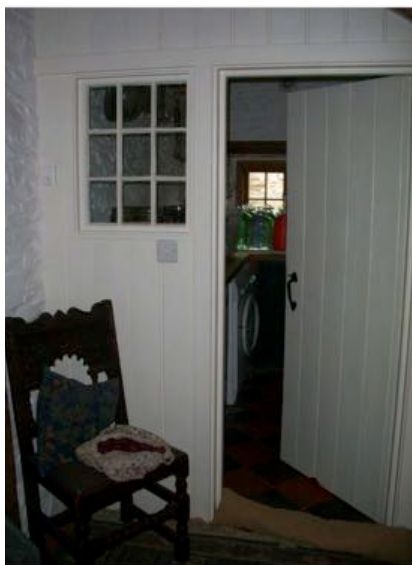
Opposite: utility room window and partition salvaged from slating room that would need improving to provide required fire resistance

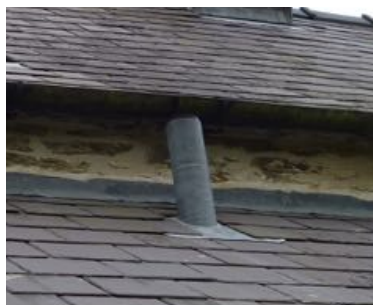
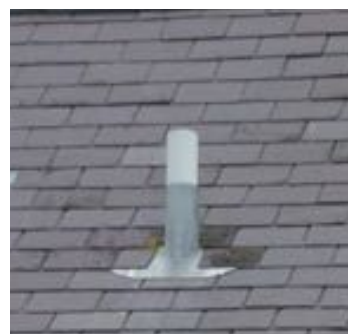
Below: soil and vent pipe to lean-to north roof Below: soil and vent pipe to south roof slope

- C) Extending pipes through the roof to a proprietary slate vent: The applicant initially discounted this option as the slates were usually man made with plastic inserts and this was therefore not a traditional option. The slate vent is advantageous however in that it is discreet with no pipe penetrations above the roof. Materials have also evolved since 2010 and Welsh Slate manufacture a natural slate with plastic insert which would be more in keeping with the surrounding slates. The applicant therefore proposes to replace the lead sleeves with slate vents.

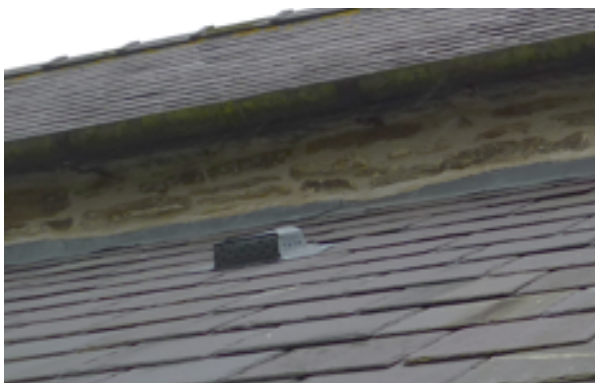
Above: Lead cowl fitted to north lean-to roofslope serving shower room

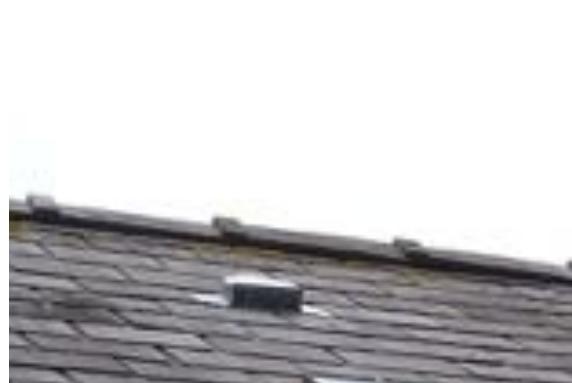
Above: Lead cowl fitted to main house north roofslope serving bathroom

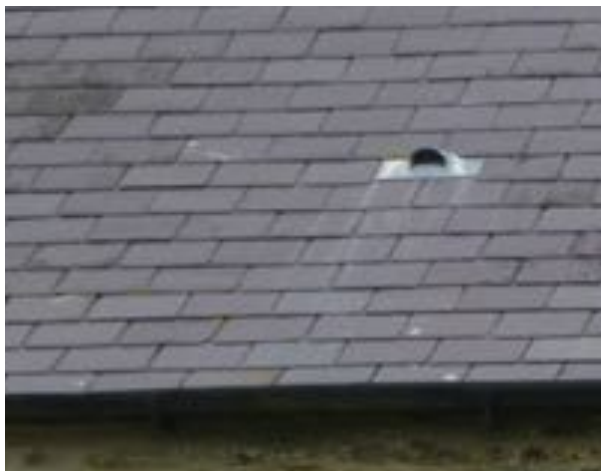
Above: Lead cowl fitted to south roofslope serving ensuite

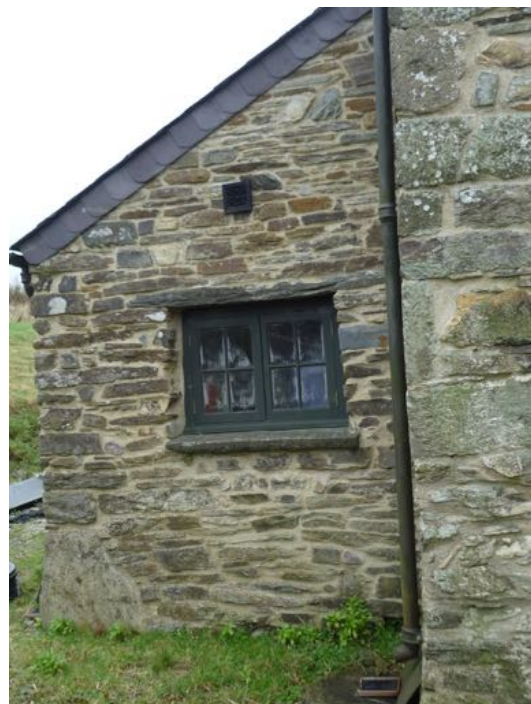
Above: Cast iron air brick fitted to west elevation serving utility room

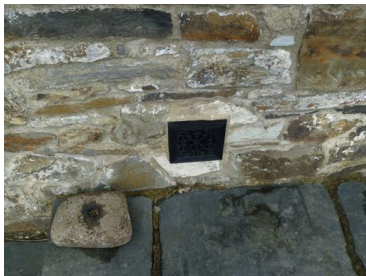
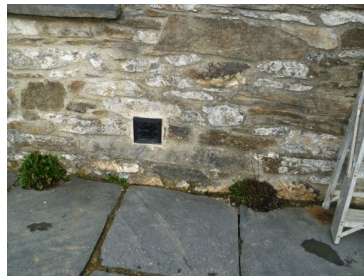
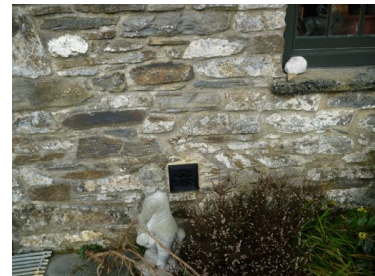
The air supply is usually provided though permanent passive vents. Trickle vents or sash locks to windows are not suitable as they can be closed and the vents are best located at low level too. The air supply must not be obstructed or draw air direction from the exterior. Air bricks are the most common method of providing the air supply but piped supplies with cowls or grills may also be suitable as shown in the image opposite. Given that several of these needed to be located on the southern wall and primary elevation, air bricks were the preferred option as they would sit flush with the wall. As outlined in the options for mechanical ventilation, air bricks in a variety of materials are available but the applicant wanted a traditional finish and opted for cast iron, the use of which had already been approved on the consented drawings.

Below: 3no. cast iron air bricks fitted to central area of south wall at low level

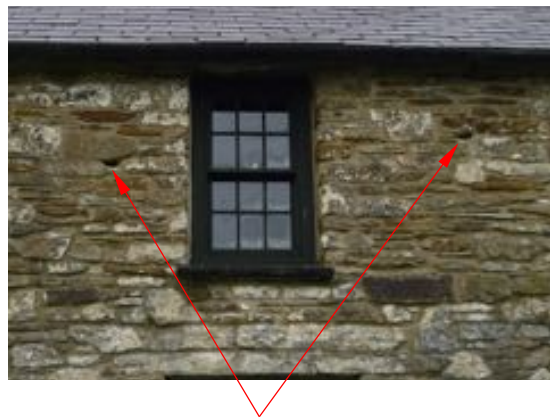
Above: Holes in stonework for bats

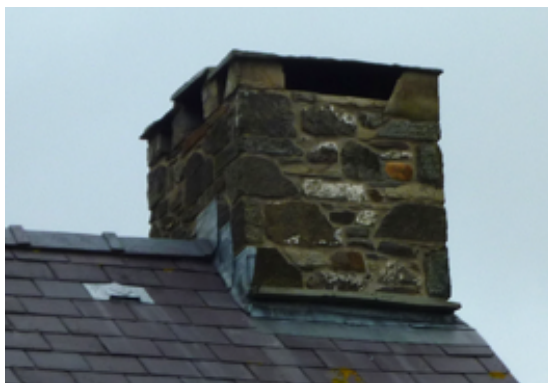
Below: Lead bat access point near east chimney

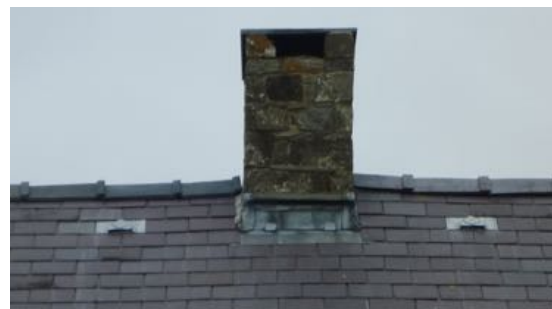
Below: Two lead bat access point near west chimney
