Historic Building Record Level 2

Wood Farm,
Walwyn's Castle,
Pembrokeshire,
SA62 3DZ

May 2022 | Project Ref 07153C

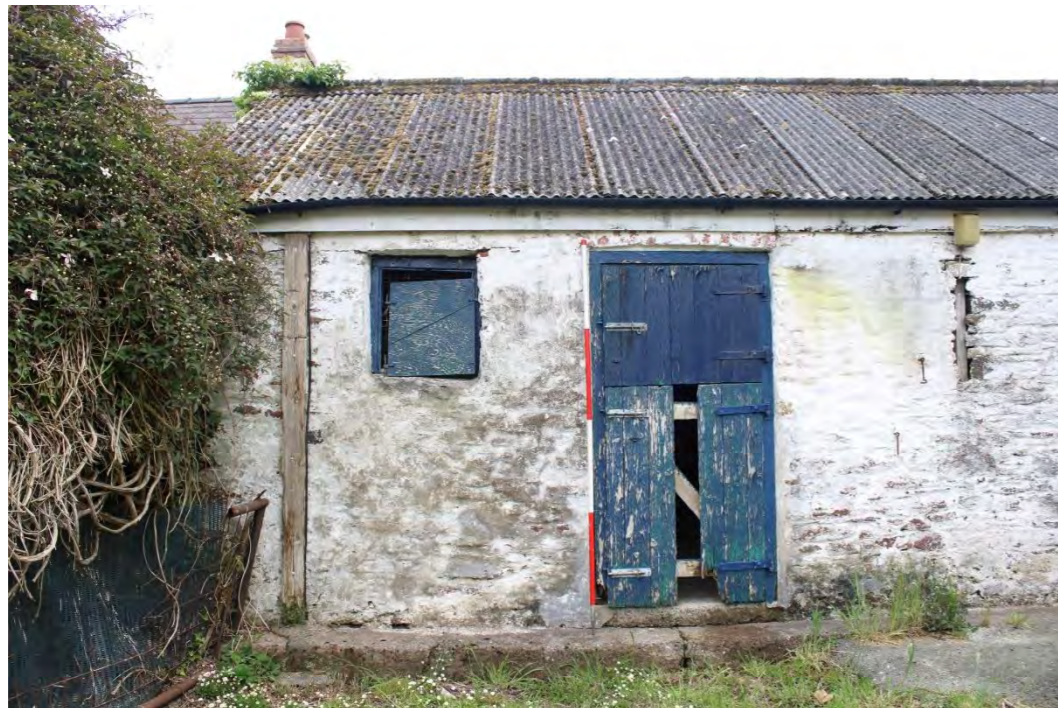
Photo 2: Western side of southern façade of Building B

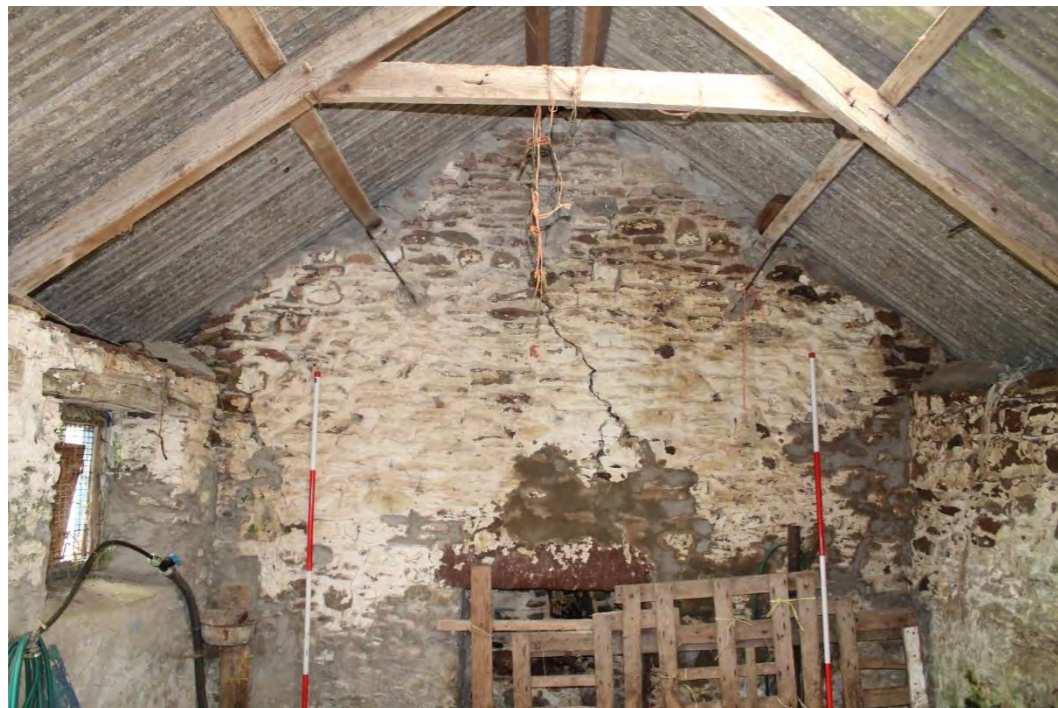
Photo 6: View of western interior gable end and roof structure of Building B

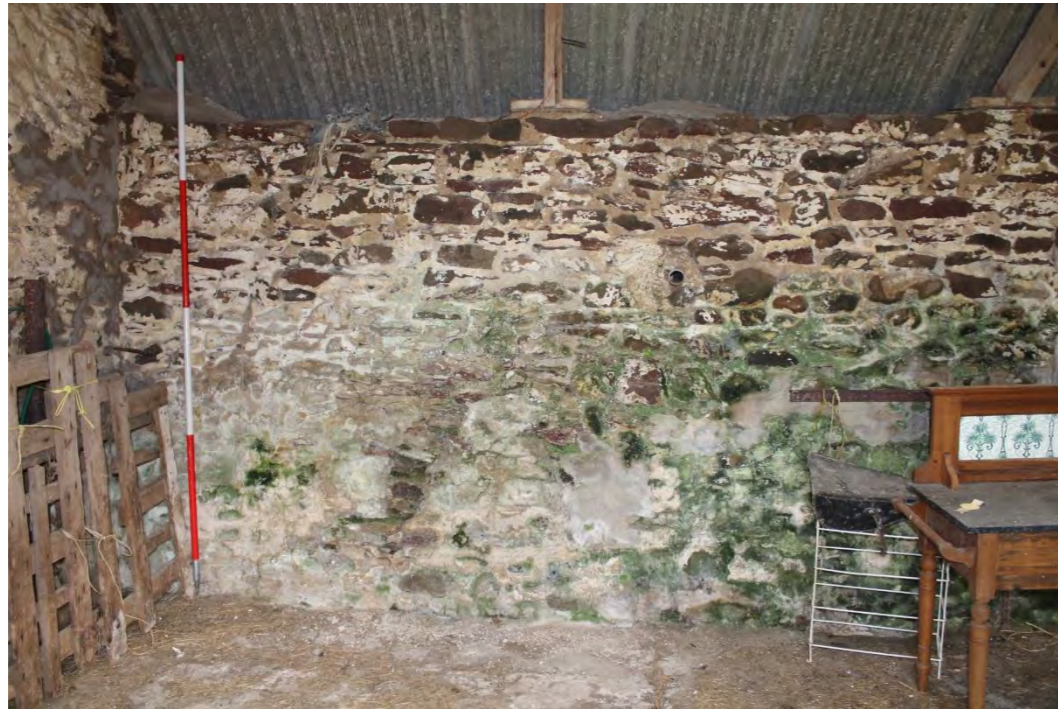
Photo 9: Northern interior wall of Building B, western side

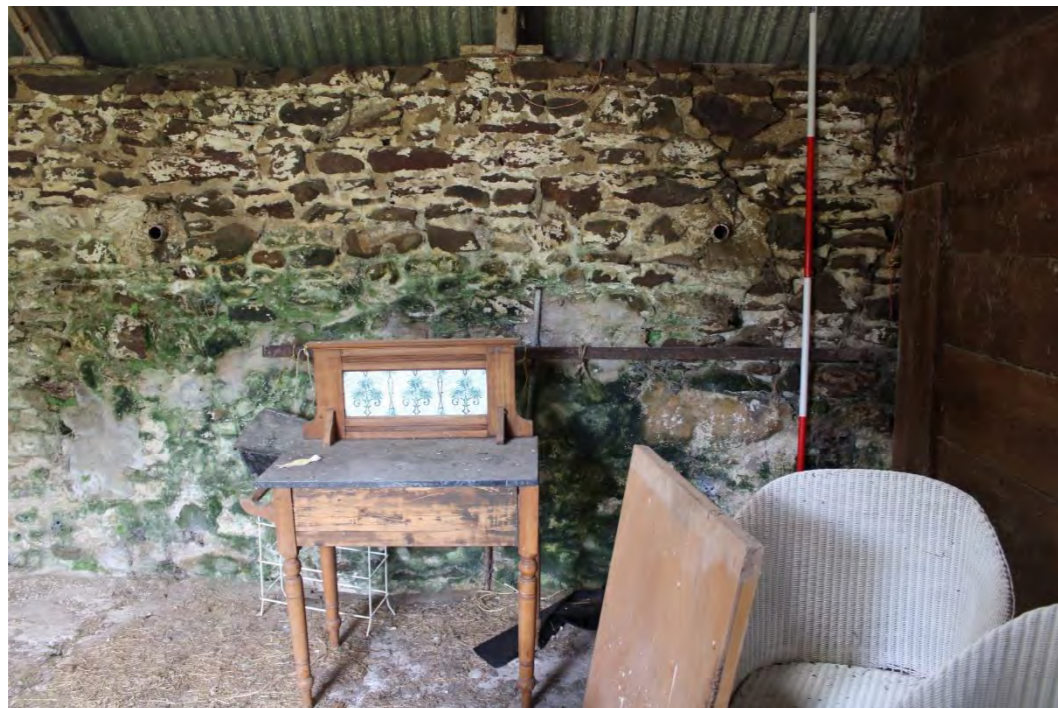
Photo 10: Northern interior wall of Building B and wooden partition to right

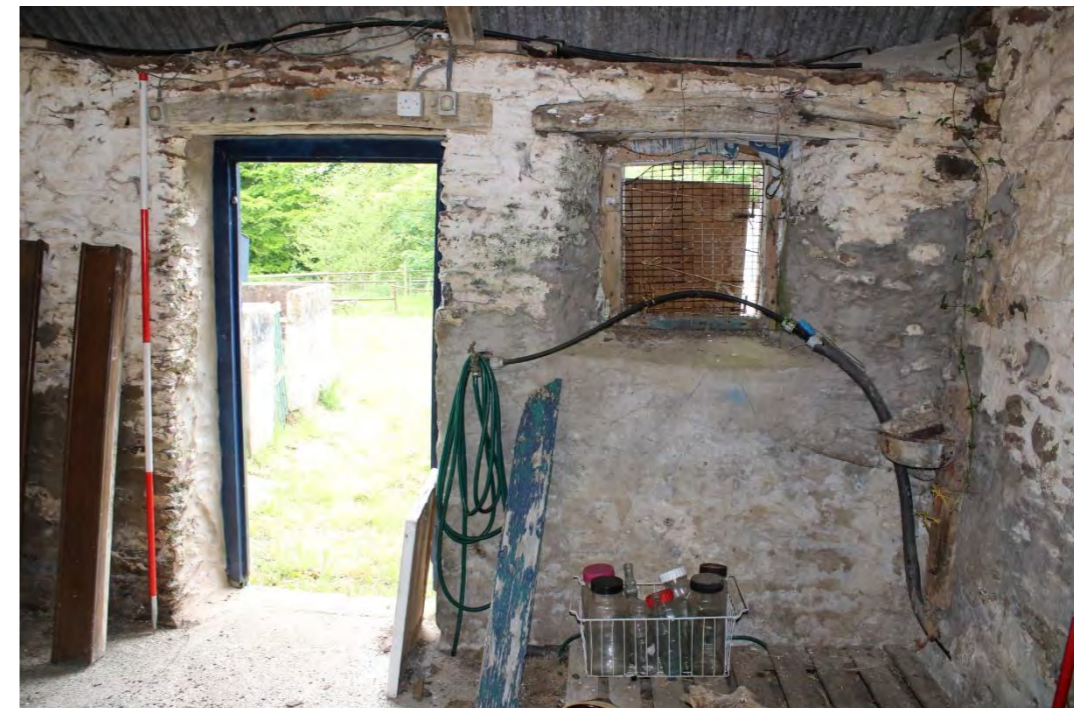
Photo 12: View of southern wall interior of Building B showing doorway and western window

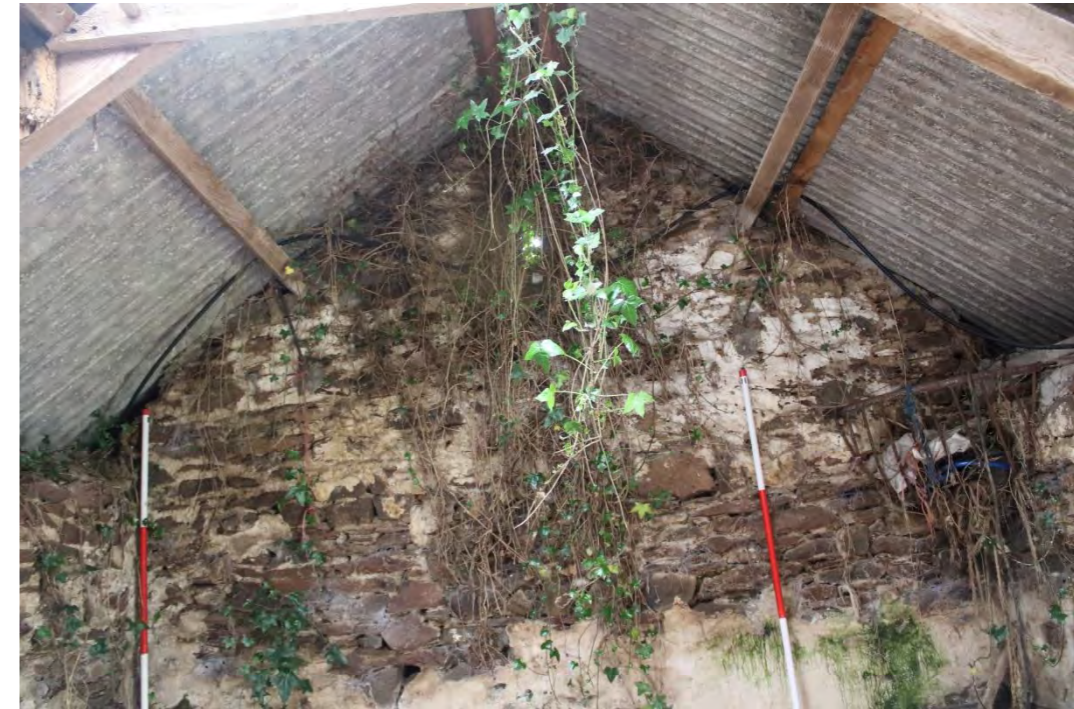
Photo 15: Eastern gable end wall of Building B showing roof structure with window light near apex of roof and feeder to right

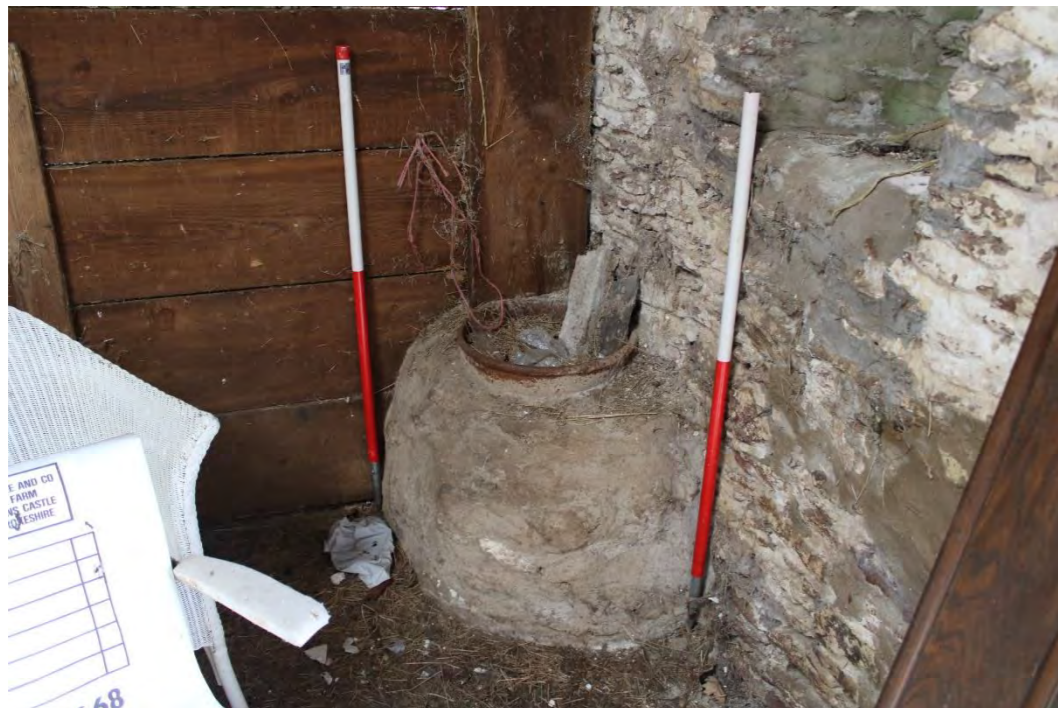
Photo 14: View of feeder in southeastern corner of western room within Building B

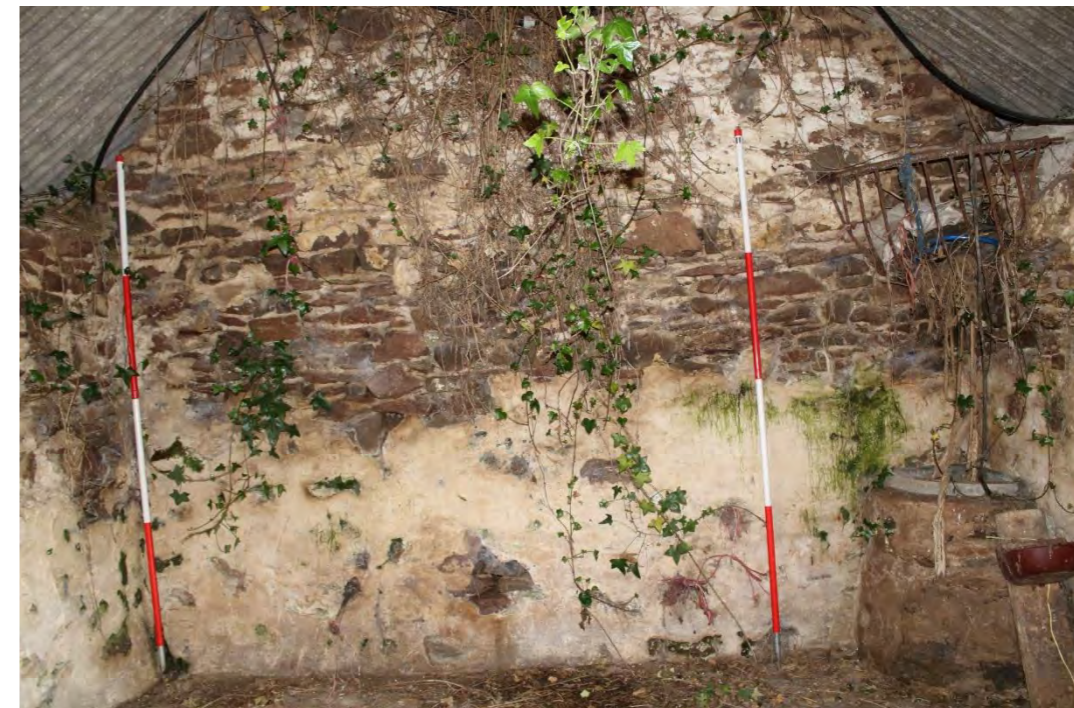
Photo 16: Lower part of eastern gable end wall of Building B showing feeder and water trough in southeastern corner

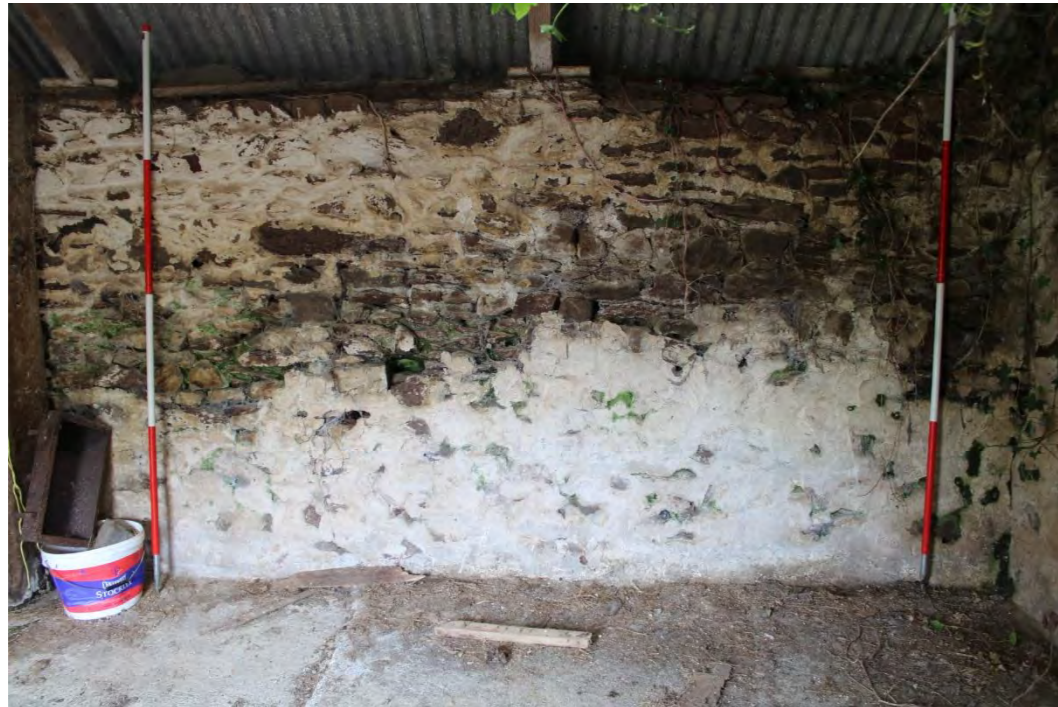
Photo 17: View of northern interior wall of eastern side of Building B

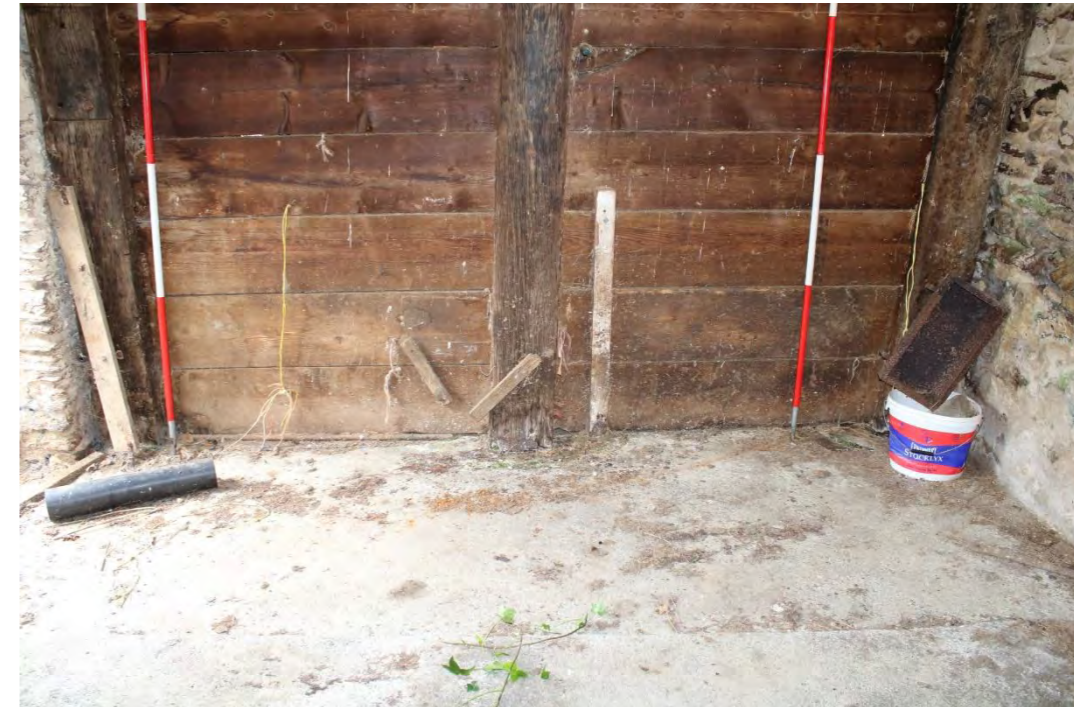
Photo 19: Wooden partition in centre of Building B, facing west, with change in floor level in foreground

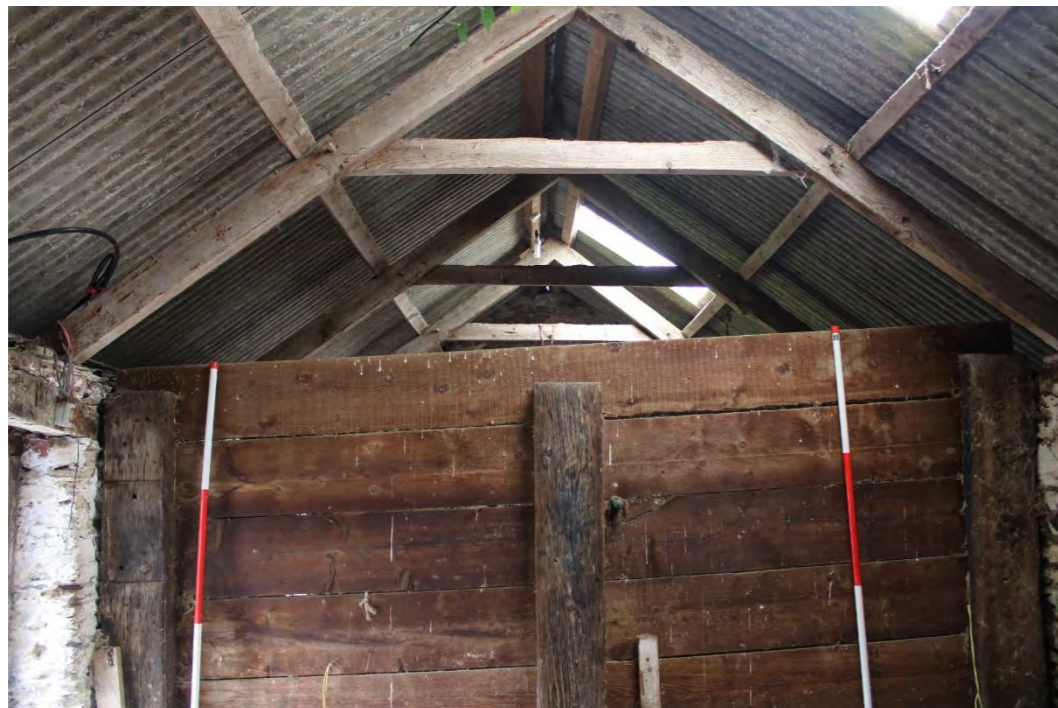
Photo 18: Wooden partition in Building B, facing west showing roof structure

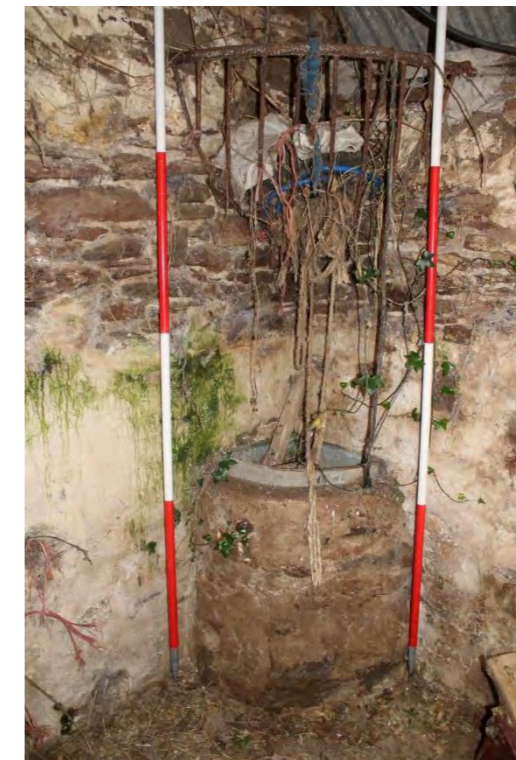
Photo 20: Detail of feeder and water trough in southeastern corner of Building B

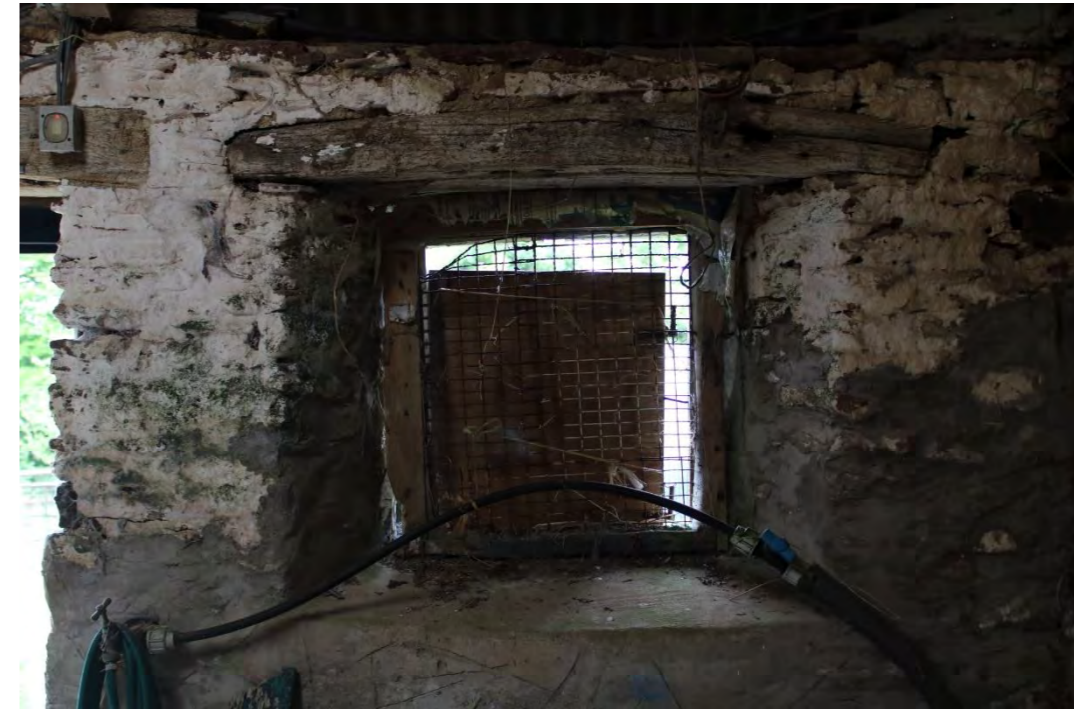
Photo 23: Detail of window in western end of interior southern wall of Building B

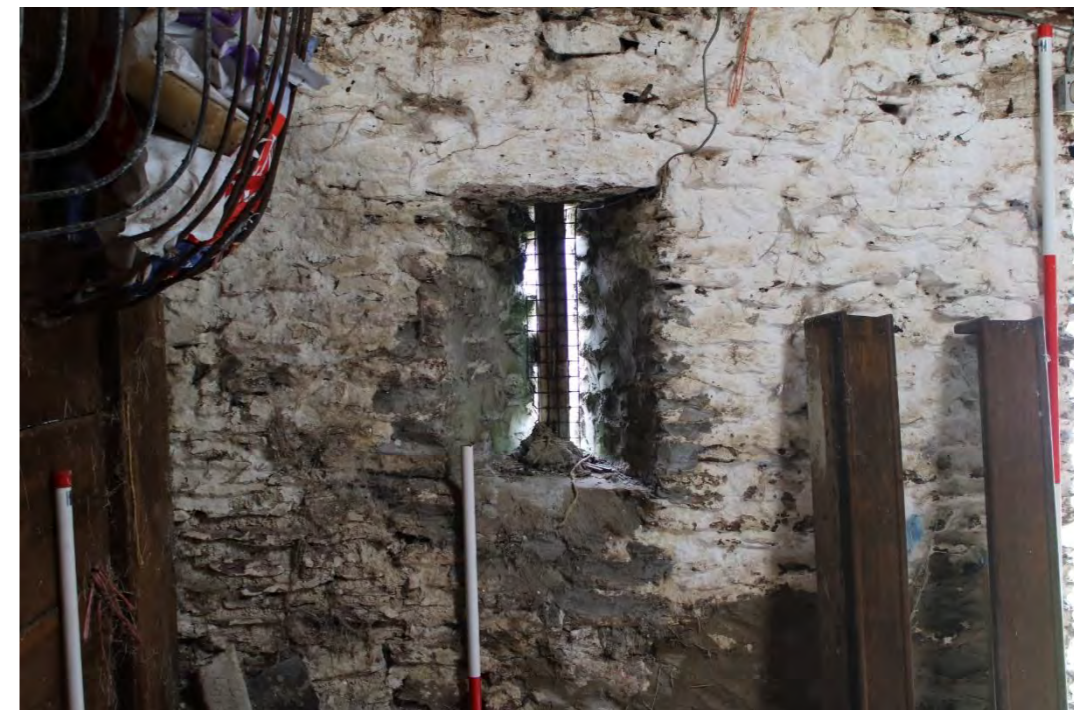
Photo 24: Detail of central splayed window in interior southern wall of Building B

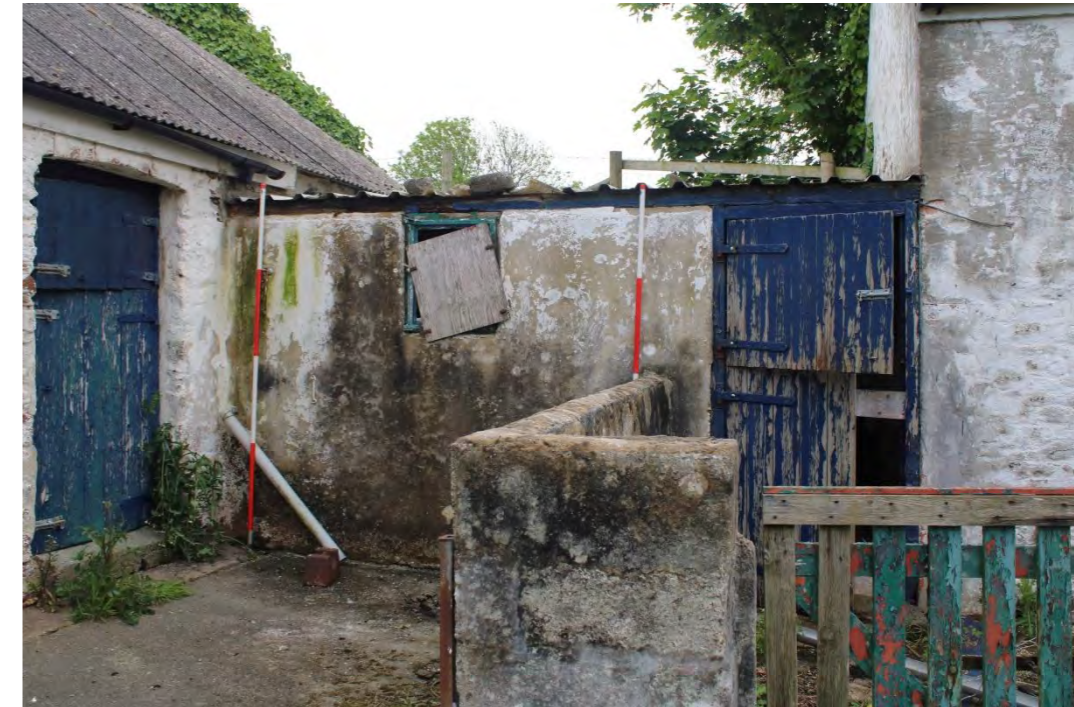
Photo 25: View east of western façade of Building C, with Building B to left and Building D and animal pen to right

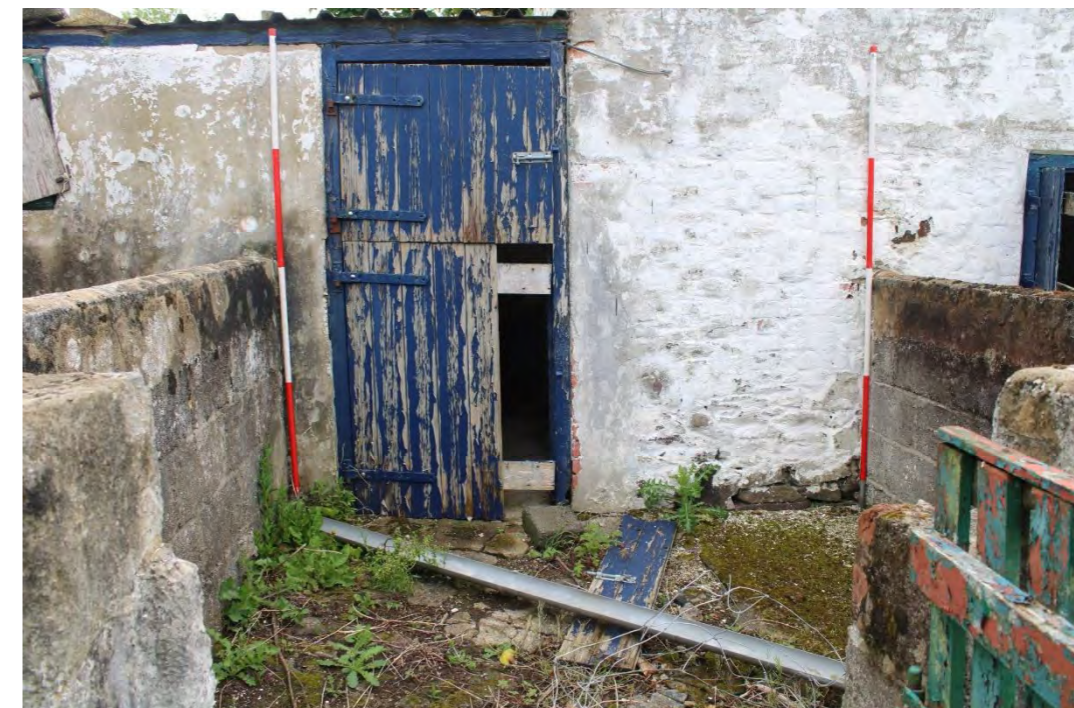
Photo 26: View of doorway into Building C in its western façade, with Building D to right and inside of animal pen in front of doorway

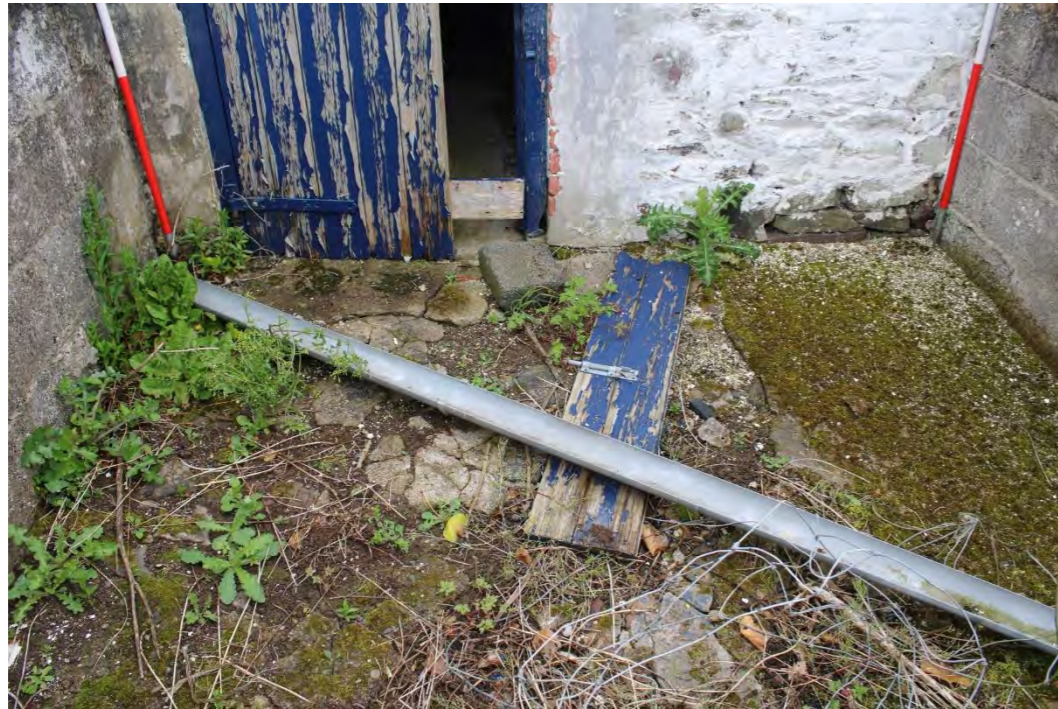
Photo 27: Floor of animal pen west of doorway into Building C

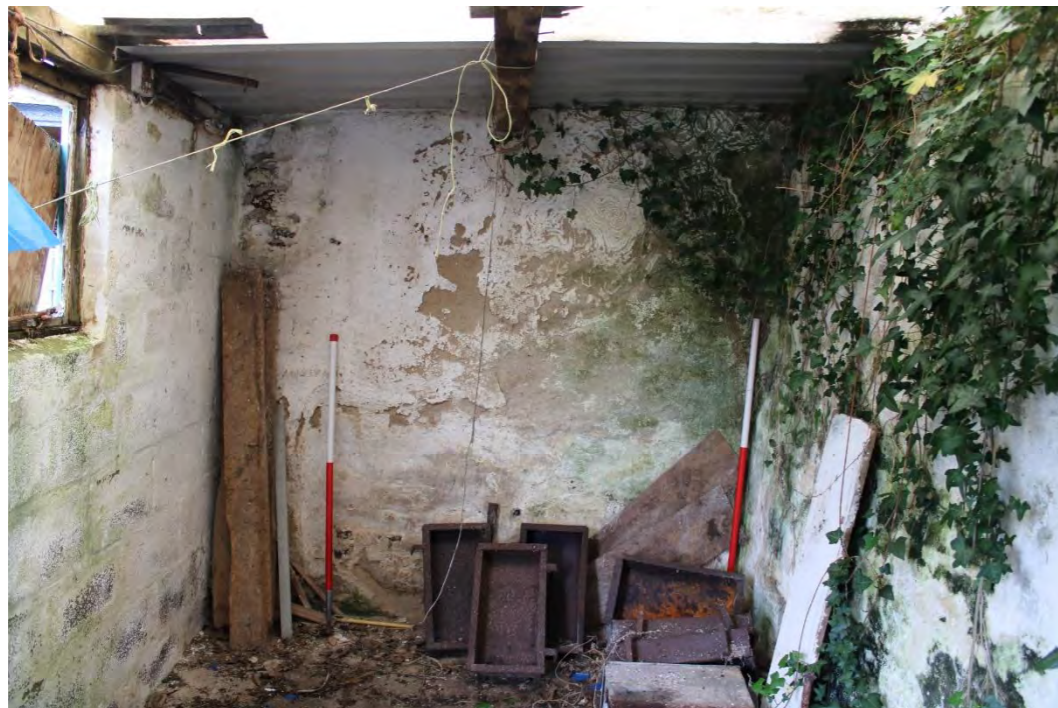
Photo 28: View of interior northern wall of Building C, which is the outer wall of Building B

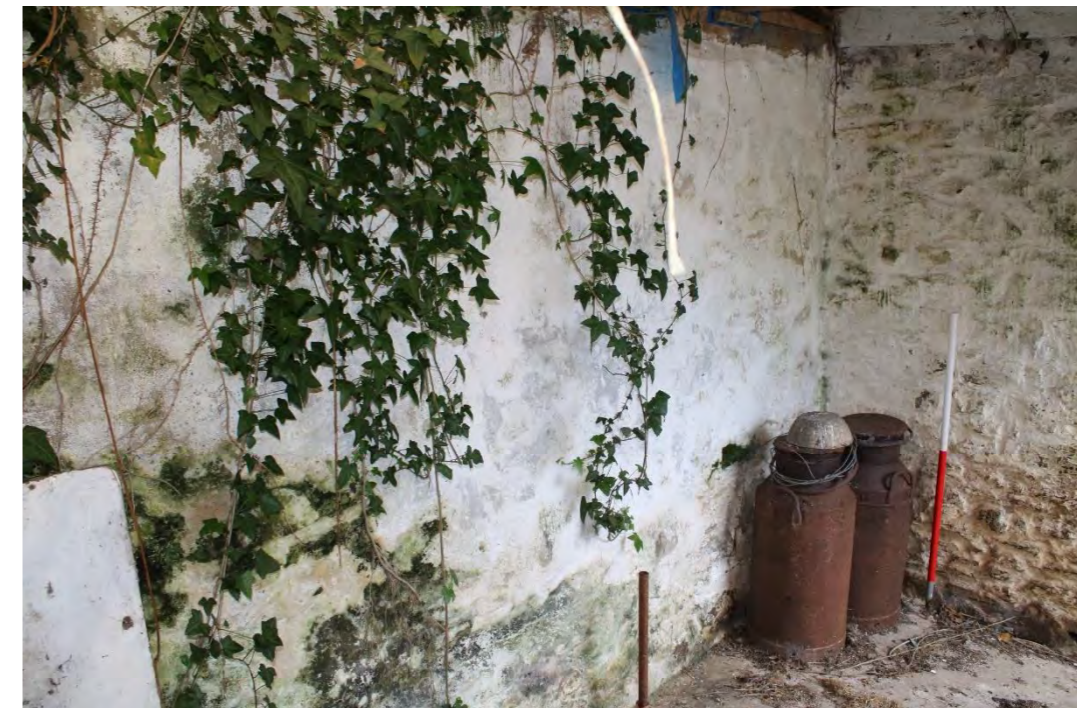
Photo 30: View southeast of eastern interior wall of Building C, which is probably a former revetment wall holding up the bank material to the east

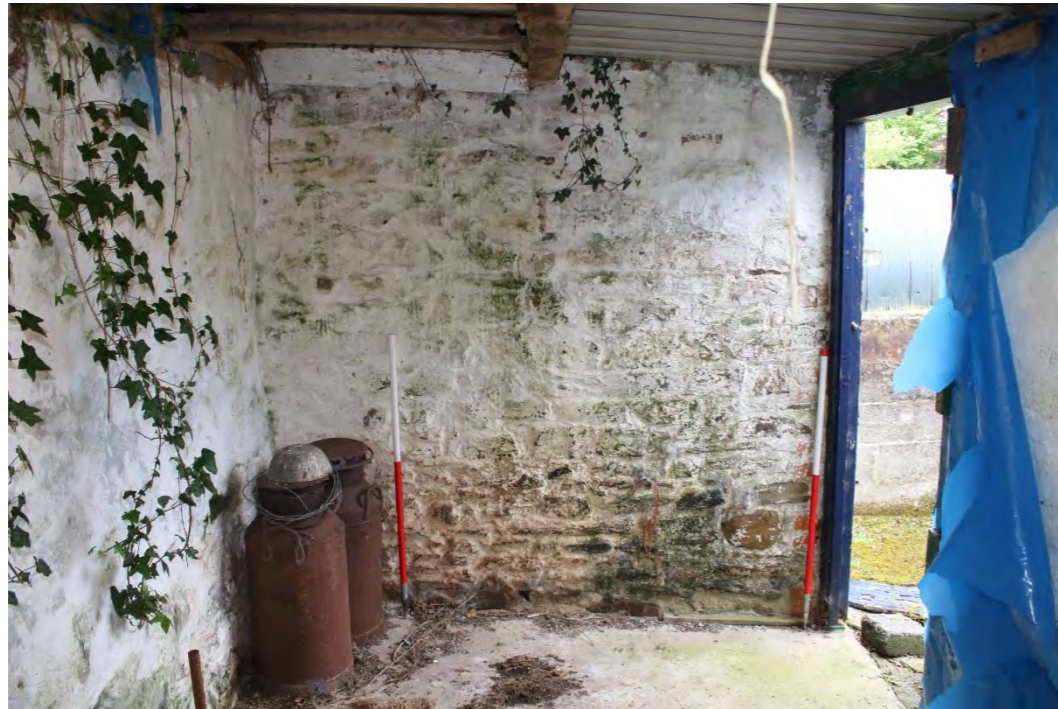
Photo 31: View of southern interior wall of Building C, which is part of the external wall of Building D

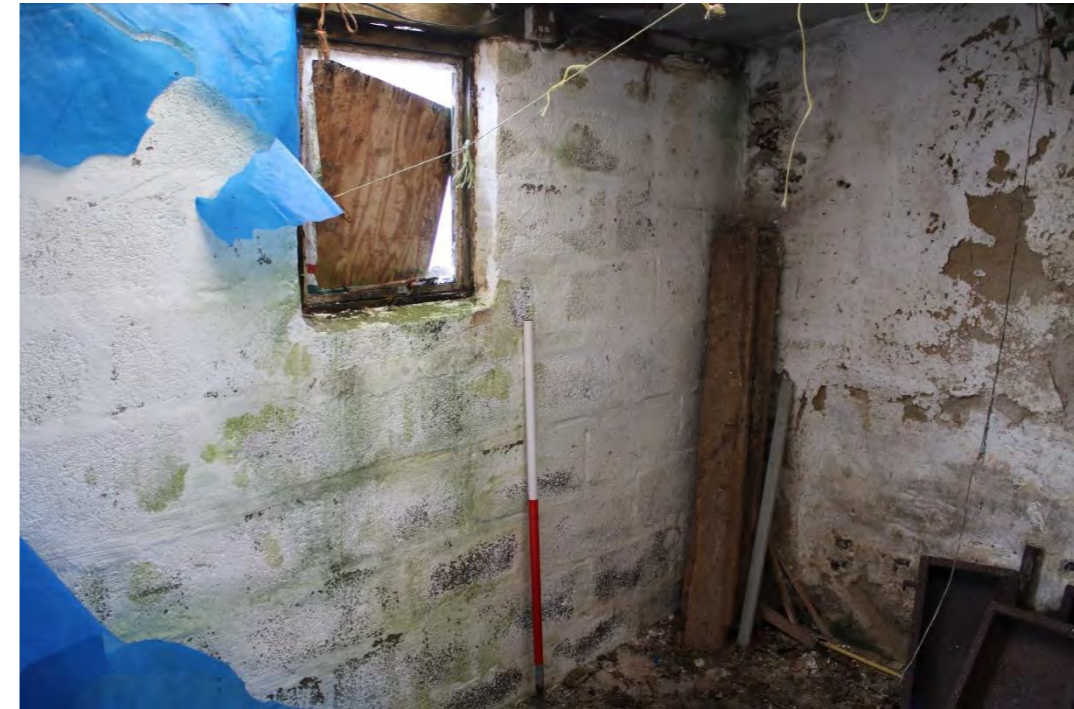
Photo 33: View northwest of window in western interior wall of Building C

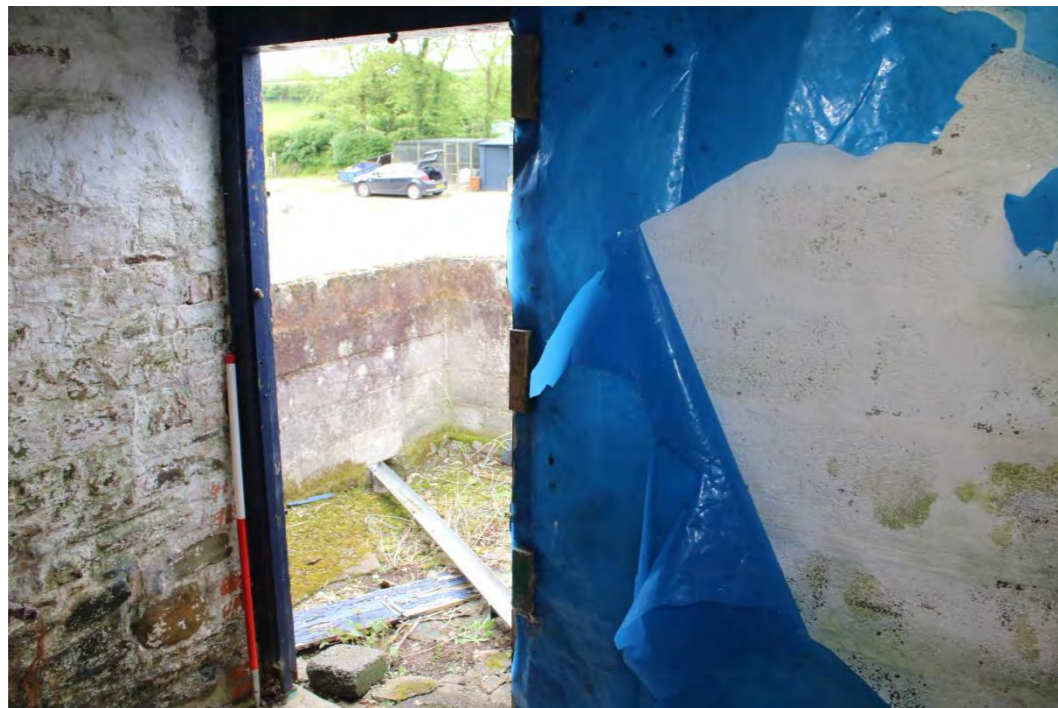
Photo 32: View southwest of doorway in western interior wall of Building C

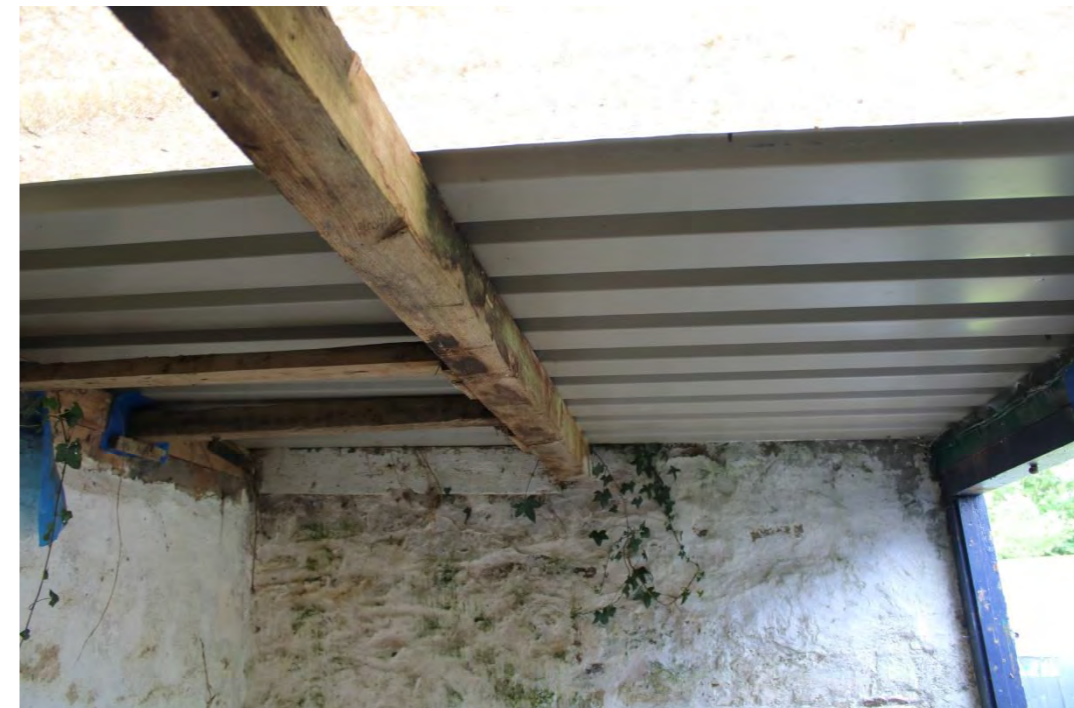
Photo 34: View of roof structure of Building C looking south

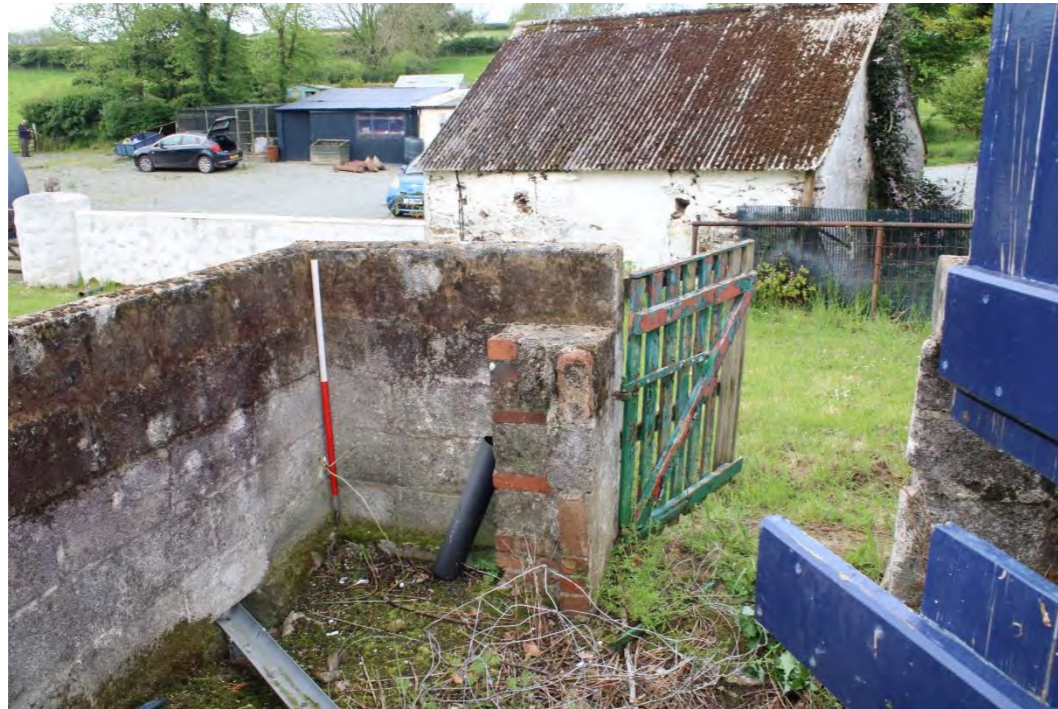
Photo 35: View west from doorway of Building C into the animal pen enclosure and entrance into it

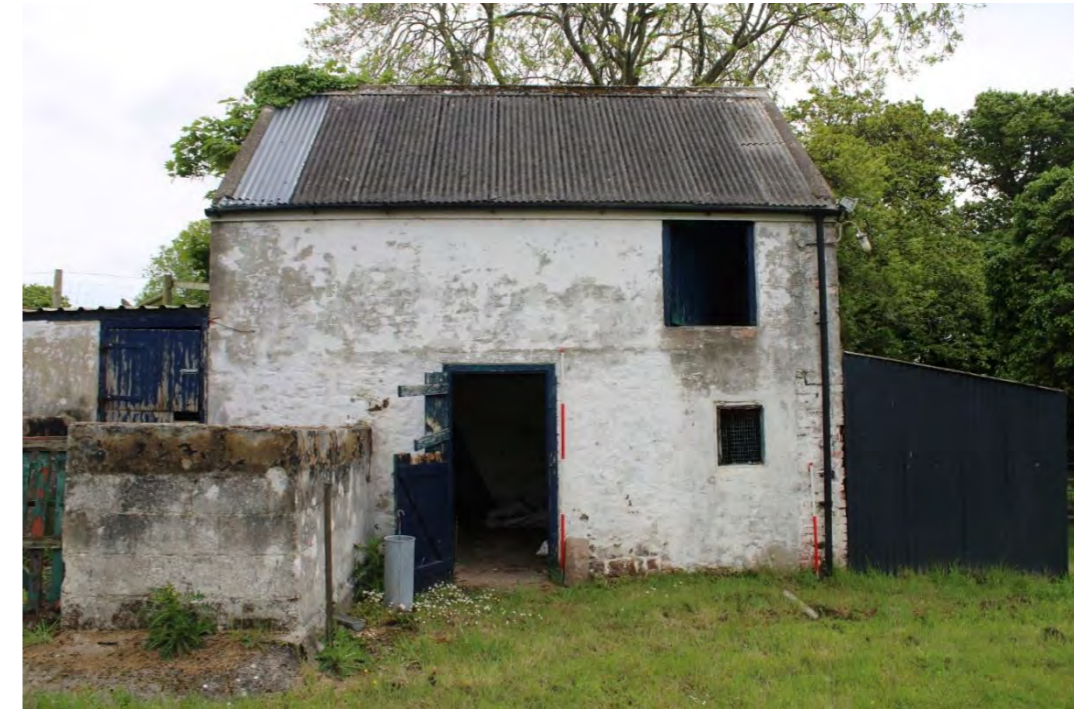
Photo 36: View of western facade of Building D, with animal pen and Building C to left and Building E to right

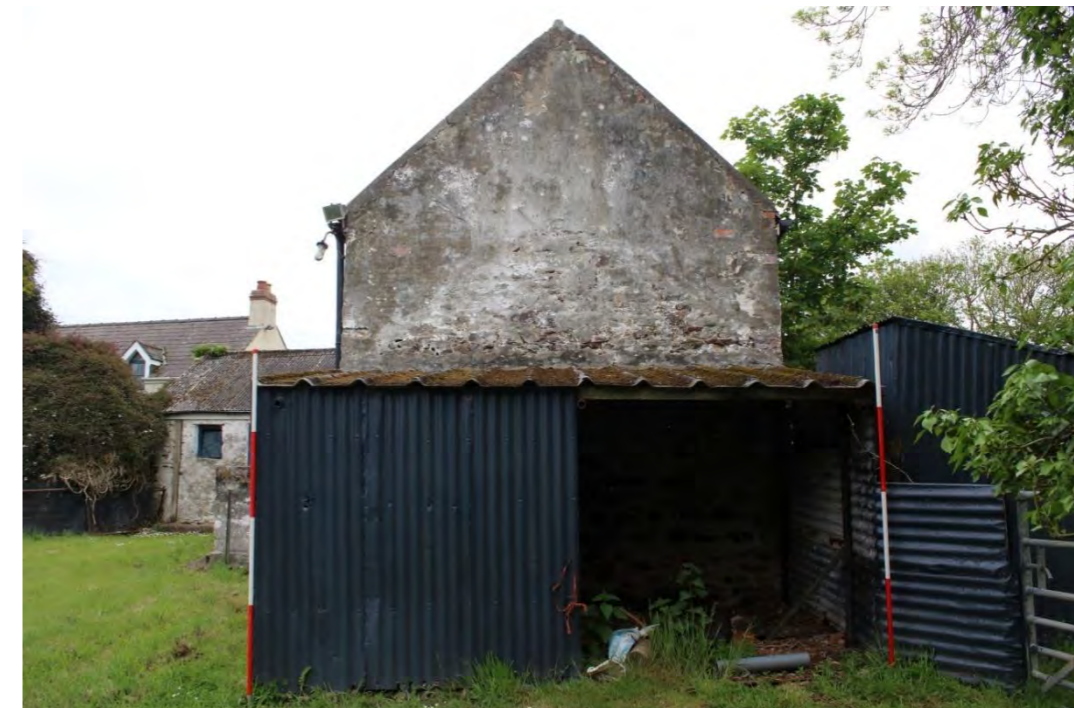
Photo 37: View of exterior of southern gable end of Building D, with Building E in front

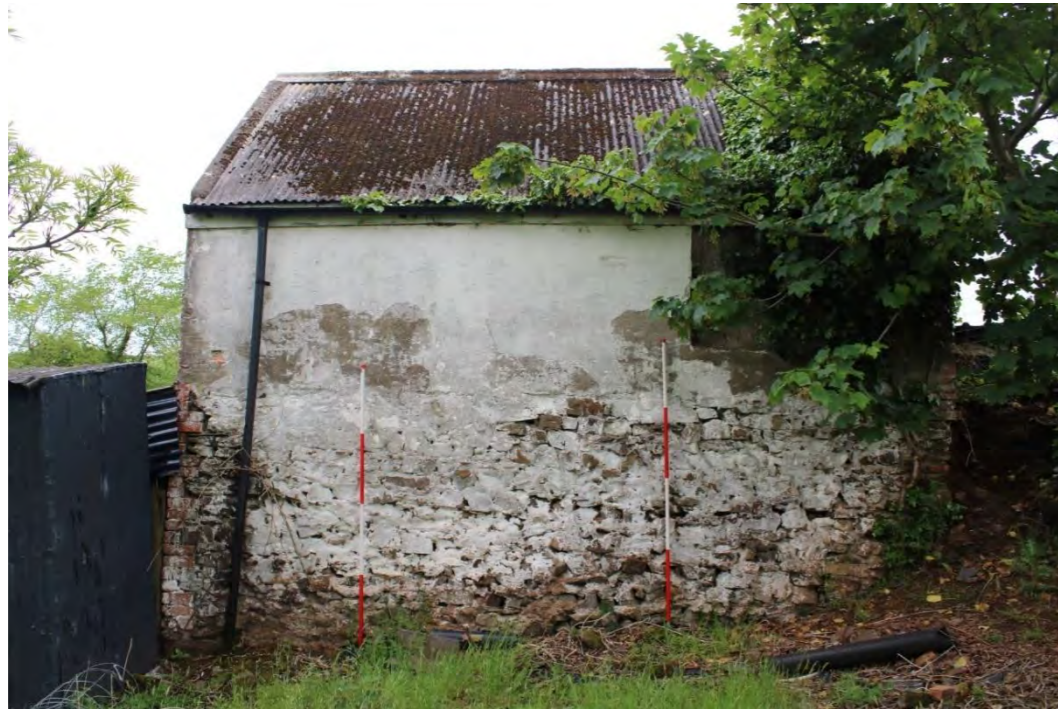
Photo 38: View of eastern elevation of Building D, with blocked entrance at first floor level on northern end

- 4.26 Building E was a lean to shed at the southern end of Building D (Photo 38), built of timber frame and zinc galvanised corrugated iron, painted black. The building measured 2.74m in length and 2.34m in width, with a doorway on the southern elevation measuring 1.76m in width. There is no indication that this ever had a door. The rear wall of Building E was formed by the southern wall of Building D.
- 4.27 It had a cat slide roof also built of timber supporting black galvanised corrugated iron sheeting. The roof height was 2m adjacent to Building D, falling to 1.68m at its southern side.
- 4.28 A free standing shed built of the same material lay to the east of Building E.
- 4.29 The building seems to have been a simple storage shed added to the end of Building D to create a lean-to store. The adjacent shed to the east is likely to have been a contemporary addition.

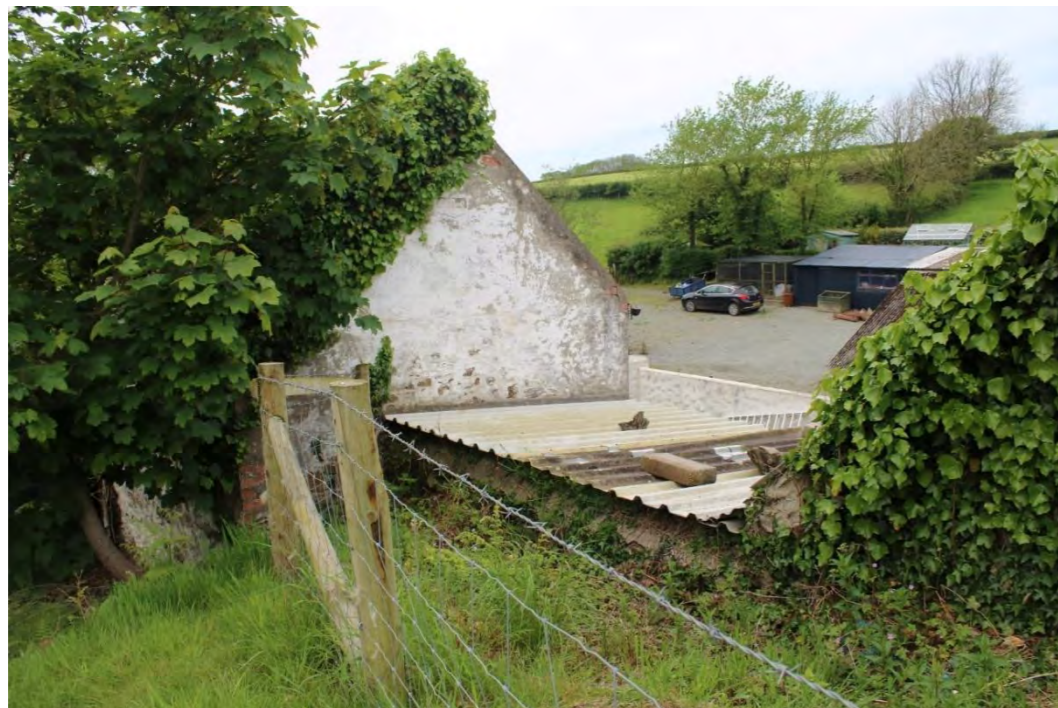
Photo 39: Part of northern gable end of Building D, with roof of Building C in middle ground and start of eastern gable end of Building B to right

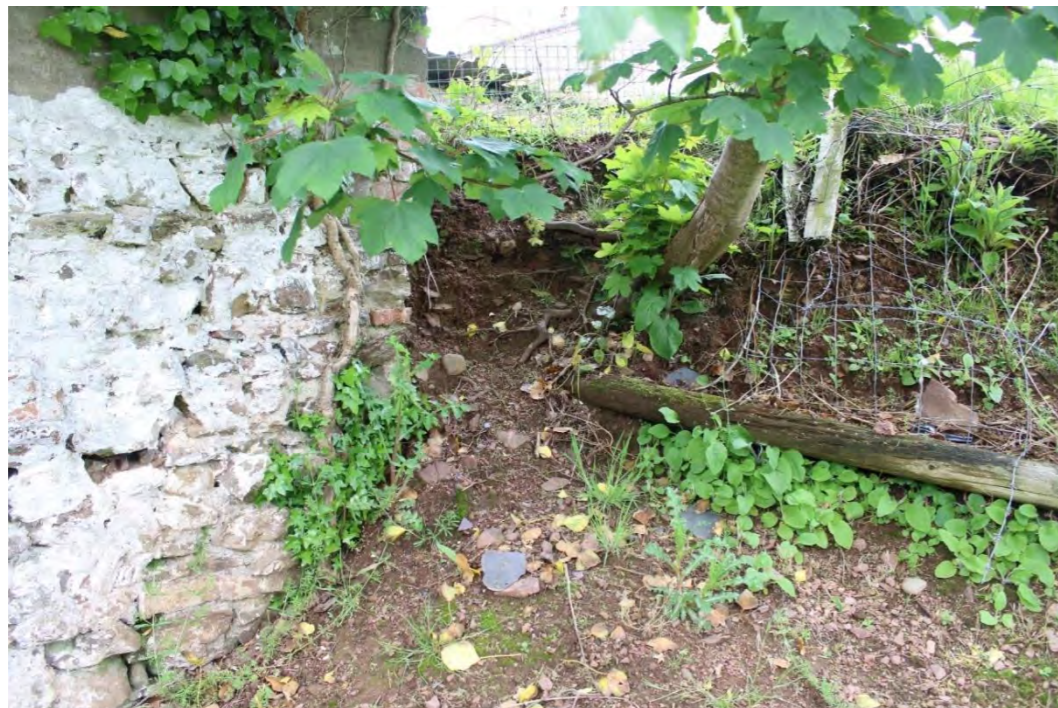
Photo 42: Detail of northeastern corner of Building D where it is partly dug into the raised ground level

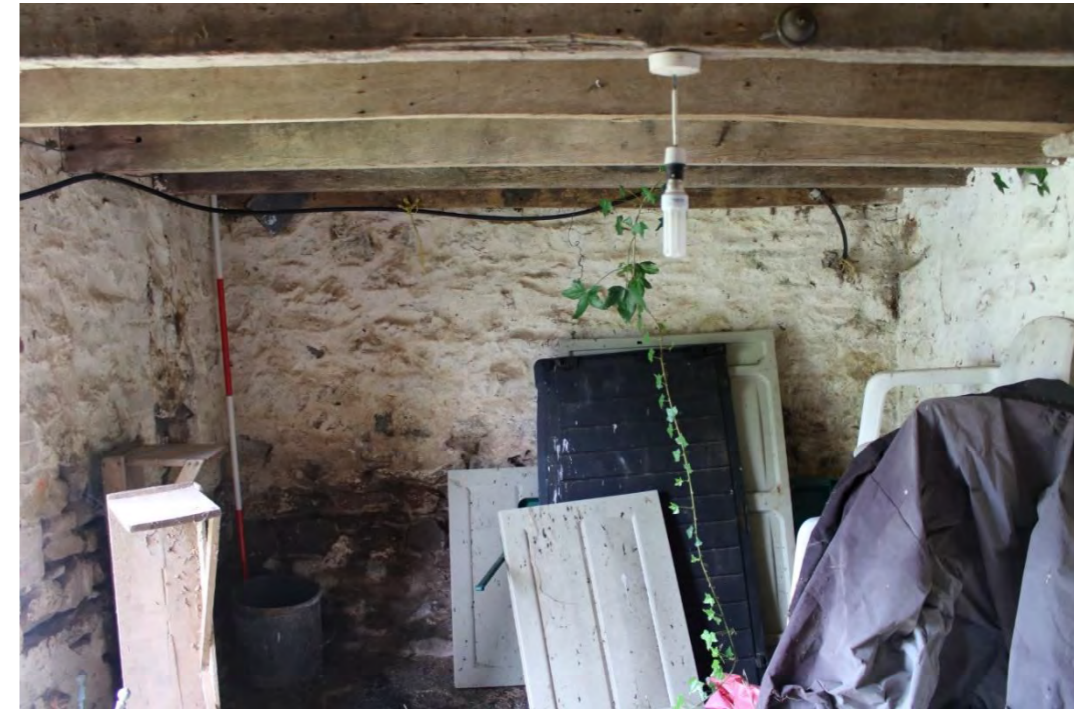
Photo 47: View of northern gable end wall at ground level in Building D
