Historic Building Record Level 2

Wood Farm,
Walwyn's Castle,
Pembrokeshire,
SA62 3DZ

May 2022 | Project Ref 07153C

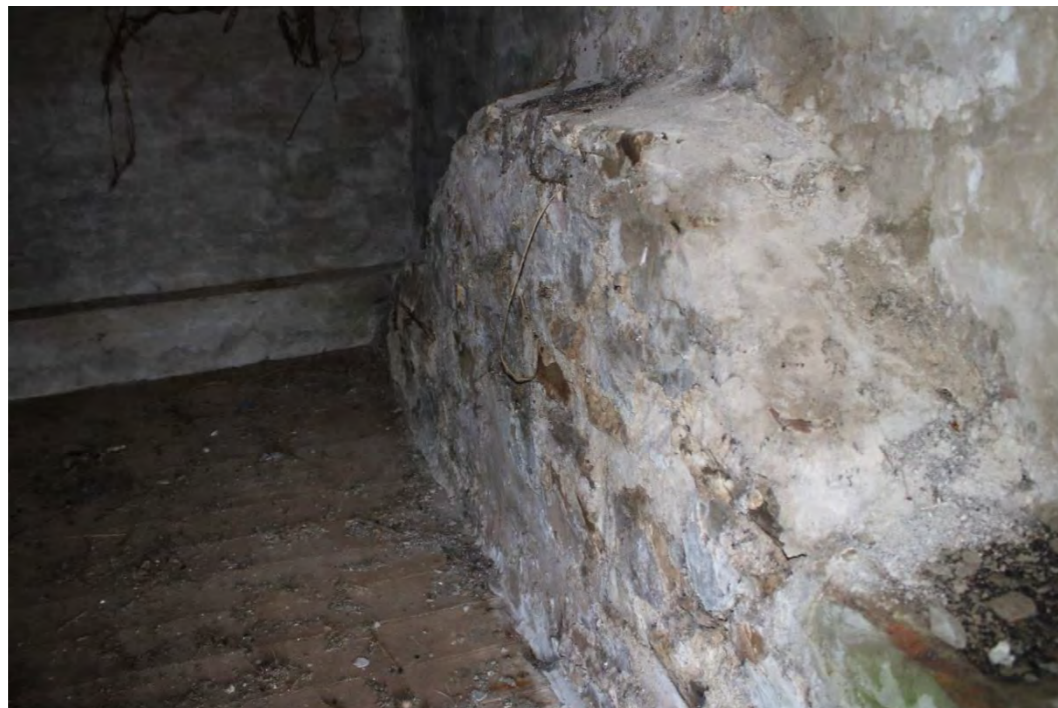
Photo 46: Top of original stone northern gable end wall, with brick heightening above

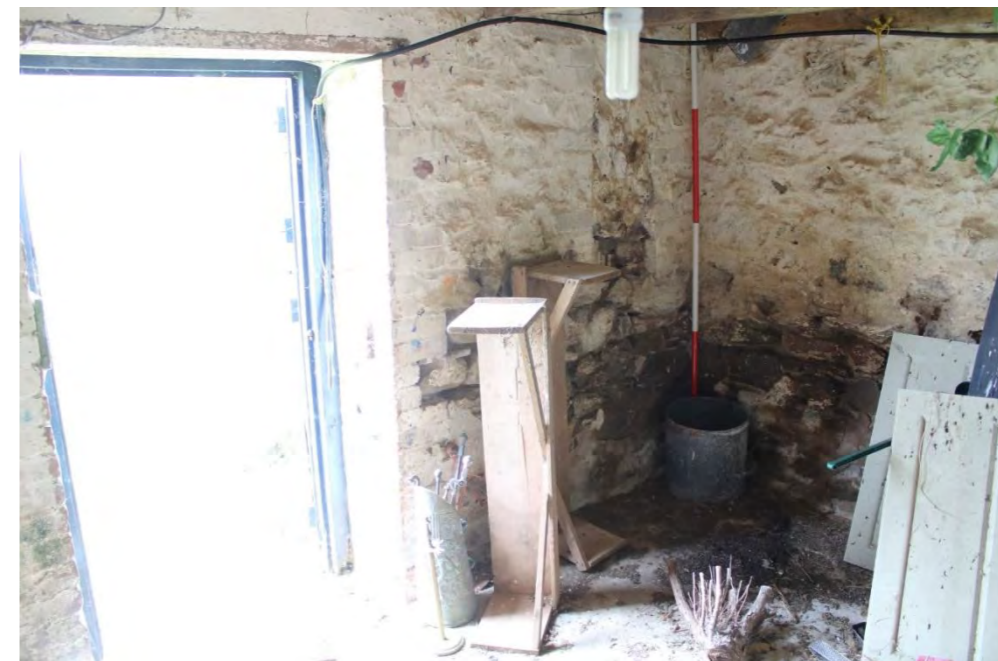
Photo 48: View of northwestern corner of ground floor of Building D, showing doorway to left and blocked window to right

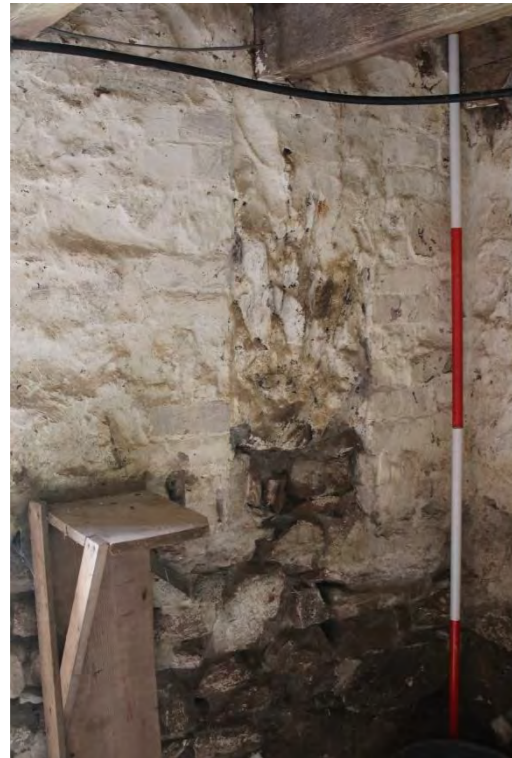
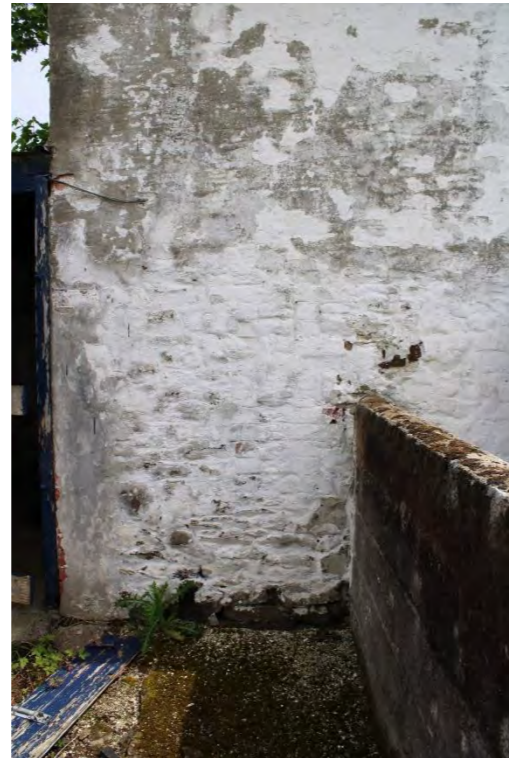
Photo 49 (left): Detail of blocked window in northern part of the interior western wall of Building D; Photo 50 (right): View of western façade of Building D where the northern blocked window is visible

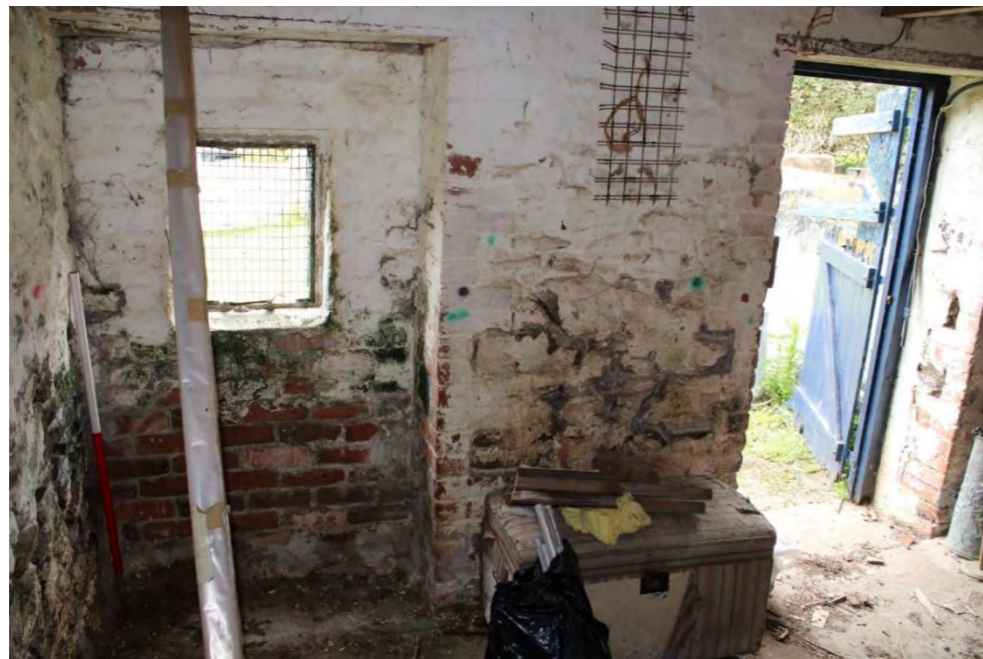
Photo 51: View of doorway and southern window in western interior wall at ground floor level within Building D, with brick blocked doorway to left

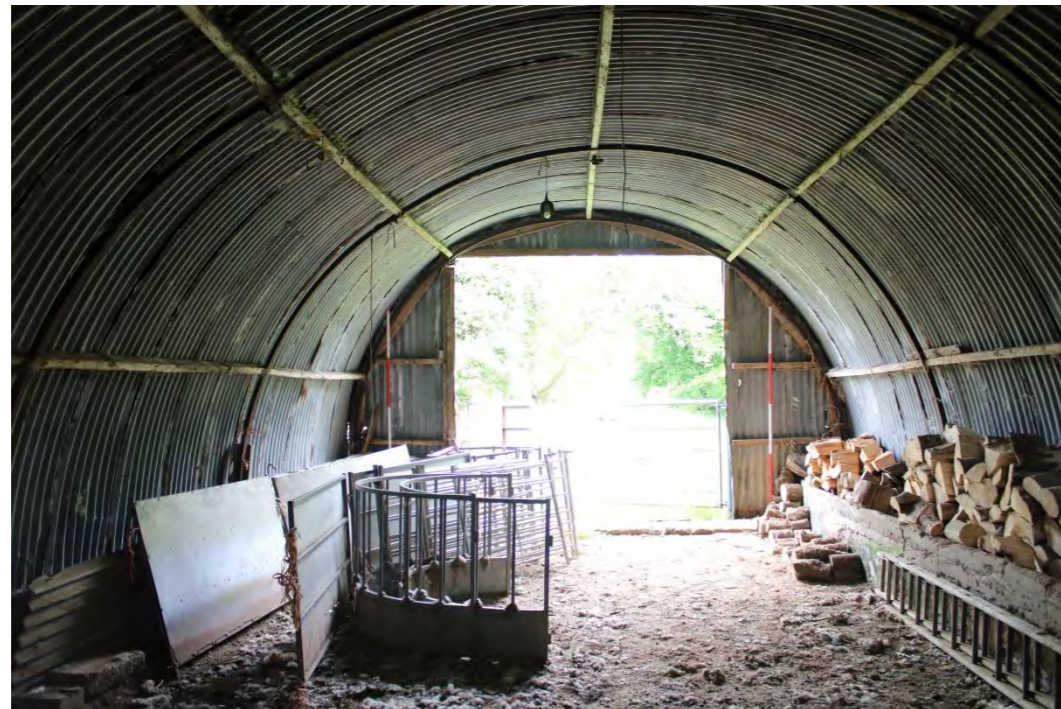
- 4.34 The structure had warped slightly and leant to the north.
- 4.35 It is most likely that the building is a reused Nissen Hut purchased after World War II for reuse as an agricultural building, a common occurrence across the UK. The building measured approximately 16ft x 36ft (5m x 11m) which was standard size for a Nissen hut, typically being either 16, 24 or 36ft in width and their length being based on multiples of 6ft to tie in with the gaps between the metal semi-circular frames used in their construction. Whether the panels stamped with Ruddington and the reference numbers are contemporary, or later replacement panels is uncertain, although the stencilled font used appears militaristic.

Photo 72: View east along Building F towards eastern end

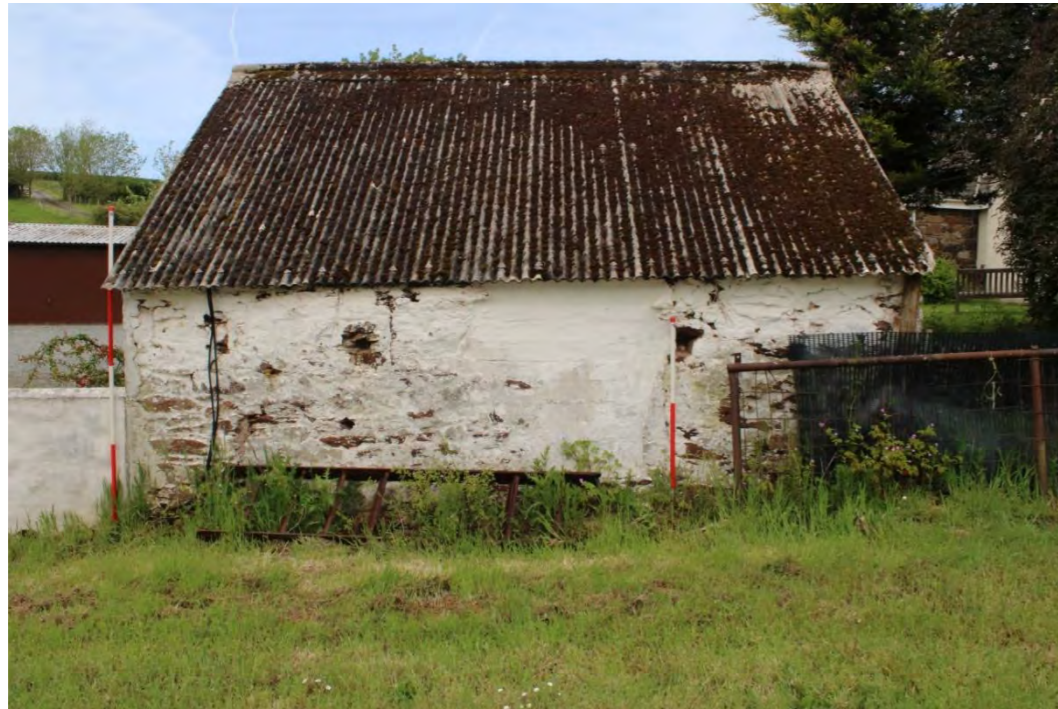
- 4.40 The second window was on the northern end of the eastern wall and measured 0.70m in height and 0.70m in width. It was also blocked with breeze block. This had a very large stone lintel above which could be seen through the render. The bottom of this window was 0.76m above floor level. The opening for the eastern window was partly visible, but seemed more extensive than the interior indicated.

Photo 77: Eastern elevation of Building G from within main farm courtyard with blocked window to left of right hand scale bar

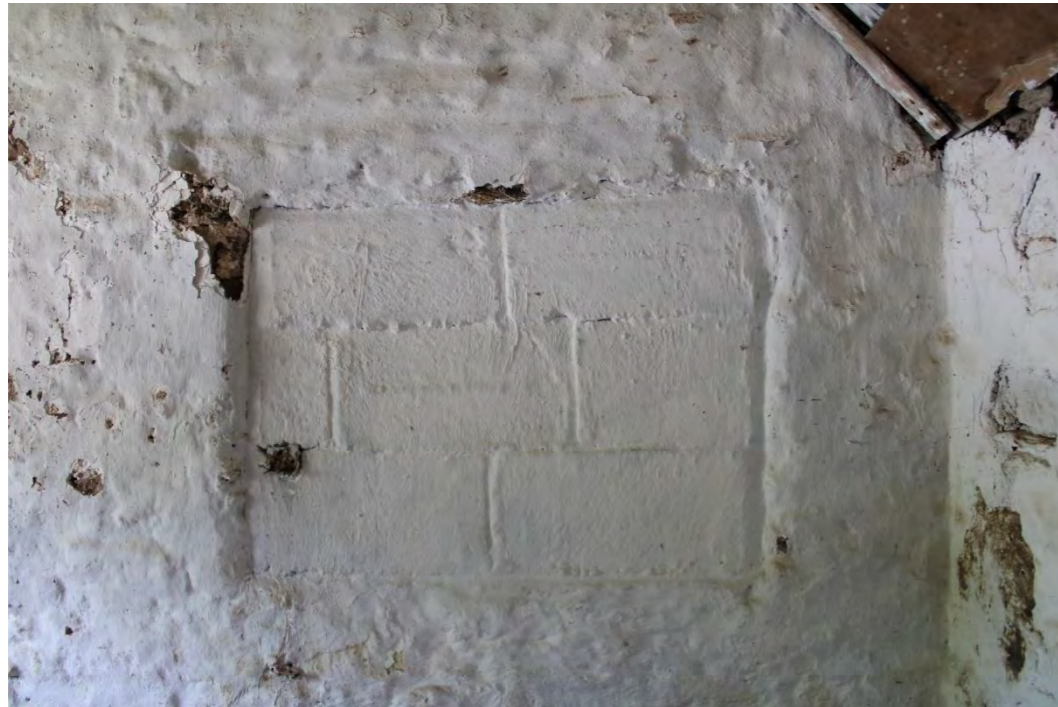
Photo 85: Detail of blocked window in northern gable end wall of Building G

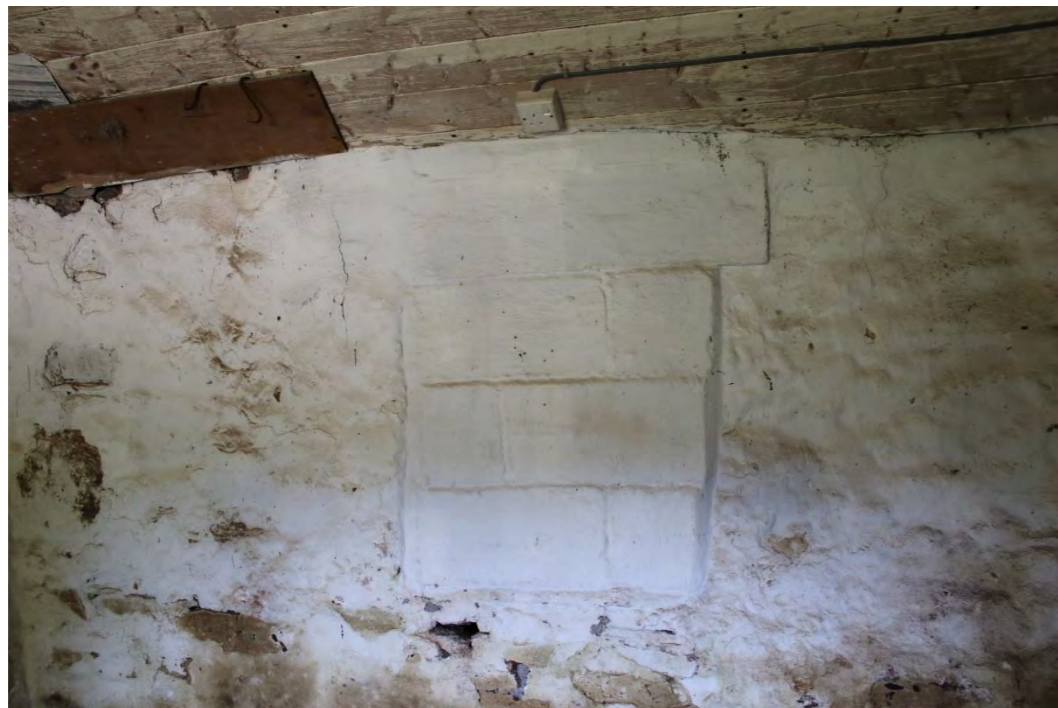
Photo 86: Interior view showing detail of blocked window in eastern wall of Building G

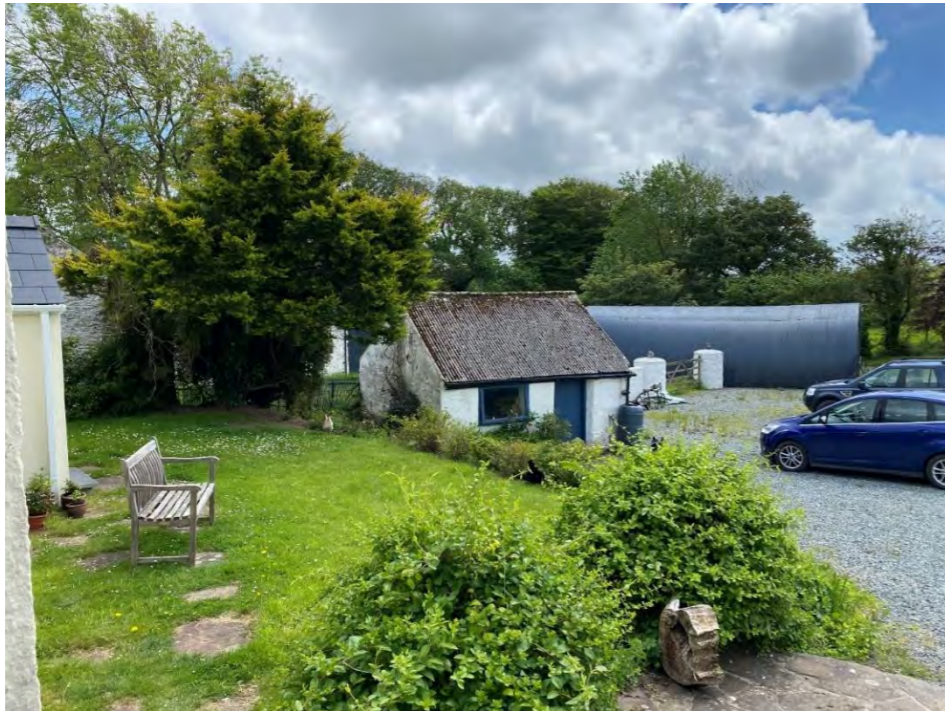
Photo 89: View south-southeast from farmhouse towards courtyard Buildings G and F

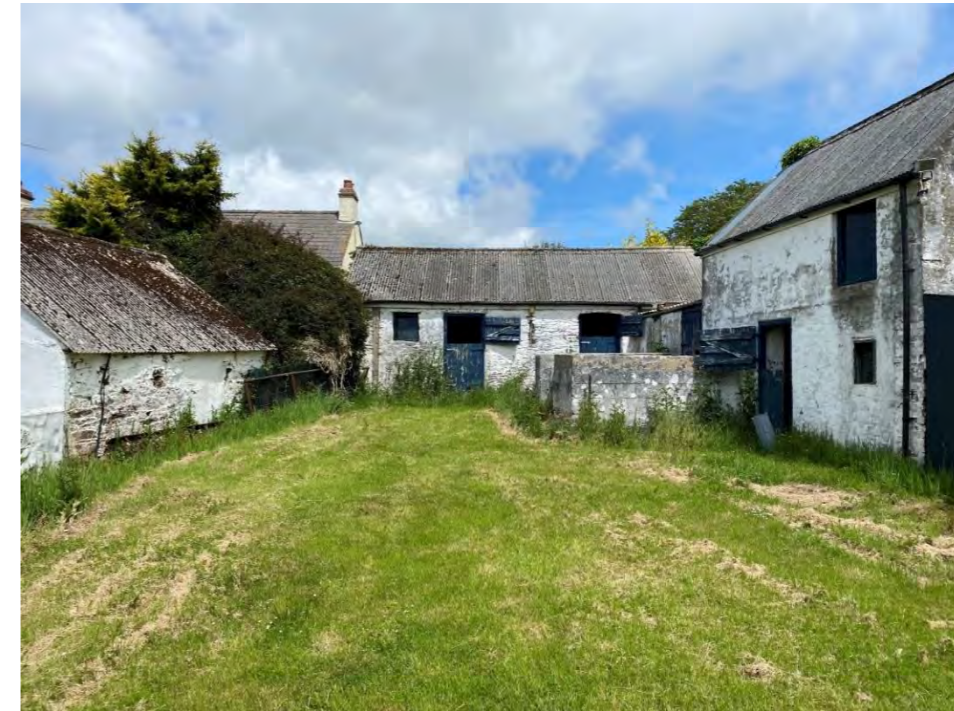
Photo 91: View north inside courtyard with Building G to left, Building B centre and Building D to right

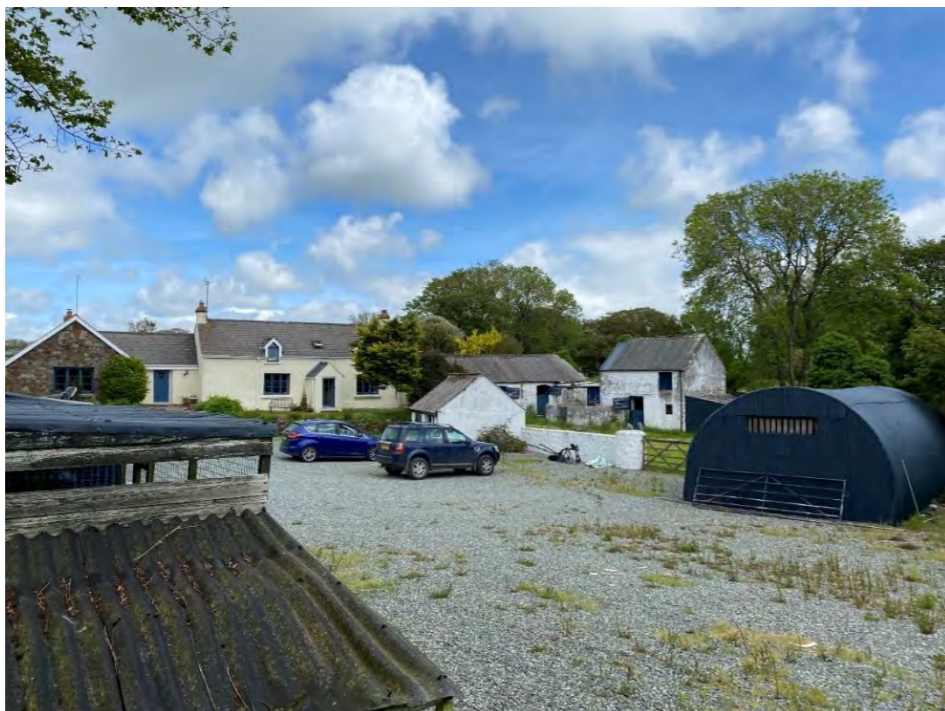
Photo 90: View northeast through farmyard towards farmhouse (Building A, left) and courtyard Buildings B – G (right)

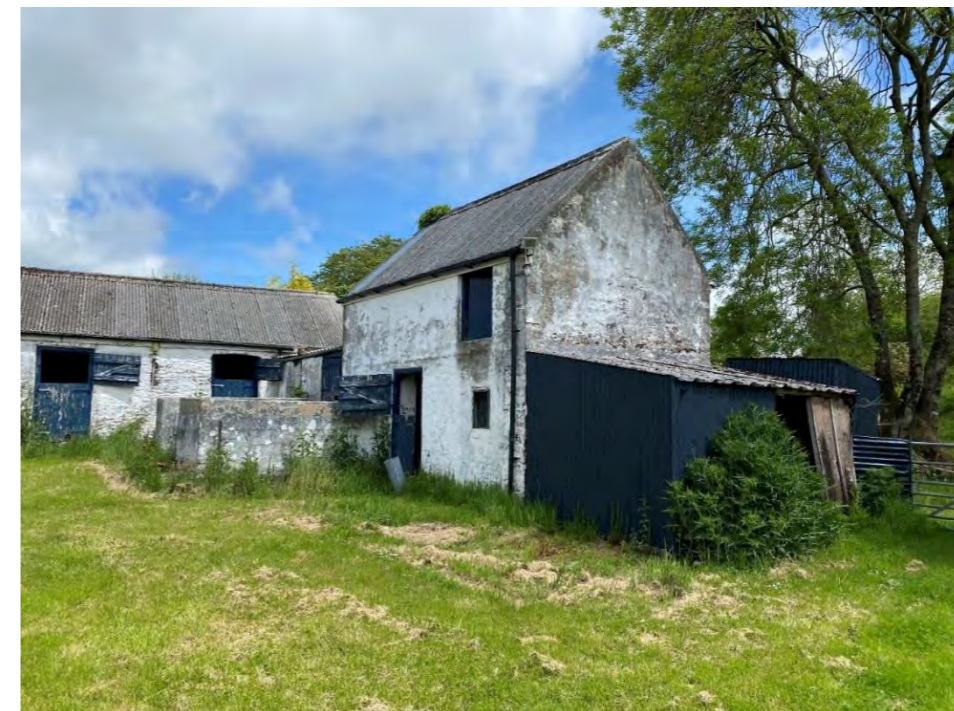
Photo 92: View northeast inside courtyard with Building B to left and Building C linking it to Building D, with Building E lean-to extension to right

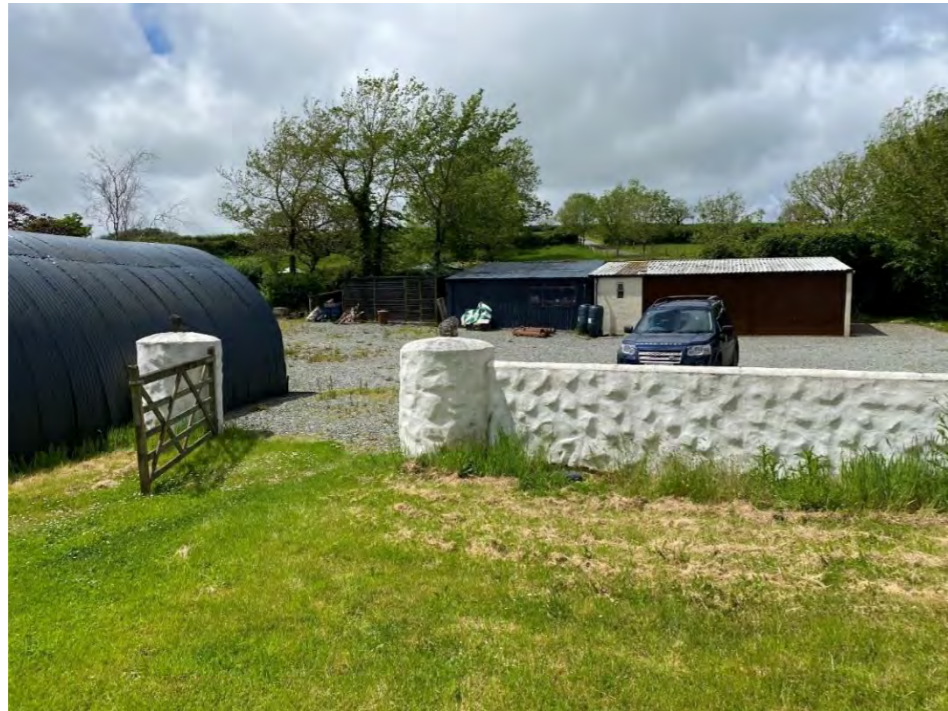
Photo 93: View west from inside courtyard to western gate with Half-round to left (Building F) and Building H beyond

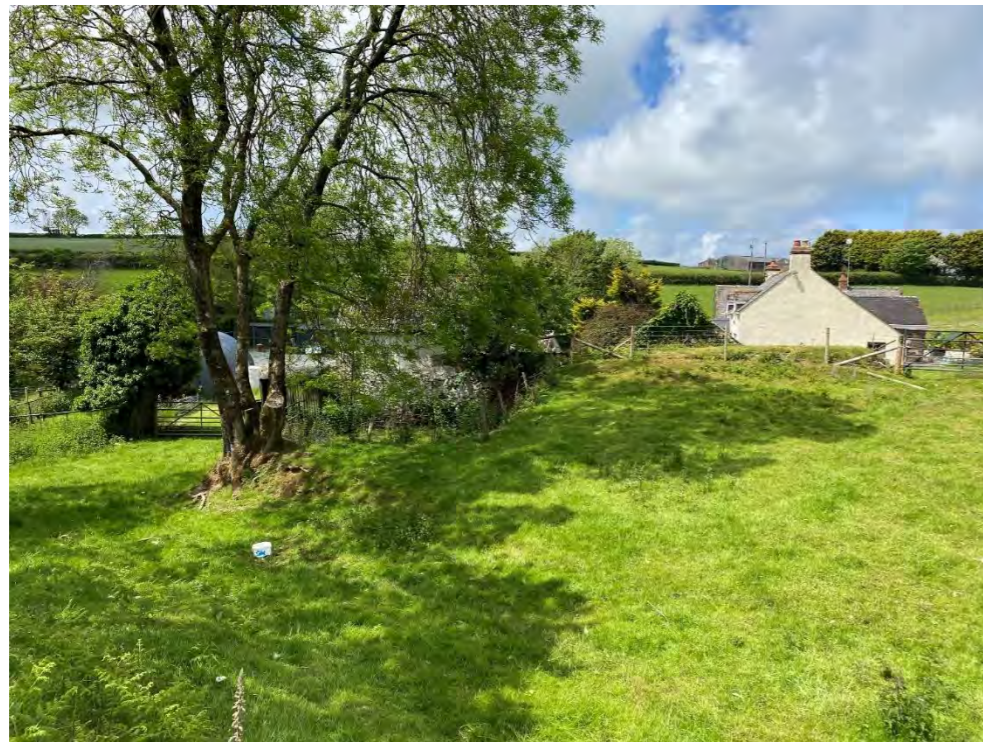
Photo 94: View west from eastern side of courtyard showing farmhouse, Building A to right and Building D behind tree
